FINAL SWMU CLASSIFICATION REPORT SENECA ARMY DEPOT ACTIVITY

**SOLID WASTE MANAGEMENT
CLASSIFICATION STUDY
SENECA ARMY DEPOT
ROMULUS, NEW YORK**

**Seneca Army Depot Activity
Romulus, New York**

**Engineering-Science, Inc.
Prudential Center
Boston, Massachusetts**

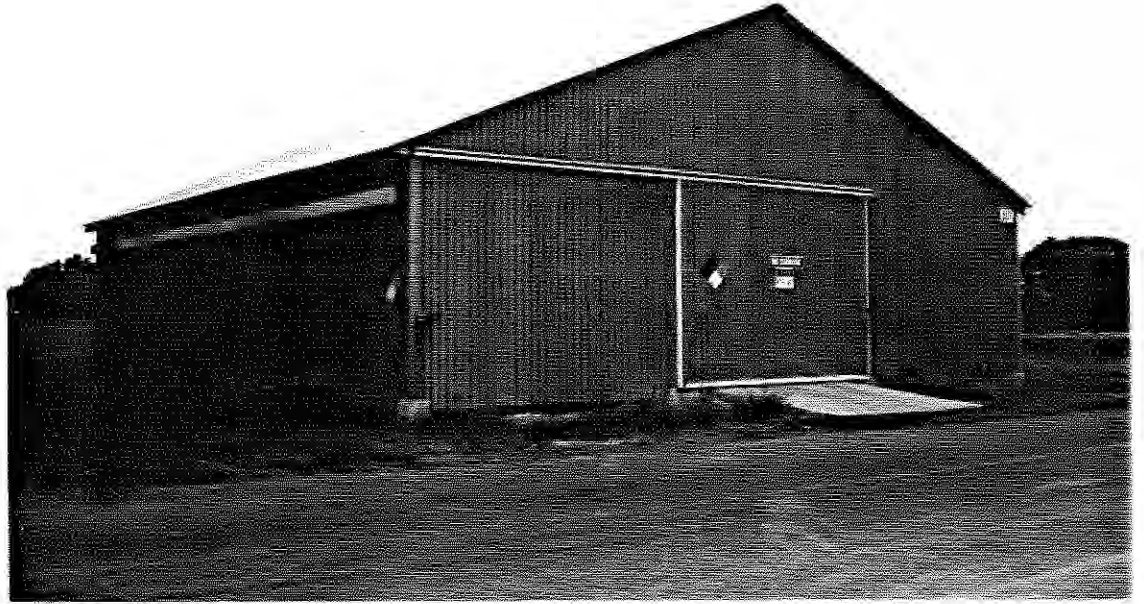
Photo 1: SEAD-1, 9/14/90. View of the Hazardous Waste Container Storage Facility - Building 307, facing northeast.

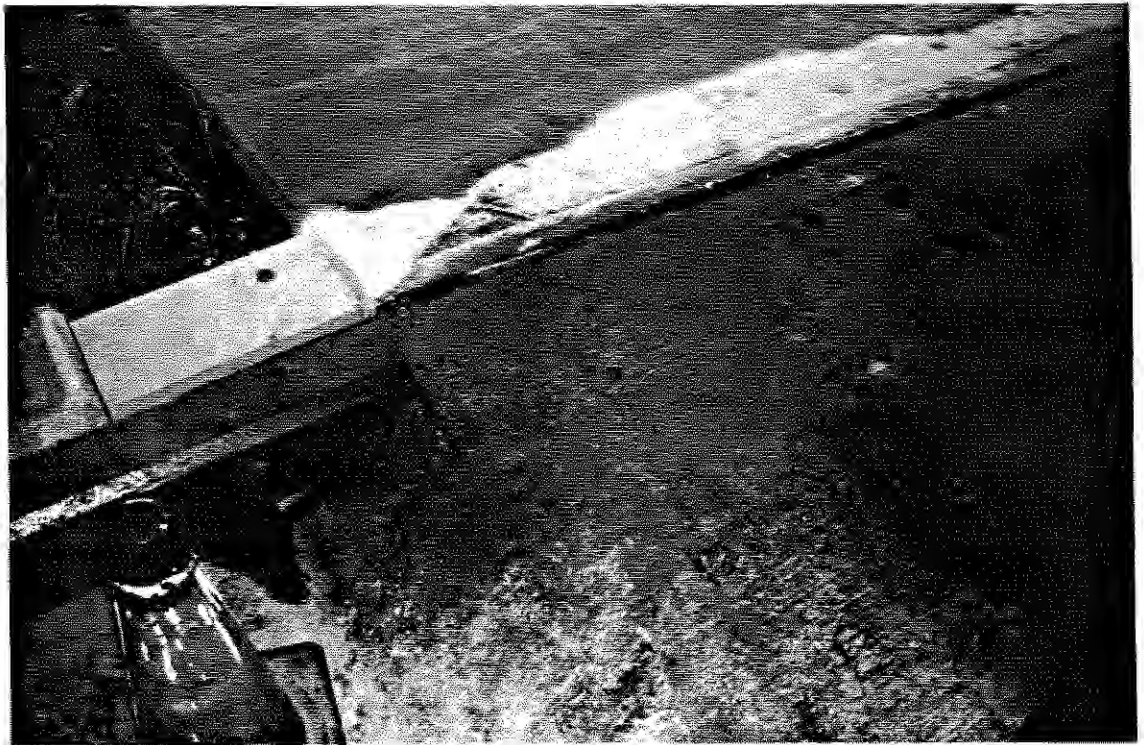
Photo 2: SEAD-1, 11/27/90. View of the monolithic concrete slab floor and 6-inch curb - Building 307, facing south.

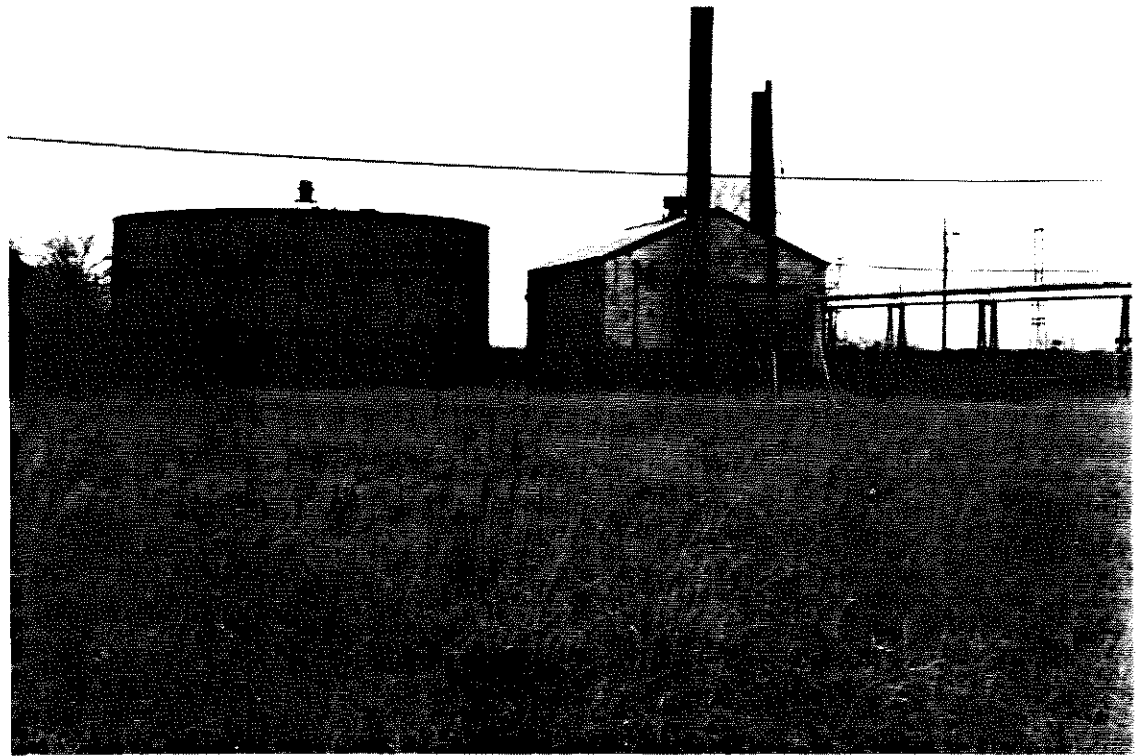
Photo 8: SEAD-4, 11/29/90. View of the Munitions Washout Facility Leach Field, facing northeast.

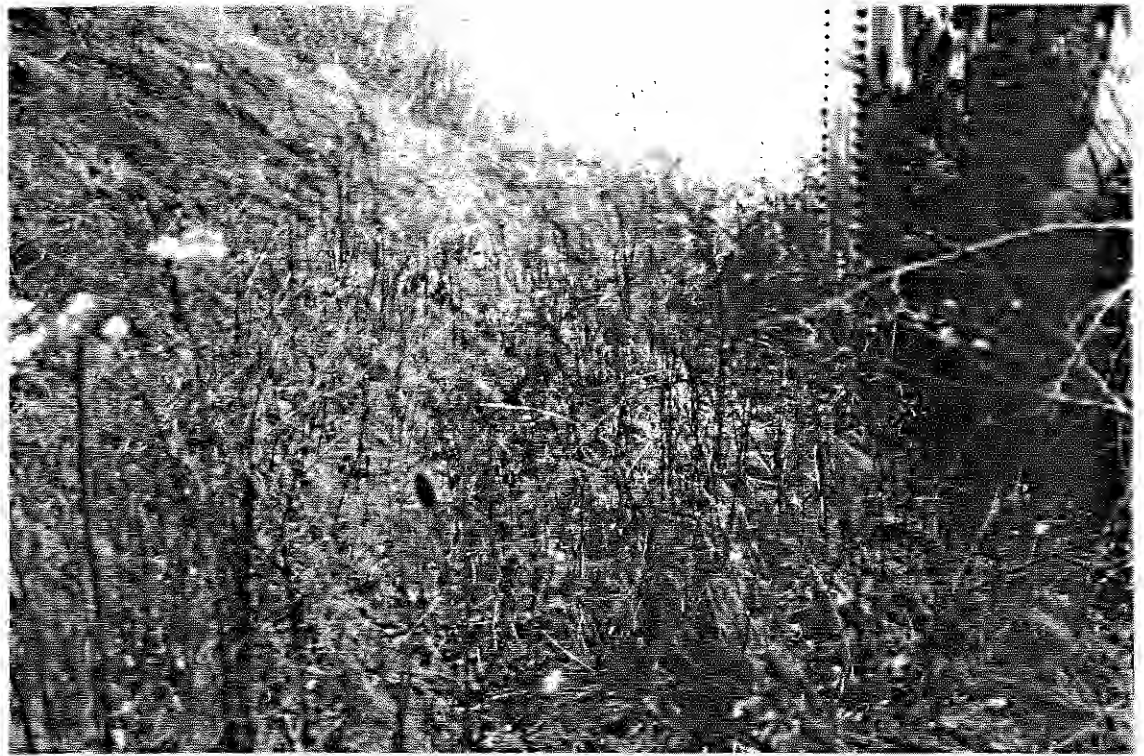
Photo 10: SEAD-4, 11/29/90. View of the drainage ditch at the Munitions Washout Facility Leach Field, facing northwest.

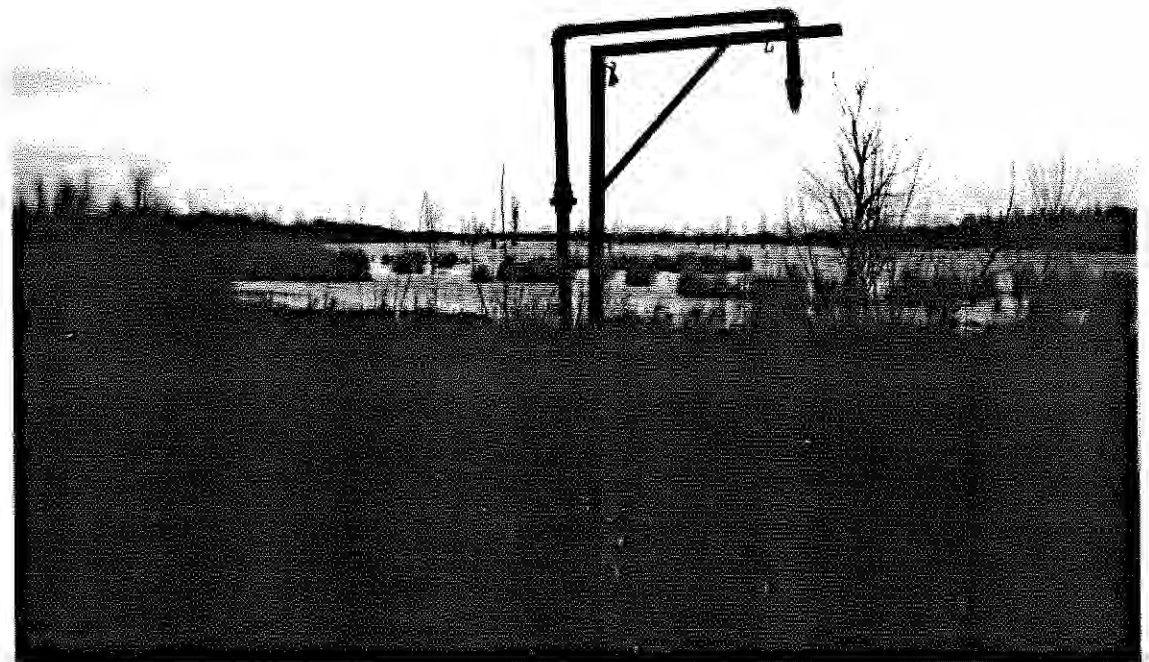
Photo 36: SEAD-13, 11/27/90. View of the aboveground piping observed on the southwest side of the Duck Ponds, facing north. The piping may be the deluge shower referred to in the 1960 IRFNA Disposal Report. Similar piping was observed on the southeast side of the Duck Ponds.

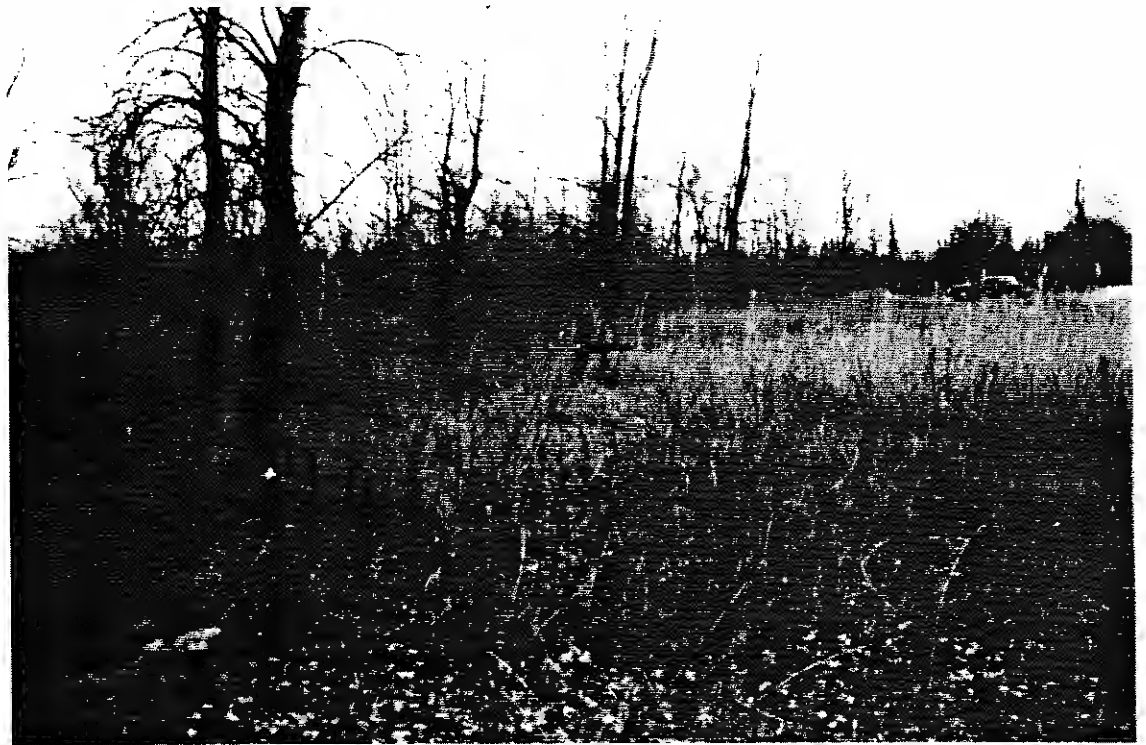
Photo 37: SEAD-13, 11/27/90. View of the aboveground piping observed in the general area of the IRFNA Disposal Site, facing north towards East-West Base Line Road, on the east side of the Duck Ponds.

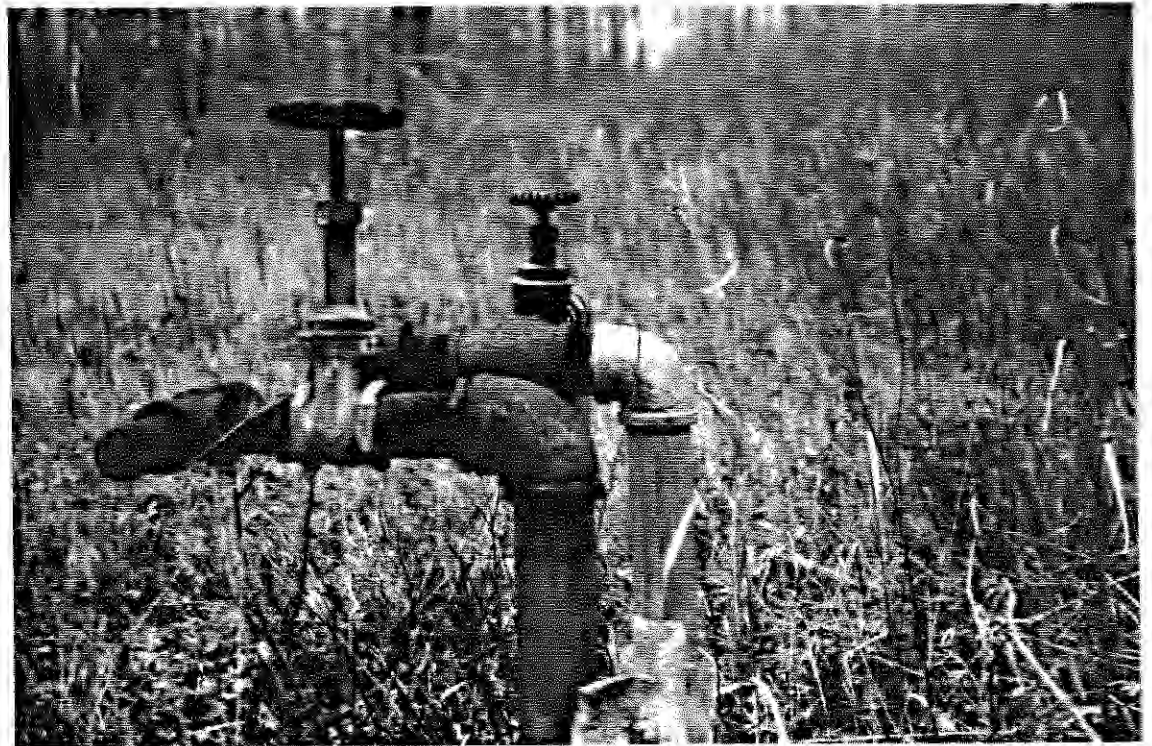
Photo 38: SEAD-13, 11/27/90. Close-up of the aboveground piping shown in Photograph 37, facing south

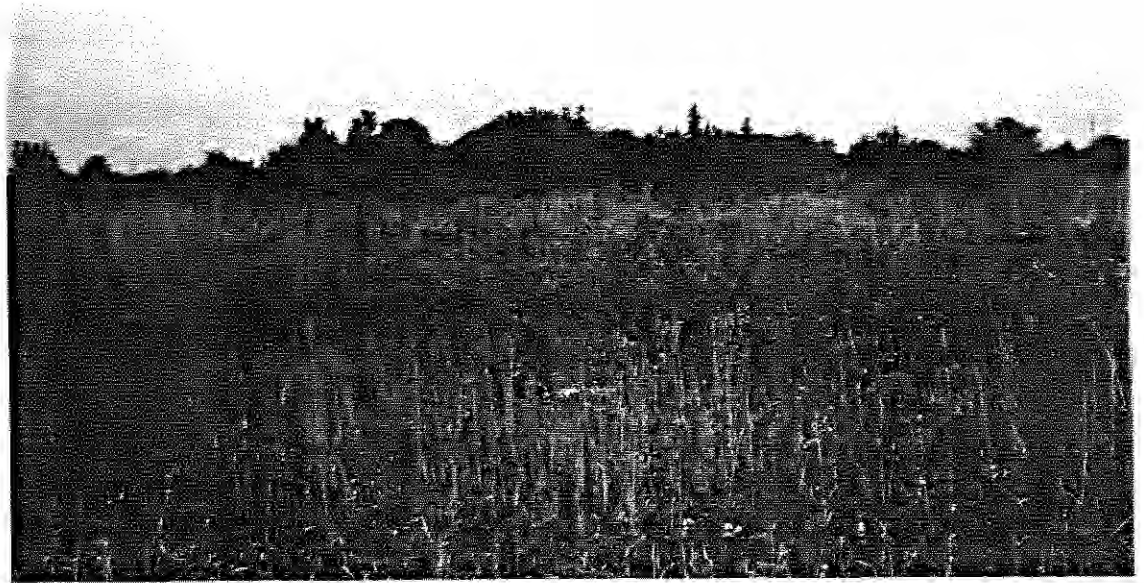
This SWMU is classified as a High Priority Area of Concern. It is part of the Ash Landfill Operable Unit that is currently being investigated under the CERCLA RI/FS process.

Photo 39: SEAD-14, 9/14/90. View of the Refuse Burning Pits, facing northeast; the orange flagging shows the approximate location of the pits.

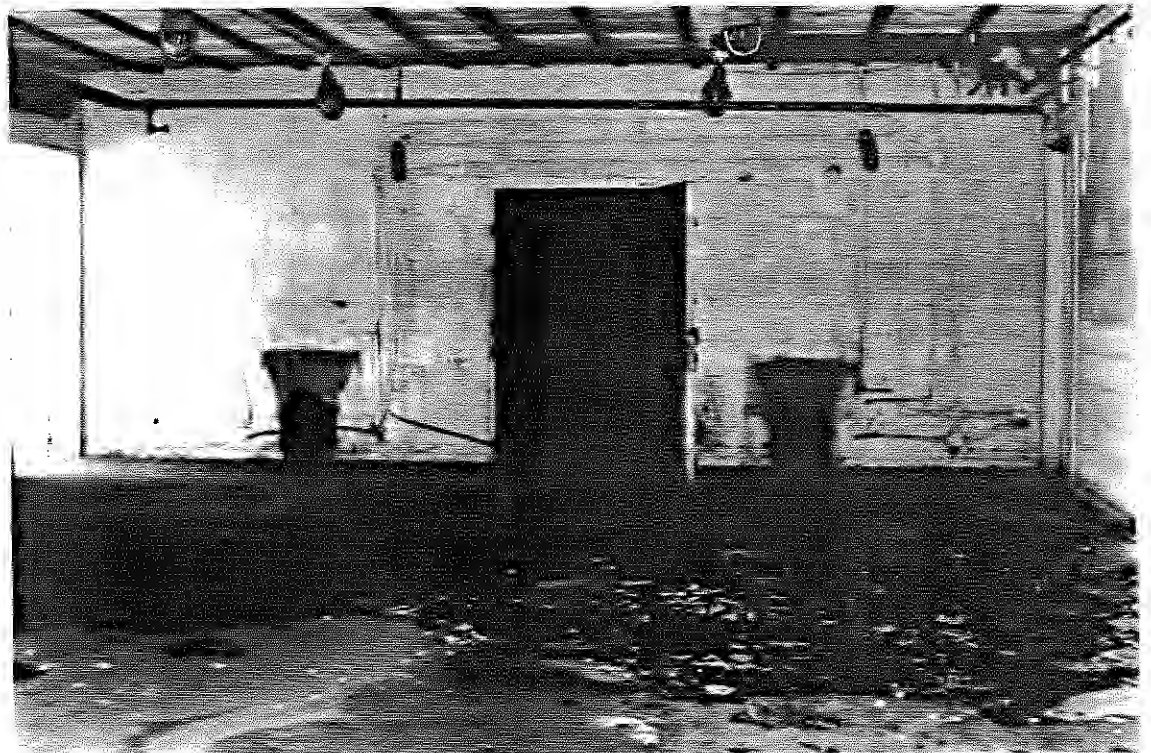
Photo 45: SEAD-16, 9/13/90. Interior of the Abandoned Deactivation Furnace - Building S-311, the doorway on the south wall is the entrance to the furnace room.

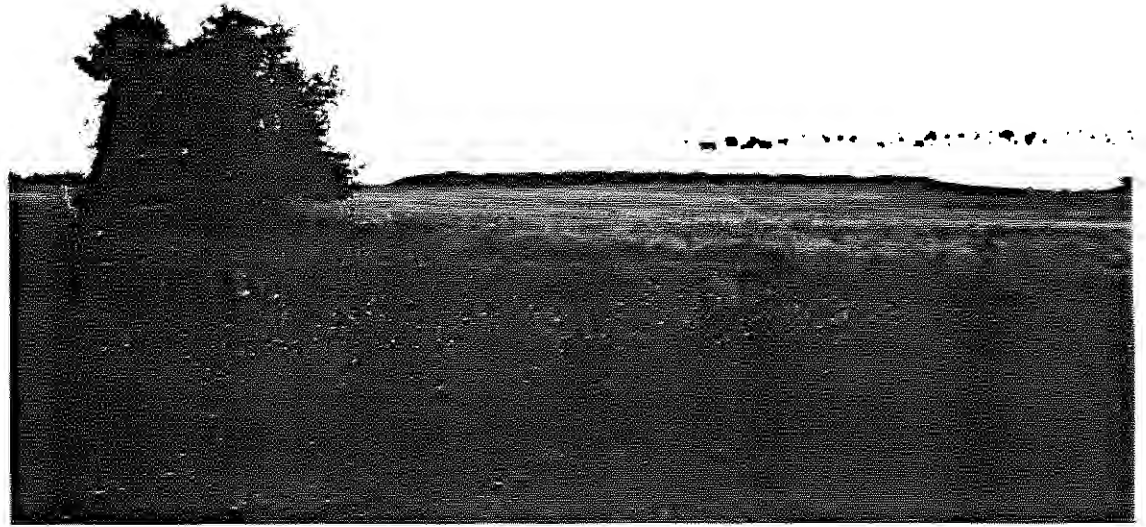
Photo 66: SEAD-23, 9/11/90. View of the one of the nine burning pads - Open Burning Ground, facing southeast.

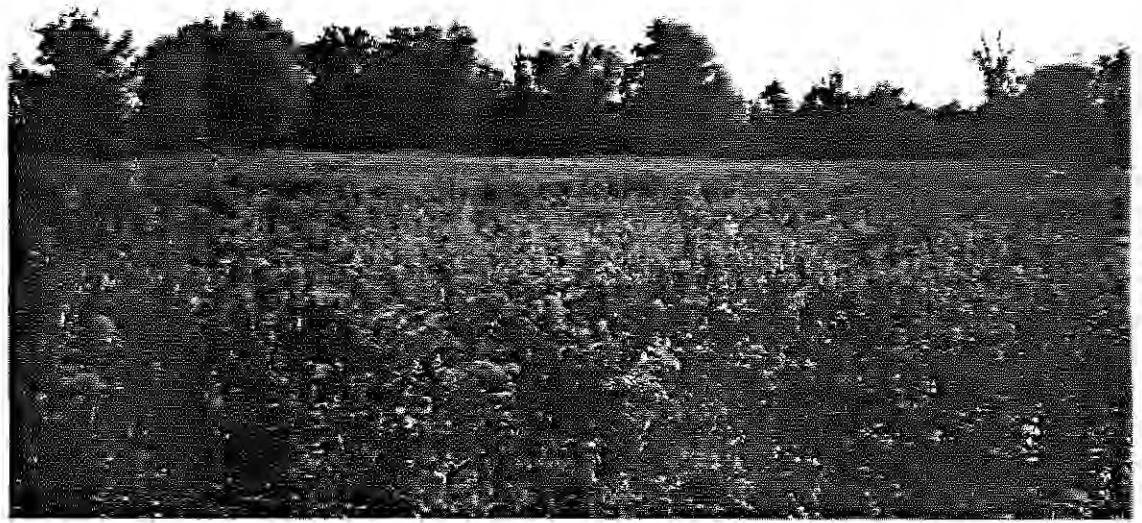
Photo 69: SEAD-24, 9/10/90. View of the Abandoned Power Burning Pit, facing south.

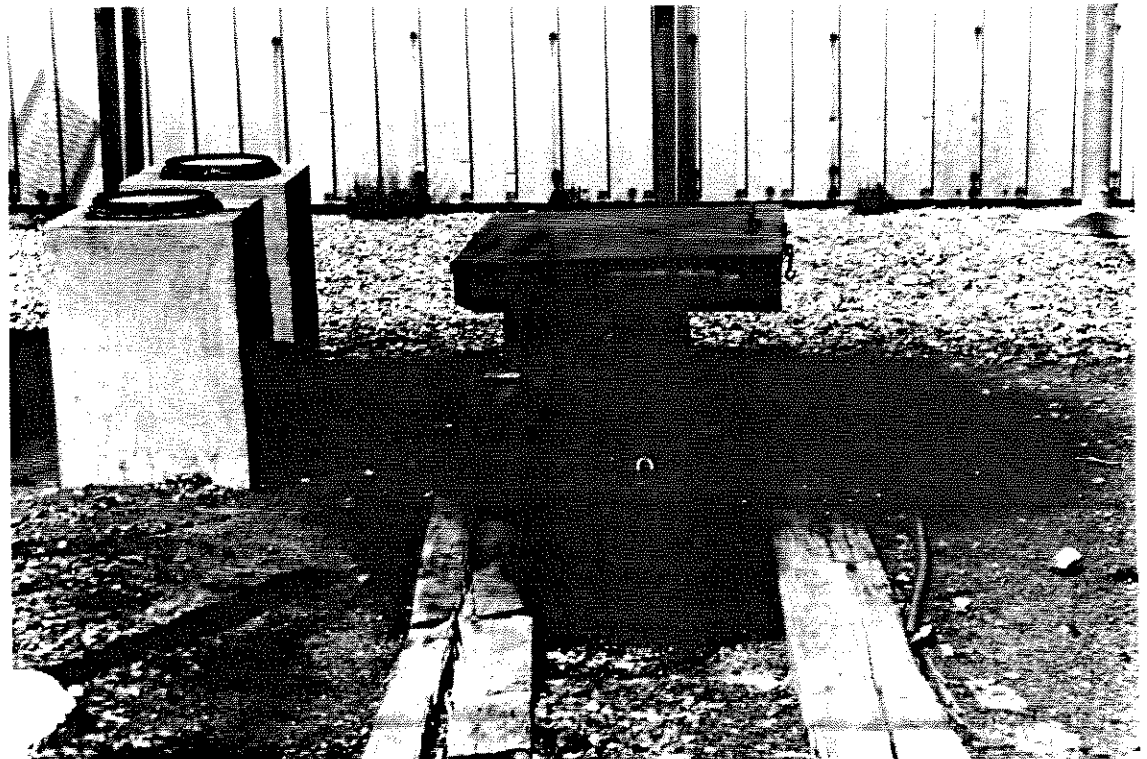
Photo 86: SEAD-28, 9/12/90. Close-up of the right Underground Waste Oil Tank, facing northeast.

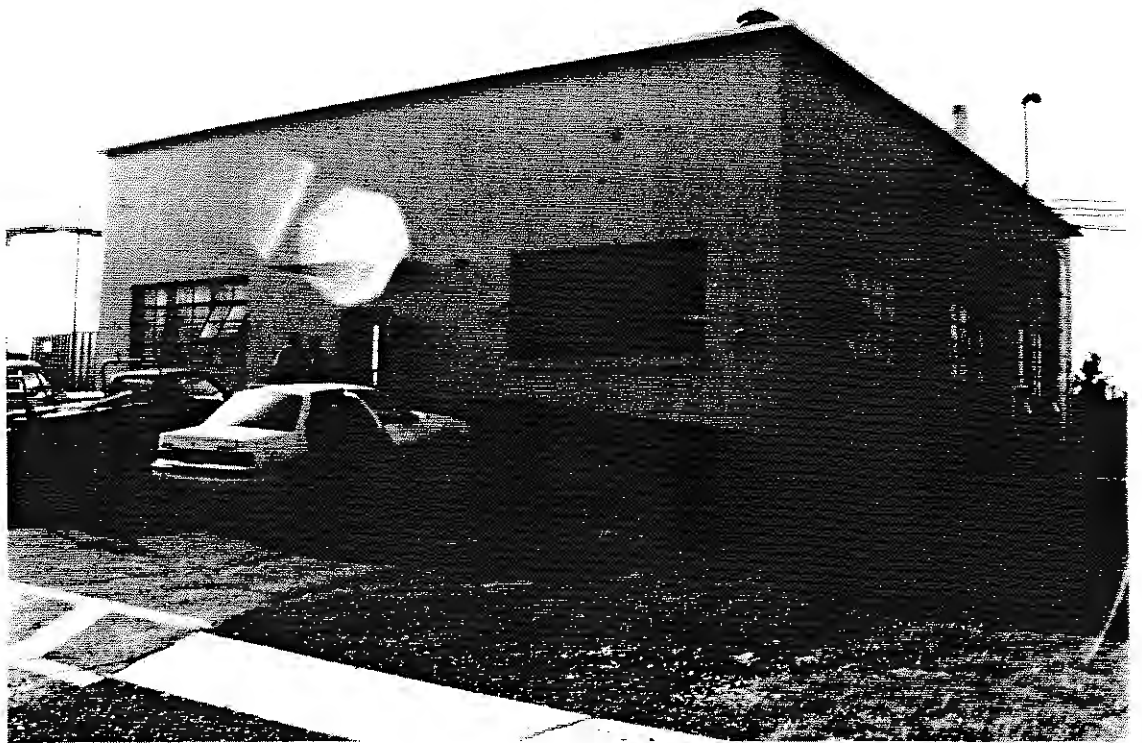
Photo 97: SEAD-35 and SEAD-41, 9/13/90. View of Building 718 where three Waste Oil - Burning Boilers are located, facing south; the Boiler Blowdown Leach Pit (SEAD-41) is located in the vicinity of the building.

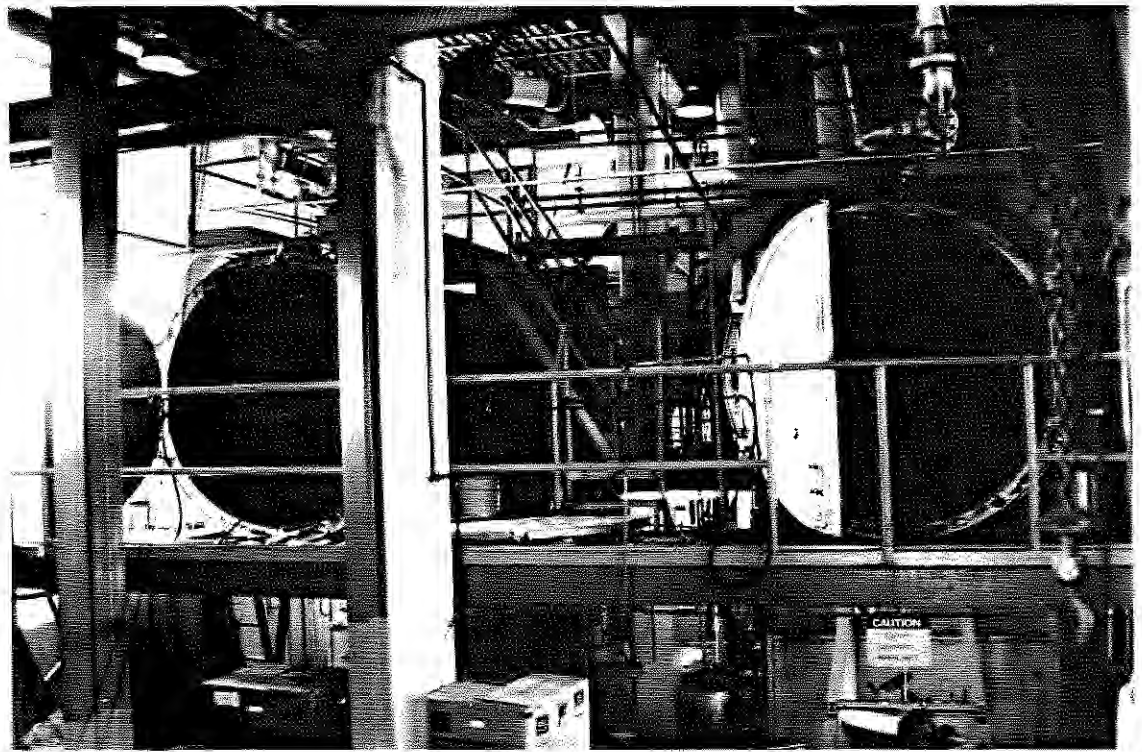
Photo 98: SEAD-35, 9/13/90. View of the most easterly and central boilers of the three Waste Oil - Burning Boilers - Building 718, facing south.

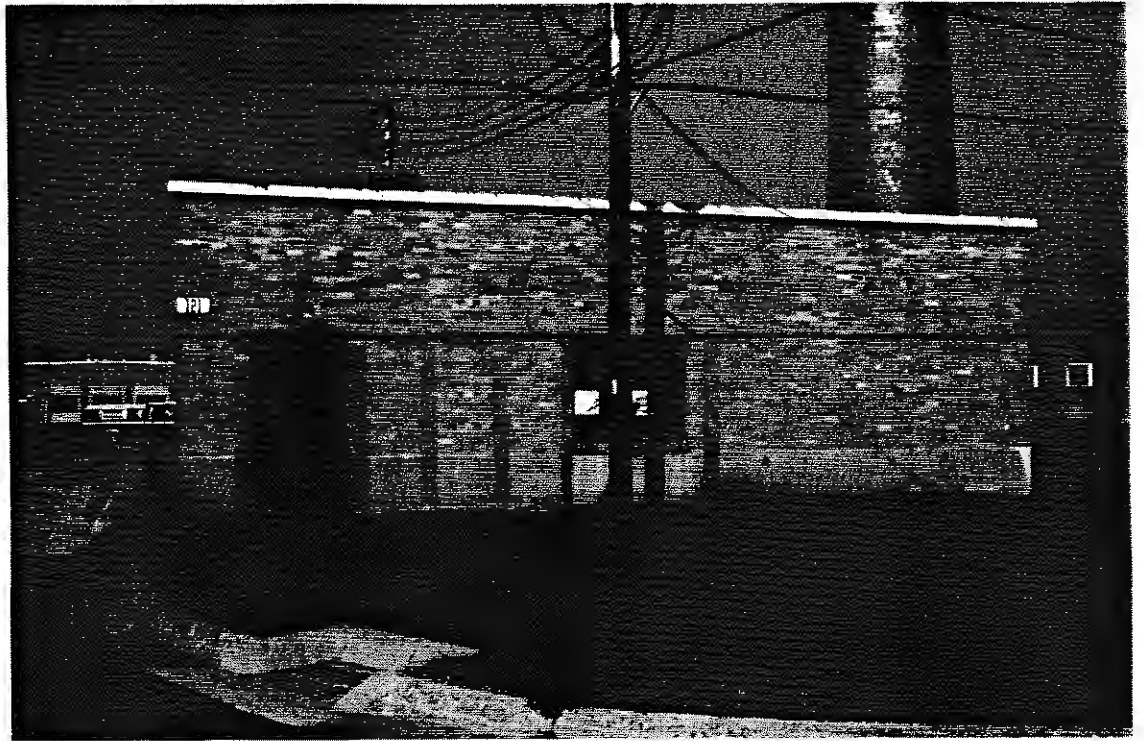
Photo 100: SEAD-36 and SEAD-39, 9/12/90. View of Building 121, where three Waste Oil - Burning Boilers are located, facing west; the Boiler Blowdown Leach Pit (SEAD-39) is located in the vicinity of the building.

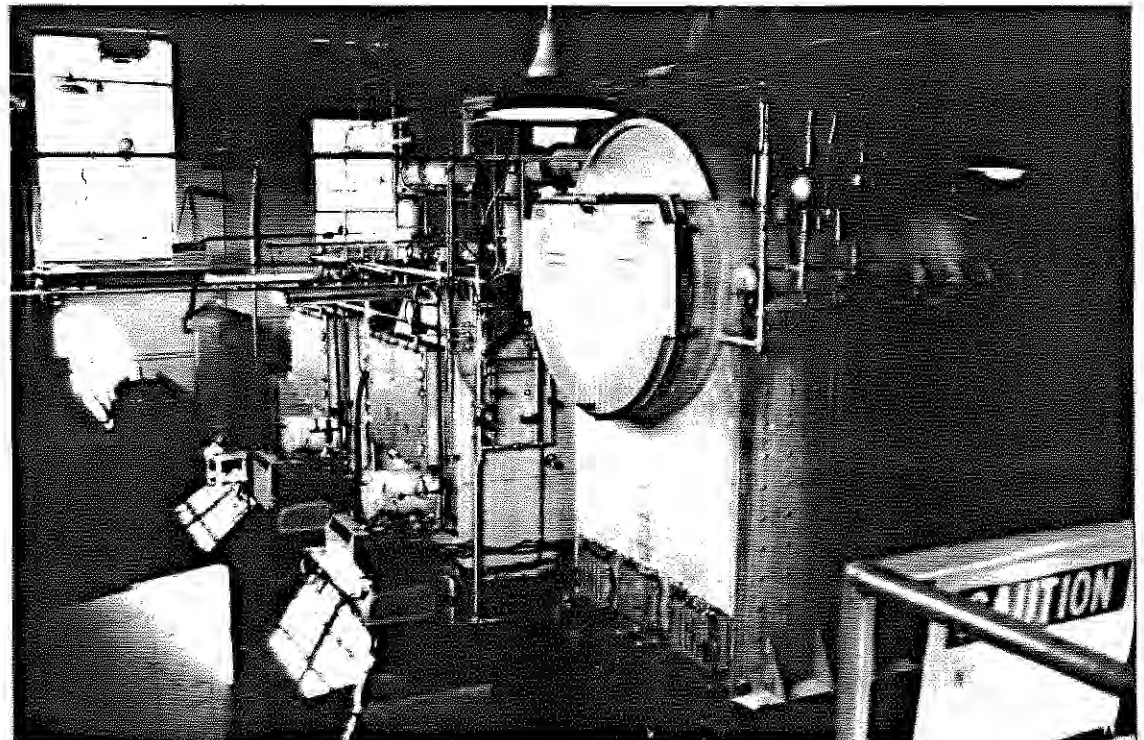
Photo 101: SEAD-36, 9/12/90. View of two Waste Oil - Burning Boilers - Building 121, facing northwest. The largest boiler is a coal fired unit that never burned waste oil

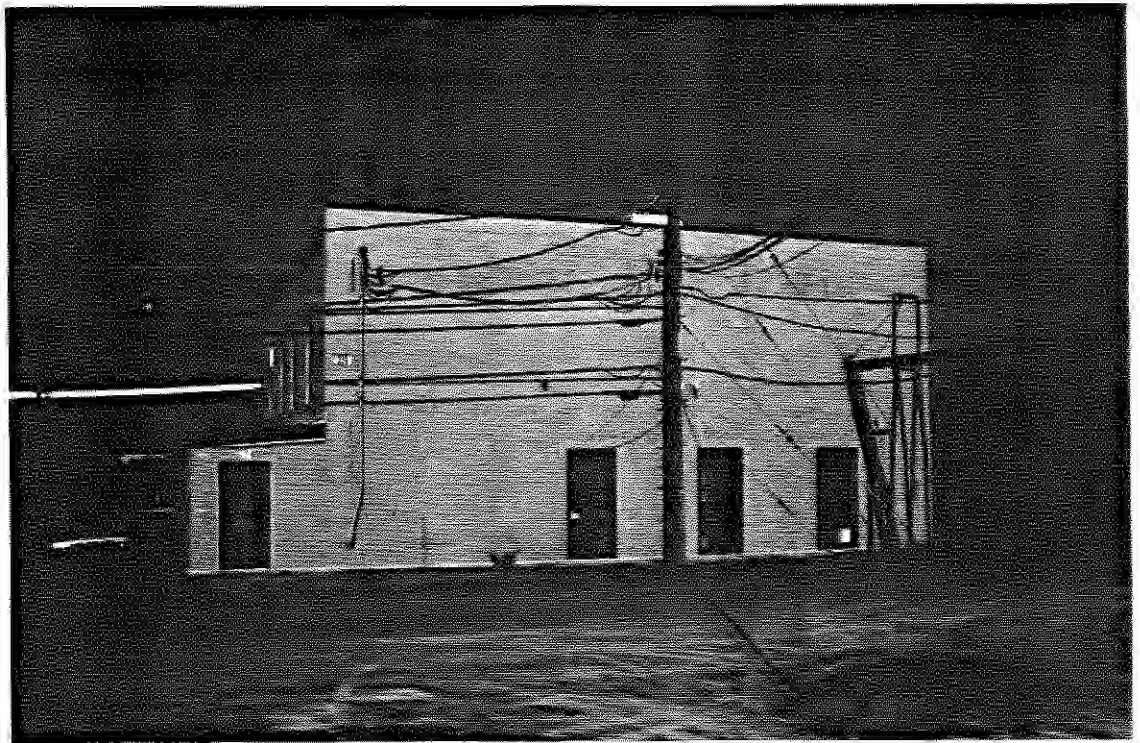
Photo 102: SEAD-37 and SEAD-40, 9/12/90. View of Building 319, where two Waste Oil - Burning Boilers are located, facing northeast; the Boiler Blowdown Leach Pit (SEAD-40) is located in the vicinity of the building.

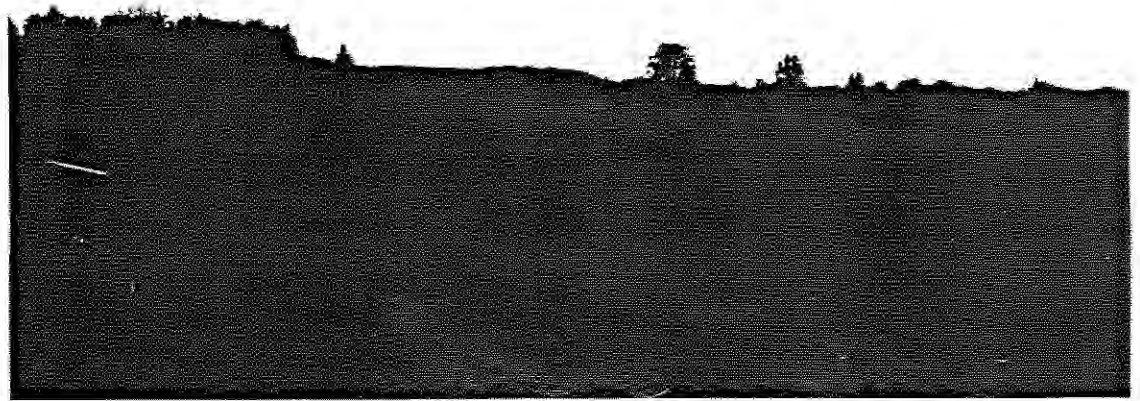
This SWMU is classified as a High Priority Area of Concern. It is currently being investigated under the CERCLA 10 SWMU SI program.

Photo 114: SEAD-45, 9/11/90. View of the detonation grounds - Open Burning Ground, facing northwest.

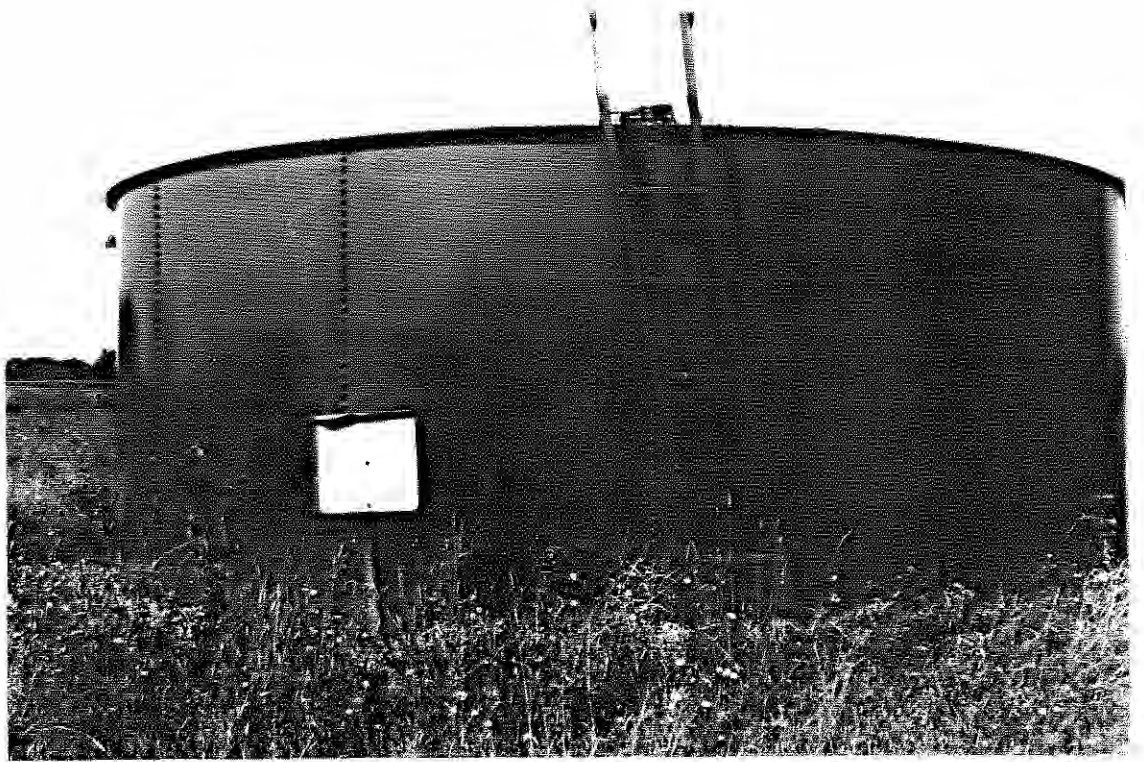
Photo 121: SEAD-50, 9/12/90. View of the Sulfide Ore Tank (Tank No. 8) located at the Tank Farm, facing north.

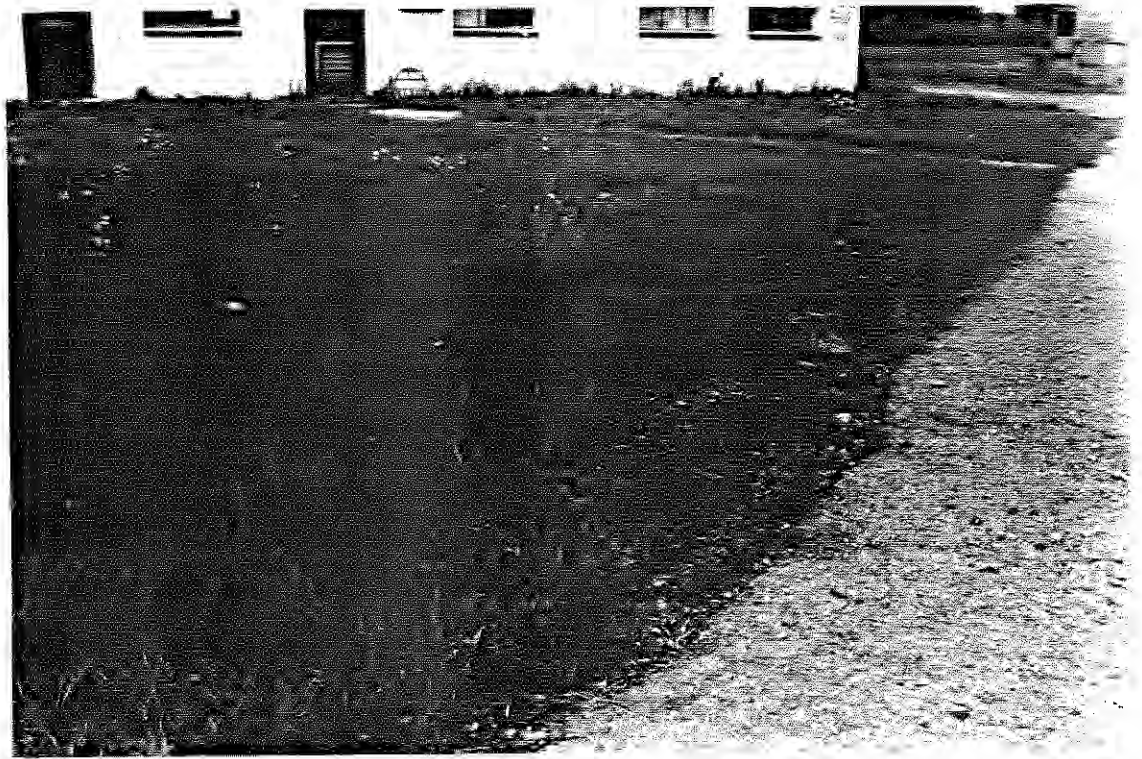
Photo 131: SEAD-56, 9/12/90. Stressed vegetation located close to the Herbicide and Pesticide Storage Area - Building 606, facing north.

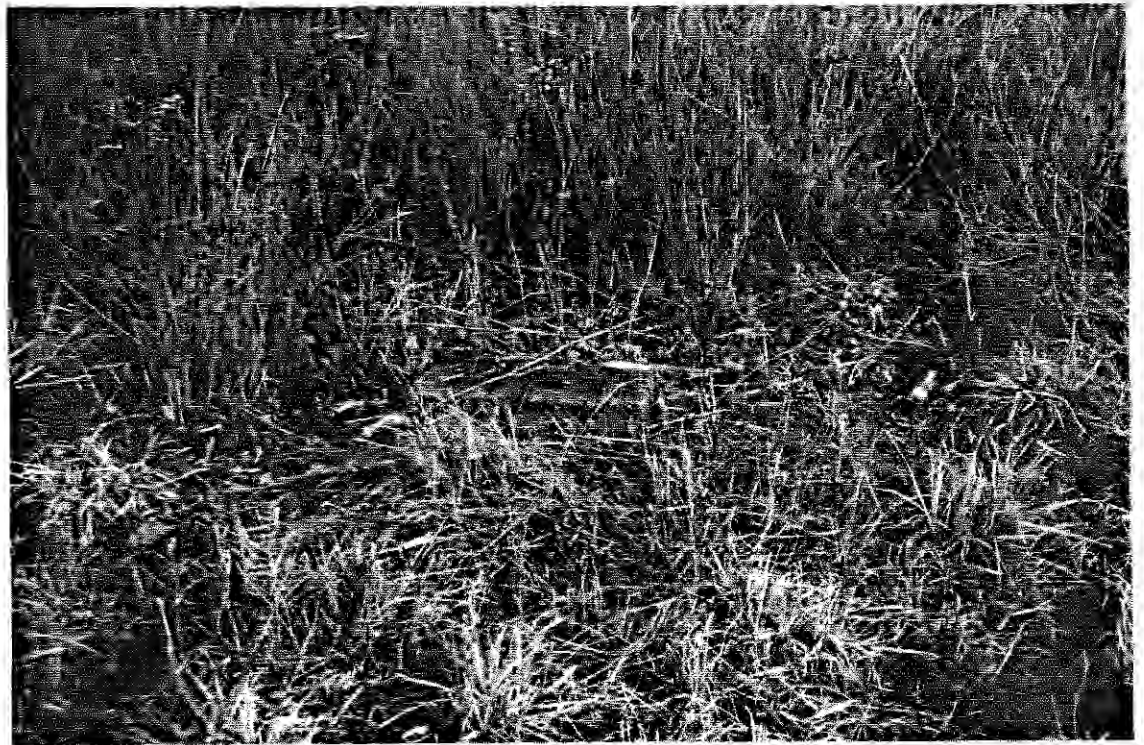
Photo 167: SEAD-65, 11/29/90. View of concrete foundation, Location A, Acid Storage Area.

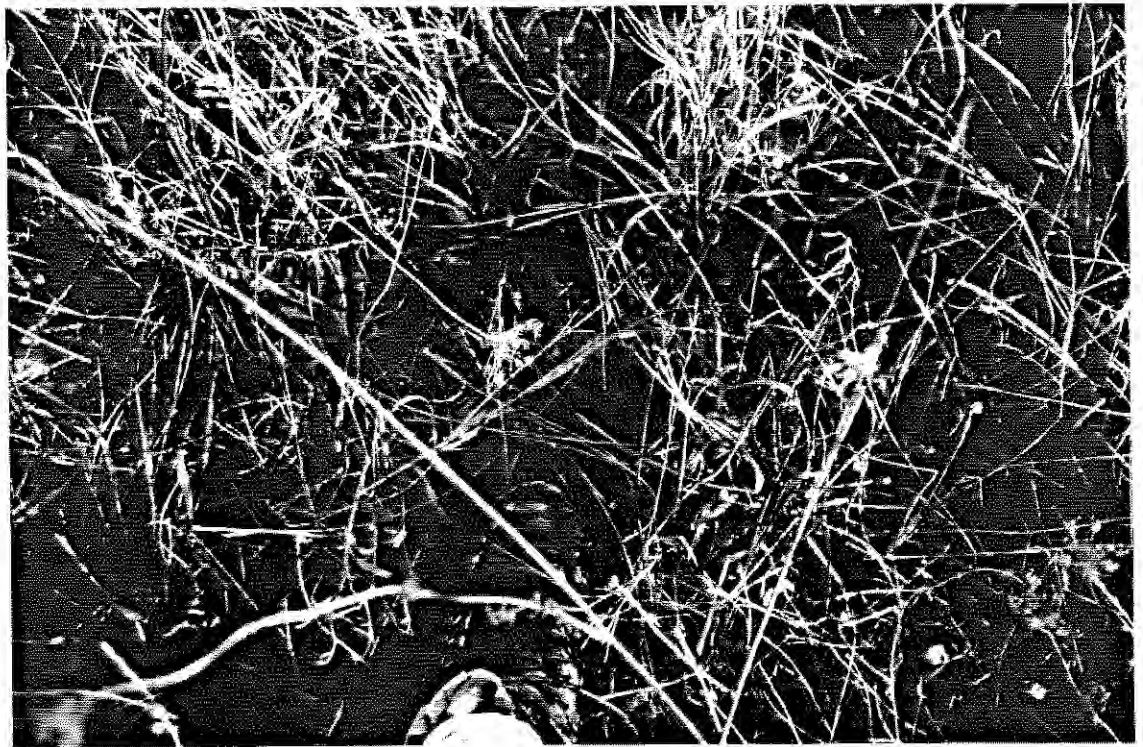
Photo 169: SEAD-65, 11/29/90. View of concrete foundation, Location B, Acid Storage Facility.

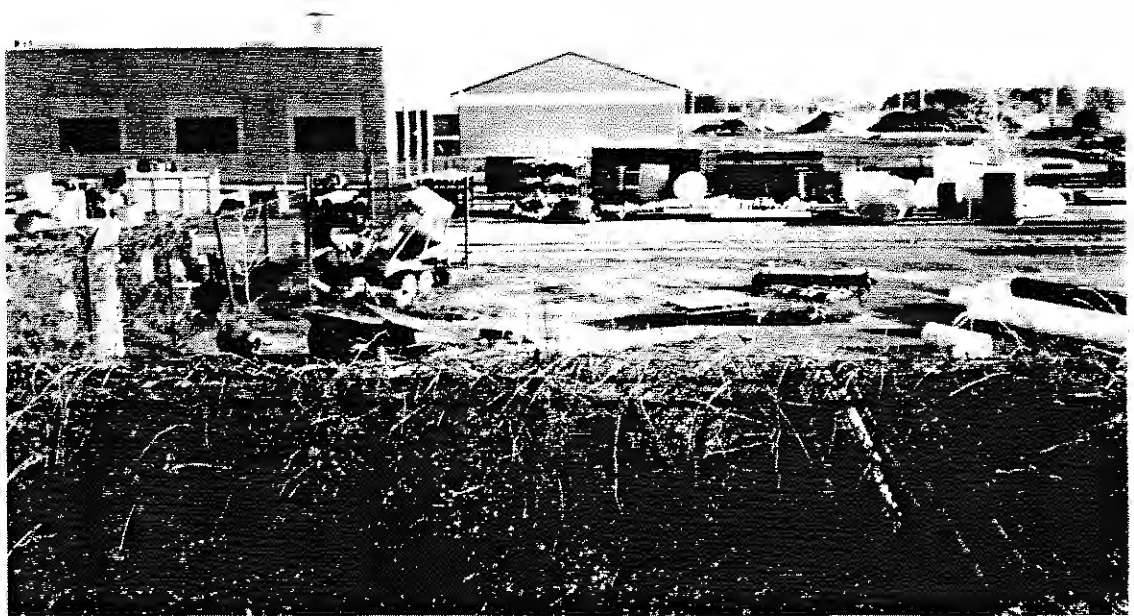
Photo 188: SEAD-71, 4-4-94. View of the Alleged Paint Disposal Area which is located beyond the first set of railroad tracks, facing south.

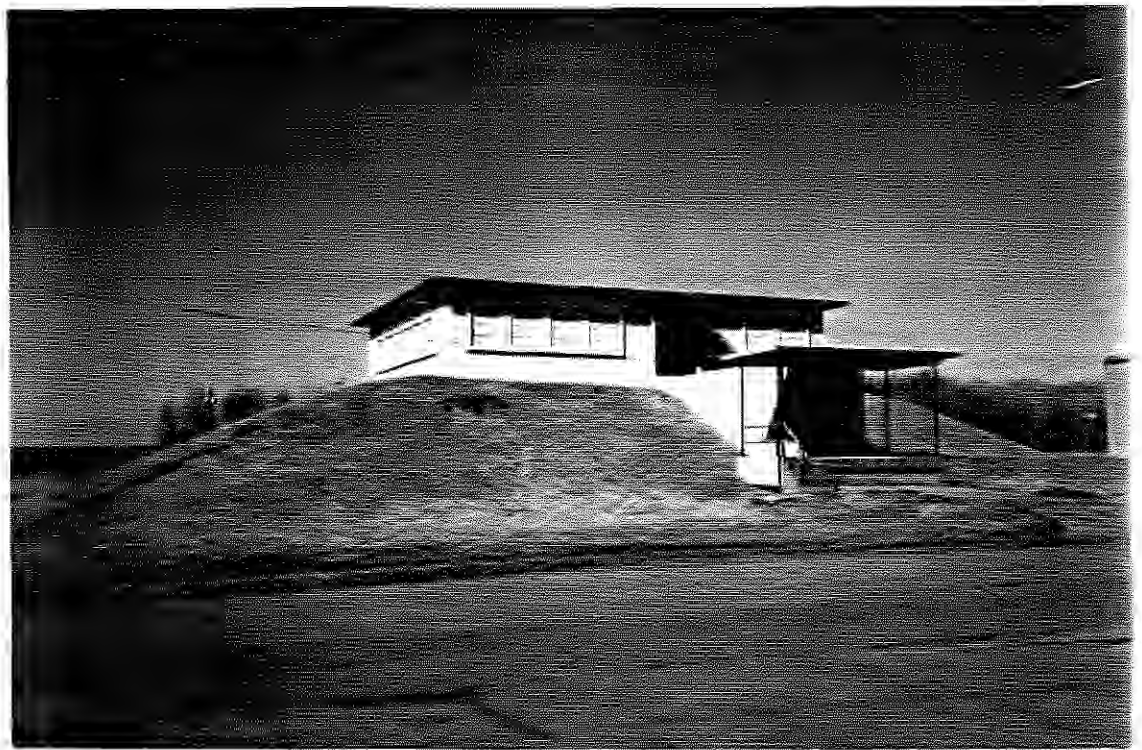
Photo 190: SEAD-72, 4-4-94. View of Building 803, the Mixed Waste Disposal Facility, facing north.
