DECISION DOCUMENT FOR REMOVAL ACTIONS
AT SWMUs SEAD-38, SEAD-39, SEAD-40, SEAD-41,
AND SEAD-60

SENECA ARMY DEPOT ACTIVITY

FEBRUARY 1999

**Parsons Engineering Science, Inc.
Canton, Massachusetts**

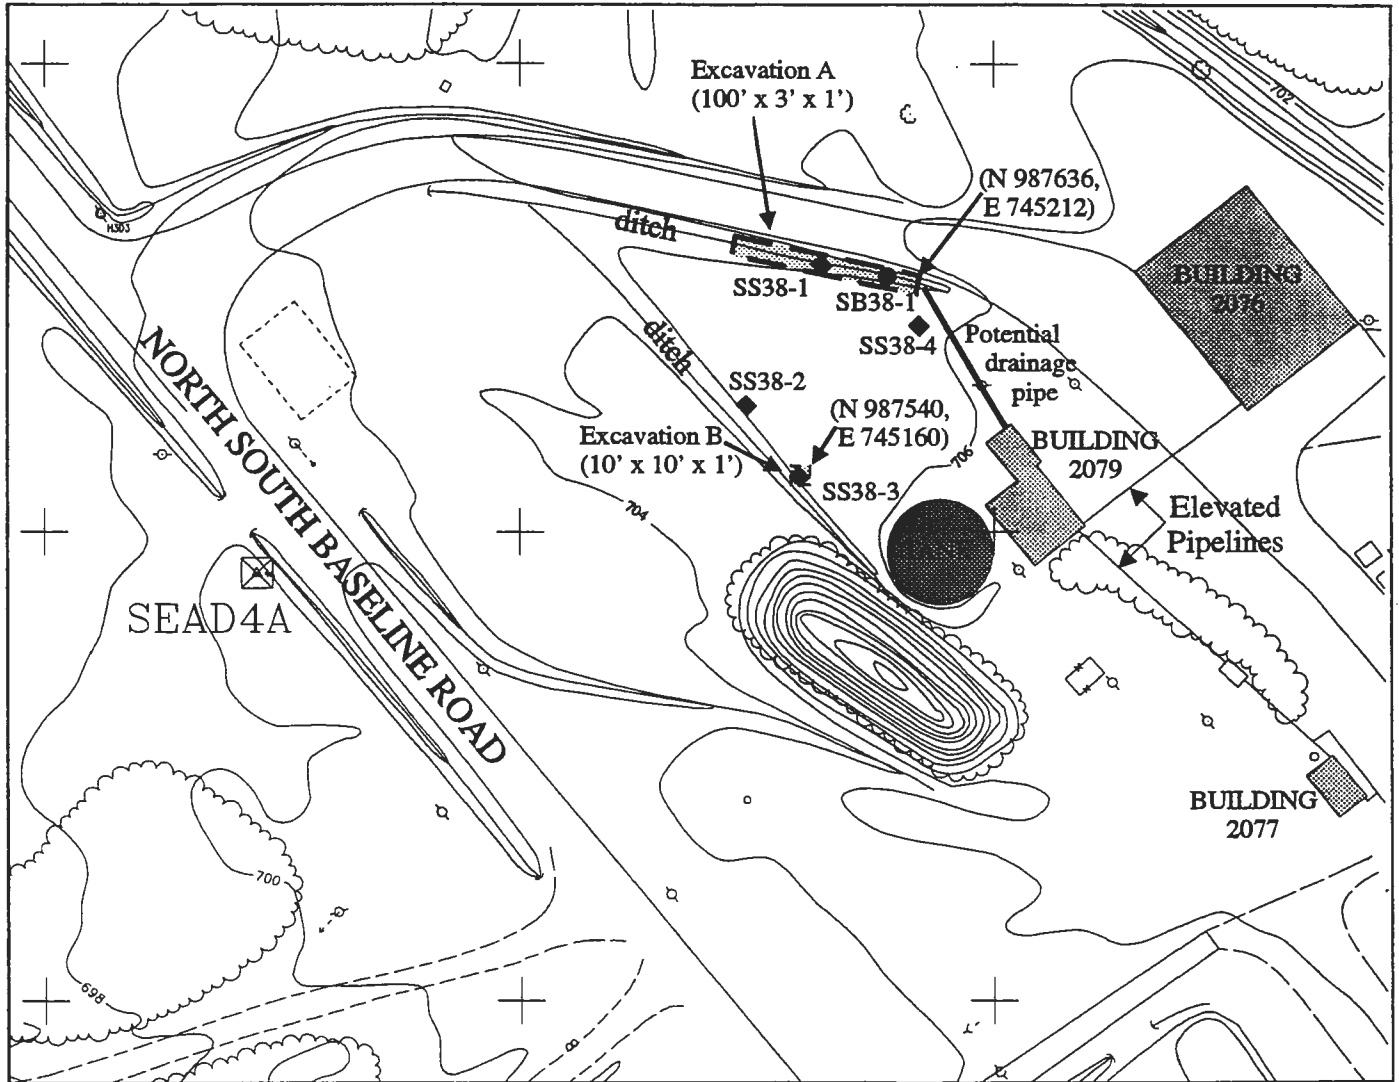
FIGURE 1

A limited sampling program was performed in 1993 and 1994 to obtain evidence of a release. One soil boring was advanced in the roadside drainage ditch north-northeast of the northeast corner of Building 2079. The soil boring was located at the mouth of a drainage pipe that originates in Building 2079 and is suspected to have transmitted blowdown liquids. The boring was terminated in weathered bedrock at 6.3 feet below grade at spoon refusal. The water table was not encountered. No volatiles were detected with the field screening instrument, and no staining of the soil was observed, so the deepest sample with sufficient volume (2-4') was submitted to the lab for chemical analysis. One surface soil sample (0-2") was collected from the roadside drainage ditch downstream of the soil boring location and three surface soil samples were collected from the grassy field between Building 2079 and the roadside drainage ditch. Chemical analyses consisted of pH analyzed by Environmental Protection Agency (EPA) Method 9045 and total recoverable petroleum hydrocarbons (TRPH) by EPA Method 418.1. The sample locations are shown in Figure 1.

The results of the soil sampling program are presented in Table 1. Petroleum hydrocarbons were detected in the subsurface soil sample and all four of the surface soil samples. Surface soil samples SS38-2 and SS38-4 contained 104 and 110 ppm of TRPH, respectively, and surface soil samples SS38-1 and SS38-3 contained significantly higher concentrations of 1840 and 1940 ppm, respectively. The subsurface soil sample SB38-1 contained 85 ppm TRPH. The pH of the soil samples ranged from 7.35 to 7.47 in the surface soil samples and was 8.93 in the subsurface soil sample.

The detection of petroleum hydrocarbons in all of the samples show that a release did occur. The low concentration of petroleum hydrocarbons in the subsurface sample suggests that the petroleum hydrocarbon impacts diminish with depth.

Removal of petroleum hydrocarbon-impacted soil is recommended in the roadside drainage ditch and in a small area between the boiler plant and the drainage ditch. Because the blowdown liquids are believed to have been drained directly into the roadside drainage ditch, the soil that would require remediation would primarily be the soil in the drainage ditch. Starting at the mouth of the pipe where soil boring SB38-1 was advanced, an area 3 feet across the ditch, and 100 feet in the downstream flow direction should be excavated. The subsurface soil sample that was collected at the mouth of the drainage pipe shows that there is little vertical extent of the impacted soil, so the ditch should only be excavated to a depth of 1 foot. The surface sample SS38-3 indicates that some of the soil in the field between the boiler plant and the drainage ditch needs to be remediated as well. Of the three samples collected in the field, sample SS38-3 was the only sample where a high petroleum hydrocarbon concentration was detected. Because the extent of the elevated petroleum hydrocarbon-impacted soil appears to be localized, a 10-foot square area around the SS38-3 sample location should be excavated to a depth of 1 foot. The locations of the areas to be remediated are shown in Figure 1.

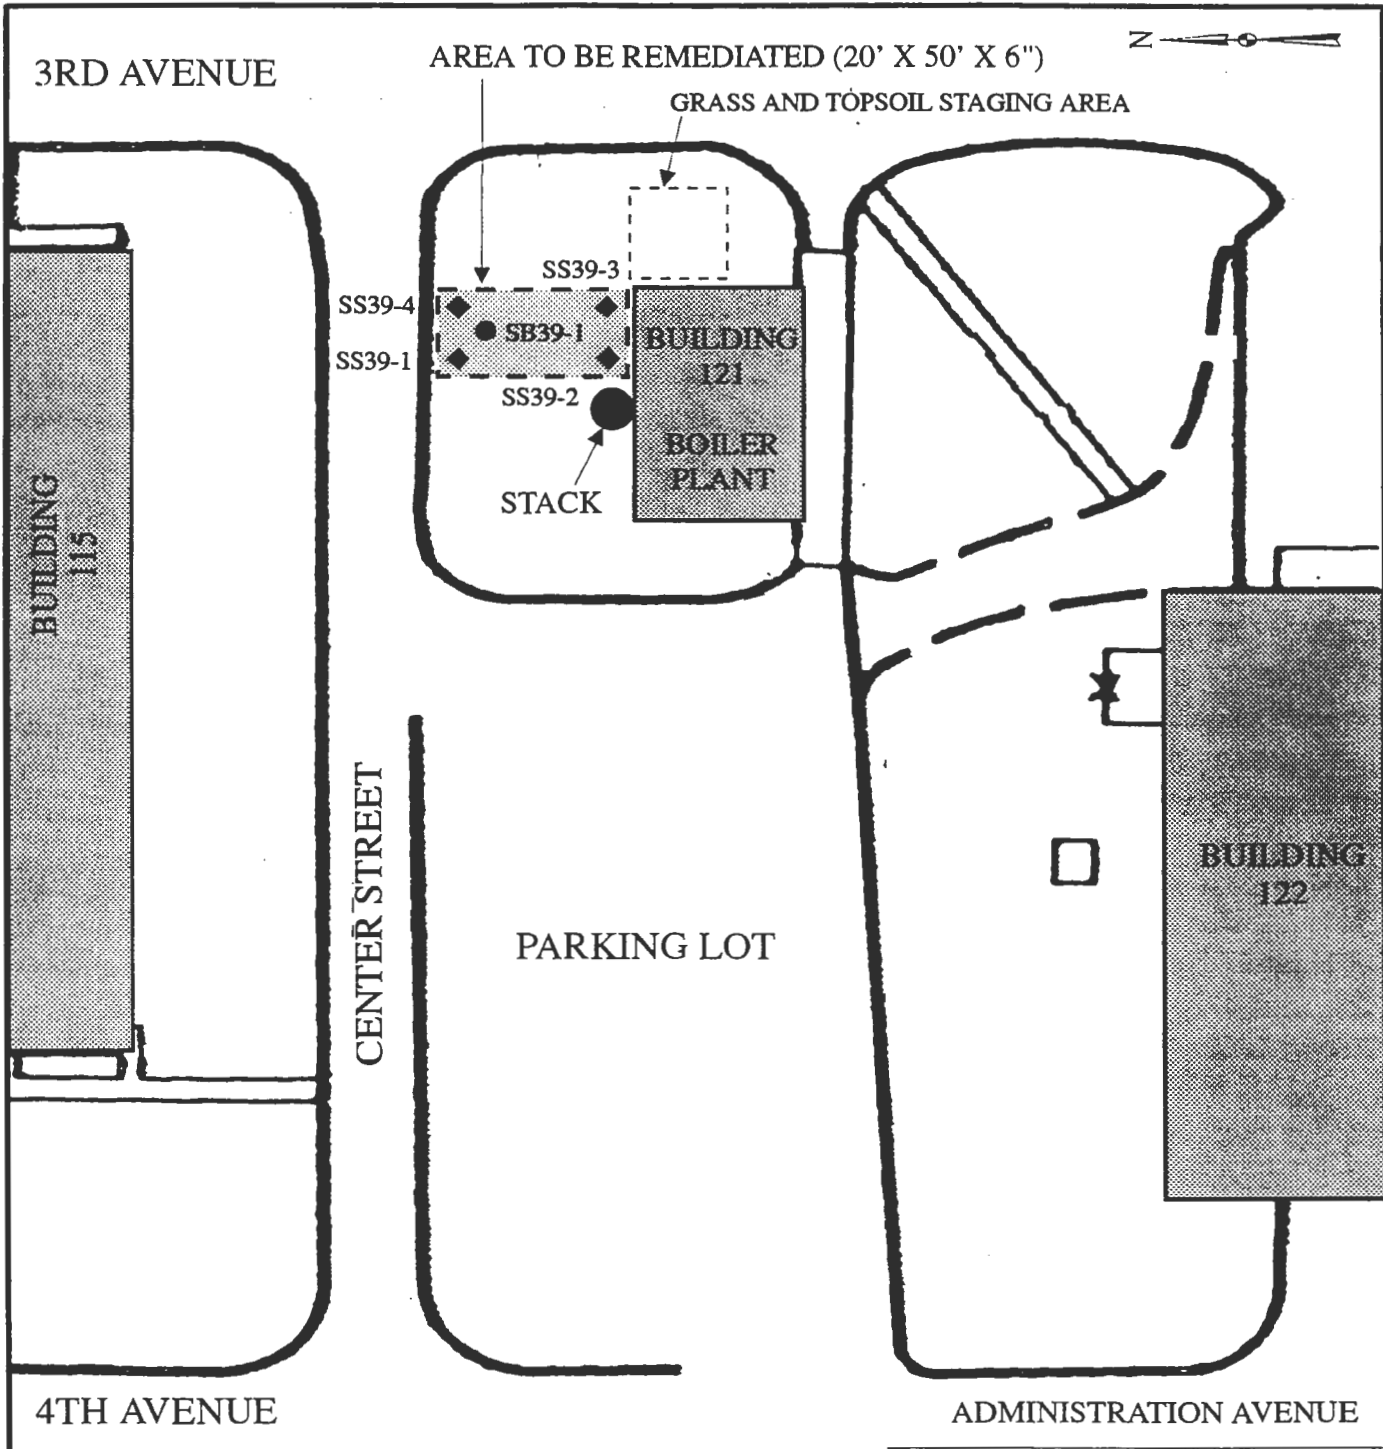
FIGURE 1
 SAMPLE LOCATIONS AND
 APPROXIMATE AREA TO
 BE REMEDIATED

A limited sampling program was performed in 1993 and 1994 to obtain evidence of a release. One soil boring was advanced midway between the building and the street directly to the north of the northeast corner of Building 121. The boring was terminated in weathered bedrock at split-spoon refusal, 5.7 feet below grade. The water table was encountered 5.2 feet below grade. No volatiles were detected with the field screening instrument, and no stained soil was observed, so the sample collected above the water table (3-5') was submitted to the lab for chemical analysis. The top six inches of the ground is filled topsoil which accounts for the mounding of the ground surface between the building and Center Street. Because of the mounding, surface soil samples would not be representative of impacts caused by the blowdown liquids because the ground surface is at a higher elevation than the discharge point for the blowdown liquid. Instead of collecting surface soil samples, soil samples were collected from driving a split-spoon from 0-2' at four locations surrounding the soil boring. One sample was collected from each split-spoon sample. Chemical analyses consisted of pH analyzed by Environmental Protection Agency (EPA) Method 9045 and total recoverable petroleum hydrocarbons (TRPH) by EPA Method 418.1. The sample locations are shown in Figure 1.

The results of the soil sampling program are presented in Table 1. Petroleum hydrocarbons were detected in all of the soil samples collected from SEAD-39. All of the soil samples, with the exception of SS39-1 contained TRPH concentrations less than 100 ppm. SS39-1 contained 118 ppm TRPH. The pH of the soil samples ranged from 7.9 to 8.9.

The detection of petroleum hydrocarbons in all of the samples show that a release did occur, however, the concentrations detected in the samples were low. The approximate area of soil that appears to be impacted is 20 feet by 50 feet. This area is outlined in Figure 1.

To remove the petroleum-impacted soil at SEAD-39, a 20 by 50 foot area should be excavated down to one foot, as outlined in Figure 1. Because the fill that lies above the blowdown liquid discharge level is not likely to be contaminated, the top six inches of the topsoil need not be remediated.

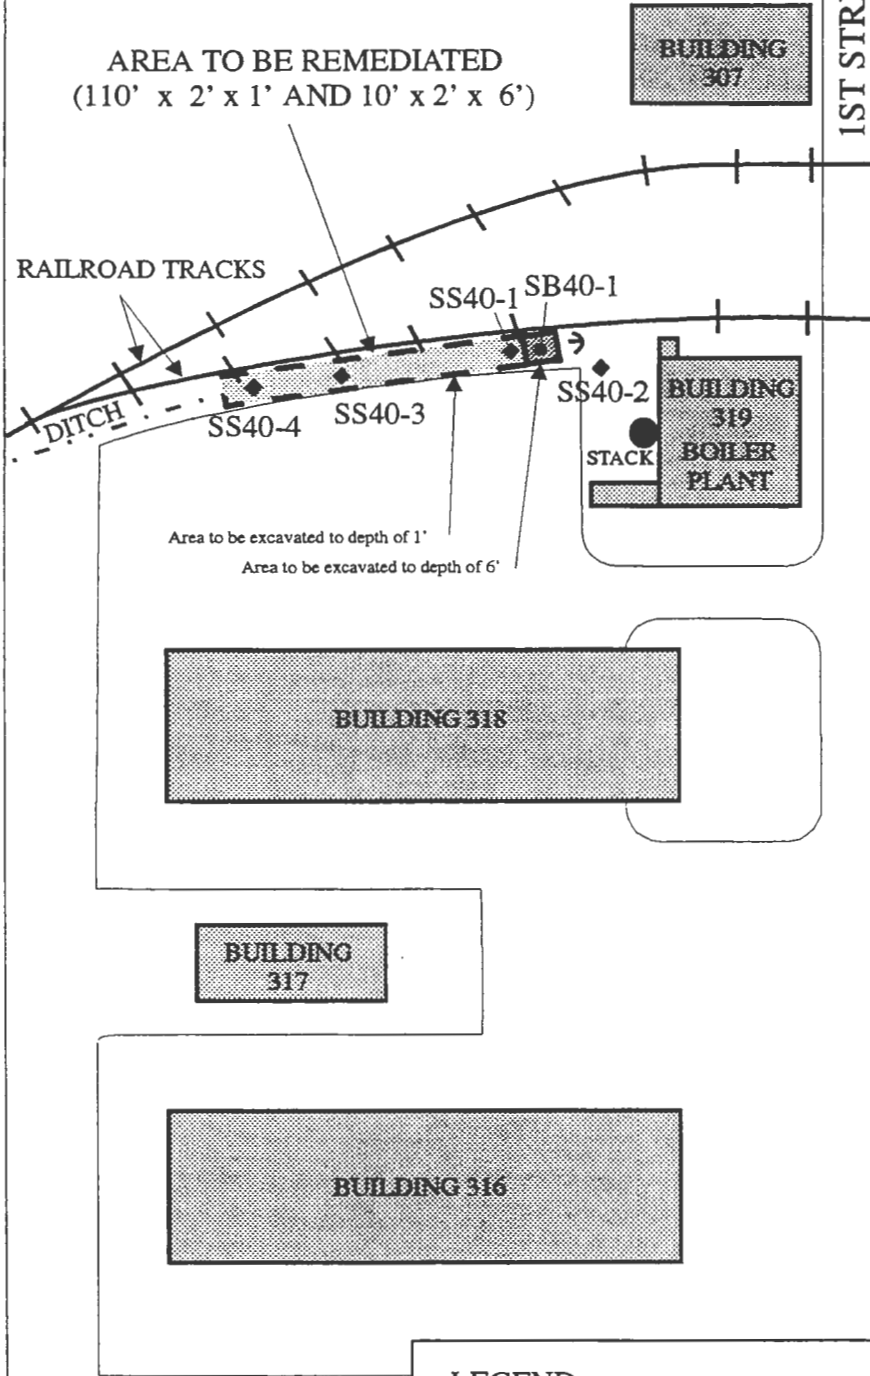
AREA TO BE REMEDIATED
(110' x 2' x 1' AND 10' x 2' x 6')

NOTE: The origin of the ditch where the soil is to be excavated is approximately 40 feet from the northeast corner of Building 319.

A limited sampling program was performed in 1993 and 1994 to obtain evidence of a release. One soil boring was advanced in the ditch at the mouth of the drainage pipe. The boring was terminated in weathered bedrock at spoon-spoon refusal, 5.8 feet below grade. The water table was not encountered. No volatiles were detected with the field screening instrument, and no stained soil was observed, so the deepest sample collected (4-6') was submitted to the lab for chemical analysis.

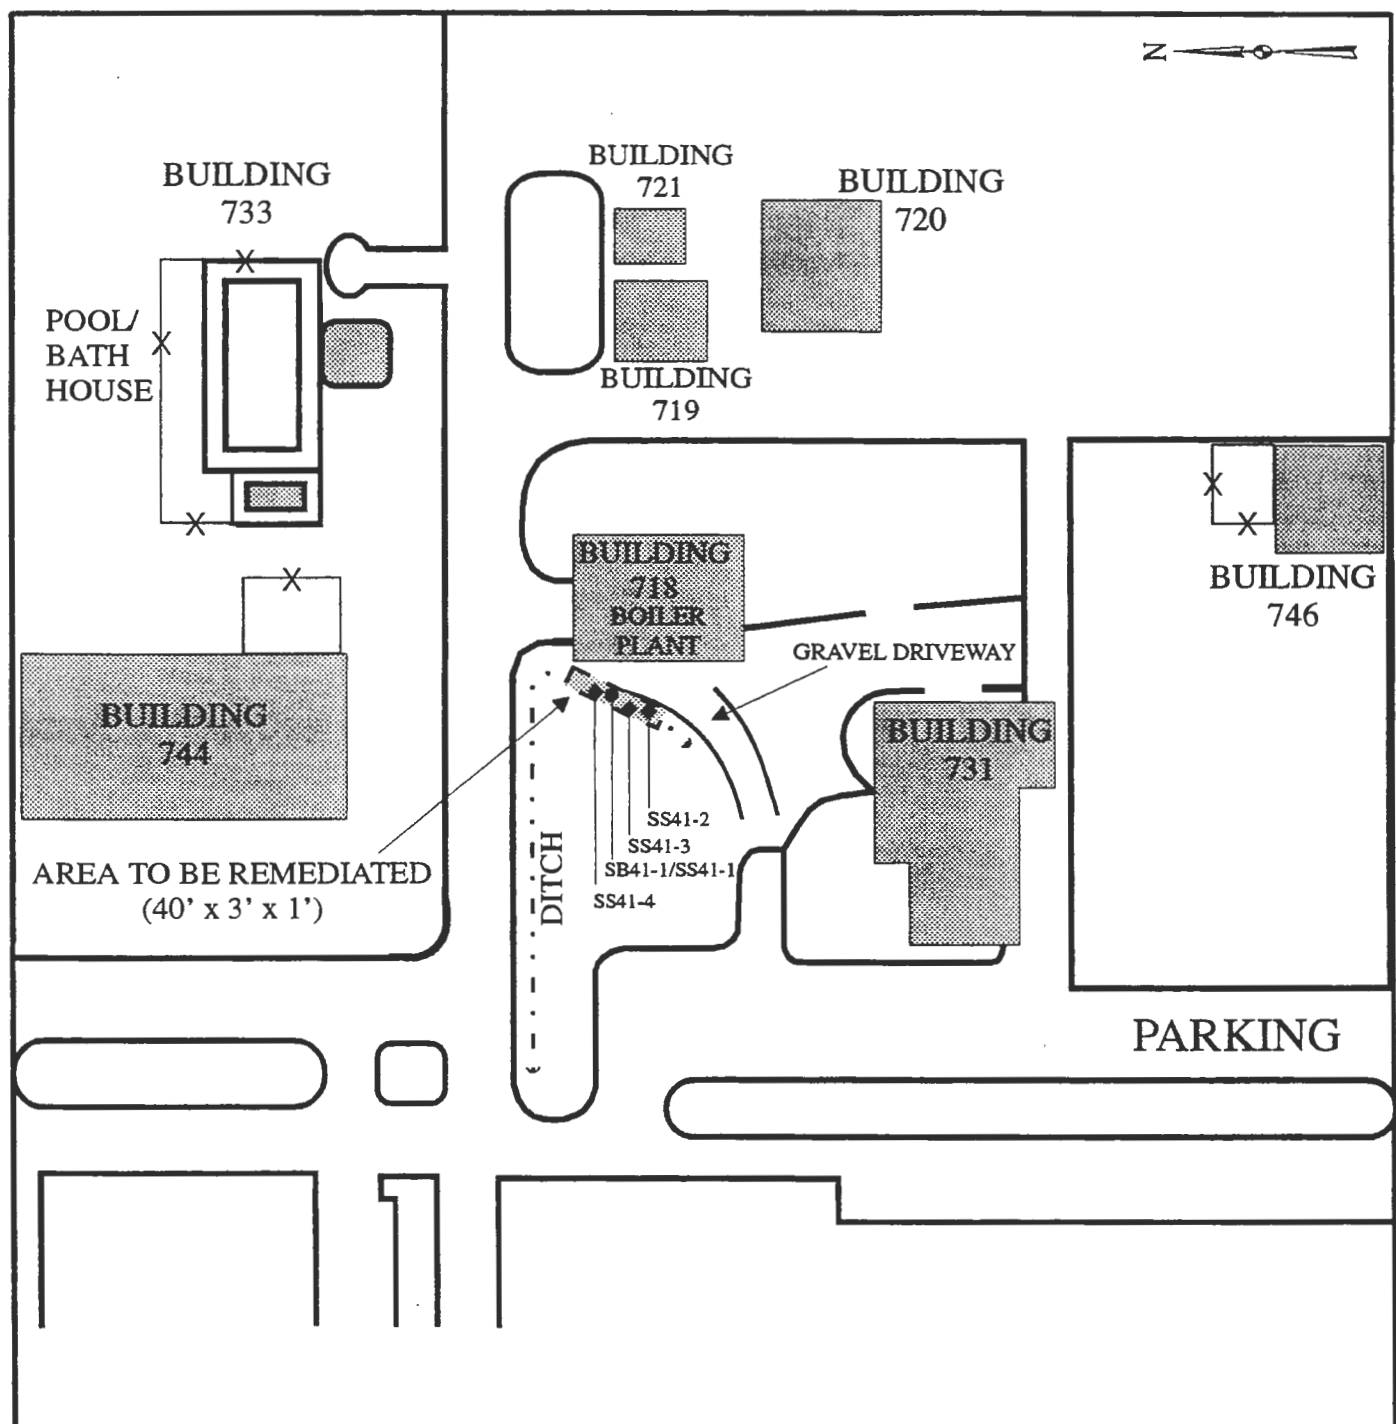
A limited sampling program was performed in 1993 and 1994 to obtain evidence of a release. One soil boring was advanced in the drainage ditch immediately to the west of where the blowdown liquids were suspected to have been discharged from Building 718. The boring was terminated in weathered bedrock at split-spoon refusal, 6.3 feet below grade. The water table was encountered 4.0 feet below grade. No volatiles were detected with the field screening instrument, and no stained soil was observed, so the sample collected above the water table (2-4') was submitted to the lab for chemical analysis. Another soil sample was submitted from the 0-2' interval. Because of the steep sides of the drainage ditch, surface soil samples collected near the ditch would not be representative of impacts caused by the blowdown liquids because the ground surface is at a higher elevation than the elevation at which the blowdown liquids were probably being discharged. Instead of collecting surface soil samples, soil samples were collected from driving a split-spoon from 0-2' at three locations surrounding the soil boring. One sample was collected from each split-spoon sample. Chemical analyses consisted of pH analyzed by Environmental Protection Agency (EPA) Method 9045 and total recoverable petroleum hydrocarbons (TRPH) by EPA Method 418.1. The sample locations are shown in Figure 1.

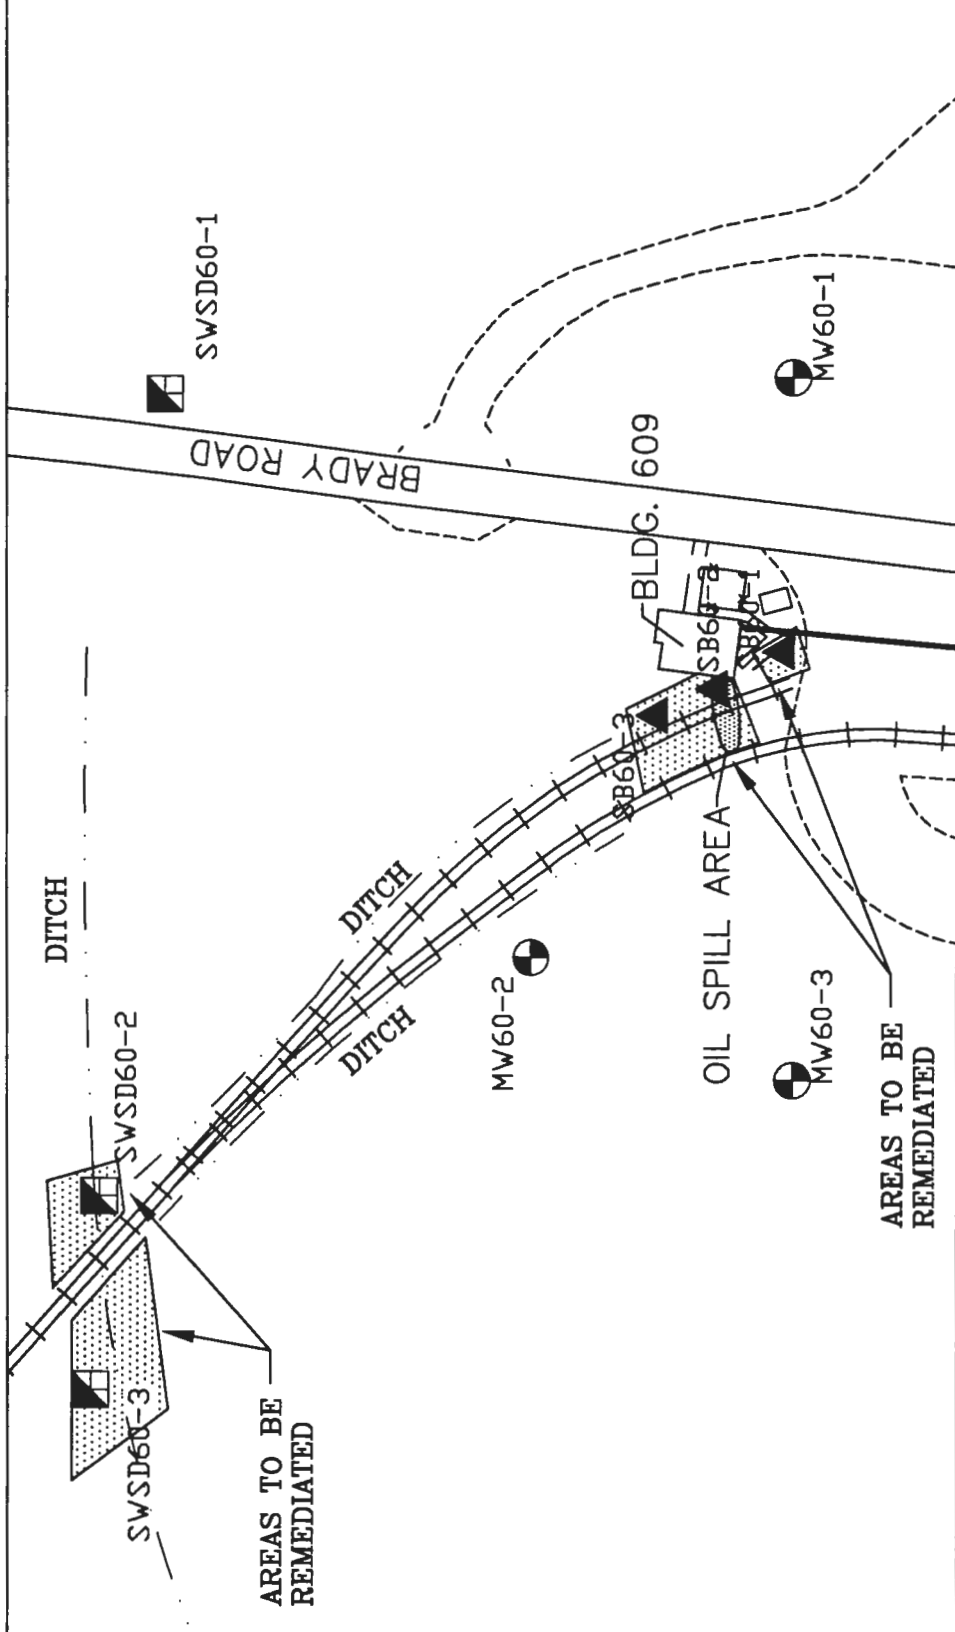
SEAD-60 is located in the southeastern portion of SEDA and represents an area of oil stained soil adjacent to the southwest corner of Building 609. SEAD-52 is adjacent to the southern boundary of the SWMU area, and SEAD-62 is located to the east. The site is located within the ammunition storage area and access to the site is restricted. The site plan is shown in Figure 1.

The spill area, which is evidenced by visibly stained soils, approximately 6 feet by 30 feet in area, extends west of the easternmost railroad spur. No vegetation is present in the visibly stained soil area.

A total of 3 surface and 6 subsurface soil samples were collected at SEAD-60 in the immediate vicinity of the oil-stained soil. To assess the potential impact from surface water runoff, 3 surface water and sediment samples were collected in drainage ditches north of the site that are suspected to receive surface water runoff from the site; one of these three sample locations (SWSD60-1) is an upstream sample. Three monitoring wells were also sampled as part of this investigation. The following sections describe the nature and extent of contamination identified at SEAD-60. The sample locations are shown in Figure 1.

Removal of petroleum hydrocarbon-impacted soil is recommended in the spill area between the railroad spurs adjacent to the southwestern corner of Building 609 and in the drainage ditch area near the sediment sampling locations. Between the railroad spurs, an area approximately 35 feet across and 50 feet long should be excavated. The ends of the excavation should be near soil borings SB60-2 and SB60-3. A 15-foot by 15-foot area around soil boring SB60-1, which is located on the southern side of Building 609, should also be excavated. The sediment from the drainage ditch area near the SWSD60-2 and SWSD60-3 sample locations should be excavated. The soil in these areas should only be excavated to a depth of 1 foot. The locations of the areas to be remediated are shown in Figure 1.
