SUBJECT: Draft 2014 Land Use Controls Inspection Report for the Former Solid Waste Management Units at Seneca Army Depot Activity; Contract W912DY-08-D-0003, Delivery Order 0015

SUBJECT: Draft 2014 Land Use Controls Inspection Report for the Former Solid Waste Management Units at Seneca Army Depot Activity, Romulus, NY; EPA Site ID# NY0213820830 and NY Site ID# 8-50-006

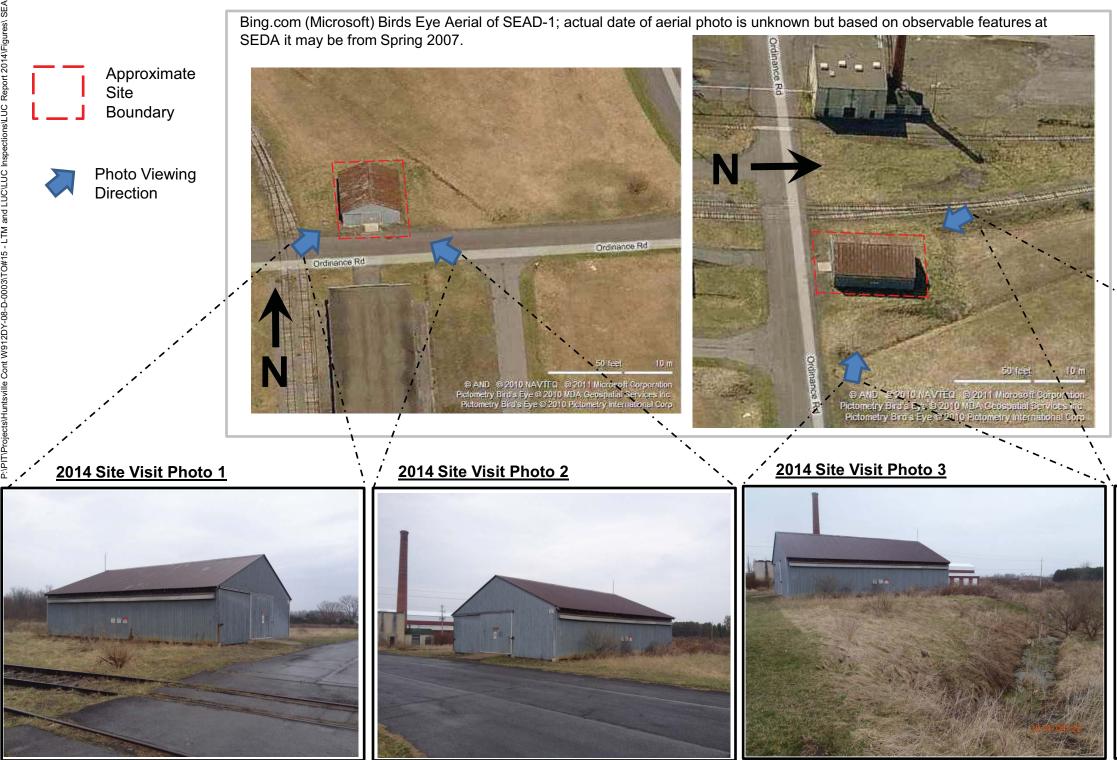
Status as of: 4/22/14 Description: Building 307 Photo ID: IMG 4081.JPG

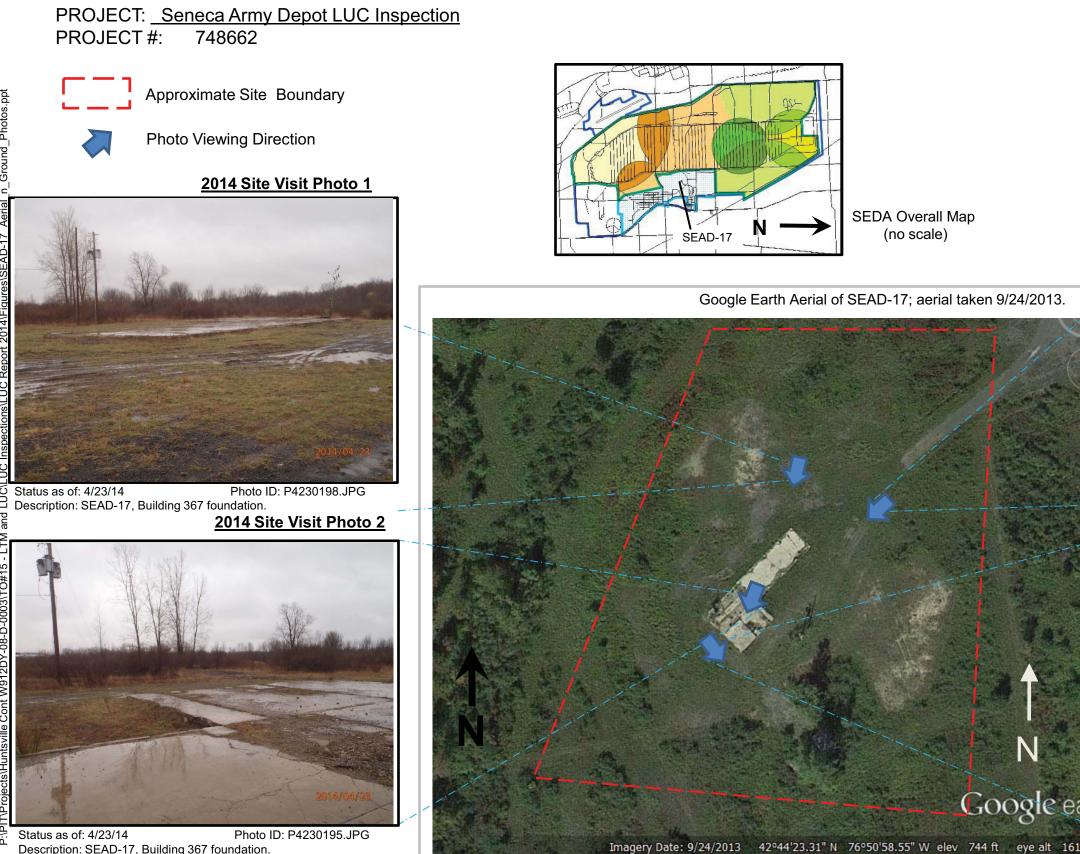
i. Description: SEAD-17, Building 367 foundation.

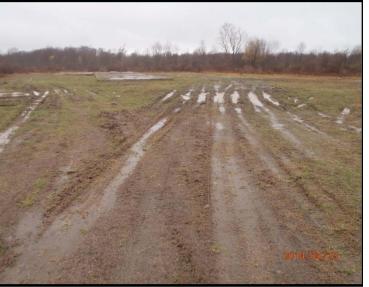
2014 Site Visit Photo 3

Photo ID: P4230194.JPG Status as of: 4/23/14 Description: SEAD-17, Building 367 foundation.

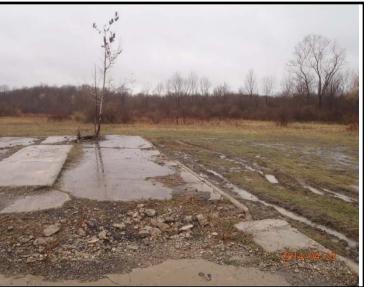
2014 Site Visit Photo 4

Status as of: 4/23/14 Photo ID: P4230196.JPG Description: SEAD-17, Building 367 foundation.

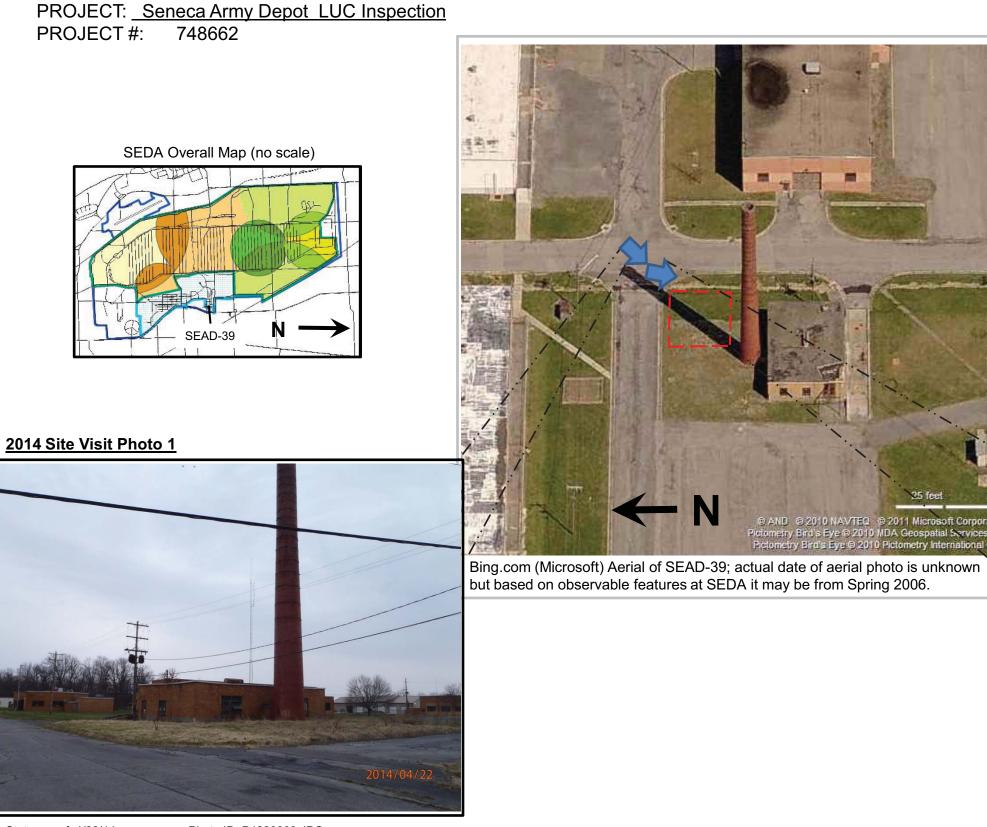
Status as of: 4/22/14 Photo ID: P4220003.JPG Description: SEAD-39 blowdown pit in foreground

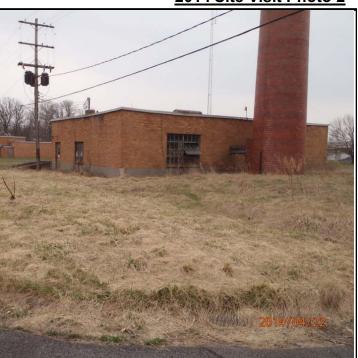
2014 Site Visit Photo 2

Photo ID: P4220007.JPG Description: SEAD-39, area of blowdown leaching pit.

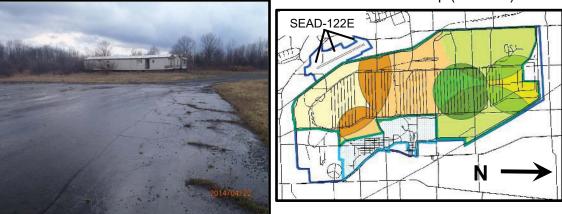
Status as of: 4/22/14 Photo ID: P4220121.JPG Description: SEAD-122E, abandoned trailer homes in distance.

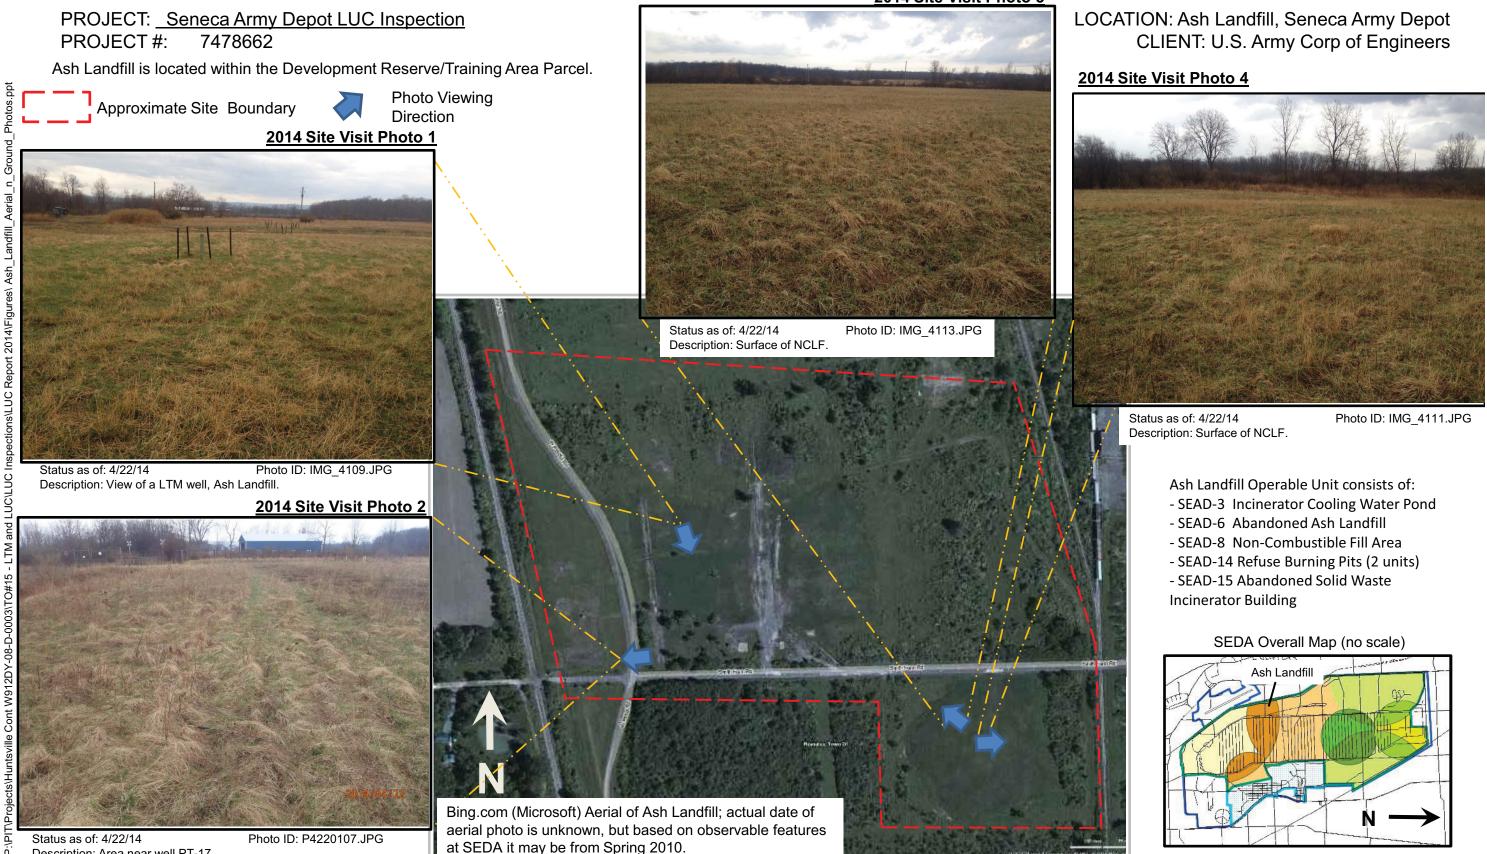
Description: Area near well PT-17.

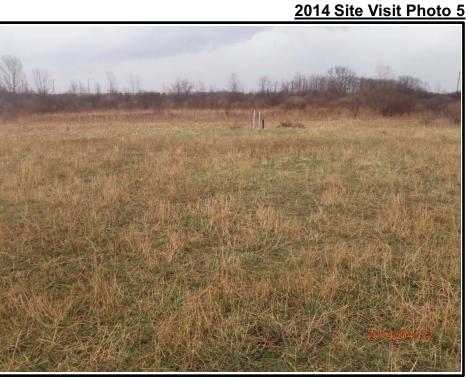
Status as of: 4/22/14 Photo ID: IMG_4117.JPG Description: Looking east across portion of Ash Landfill at well MW-40. 2014 Site Visit Photo 6

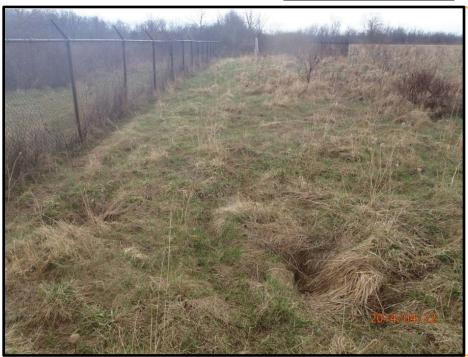
Status as of: 4/22/14 Photo ID: P4220110.JPG Description: Area of ZVI wall. Looking north towards well PT-24.
