# TECHNICAL MEMORANDUM

Date:	May 19, 2008	00473					
То:	Julio Vazquez, USEPA						
	Kuldeep Gupta, NYSDEC						
	Mark Sergott, NYSDOH						
From:	Todd Heino, Parsons; Jacqueline Tra	ivers, Parsons					
Subject:	Year 1, Round 2 – Long-Term Mo Depot Activity, Romulus, New York	-	Grounds at Seneca Army

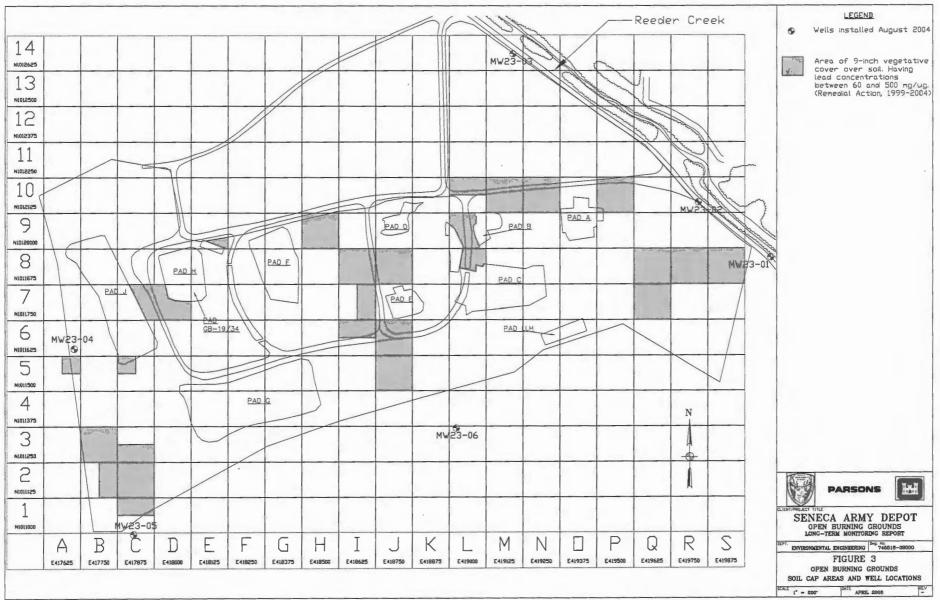
The cap inspection consisted of documenting observations of the 25 125 by 125-foot grids, where cover was placed over areas of the site where total lead has been detected at concentrations between 60 and 500 mg/kg. These grids are shown on **Figure 3**.

Overall, minimal erosion and a lack of animal burrowing activity were observed in the capped areas. There had been surface melt of snow and the accumulation of new snow, since the Round 2 cap inspection was completed. Shallow surface water drainage paths were observed in three grids (L8, I8, and J6). At Grid I8, sparse vegetation was observed.

The observations were reported to the Army, and the washout areas observed in grids L8, I8, and J6 were immediately repaired in May 2008. The areas of the cap that were sparsely vegetated were reseeded.
