SUBJECT: Final Annual Report and One-Year Review for the Open Burning Grounds at Seneca Army Depot Activity; Contract DACA87-02-D-0005, Delivery Order 0036

SUBJECT: Final Annual Report and One-Year Review for Open Burning Grounds at Seneca Army Depot Activity; EPA Site ID# NY0213820830 and NY Site ID# 8-50-006

FINAL
ANNUAL REPORT AND ONE-YEAR REVIEW
FOR THE OPEN BURNING GROUNDS
SENECA ARMY DEPOT ACTIVITY

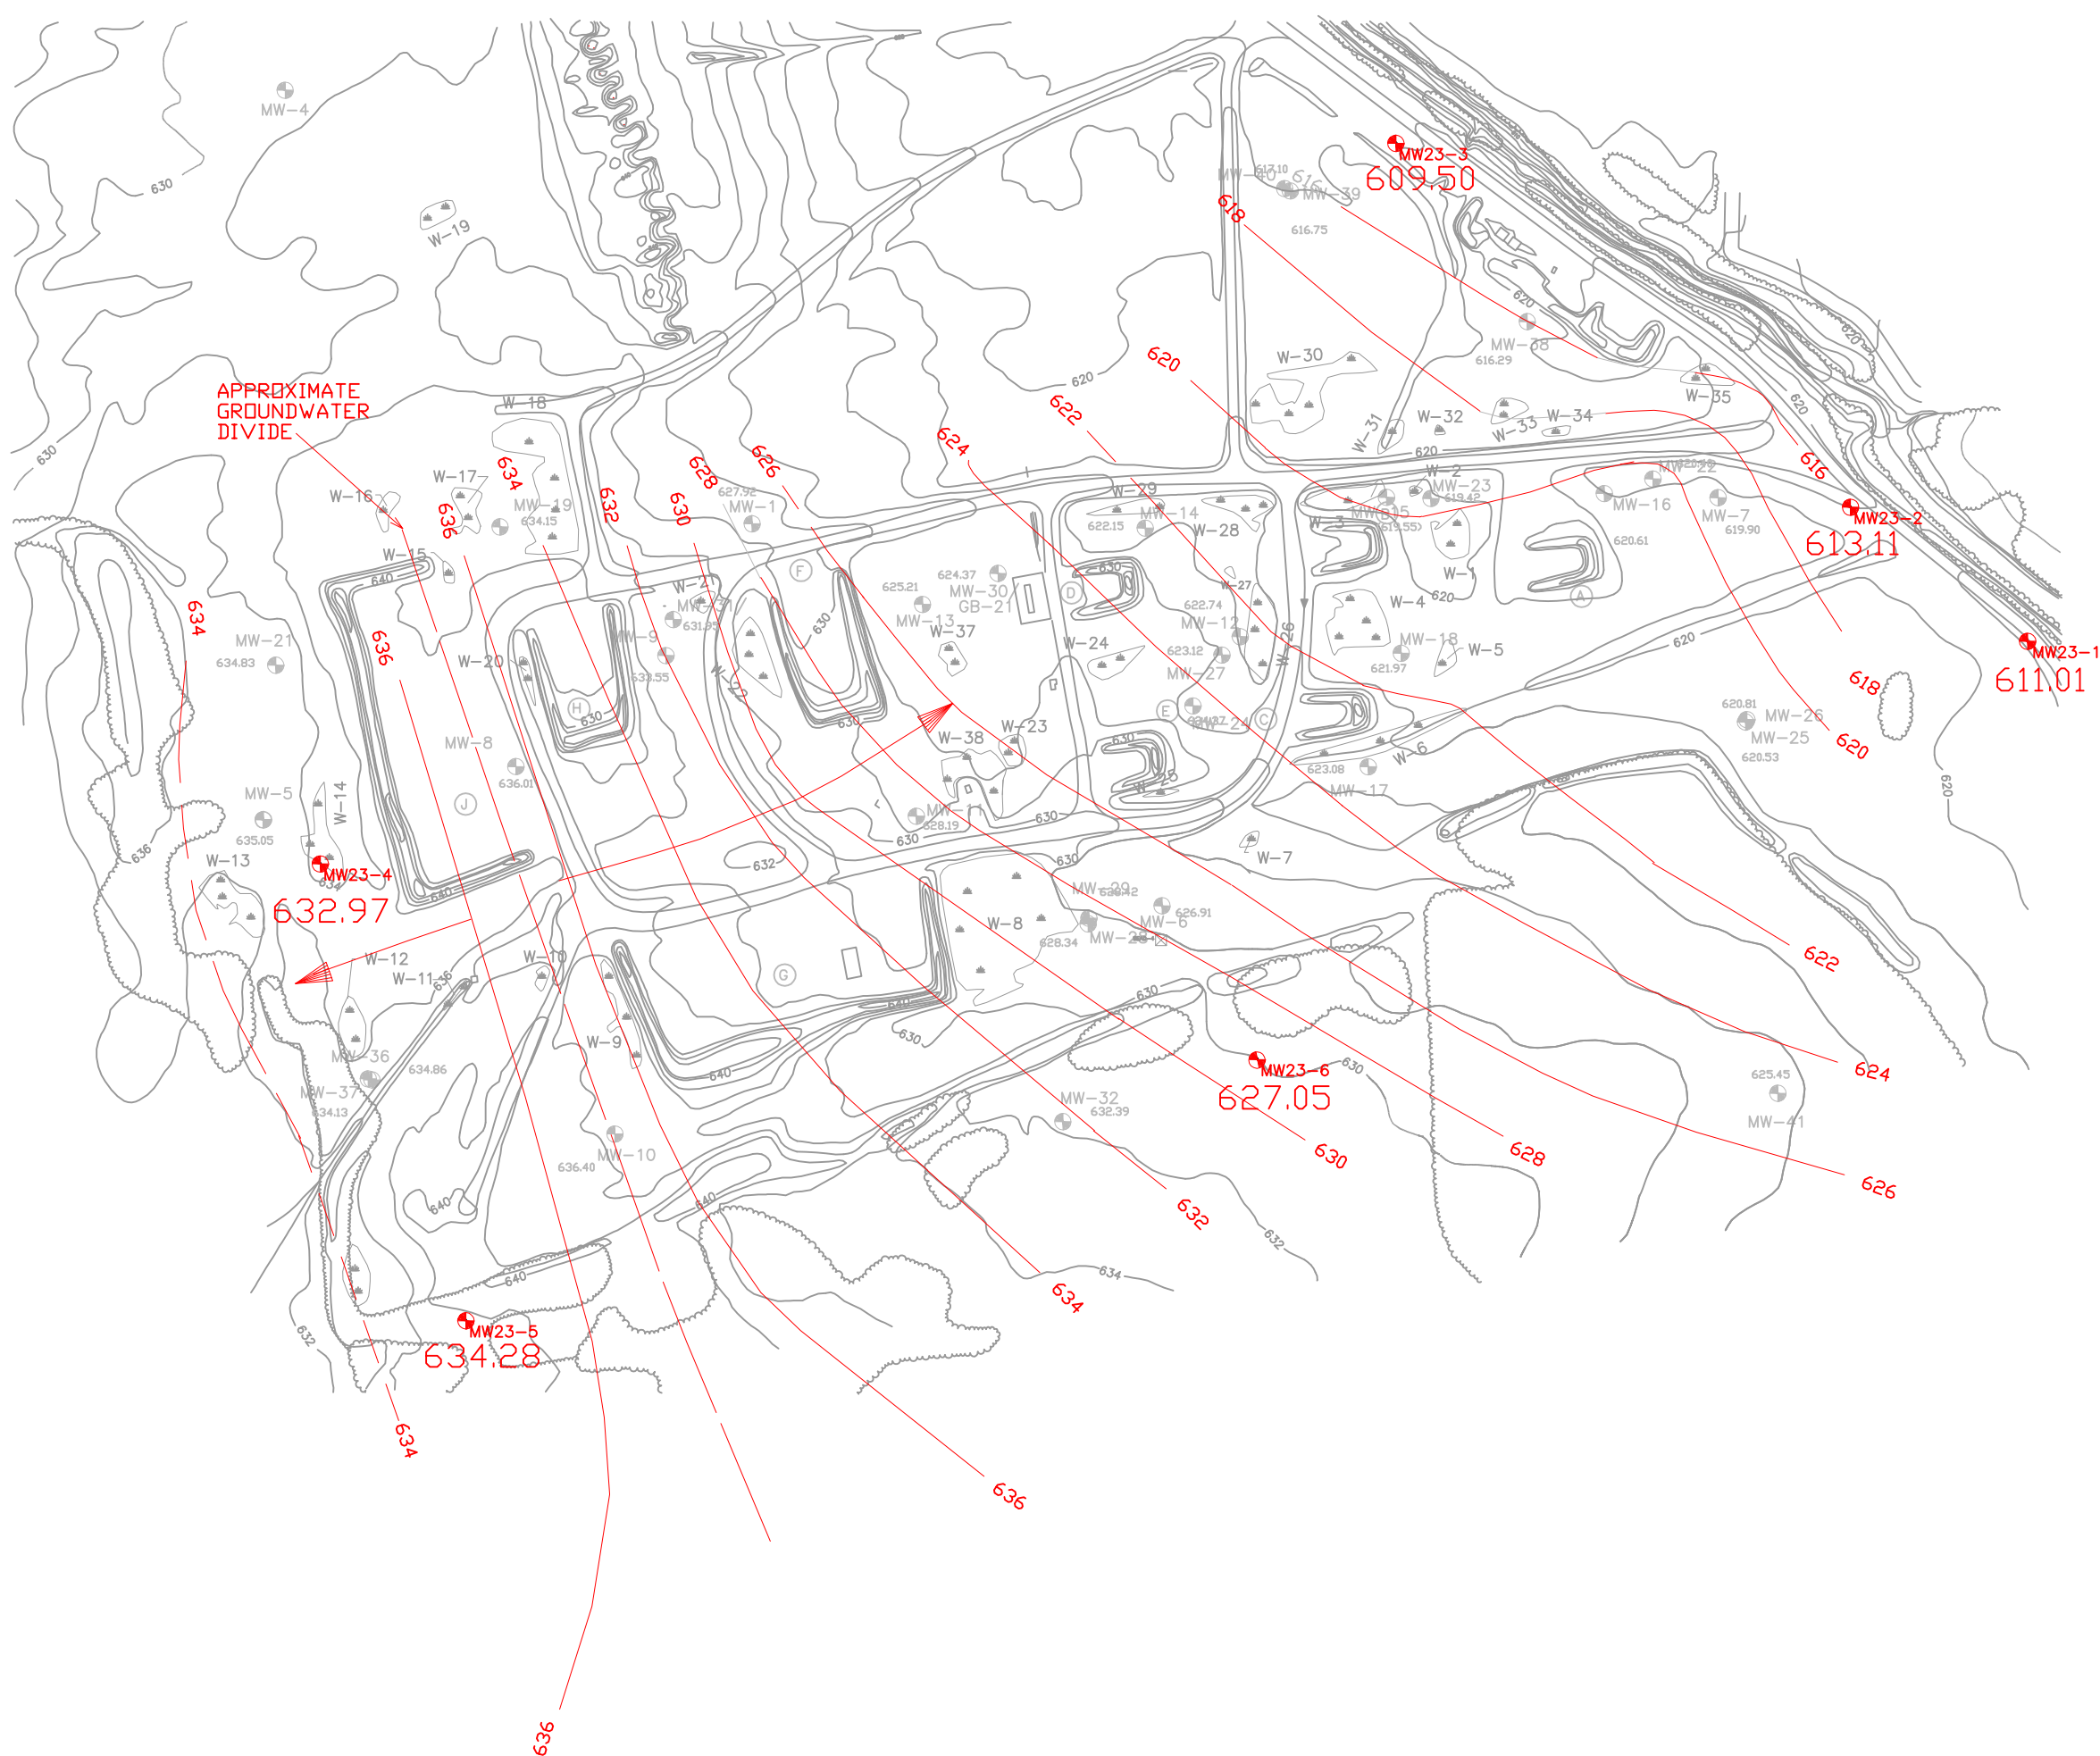
The stratigraphy of the OB Grounds generally consists of between 2 and 10 feet of glacially derived till below which is a zone of weathered bedrock. The depth to groundwater in the till/weathered shale aquifer varies seasonally between approximately 2 and 7 feet below the ground surface. Infiltration of precipitation is the sole source of groundwater for the overburden aquifer and the direction of the groundwater flow in the till/weathered shale aquifer at the OB Grounds is generally to the east towards Reeder Creek as shown in **Figure 2**.

Historic groundwater elevation monitoring in wells located at the OB Grounds prior to the remedial action indicated the presence of a groundwater divide near the western edge of the site. The approximate location of the apparent groundwater divide found in April 1993 is highlighted on **Figure 2** and represents a high point of the upgradient groundwater flow regime. The divide diverts a portion of the groundwater to the west, away from Reeder Creek, which lies to the east. Historic sampling results from wells located west of the identified divide suggest that the quality of groundwater has not been impacted by soils at the OB Grounds.

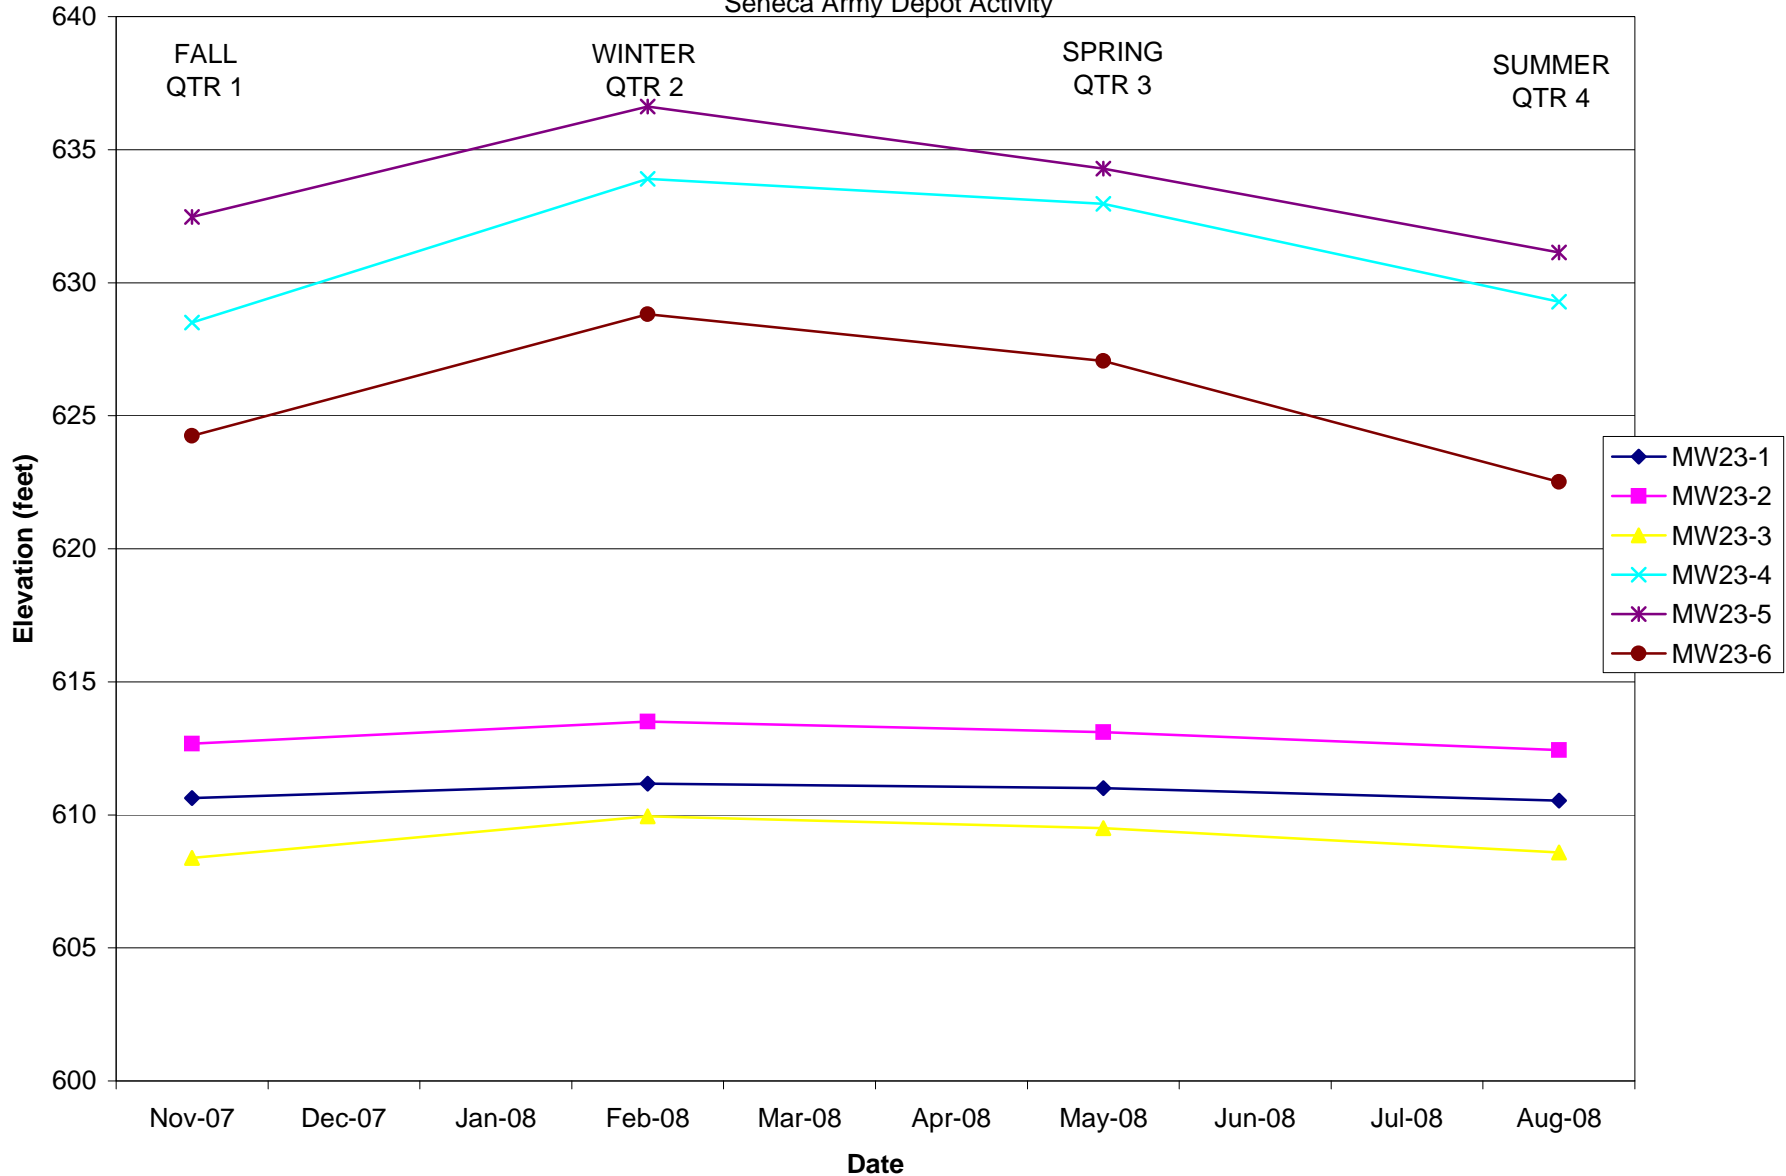
Figure 3
 Groundwater Elevation Profile
 OB LTM Annual Report, Year 1
 Seneca Army Depot Activity

Further, evaluation of the new groundwater elevation data indicates that all of the highest elevations were found during the Round 2 (February 2008) monitoring event, with five of the six wells (all except MW23-4) reaching their lowest elevations during the Round 4 (August 2008) event. The lowest groundwater level measured at MW23-4 was recorded during the Round 1 (November 2007) event.

Note: Groundwater elevation was measured on the following dates: November 20, 2007, February 25, 2008, May 20, 2008, and August 25, 2008 .

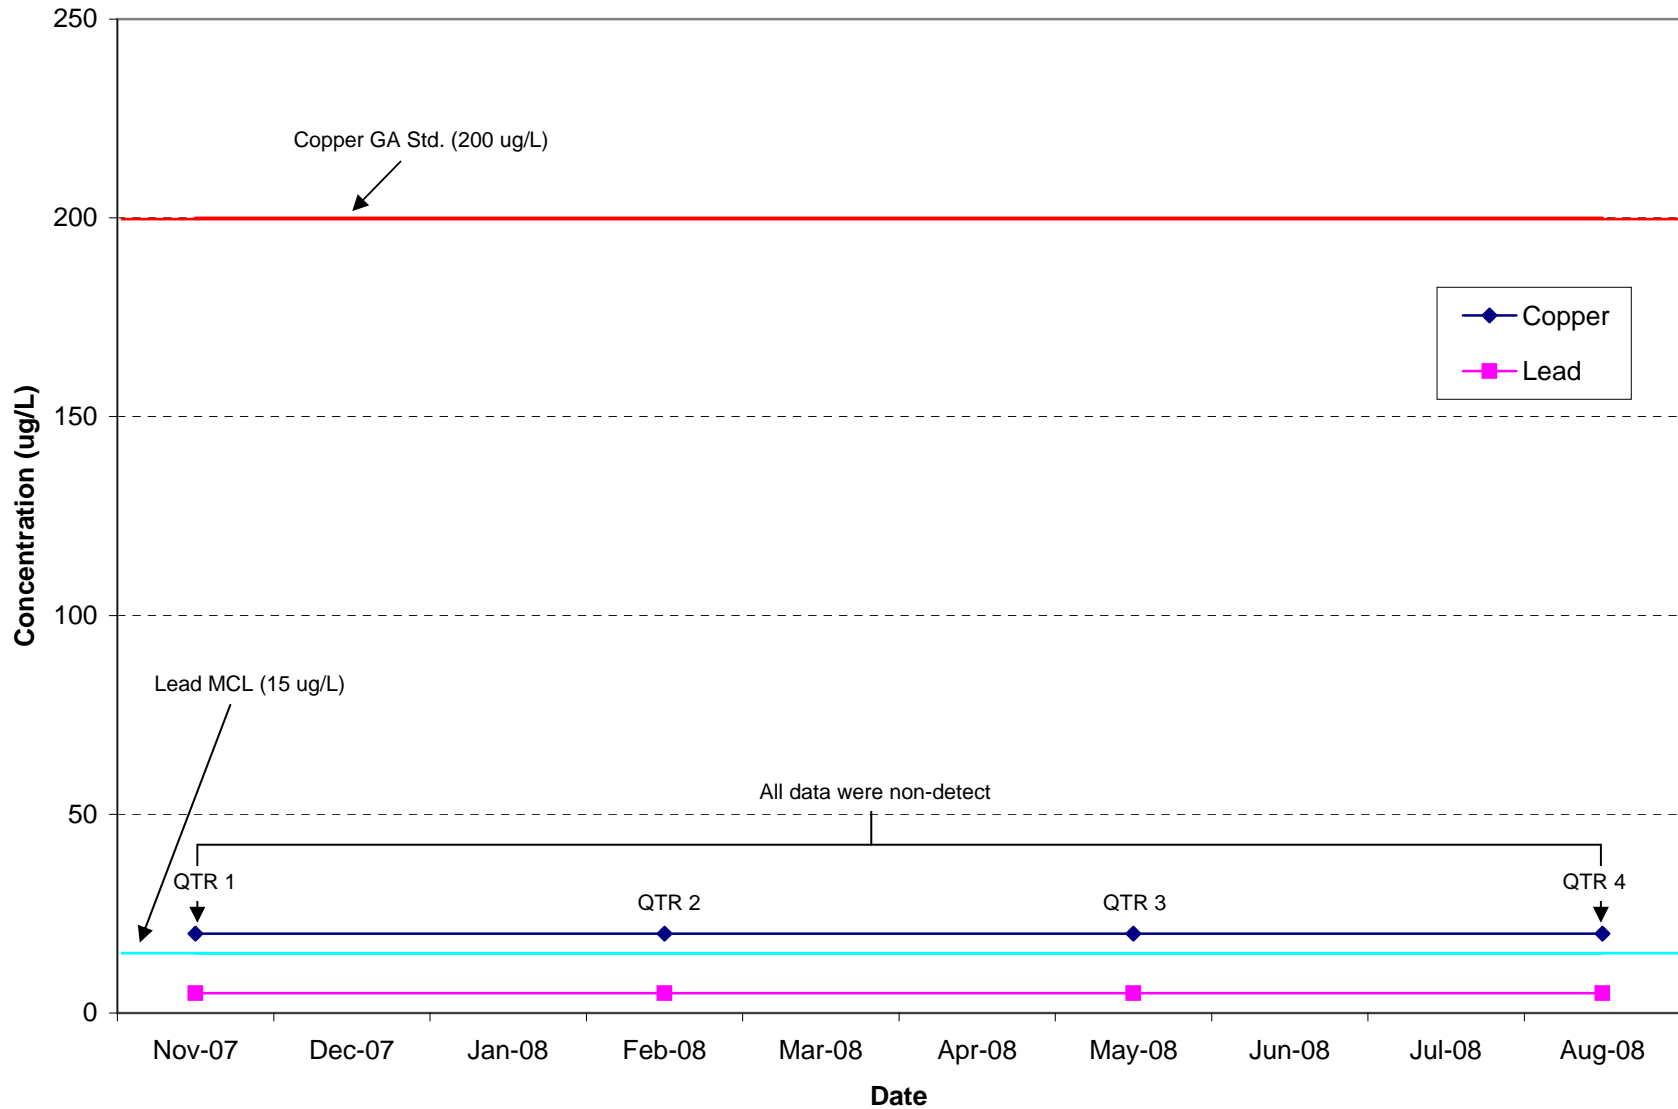
Figure 4
 Concentrations of Lead and Copper at MW23-1
 OB Grounds LTM Annual Report, Year 1
 Seneca Army Depot Activity

Note: Groundwater samples were collected on the following dates: November 21, 2007, February 25, 2008, May 21, 2008, and August 26, 2008.
 All groundwater concentrations were below detection limits.

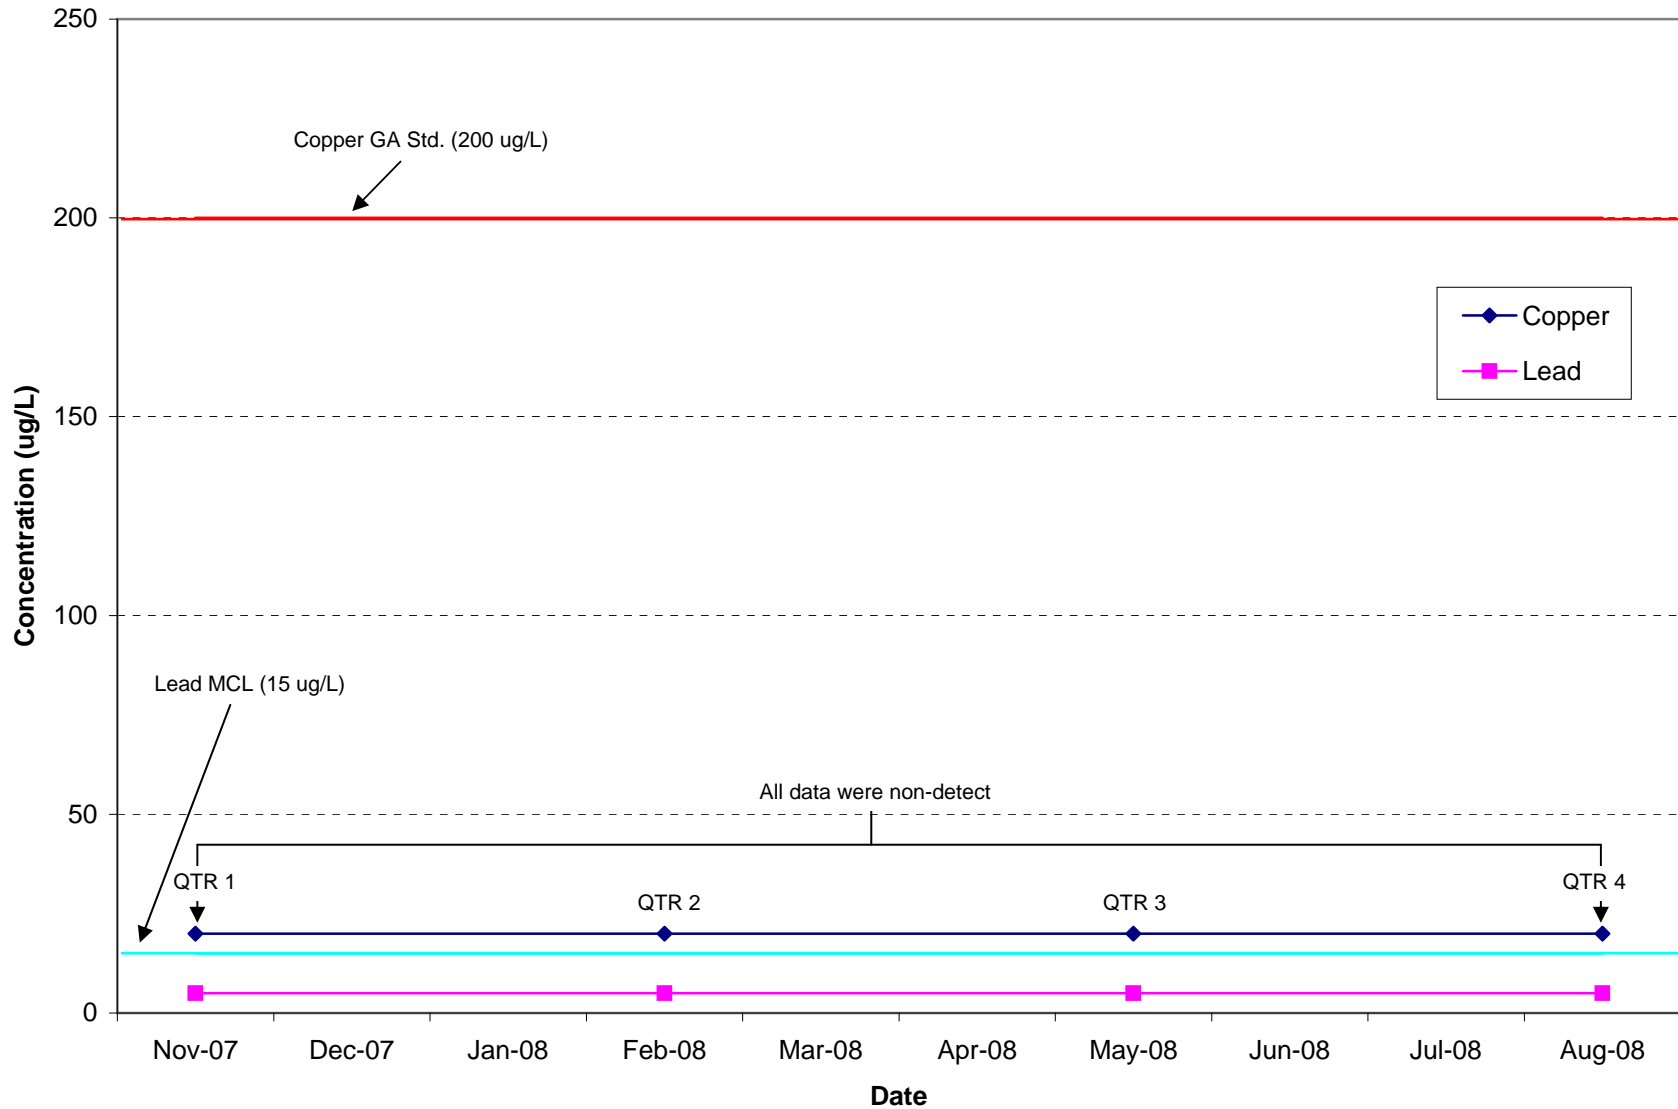
Figure 5
 Concentrations of Lead and Copper at MW23-2
 OB Grounds LTM Annual Report, Year 1
 Seneca Army Depot Activity

Note: Groundwater samples were collected on the following dates: November 21, 2007, February 25, 2008, May 21, 2008, and August 26, 2008.
 All groundwater concentrations were below detection limits.

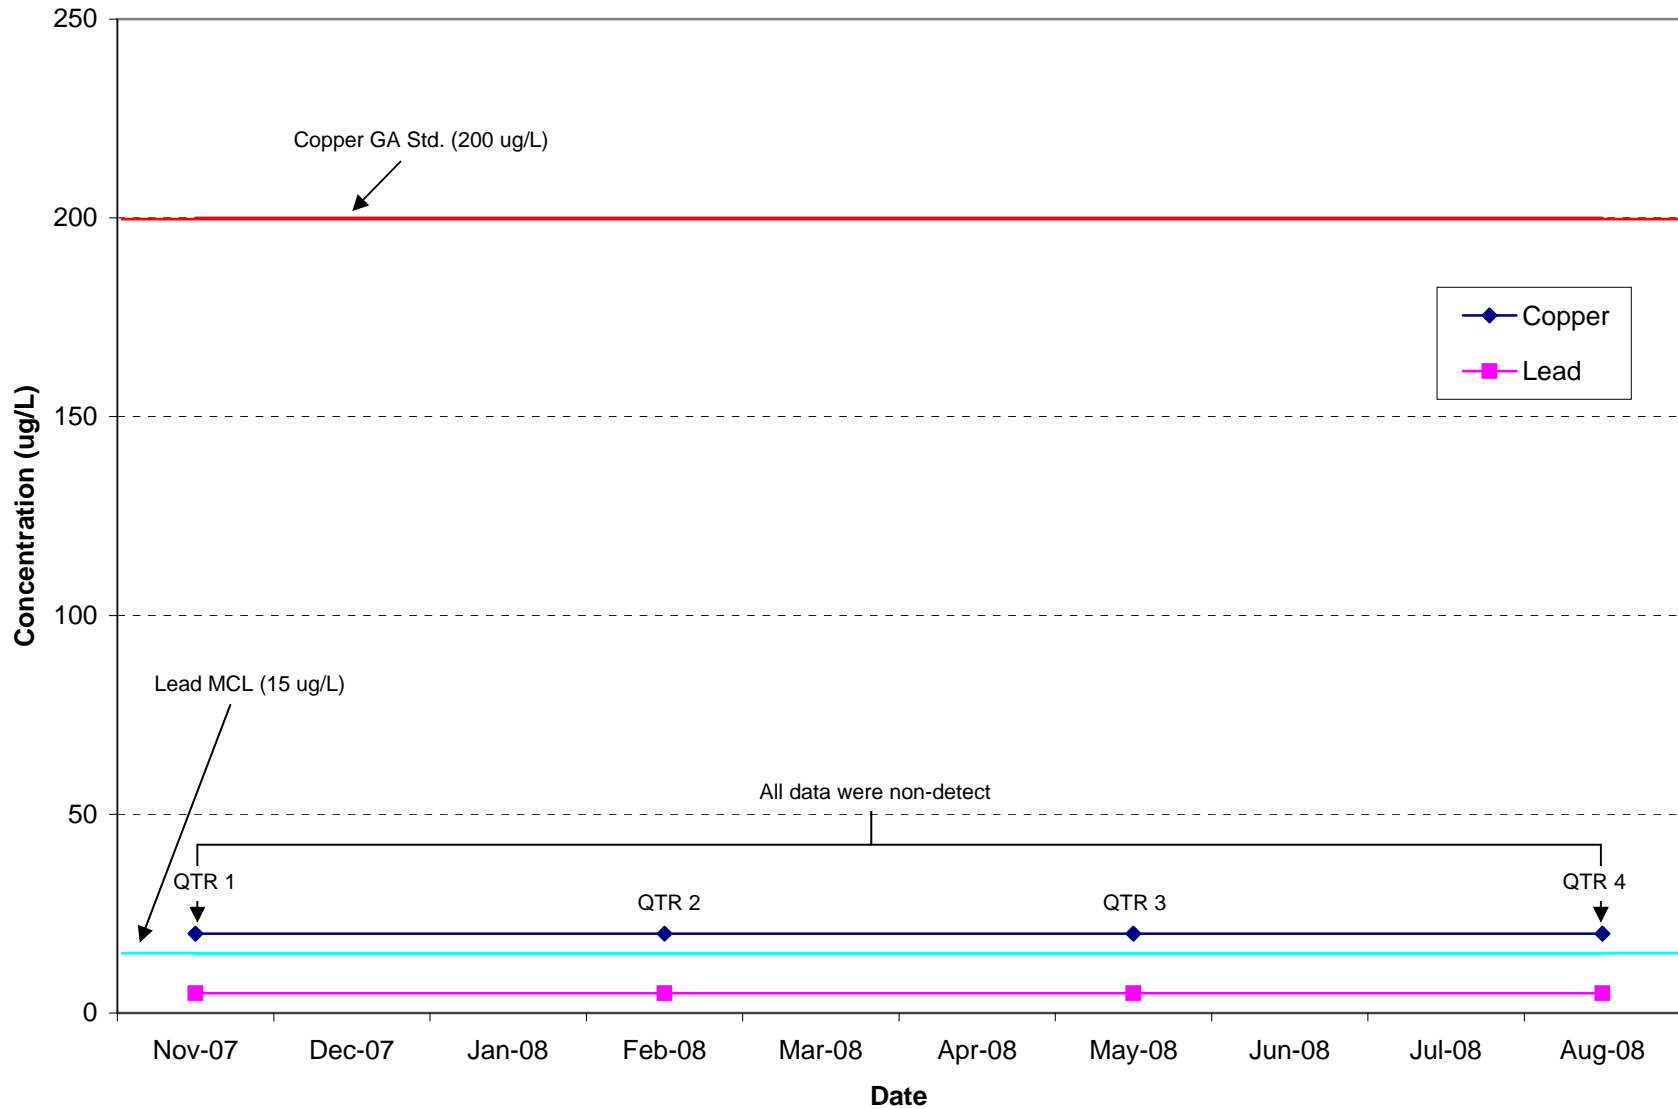
Figure 6
 Concentrations of Lead and Copper at MW23-3
 OB Grounds LTM Annual Report, Year 1
 Seneca Army Depot Activity

Note: Groundwater samples were collected on the following dates: November 21, 2007, February 25, 2008, May 21, 2008, and August 26, 2008.
 All groundwater concentrations were below detection limits.

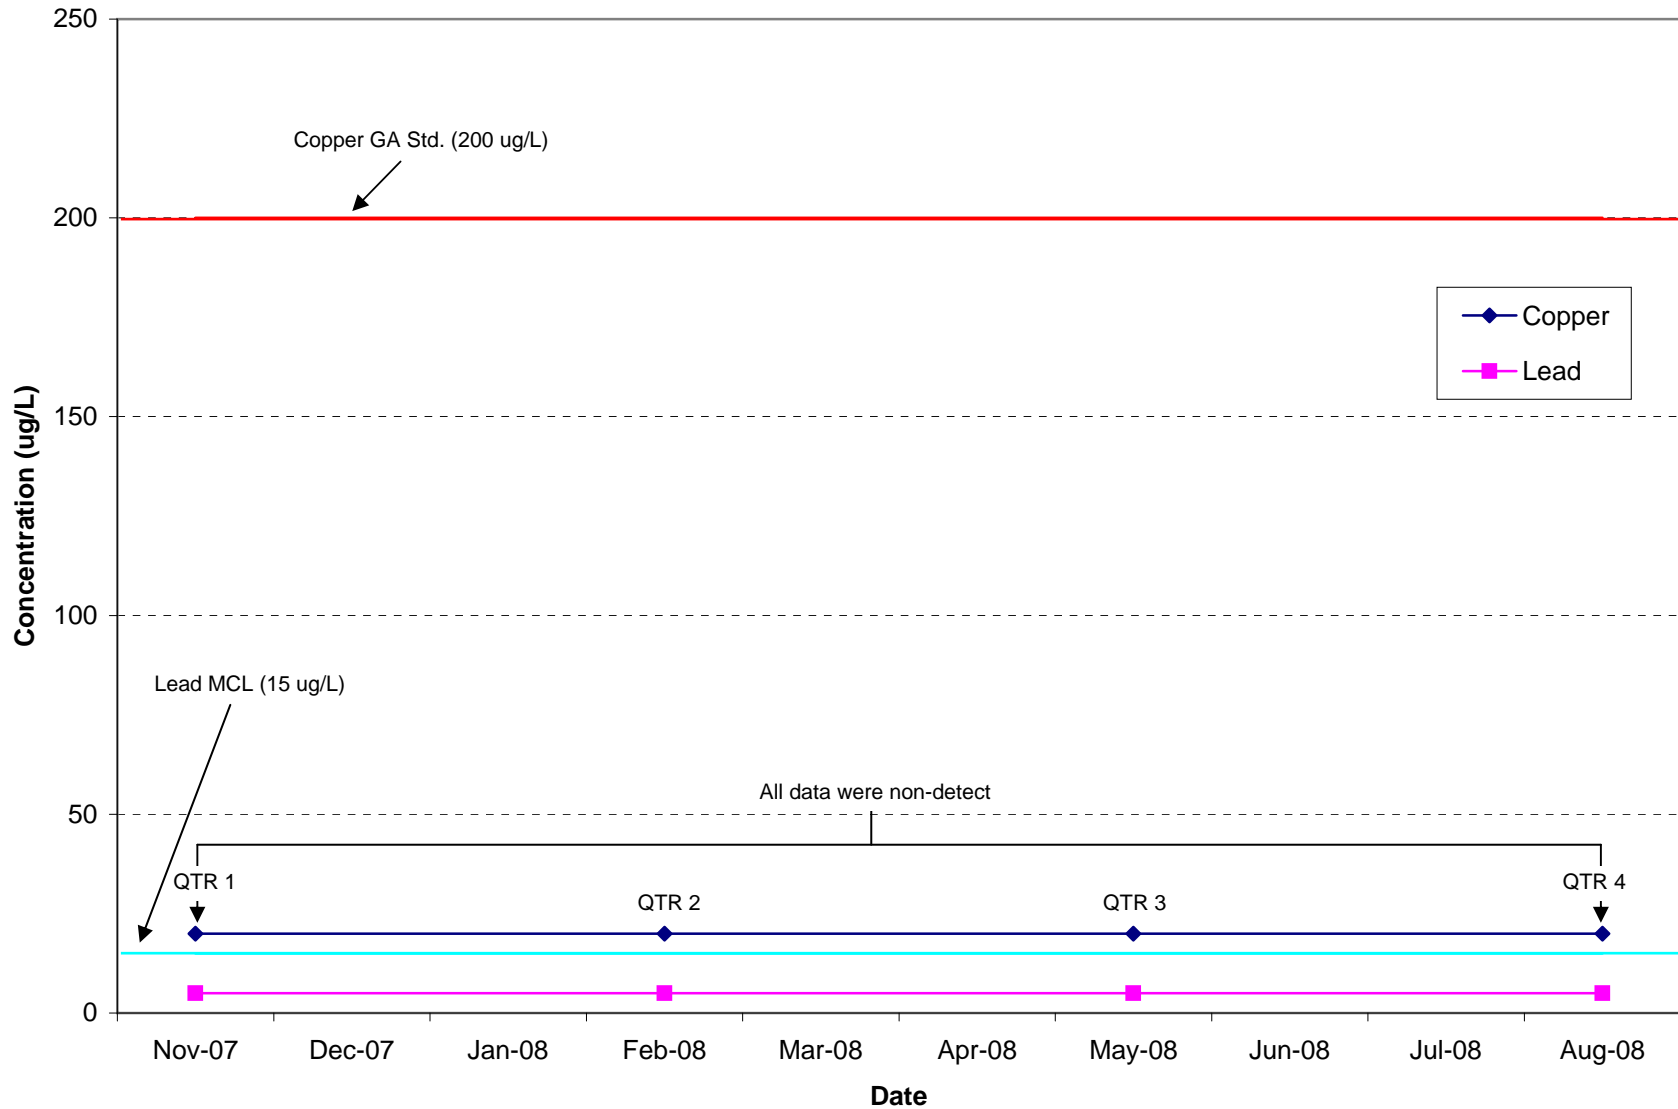
Figure 7
 Concentrations of Lead and Copper at MW23-4
 OB Grounds LTM Annual Report, Year 1
 Seneca Army Depot Activity

Note: Groundwater samples were collected on the following dates: November 21, 2007, February 25, 2008, May 21, 2008, and August 25, 2008.
 All groundwater concentrations were below detection limits.

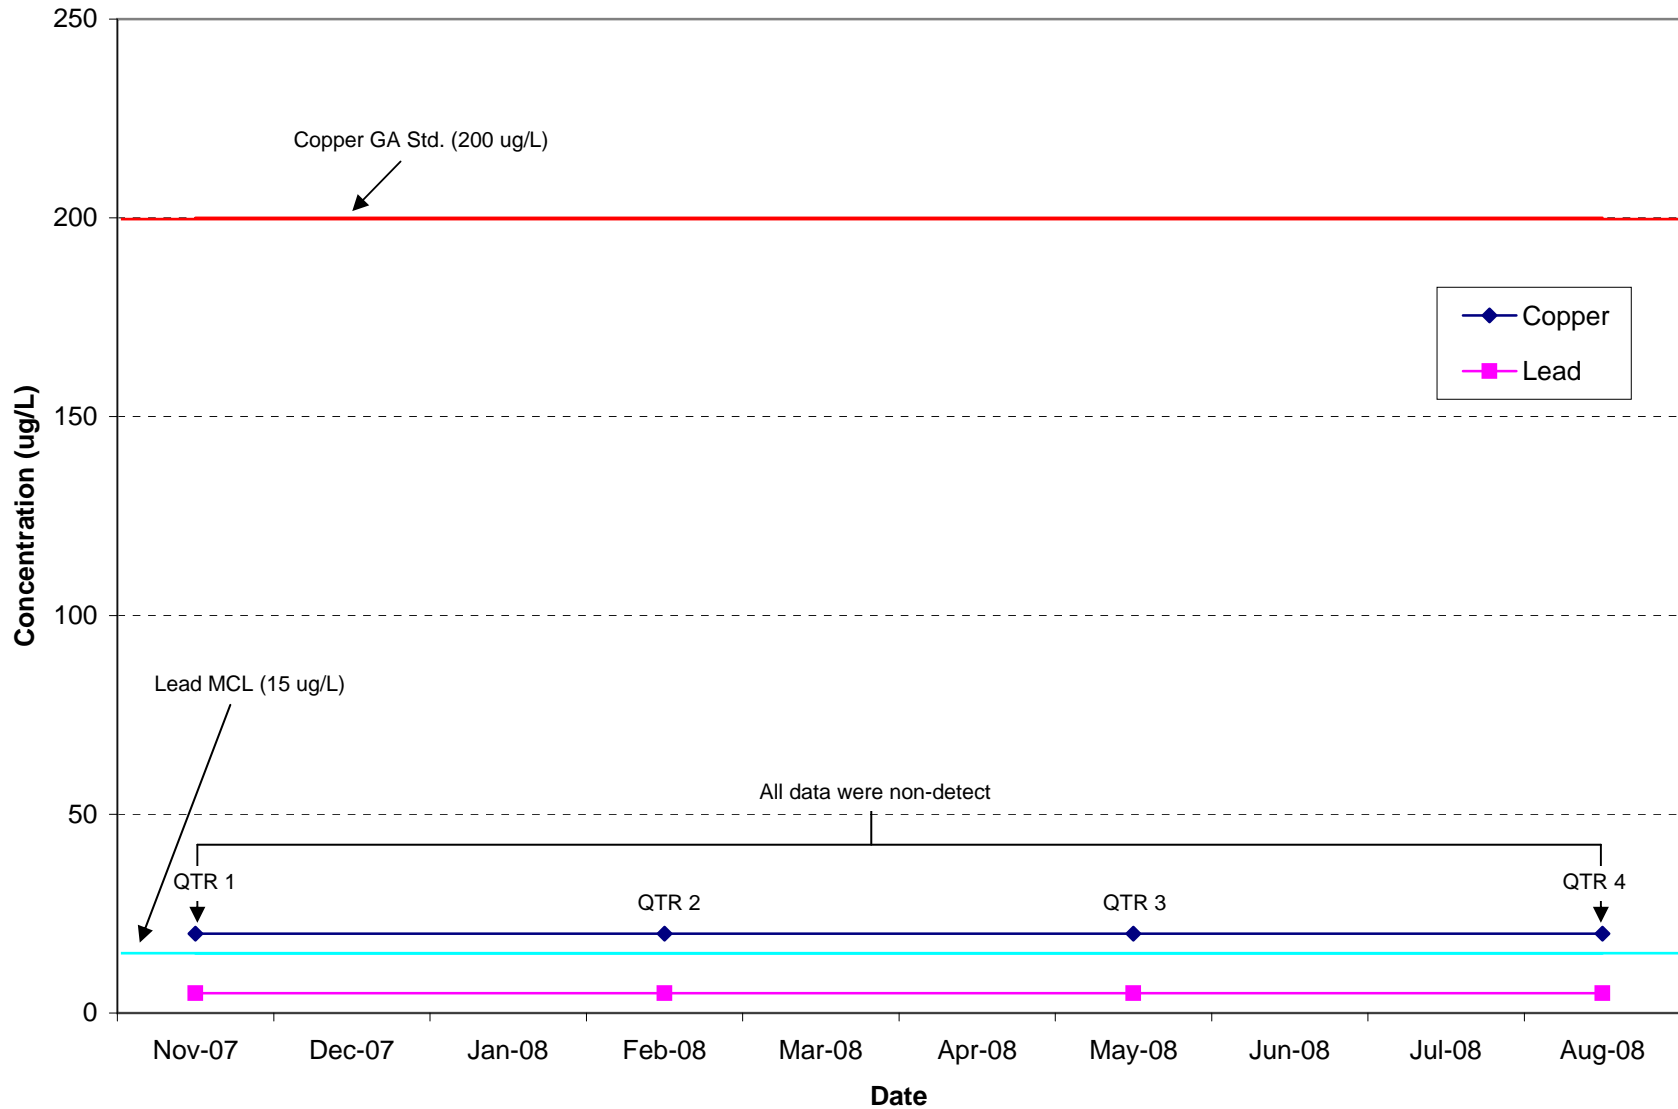
Figure 8
 Concentrations of Lead and Copper at MW23-5
 OB Grounds LTM Annual Report, Year 1
 Seneca Army Depot Activity

Note: Groundwater samples were collected on the following dates: November 21, 2007, February 25, 2008, May 21, 2008, and August 25, 2008.
 All groundwater concentrations were below detection limits.

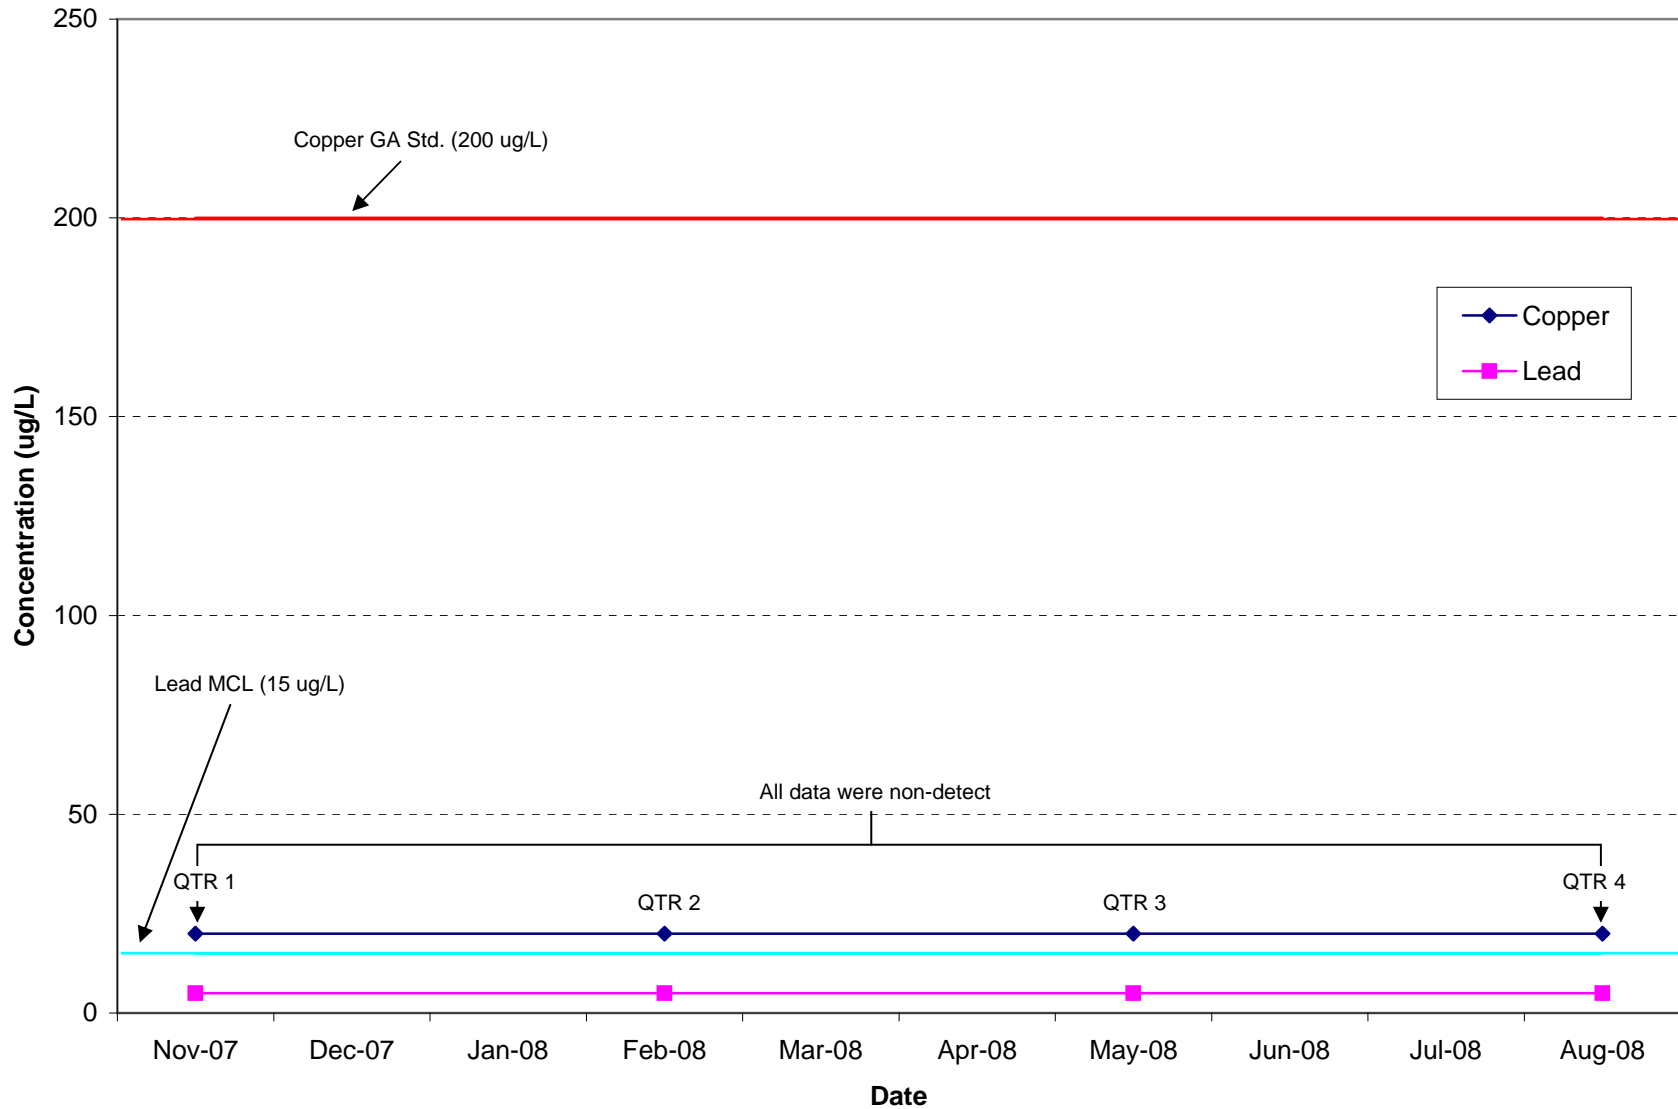
Figure 9
 Concentrations of Lead and Copper at MW23-6
 OB Grounds LTM Annual Report, Year 1
 Seneca Army Depot Activity

Note: Groundwater samples were collected on the following dates: November 28, 2007, February 25, 2008, May 20, 2008, and August 25, 2008.
 All groundwater concentrations were below detection limits.

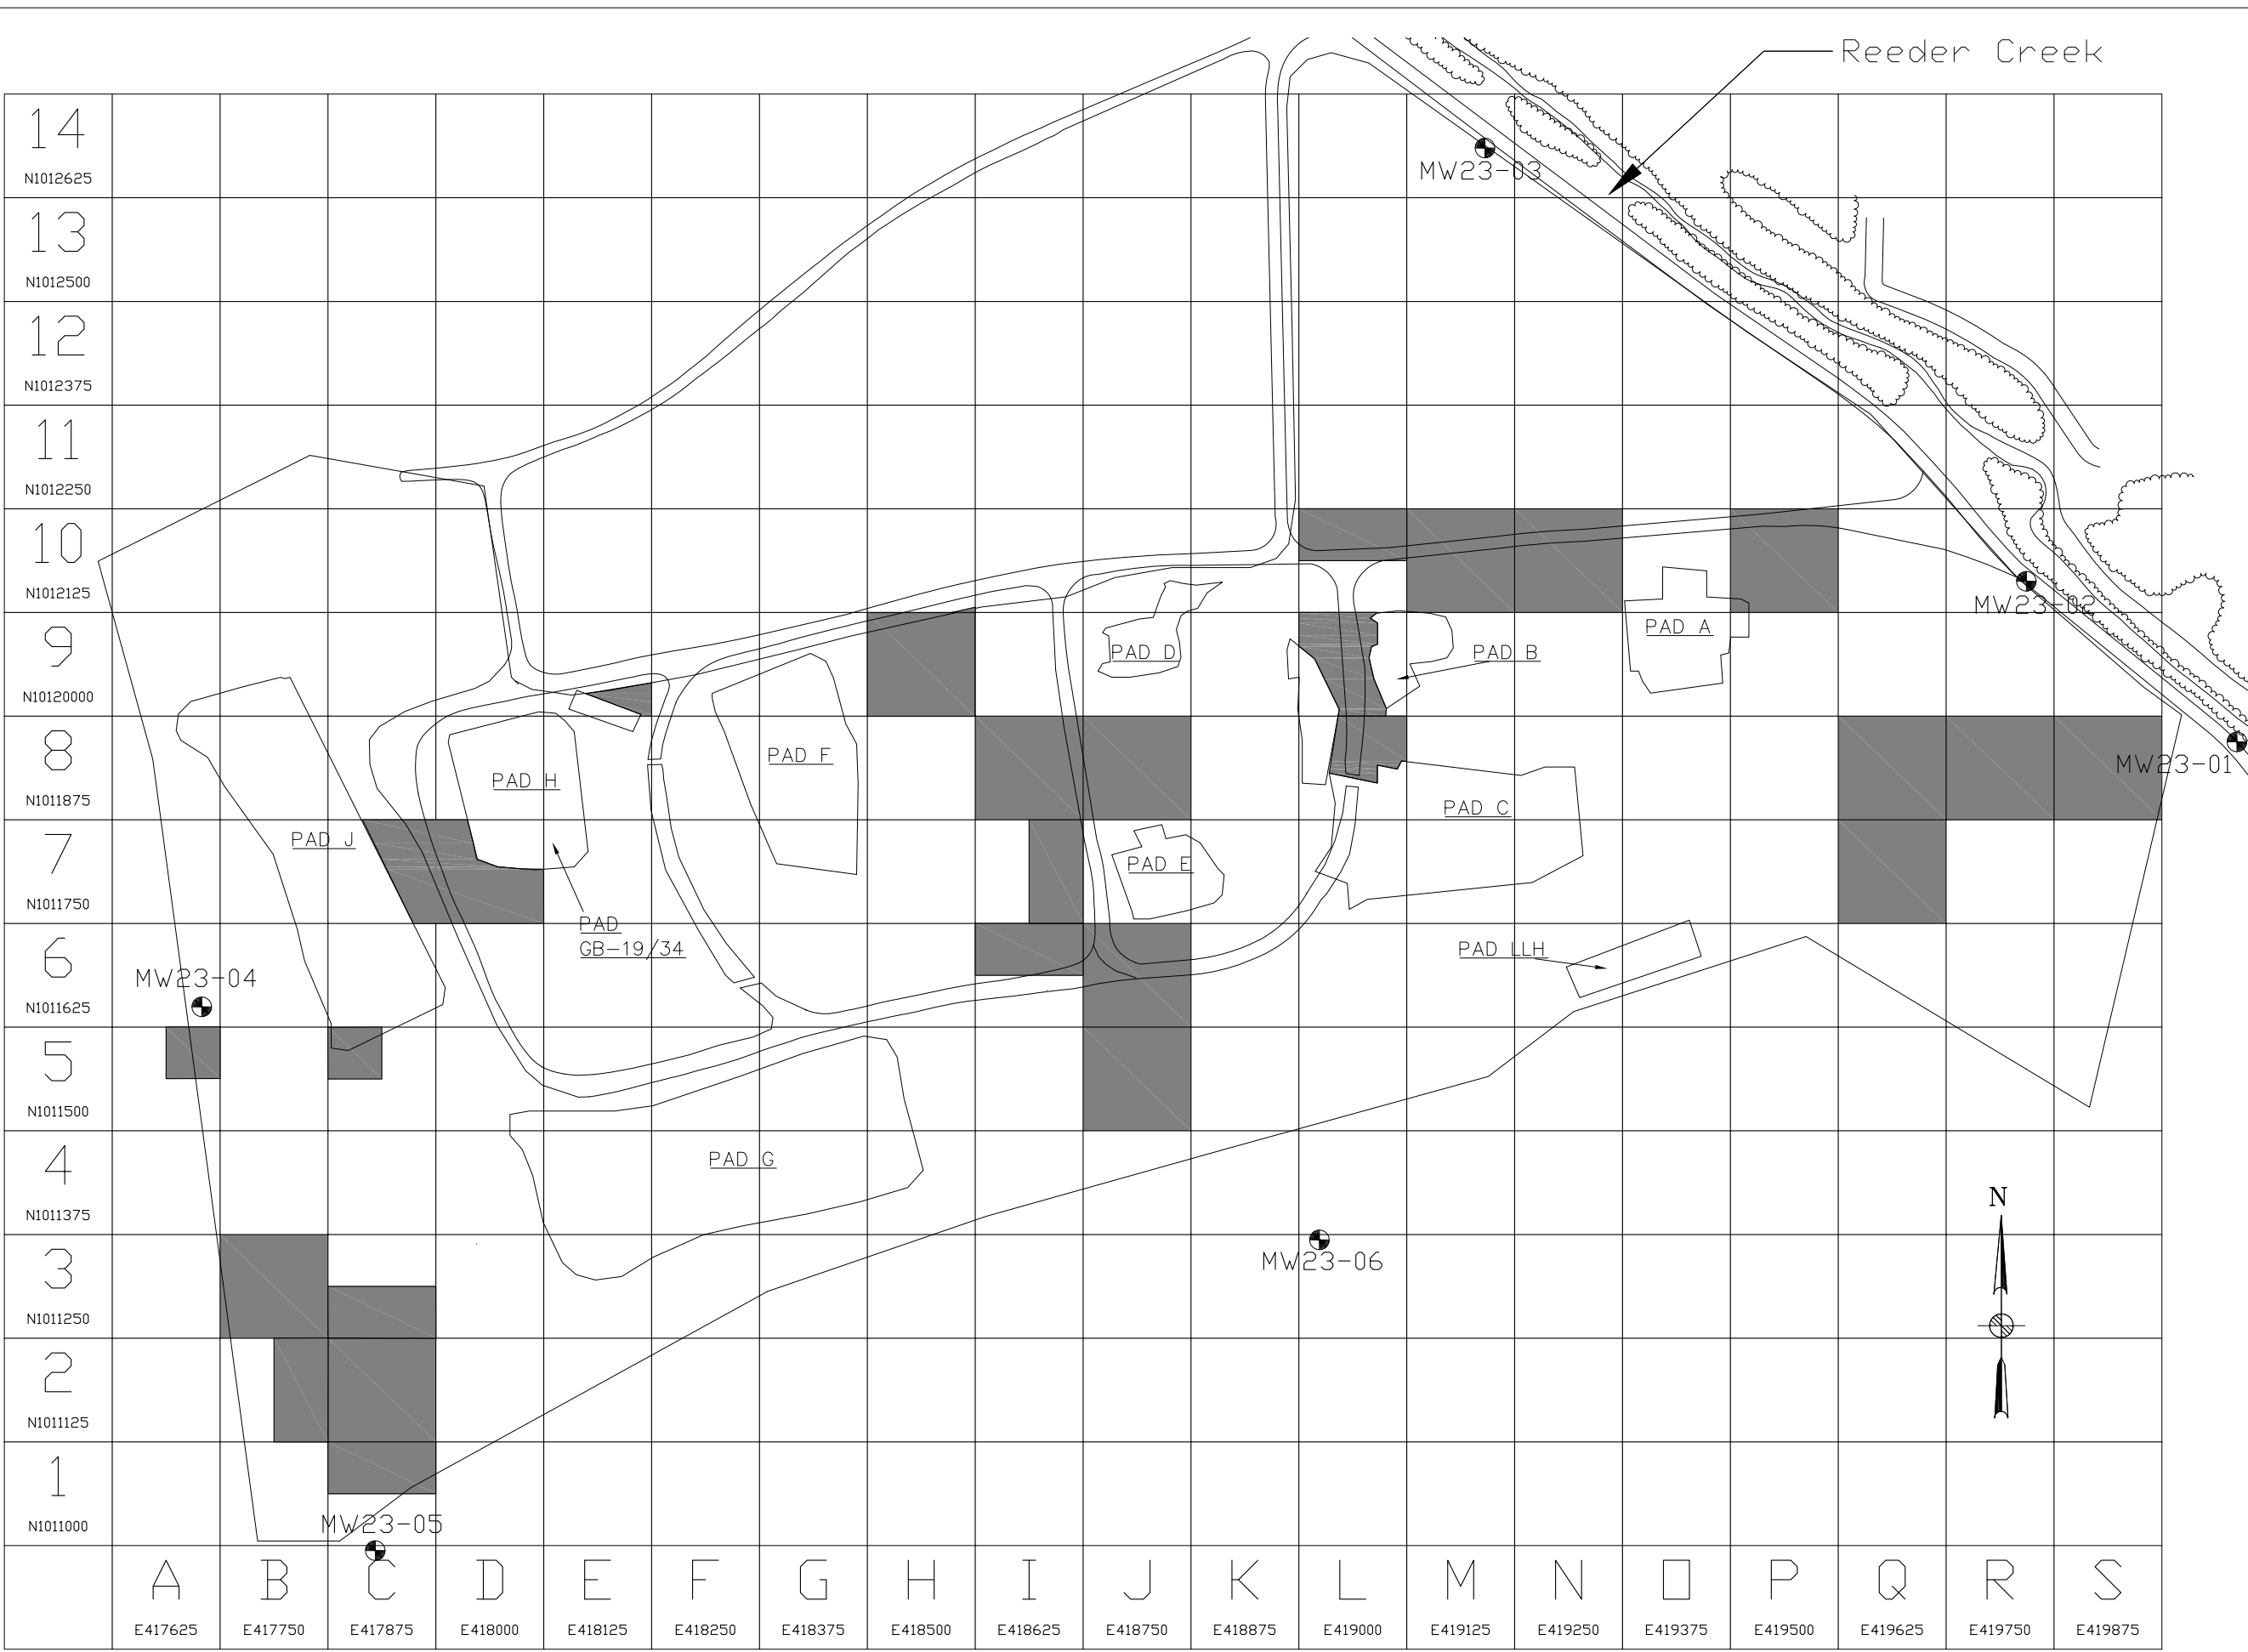
FIGURE 10
 OPEN BURNING GROUNDS
 SOIL CAP AREAS AND WELL LOCATIONS

The cap inspection consisted of documenting observations of the 25, 125- by 125-foot grids, where soils with residual lead concentrations between 60 mg/Kg and 500 mg/Kg were interred under a 9-inch soil cover. The locations of the grids are shown on **Figure 10**. Cap inspections were completed on January 10, February 25, May 20, and August 25, 2008 during the four monitoring events. Observations made during the cap inspections are noted below.

Minimal erosion and animal burrowing activity were observed in the capped areas. Less than half the grids had between one to six small holes (e.g., animal burrows) that extended between 2 and 6 inches deep into the cover. No holes were observed greater than this depth, indicating that the depth of the cap had not been penetrated. No excessive erosion was observed.

Minimal erosion and a lack of animal burrowing activity were observed in the capped areas. There had been surface melt of snow and the accumulation of new snow, since the Round 1 cap inspection was completed. Shallow surface water drainage paths were observed in three grids (L8, I8, and J6). At Grid I8, sparse vegetation was observed.

Minimal erosion and a lack of animal burrowing activity were observed in the capped areas. At Grid R8, a mouse hole approximately 6 inches wide and approximately 6 inches deep was observed. The mouse hole was repaired in August 2008.

The observations were reported to the Army, and the washout areas observed in grids L8, I8, and J6 were repaired in May 2008. The areas of the cap that were sparsely vegetated were reseeded.
