SUBJECT: Final Annual Report and One-Year Review for the Open Burning Grounds at Seneca Army Depot Activity; Contract DACA87-02-D-0005, Delivery Order 0036

Delivery Order No. 0036 EPA Site ID# NY0213820830 NY Site ID# 8-50-006

FOR THE OPEN BURNING GROUNDS SENECA ARMY DEPOT ACTIVITY, ROMULUS, NEW YORK

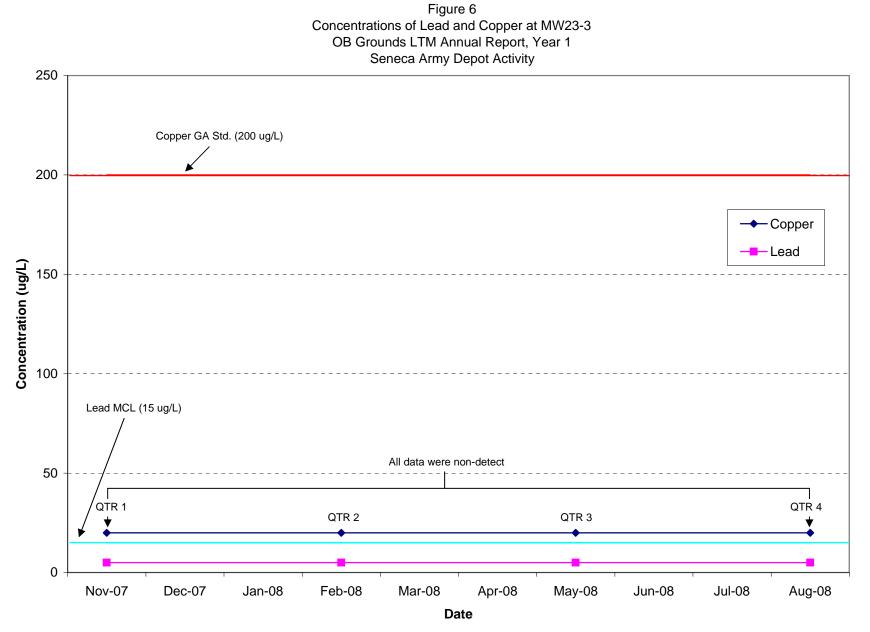
Note: Groundwater samples were collected on the following dates: November 21, 2007, February 25, 2008, May 21, 2008, and August 26, 2008. All groundwater concentrations were below detection limits.

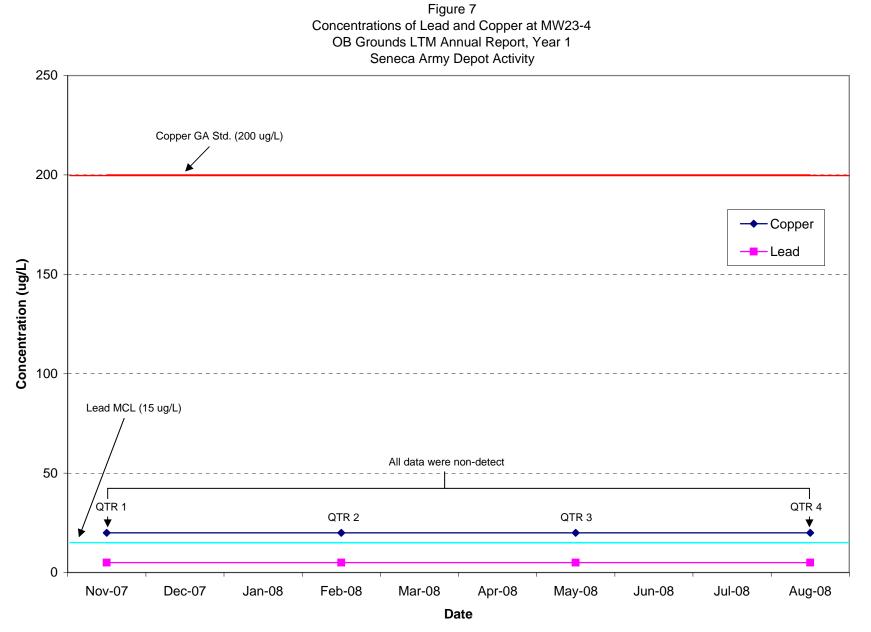
Note: Groundwater samples were collected on the following dates: November 21, 2007, February 25, 2008, May 21, 2008, and August 25, 2008. All groundwater concentrations were below detection limits.

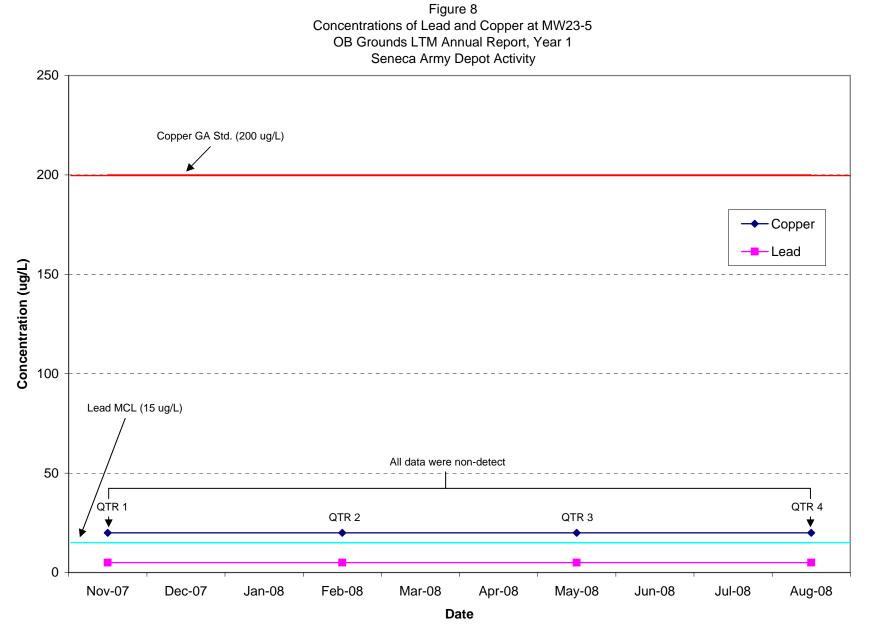
Note: Groundwater samples were collected on the following dates: November 21, 2007, February 25, 2008, May 21, 2008, and August 25, 2008. All groundwater concentrations were below detection limits.
