SUBJECT: Final Annual Report and One-Year Review for the Open Burning Grounds at Seneca Army Depot Activity; Contract DACA87-02-D-0005, Delivery Order 0036

October 2009

FINAL

FOR THE OPEN BURNING GROUNDS SENECA ARMY DEPOT ACTIVITY, ROMULUS, NEW YORK

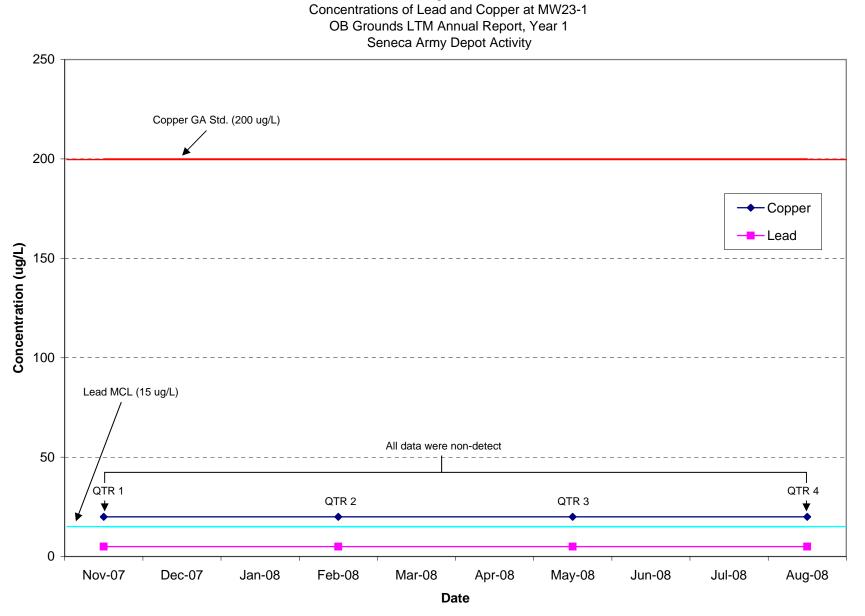
Figure 4

Note: Groundwater samples were collected on the following dates: November 21, 2007, February 25, 2008, May 21, 2008, and August 26, 2008. All groundwater concentrations were below detection limits.

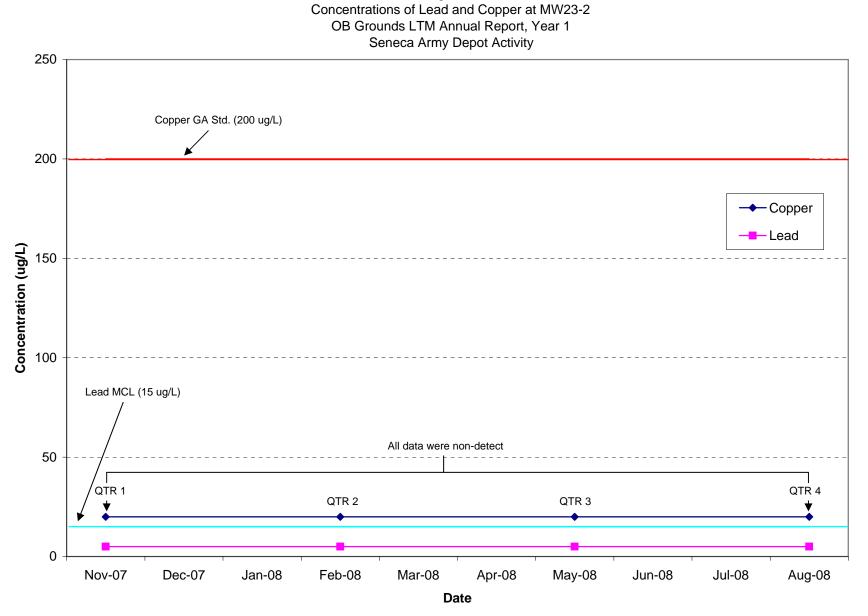
Figure 5

Note: Groundwater samples were collected on the following dates: November 21, 2007, February 25, 2008, May 21, 2008, and August 26, 2008. All groundwater concentrations were below detection limits.

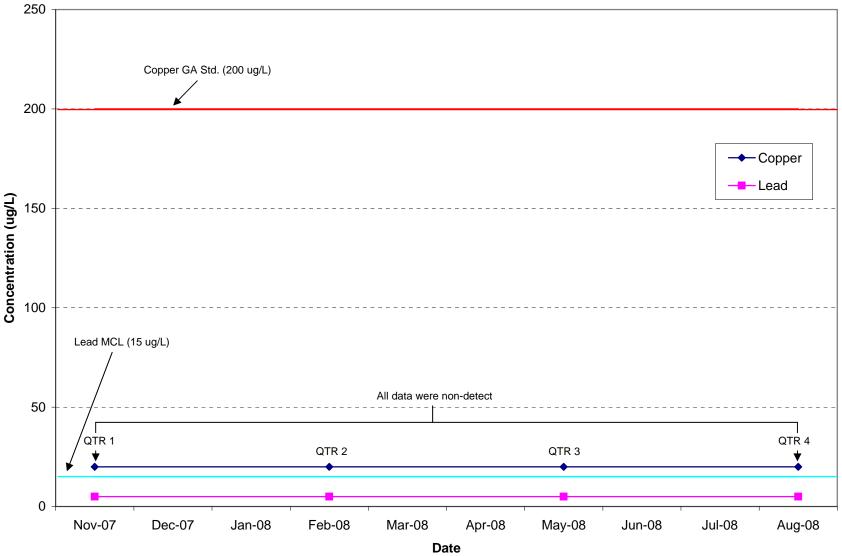
Figure 9 Concentrations of Lead and Copper at MW23-6 OB Grounds LTM Annual Report, Year 1 Seneca Army Depot Activity

Note: Groundwater samples were collected on the following dates: November 28, 2007, February 25, 2008, May 20, 2008, and August 25, 2008. All groundwater concentrations were below detection limits.

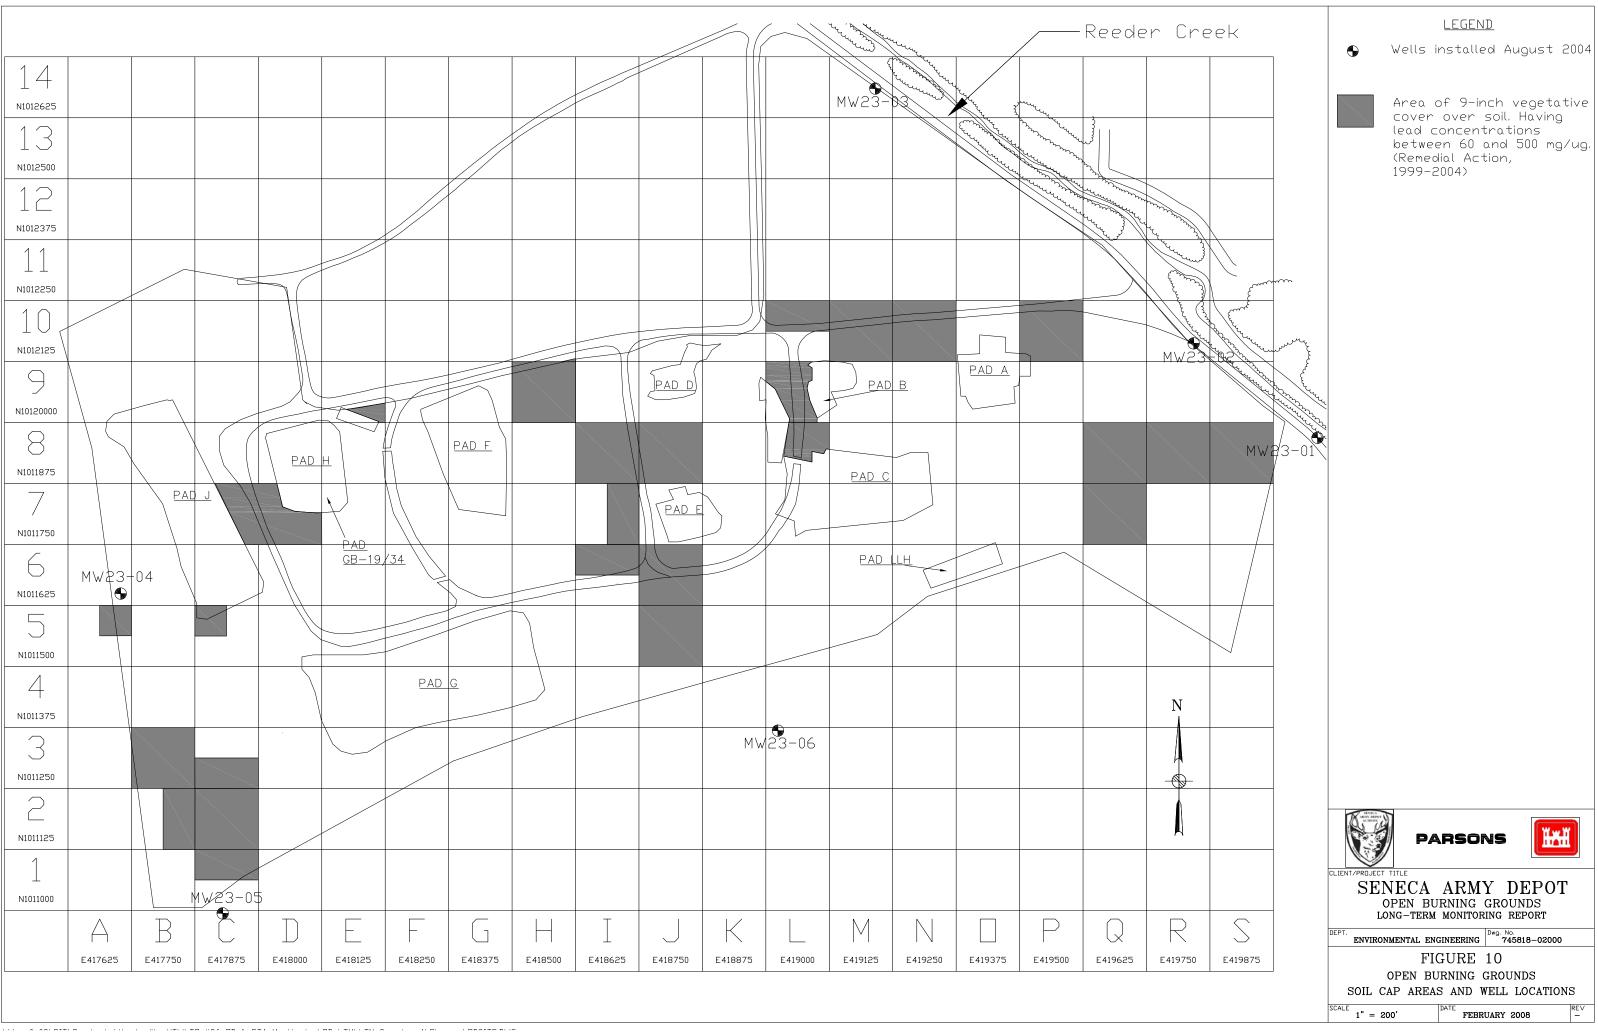
Minimal erosion and animal burrowing activity were observed in the capped areas. Less than half the grids had between one to six small holes (e.g., animal burrows) that extended between 2 and 6 inches deep into the cover. No holes were observed greater than this depth, indicating that the depth of the cap had not been penetrated. No excessive erosion was observed.

Minimal erosion and a lack of animal burrowing activity were observed in the capped areas. There had been surface melt of snow and the accumulation of new snow, since the Round 1 cap inspection was completed. Shallow surface water drainage paths were observed in three grids (L8, I8, and J6). At Grid I8, sparse vegetation was observed.

Minimal erosion and a lack of animal burrowing activity were observed in the capped areas. At Grid R8, a mouse hole approximately 6 inches wide and approximately 6 inches deep was observed. The mouse hole was repaired in August 2008.

The observations were reported to the Army, and the washout areas observed in grids L8, I8, and J6 were repaired in May 2008. The areas of the cap that were sparsely vegetated were reseeded.
