# 2017 LAND USE CONTROLS INSPECTION SEAD 1, 2, 5, 12, 13, 16, 17, 25, 26, 27, 39, 40, 41

# DRAFT 2017 LAND USE CONTROLS INSPECTION REPORT

SEAD 1, 2, 5, 12, 13, 16, 17, 25, 26, 27, 39, 40, 41, 43, 44A, 44B, 52, 56, 59, 62, 64A, 64B, 64C, 64D, 66, 67, 69, 71, 121C, 121I, 122B, 122E, AND THE ASH LANDFILL OPERABLE UNIT (SEADs 3, 6, 8, 14, and 15) SENECA ARMY DEPOT ACTIVITY, ROMULUS, NEW YORK

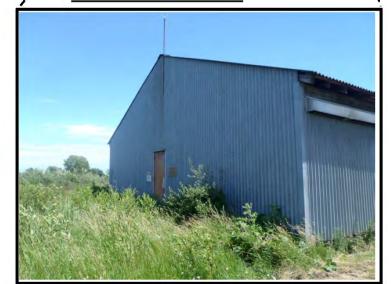
### 2017 Site Visit Photo 1

Status as of: 6/26/2017 Description: Building 307

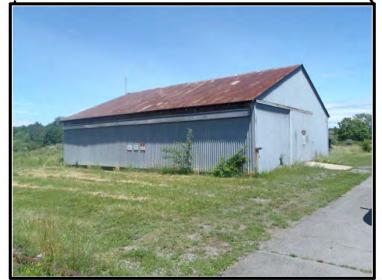
### 2017 Site Visit Photo 2

Status as of: 6/26/2017 Description: Building 307

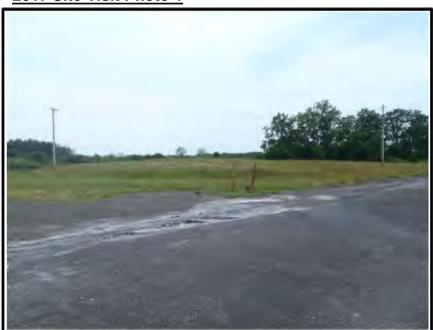
2017 Site Visit Photo 1

Status as of: 6/29/2017 Description: SEAD-5 Cap

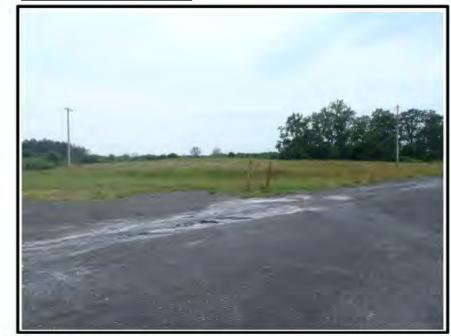
# 2017 Site Visit Photo 2

Status as of: 6/29/2017 Description: SEAD-5 cap

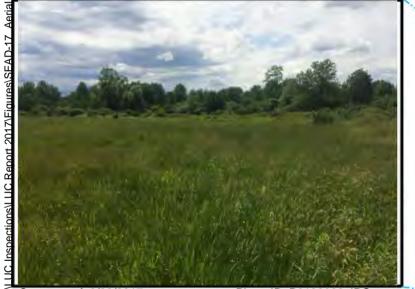
### 2017 Site Visit Photo 1

Description: SEAD-17, Building 367 foundation.

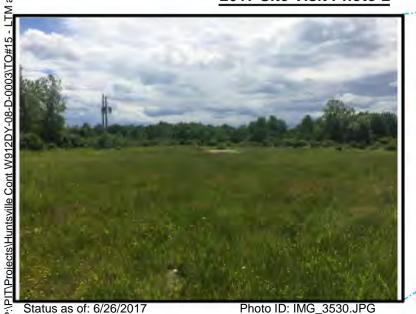
2017 Site Visit Photo 2

Description: SEAD-17, Building 367 foundation.

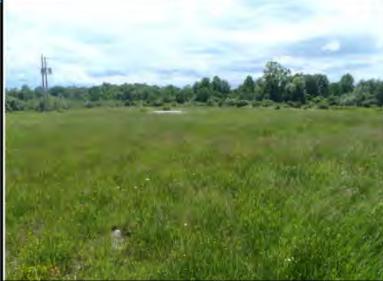
### 2017 Site Visit Photo 3

Status as of: 6/26/2017 Photo ID: P6260058.JPG Description: SEAD-17, Building 367 foundation.

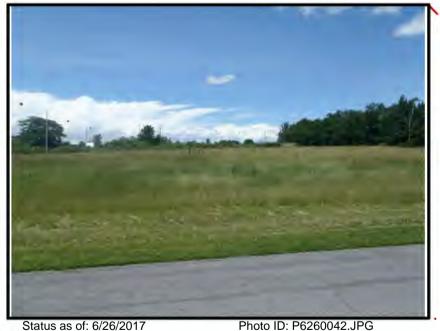
### 2017 Site Visit Photo 1

Status as of: 6/26/2017 Description: SEAD-25 Former Pad Area

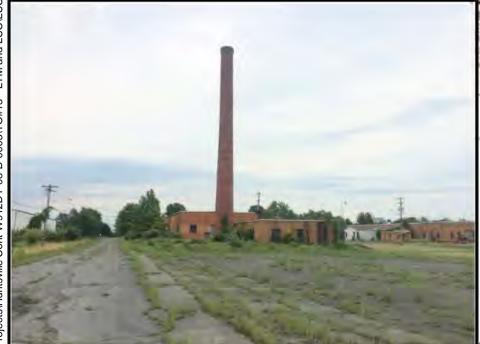
### 2017 Site Visit Photo 1

Status as of: 6/29/2017 Photo ID: IMG\_3597.JPG Description: SEAD-39 blowdown pit in foreground

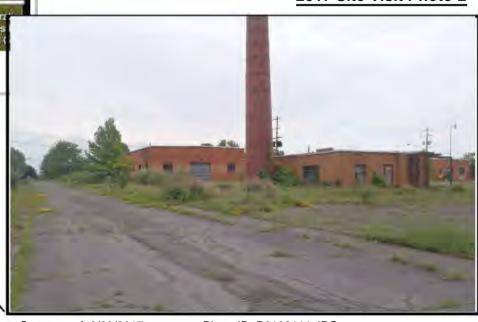
### 2017 Site Visit Photo 2

Status as of: 6/29/2017 Photo ID: P6130111.JPG Description: SEAD-39, area of blowdown leaching pit.

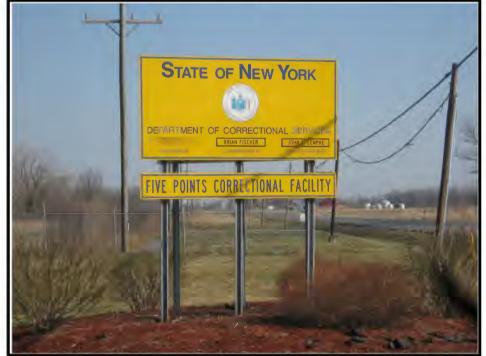
#### 2017 Site Visit Photo 1

Status as of: 6/26/17 Photo ID: IMG\_4088.JPG Description: Entrance to Correctional Facility. Photos within the Correctional Facility are prohibited.

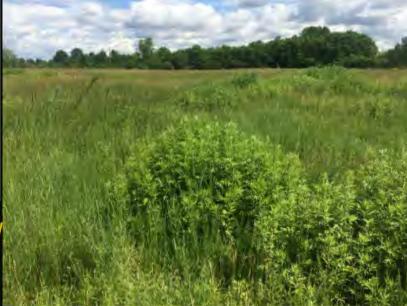
#### 2017 Site Visit Photo 4

Status as of: 6/26/17 Description: Surface of NCLF.

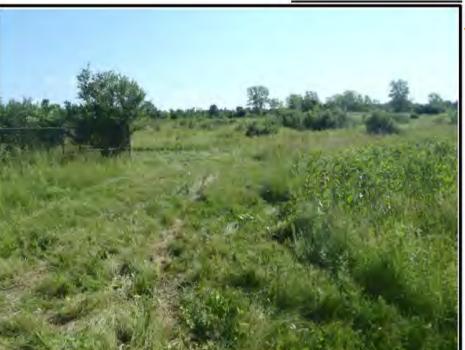
Description: Looking north across portion of biowall within the Ash 2017 Site Visit Photo 6

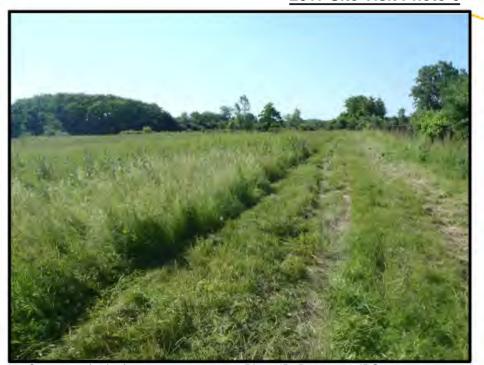
Status as of: 6/26/17 Photo ID: P6280086.JPG Description: Looking south across the western portion of Ash Landfill.
