SUBJECT: Final Land Use Controls Inspection for the Former Seneca Army Depot in Romulus, NY;
EPA Site ID# NY0213820830 and NY Site ID# 8-50-006

2023 LAND USE CONTROLS INSPECTION REPORT FINAL

Former Seneca Army Depot Romulus, New York

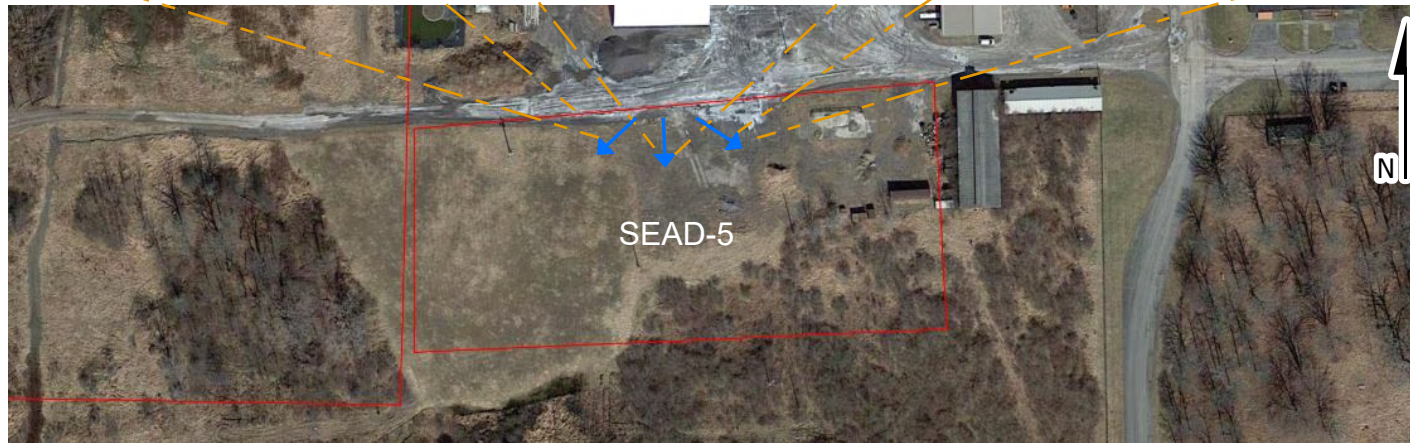
Figure B-3
 SEAD-5
 2023 LUC Inspection - Photo Log
 Former Seneca Army Depot
 Romulus, New York
 Map Date: 7/13/2023 11:44 AM
 Source: Google Earth 2020
 Projection: NAD 1983 (2011) StatePlane
 New York Central FIPS 3102 Ft US

2.1.4.4.1 SEAD-5 was inspected on 26 June 2023 to assess whether required LUCs imposed by the approved RODs are being maintained (**Tables 1 and 2**). The site inspection confirmed that no prohibited facilities (residential housing, schools, childcare facilities, and playgrounds) were present or had been constructed at the site and no access to, or use of, groundwater was evident. No evidence of unauthorized excavations or digging was present at the site. The soil cap and vegetative cover was observed to be in good condition. Photographs from the LUC inspection are provided in **Appendix B, Figure B-3**. LUC inspection forms are provided in **Appendix C**. The selected remedy is still protective of public health and the environment.

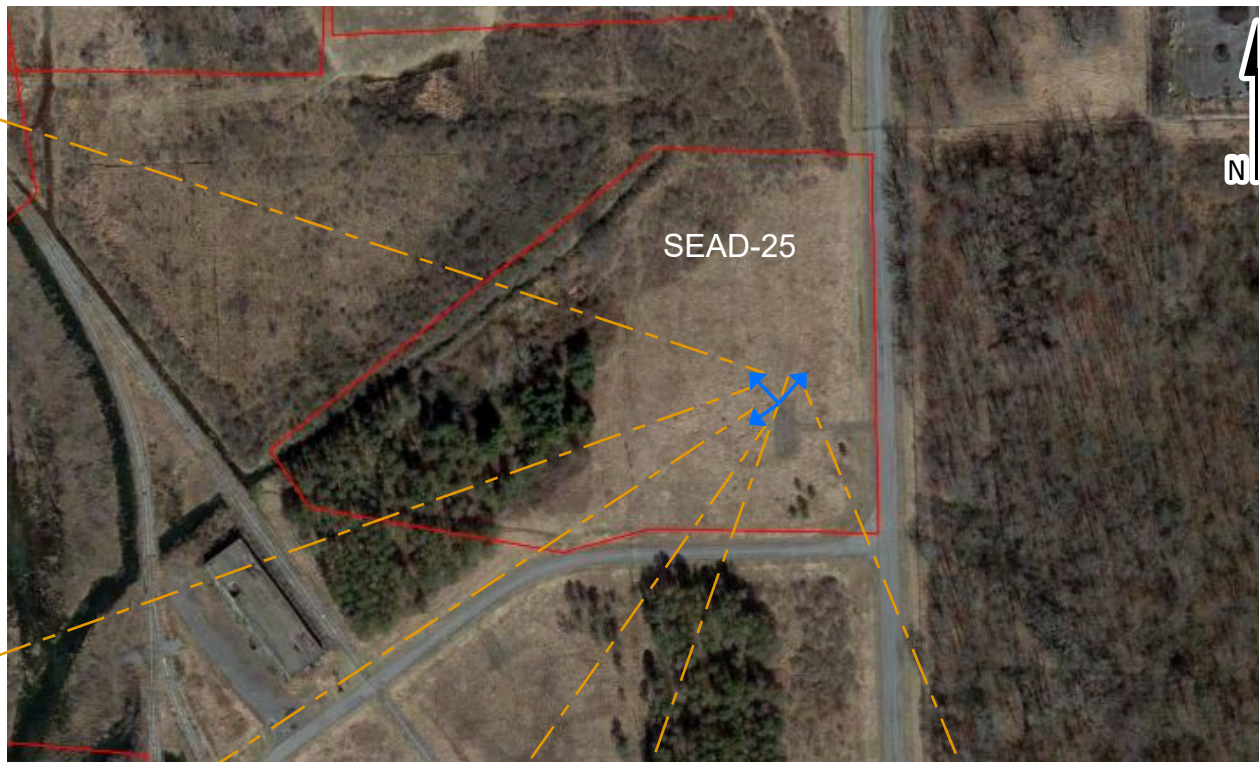
Figure B-6
 SEAD-25
 2023 LUC Inspection - Photo Log
 Former Seneca Army Depot
 Romulus, New York
 Map Date: 7/13/2023 12:14 PM
 Source: Google Earth 2020
 Projection: NAD 1983 (2011) StatePlane
 New York Central FIPS 3102 Ft US

2.1.7.4.1 SEAD-25 was inspected on 27 June 2023 to assess whether required LUCs imposed by the approved RODs are being maintained (**Tables 1 and 2**). The site inspection confirmed that no prohibited facilities (residential housing, schools, childcare facilities, and playgrounds) were present or had been constructed at the site and no access to, or use of, groundwater was evident beyond that which is gained by the existing monitoring well network. Monitoring well locks were in place and wells were in good condition aside from the evidence of heaving, causing the surface casing to not operate correctly. Photographs from the LUC inspection are provided in **Appendix B, Figure B-6**. LUC inspection forms are provided in **Appendix C**. The selected remedy is still protective of public health and the environment.
