FINAL INTERIM LAND USE CONTROL IMPLEMENTATION PLAN

**Open Detonation Grounds
Munitions Response Site**

**Former Seneca Army Depot
Romulus, New York**

February 2024

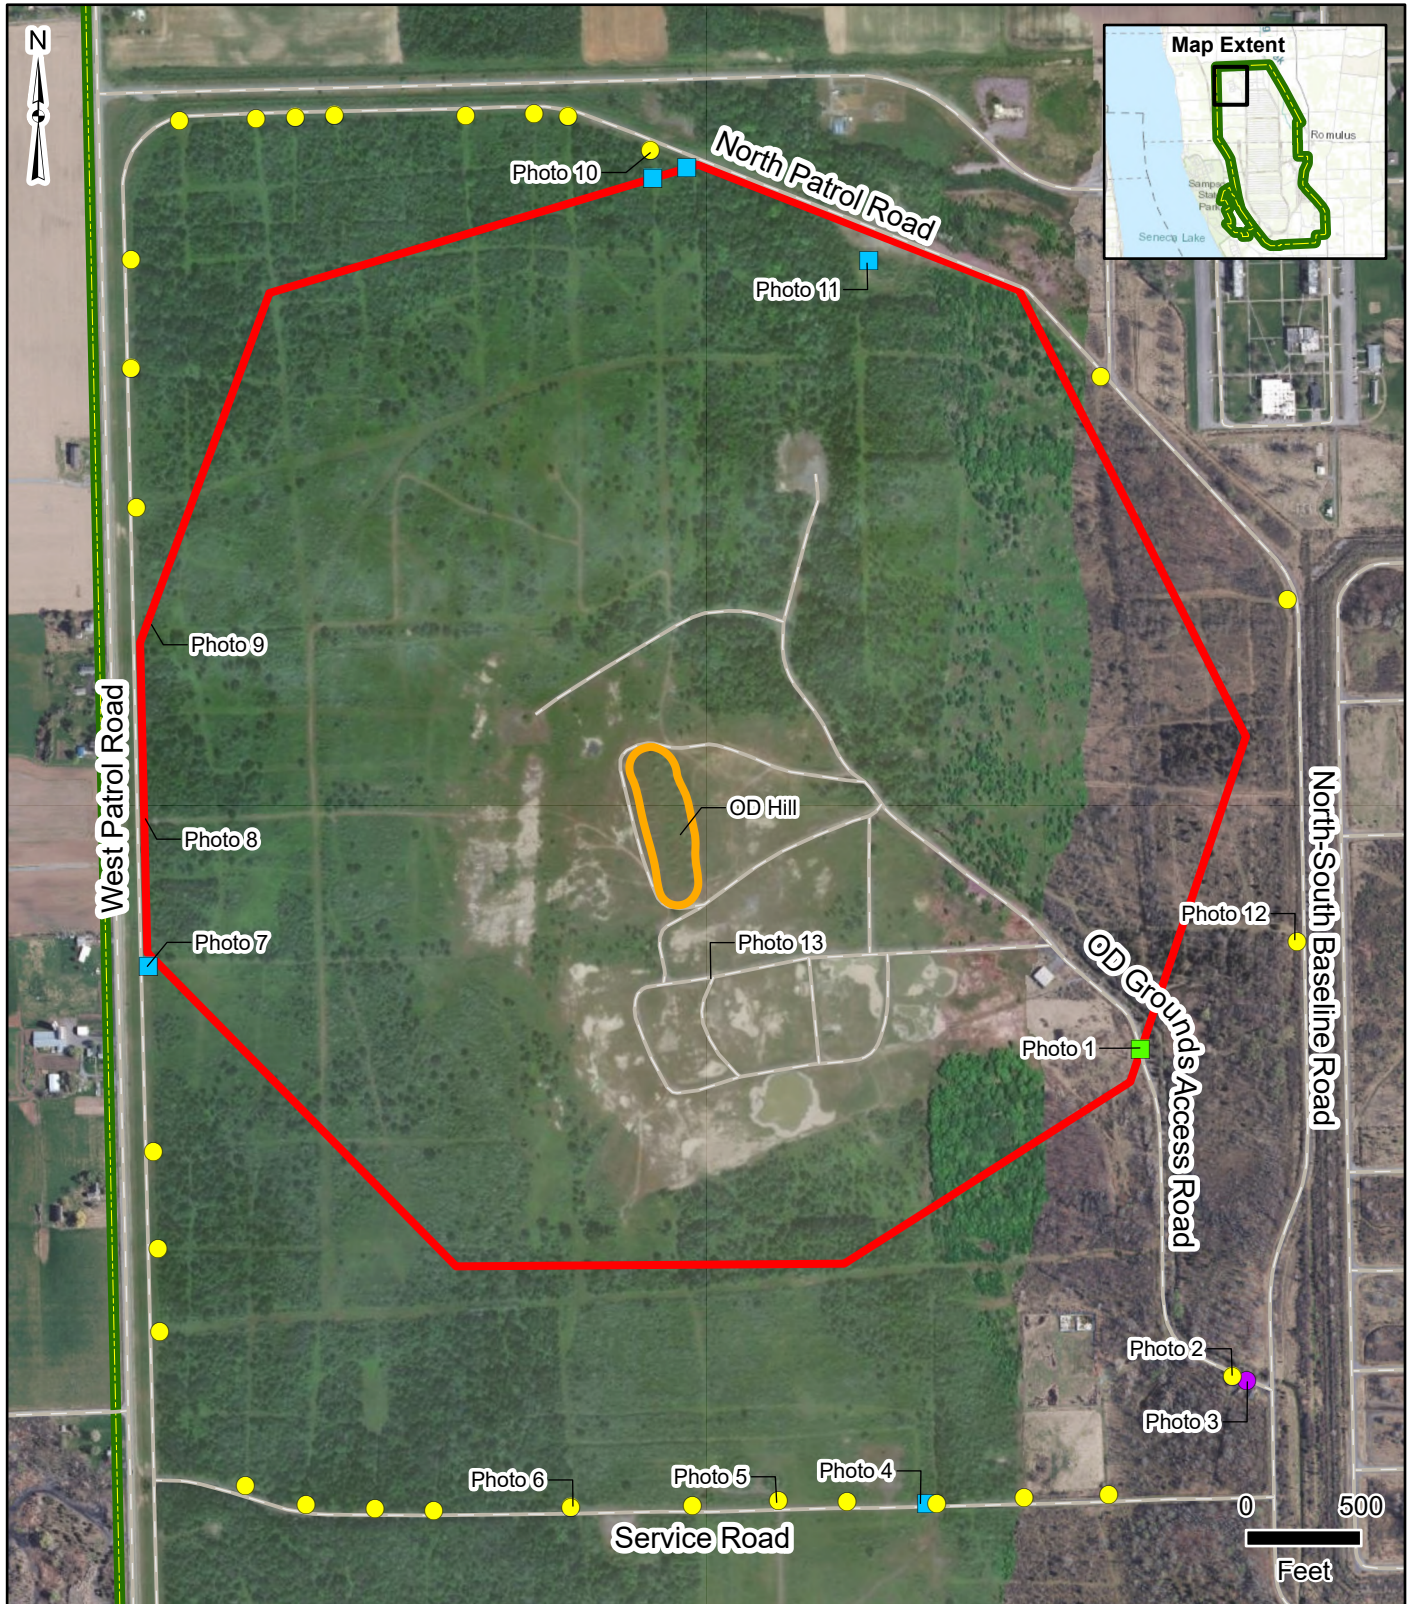
Figure 2-1
OD Grounds MRS Signage and Barrier Locations

MRS. Signage at these areas alert users that they are headed towards a boundary where unauthorized access is prohibited and that explosive danger is present. “Warning Signage” placement is presented on **Figure 2-1** and detailed below.

Jersey barriers accompanied by additional signage will be located at areas along the boundary of the OD Grounds MRS where the MRS abuts surrounding roads, and where evidence of illegal access has been observed (mowing and or worn vehicle tire paths, evidence of access directly from the boundary road onto the OD Grounds MRS). Jersey barrier locations are presented on **Figure 2-1**.

The entrance road, Seneca Army Depot Road, is the planned location for the construction of a locked gate to deter unauthorized access. This road is the only paved entrance to the OD Grounds. “Boundary Signage” will be placed alongside the gate to deter trespassing and alert all users to explosive hazards. An additional “Alert Sign” will be posted at the beginning of the road to alert users that a locked gate lies ahead, encouraging unauthorized users to turn around. A “Warning Sign” will also be posted at the beginning of the road to warn that a restricted area lies ahead, no unauthorized access is permitted, and that there is an explosive hazard. Gate placement and accompanying signage is presented on **Figure 2-1** and detailed below.

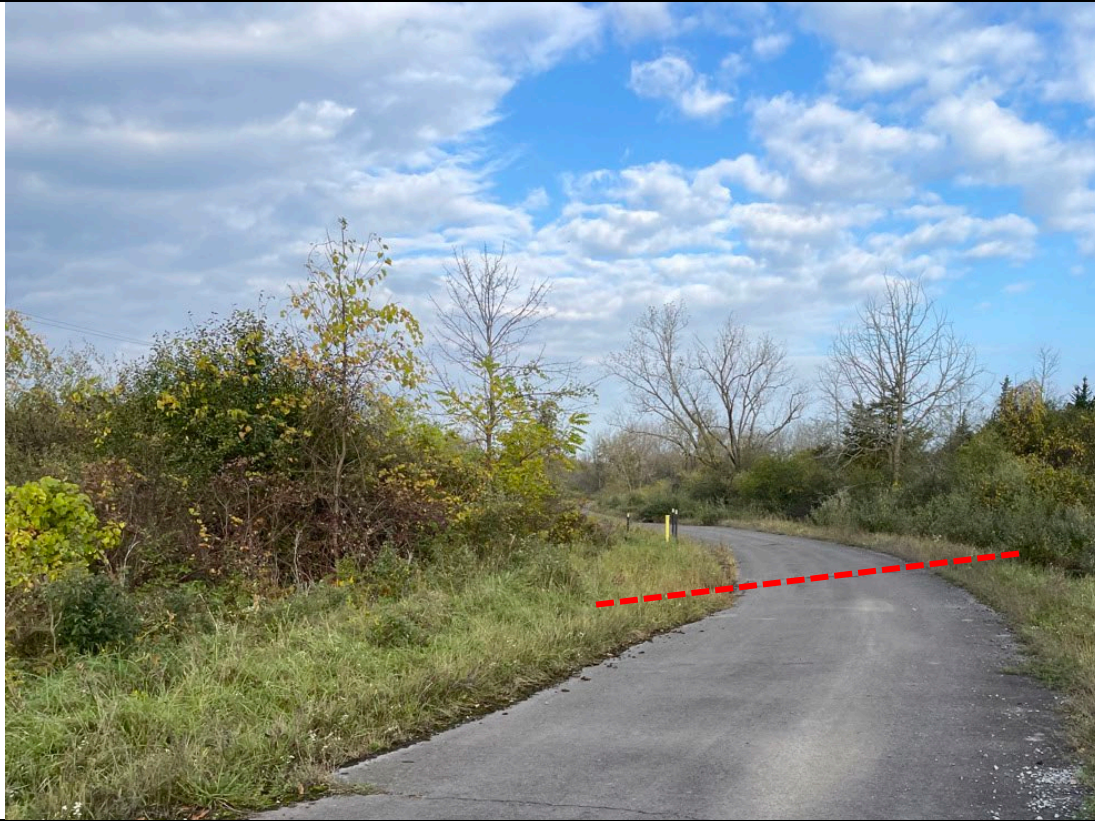
Photograph No. 1	Date: 10/12/2023
Direction Photo Taken: N	
Description: Boundary to OD Grounds MRS. Planned locked gate location. Red dashed line indicates potential gate location.

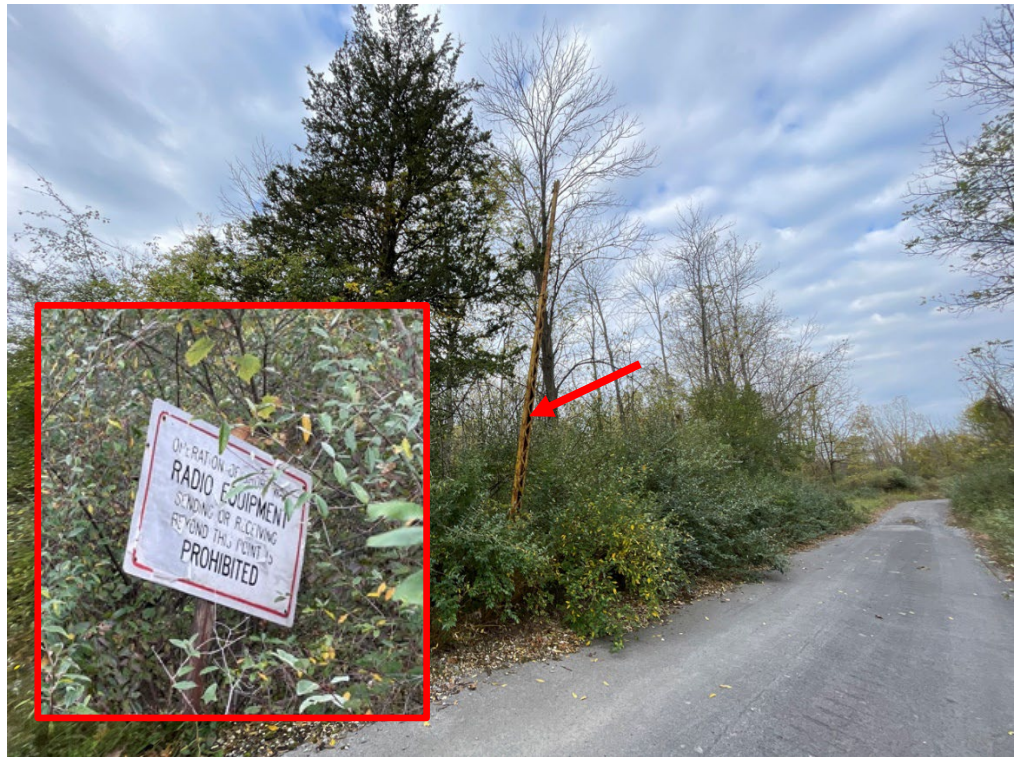
Photograph No. 2	Date: 10/12/2023
Direction Photo Taken: NE	
Description: Red arrow indicates historic gate left on site. Outside of OD Grounds property. Inset photo shows decrepit sign located across from the historic gate.

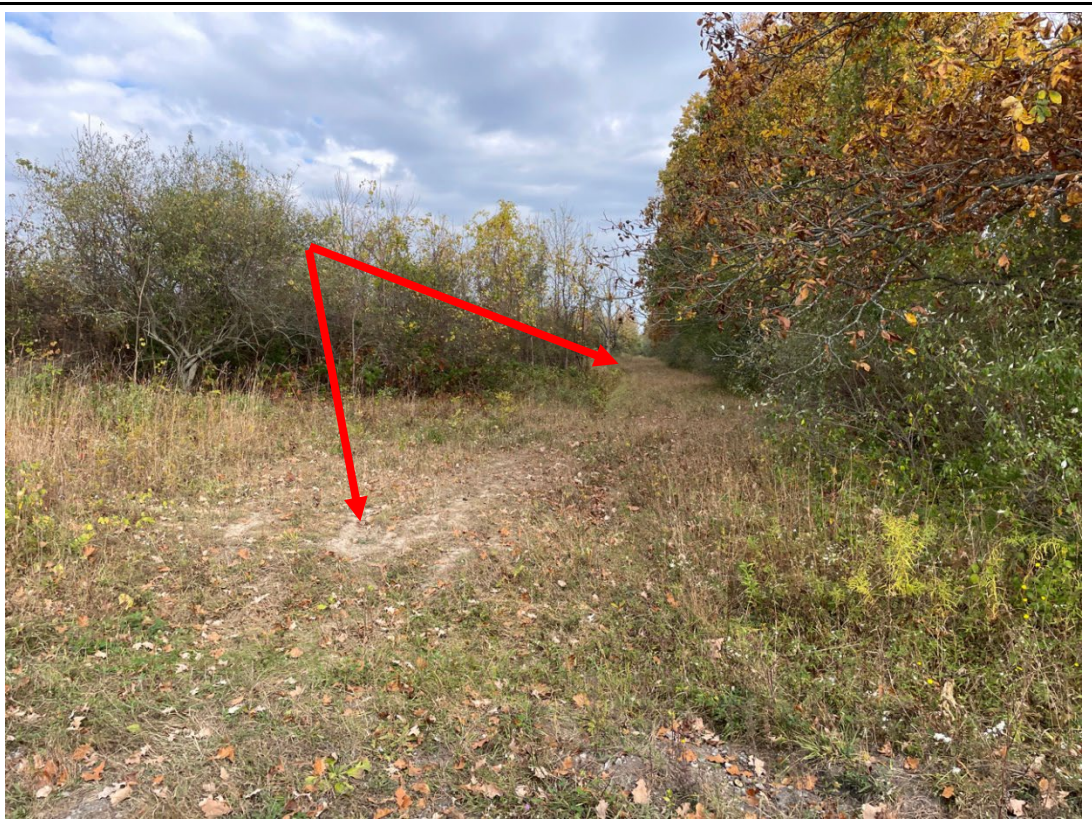
Photograph No. 4	Date: 10/12/2023

Direction Photo Taken: N		
Description: Photo taken along Seneca Army Depot Road, looking north. Photo taken from SEAD 003-R-01. Note the mowed path, and bare soil (indicated by red arrows). Cleared swatch of trees runs directly north toward OD Grounds MRS boundary. Suggested site for Jersey Barriers.

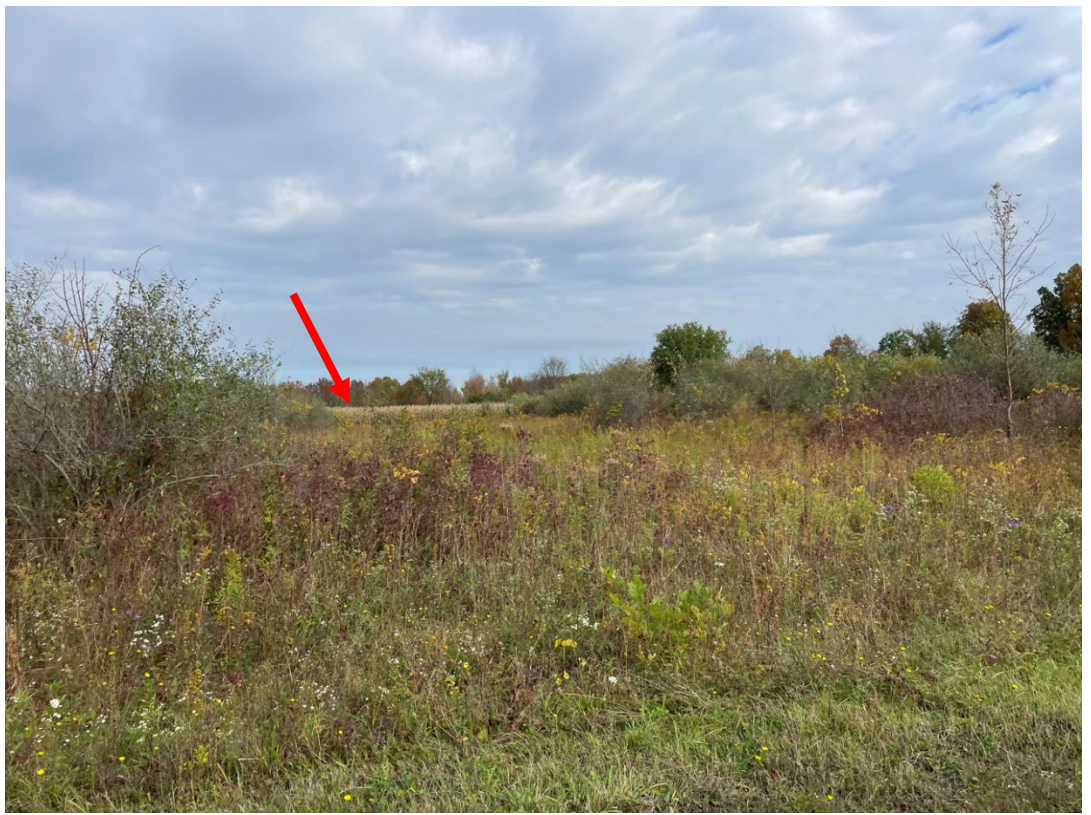
<p>Photograph No. 5</p>	<p>Date: 10/12/2023</p>

<p>Direction Photo Taken: N</p>		
<p>Photo taken along Seneca Army Depot Road, looking north. Photo taken from SEAD 003-R-01. Note the corn (feet lot) growing north of SEAD 003-R-01 (indicated by red arrow).</p>		
<p>Photograph No. 6</p>	<p>Date: 10/12/2023</p>

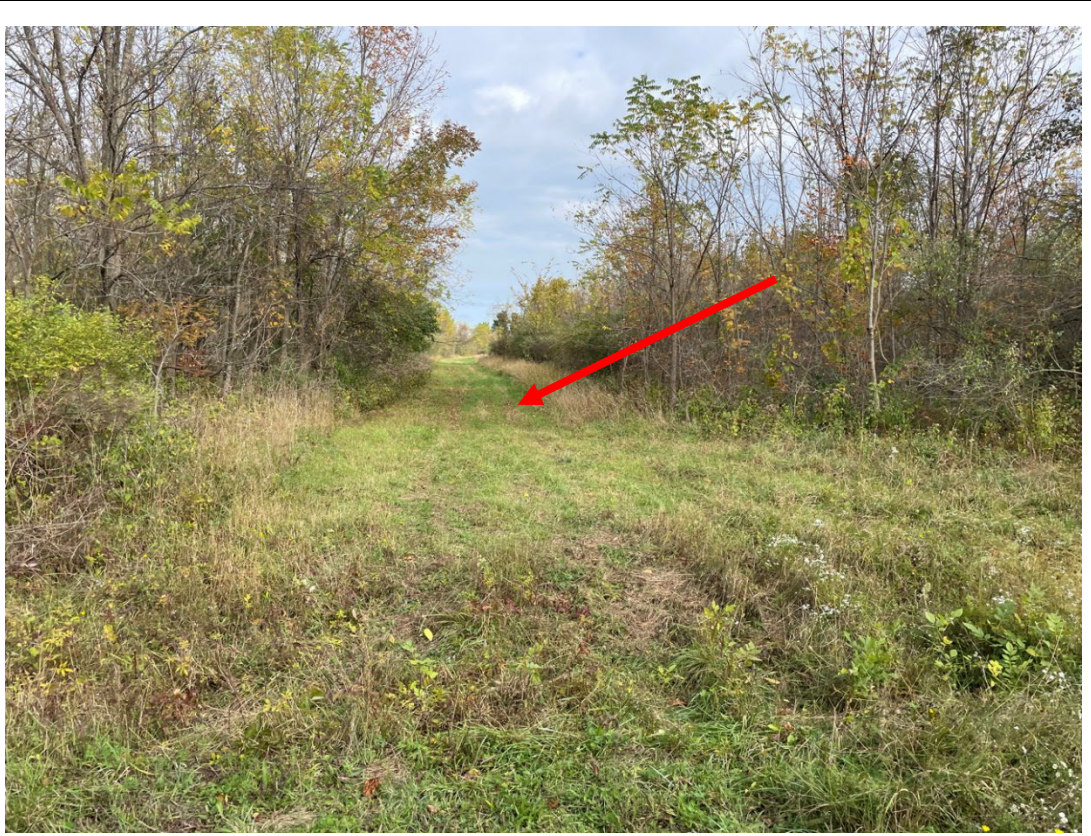
<p>Direction Photo Taken: N</p>		
<p>Description: Photo taken along Seneca Army Depot Road, looking north. Note the mowed path (indicated by red arrow). Cleared swatch of trees runs directly north toward OD Grounds MRS boundary. Suggested site for “warning” signage. Location is on private property.</p>

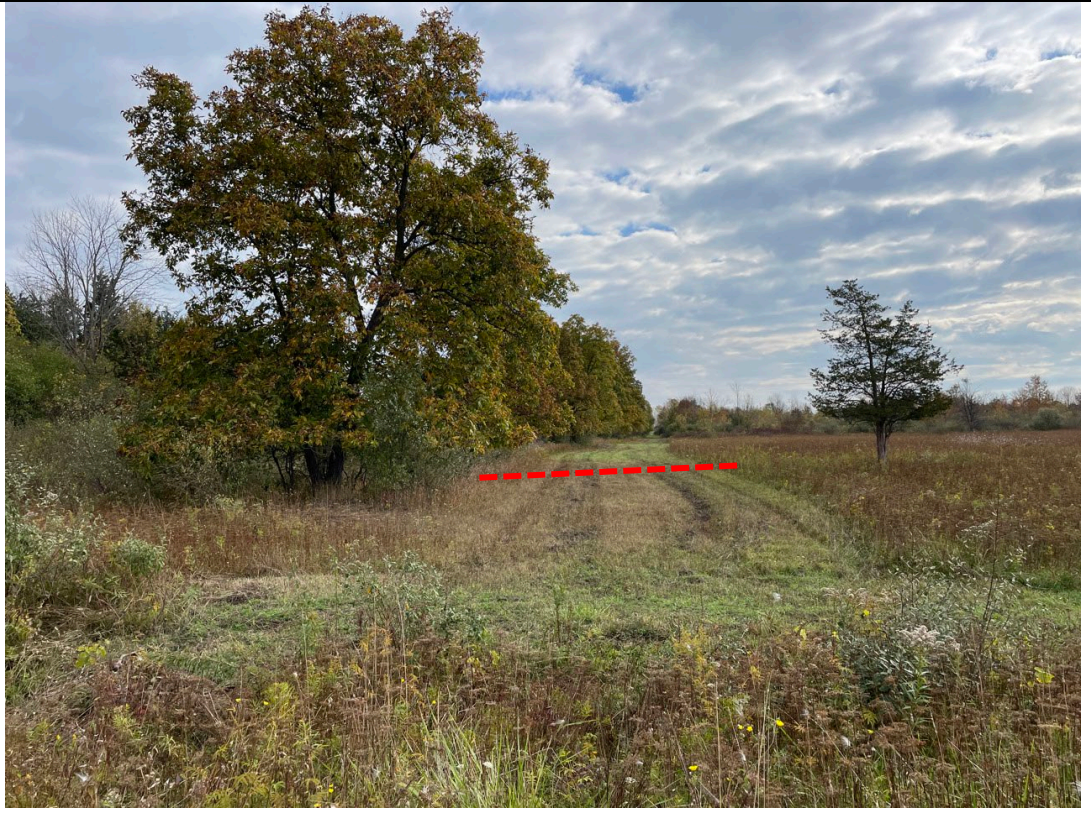
<p>Photograph No. 7</p>	<p>Date: 10/12/2023</p>

<p>Direction Photo Taken: E</p>		
<p>Description: Photo taken from W. Patrol Road, note the mowed vegetation. Red dashed line approximately indicates OD Grounds MRS boundary. Location is also proposed jersey barrier location.</p>		
<p>Photograph No. 8</p>	<p>Date: 10/12/2023</p>

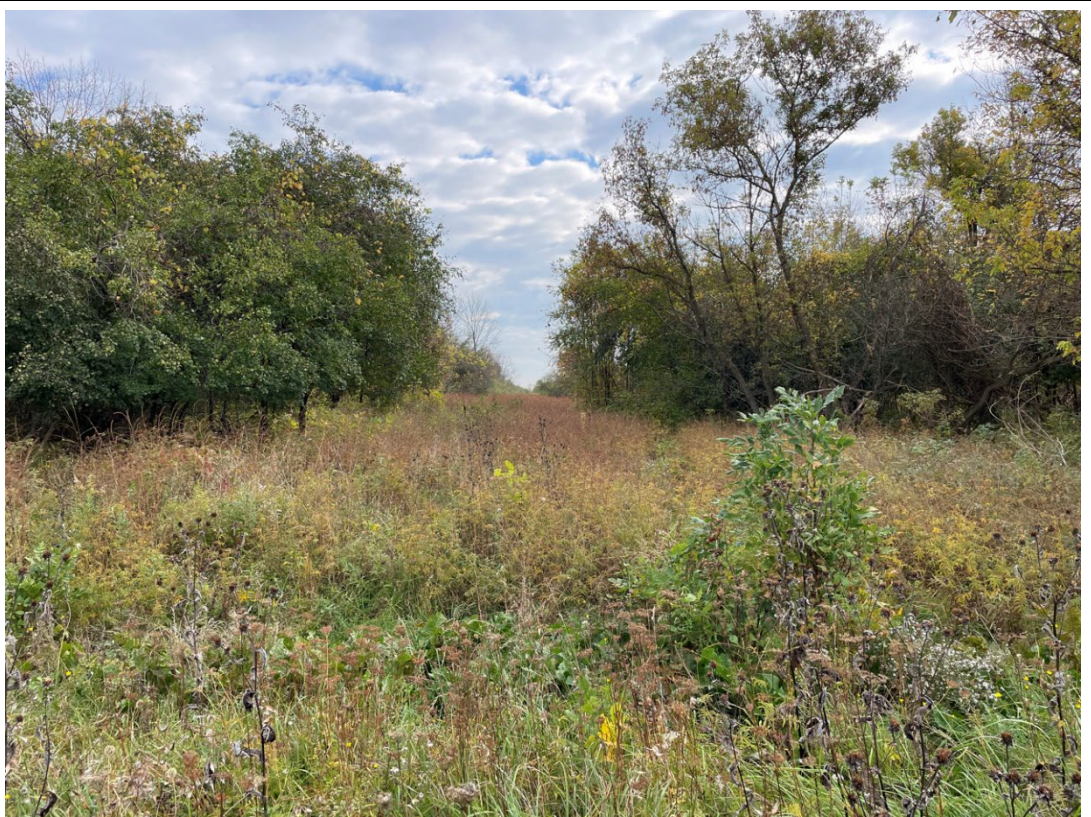
<p>Direction Photo Taken: E</p>		
<p>Description: Photo taken from W. Patrol Road of OD Grounds MRS. Note un-mowed vegetation, although the area is cleared of trees. Area is not a candidate for a jersey barrier as evidence of trespassing is not observed.</p>

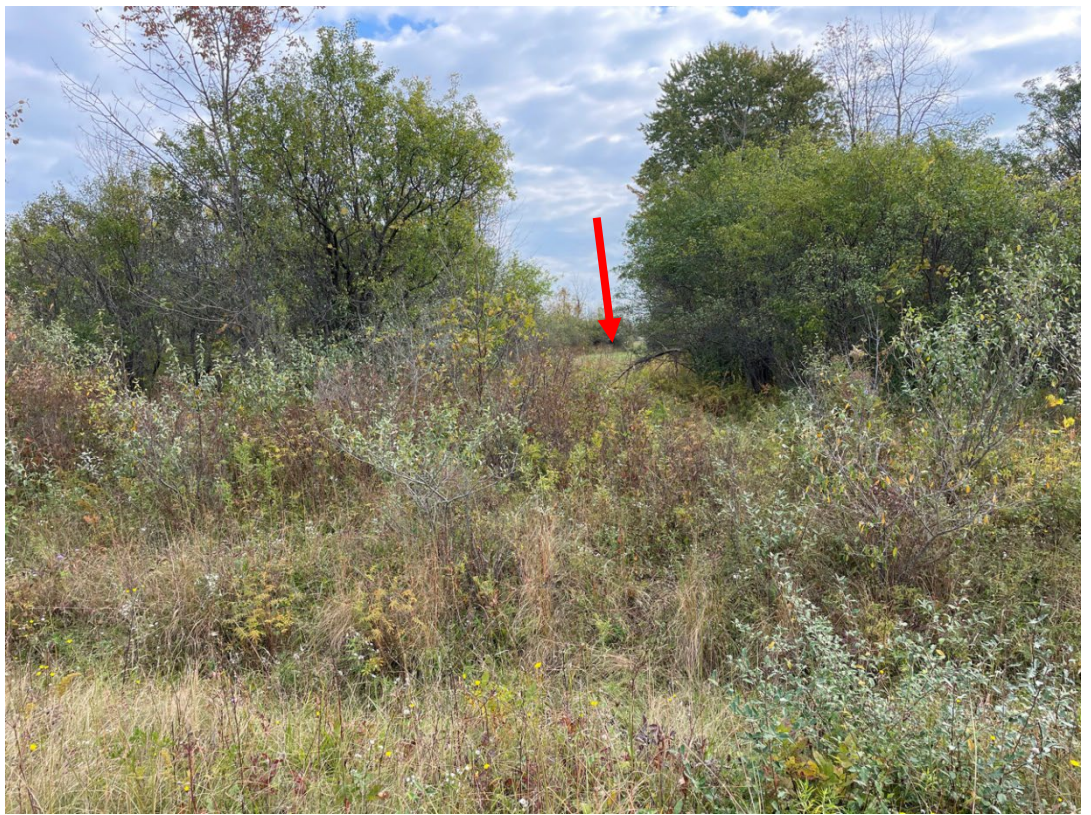
<p>Photograph No. 9</p>	<p>Date: 10/12/2023</p>

<p>Direction Photo Taken: E</p>		
<p>Description: Photo taken from W. Patrol Road of OD Grounds MRS. Note mowed vegetation observed within the OD Grounds MRS boundary (indicated by red arrow).</p>		
<p>Photograph No. 10</p>	<p>Date: 10/12/2023</p>

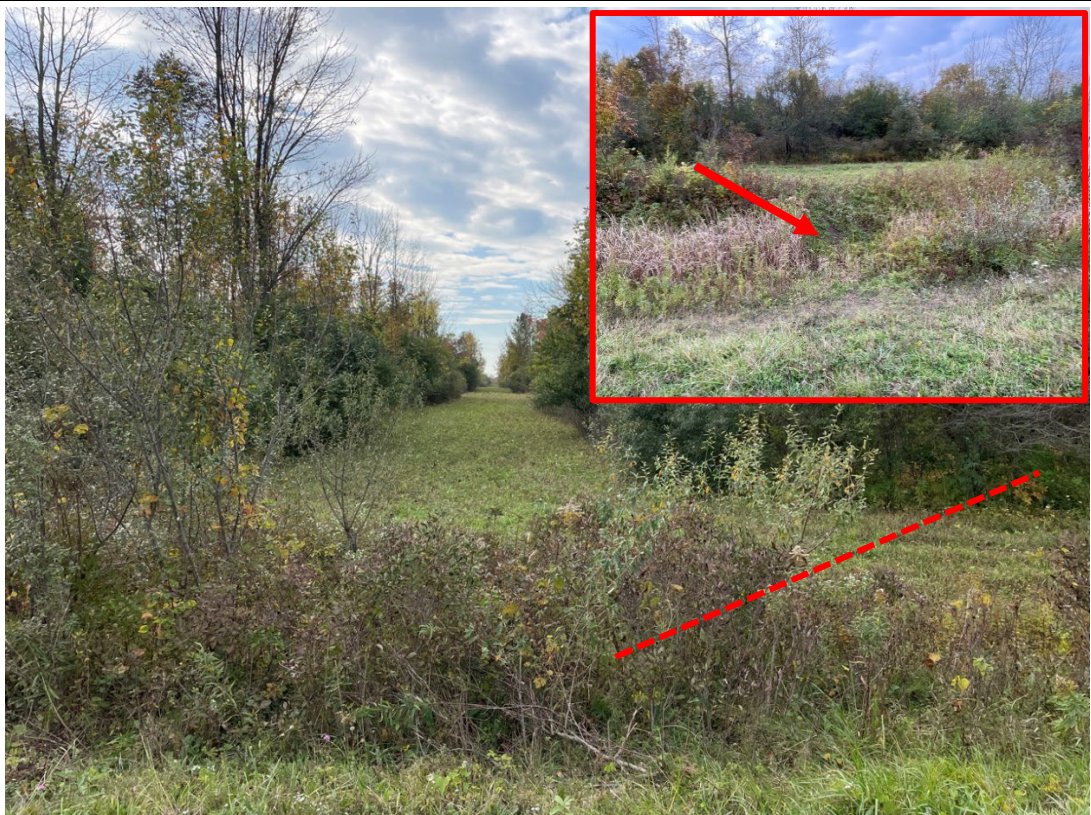
<p>Direction Photo Taken: S</p>		
<p>Description: Photo taken from N. Patrol Road (looking at OD Grounds MRS). Note mowed vegetation observed on the OD Grounds MRS. Proposed location for "Boundary Signage" as well as jersey barriers. Red dashed line indicates approximate OD Grounds MRS boundary. Two-track tire marks observed from N. Patrol Road, indicated by inset photo and red arrow.</p>

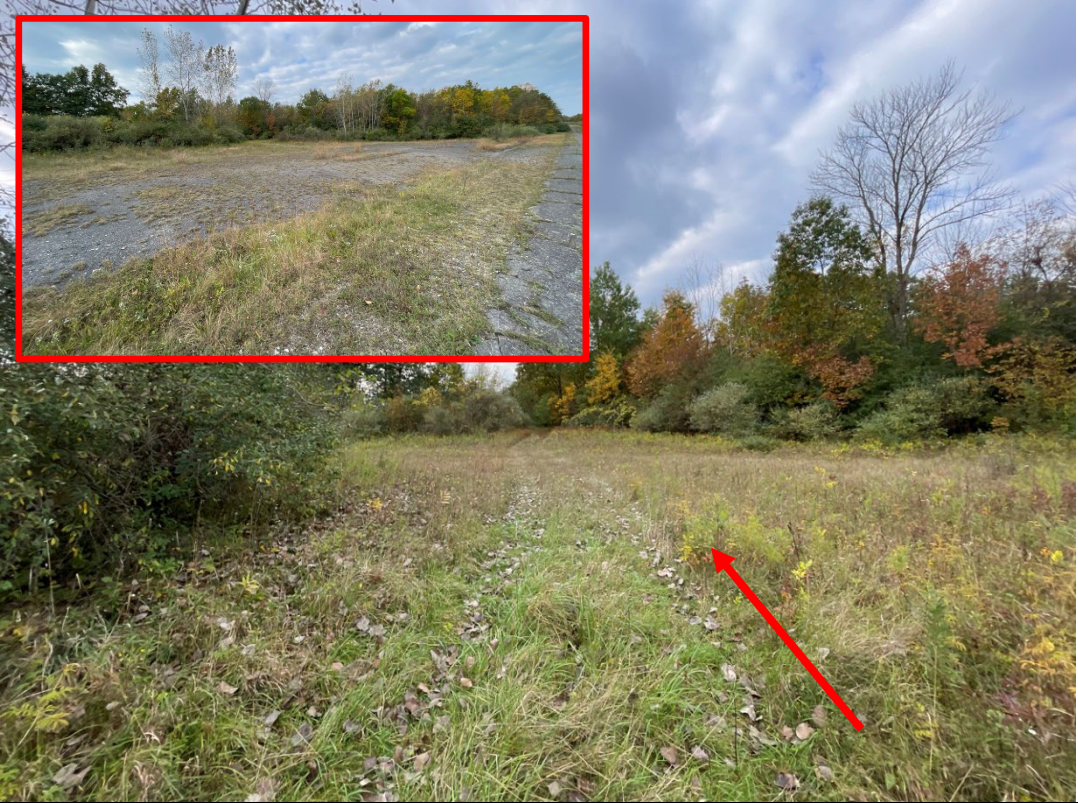
<p>Photograph No. 11</p>	<p>Date: 10/12/2023</p>

<p>Direction Photo Taken: S</p>		
<p>Description: Photo taken from N. Patrol Road (looking at OD Grounds MRS). Note tire tracks observed on the OD Grounds MRS, leading deeper onto OD Grounds MRS property (red arrow). Proposed location for “Boundary Signage” as well as jersey barriers. Inset photo illustrates the large pull off area from N. Patrol Road.</p>		
<p>Photograph No. 12</p>	<p>Date: 10/12/2023</p>

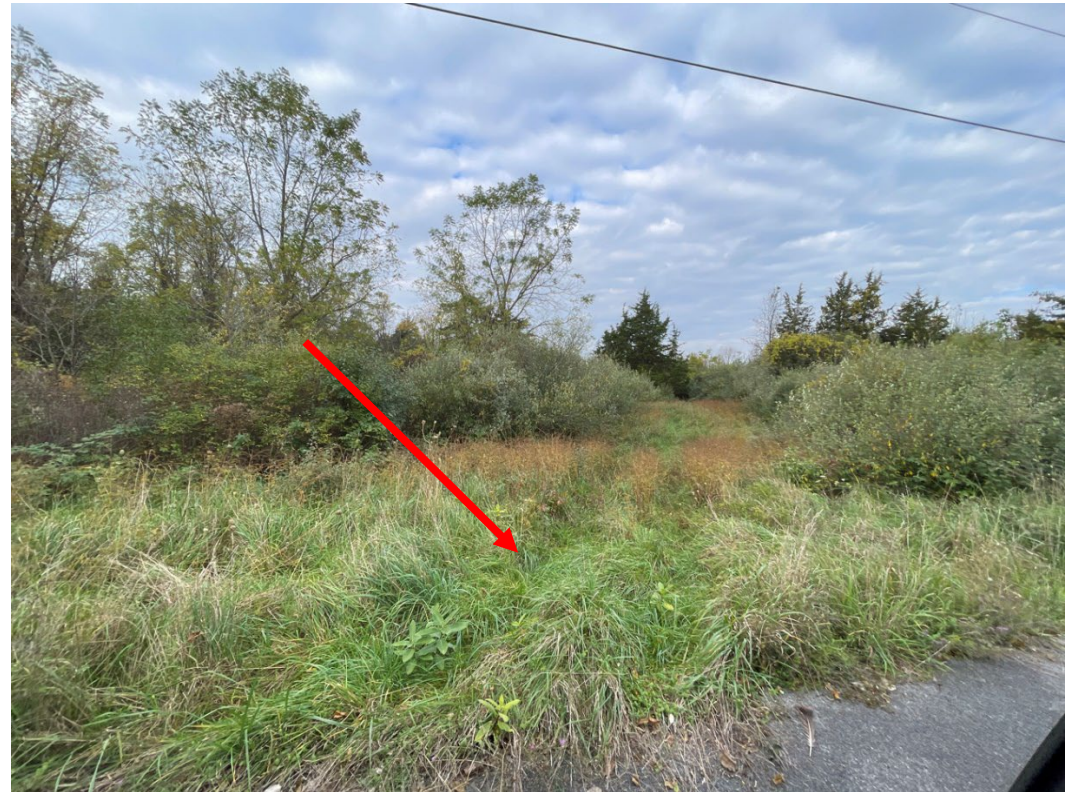
<p>Direction Photo Taken: W</p>		
<p>Description: Photo taken from North-South Baseline Road looking at private property. Note two tracks in vegetation (indicted by red arrow). Aerial imagery indicates this cleared path runs towards the OD Grounds MRS boundary, approximately 500 feet west of where this photo was taken.</p>
