EXPANDED SITE INSPECTION

EIGHT MODERATELY LOW PRIORITY AOCs

**SEADs 5, 9, 12(A AND B), (43, 56, 69), 44(A AND B),
50, 58, AND 59**

**EXPANDED SITE INSPECTION REPORT
EIGHT MODERATELY LOW PRIORITY AREAS OF CONCERN
SENECA ARMY DEPOT
ROMULUS, NEW YORK**

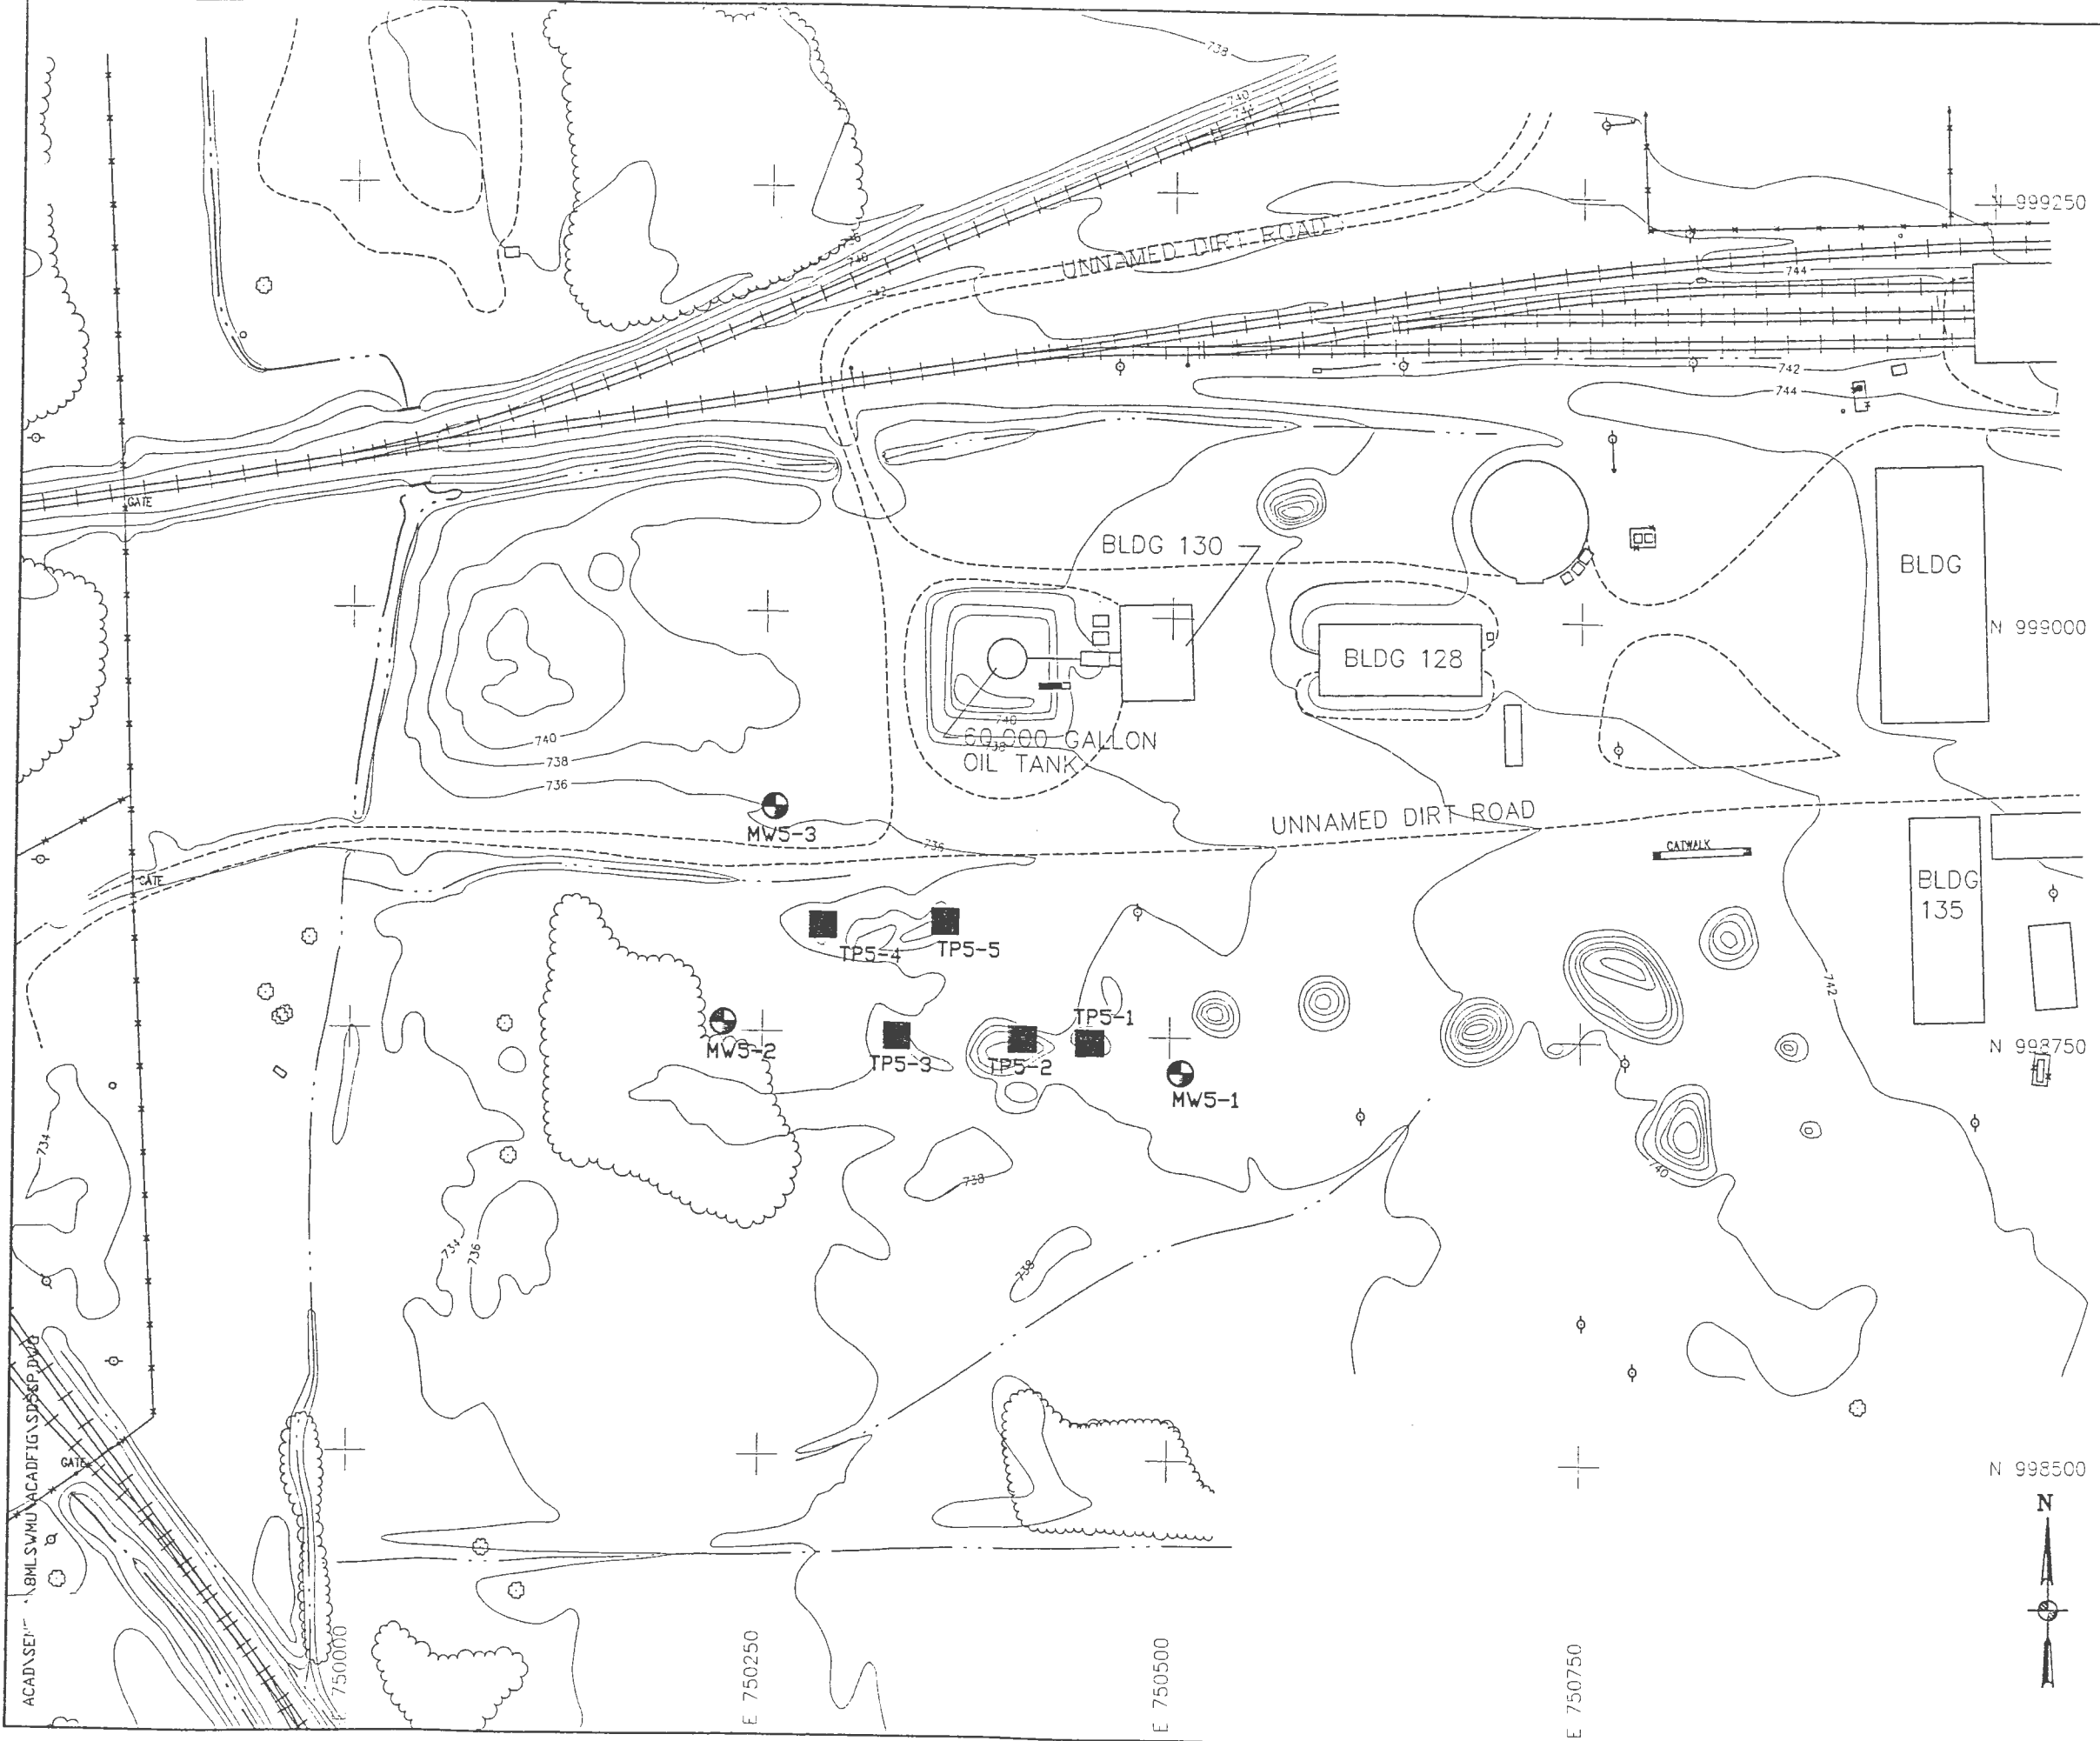
FIGURE 2.3-1
 SEAD-5 SEWAGE SLUDGE WASTE PILES
 LOCATION OF GEOPHYSICAL SURVEYS

Four (4) 115 foot long seismic refraction profiles were surveyed on 4 lines positioned along each boundary of the AOC. The seismic refraction transect locations are shown in Figure 2.3-1. Data from the survey were used to determine the direction of groundwater flow and to adjust the monitoring well locations to assure that one monitoring well was installed upgradient and two monitoring wells were installed downgradient of the AOC. Because of the relative position SEAD-5 has with SEADs 59 and 71, seismic line locations were selected which would yield the best information without overlap or repetition on bordering SEADS.

The overburden velocities of profiles P1 and P2 were slightly elevated (1,590 ft/sec. and 1780 ft./sec., respectively) in comparison to the overburden velocities normally measured at SEDA (in the range of 1000 ft./sec. to 1400 ft./sec.). These two seismic transects were located in areas of high traffic. The compaction of the soils in these areas should be considered as the probable cause of the elevated overburden velocities observed at SEAD 5. The locations of these seismic profiles are shown in Figure 2.3-1.

Saturated overburden was detected beneath profiles P1, P3, and P4 (see Figure 2.3-1 for the profile locations). At the location of profile P2, saturated overburden was not detected, however, a layer of compact till (3400 ft./sec.) was resolved at depths of 3.4 feet (at the western end of the seismic line) to 4.6 feet (at the eastern end of the seismic line).

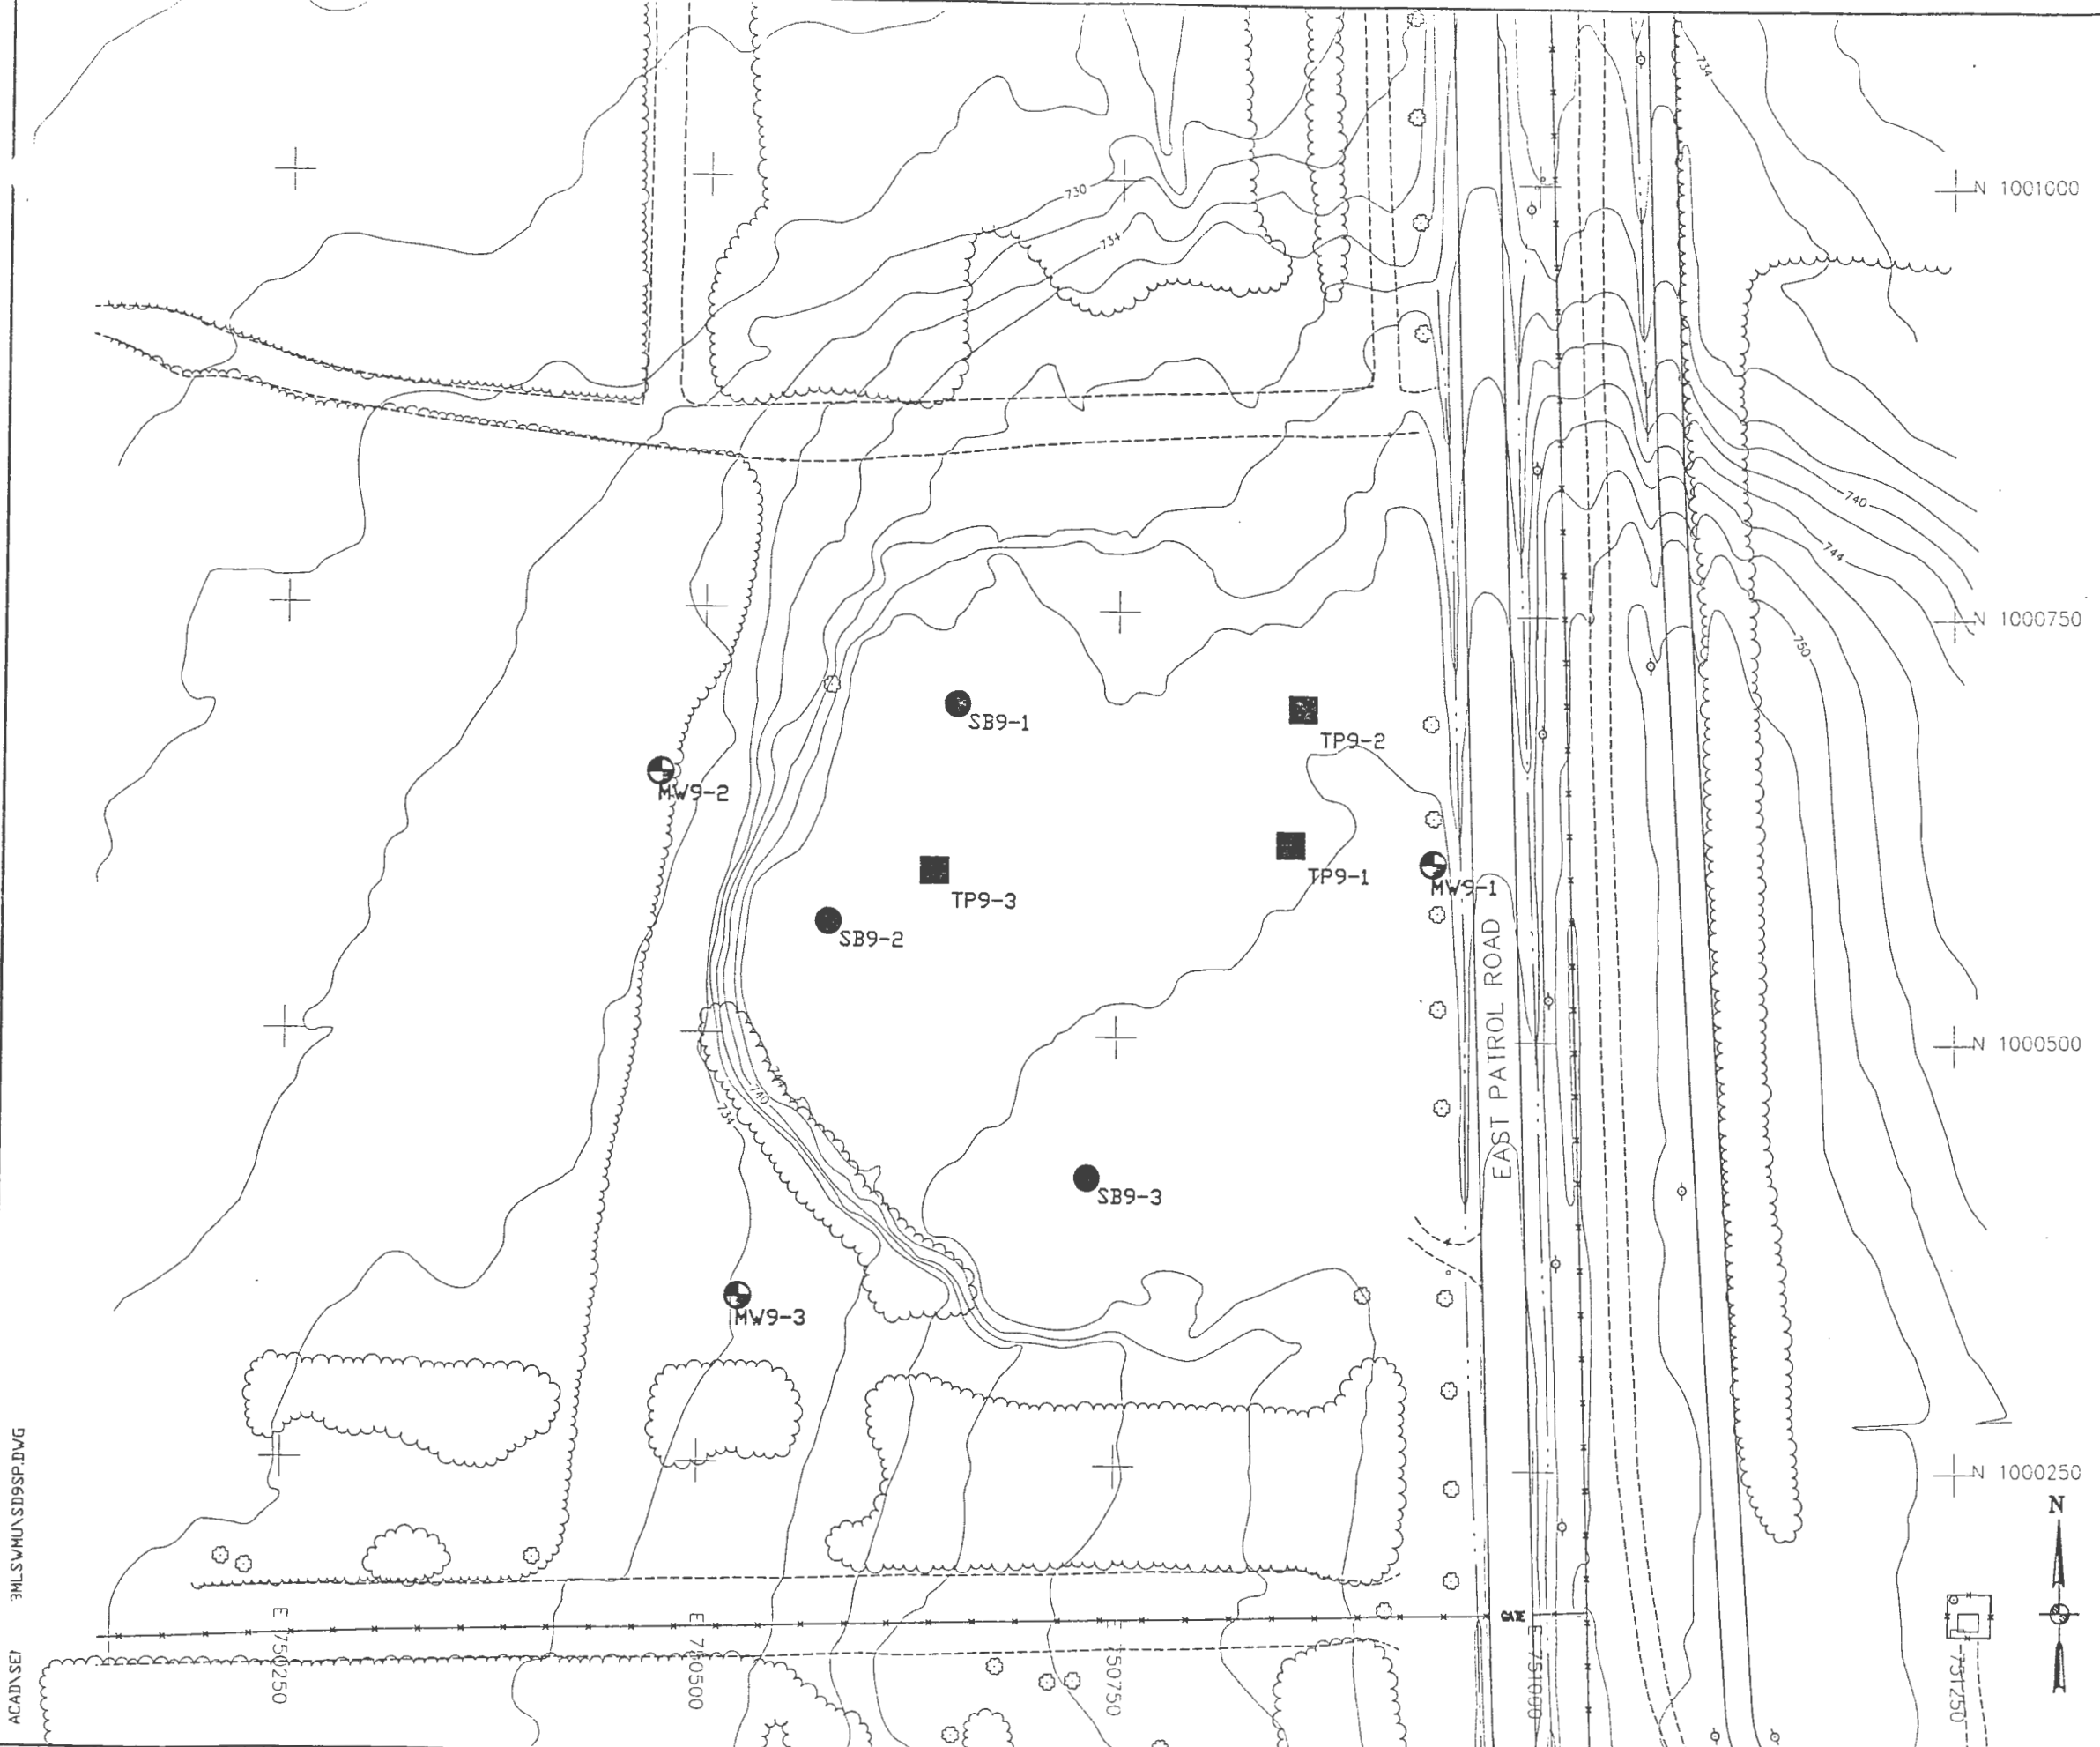
SEAD 12A is located in the northeastern corner of the Q area of SEDA. Five (5) small disposal pits containing lab wastes were suspected to have been located in this area. The locations of these pits were not known and the nature of their construction remained in question. A stream, flowing east to west, was situated along the southern boundary of SEAD-12A. The primary migrational pathways considered for SEAD-12A were leaching of contaminants into the surrounding soils, and transport via groundwater and surface water runoff. The groundwater at SEAD-12A has been classified as GA, meaning that it is

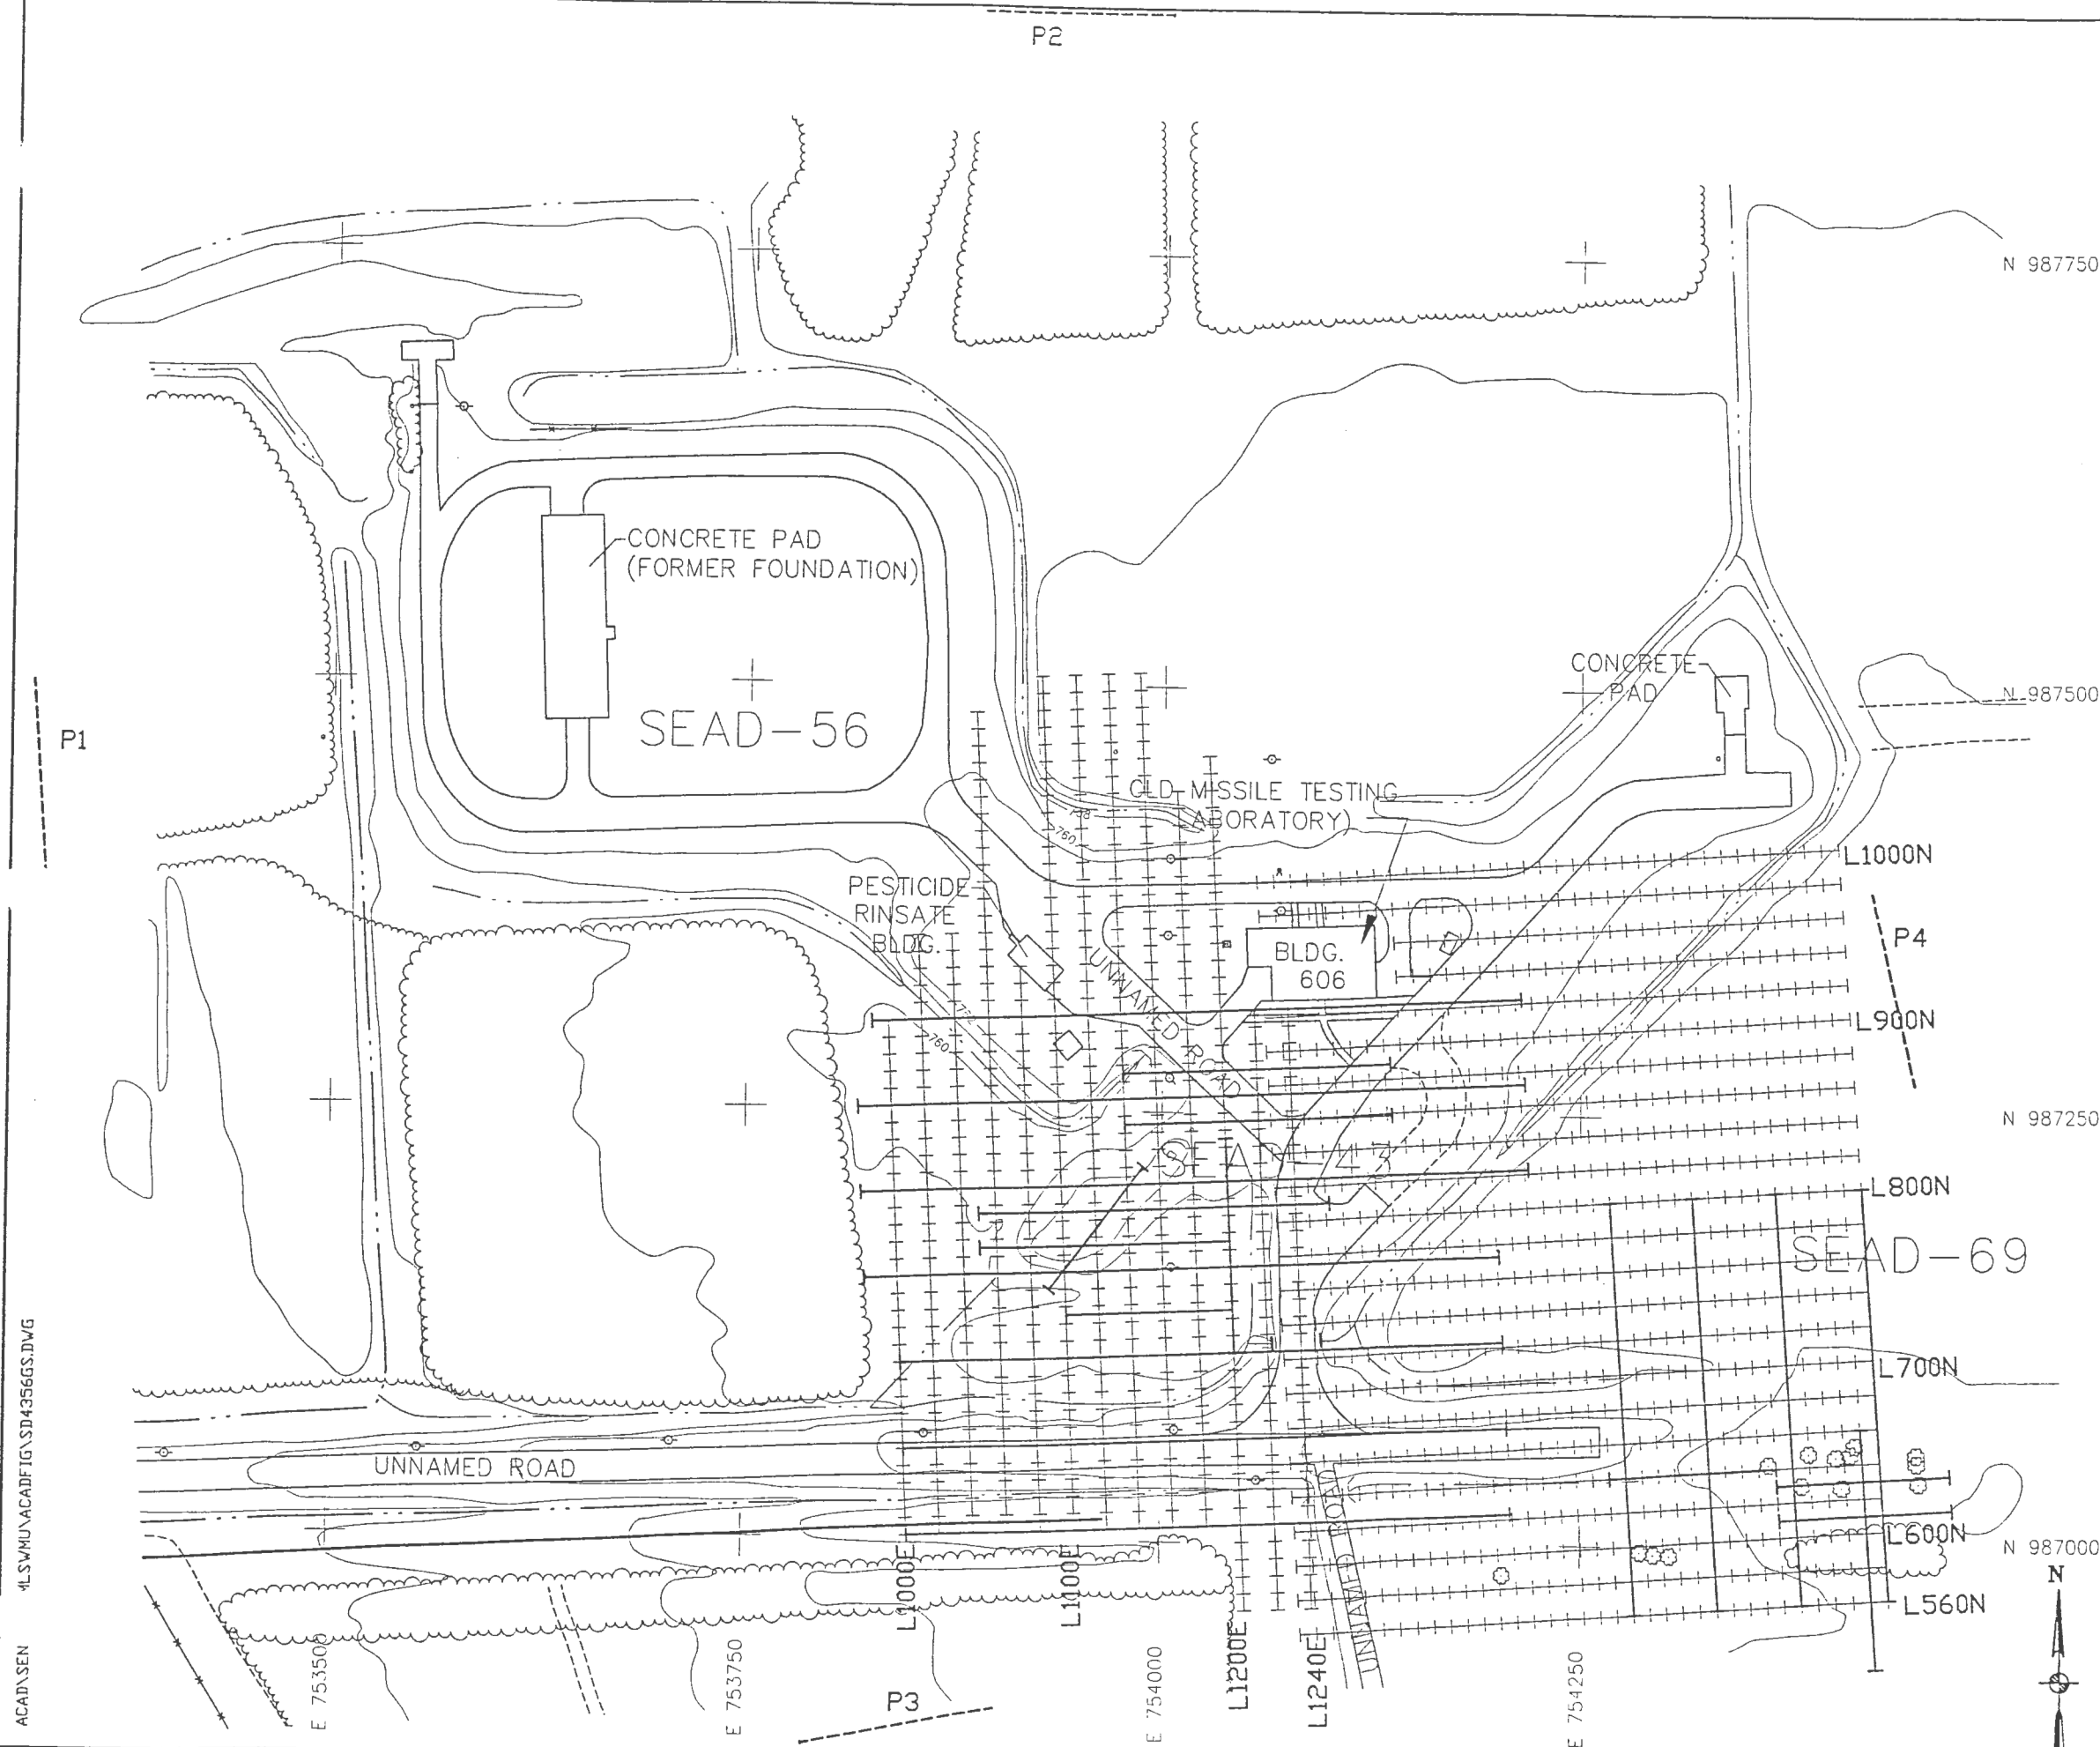
A total of ten (10) soil borings were performed at SEADs-43, 56, and 69; three (3) borings at SEAD-56 and 69, and 4 borings at SEAD-43. The soil boring locations are shown in Figure 2.7-2. A total thirty (30) samples from ten (10) soil borings were submitted for the chemical analyses identified in 2.7.3 (Table 2.7-1).

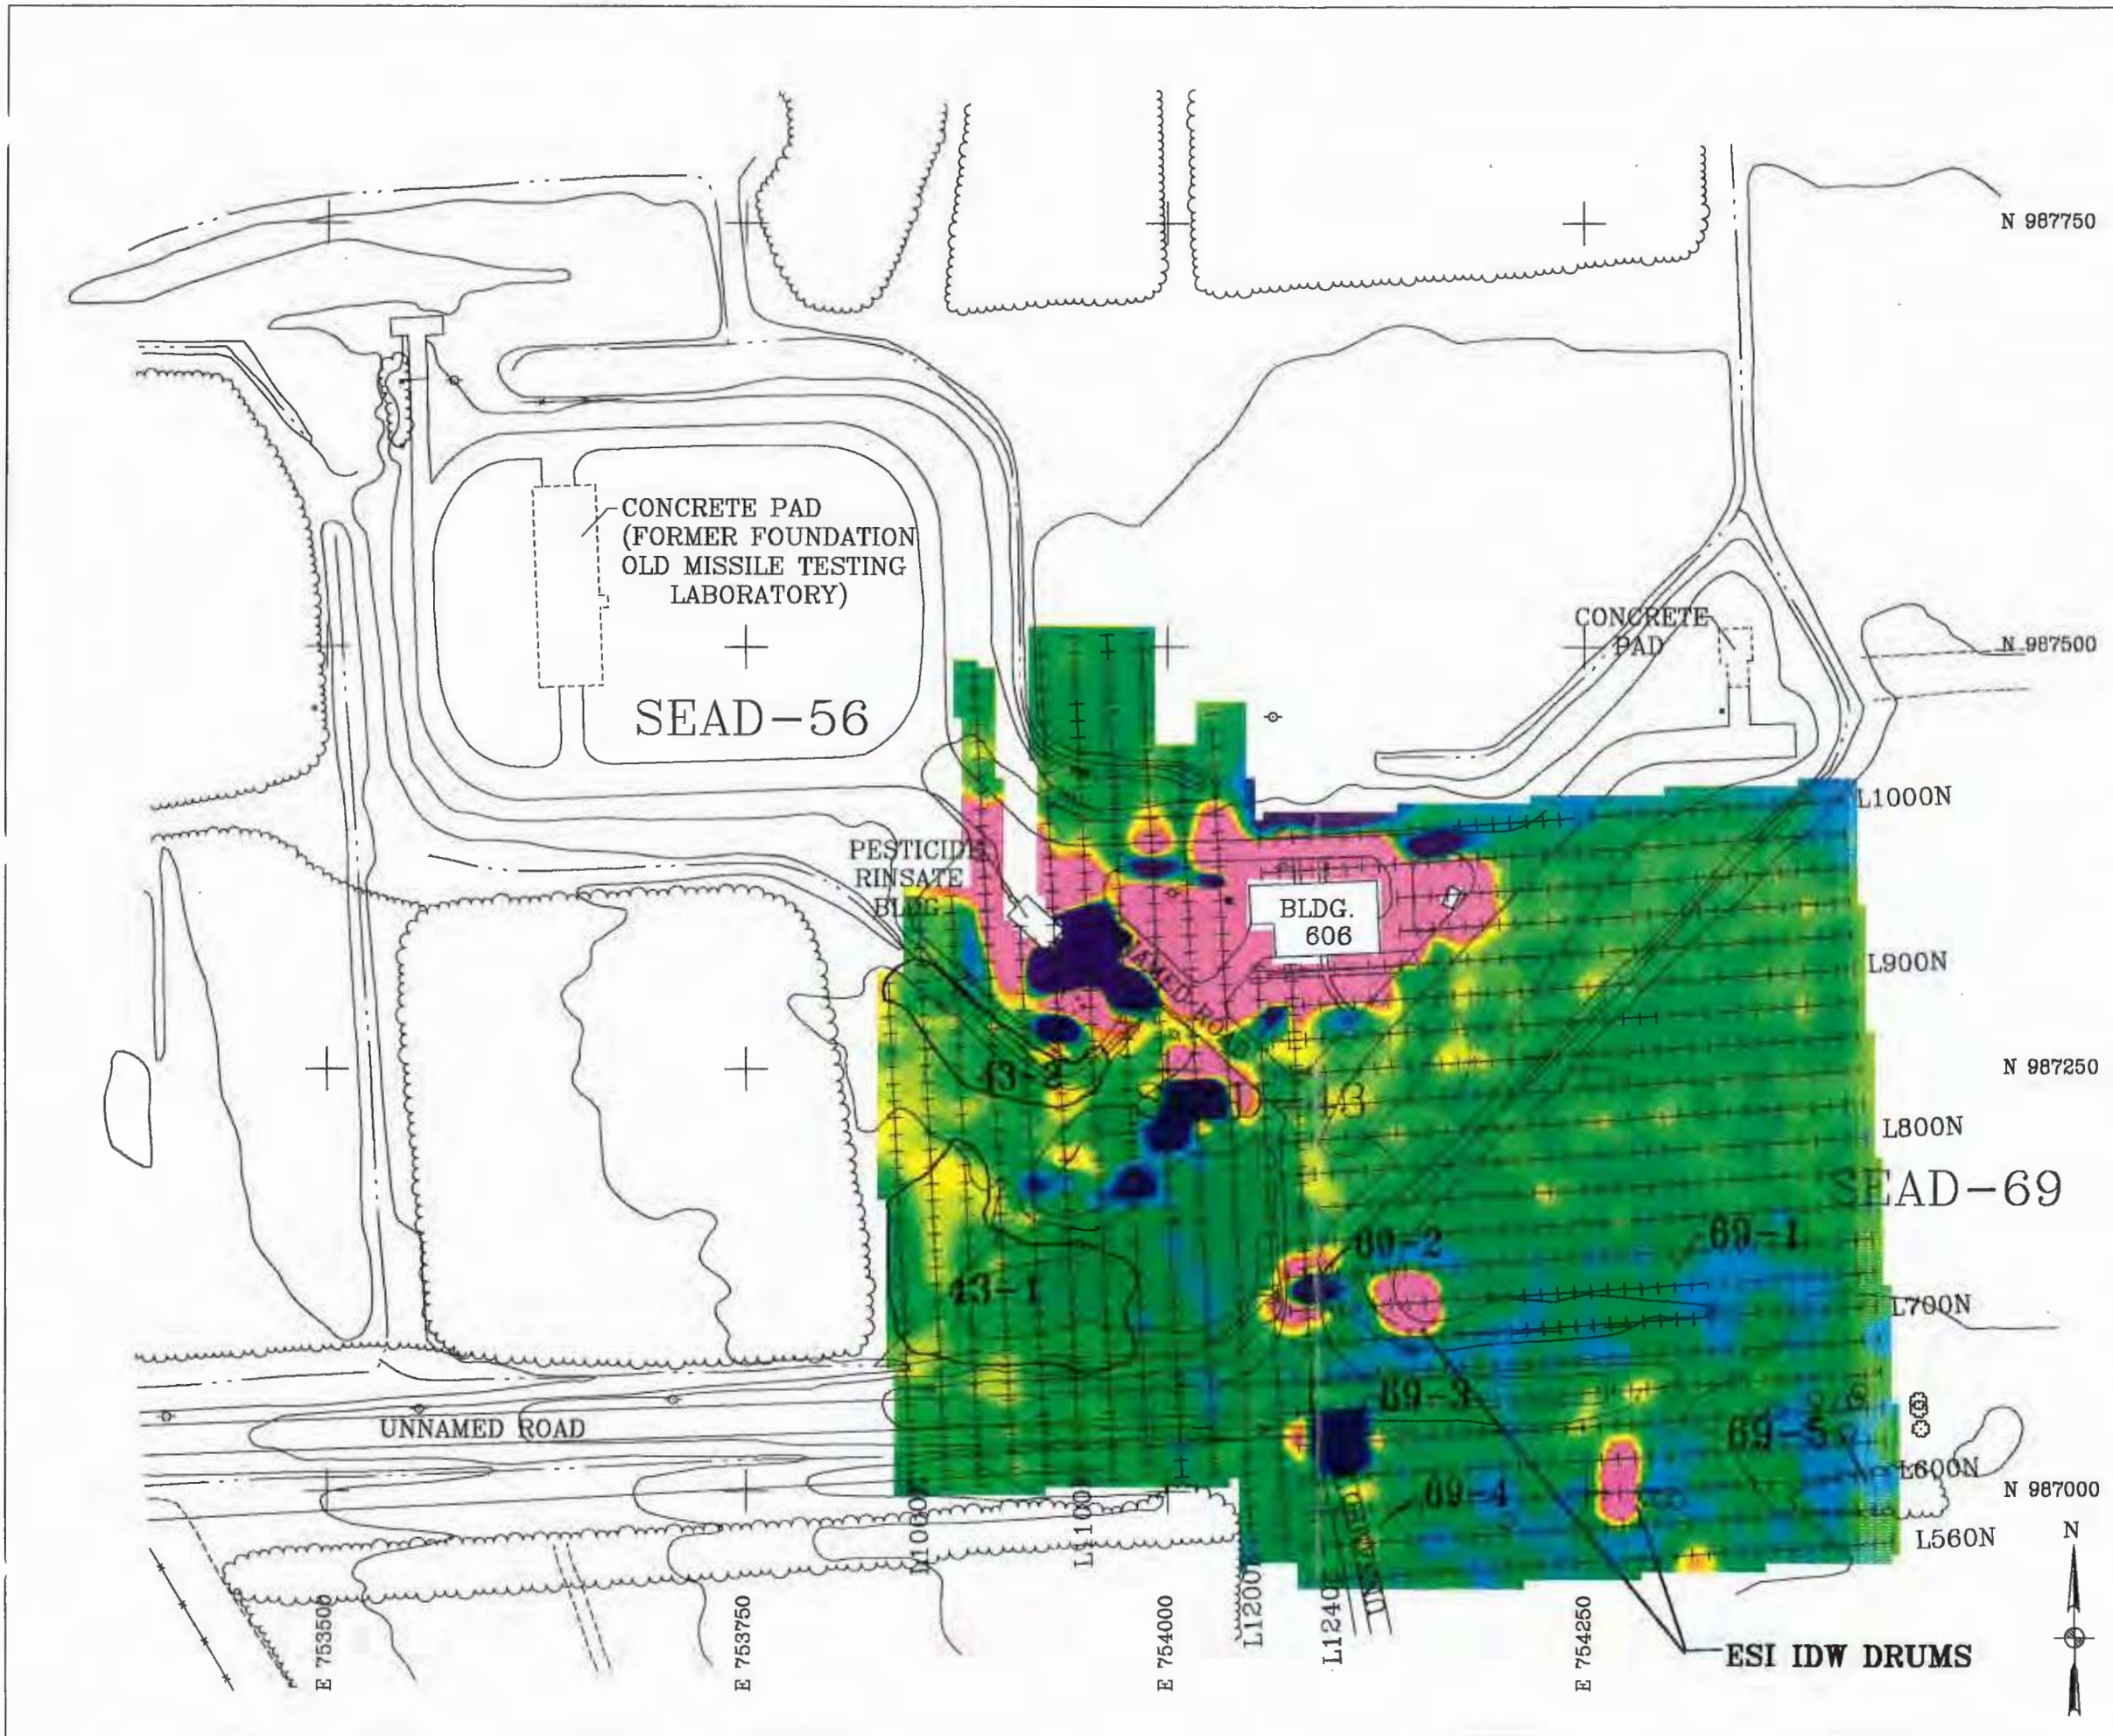
**FIGURE 3.5-1**  
SEAD-43,56,69 EM SURVEY,  
QUADRATURE SURVEY

Figure 3.5-1 shows the results of the apparent ground conductivity survey performed at SEADs 43 and 69. An area of elevated apparent ground conductivity (anomaly 43-1) is clearly evident in the southeastern portion of the EM grid. This area is situated immediately south and west of the mound presumably associated with the septic system being investigated as SEAD-43. A second area of elevated ground conductivity (43-2) was detected in the area of the drainage swale surrounding the pesticide/herbicide rinse pad. These two areas of elevated apparent ground conductivity may be due to an increase in the clay content of the soils or to an increase in the content of dissolved solids in the ground water or soil moisture. Since the most conductive soils coincided with drainage swales along the access roads around SEAD 43, road salt should be considered a possible explanation for these increases in apparent ground conductivity.
