**EXPANDED SITE INSPECTION
SEVEN HIGH PRIORITY SWMU's
SEAD 4, 16, 17, 24, 25, 26, AND 45**

DECEMBER 1995

**EXPANDED SITE INSPECTION REPORT
SEVEN AREAS OF CONCERN
SENECA ARMY DEPOT
ROMULUS, NEW YORK**

**Engineering-Science, Inc.
Prudential Center
Boston, Massachusetts**

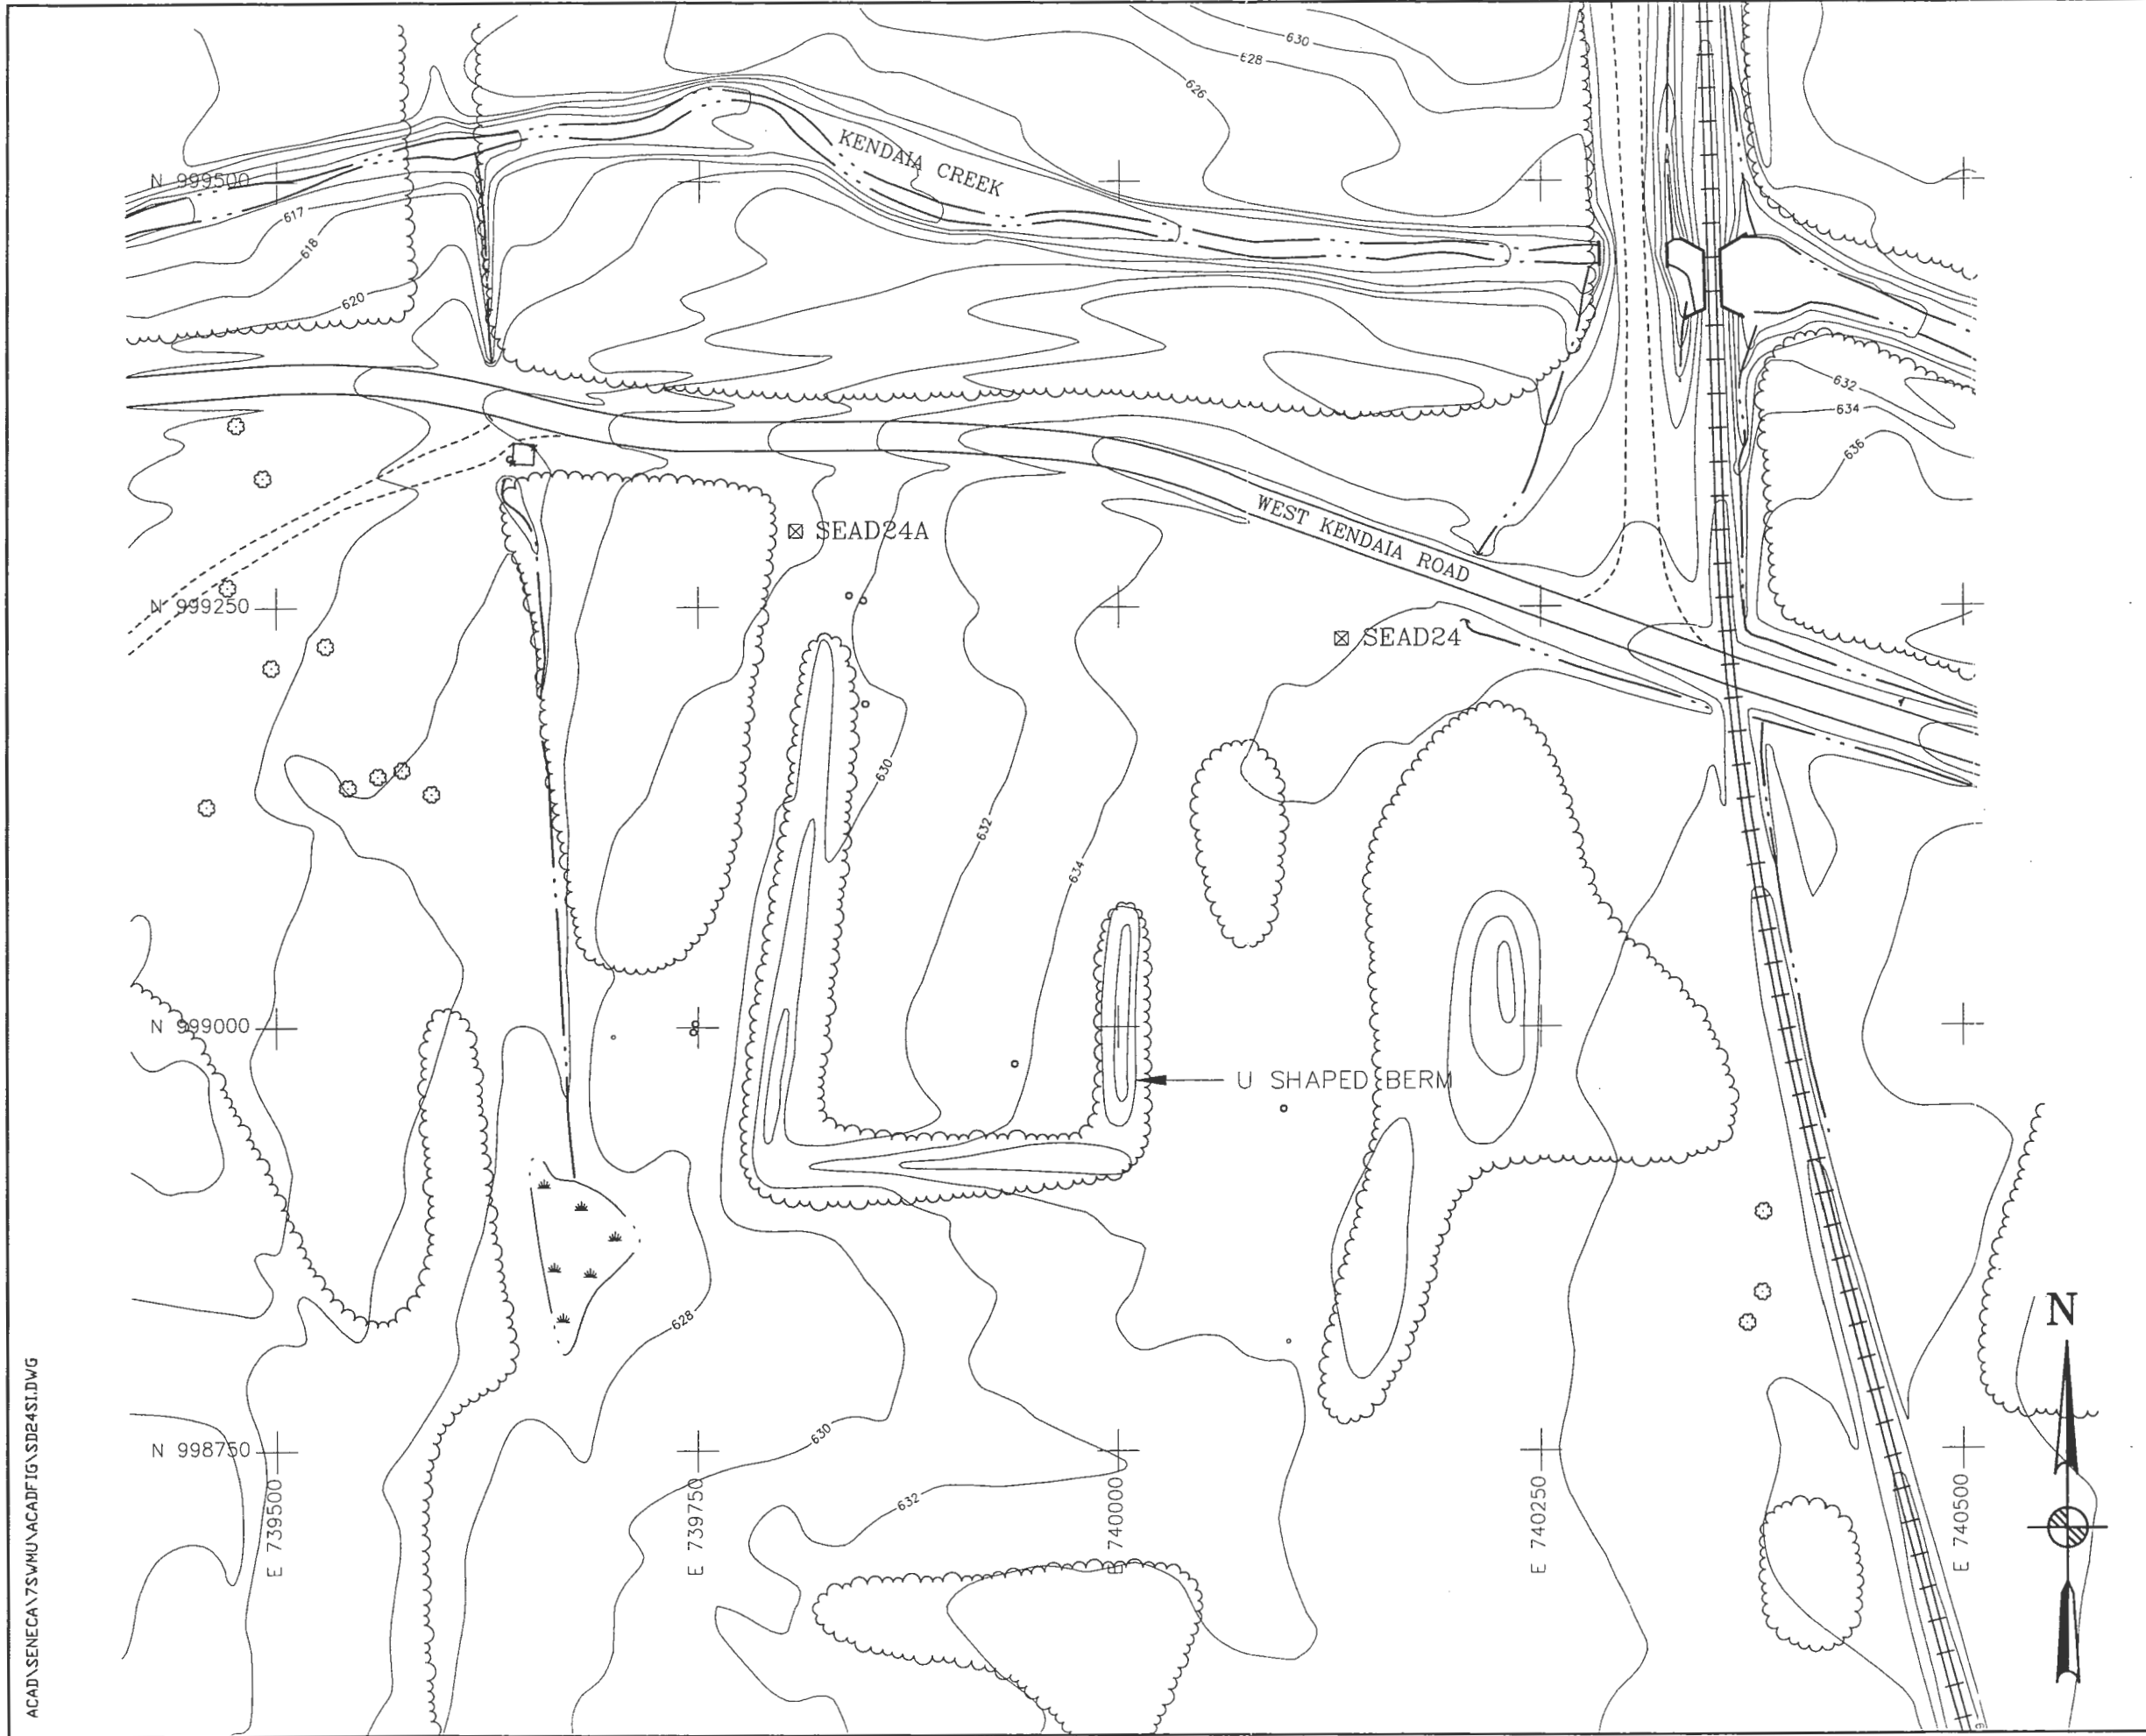
FIGURE 1.1-15
SEAD-24 POWDER BURNING PAD
SITE PLAN

Locally, the topography on-site slopes gently in all directions away from the center of the mound. Regionally, the topography slopes to the south-southwest. However, in the immediate vicinity of the site, the pad represents a small topographic high and the topography slopes to the west, south and east around it. East of the site across Administration Drive, the topography slopes gently toward a small ditch which drains to the south. West of the site the topography slopes to the west toward a small drainage ditch located approximately 300 feet from the site. A drainage swale parallels Administration Drive and divides in the

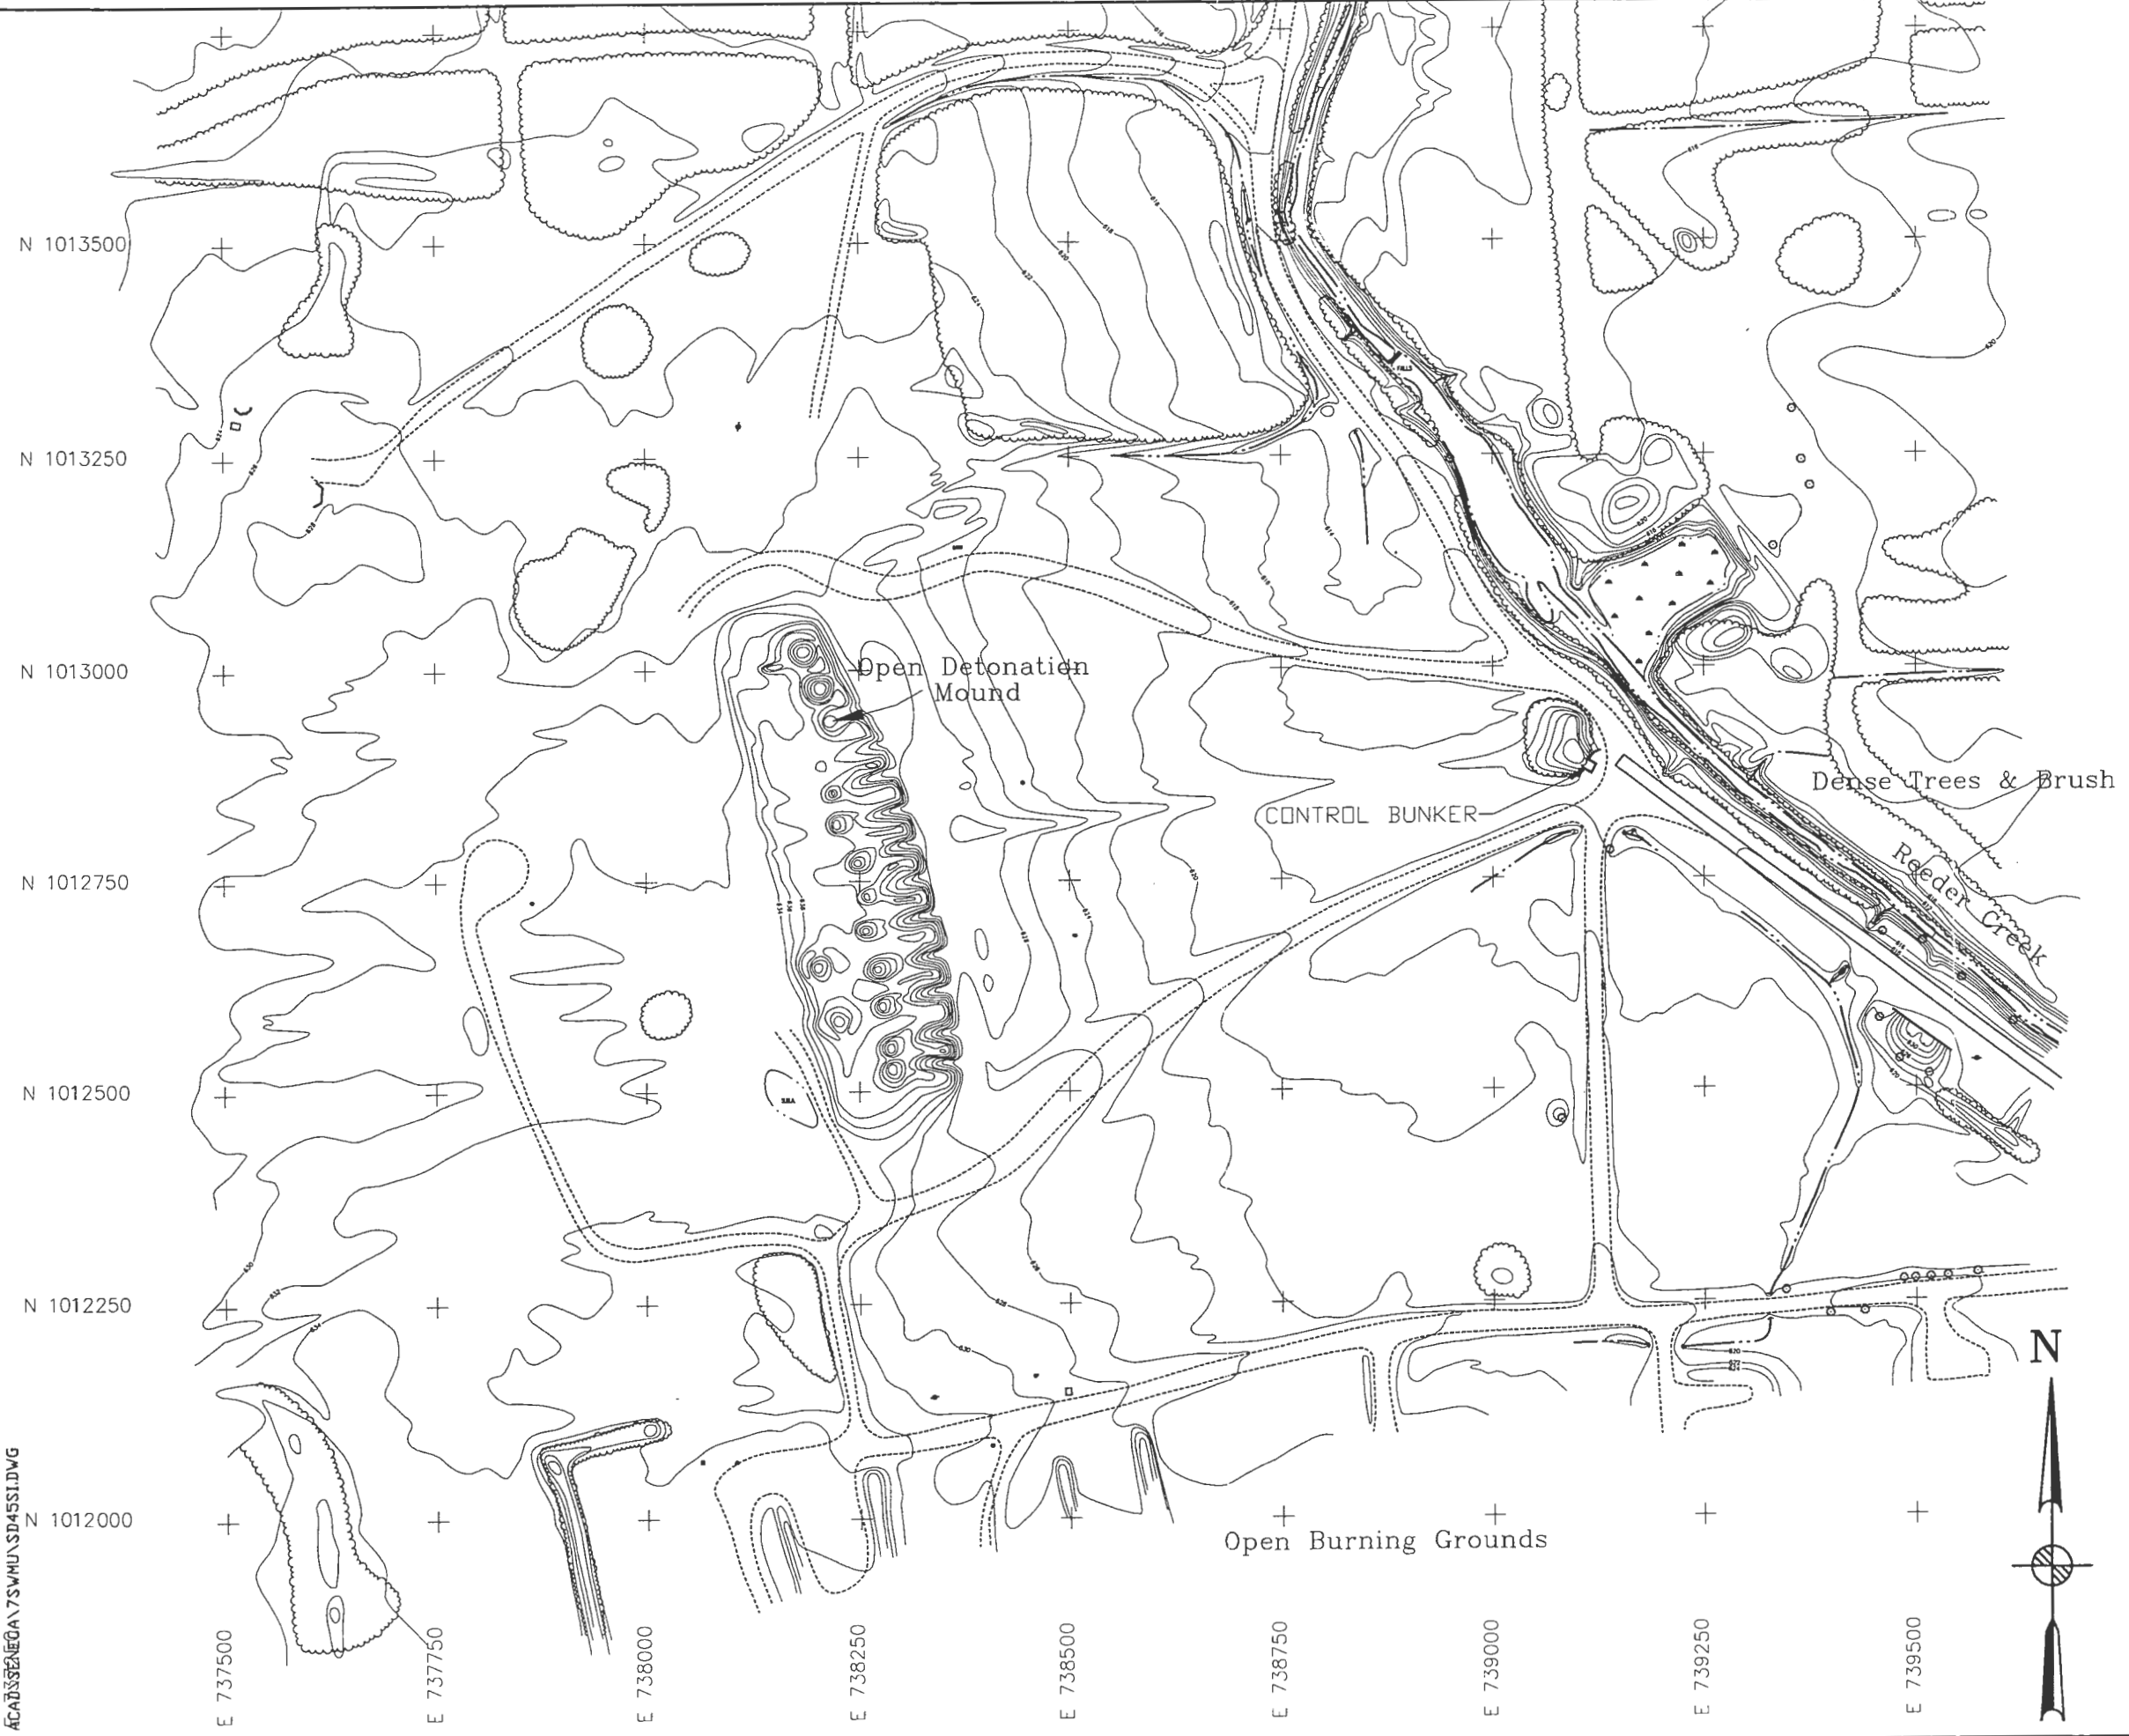
The OD facility (SEAD-45) consists of a detonation mound which covers approximately 1.0 acre. The hill is glacial material which is moved via bulldozer in support of OD operations. The detonation area has been in use from 1941 to the present and the operation is regulated under RCRA interim status. The operation of the open detonation facility is regulated under Subpart X of RCRA. The permit application is pending NYSDEC approval.

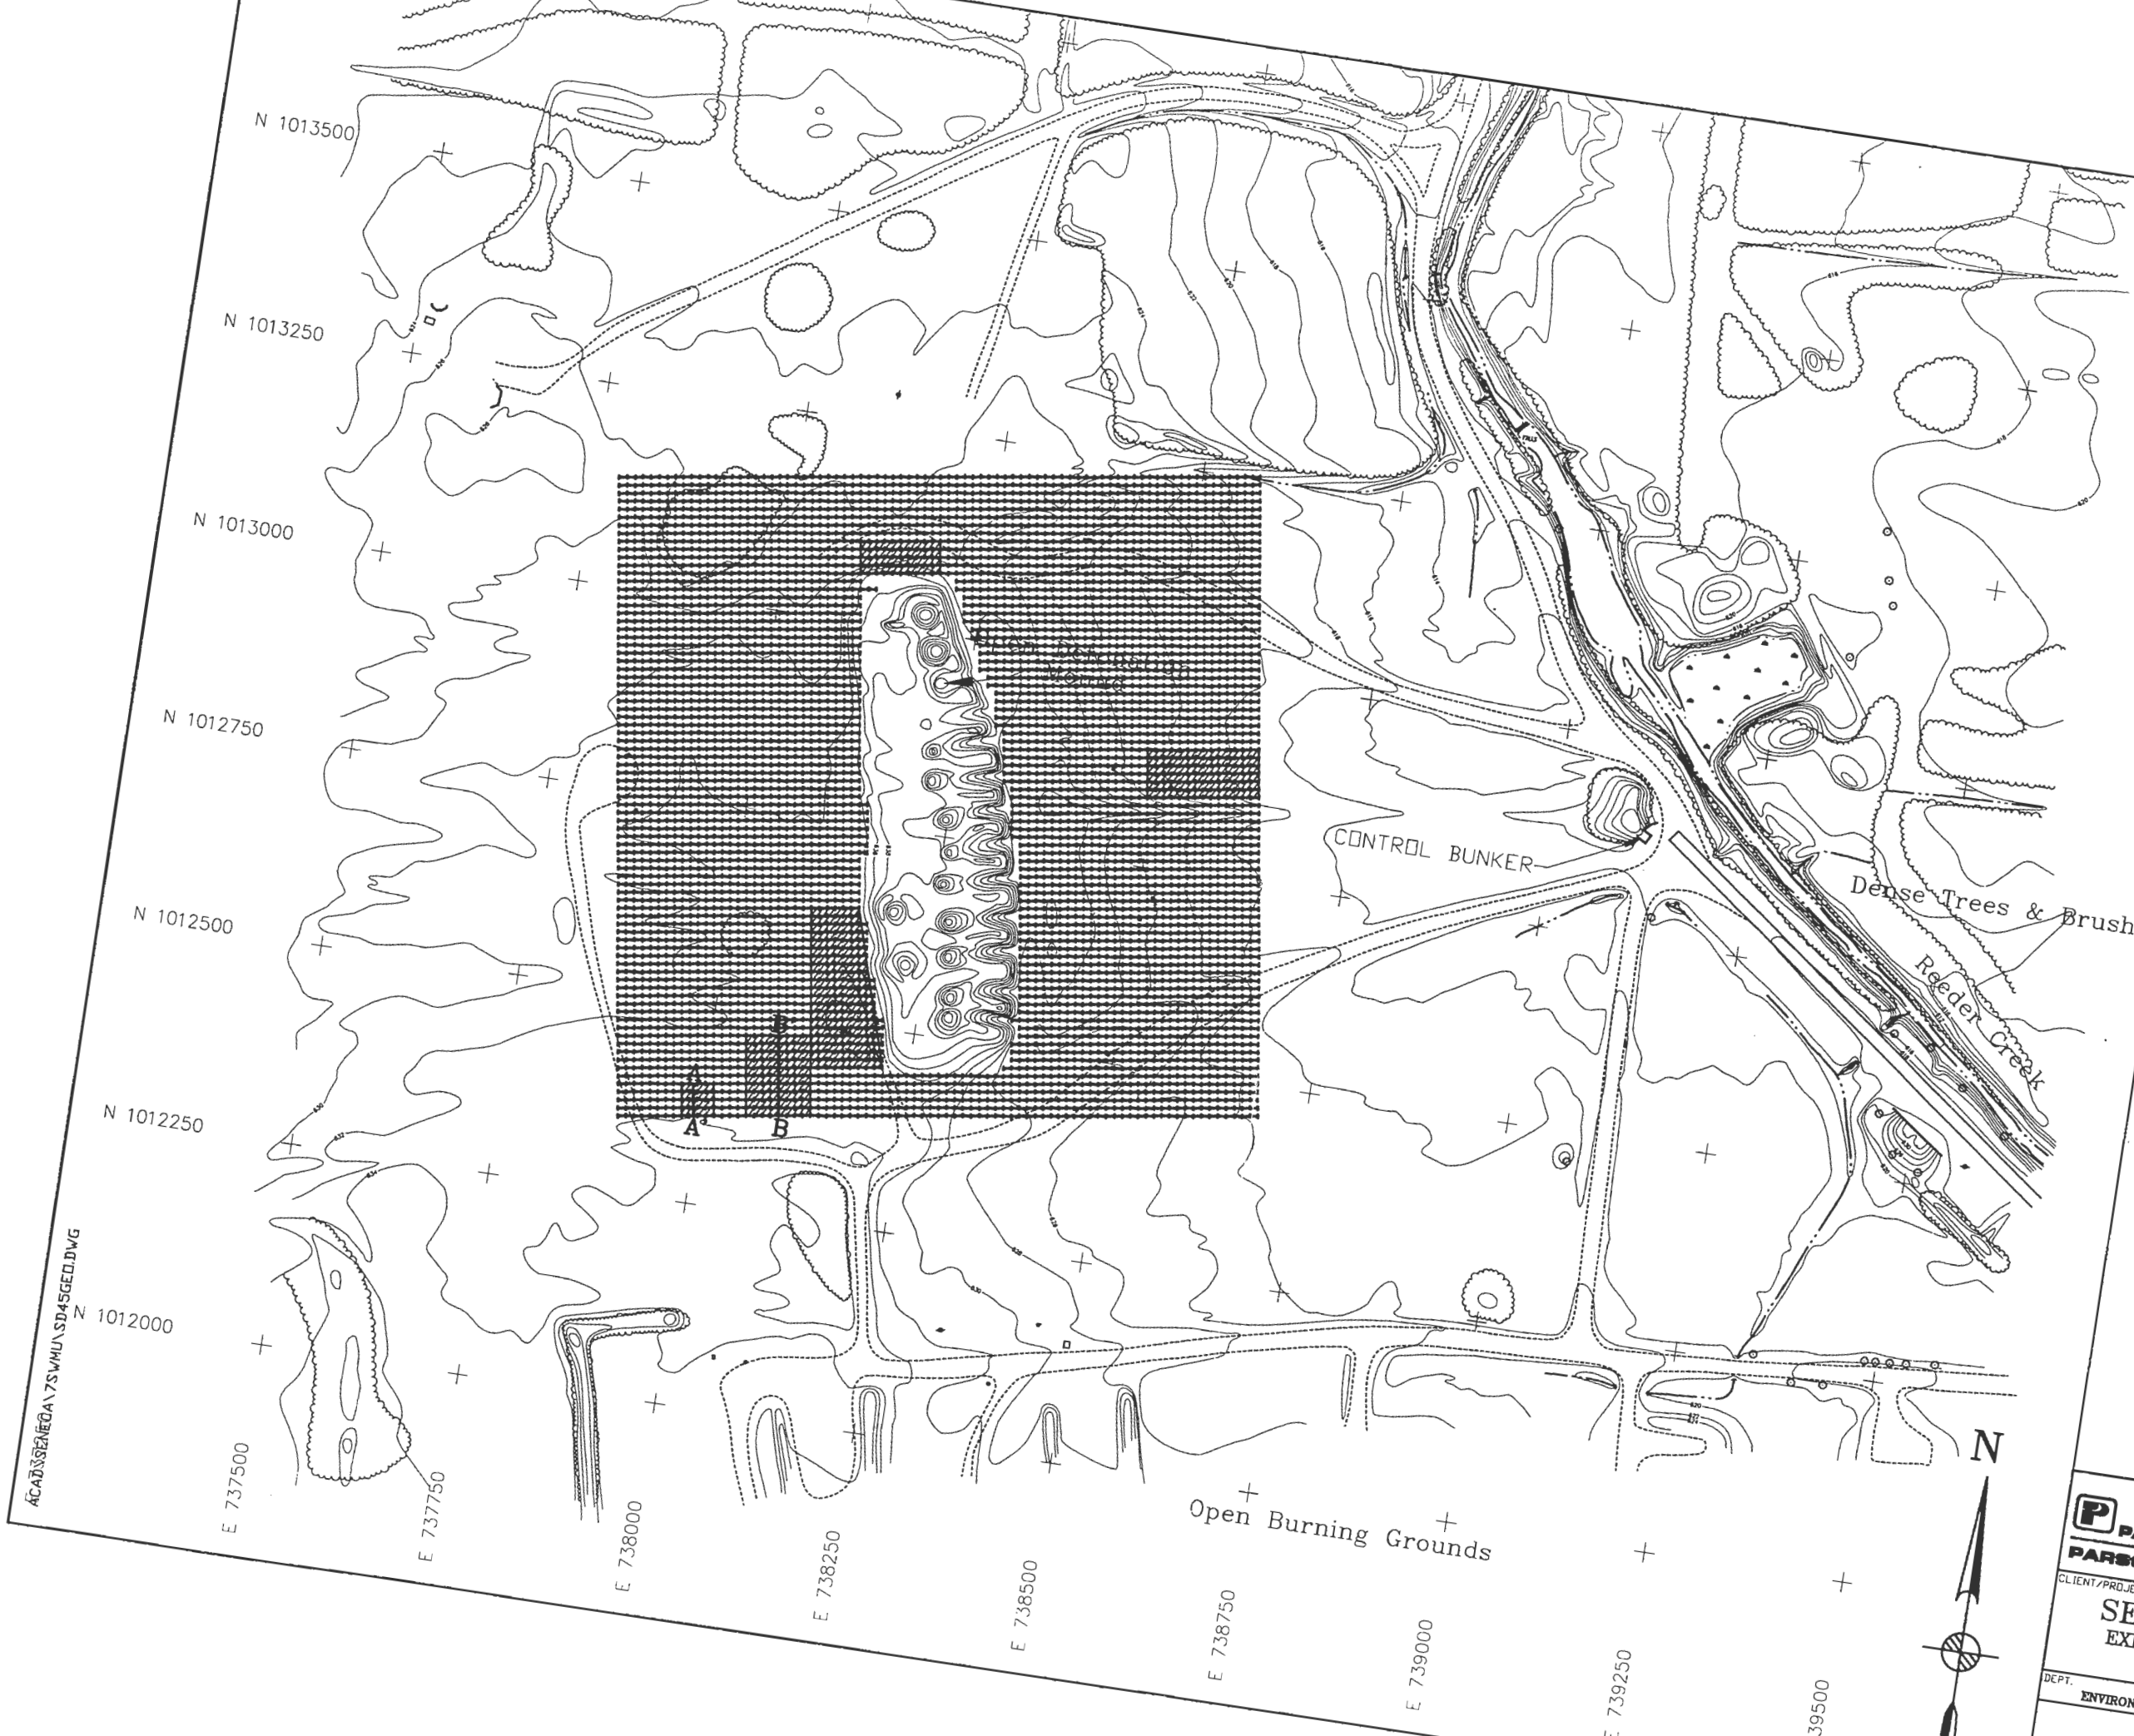
To evaluate the potential for buried unexploded ordinance at the OD ground, GPR and EM-31 surveys were performed in the area surrounding the elongate detonation hill (Figure 2.9-1). The electromagnetic data was collected along profiles spaced at 10-foot intervals with readings spaced every 5 feet along each profile. Where the electromagnetic data indicated anomalies possibly associated with buried metallic objects, a subsequent ground-penetrating survey was performed to characterize the anomaly source. Approximately 310 feet of GPR profiles were acquired and 27,800 feet of EM data was collected. A total of 10 test pits were excavated to observe the types of buried metallic objects present at this AOC.

Five detailed GPR grids were conducted to further characterize several anomalies identified by the EM survey. Figure 2.9-1 shows the locations of these grids. The first GPR grid was conducted over a small in-phase anomaly in the southwest corner of the EM grid. The GPR record collected along profile A-A' (Figure 3.7-3) shows the suspected GPR signature of the EM anomaly. The anomaly is located at a depth of about 12 ns (about 2.5 feet) at a profile distance of 14 to 18 feet. This anomaly is 10 to 12 feet long.

Ten test pits were excavated to identify the sources of various EM anomalies. The test pit locations have been shown in Figure 2.9-2, and the test pit reports are presented in Appendix B. This section presents a summary of the test pit results as related to the interpretation of the EM survey.
