FINAL Findings Report
Small Arms Range
Lake Housing Area

SENECA ARMY DEPOT ACTIVITY (SEDA)

March 2004

FINAL Findings Report
Small Arms Range, Lake Housing Area
SEAD-119B

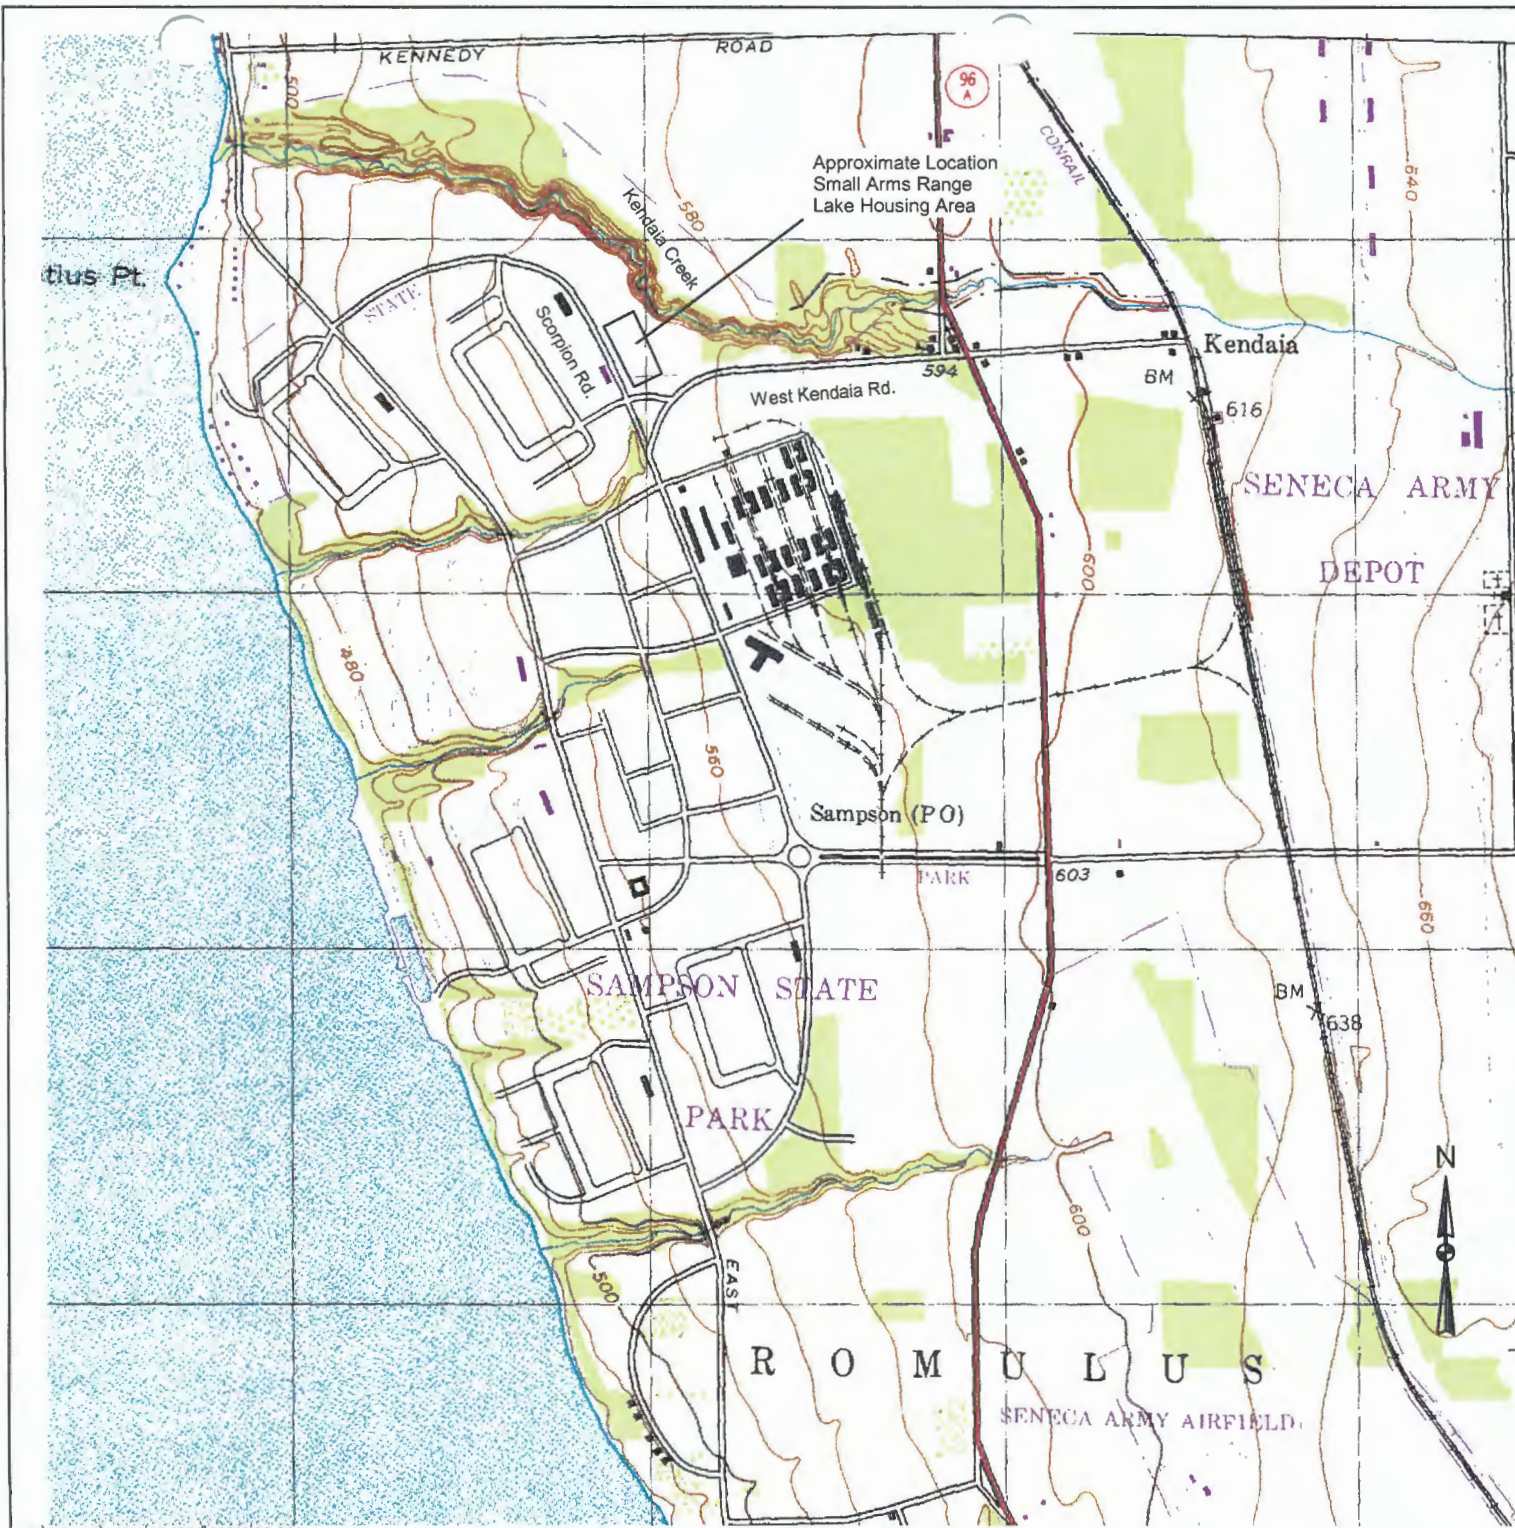
**Figure 2-2
Small Arms Range
Lake Housing Area**

Structures parallel to Scorpion Road were observed to the northeast of Scorpion Road on the aerial photograph taken in 1954, indicating the Small Arms Range existed in 1954. Examination of aerial photographs taken in 1959 and 1968 does not provide evidence of the suspected range or of the small shack and tower described in the OE ASR, perhaps due to the small footprint of these structures, and the high elevation of the aerial photography. By 1998 when the ASR site visit was conducted, the area in question was overgrown with thick underbrush and small trees. This condition prevailed when the field investigation began in March 2002.

Additionally, several metal pipes aligned in straight lines running parallel to, but offset in a easterly direction from, Scorpion Road, which may have once been used either to hold target lines or to mark firing lines, were also observed once the brush was cleared. Thus, this area became the focal area of the subsequent site investigation.

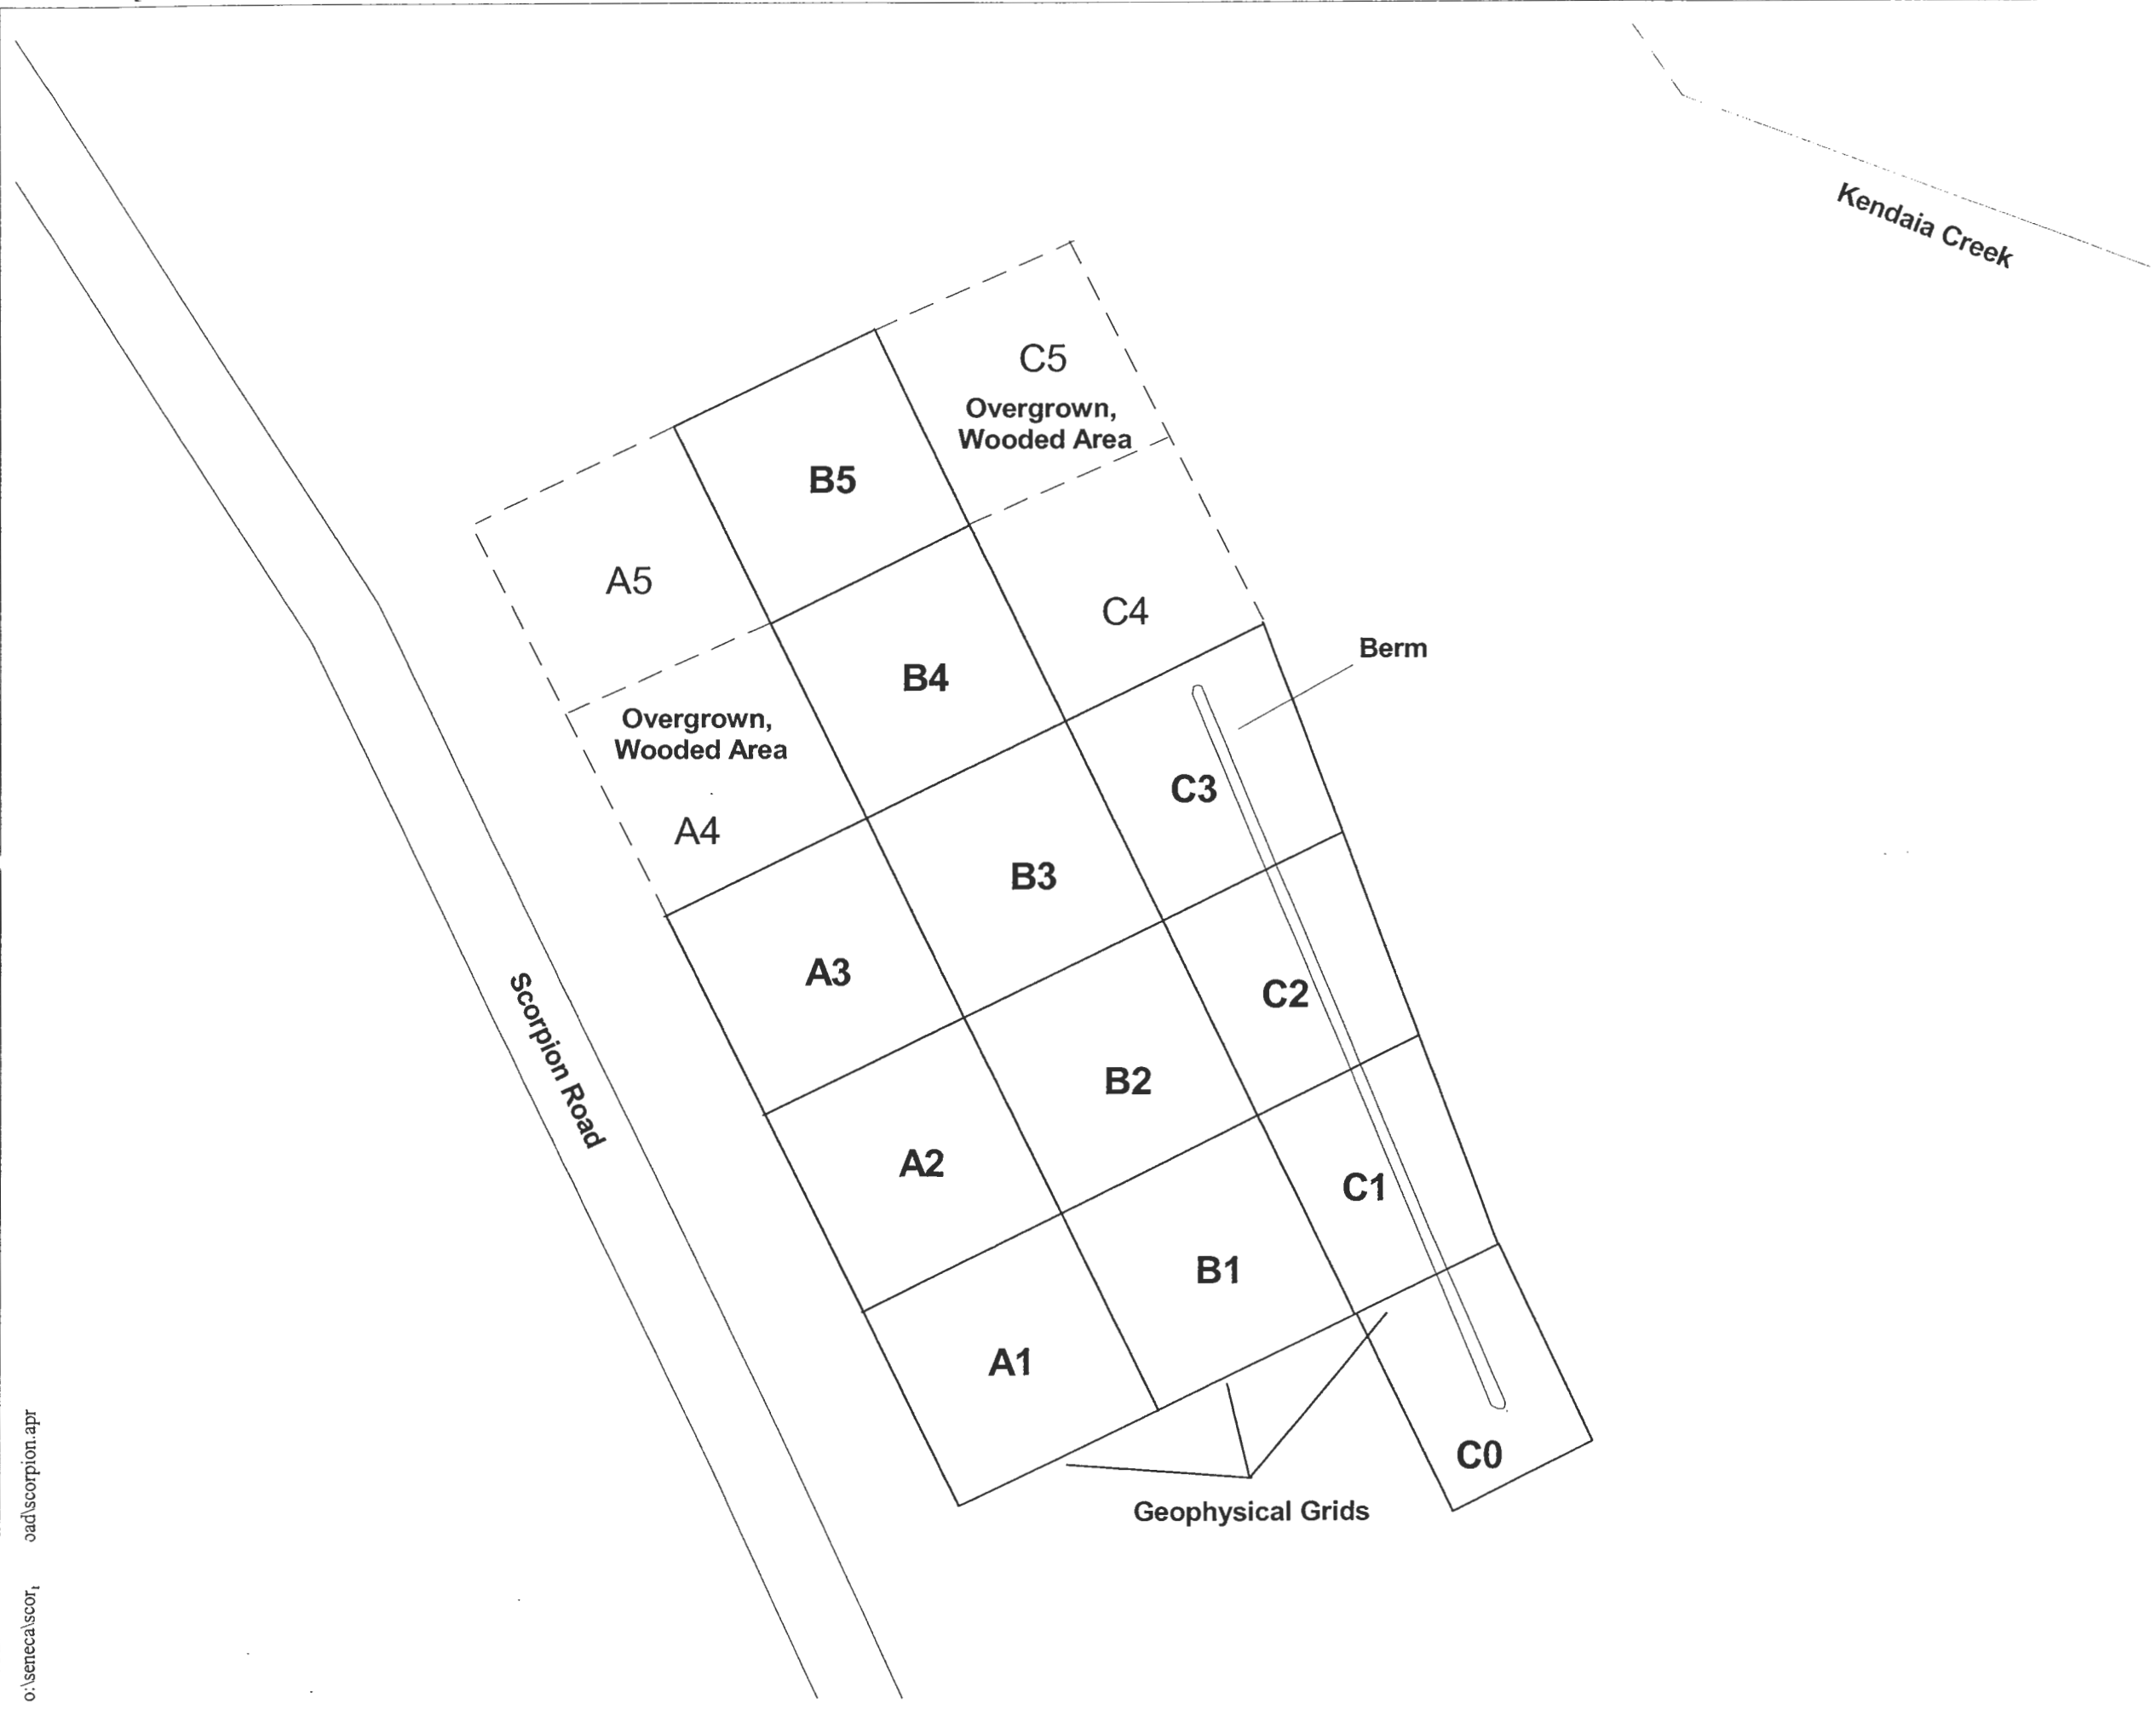
**FIGURE 2-3
GRIDS SET FOR GEOPHYSICAL SURVEY
AT THE SMALL ARMS RANGE**

Note: Berm is approximately
4 ft wide by 4 ft high

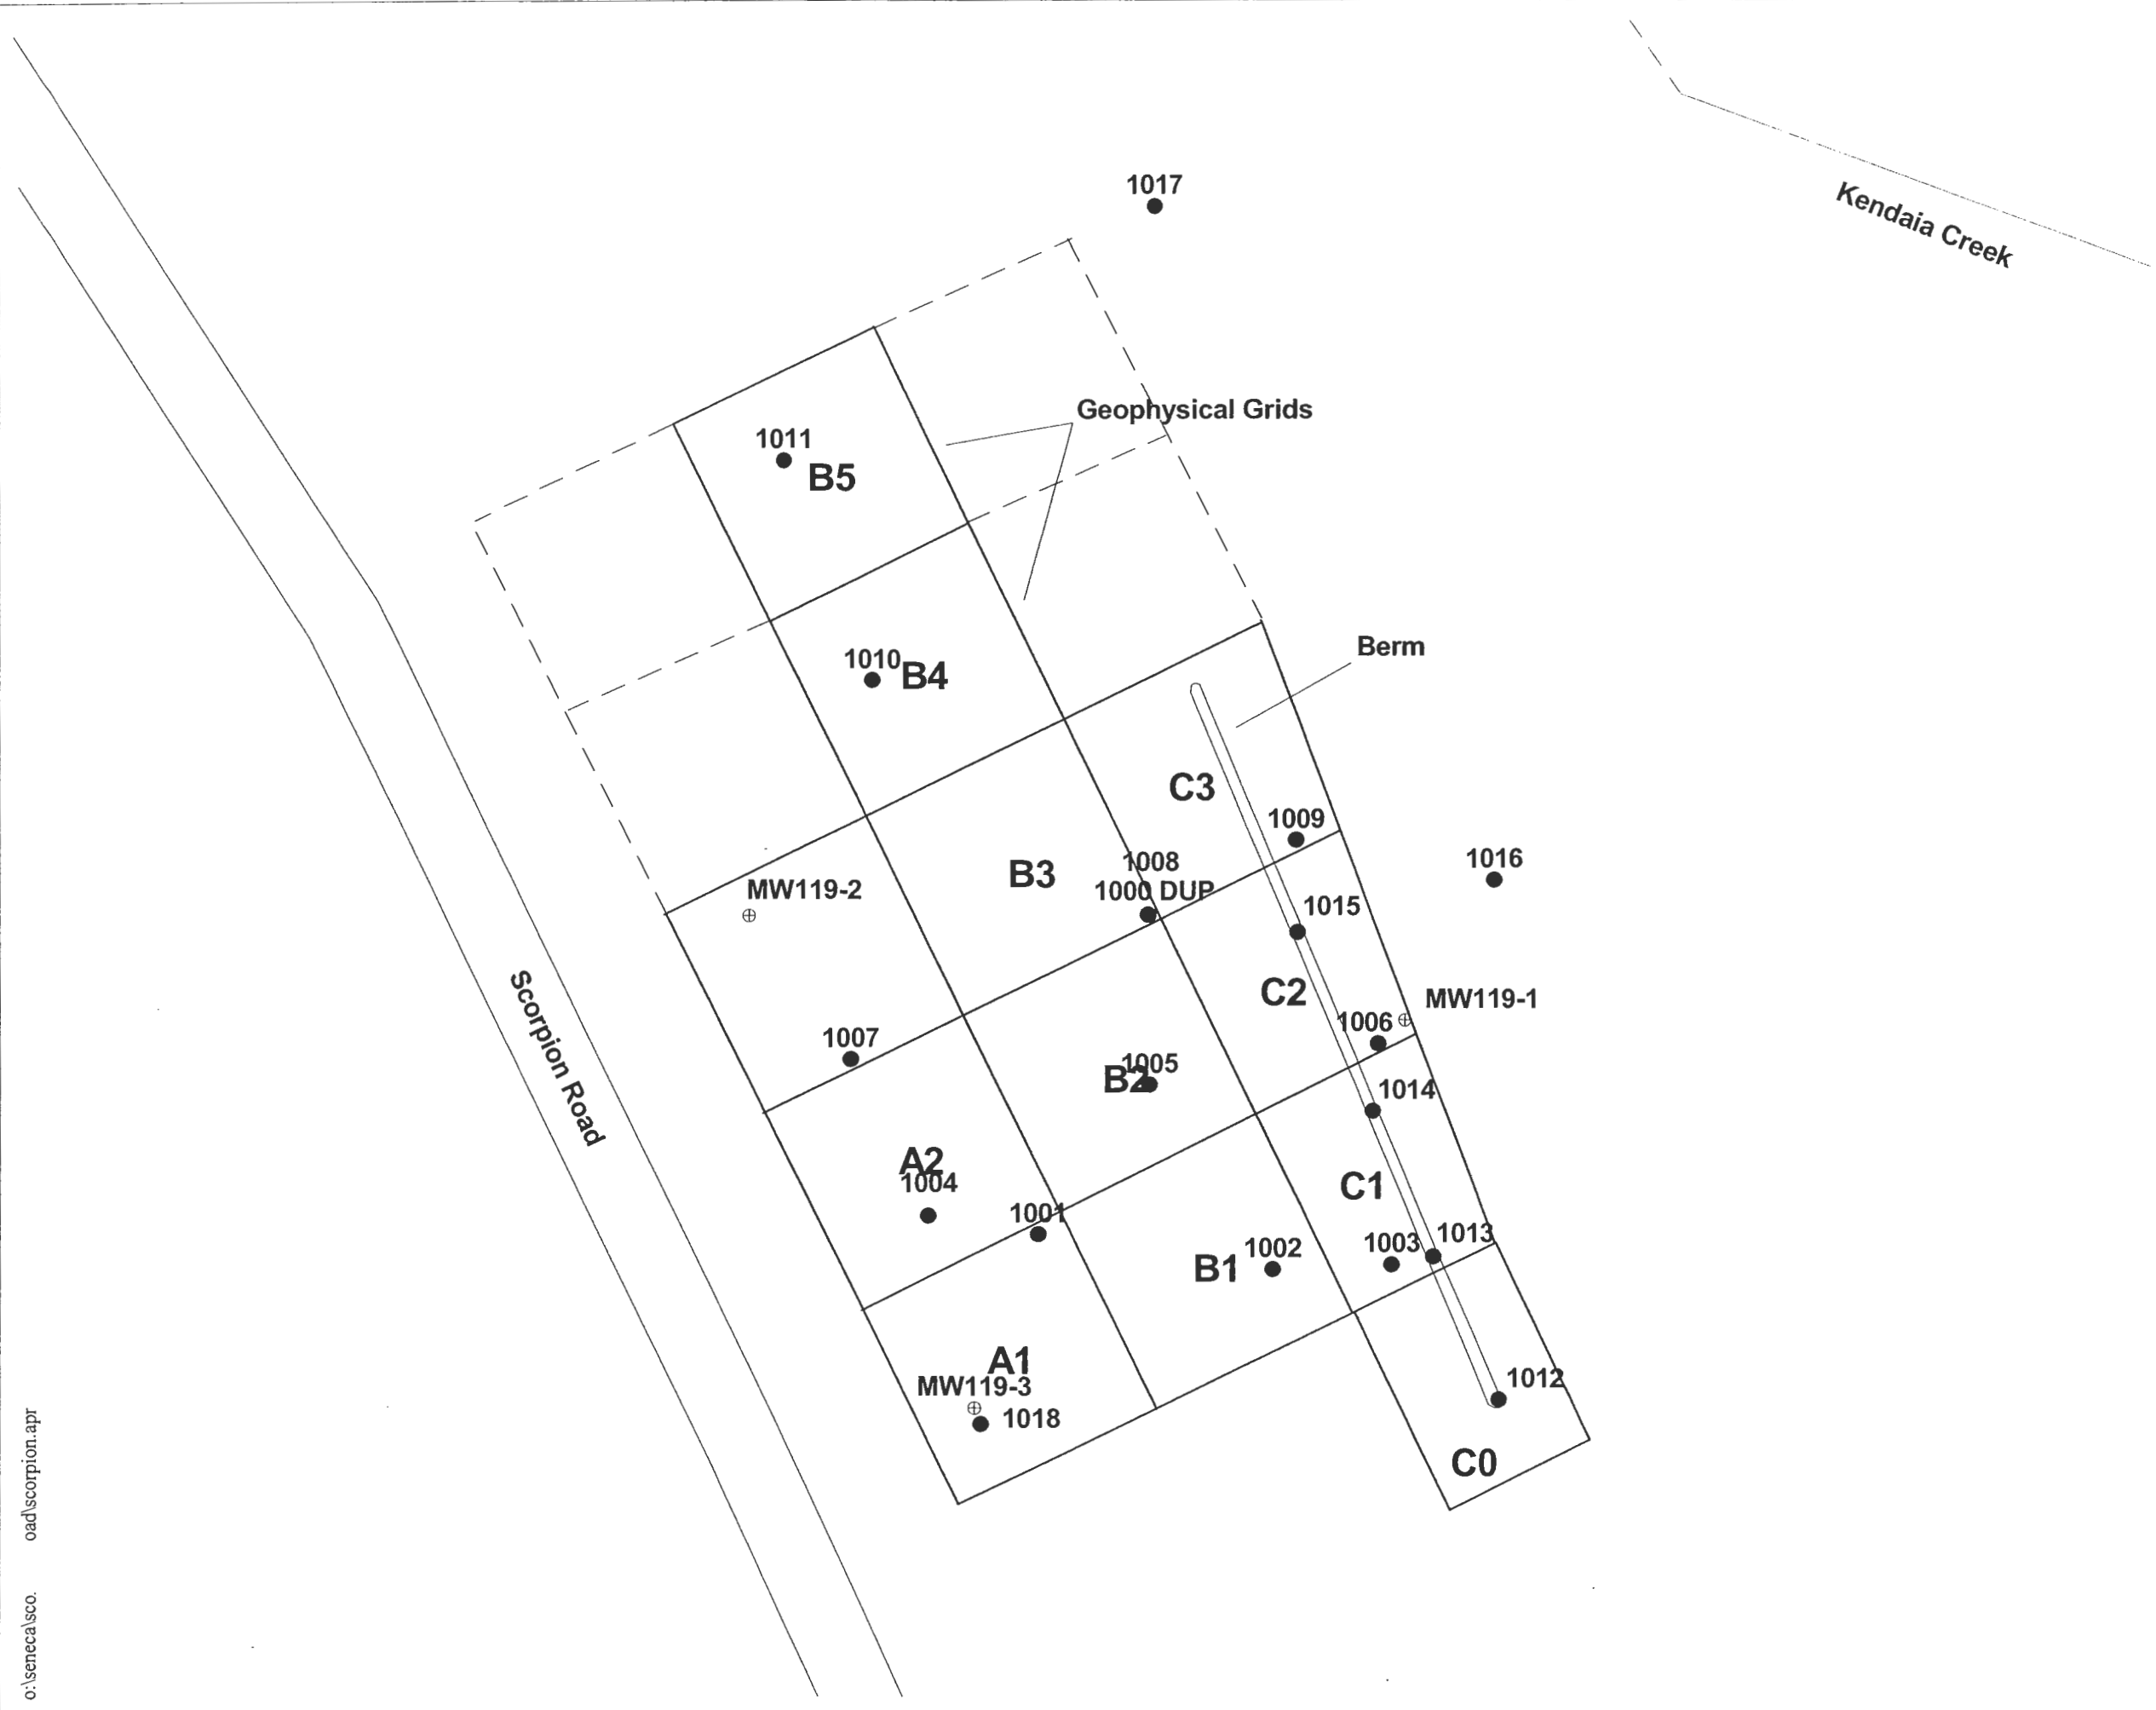
FIGURE 2-4
MONITORING WELL AND
SURFACE SOIL SAMPLE LOCATIONS

- 0001 ● Surface Soil Sample Location
- MW119-1 ⊕ Monitoring Well Location

Note: Berm is approximately 4 ft wide by 4 ft high

Surface soil samples were collected at 18 locations as part of the Small Arms Range investigation (**Figure 2-4**). Eleven of the surface soil samples were collected at randomly selected locations; one sample was collected from each of the 11 grid blocks originally set for the geophysical survey (samples SS119-1001 to -1011). The remaining seven surface soil samples (SS119-1012 to -1018) were collected from biased locations that were selected based on observed site features. Four of these were collected along the berm at 70-foot intervals, two were collected behind the berm (towards Kendaia Creek) to assess the potential impact of ammunition that overshot the berm, and one was collected in the assumed location of the firing line.

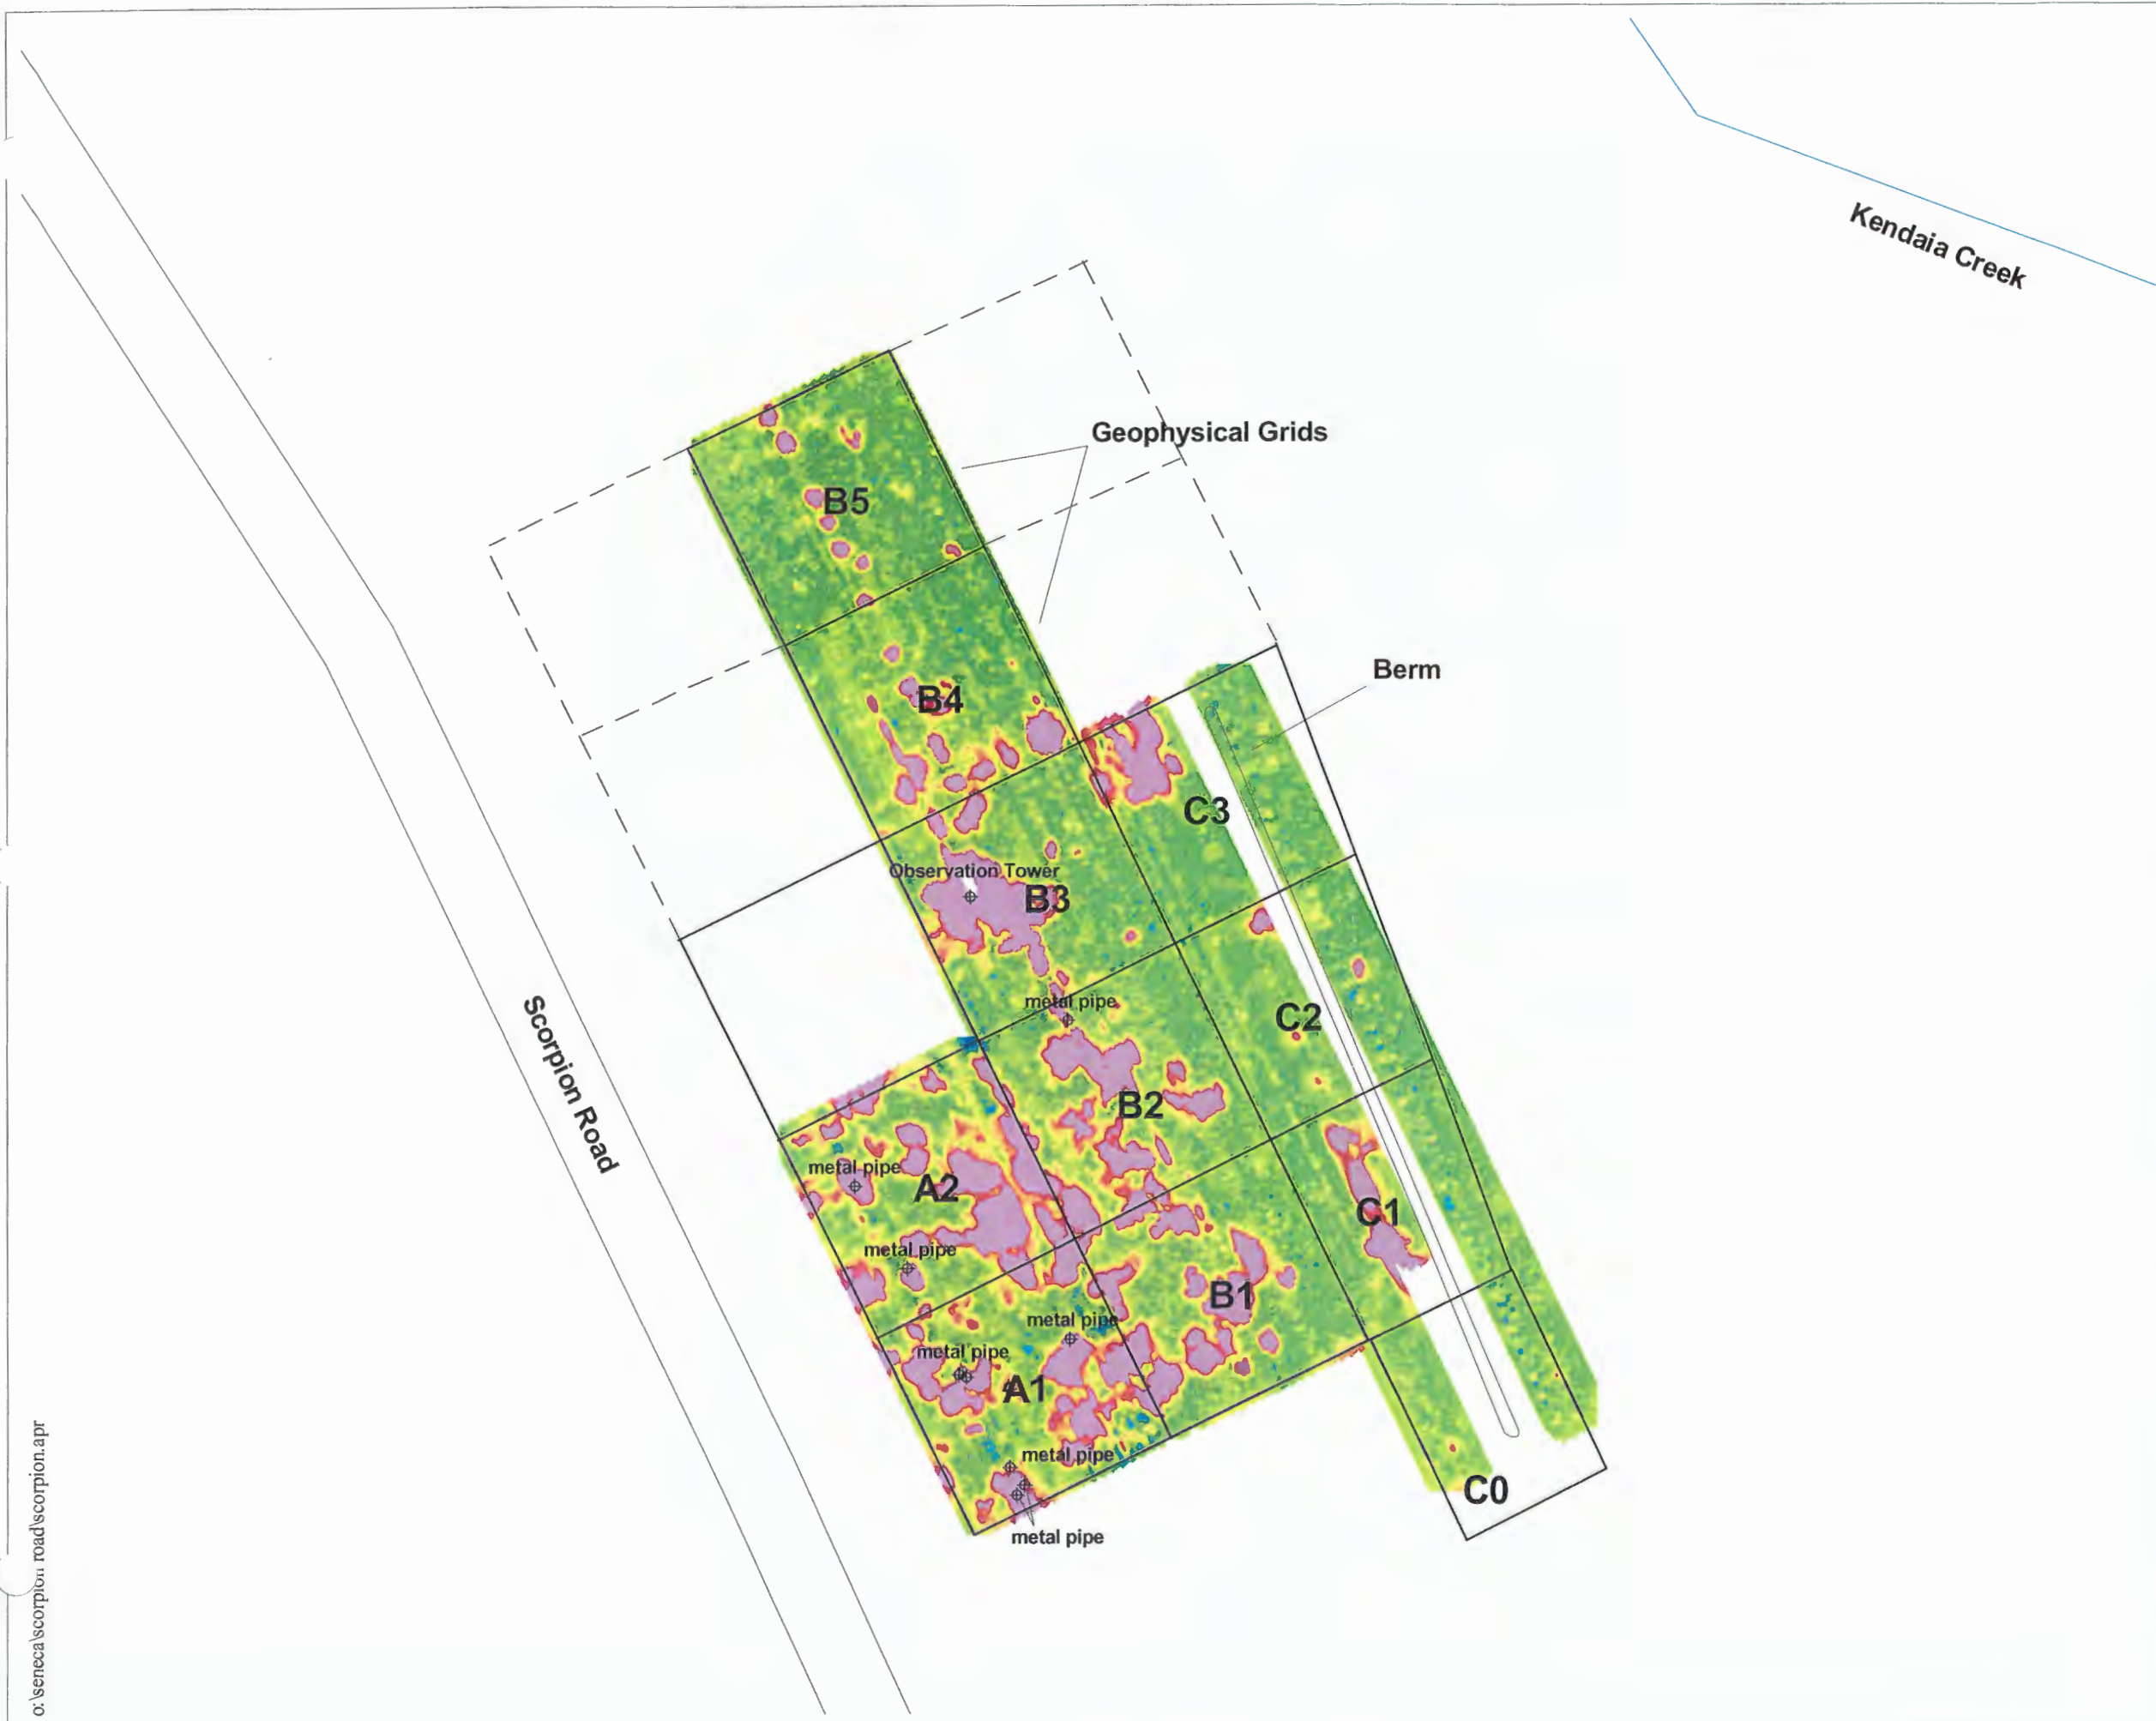
**FIGURE 3-1
RESULTS OF GEOPHYSICAL SURVEYS
AT THE SMALL ARMS RANGE**

⊕ Known Geophysical Anomaly

Note: Berm is approximately 4 ft wide by 4 ft high

EM-61 Response (mv)

During the collection of the geophysical data, Parsons also visually examined the surface of the grid blocks and noted where metallic debris such as pipe was present. Locations of metal pipes are provided in Figures 3-1 and 3-2. No bullets or casings were noted as a result of the physical examination of the site.

The geophysical survey results showed anomalous areas within the small arms range area that could have been interpreted as fill. Accordingly, the Army decided to excavate test pits at locations of representative anomalies to determine if filled materials were present. On February 14, 2003, four test pits were excavated in the area of the small arms range. These test pits were located based on the results of the EM-61 survey. All test pits were excavated to the top of bedrock and no fill material was detected in the test pits with the exception of a few vitrified clay tiles found in two test pits. The test pit results are provided in **Appendix E**. The material removed from each test pit was returned to the excavated area at the completion of each test pit investigation. Test pitting procedures are provided in Section 3.4.3 of Appendix A, Field Sampling and Analysis Plan in the Generic Workplan.

Although the results of geophysical survey suggested several large anomalies, subsequent test pitting did not result in the discovery of any significant buried non-metallic or metallic objects. No bullets, bullet fragments or shell casings were observed during any phase of the work.

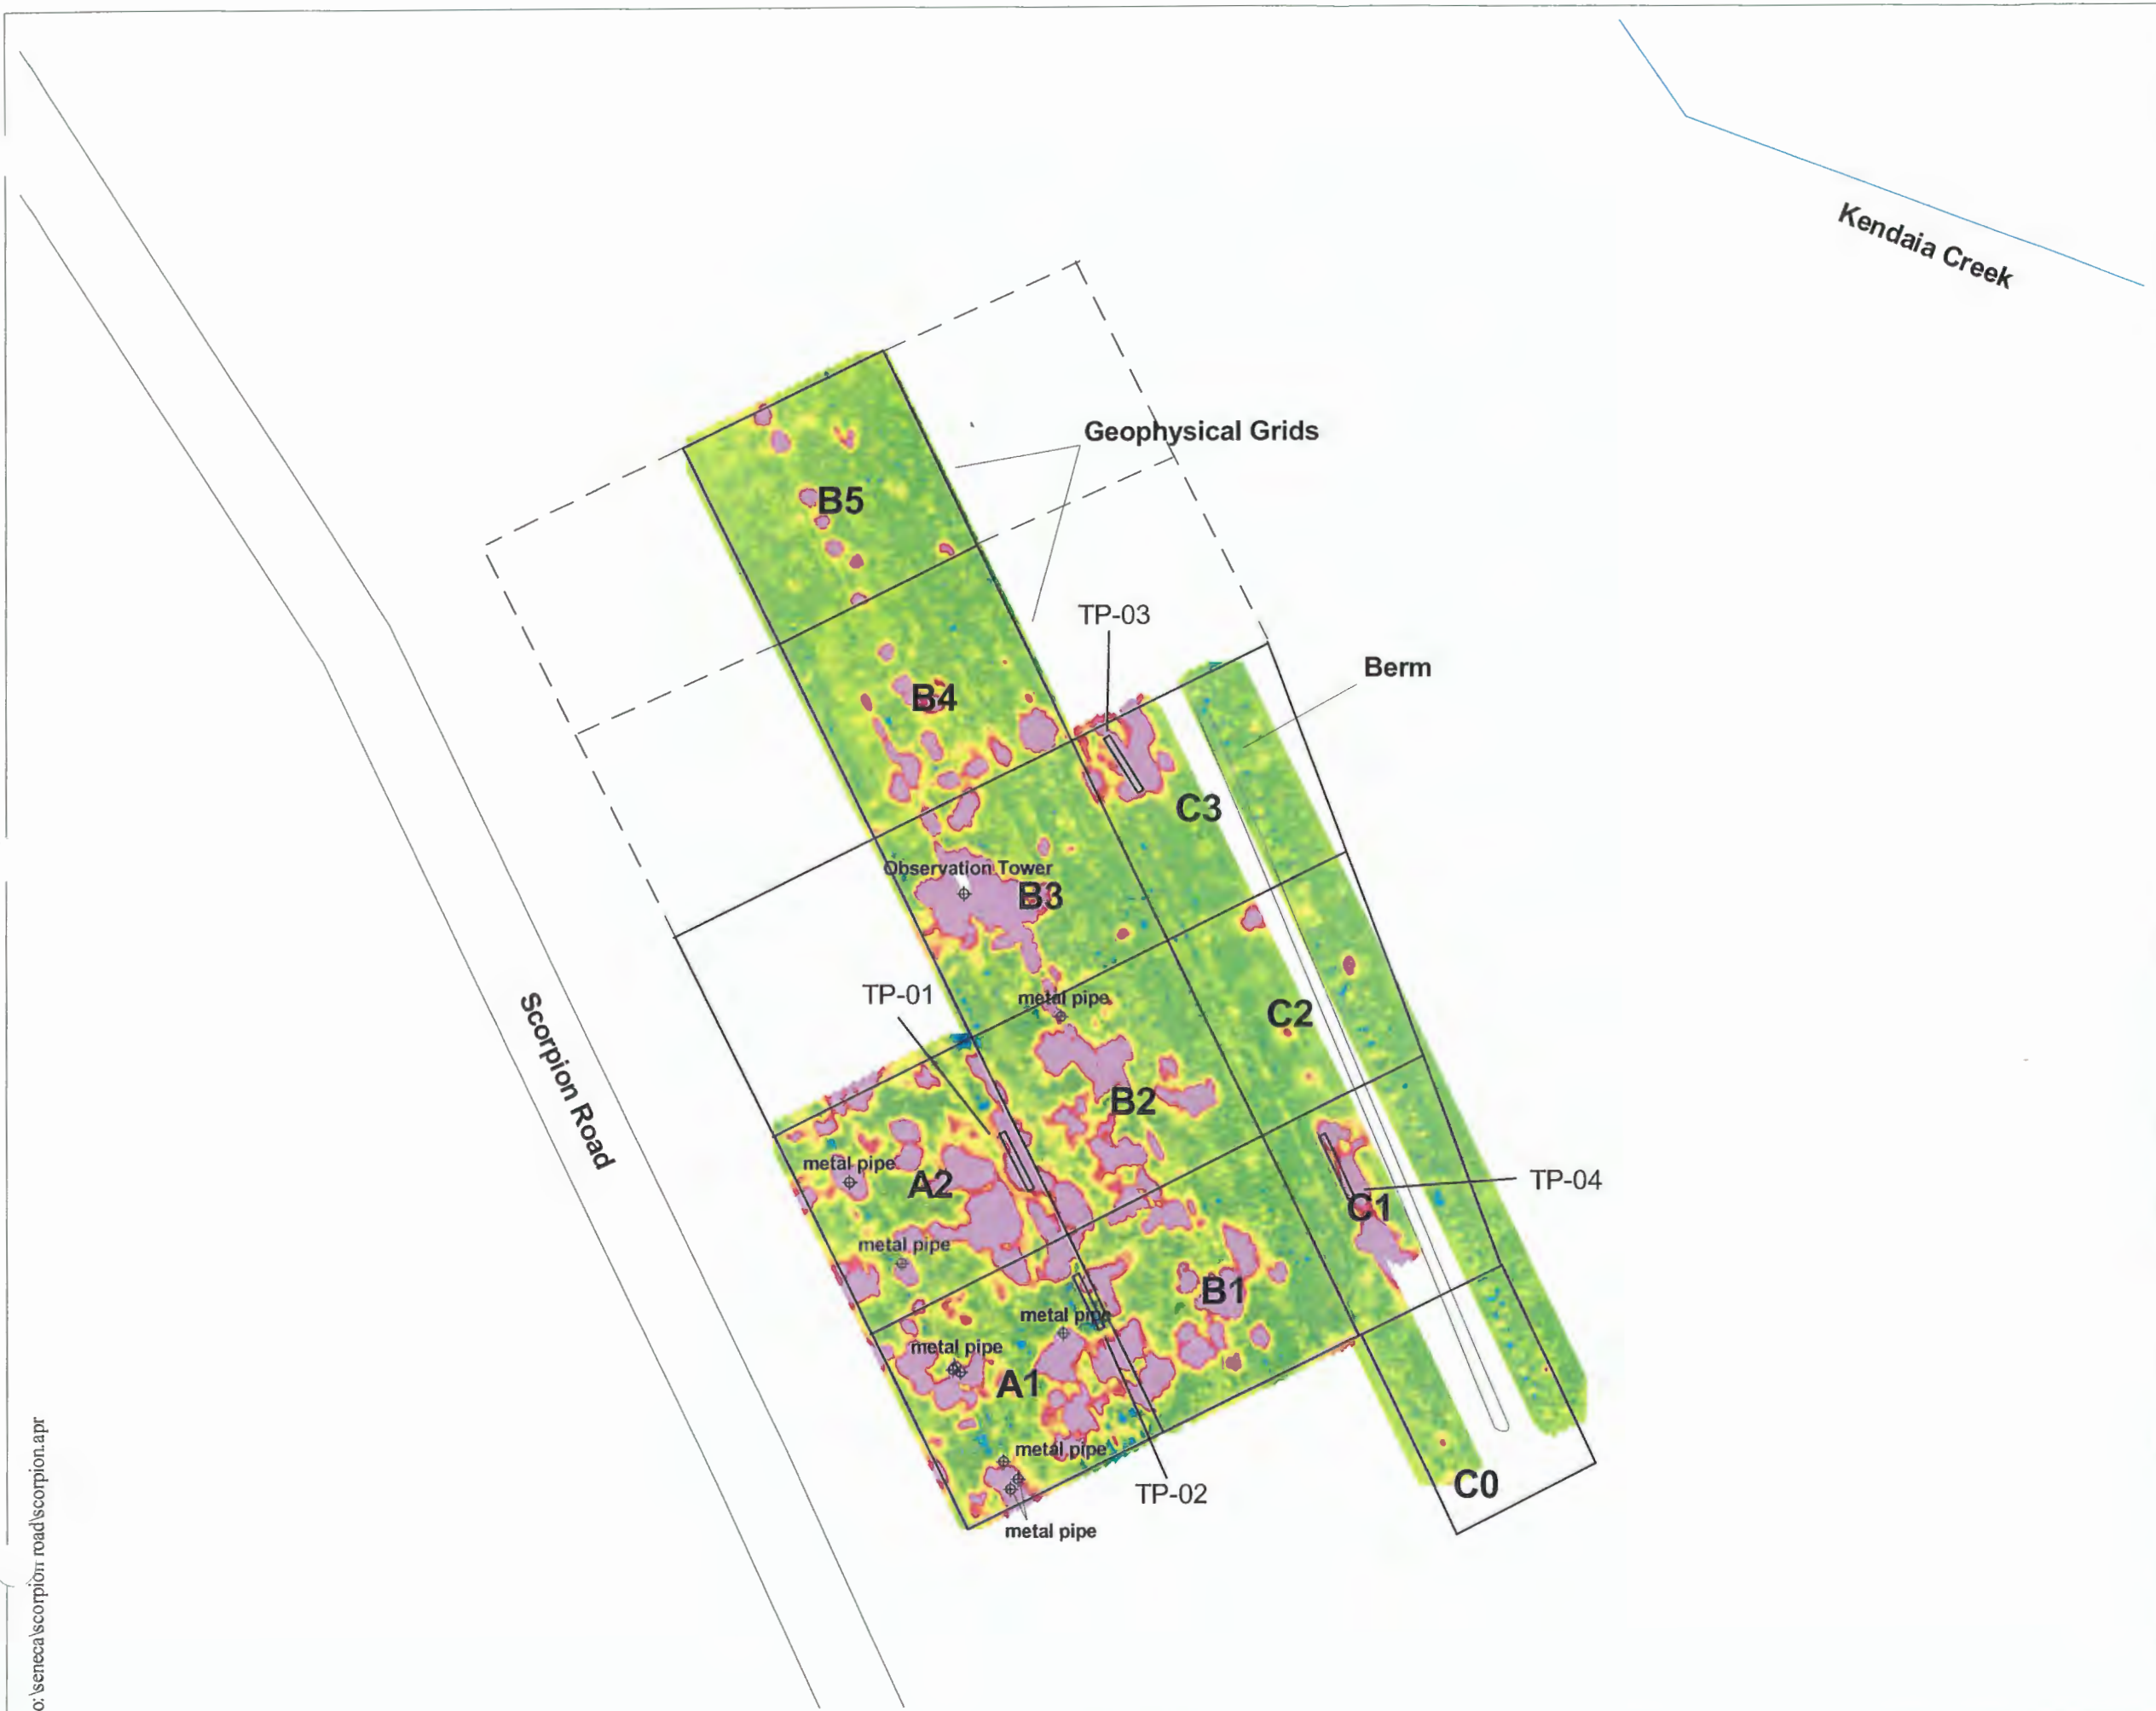
The results of the EM-61 investigation at the Small Arms Range are shown in **Figure 3-1**. Background EM-61 readings, which were normalized to approximately 0 millivolts (mV) during post-processing, appear as green on this figure. Items typically fired on a small arms range (ammunition up to 50 cal.) can produce electromagnetic responses that are just above background values (2-3 mV), so the data collected were contoured from -5 to 10 mV in order to differentiate anomalies of this magnitude from background. Therefore, responses greater than 10 mV appear pink on the map, while smaller anomalies appear as yellow or red.

4. **Section 3.1, Geophysical Results, Page 3-1.** The discussion of results of the geophysics indicates that “anomalies greater than 80 mV are present...” within the investigation grid. However, review of Figures 3-1 and 3-2 shows results no higher than 10 mV, as represented by pink shading. If the scale on the figures was somehow zeroed to the data, please indicate this in the text. If not, clarify the reference to 80 mV in the text or correct the scale on the figures, whichever is appropriate.

Response: Acknowledged. It should be noted that Figure 3-1 provides contour with EM-61 response equal to or greater than 10 mV, as anything above 10 mV is generally not expected at a small arms range. The contour with EM-61 response equal to or greater than 80 mV is not presented in the figure. The scale in Figures 3-1 and 3-2 has been revised to reflect the above discussion.

8. **Figures 3-1 and 3-2.** Please clarify the anomalies identified as "steel pipes" on these two figures. Are these the same objects that are referred to as "metal posts" in the Physical Site Characterization in Section 2.3? If they are different objects, revise the text to provide a description and presumed purpose of these steel pipes.
-

Response: Acknowledged. The steel pipes and metals posts are the same objects. The Army believes that these pipes may have once been used either to hold target lines or to mark firing lines. Figures 3-1 and 3-2 and the text have been revised to reflect the above discussion.

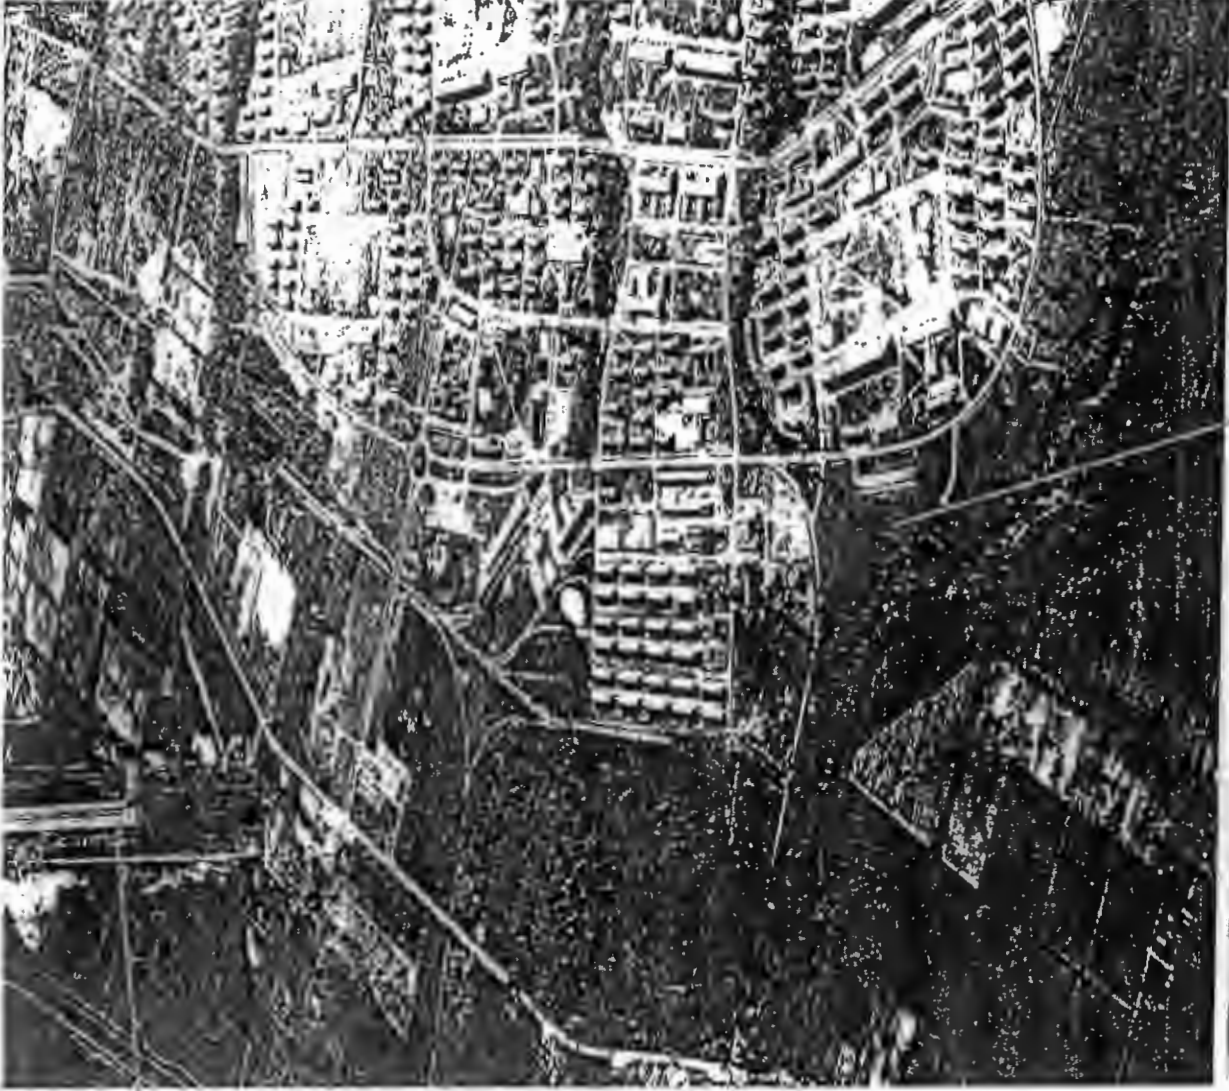
1954 Photo

Scorpion Road

Small Arms Range
