**DRAFT Findings Report  
Suspected Small Arms Range  
Lake Housing Area**

**SENECA ARMY DEPOT ACTIVITY (SEDA)**

**DRAFT Findings Report**  
**Small Arms Range, Lake Housing Area**  
**SEAD-119B**

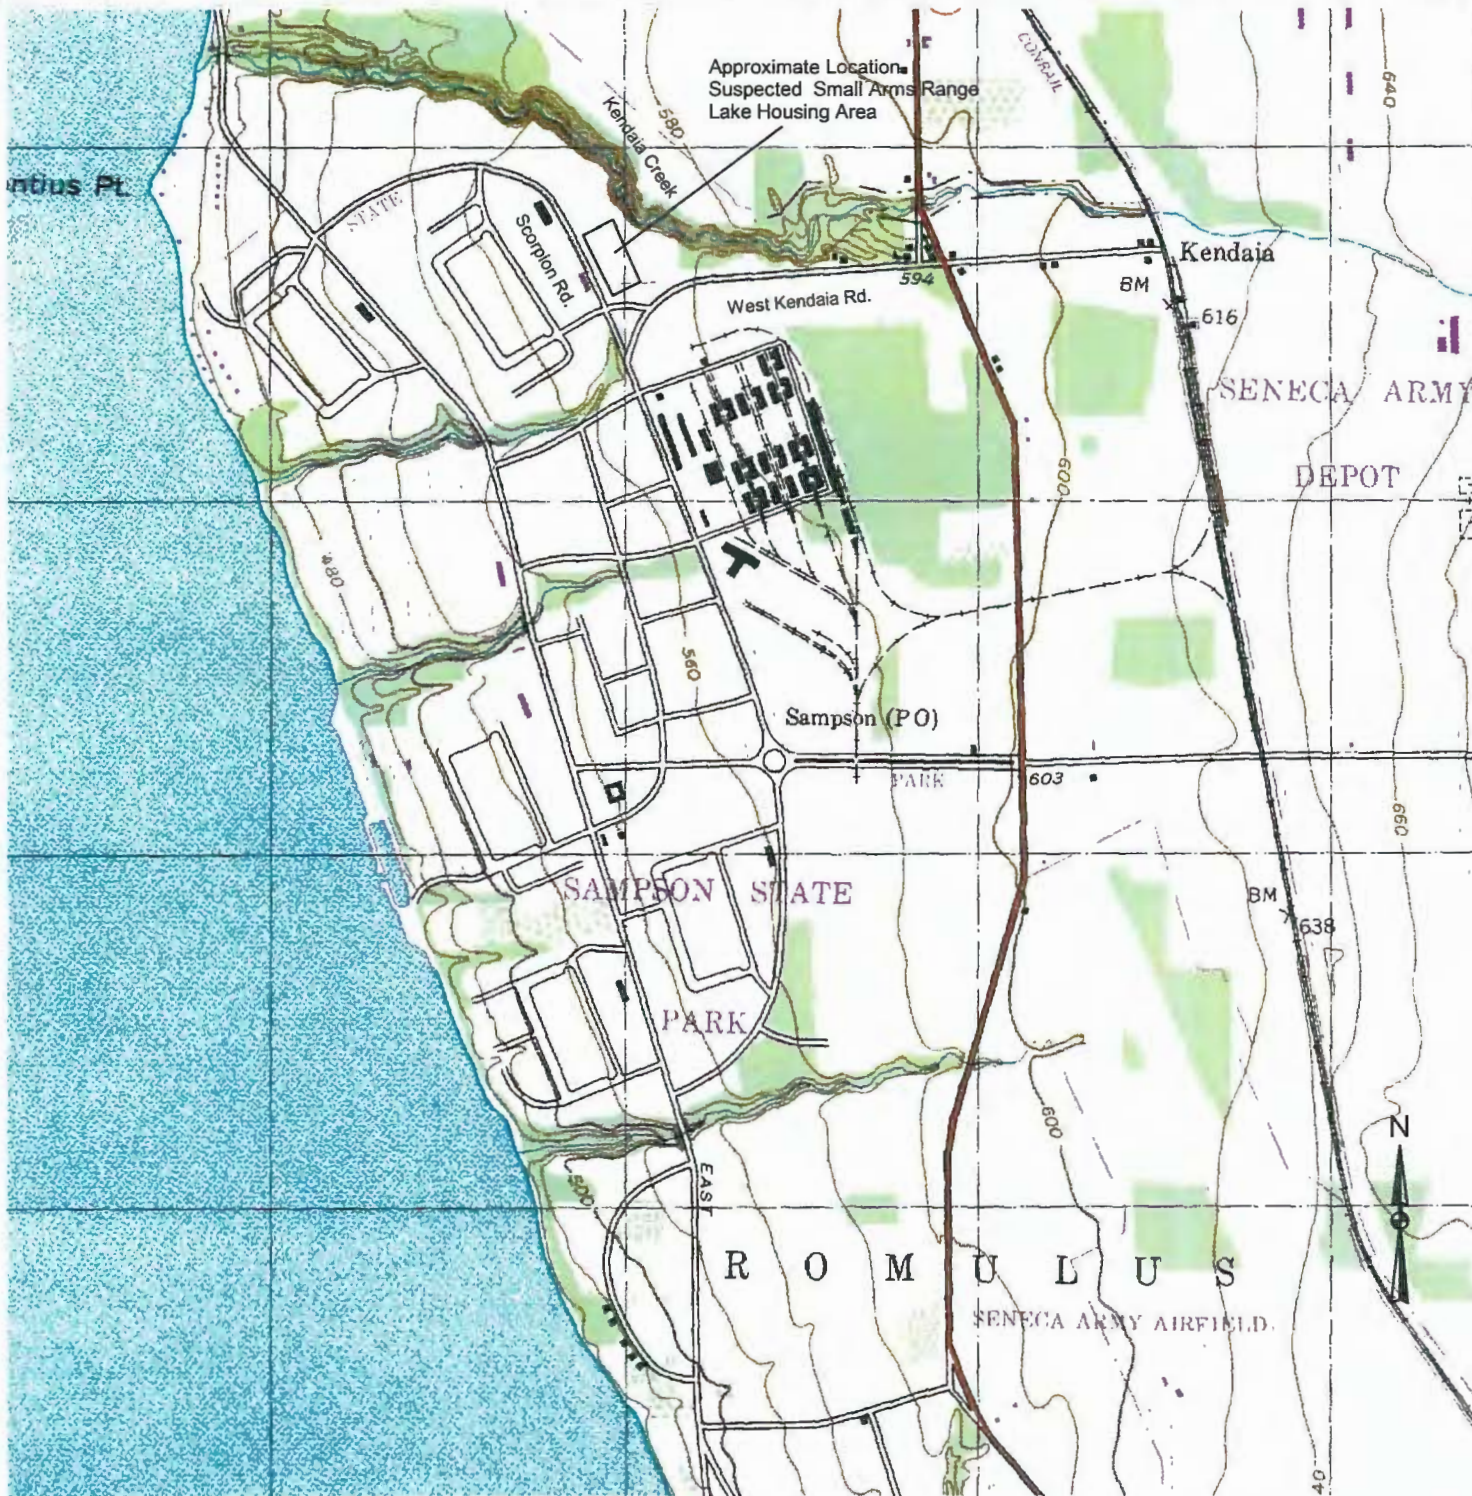
**Figure 2-2**  
**Suspected Small Arms Range**  
**Lake Housing Area**

The area suspected to be the location of the Small Arms Range at the Lake Housing Area was identified based on the map of sites investigated during the ASR. The suspected range is located approximately 5,000 feet west of the main portion of the Depot and State Route 96A, near the intersection of West Kendaia and Scorpion Roads (**Figure 2-2**). The elevation of the site varies from approximately 560 to 580 feet (NGVD 1929). The land slopes gently towards Seneca Lake (elevation 445 feet), which is located 4,000 feet to the west of the suspected Small Arms Range. The site is bounded on the north and the east by the gorge through which Kendaia Creek flows and which is 80 to 100 feet deep in this area, by Scorpion Road on the west, and by West Kendaia Road to the south. **Figure 2-2** shows a map of the area suspected to be the Small Arms Range.

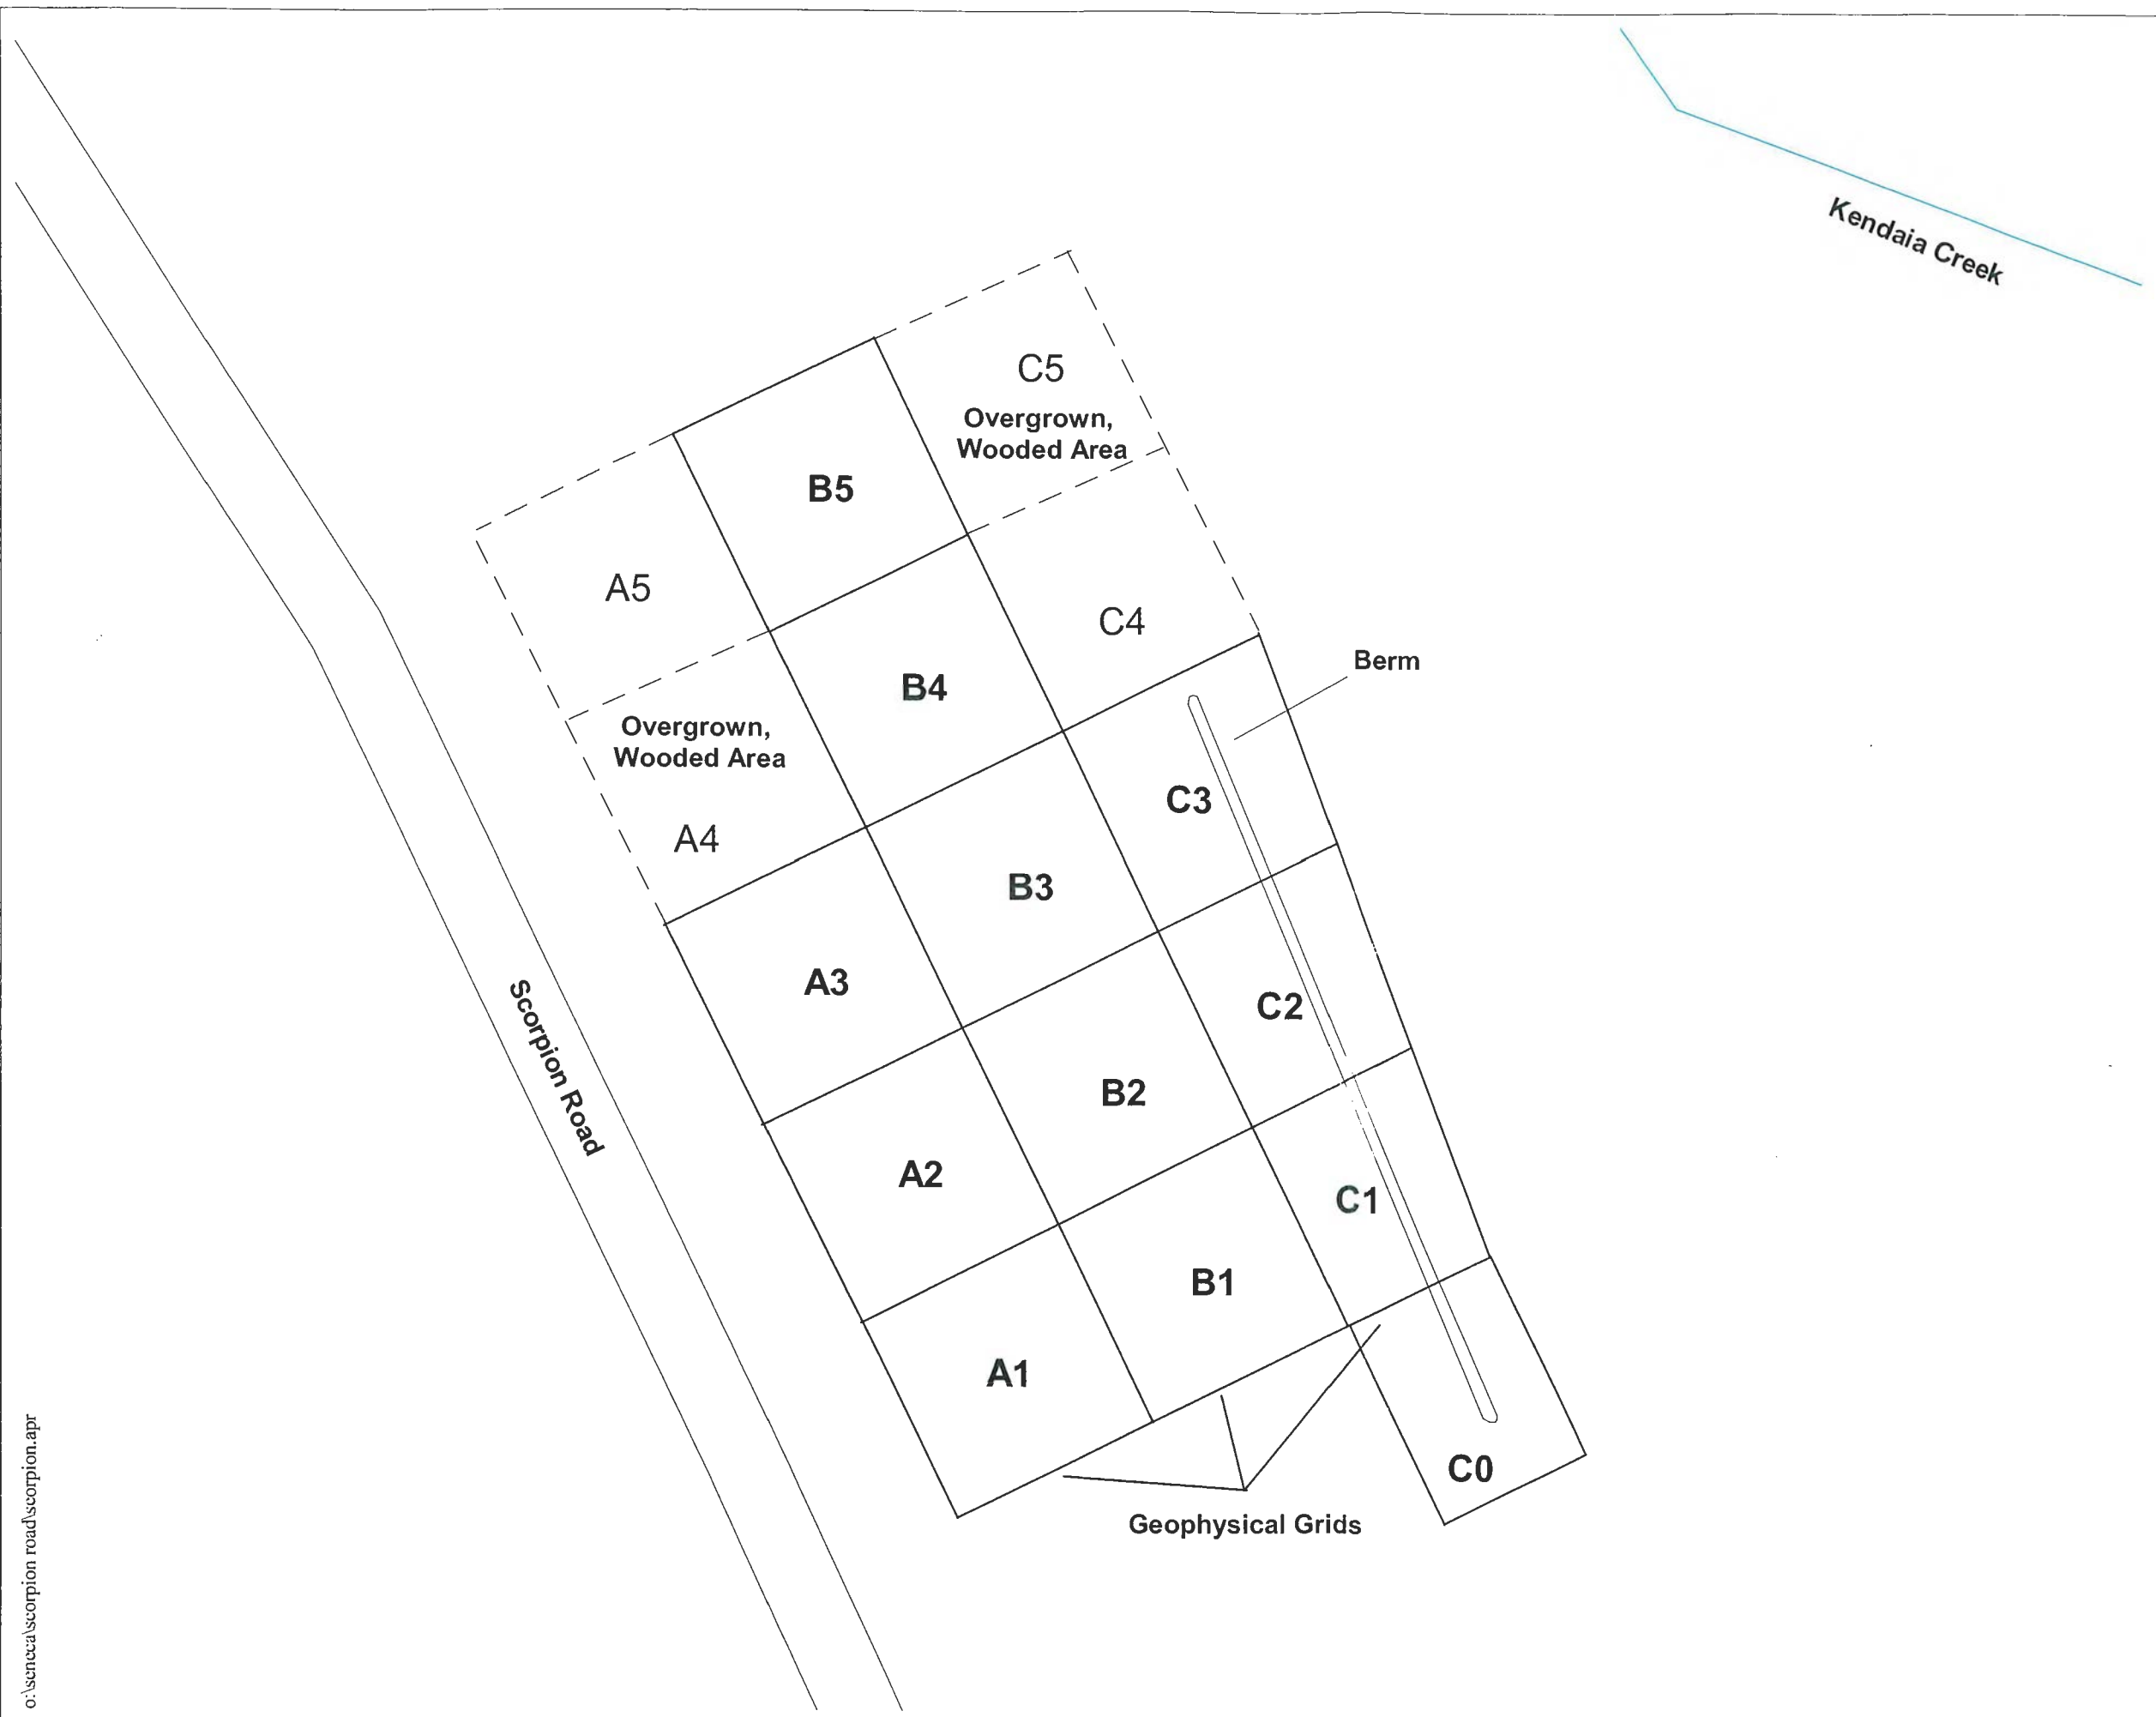
**FIGURE 2-3  
GRIDS SET FOR GEOPHYSICAL SURVEY  
AT THE SMALL ARMS RANGE**

Prior to the start of the fieldwork, a system of 11, 100-foot by 100-foot grids was laid out on the site using measuring tapes (**Figure 2-3**). The grids were laid out parallel to the berm, with the majority of the gridded area covering the region to the west of the berm, as this was on the side of the observation tower and thus between the location of the presumed firing line and the identified berm. The two, 200-foot long by 100-foot wide blocks that comprise the northeastern and northwestern most corners of a full 15 grid sector (5 block long by 3 block wide), rectangular system (i.e., imaginary grids A4, A5, C4, and C5) were excluded due to being heavily wooded which made pulling the EM-61 coils impossible. However, as these grid cells are generally beyond the northern end of the presumed firing line (imaginary grid cells A4 and A5) and beyond the northern end of the presumed backstop berm (imaginary grid cells C4 and C5) and perpendicular to the presumed path of firing, it is likely that they received little, if any, fire from the range.

Note: Berm is approximately  
4 ft wide by 4 ft high

At the time the geophysical survey was performed (early April 2002), the grid cell located in the northwest corner of the 11 grid block setup (i.e., grid block A3) was extremely wet and could not be surveyed with the EM-61 due to the inability to pull the coils through the marshy terrain. Therefore, geophysical data were collected in the remaining 10 grid blocks and a partial grid was added at the southeast corner (i.e., grid block C0) of the site to cover the area surrounding the southern-most length of the identified berm. Data were collected along parallel survey lines spaced 2.5 feet apart, which were traversed over a known distance with data being collected incrementally with distance. Electromagnetic (EM) measurements were collected each time the instrument's tire rotated a specified distance. Fiducial marks were manually inserted by the operator at 50-foot intervals and these were used during the post processing of the data to correct data line length by compressing or expanding the recorded measurement locations for each line so that the lines covered the actual distance traveled. This operation was required to compensate for variations in the terrain along the survey line, typically resulting in an extension in the recorded line length over the actual line length. The survey data were then rotated and translated from the local coordinate system they were collected in (where the southwest corner of the grid surveyed was assigned a coordinate of 0E, 0N) to the

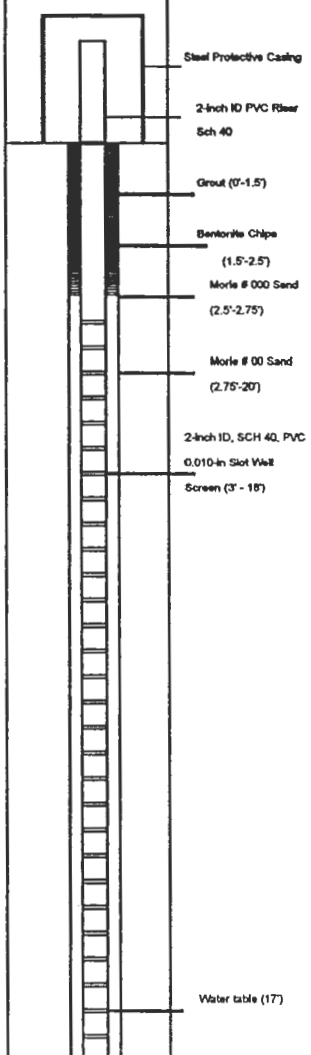
2		6						
3		7						
4		9						
5		23	100	NA	(2'-4'):Brown, silt with fine sand, fine-medium gravel, dry. (SM)			
6		15						
7		19						
8		23						
9		19	50	NA	(4'-6'):Brown, silt with fine sand, trace fine gravel, black shale fragments, dry. (ML/SM)-Till			
10		28						
11		34						
12		36						
13		31	10	NA	(6'-8'):Same As Above. (ML/SM)- Till			
14		35						
15		41						
16		47						
17		21	10	NA	(8'-8.9'): Same As Above. (ML/SM)- Till Refusal at 8.9 feet. Drilled to 10 feet with HSAs.			
18		50/4						
19								
20		50/4	10	NA	(10'-10.4'): Same As Above. (ML/SM)- Till Refusal at 10.4 feet. Drilled to 12 feet with HSAs.			
21								
22								
23		50/1	0	NA	(12'-12.1'): No recovery Refusal at 12.1 feet. Drilled to 14 feet with HSAs.

<b>SAMPLING METHOD</b> SS = SPLIT SPOON A = AUGER CUTTINGS C = CORED	<b>COMMENTS:</b> No environmental samples collected. Drilled to 20 feet bgs from 16 feet bgs due to last three split spoons had no recovery.
---	--

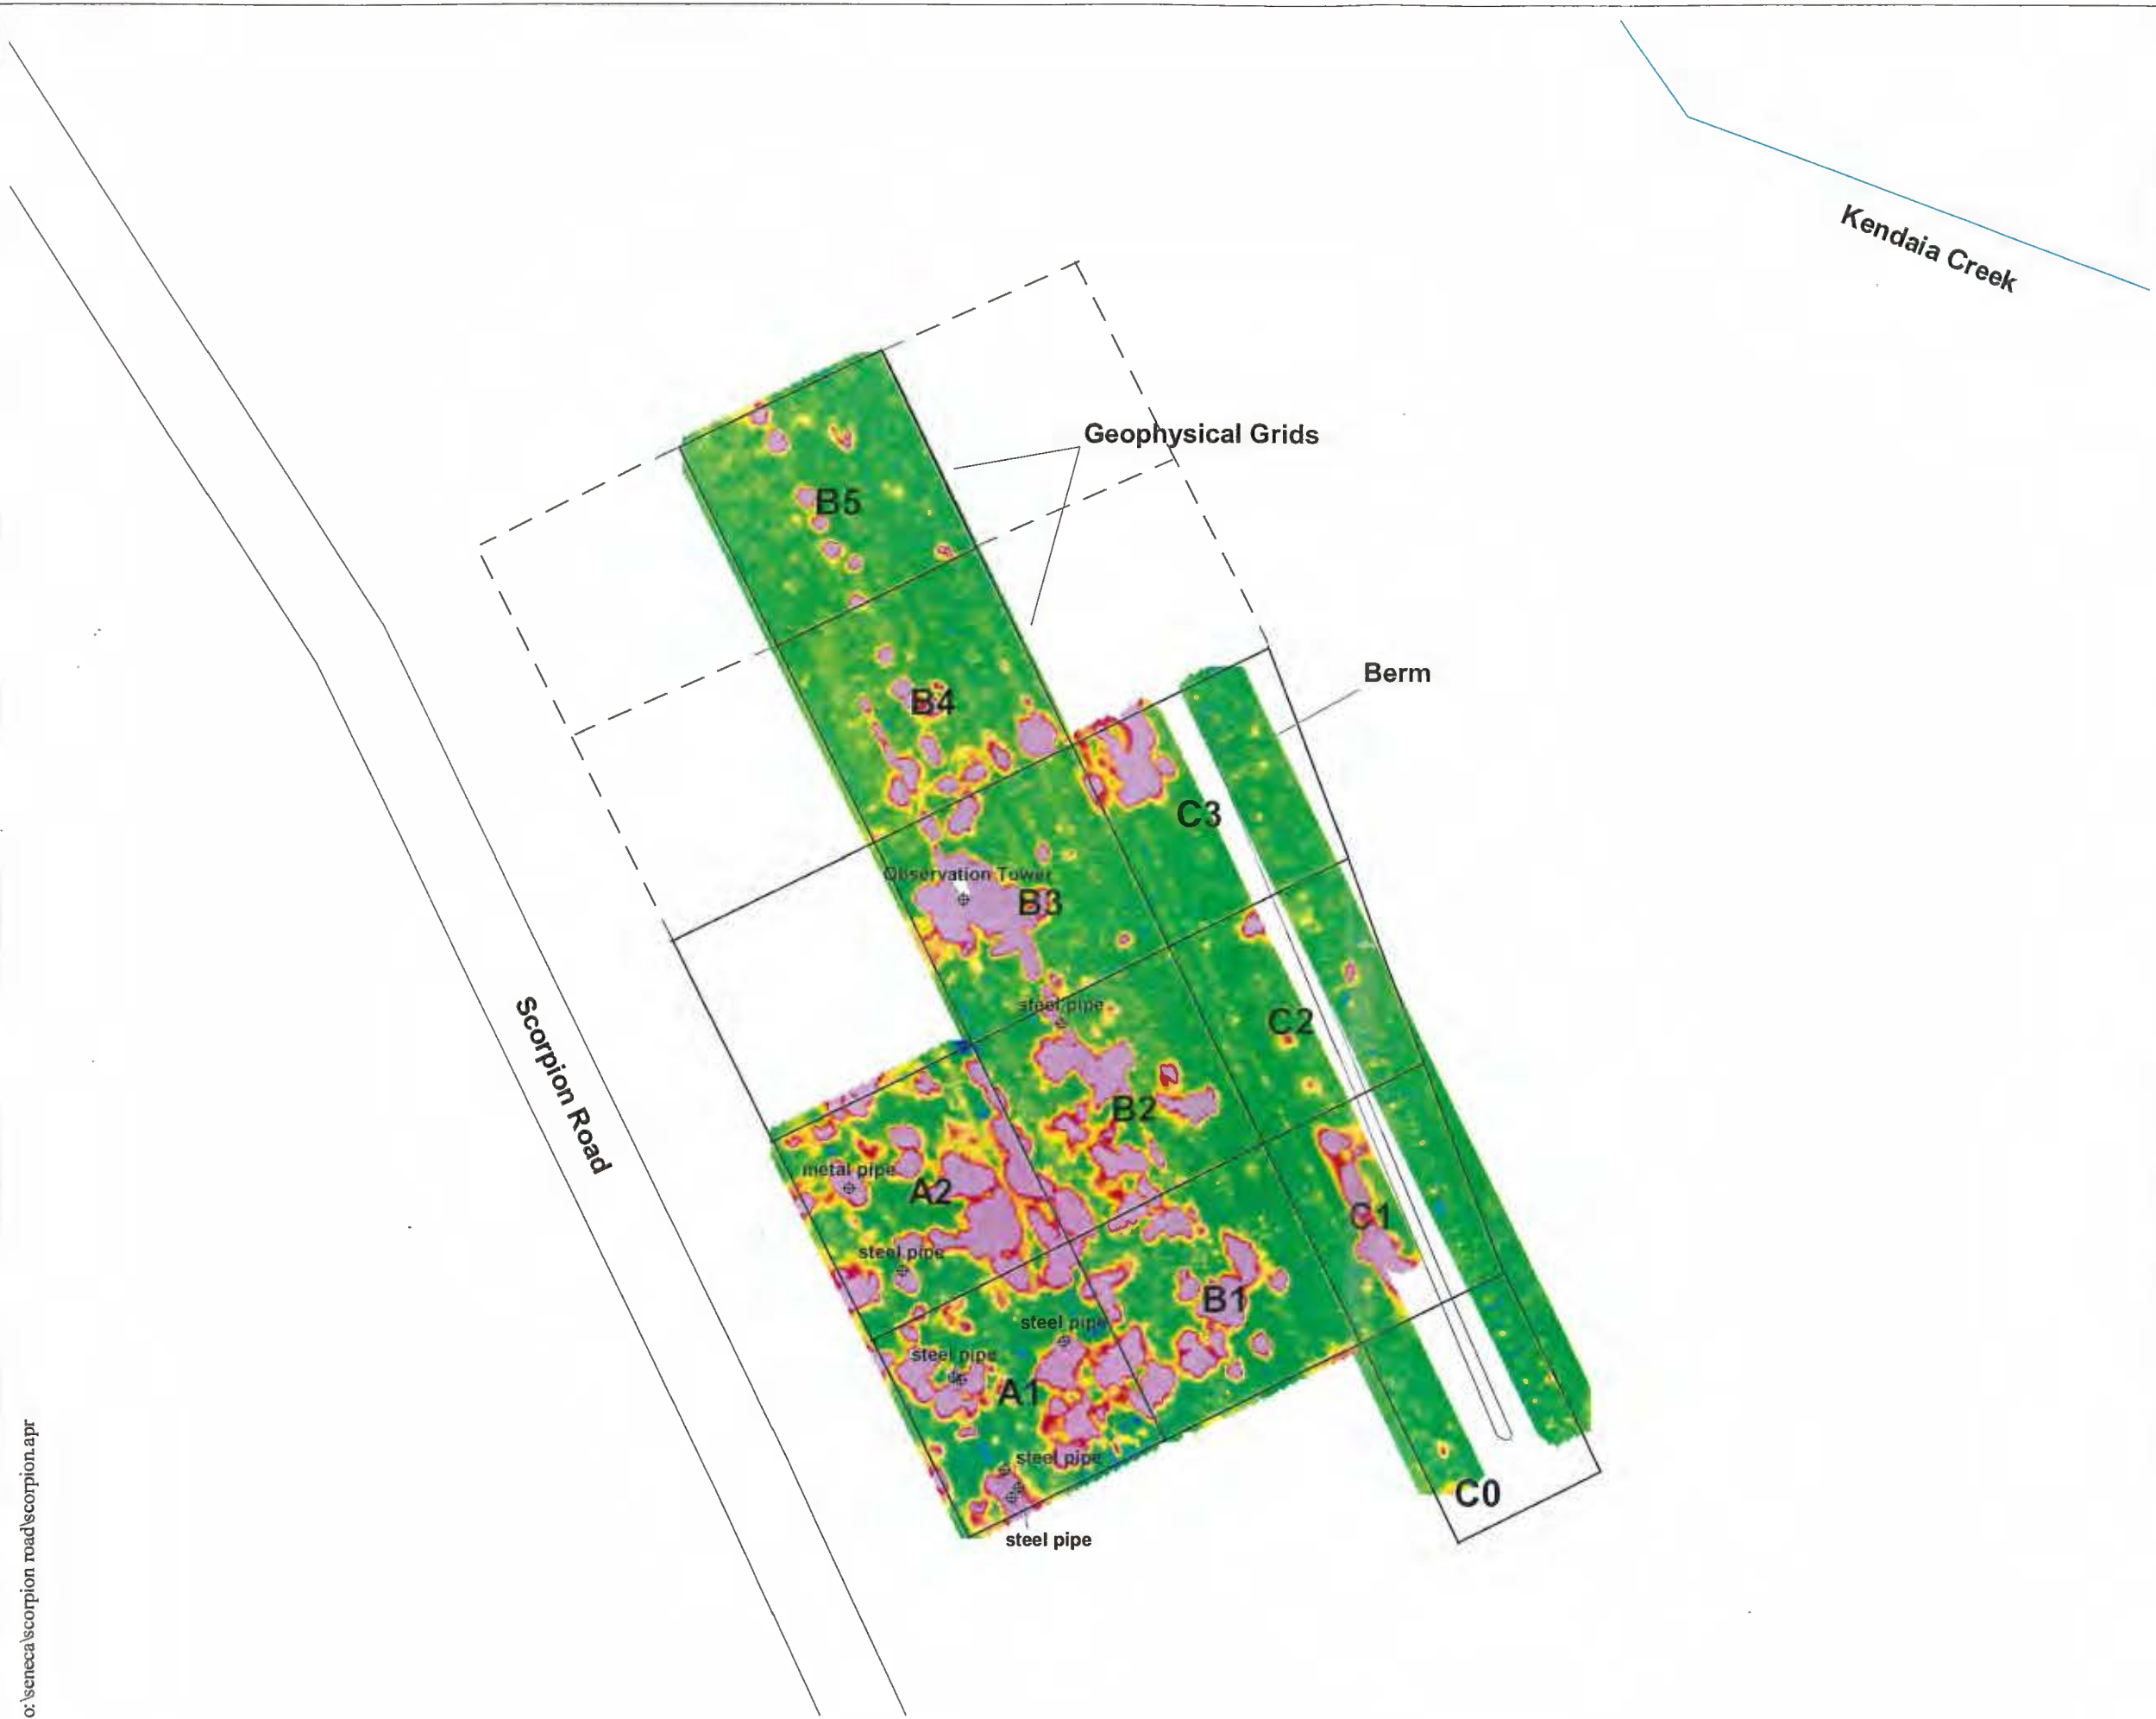
**FIGURE 3-1  
RESULTS OF GEOPHYSICAL SURVEYS  
AT THE SMALL ARMS RANGE**

The results of the EM-61 investigation at the Small Arms Range are shown in **Figure 3-1**. Background EM-61 readings, which were normalized to approximately 0 millivolts (mV) during post-processing, appear green and elevated readings appear as red or pink. Numerous large anomalies were detected in the geophysical investigation. These large anomalies not consistent with those that would be expected at a small arms range. Typically, high amplitude anomalies with a relatively large areal extent would only be expected in the immediate vicinity of the target berm, where the majority of the expended ammunition would be concentrated. Anomaly amplitude and areal extent should both decrease with increased distance from the berm. This is not the case in the collected data, as anomalies of greater than 80 mV are present at distances of over 150 feet from the berm and only approximately 50 feet from the firing line. For comparison, the highest amplitude anomaly detected during the Geophysical Prove-Out conducted for the OE EE/CA was approximately 80 mV over a 155 millimeter (mm) shell simulant buried at 21 inches; and the areal extent of the 155mm anomaly was less than that of many of the unexplained anomalies in the Small Arms Range data. Accordingly, the geophysical survey did not identify and evidence indicative of a small arms range.

⊕ Known Geophysical Anomaly

Due to the findings of the EM-61 survey, four test pits were excavated at the Small Arms Range, Lake Housing Area to investigate the numerous large anomalies. The results of the test pitting and contents of the test pits are discussed in **Section 3.3**, below.

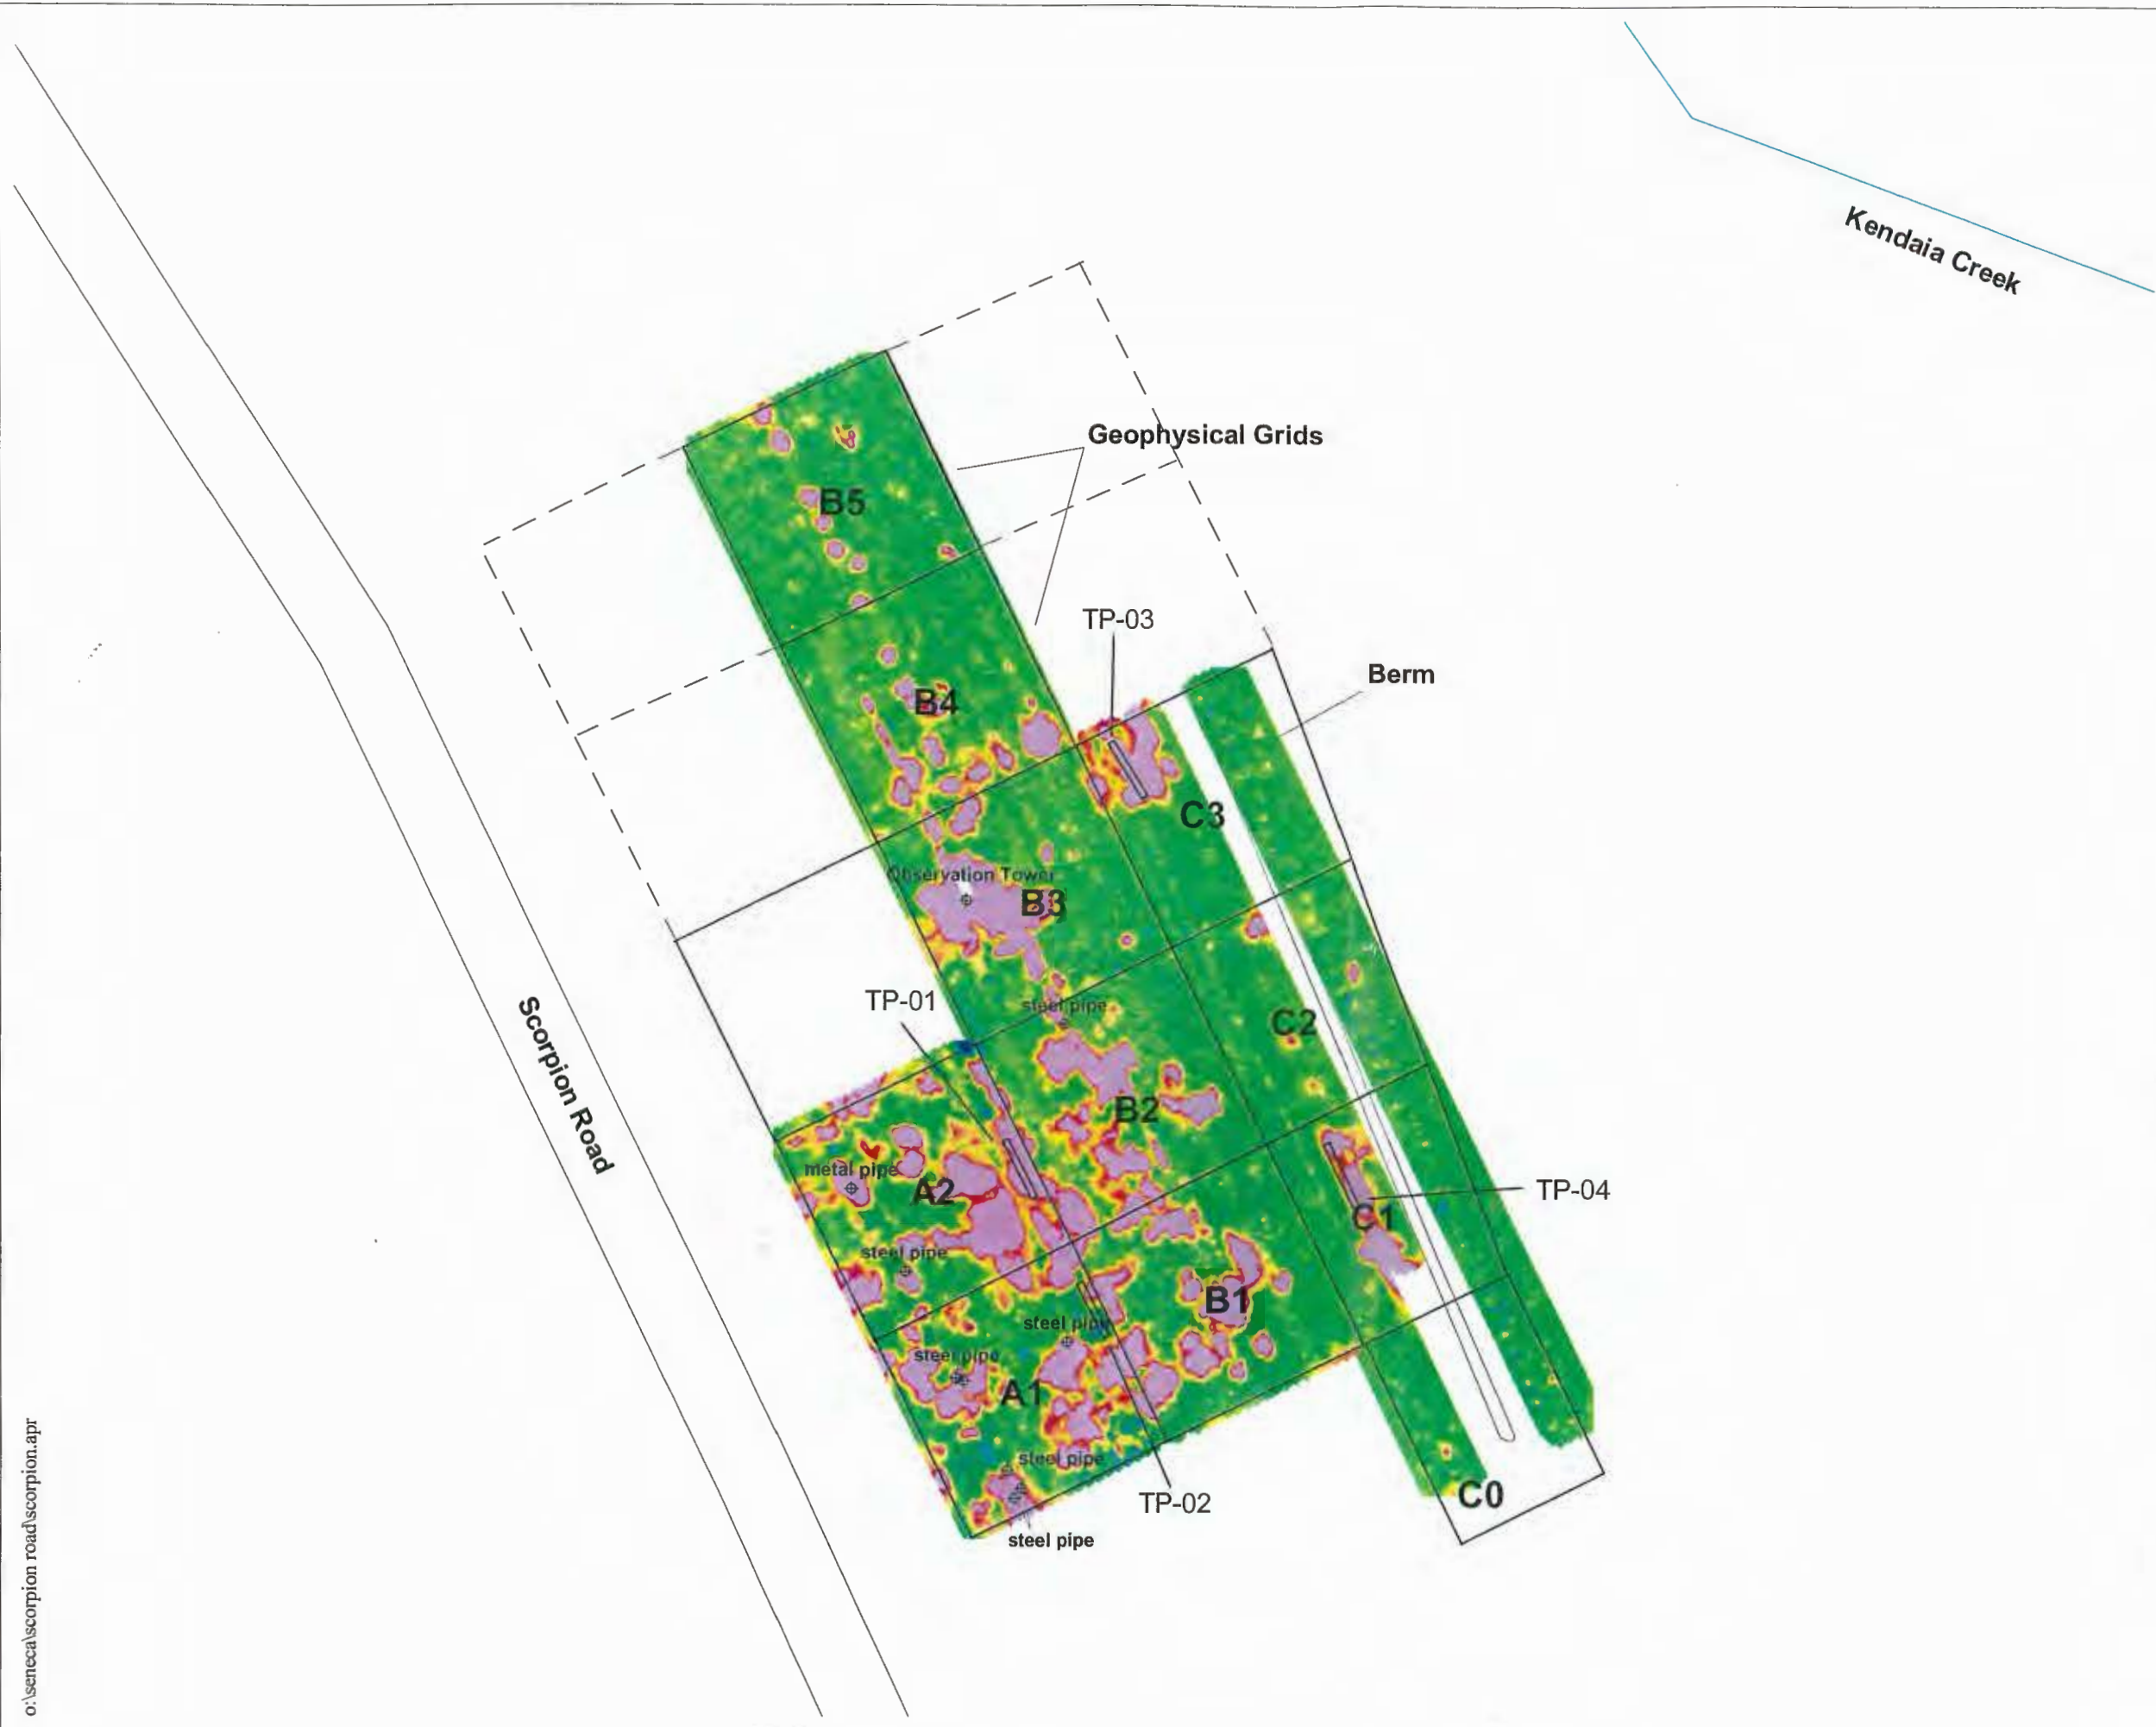
Four test pits (TP-01 through TP-04) were excavated at the Small Arms Range in an attempt to discover the source of some of the larger anomalies in the EM-61 data (Figure 3-2). Two of these pits were situated in the location of two large anomalies in the vicinity of the suspected firing line, and two were situated on anomalies immediately to the west (i.e., in front of) of the berm. Each test pit was approximately 25 feet in length and 3 feet wide; and each was dug to the glacial till – weathered shale boundary, which was consistently less than 4.5 ft below ground surface across the site.

With the exception of a few vitrified clay tiles found in two of the test pits, there was no evidence of any contaminated fill materials, trash or other buried materials. No metal of any kind was recovered, and there were no signs of anything relating to the site's possible use as a Small Arms Range. The Army believes that the geophysical anomalies are related to higher points in the weathered shale. The anomalies are not indicative of buried materials. The test pit logs are presented in Appendix C.
