**RCRA CLOSURE REPORT**  
**BUILDING 307, HAZARDOUS WASTE CONTAINER STORAGE FACILITY**  
**BUILDING 301, TRANSFORMER STORAGE BUILDING**

**Seneca Army Depot Activity**

**PARSONS**

**SEPTEMBER 2003**

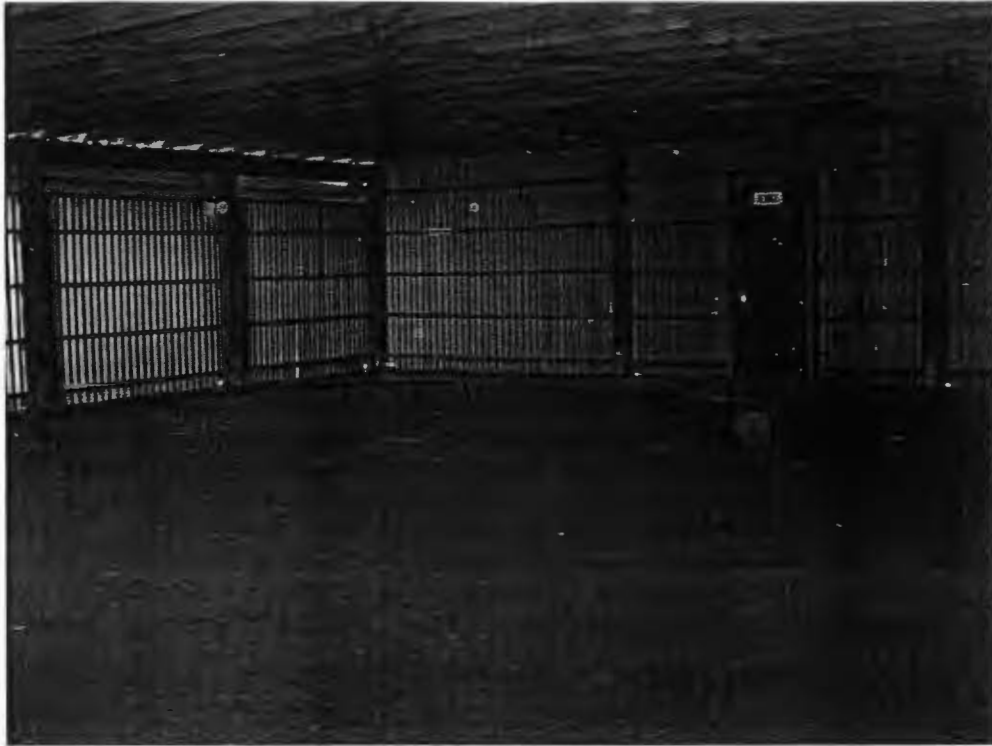
Building 307 after debris removal.

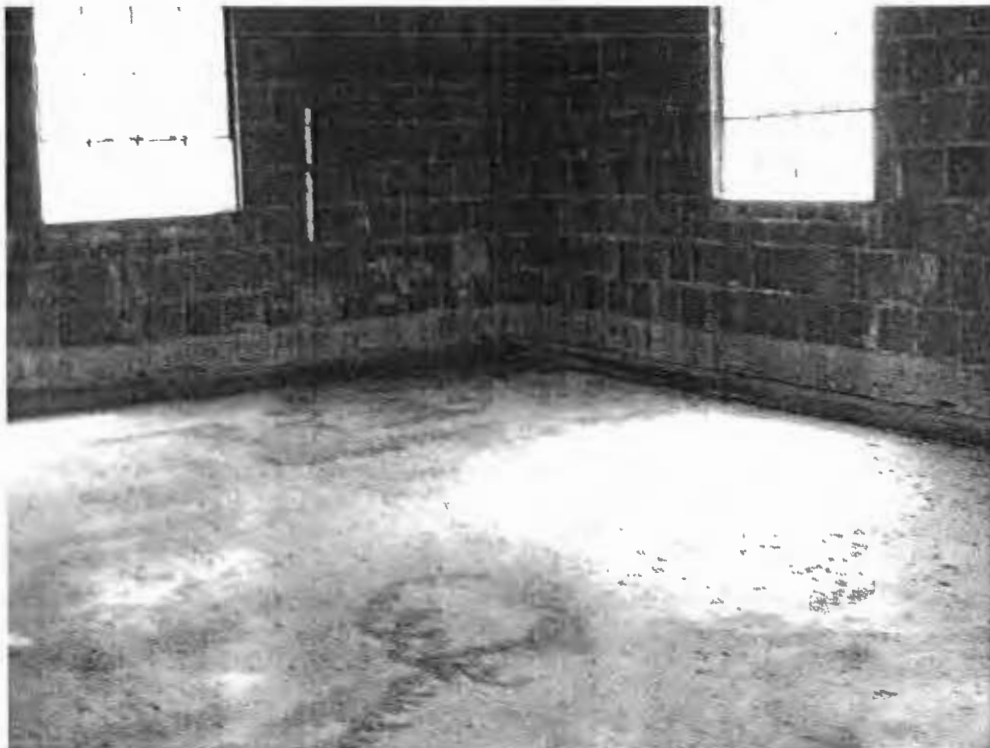
Building 301 after debris removal.

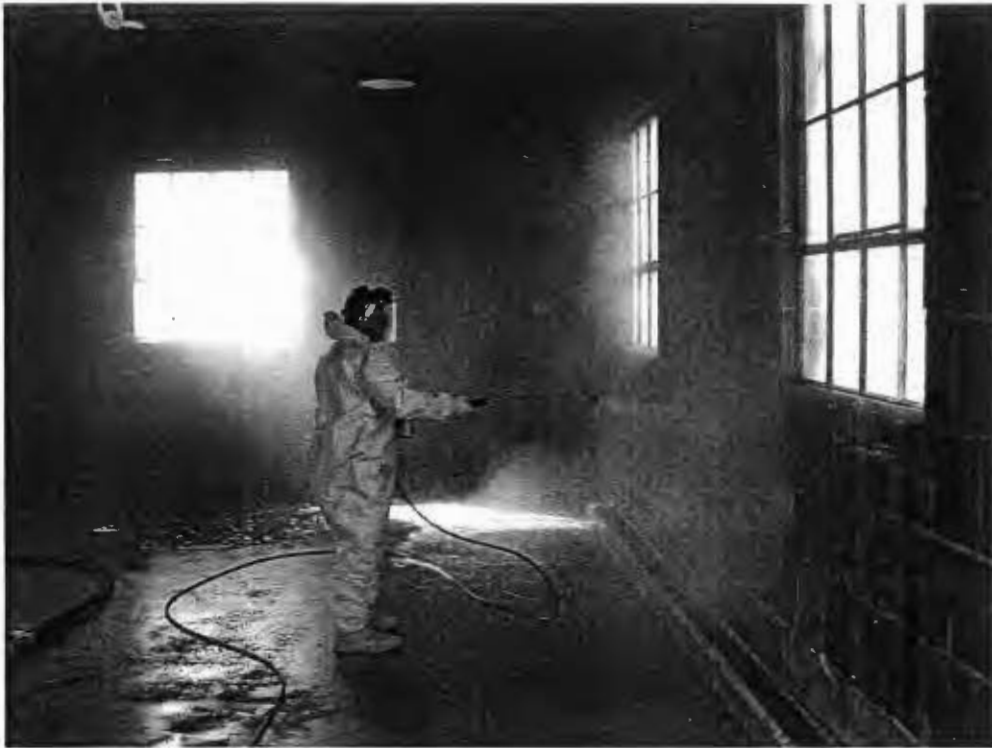
Performing cleaning operations at Bldg 301.

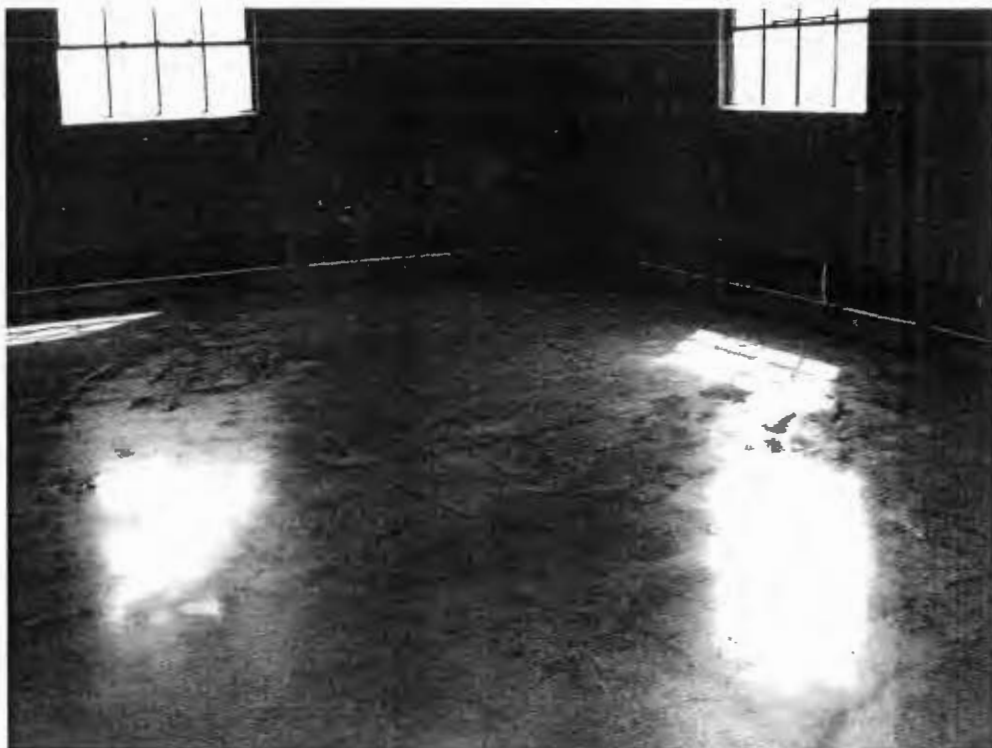
After completion of rinsing operations.

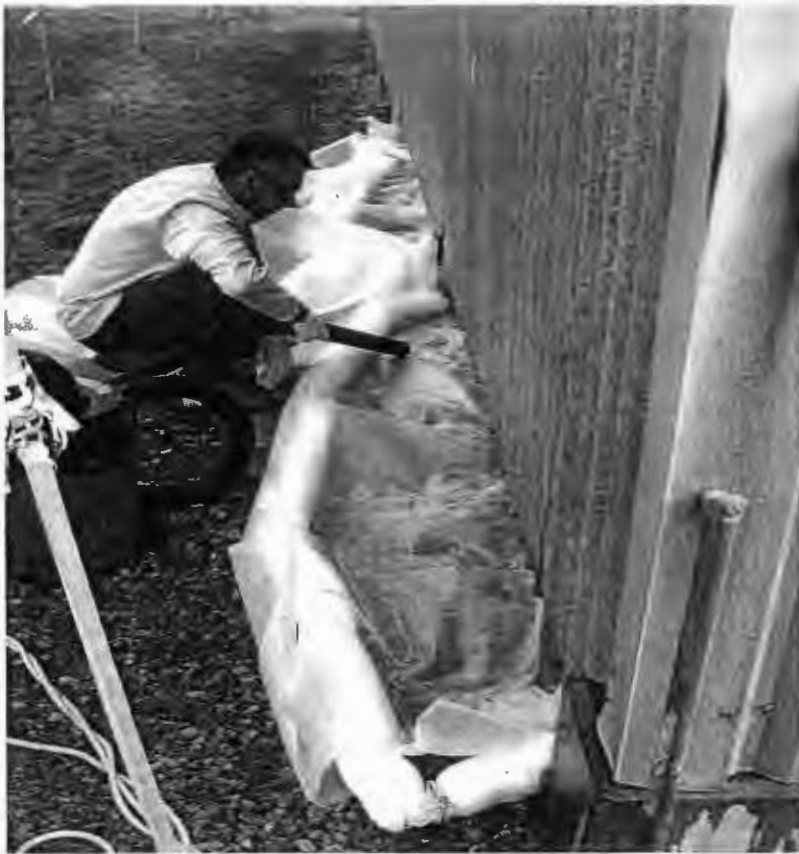
Collecting rinsate from wall washing

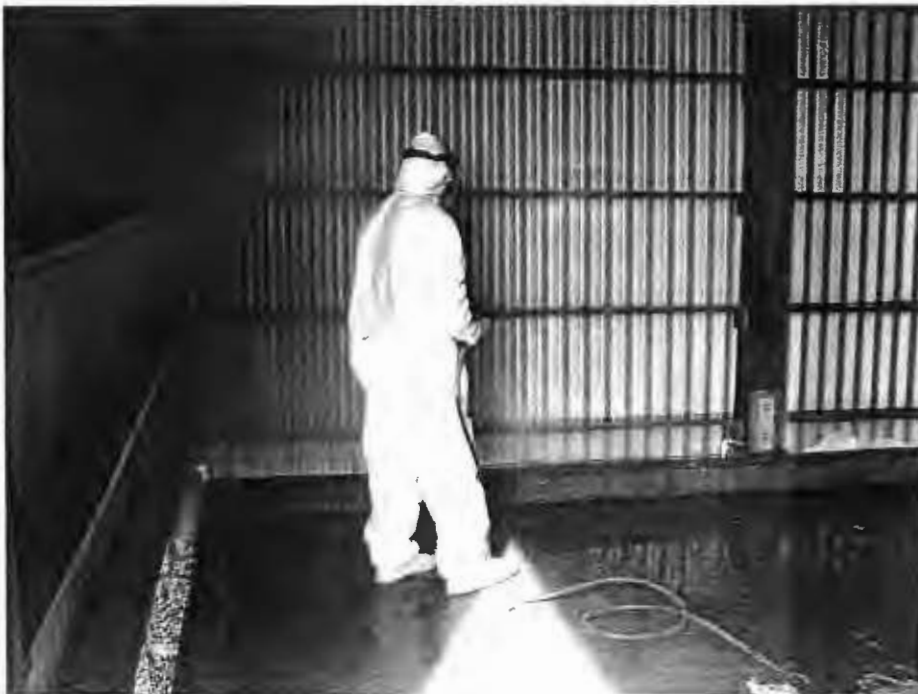
Washing inside of Bldg 307.

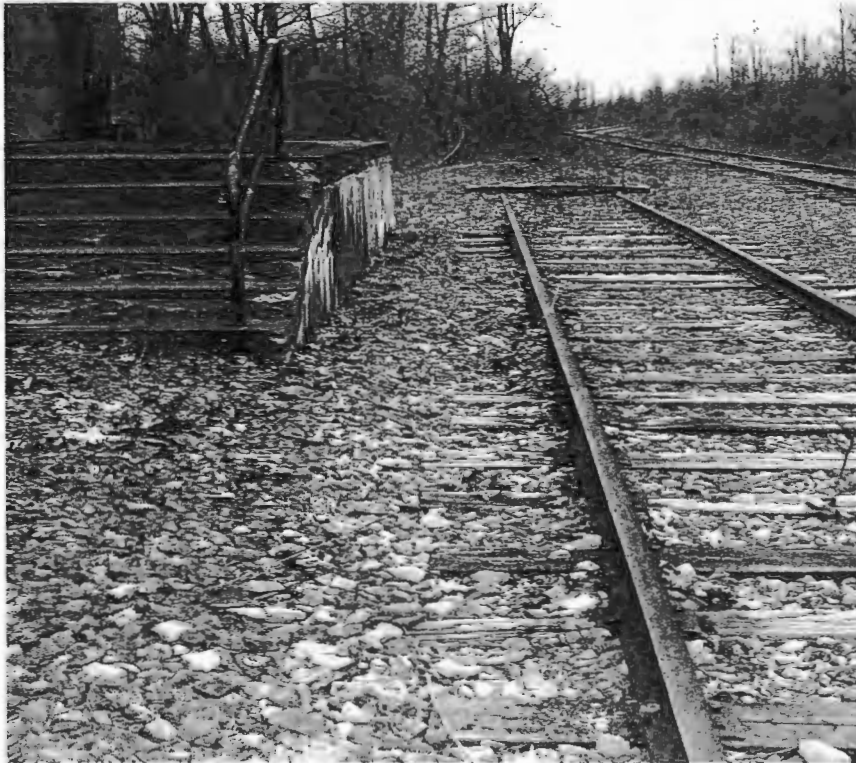
Location of railroad bed adjacent to building.

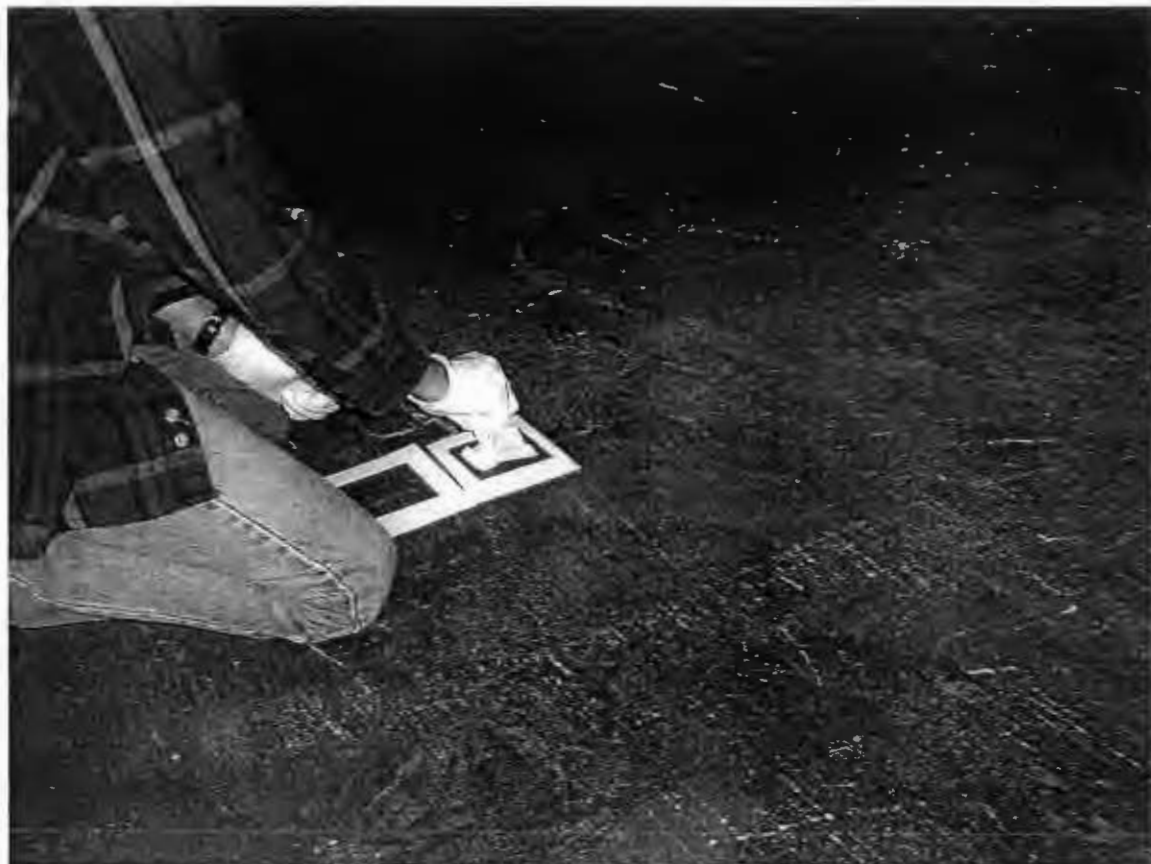
Obtaining a PCB wipe sample.

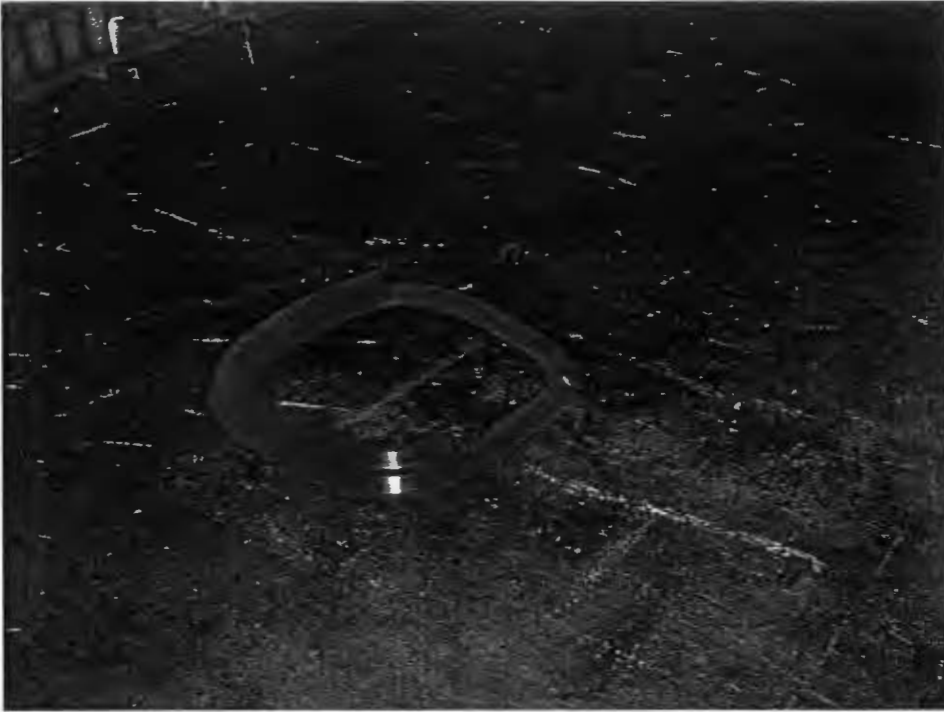
Rinsate berm.

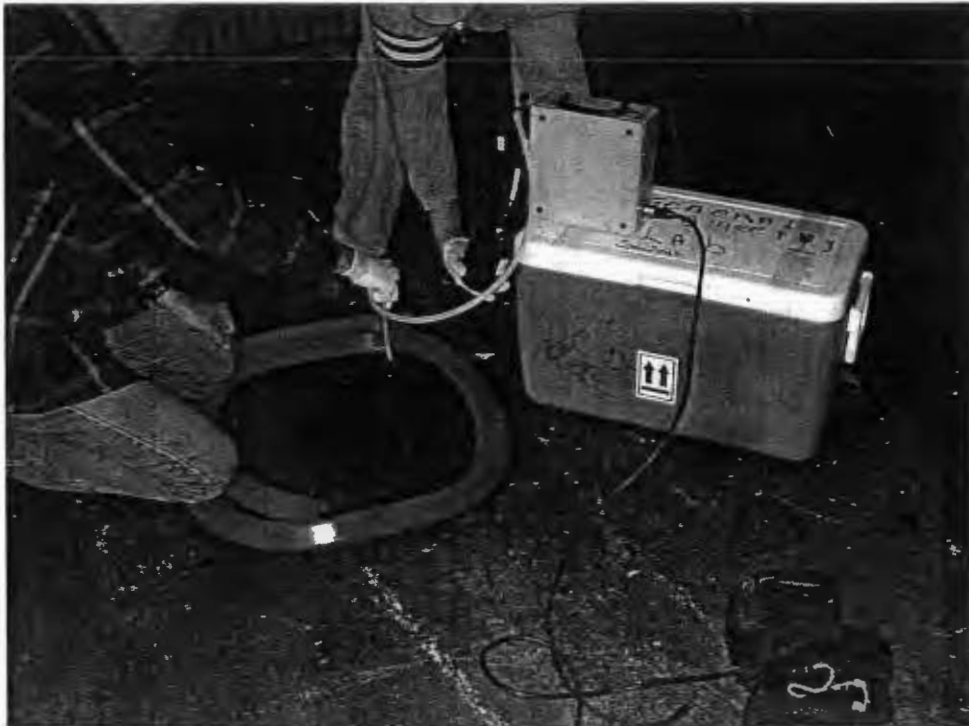
Collecting rinsate samples.

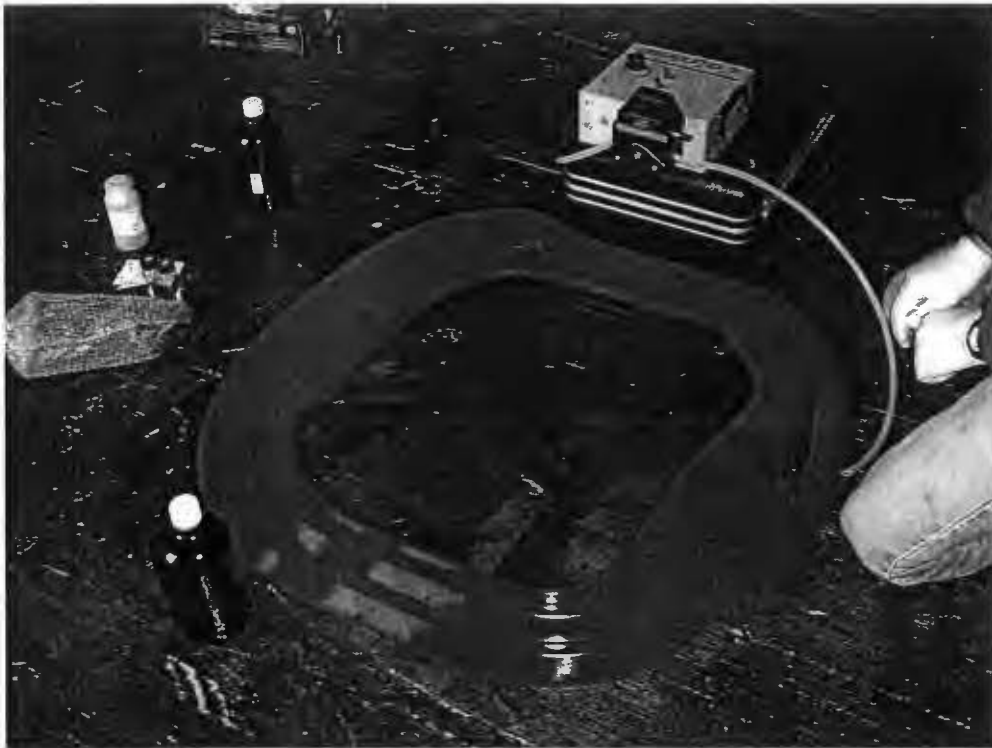
Rinsate dike and collection pump.

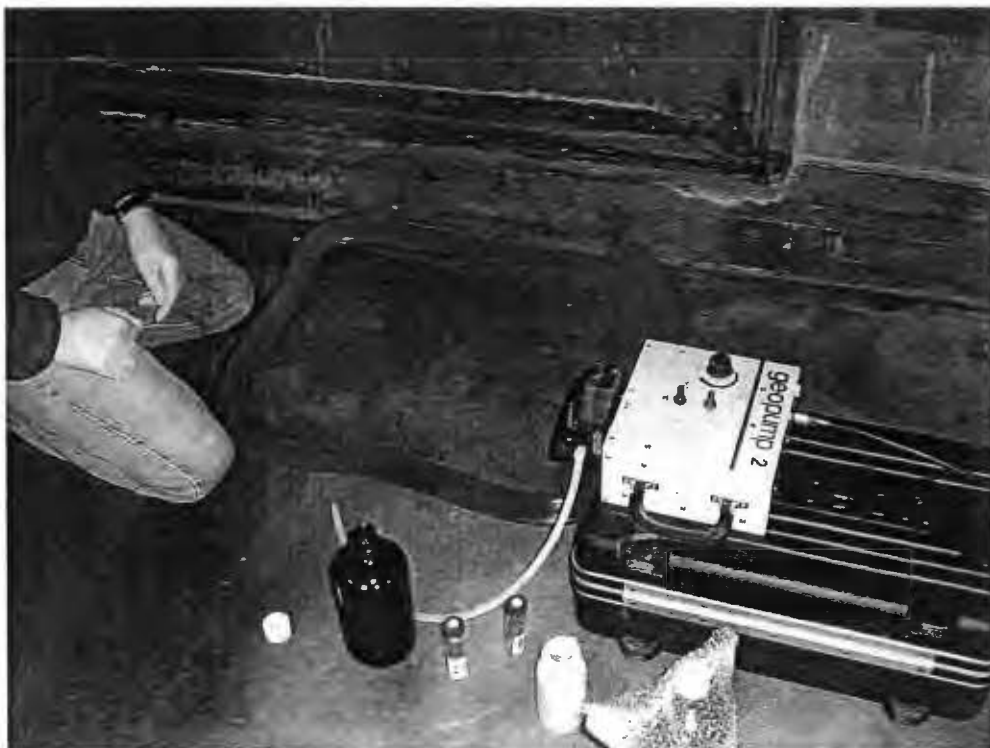
Sampling Equipment

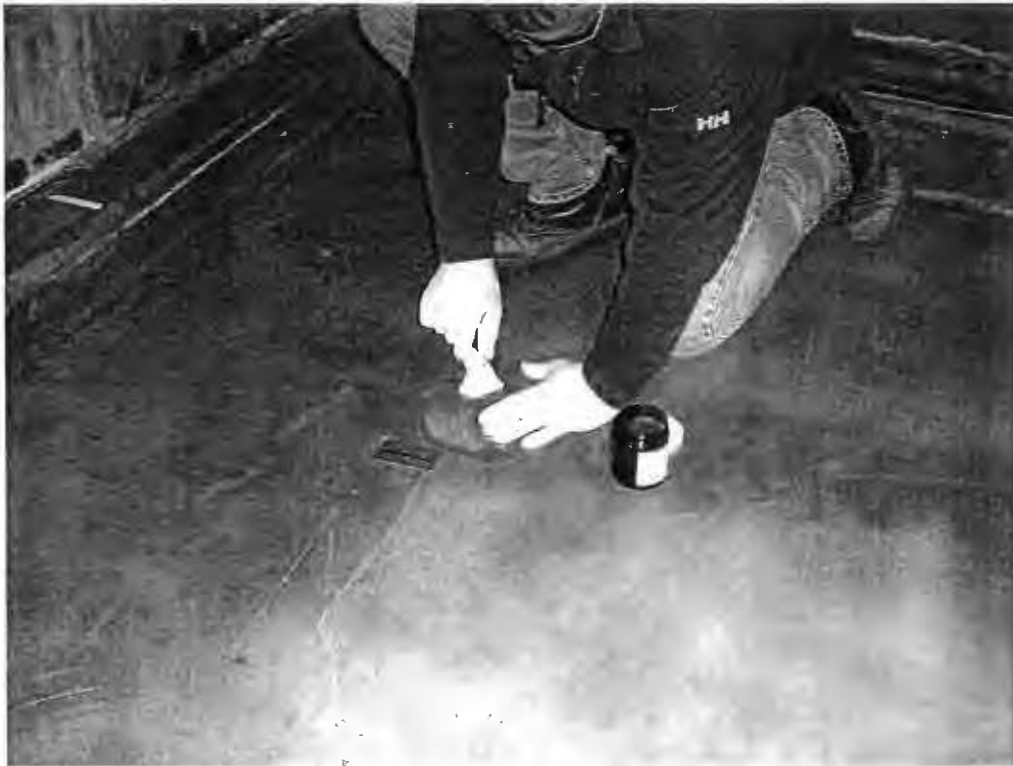
PCB Wipe sample Bldg 301.
