**Seneca Army Depot Activity  
Romulus, New York**

**DRAFT  
ANNUAL REPORT AND ONE-YEAR REVIEW  
FOR THE ASH LANDFILL OPERABLE UNIT  
SENECA ARMY DEPOT ACTIVITY**

**PARSONS**  
MARCH 2008

**ANNUAL REPORT AND ONE-YEAR REVIEW  
FOR THE ASH LANDFILL OU, SENECA ARMY DEPOT ACTIVITY**

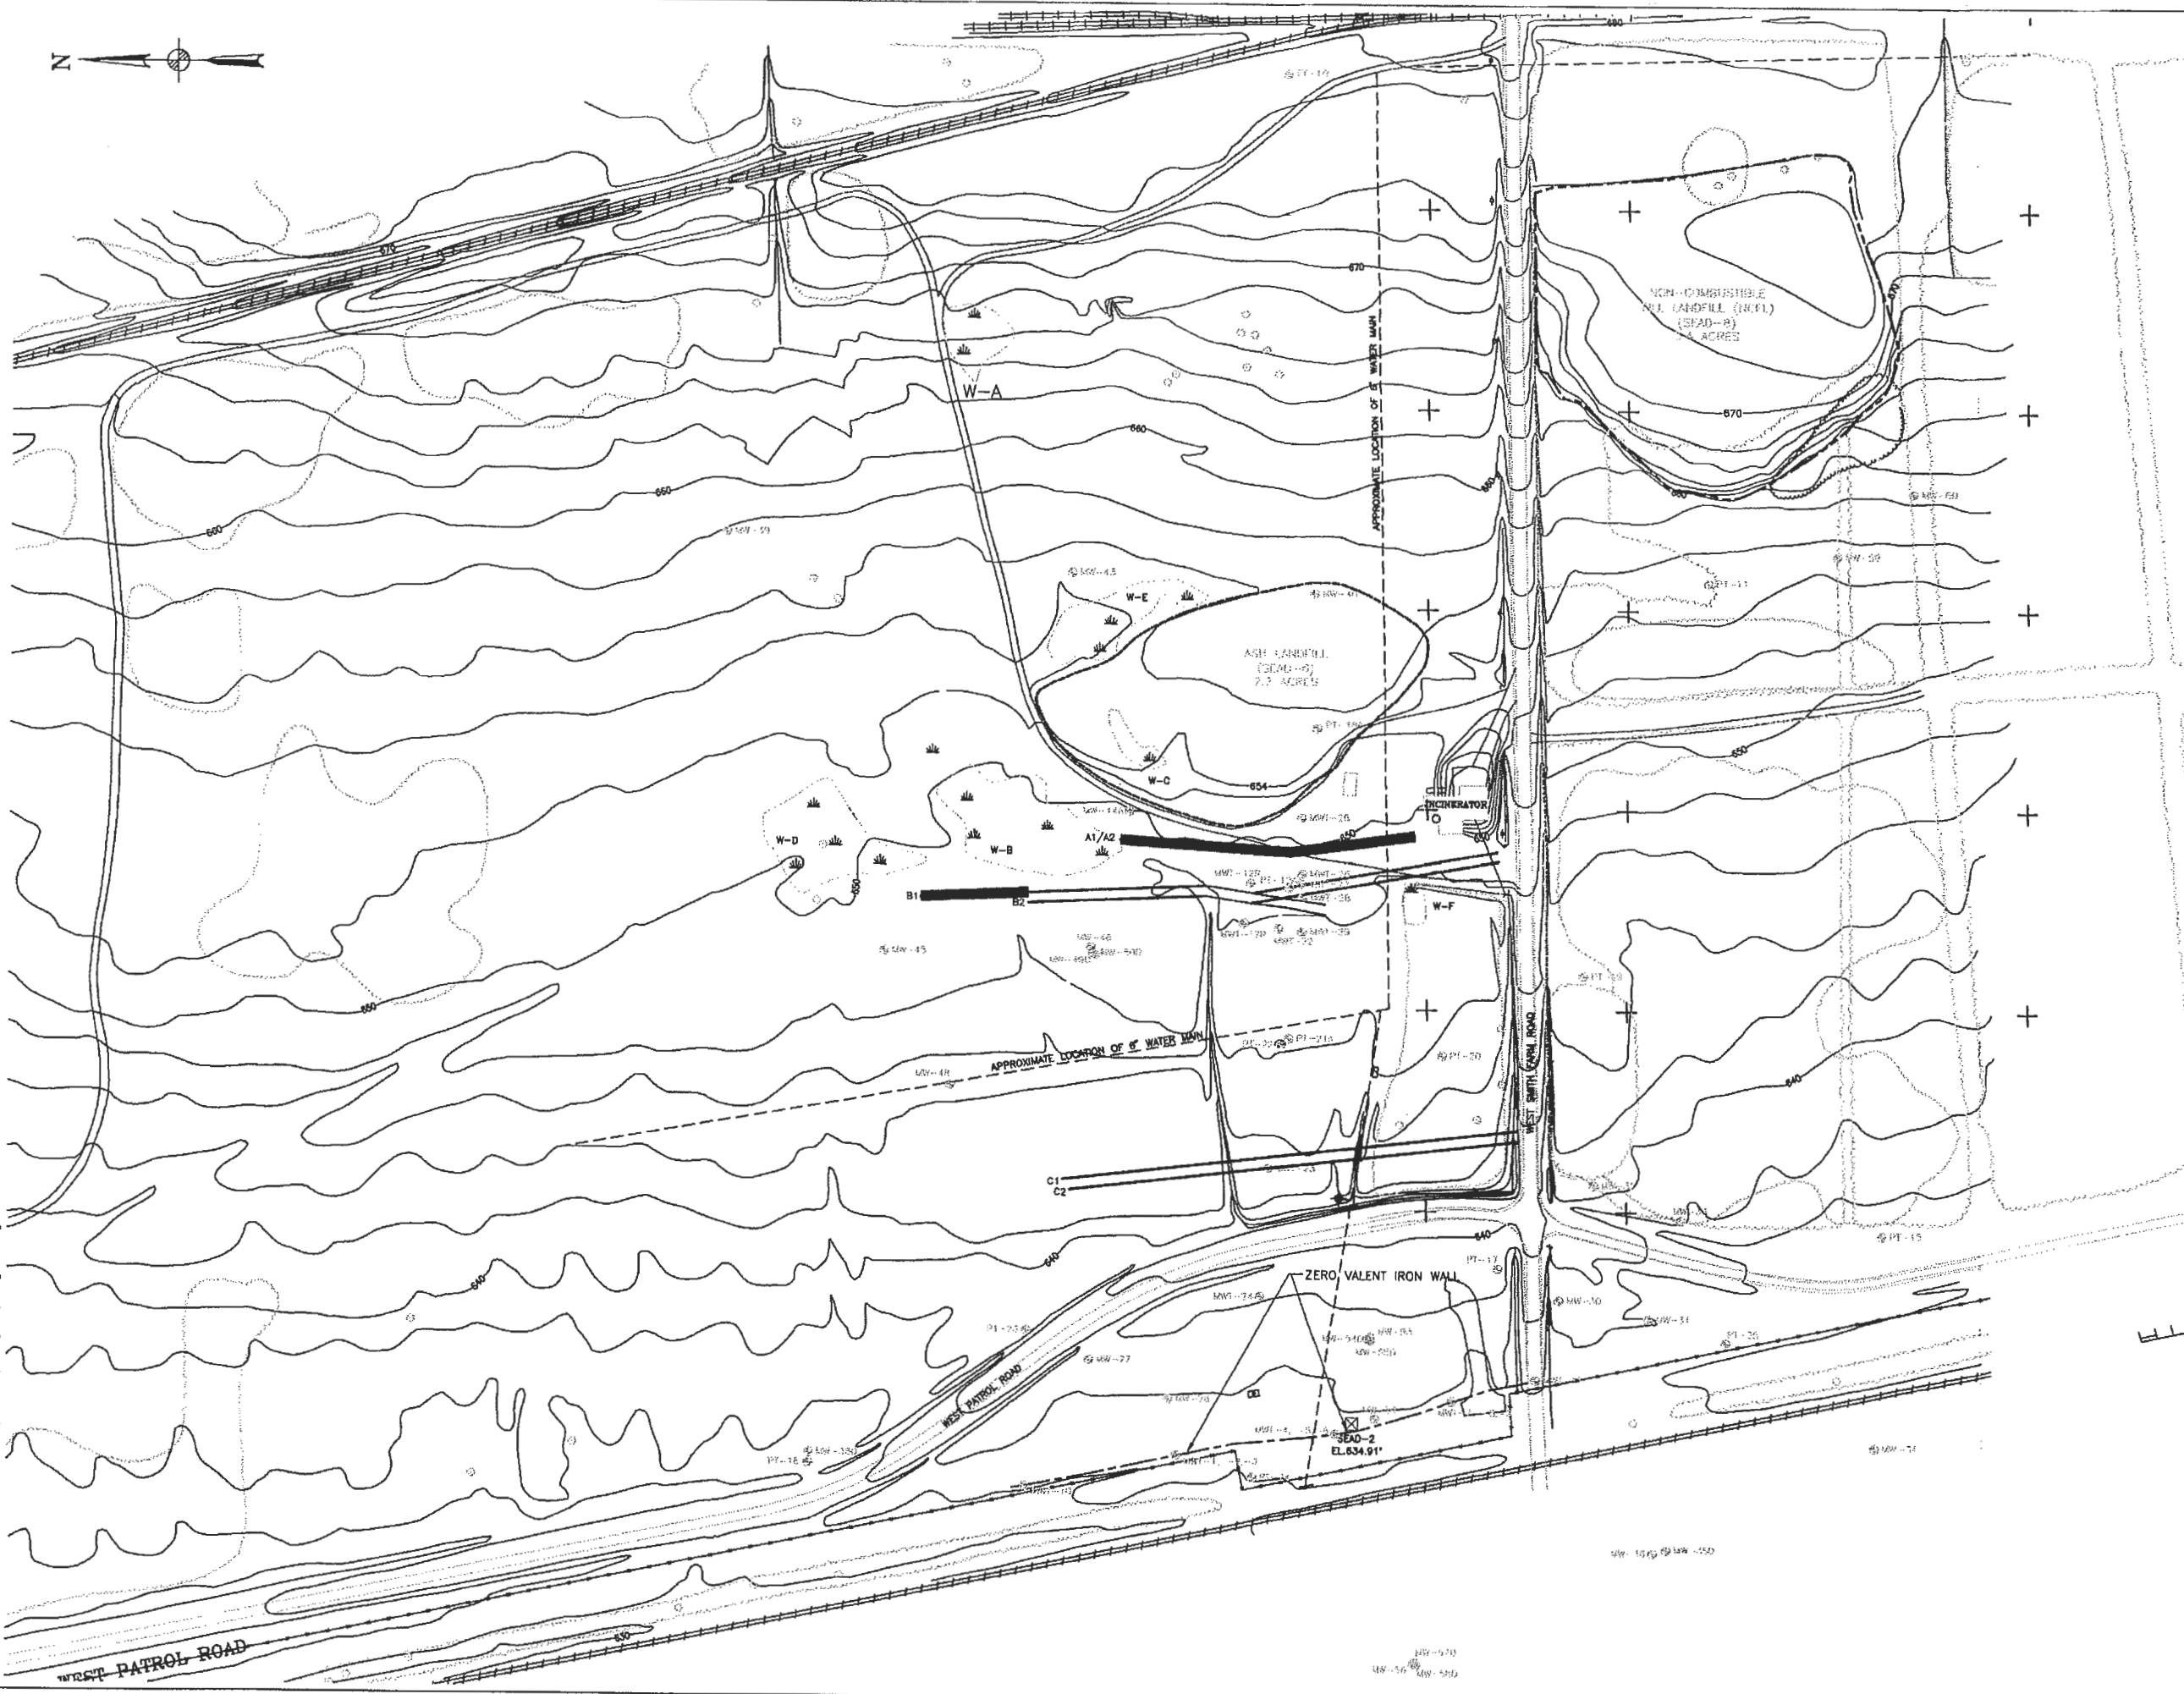
CLIENT/PROJECT TITLE		
<b>SENECA ARMY DEPOT ASH LANDFILL ANNUAL REPORT</b>		
DEPT. ENVIRONMENTAL ENGINEERING	Dwg. No. 744538-01400	
<b>FIGURE 1 ASH LANDFILL SITE PLAN</b>		
SCALE 1" = 200'	DATE MARCH 2008	REV -

Biowalls A1/A2, B1/B2, and C1/C2, shown on **Figure 1**, were constructed perpendicular to the chlorinated solvent plume in the locations prescribed in the RDR. The entire length of Biowalls A1/A2 and the northern portion of B1/B2 were combined into a single double-width trench (minimum of 6 feet in width) due to unstable soil conditions encountered, which caused trench widening. All trenches were excavated to competent bedrock. Approximately 2,840 linear feet (lf) of

Biowall process monitoring is being conducted at two locations (shown in **Figure 1**) to determine if, and when, any needed maintenance activities should be performed. The first location is within Biowalls B1 and B2 in the segment that runs along the pilot-scale biowalls installed in July 2005. The second location is within Biowall C2, the furthest downgradient biowall. The objectives of biowall process monitoring for operations and maintenance (O&M) activities are as follows:

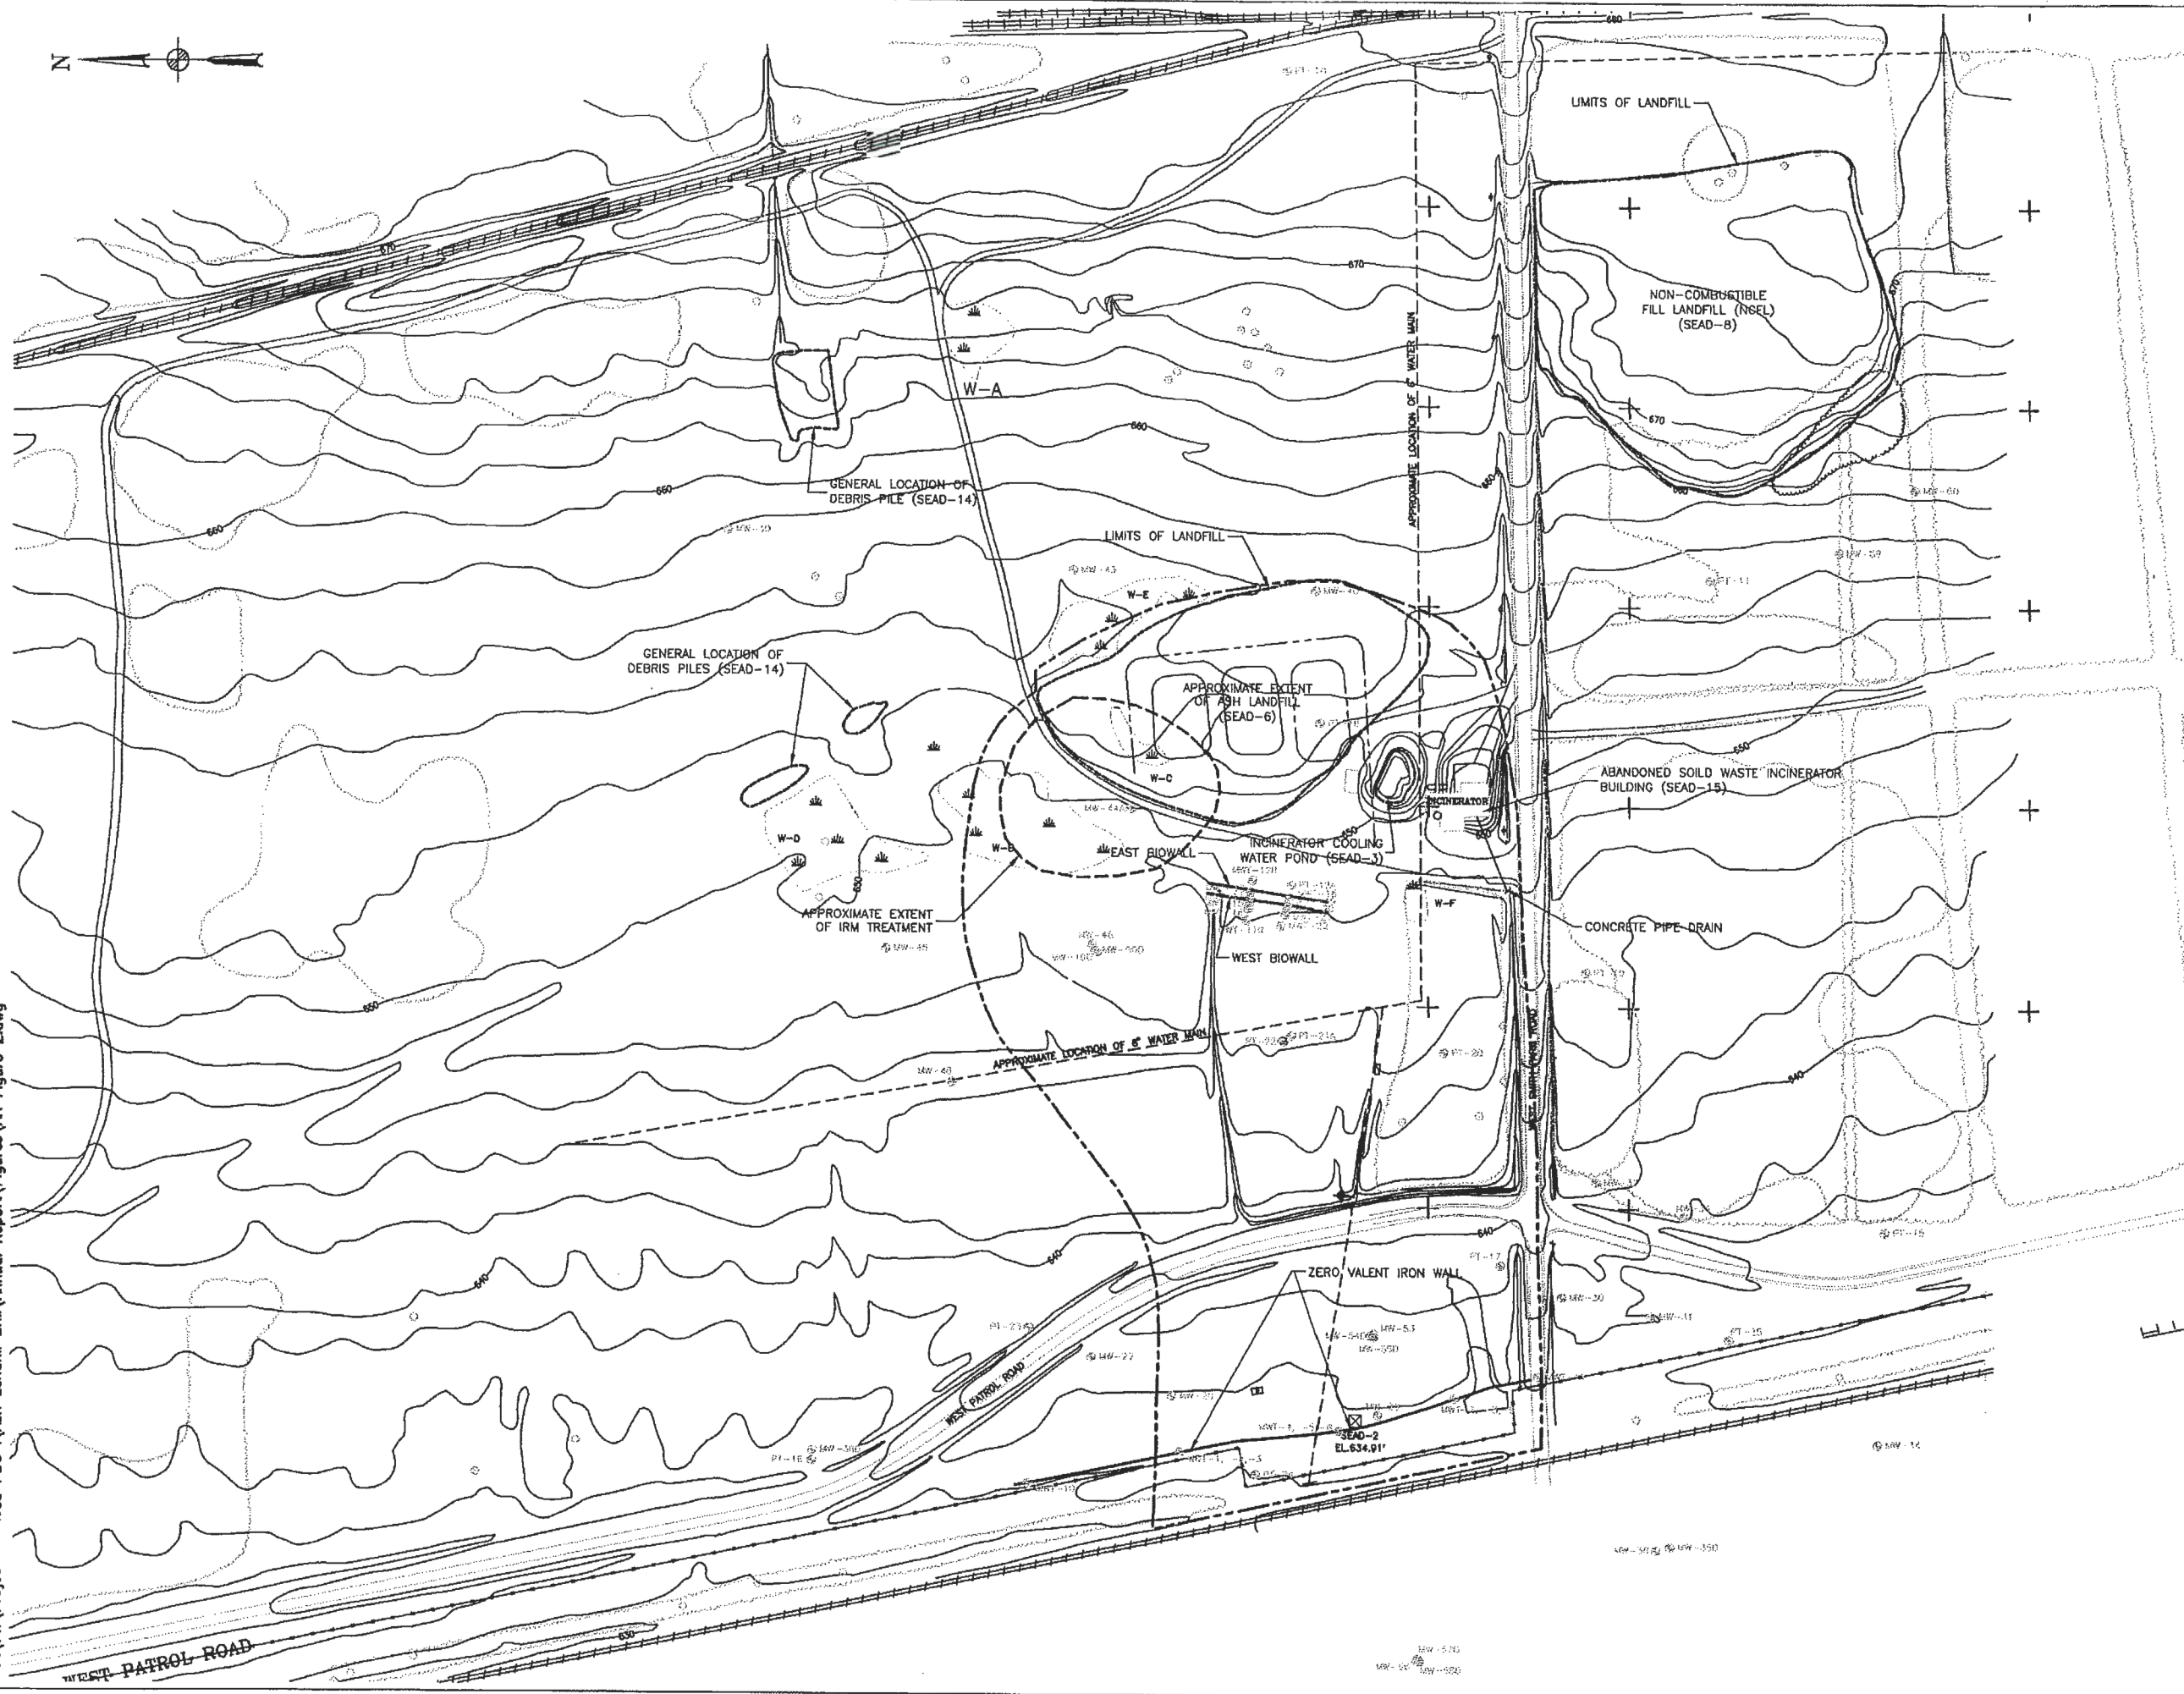
**NOTE:**  
FIGURE SHOWS PRE-CONSTRUCTION CONDITIONS

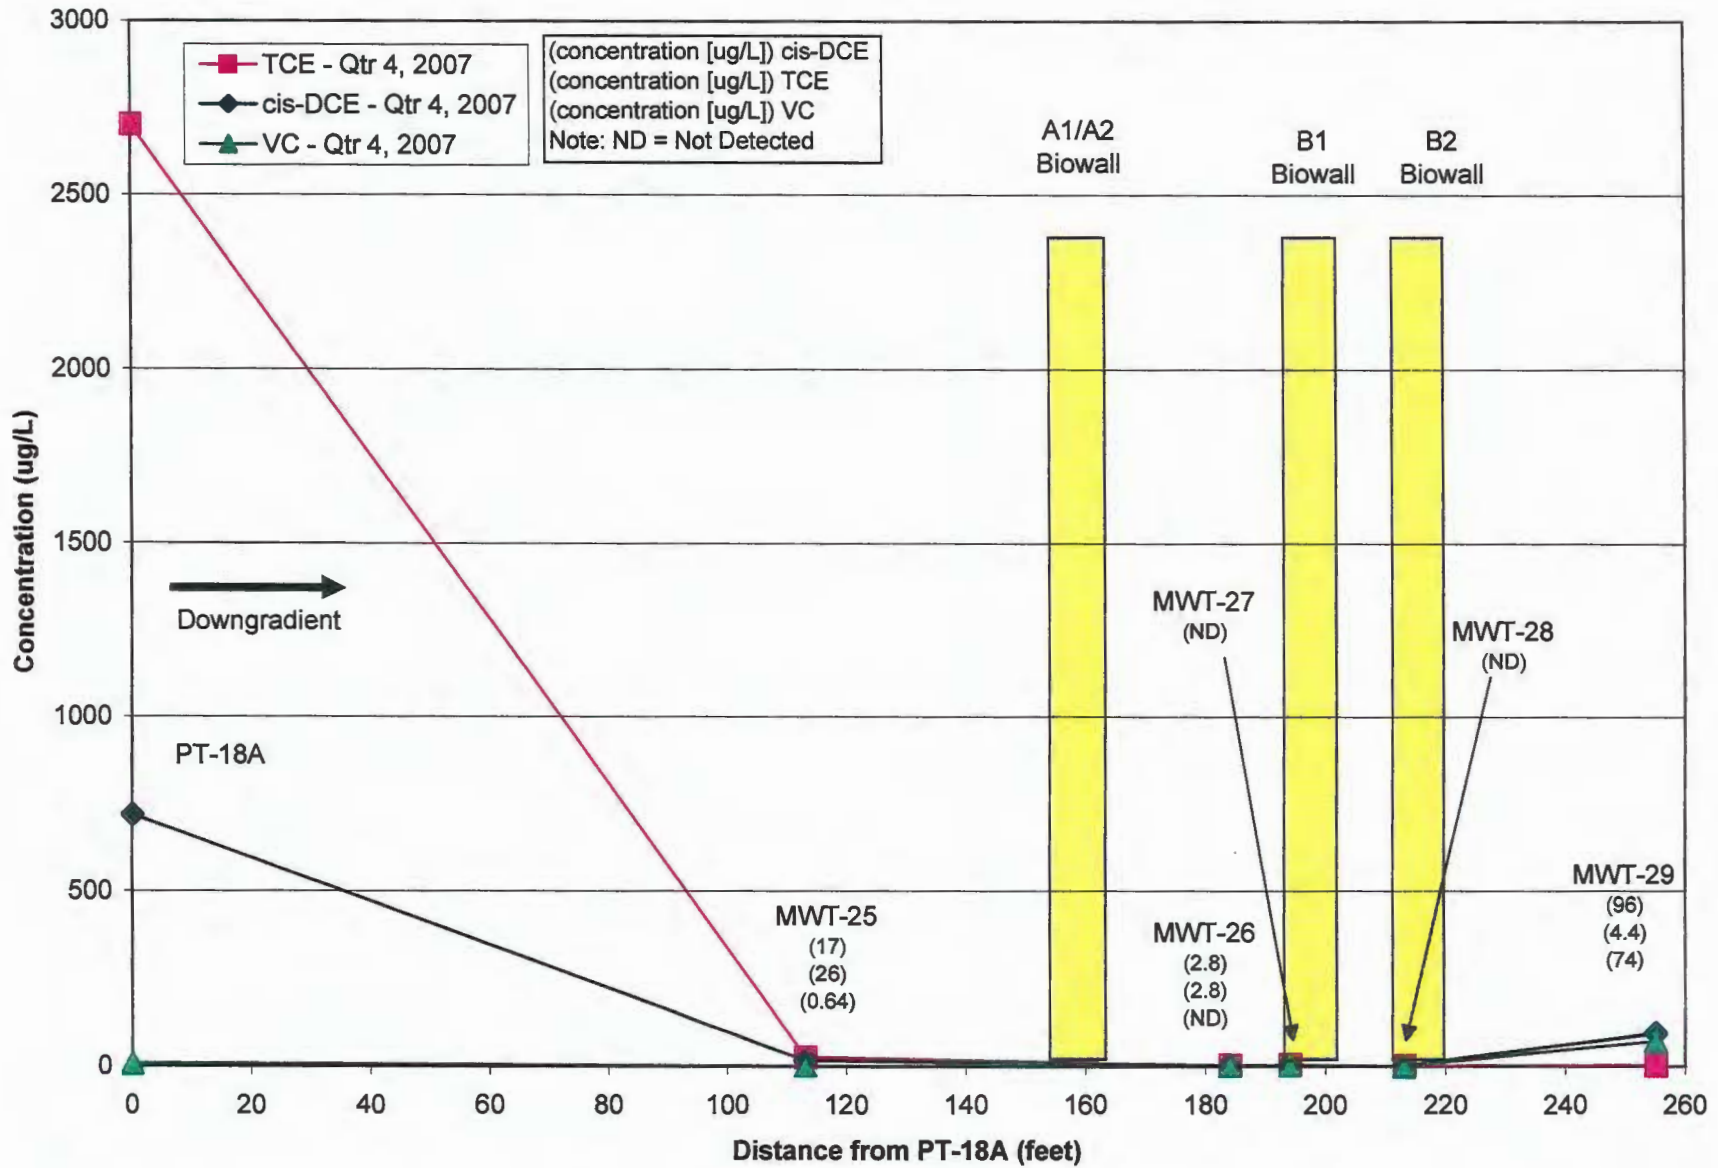
Figure 5  
 Concentrations of VOCs Along the Biowalls - Quarter 4, 2007  
 Ash Landfill Annual Report  
 Seneca Army Depot Activity

Anaerobic degradation of TCE may also occur downgradient of the biowalls in the aquifer formation due to soluble organic carbon released from the biowalls. It is notable that concentrations of cis-DCE and VC are highest downgradient of the biowalls, and not within the biowalls. This suggests that sequential biotic reductive dechlorination of chlorinated organics is the primary degradation process in the downgradient reaction zones, with low levels of TCE being released by desorption from the aquifer matrix or from back diffusion of contaminated groundwater from low permeability sediments. A further indication of biotic reductive dechlorination is the elevated concentration of ethene (200

µg/L) observed at well location MWT-29 during fourth quarter monitoring. Further downgradient, TCE was detected at MWT-7 (310 feet from C1/C2) at a maximum concentration of 510 µg/L in the fourth quarter; it is likely that the effects of the biowalls have not reached this part of the plume, which is expected after only one year since the biowall installation.

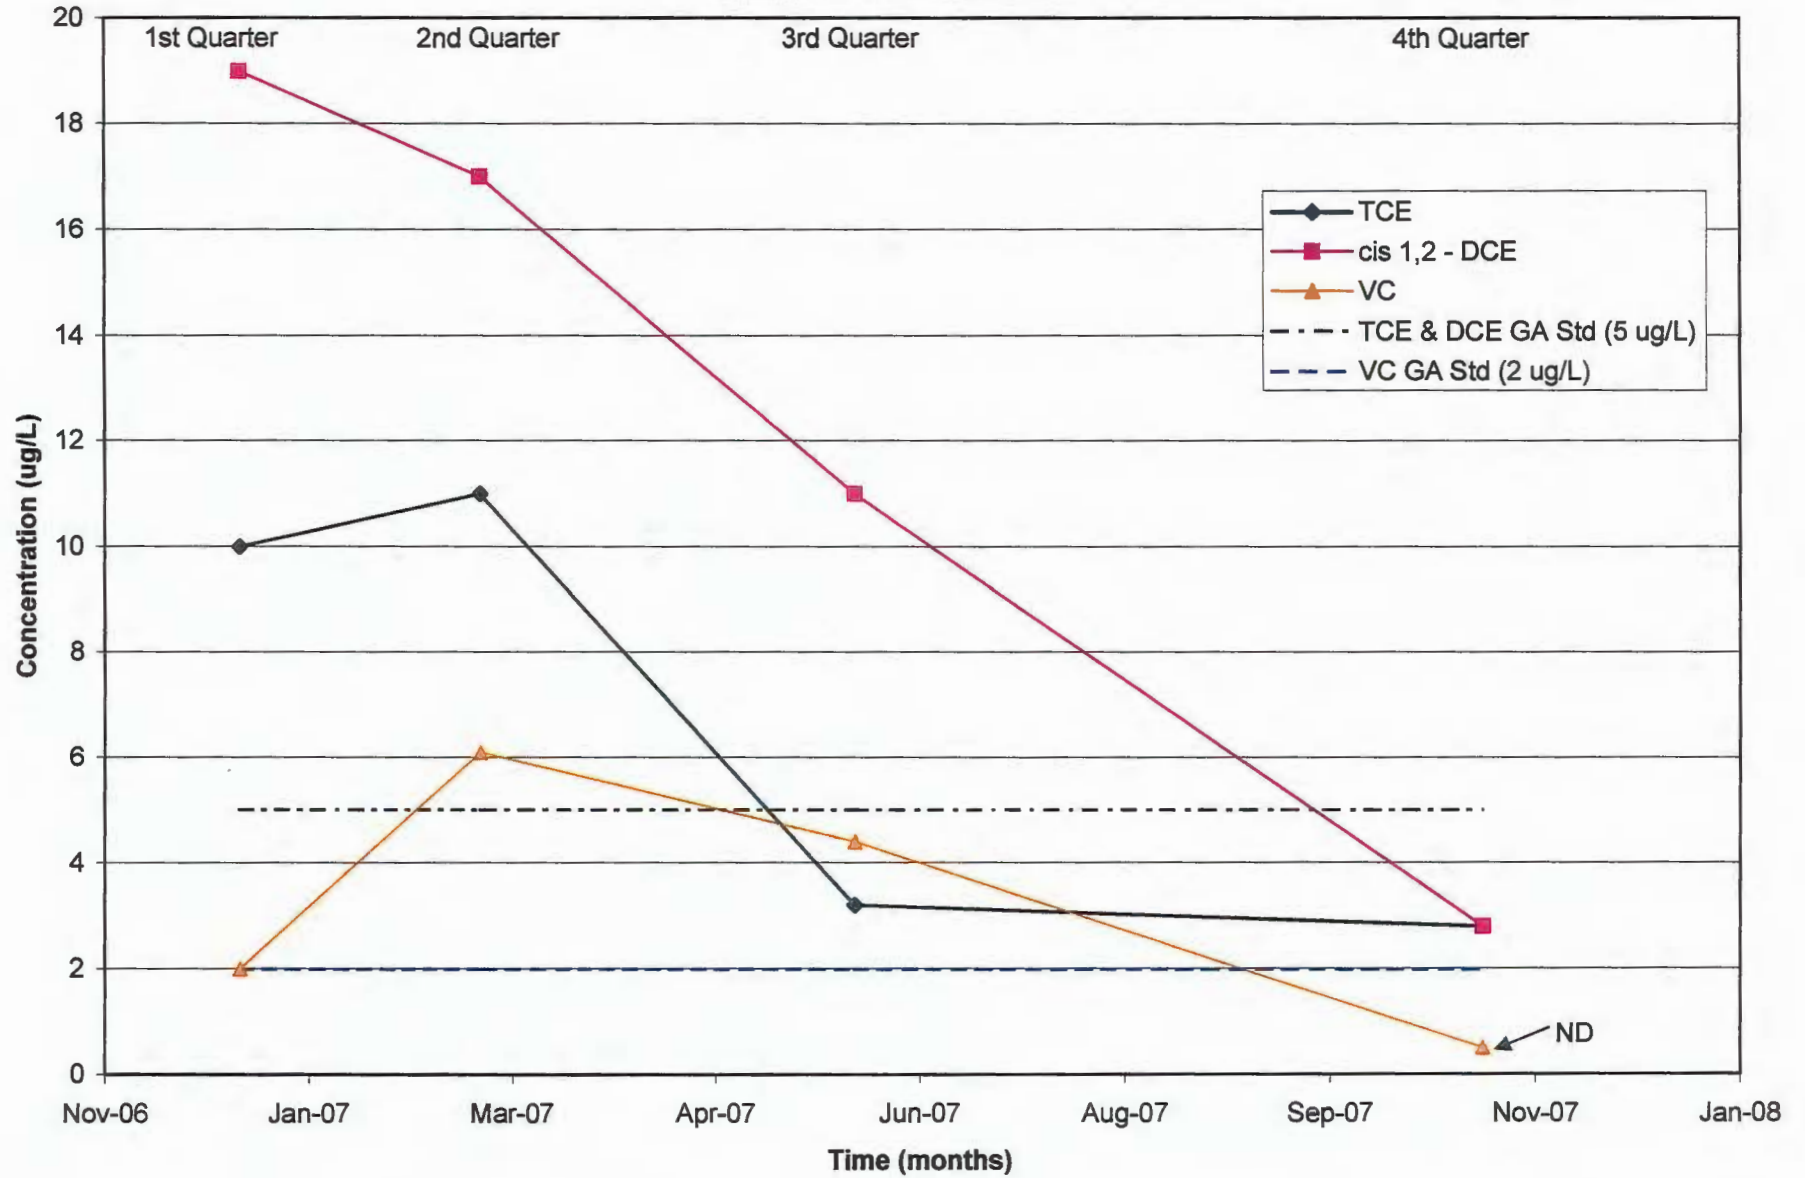
Figure 6B  
 Concentrations of Chlorinated Organics Over Time at MWT-26  
 Ash Landfill Annual Report  
 Seneca Army Depot Activity

ND = not detected.

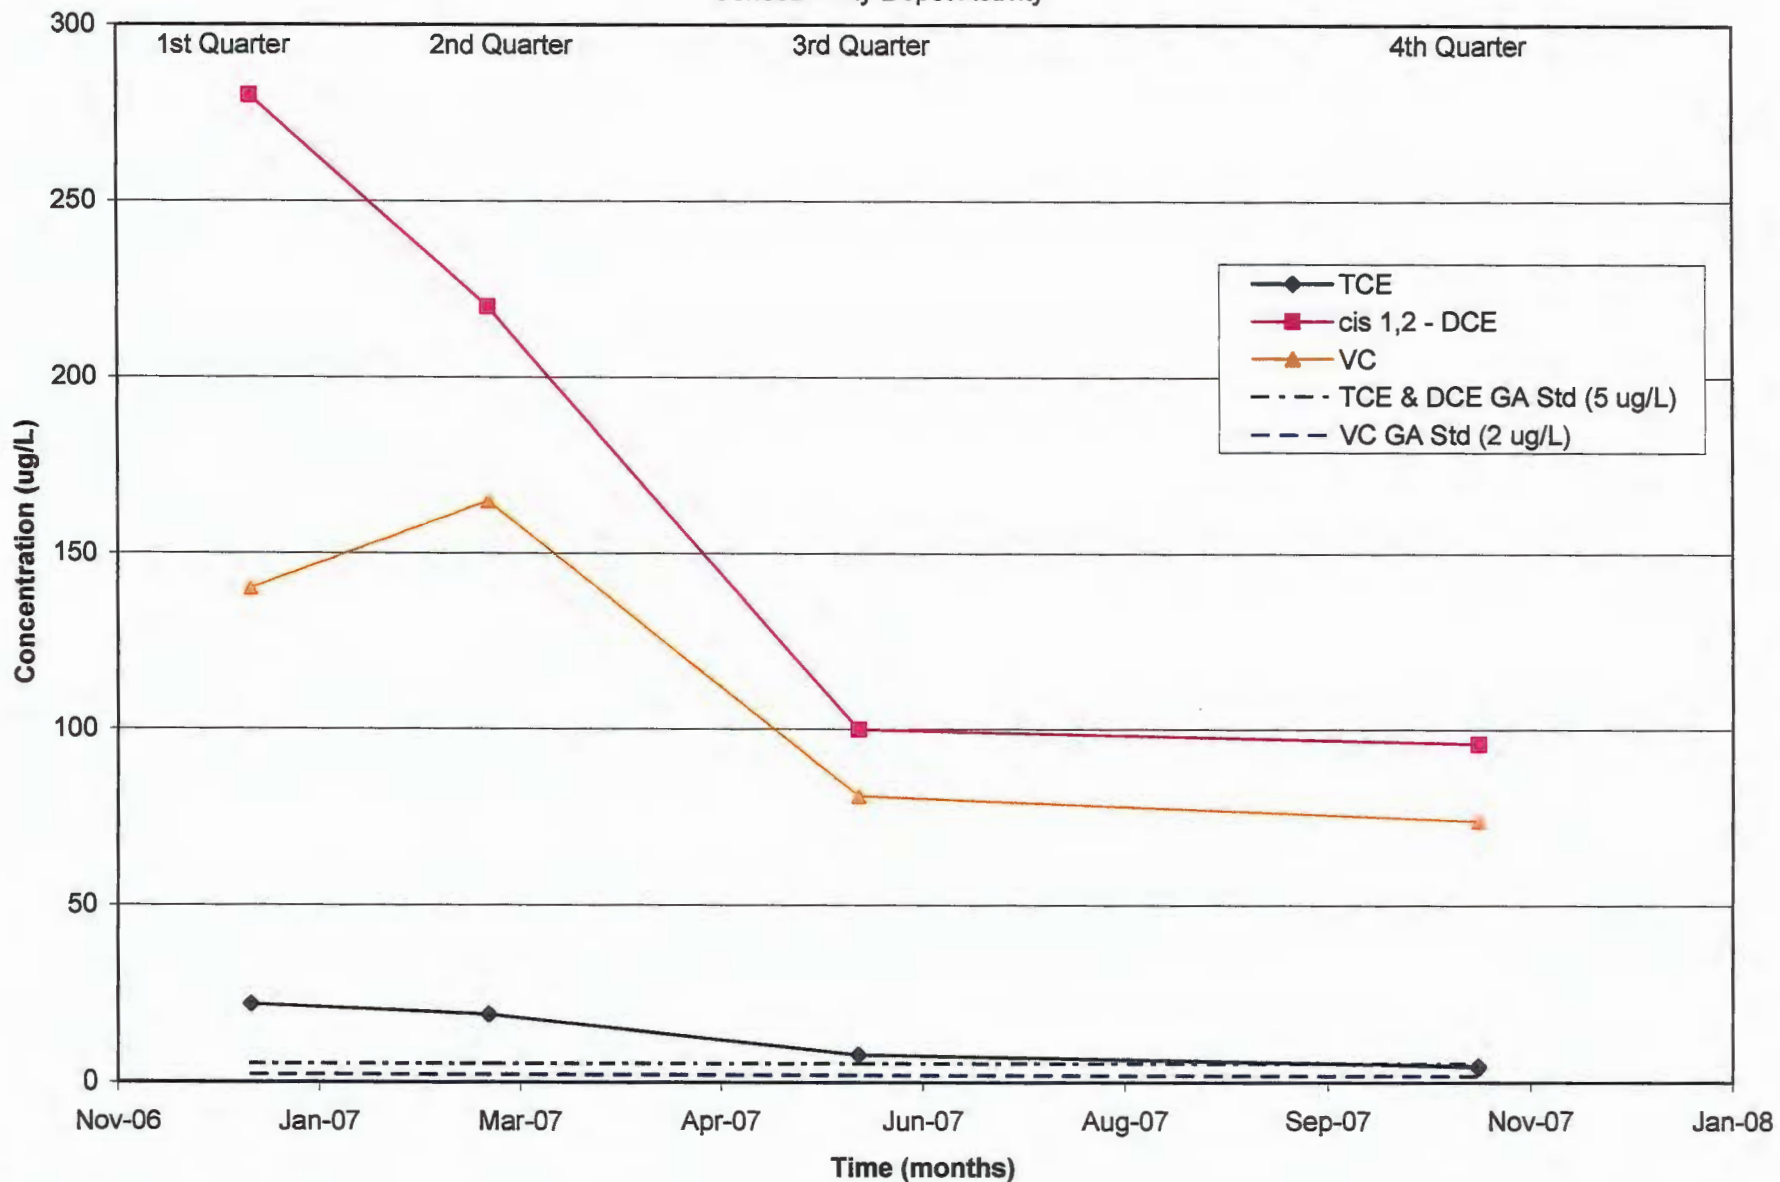
Figure 6D  
 Concentrations of Chlorinated Organics Over Time at MWT-29  
 Ash Landfill Annual Report  
 Seneca Army Depot Activity

Note:  
 Round 2 data is the average of the sample and its duplicate.

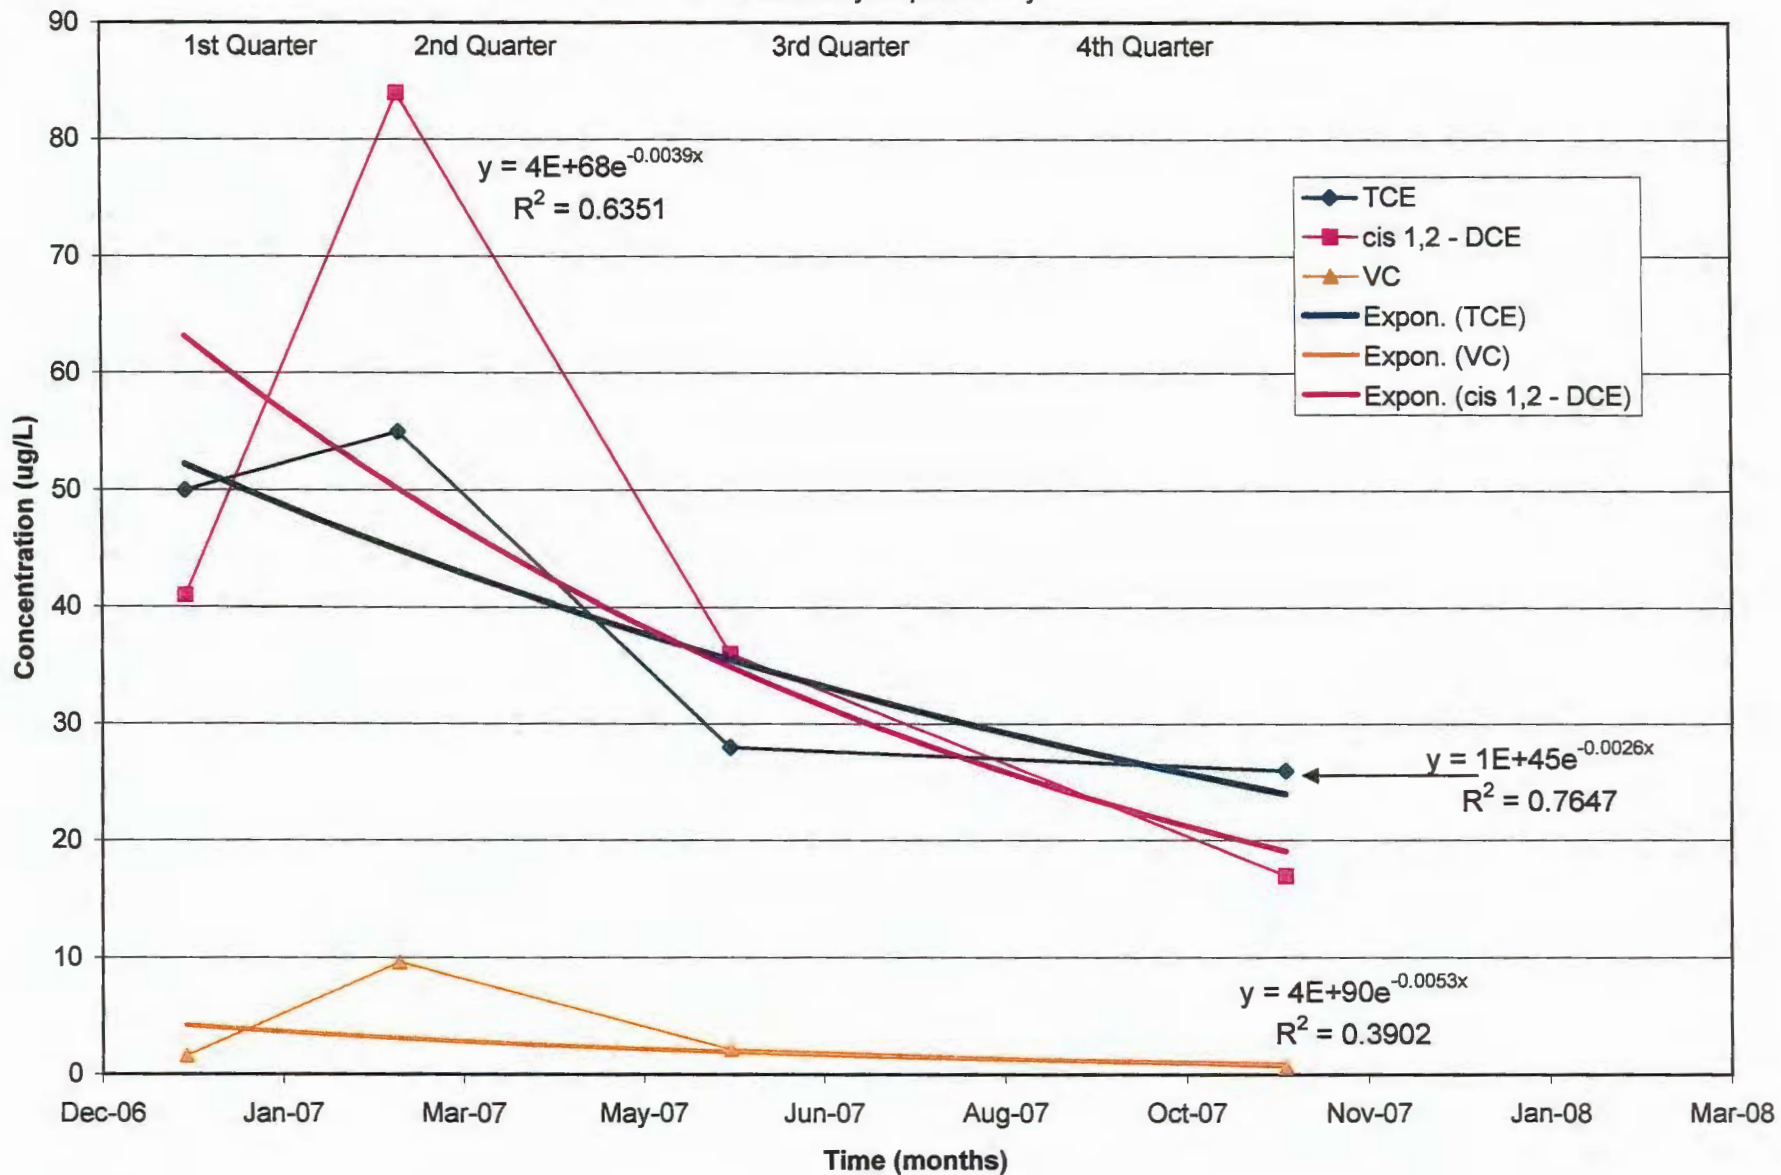
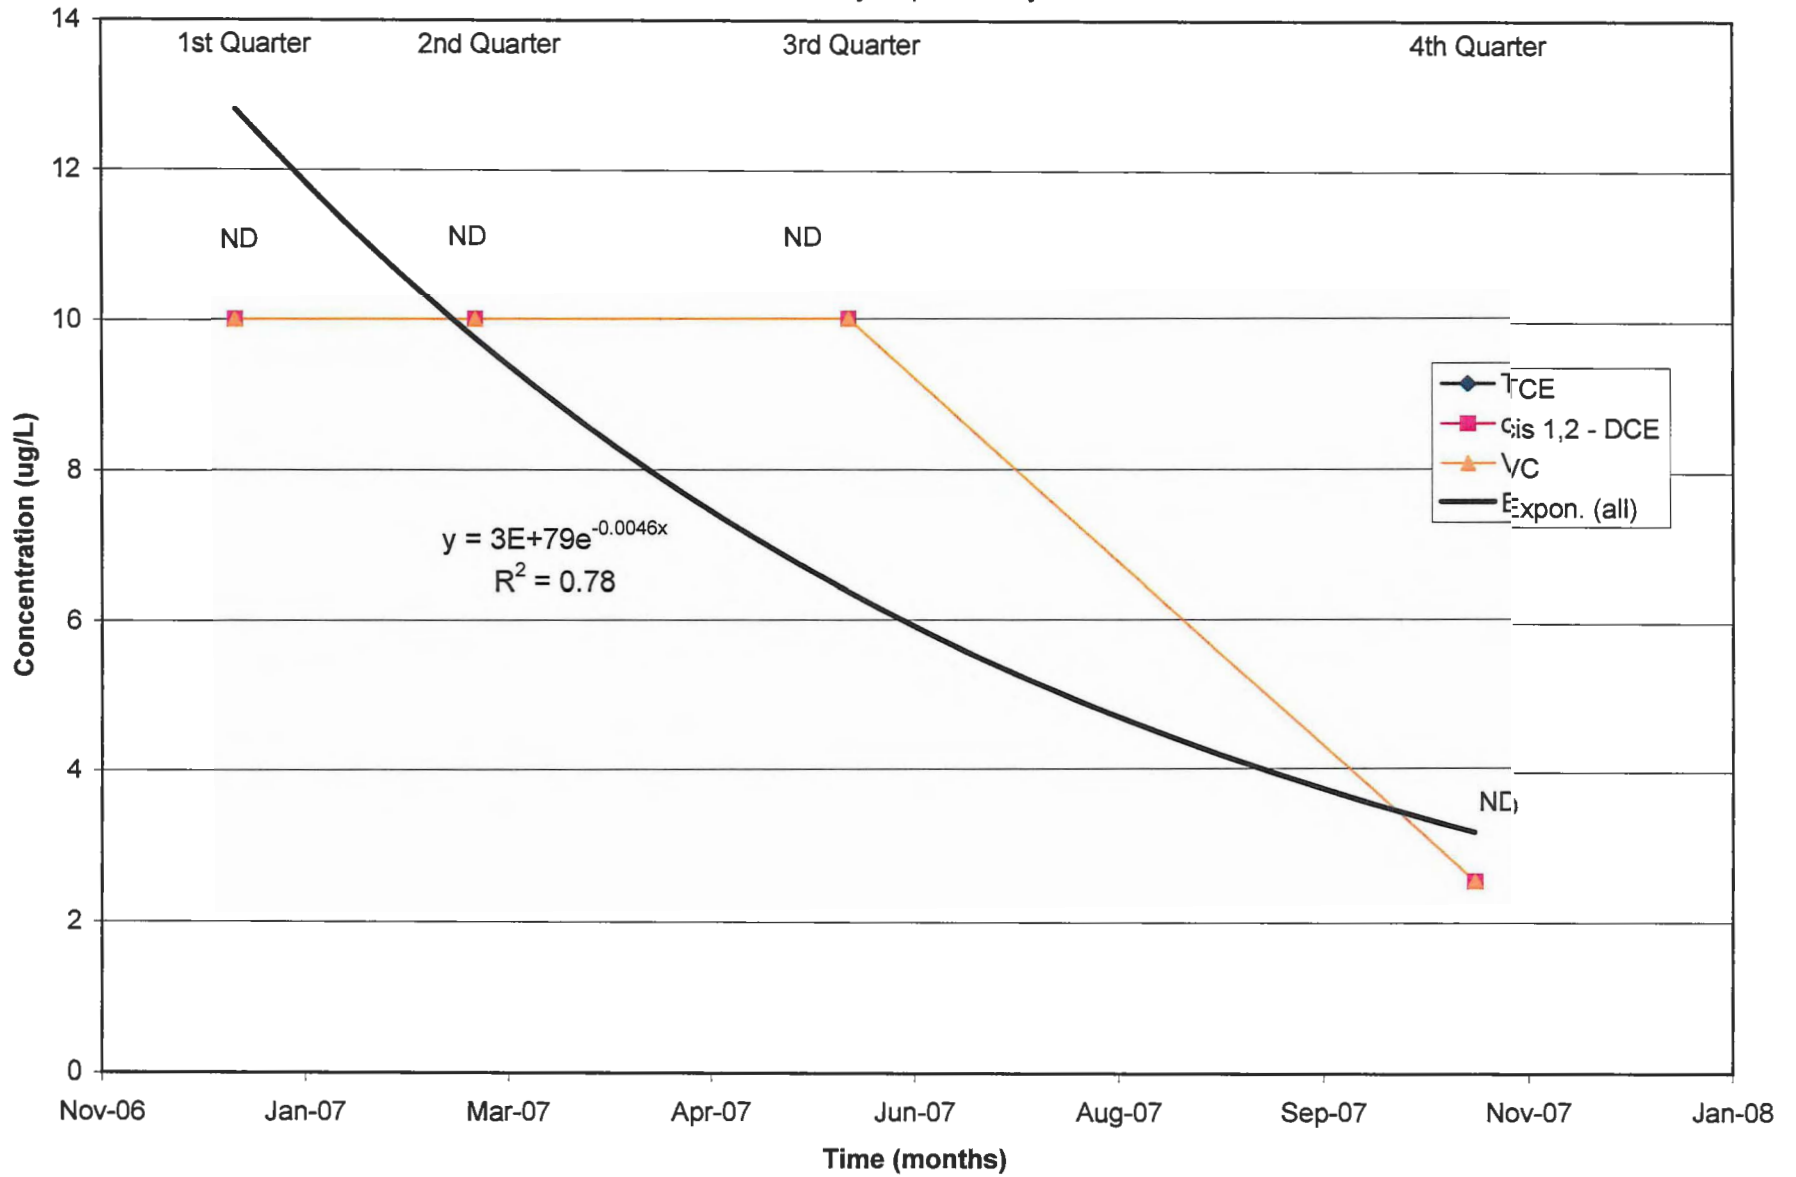
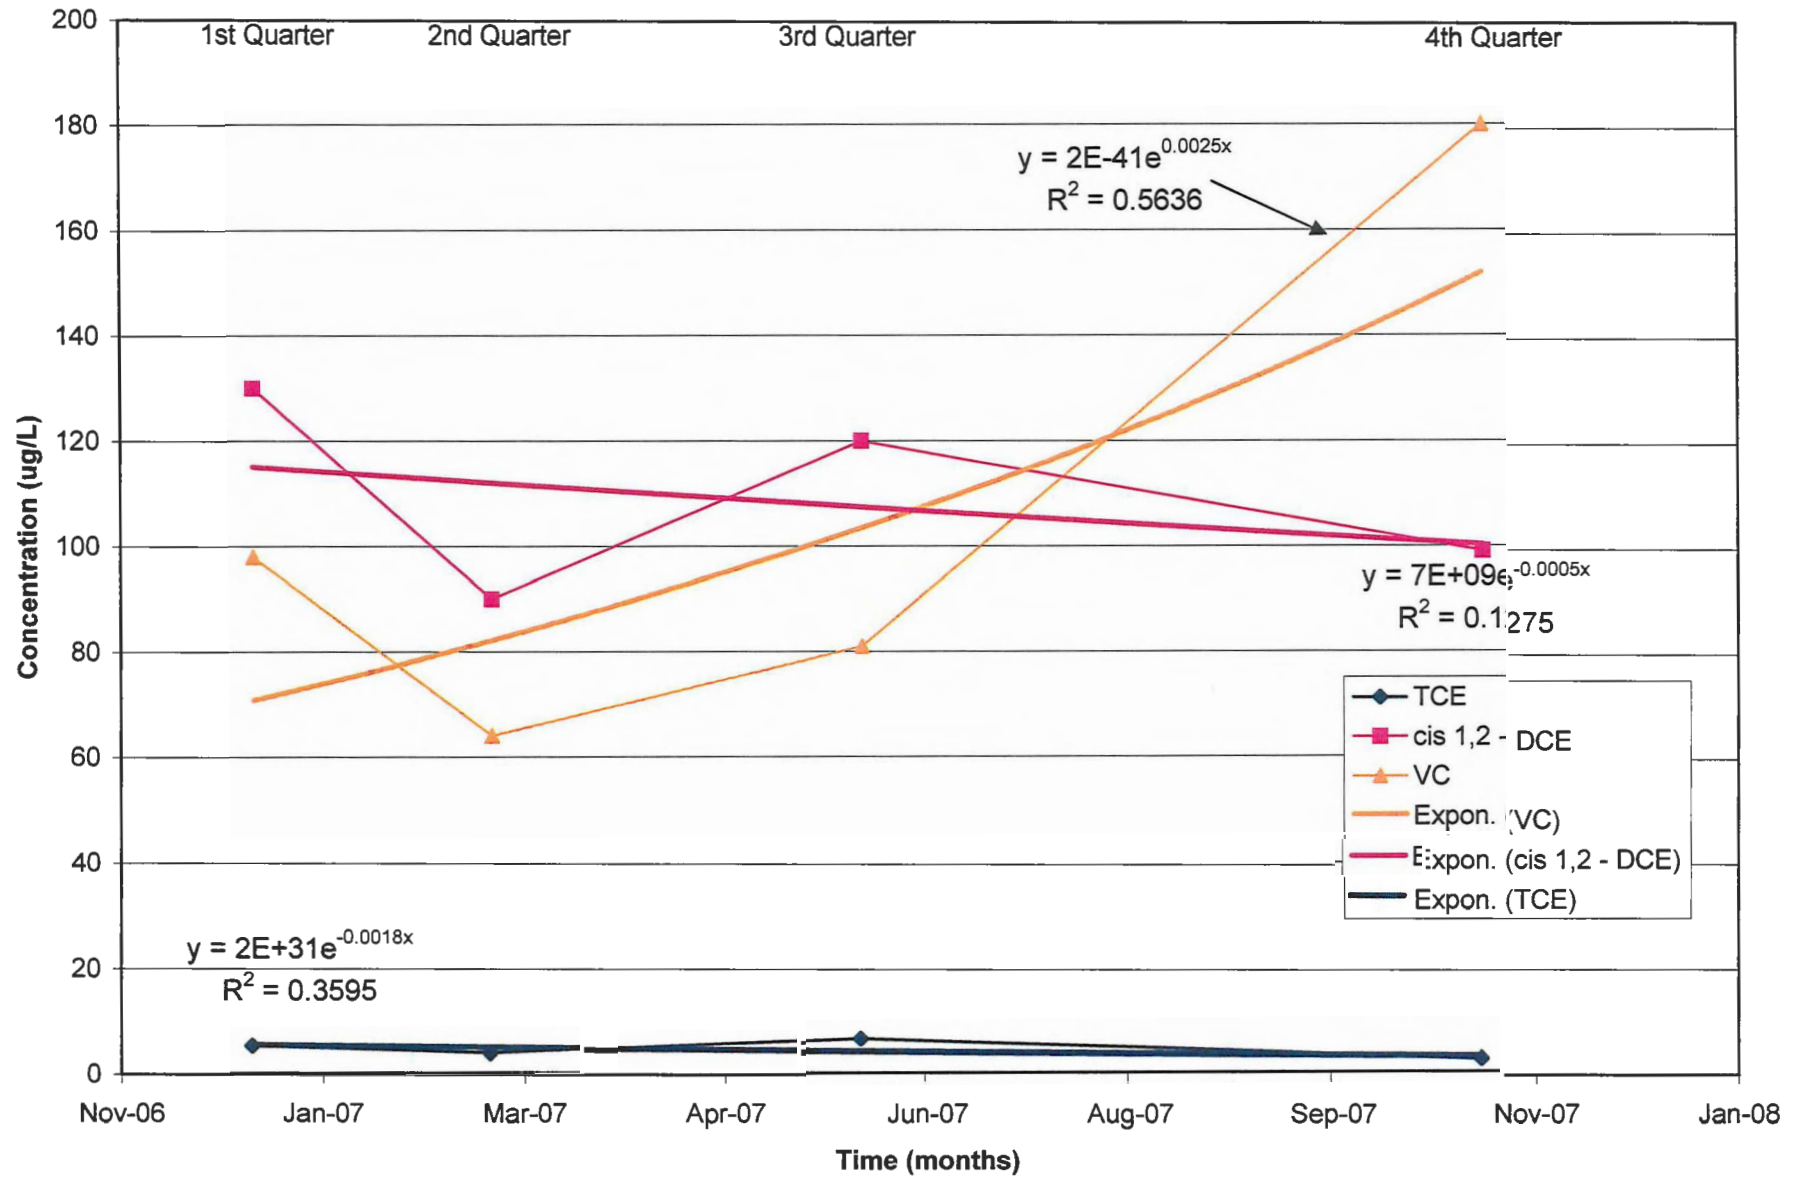
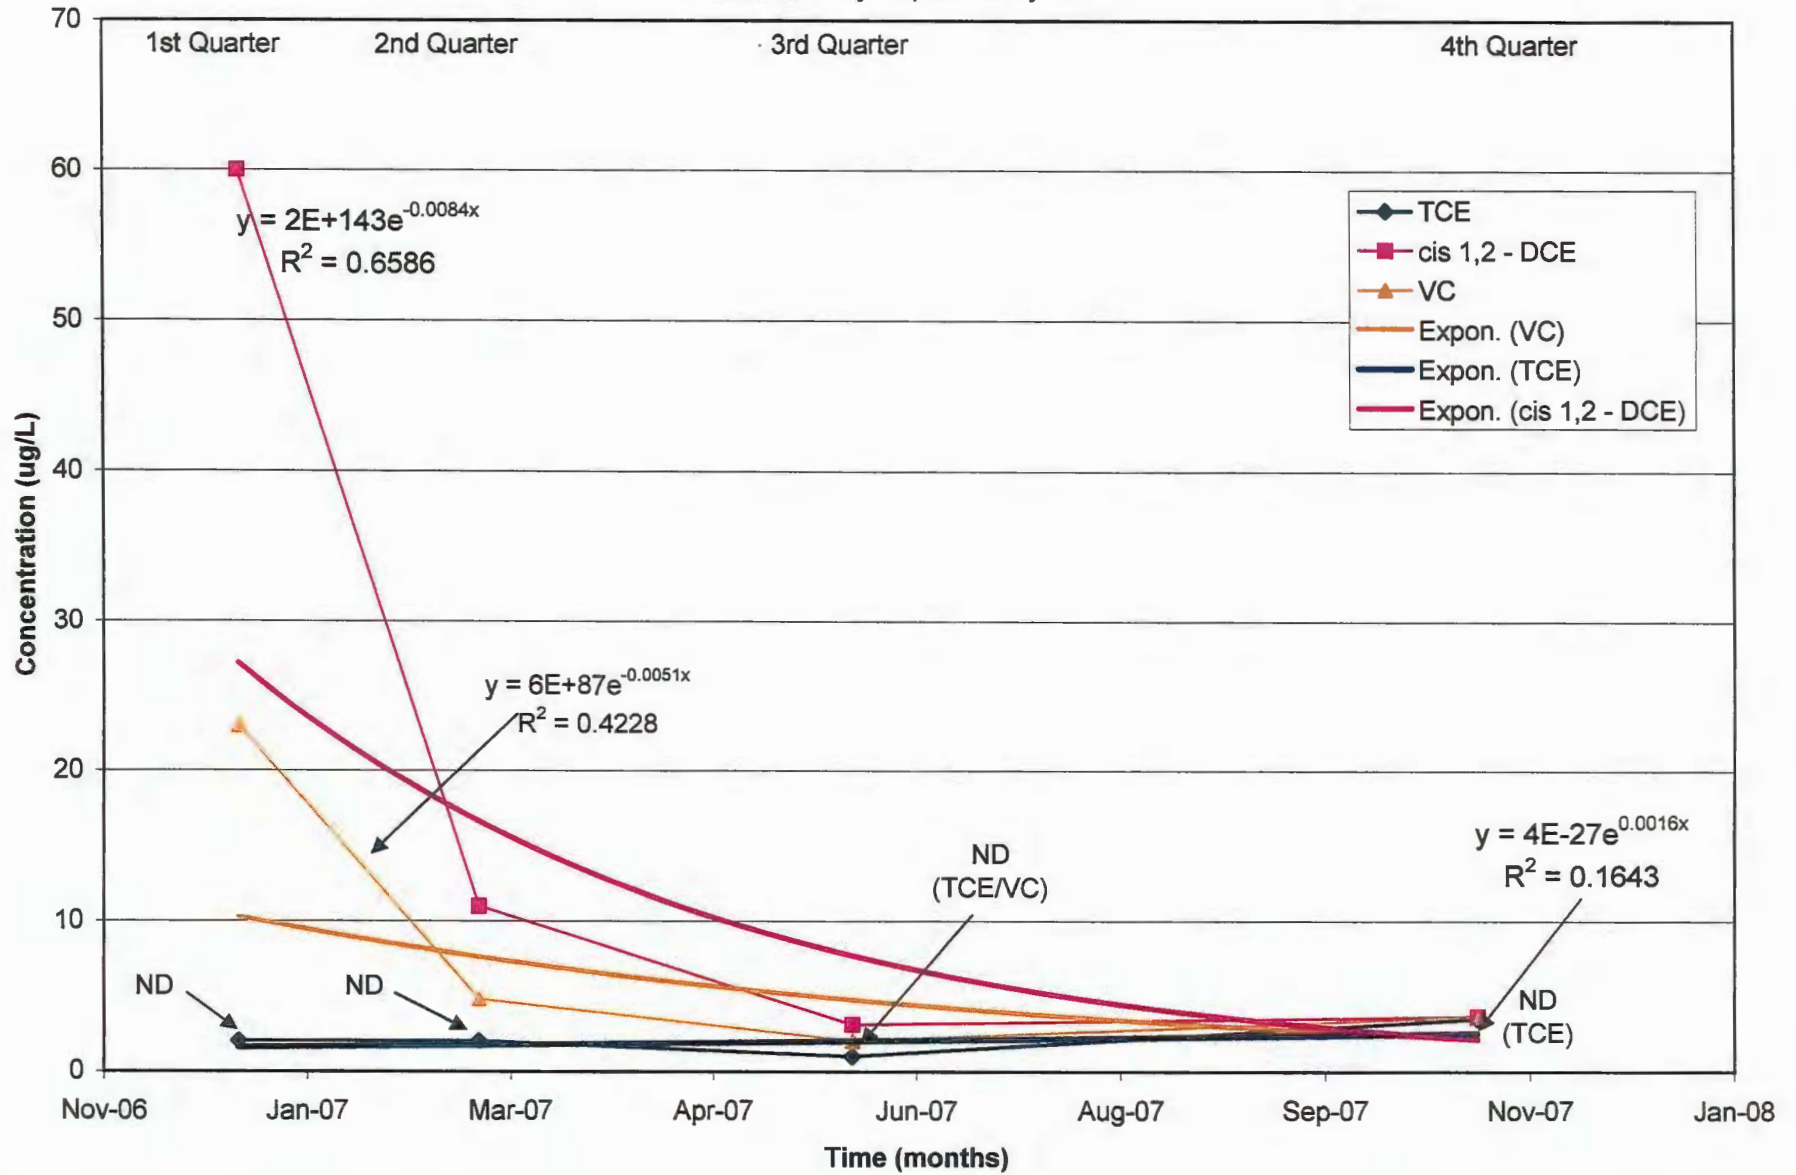
An exponential regression, which matches the rate of decay typical for biological processes, has been calculated for the monitoring wells as a means of calculating an estimate of the time it will take for the concentrations of chlorinated organics to meet their respective GA groundwater standards. **Table 4** summarizes the trend for each contaminant in each well and provides an estimate of the date that the standards will be achieved based on the exponential regressions. This table shows that with the exception of the source well (PT-18A), PT-17, and MWT-7, all concentrations at the wells have either reached the Class GA groundwater standard or are expected to reach their respective standards by 2014. These dates are intended to provide an indication of the timeframe required for concentrations to reach acceptable levels, and are not meant as a time commitment for the remedy. There may be limiting factors in reaching the groundwater standards by the specified date, such as desorption and back diffusion from low permeability sediments, which may drive the actual time required to reach compliance. The time plots with the regression lines are included as **Appendix B**.
