**SENECA ARMY DEPOT ACTIVITY
ROMULUS, NEW YORK**

**FINAL REPORT
UXO AND SOIL REMEDIATION
AREA-44A**

**UXO AND SOIL REMEDIATION
AREA-44A
SENECA ARMY DEPOT ACTIVITY
ROMULUS, NEW YORK**

WESTON SOLUTIONS, INC.
One Wall Street
Manchester, New Hampshire 03101-1501

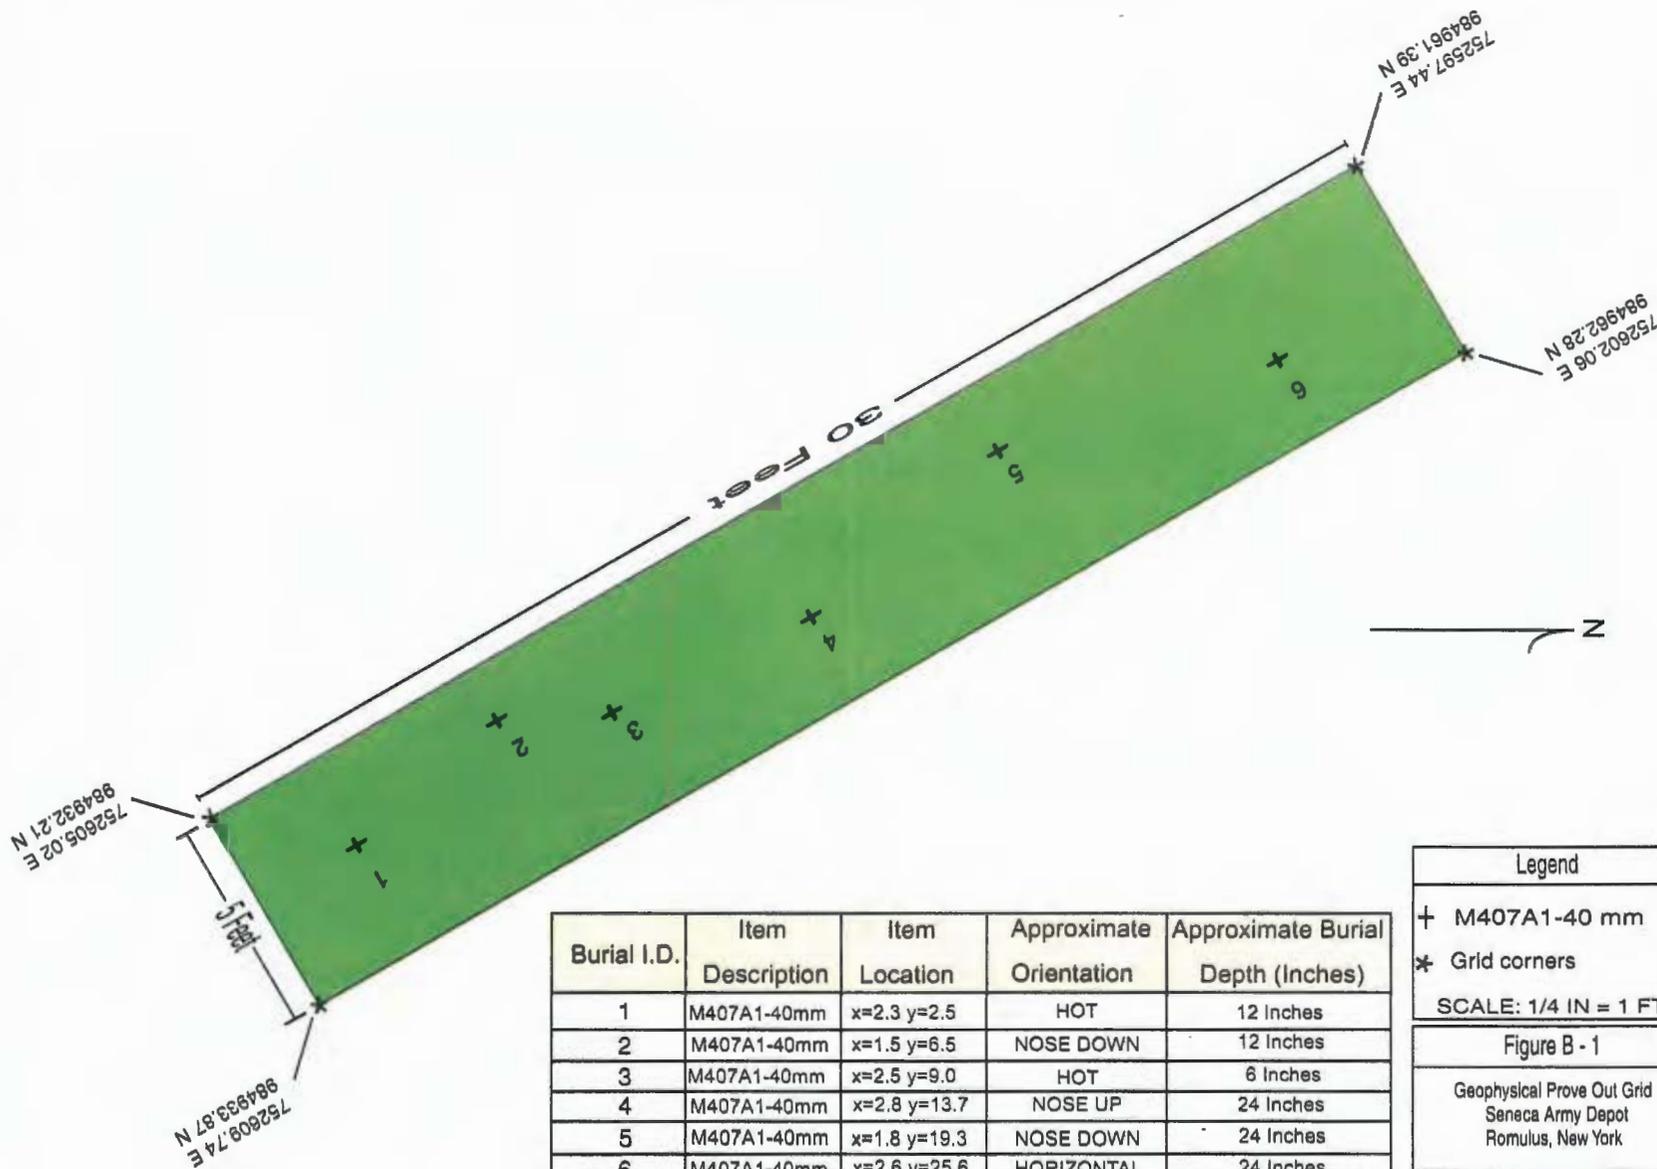
Burial I.D.	Item Description	Item Location	Approximate Orientation	Approximate Burial Depth (Inches)
1	M407A1-40mm	x=2.3 y=2.5	HOT	12 Inches
2	M407A1-40mm	x=1.5 y=6.5	NOSE DOWN	12 Inches
3	M407A1-40mm	x=2.5 y=9.0	HOT	6 Inches
4	M407A1-40mm	x=2.8 y=13.7	NOSE UP	24 Inches
5	M407A1-40mm	x=1.8 y=19.3	NOSE DOWN	24 Inches
6	M407A1-40mm	x=2.6 y=25.6	HORIZONTAL	24 Inches

Geophysical Prove Out Grid
Seneca Army Depot
Romulus, New York

NOTE: This illustration represents WESTON's design of the final test plot construction. Easting and Northing coordinates given in US Survey feet using US State Plane 1983 and NY Central 3102

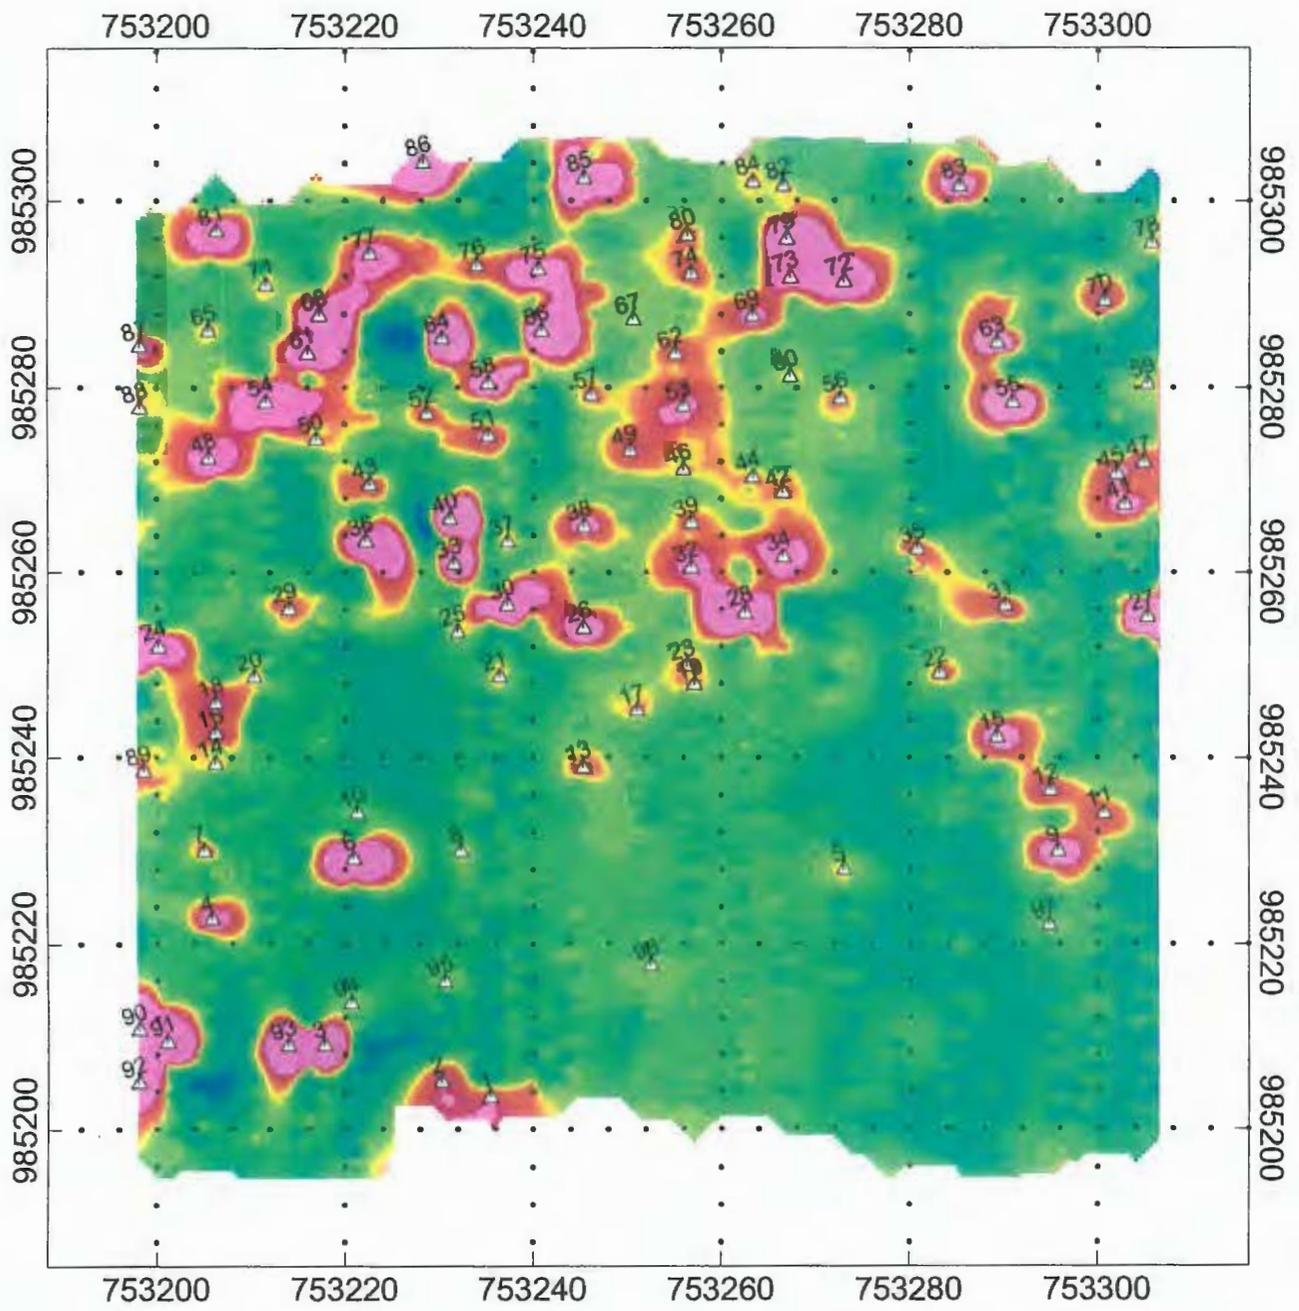
Figure C-4
Cell J-5 Area-44
Area-44 EM-61 Survey

One grid (J-5) was remapped since it failed QC inspection by WESTON. This grid is shown in Attachment C-7 in Appendix C with a total of 97 targets. The target list is included in Attachment C-8 in Appendix C.

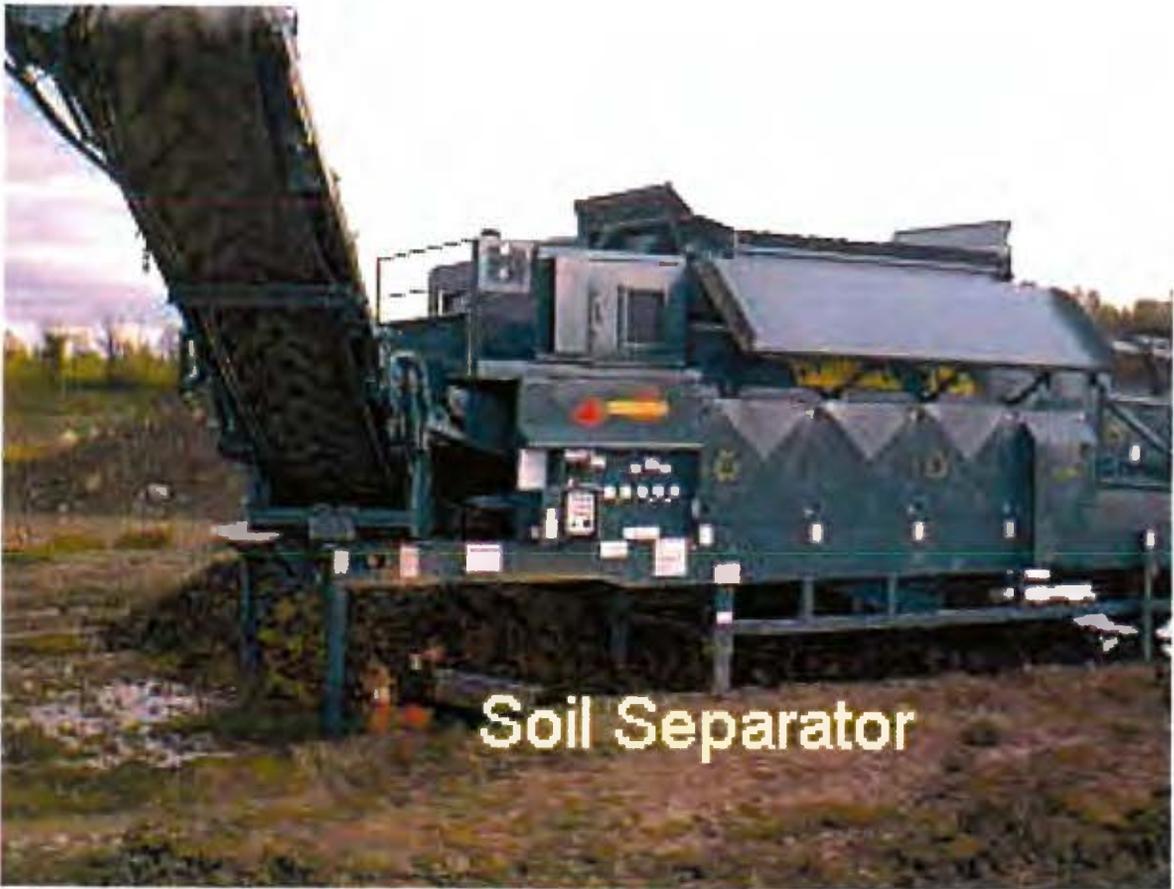
Soil Separator

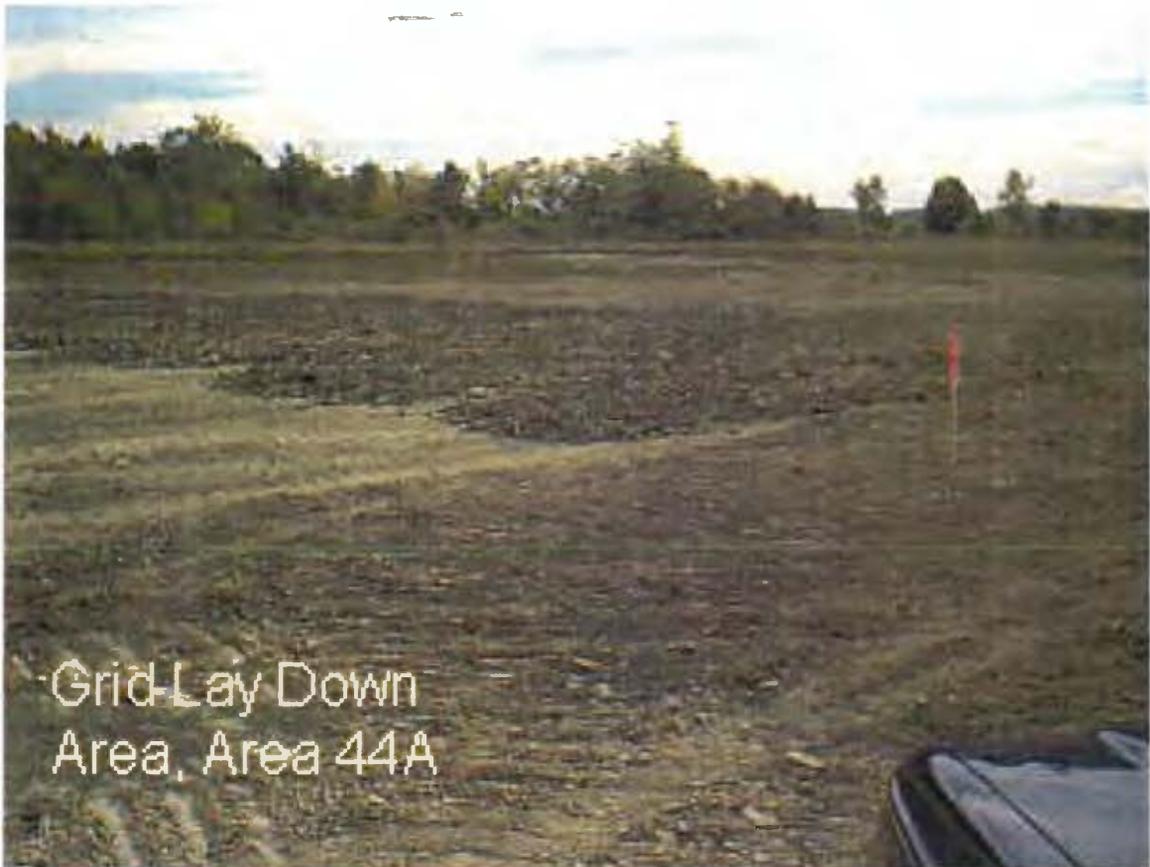
Grid Lay Down
Area, Area 44A

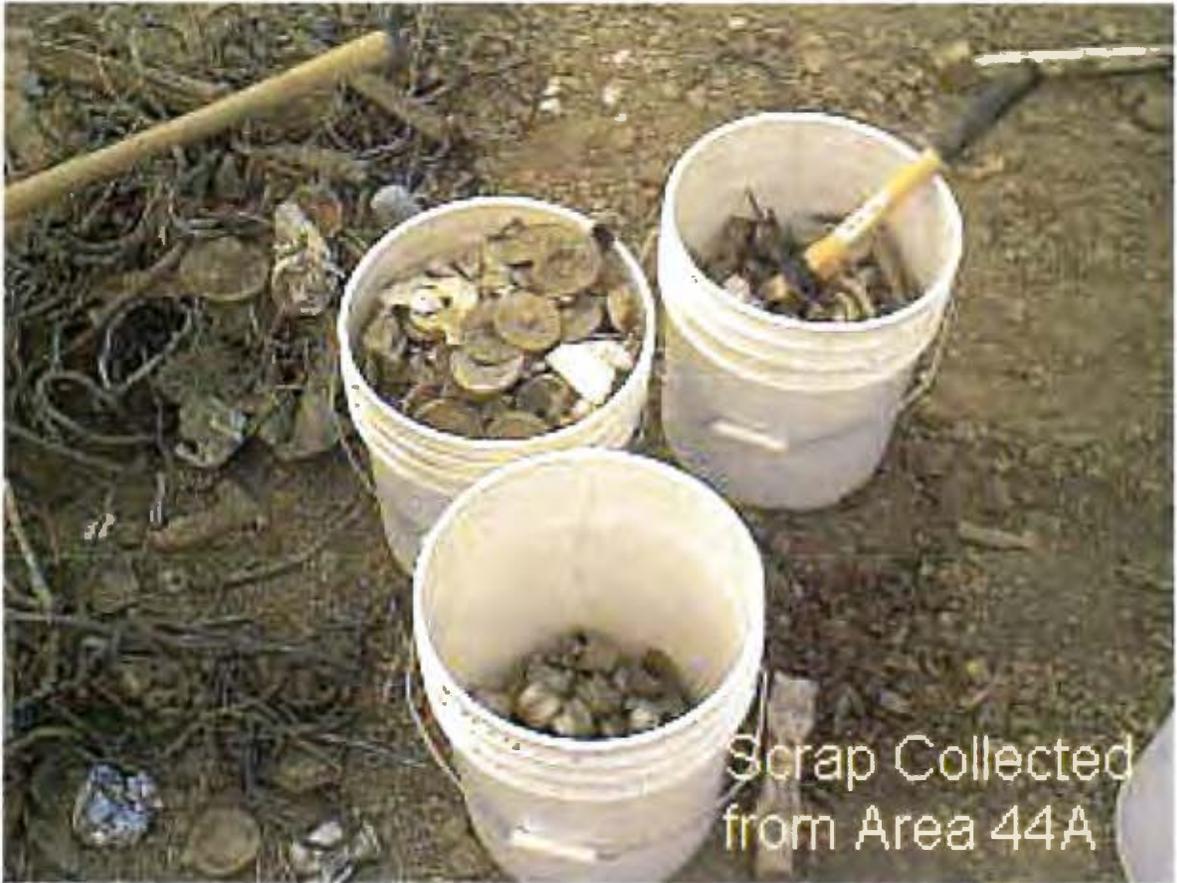
Scrap Collected
from Area 44A

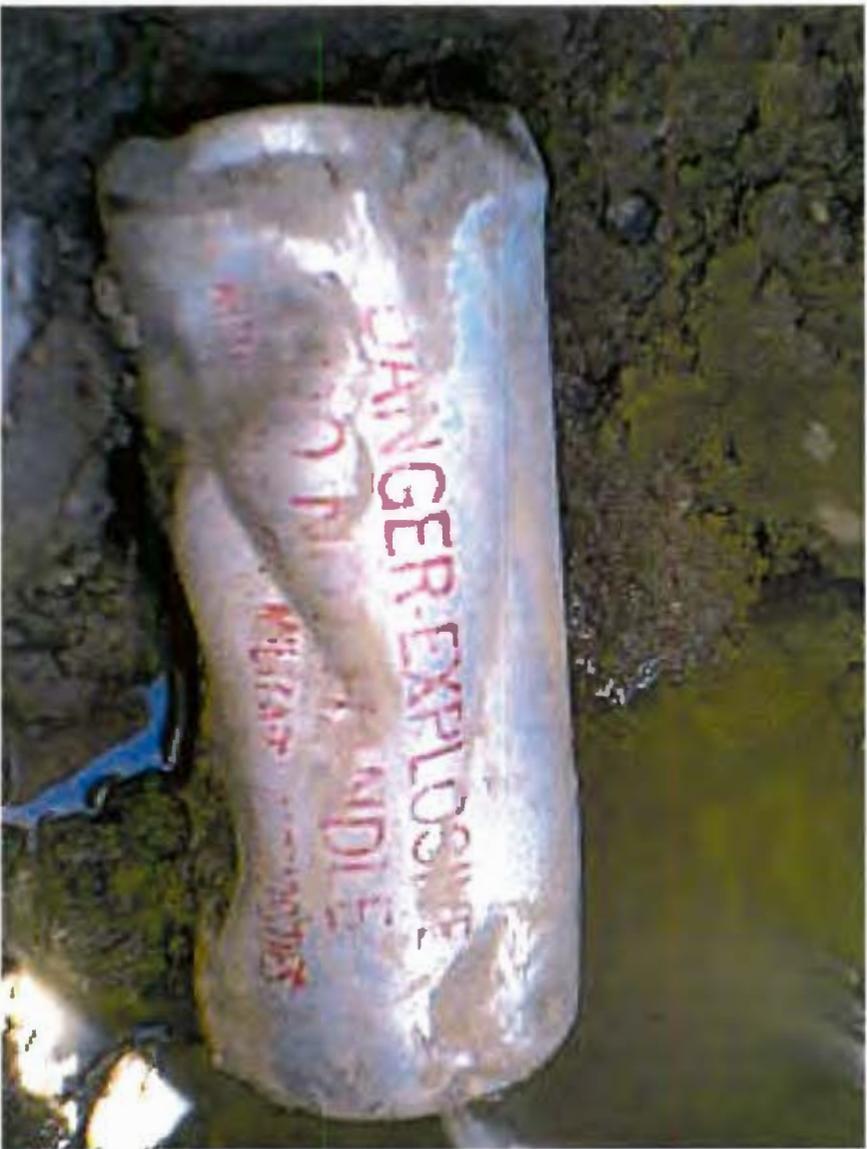
40mm M407A1
found on Area 44A

All 22 OE items found were 40-mm practice rifle grenades (M407A1). All grid areas mapped and cleared by WESTON passed QC/QA criteria specified in the *ESS* (USACE, April 2000). It is concluded by USACE that OE does not potentially exist below the clearance depth and that the property may be released for unrestricted use. It is recommended that approval be issued on the site for areas cleared by WESTON based on the successful completion of the OE removal effort at SEAD-44A.
