AREA D

## PROPOSED LIMIT OF EXCAVATION

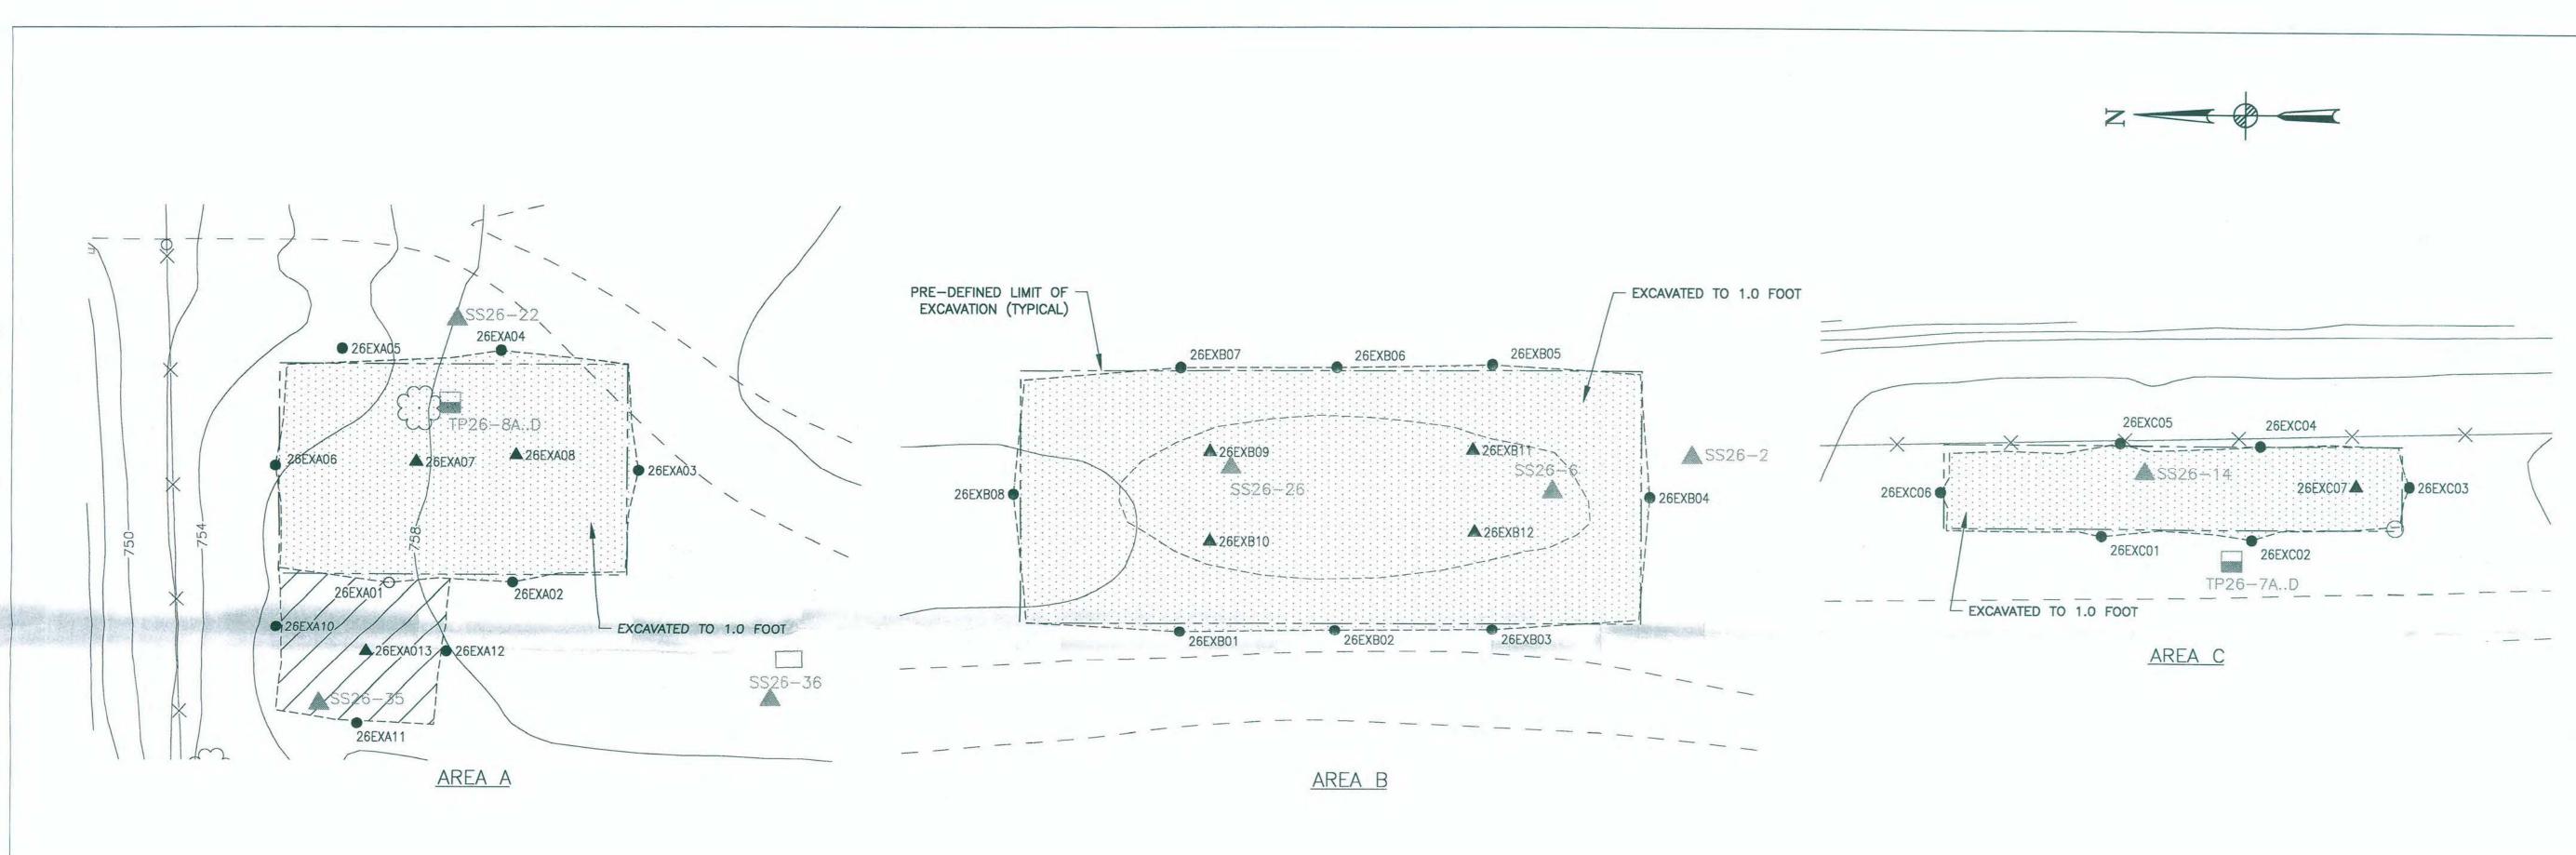
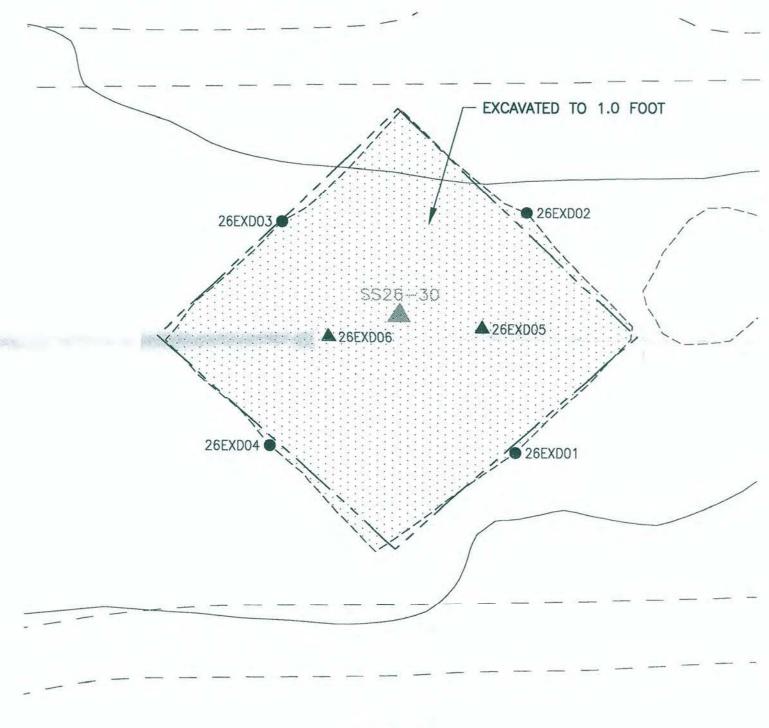
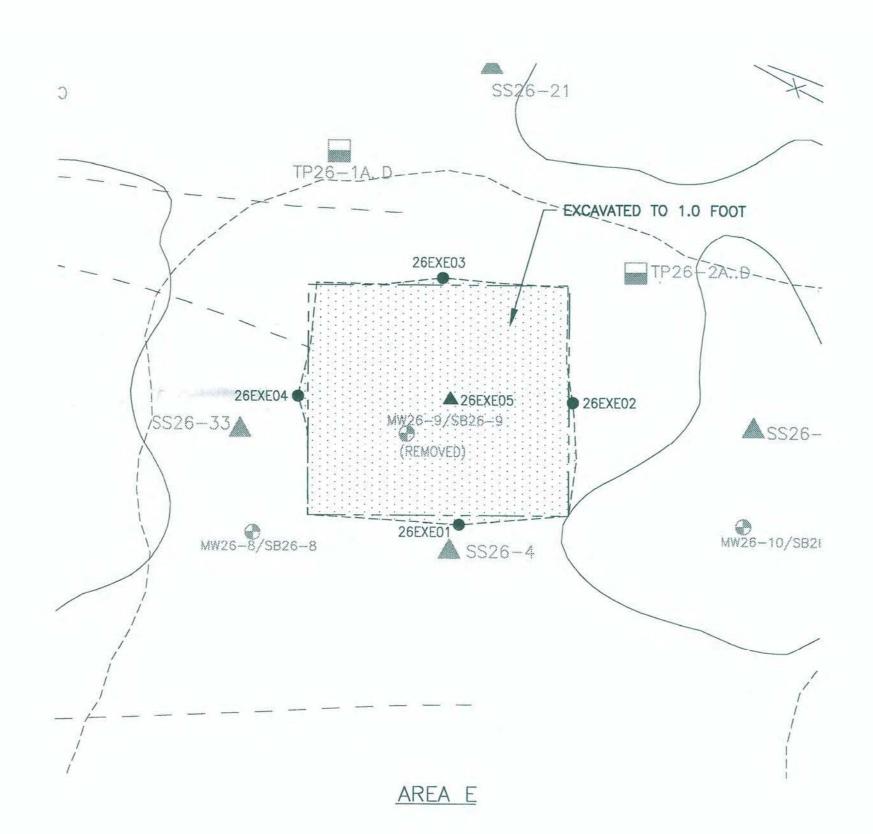
- 3. VERTICAL DATUM IS BASED ON NAD88.
- 4. EACH AREA WAS EXCAVATED TO A DEPTH OF 1 FOOT.
- 5. EXCAVATED MATERIALS WERE DIRECTLY LOADED INTO DUMP TRUCKS AND TRANSPORTED TO ONTARIO COUNTY LANDFILL BY EARTHWATCH.

- 6. EDGES OF THE EXCAVATED AREA WERE SMOOTHED TO PREVENT TRIP HAZARDS. NO EXCESS MATERIAL WAS MOVED OR HANDLED AT THE SITE.
- 7. THE INTERIM SAMPLE 26EXA01 FAILED TO MEET THE CLEANUP GOALS, AND THE SOIL AROUND THE INTERIM SAMPLE WAS EXCAVATED TO A DEPTH OF 1 FOOT. THE SOIL FROM WHICH THE INTERIM SAMPLE WAS COLLECTED HAS BEEN REMOVED FROM THE SITE AND IS NOT CHARACTERISTIC OF CURRENT SITE CONDITIONS.

- 8. DEBRIS, SUCH AS CONTAINERS, VEHICLES, AND SCRAP METAL, WERE REMOVED FROM THE SITE BY THE CONTRACTOR.
