Analysis of Environmental Impacts Pursuant to New York State Environmental Quality Review Act

Project Name:
Seneca Dairy Systems Agricultural Manufacturing Facility

Dated: May 1, 2019

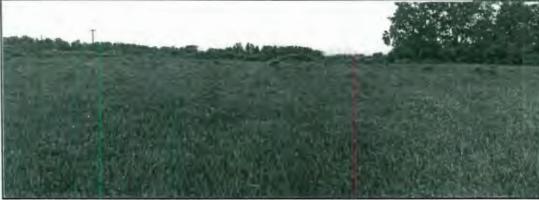
2015 Site Visit Photo 2

Status as of:6/1/15 Description: SEAD-5 cap

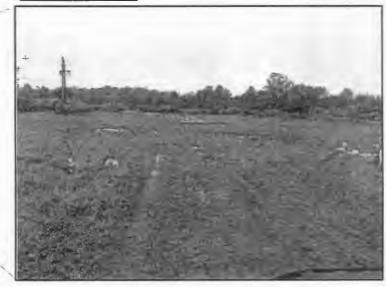
2015 Site Visit Photo 1

Photo ID: IMG 6588.JPG Status as of: 6/1/15 Description: SEAD-17, Building 367 foundation.

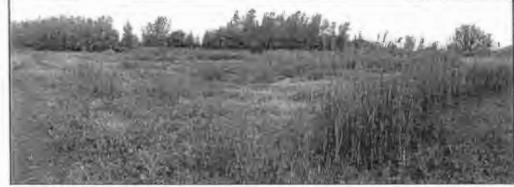
Status as of: 6/1/15 Description: SEAD-59 Photo ID: IMG_6547.JPG

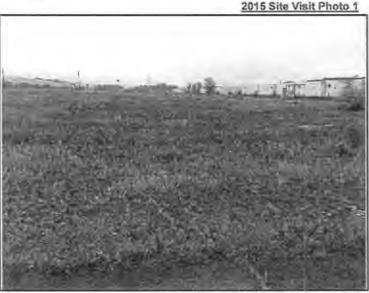
Status as of: 6/1/15 Description: SEAD-121I Photo ID: IMG_6570.JPG

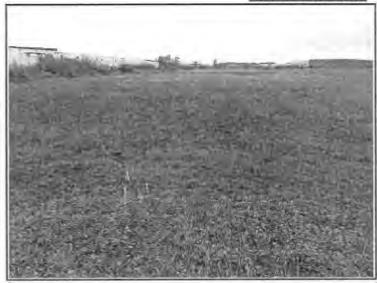
Status as of: 46/1/15 Description: SEAD-1211 Photo ID: img_6569.JPG

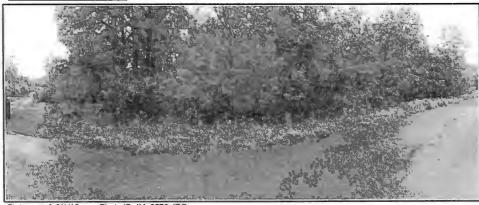
2015 Site Visit Photo 2

Status as of: 6/1/15 Photo ID: IM_6576.JPG Description: SEAD-64B
