INTERIM FINAL REPORT
GROUND-WATER CONTAMINATION SURVEY NO. 38-26-0868-88
EVALUATION OF SOLID WASTE MANAGEMENT UNITS
SENECA ARMY DEPOT
ROMULUS, NEW YORK
27-31 JULY 1987

INTERIM FINAL REPORT
GROUND-WATER CONTAMINATION SURVEY NO. 38-26-0868-88
EVALUATION OF SOLID WASTE MANAGEMENT UNITS
SENECA ARMY DEPOT, ROMULUS, NEW YORK
27-31 JULY 1987

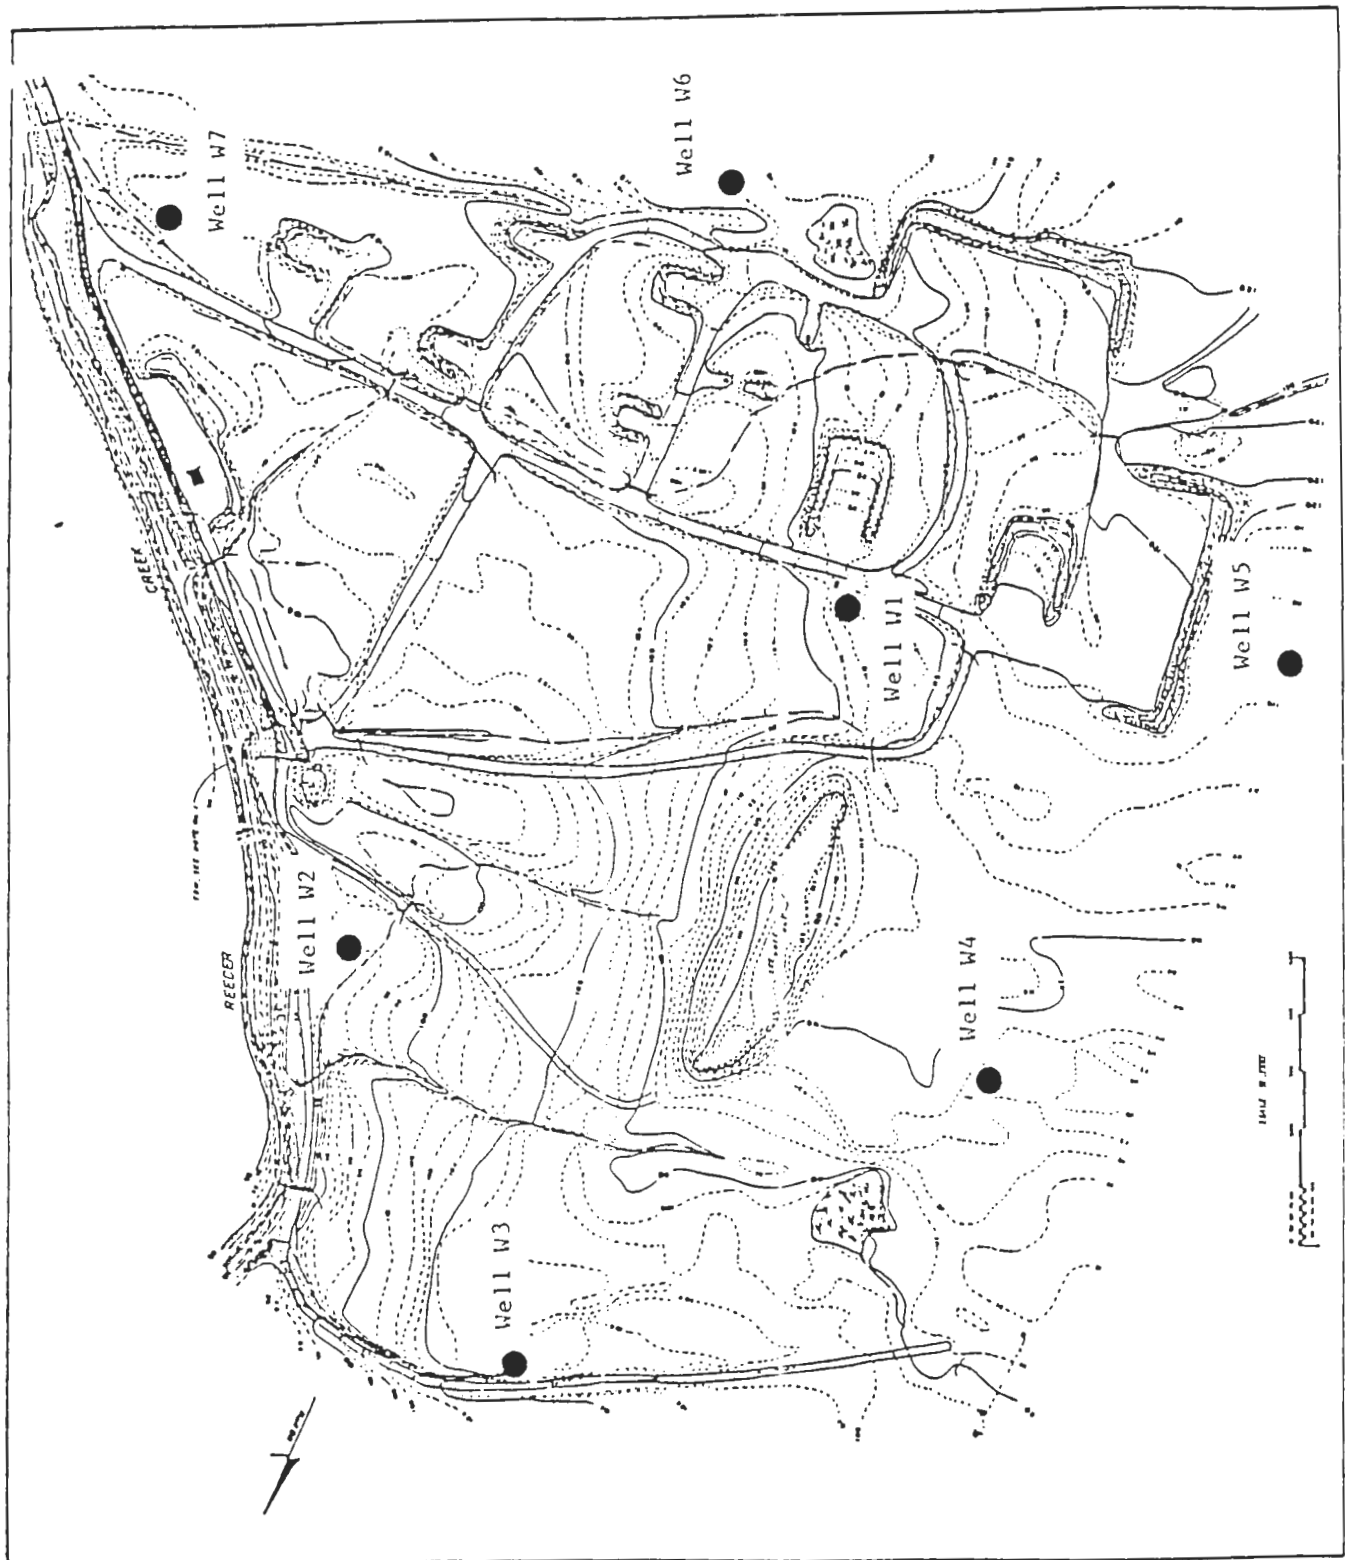
FIGURE C-3. Map of the Demolition Ground at Seneca Army Depot.

(2) Design Features. The OB/OD grounds consist of a detonation hill and nine burning pads (A through J) on a 90-acre site. The pads are constructed of broken shale, and the hill is glacial material which is moved around for the detonation activities. Figure C-3 shows the area.

(5) Present Condition and Status. The detonation ground is active, but the burning ground pads are scheduled to be closed and replaced with burning in troughs. The site is included in the revised RCRA Part B permit application.

e. Evidence of Release. Table C-2 lists the ground-water level and quality data available for the demolition grounds. Ground-water contamination by metals and explosive compounds may be present in the active section of the burning pad area, but the perimeter ground-water monitoring wells remain clean.

g. Recommendations for Sampling. No additional sampling is recommended. Continue to monitor the perimeter wells.
