HISTORIC PROPERTIES REPORT

SENECA ARMY DEPOT

NEW YORK

DECEMBER 1983

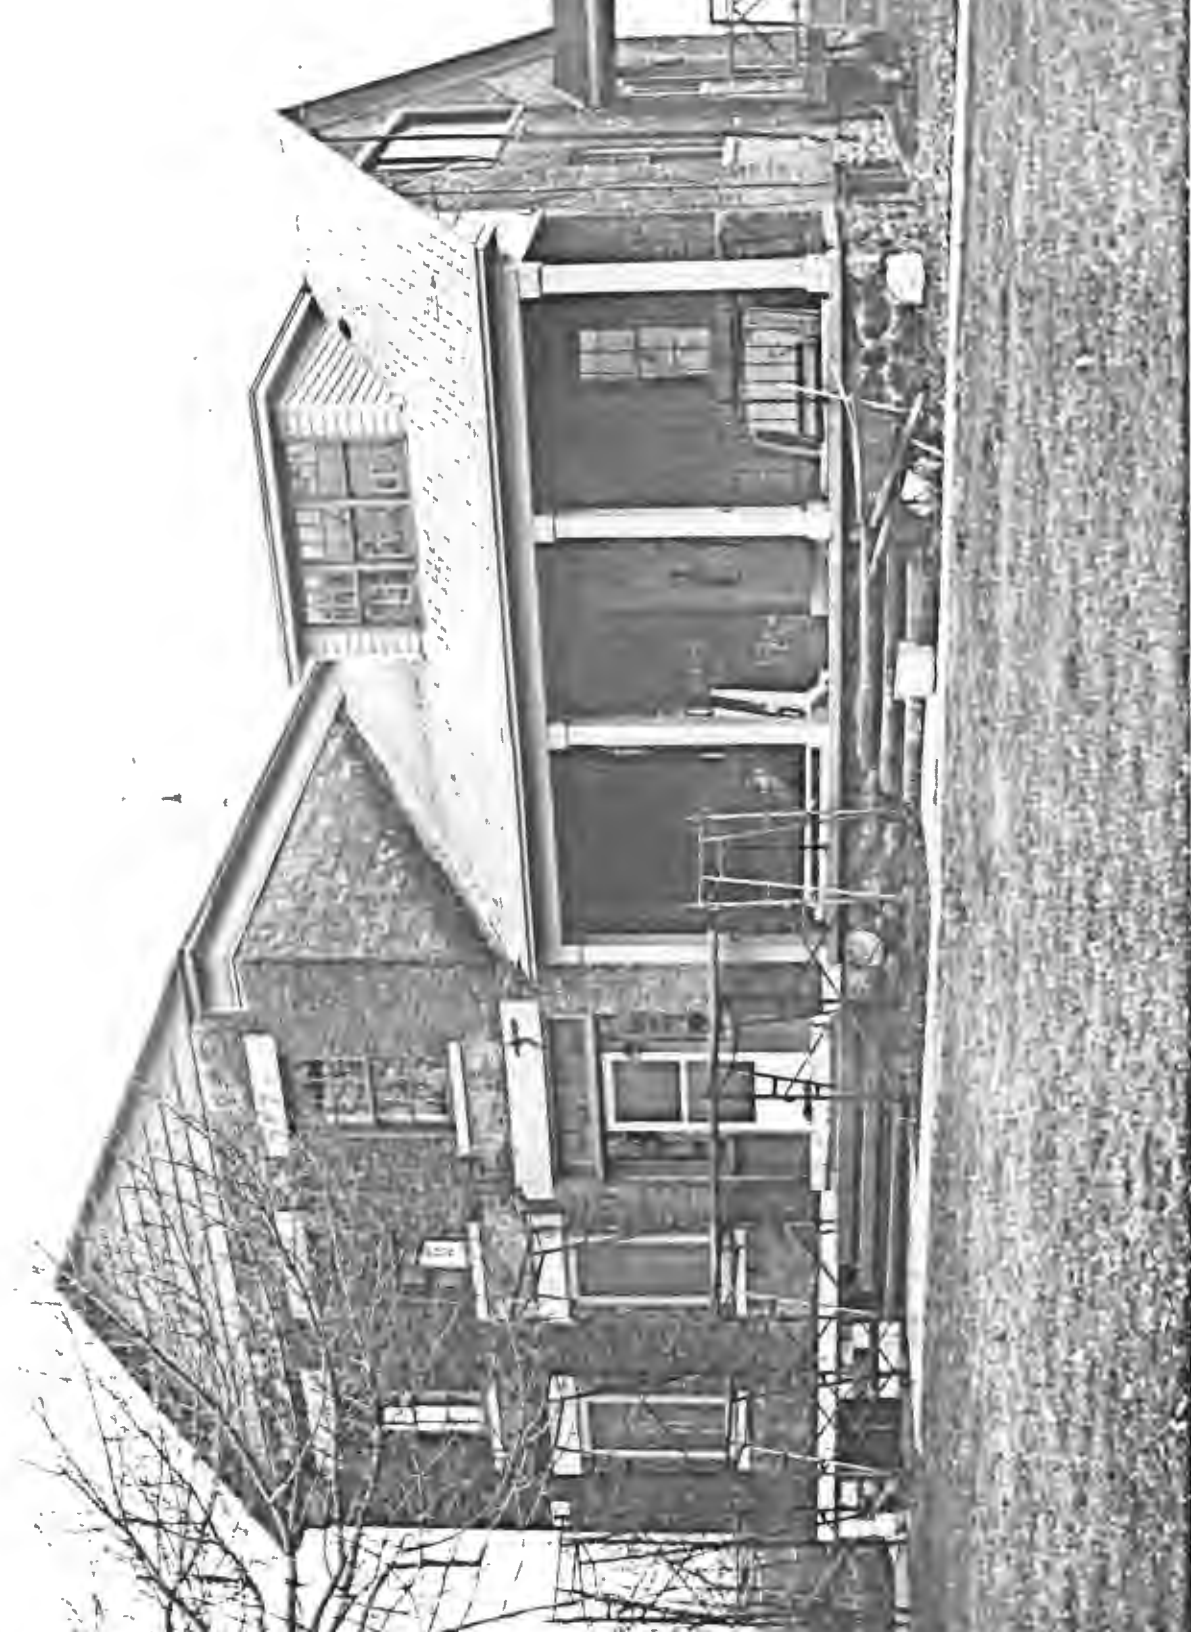
Illustration 3 Building 2301, exterior view. This brick classical revival building was probably constructed during the first two decades of the nineteenth century and may have once been a tavern and inn. Under military ownership, it has served as family housing, offices, and the depot rod and gun clubhouse. It is now being remodeled for use as a training facility and offices. (Source: Field inventory photograph, 1983, Barbara Hightower, Building Technology, Inc.)

porch is on the east side of the main block. The front (south) facade is laid in the more elaborate Flemish bond while the remaining walls are laid in 5/1 common bond. The six-over-six-light double hung sash windows on the south and west facades have stone lintels and sills, and the main entrance, a wooden panelled door flanked by sidelights, is surmounted by a transom and stone lintel. Two chimneys on the west side were removed during an earlier remodeling. The interior, which has been altered, retains what may be the original spiral staircase, mantels, door and window surrounds, and wood flooring. (Illustrations 3 and 4)

Condition and potential adverse impacts. The building is in good condition and is being remodeled for use as a training facility and offices. There are no plans to alter or destroy the remaining significant architectural elements.

Preservation recommendations. Refer to the general preservation recommendations at the beginning of this chapter for Category III properties.

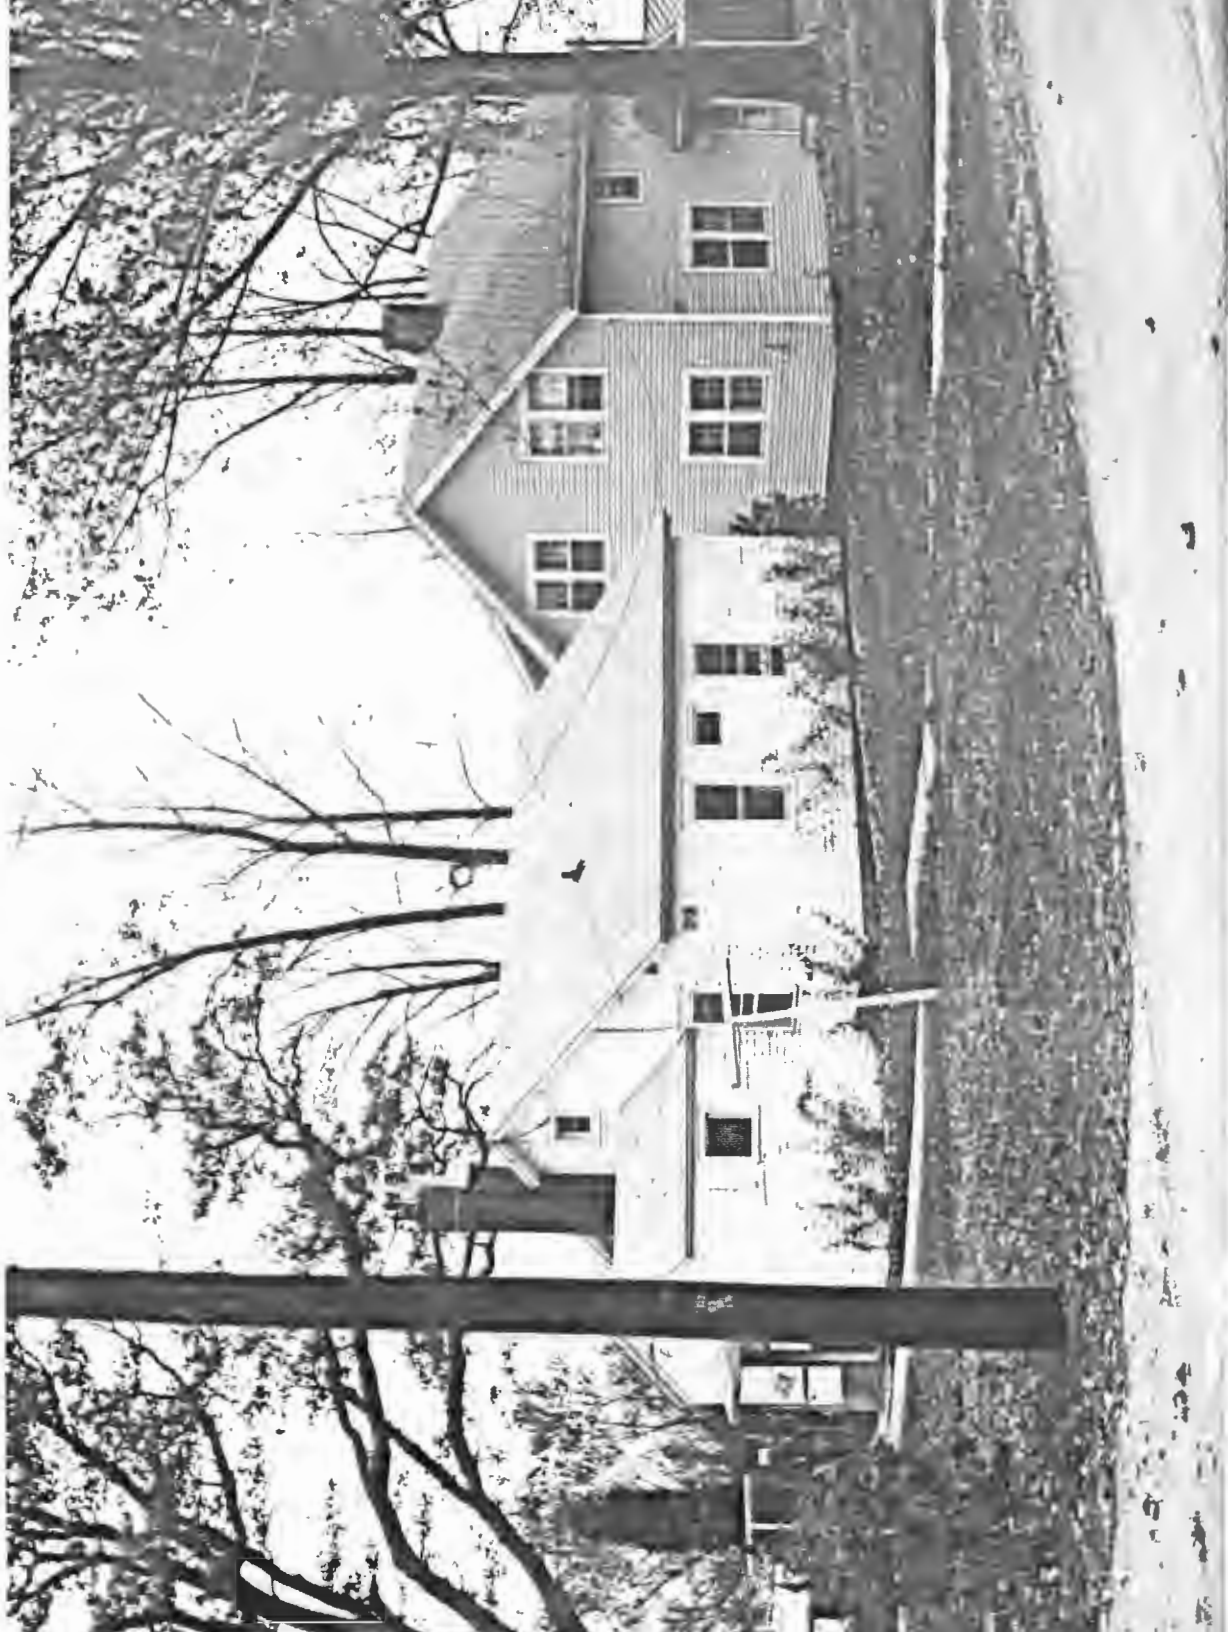
Illustration 5 Buildings 2438 and 2437. These two houses located along the eastern shore of Seneca Lake, are among 21 buildings used as family housing for depot personnel. The vernacular buildings were probably constructed during the 1920s and 1930s and used as lake cottages before being acquired by the military in 1942. (Source: Field inventory photograph, 1983, Barbara Hightower, Building Technology, Inc.)

the military, they have been used as family housing, first for Sampson Naval Training Station, later for Sampson Air Force Base, and after 1957 for the Army. The vernacular structures, which vary in appearance, are wood frame construction clad with vinyl siding and are either one, one-and-one-half, or two stories in height. (Illustration 5)

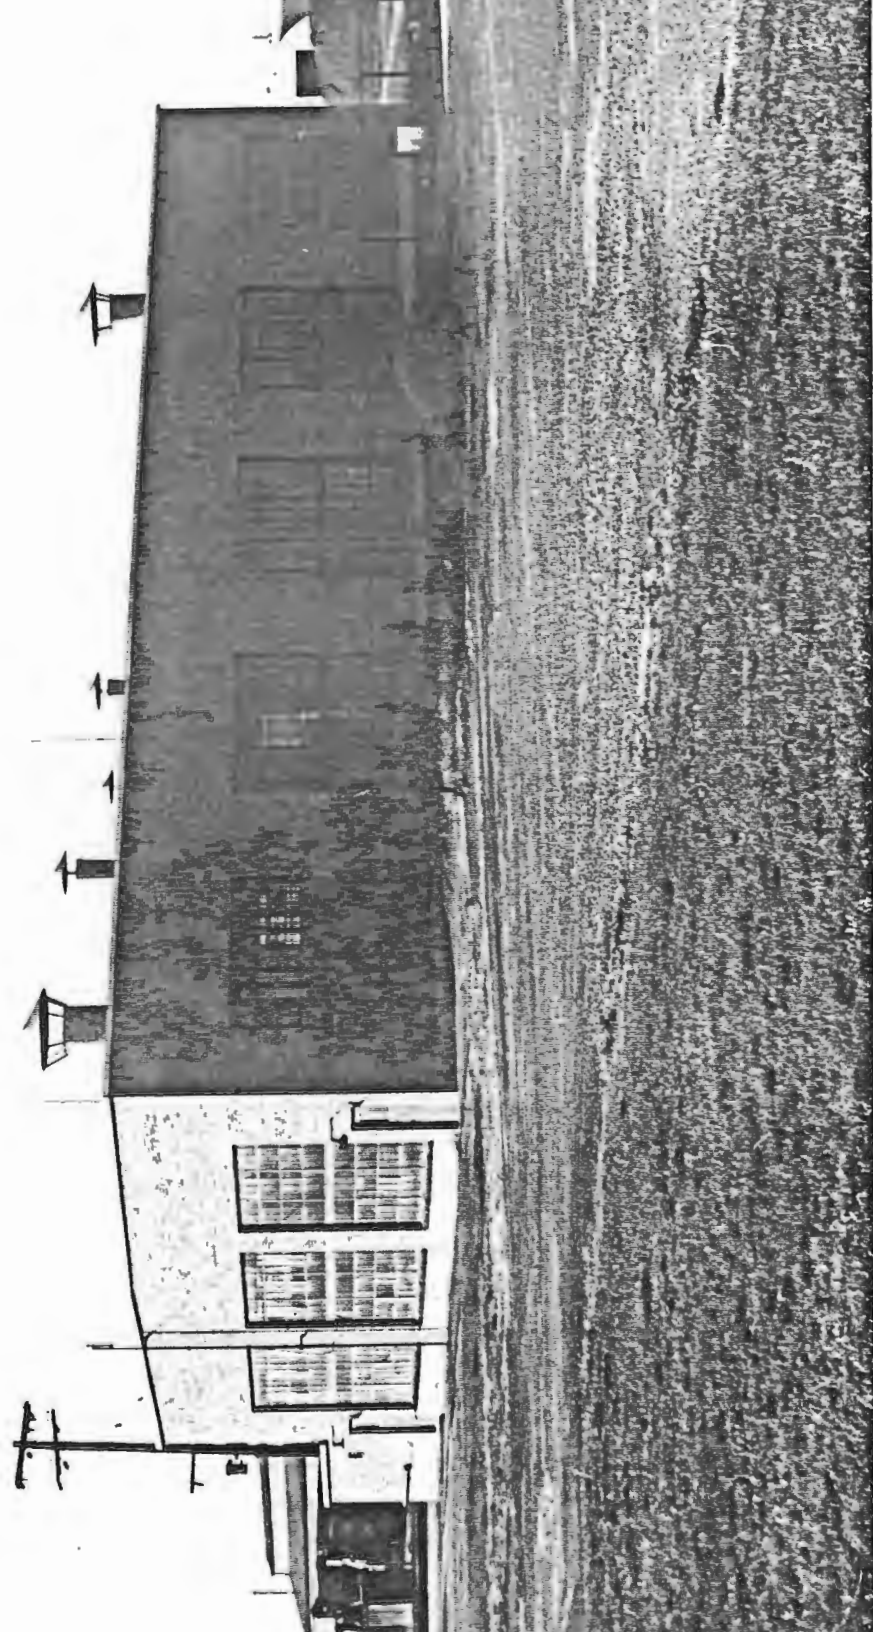
Illustration 10 Locomotive House (Building 127). Like the majority of permanent structures erected in the administration area during the initial phase of construction in 1941-1942, the locomotive house has walls of yellow and brown brick. (Source: Field inventory photograph, 1983, Barbara Hightower, Building Technology, Inc.)

The administration area to the east of the storage facilities was also begun in 1941. A two-story brick headquarters building (Building 101) was started in September, and a second two-story brick structure (Building 103) housing the dispensary, guard house, and fire station was erected north of the headquarters building shortly thereafter. Additionally, three warehouses (Buildings 114, 115, and 116), two garages (Buildings 117 and 118), a machine shop (Building 122), a carpenter shop (Building 123), a paint shop (Building 124), a paint storage facility (Building 125), a locomotive house (Building 127), a heating plant (Building 121), and four sets of noncommissioned officers' quarters (Buildings 208 and 209) were constructed in the administration area. Most are steel framed buildings clad with yellow and brown brick. The use of permanent masonry construction for these buildings was typical of administration and warehouse facilities erected on other supply depots before the spring of 1942, when masonry materials became in short supply.⁸ (Illustrations 9 and 10)

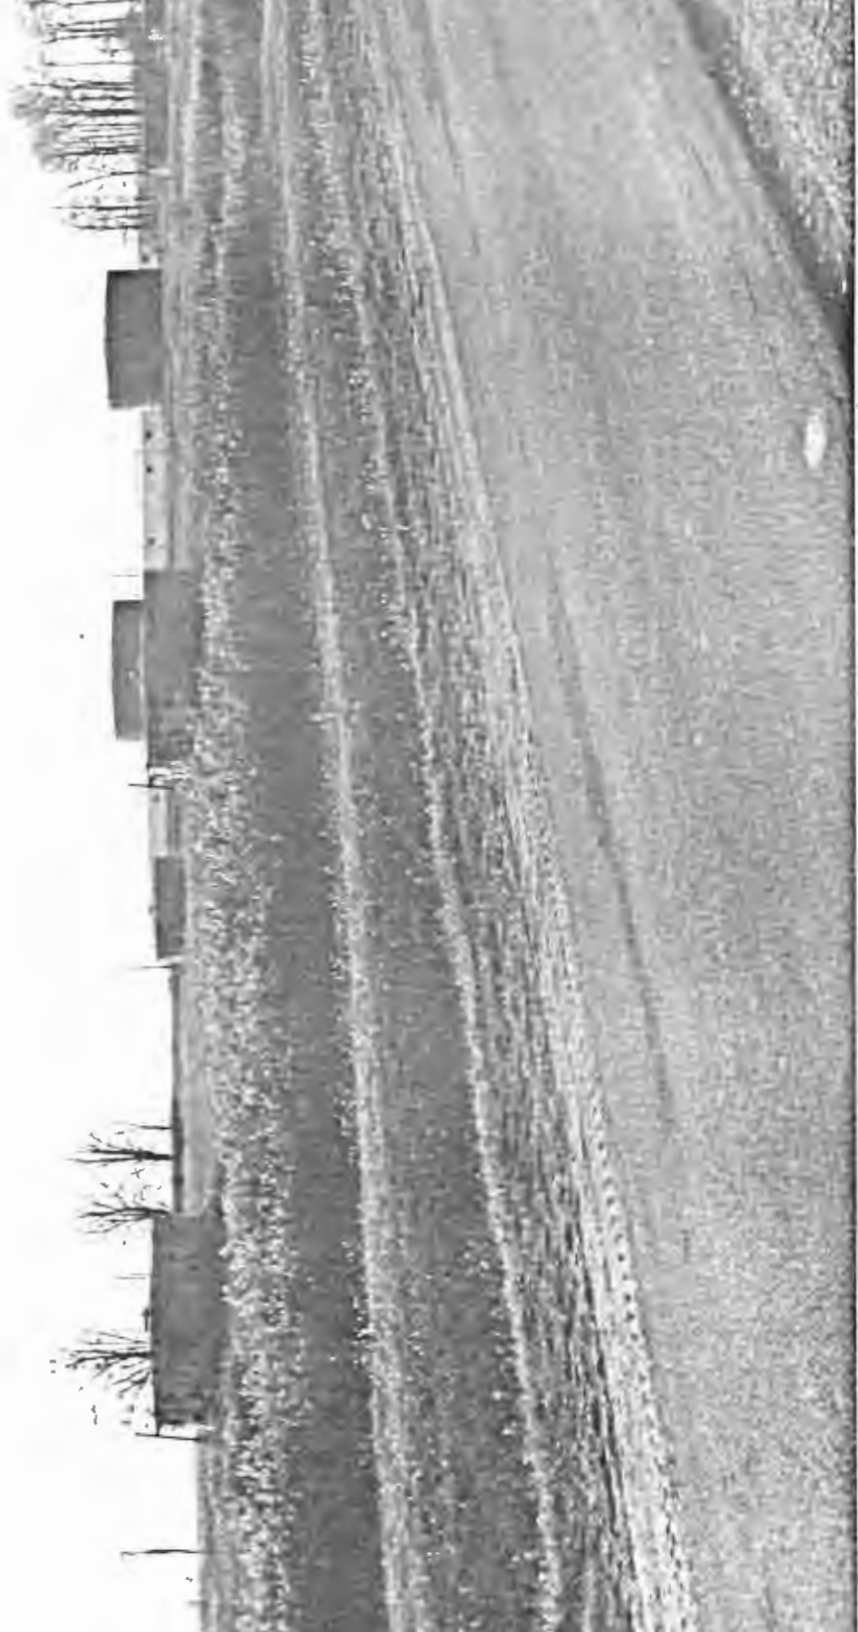
Illustration 14 Tank Farm. Located east of the warehouse area, the tank farm originally consisted of over 160 steel tanks used for dry storage. Most of the tanks have been demolished and less than a dozen remain. (Source: Field inventory photograph, 1983, Barbara Hightower, Building Technology, Inc.)

A second major storage area constructed in 1942 was a tank farm that consisted of 163 steel tanks of various sizes. They were erected east of the warehouse area for storage of dry materials such as ores. Most of the tanks have been demolished, and less than a dozen remain. (Illustration 14)

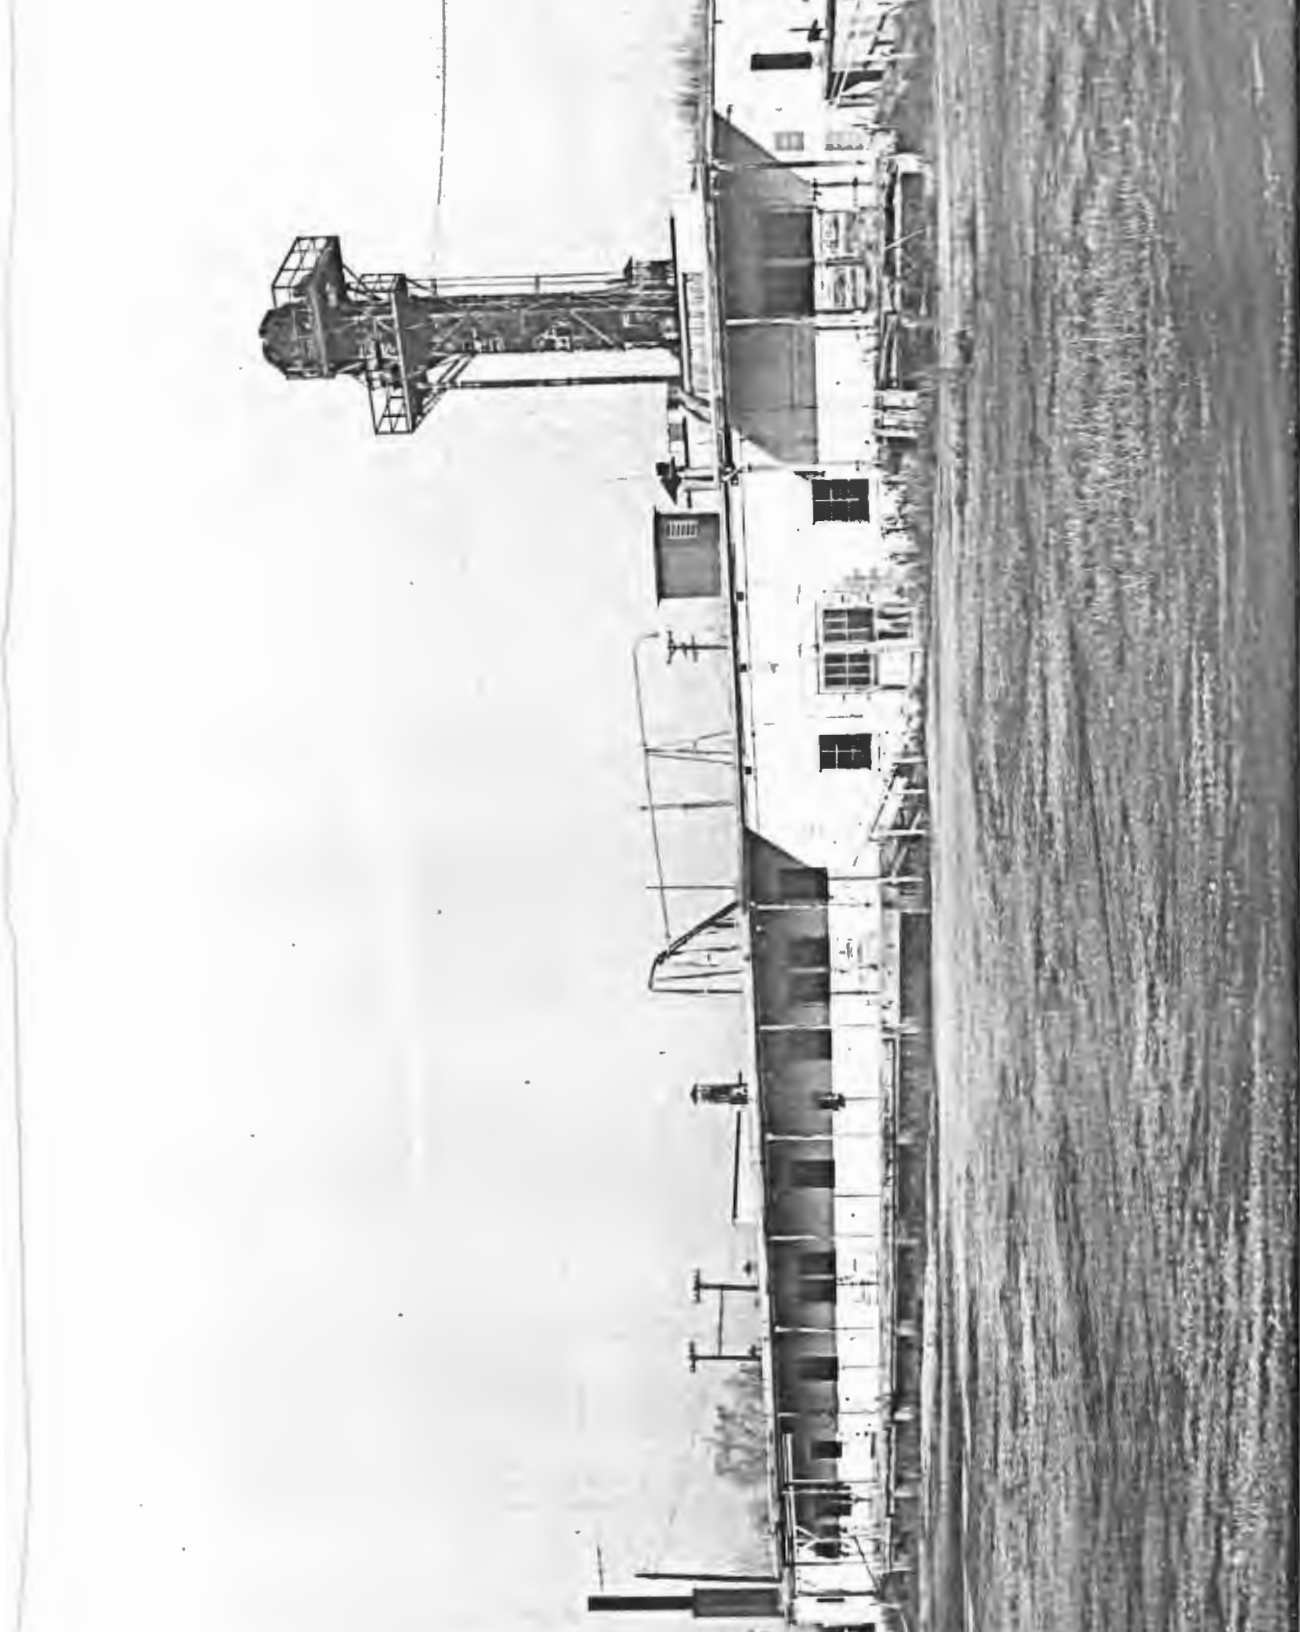
Illustration 15 "Popping" Plant (Building 311). Seneca's "popping" plant, built in 1943, was one of five such plants in operation in the United States during World War II. Cleaned ammunition shells were conveyed through the cooling tower at the south end of the building before being dropped into rail cars. (Source: Field inventory photograph, 1983, Barbara Hightower, Building Technology, Inc.)

A "popping" plant (Building 311), one of five such plants in operation in the country during World War II, was erected to the west of the administration area in 1943. Spent shells from the war front, shells used for target practice, and defective shells were shipped to the "popping" plant for cleaning. At the plant, the metal shells were fed into a furnace where the powder residue in the primer exploded. After leaving the furnace, they were carried along a conveyor through a cooling tower before being dropped into rail cars. The

metal thus salvaged was reprocessed by manufacturers. Operation of the "popping" plants was an improvement over hand cleaning methods used during World War I and substantially increased the amount of metal that was salvaged.¹⁰ (Illustration 15)
