**OE REMOVAL REPORT**

**UXO AND SOIL REMEDIATION  
OPEN BURNING GROUNDS  
SENECA ARMY DEPOT ACTIVITY  
ROMULUS, NEW YORK**

Contract No. DACW33-00-D-0007  
Delivery Order No. 0003  
DCN:SEDA2-110703-AAHK

November 2003

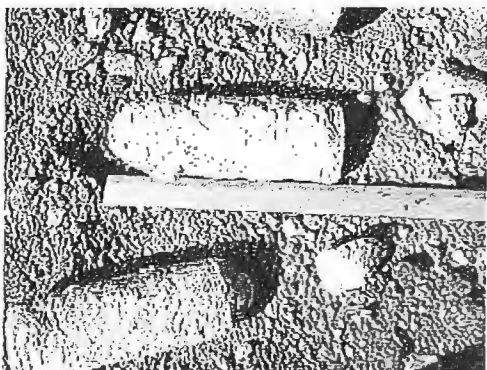
**1. 75mm Projectile found on OBG**

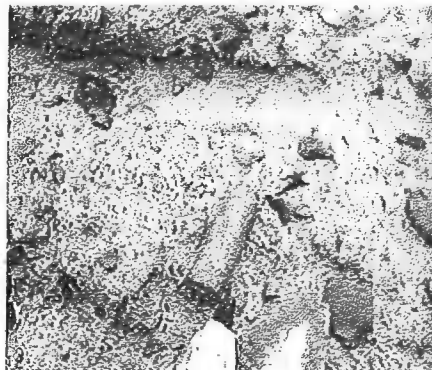
**2. 20mm Projectile on OBG**

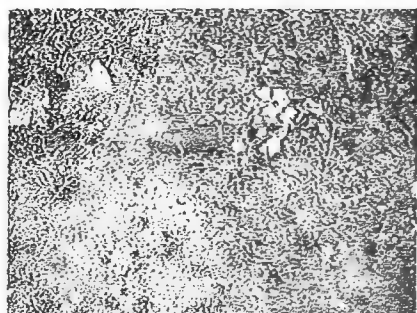
**3. 75mm Projectile found below 1 ft Cut**

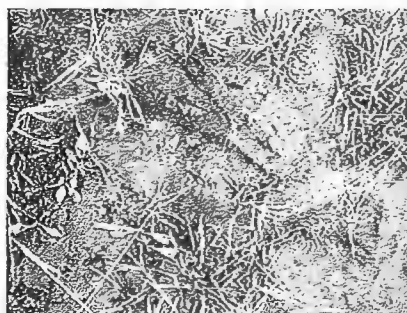
**4. 60mm Projectile found on OBG**

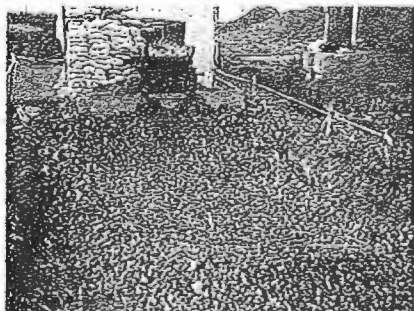
**5. End of SpecPro Hand Sorting Line**

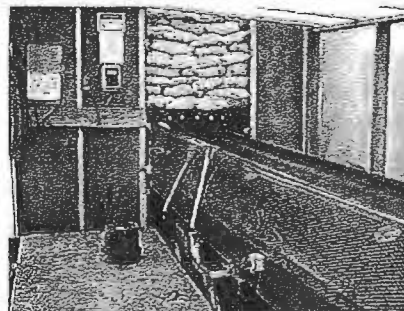
**6. SpecPro Hand Sorting Line w/side guards**

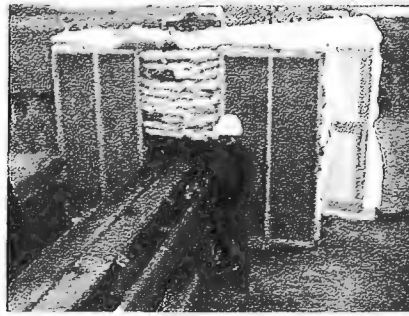
8. SpecPro Hand Sorting Line w/sandbag wall

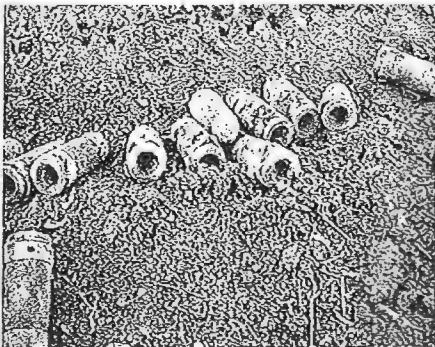
9. 75mm Projectiles after explosive demilitarization

All projectiles were demilitarized by either explosive venting or by the removal/deformation of the rotating bands and fuze wells following inspections. During OE removal operations the UXO Safety Officer soaked and cleaned the mud from over 20-75 mm projectiles. These projectiles were reclassified as ORS needing further demilitarization i.e., removal of rotating bands prior to disposal off-site.

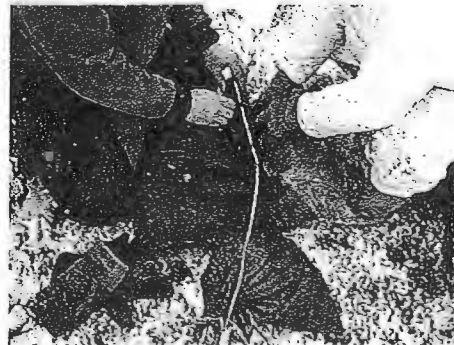
10. 75mm Projectiles being prepared for demilitarization using explosive shaped charges

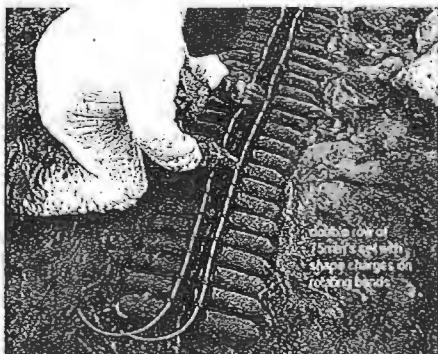
11. Double Row of 75mm Projectiles set With shape charges on rotating bands

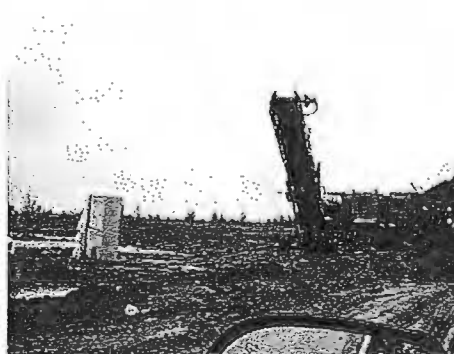
12. Soil Sifter w/Safety Booth

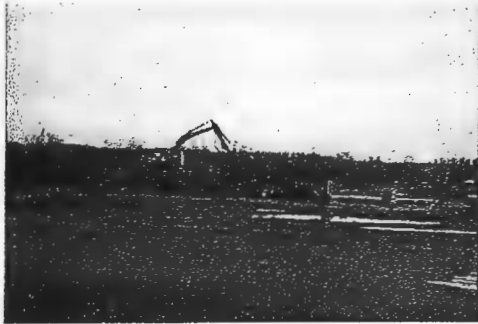
13. Sessler Metal Separator

This operation was re-evaluated with USACE and resulted in a correction to the ESS. The USACE issued approval to implement a ferrous metals separation process as well as an alternative oversize material (less ferrous items) inspection and acceptance process. The original hand sorting operation was also re-evaluated for productivity, less the ferrous material. Photos showing the material removed from the metals separation process are included in Attachment A-1 to Appendix A.

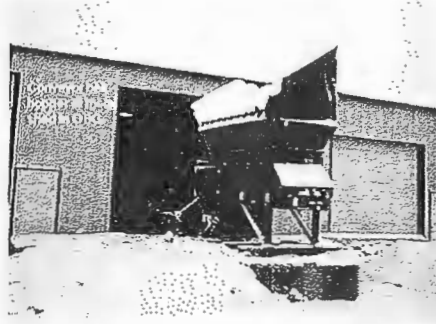
14. Conveyor hopper for metal to be Separated

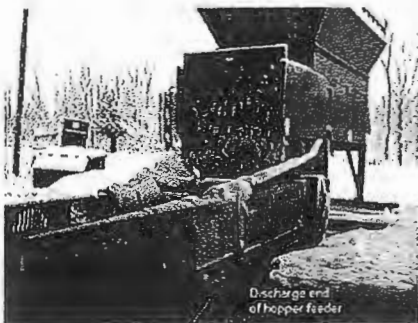
15. Discharge end of conveyor hopper

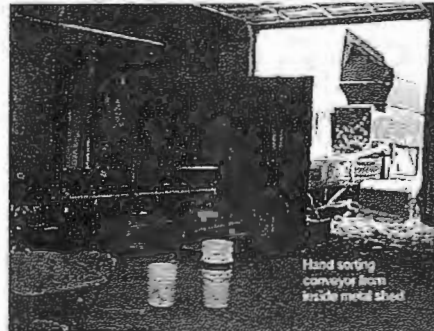
16. Hand sorting line inside metal shed w/safety shield

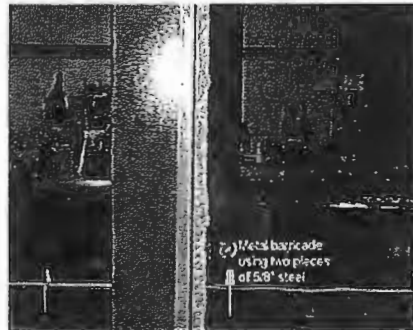
18. Metal Barricade made of two pieces of 5/8 in. steel

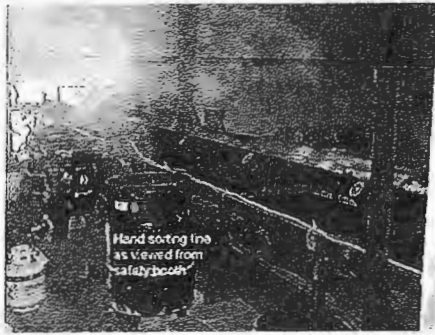
19. Hand sorting line seen from inside safety booth

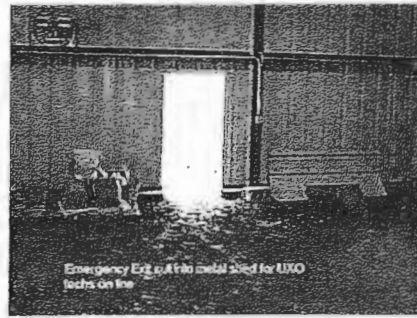
20. Emergency Exit for UXO Technicians

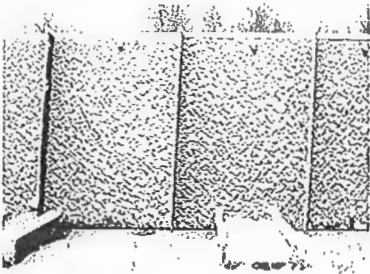
21. Emergency shield outside emergency exit for UXO technicians. Material made of two pieces of 5/8" steel

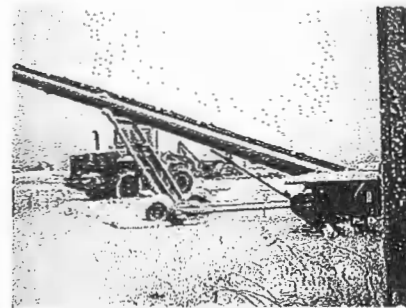
22. Discharge belt for metal scrap

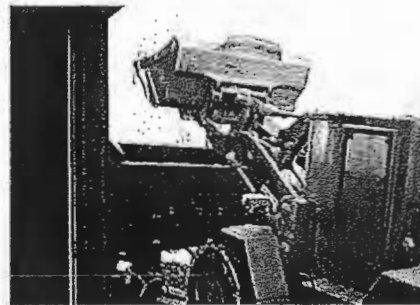
24. Front end loader loading metal separator of OE and other metal

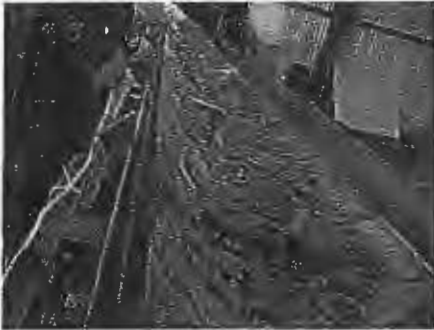
27. Various OE/ORs/Non-OE material on hand-sorting line

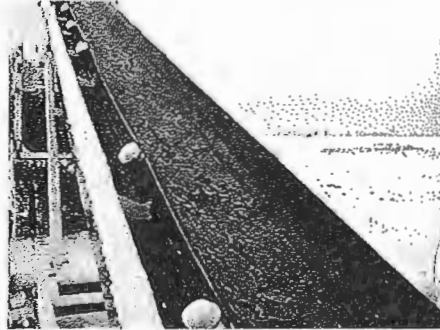
28. Scrap metal traveling up back chute after being inspected by UXO technicians

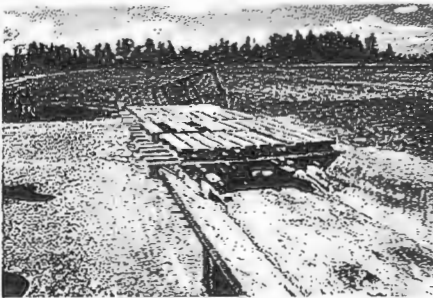
29. Setting up open burn tray

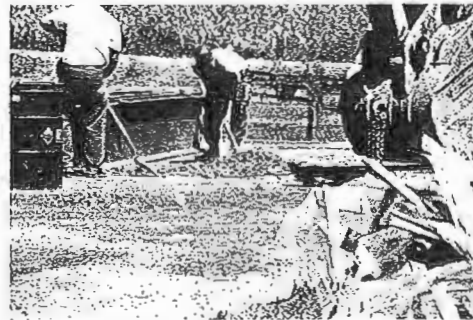
31. Loading OE Material into burn cage

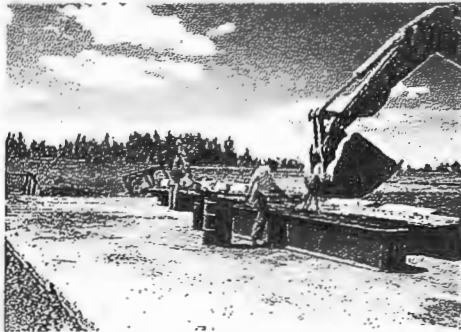
32. Using excavator to place burn cage on dunnage

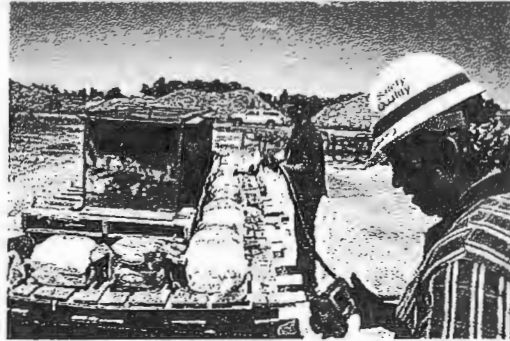
33. OE Material being soaked with diesel

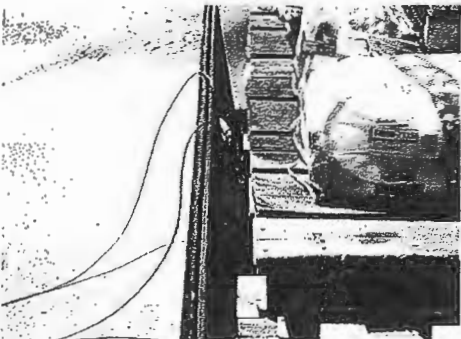
34. Smokeless powder used for burn initiation

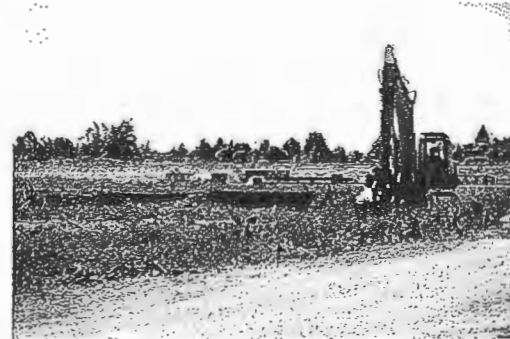
35. Burn initiation

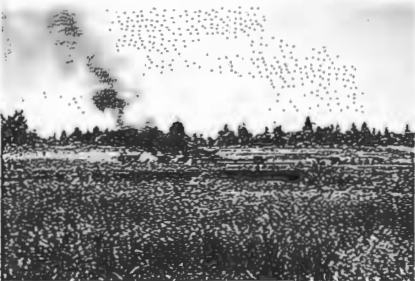
36. Burn Operation

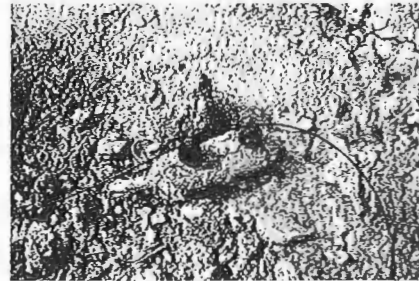
37. 20lb Fragmentation Bomb set for explosive demilitarization

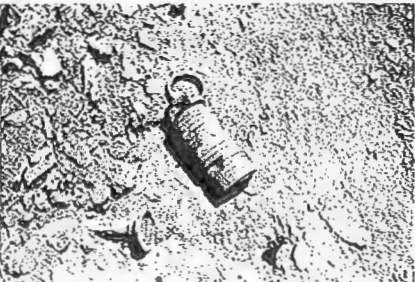
38. 20lb Fragmentation Bomb after demilitarizing

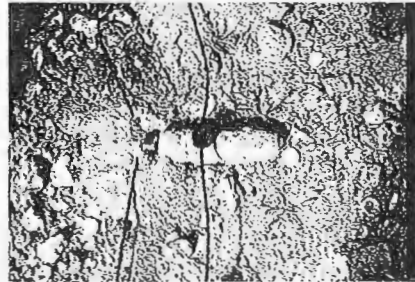
39. 75mm Projectile set for explosive demilitarization

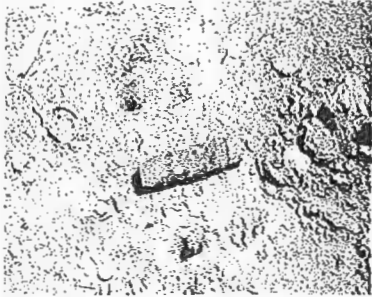
40. 75mm Projectile w/explosive vent holes

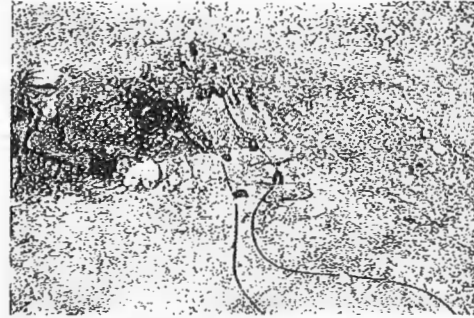
41. Explosive demilitarization shot set up

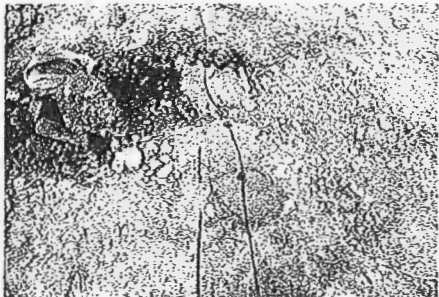
42. Demo shot set up with sand barricade

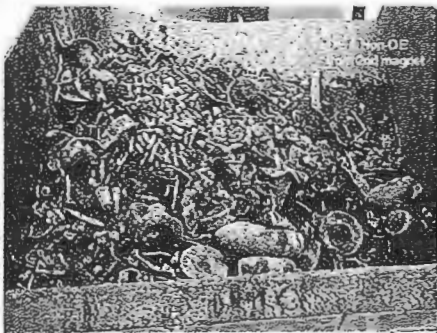
44. OE scrap inside metal catch bin

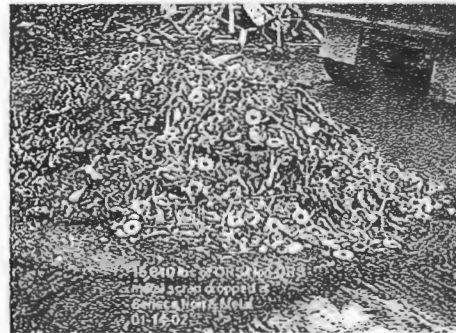
45. OE scrap disposed of at Seneca Iron and Metal

Following detonation, open burning, and/or demilitarization procedures, all demilitarized OE, ORS, and Non-OE scrap metal were disposed of off-site. The procedures outlined in DOD 4160.21.M were utilized. A total of 61,980 lbs (30.99 tons) of demilitarized OE, ORS, and Non-OE scrap metal was generated and disposed of off-site from the Site. A total of 16,720 lbs. of demilitarized OE and 45,260 lbs. of mixed demilitarized OE, ORS, and Non-OE Scrap metal were disposed of offsite.
