Environmental
Historical Bldgs.
Survey

HABS/HAER INVENTORY

Seneca Army Depot

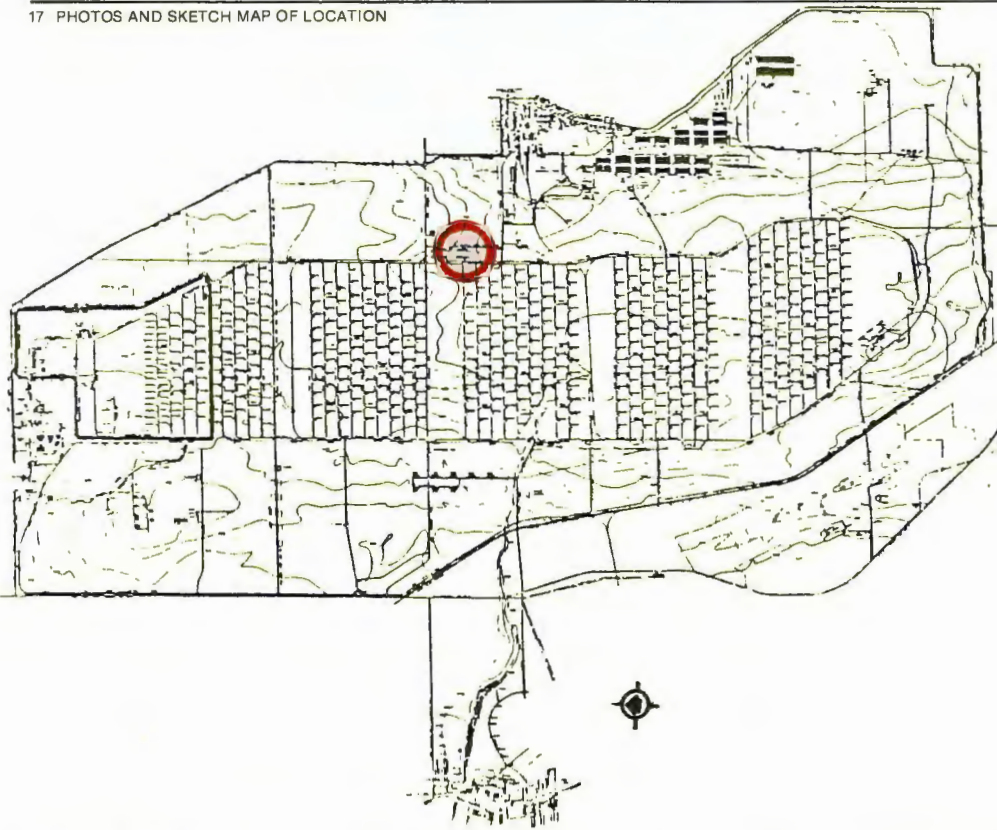
Reinforced concrete foundation. Original portion of the structure is wood frame construction clad with hollow clay tile; concrete block load bearing walls enclose original open platforms. Rectangular, 367' x 32'. One story. Gable roof on the original structure, corrugated metal; remainder of the roof is slightly pitched covered with tar and gravel. Twelve-over-twelve-light double hung sash. Wood and glass personnel and overhead doors, east side. Faces east.

DETERIORATED

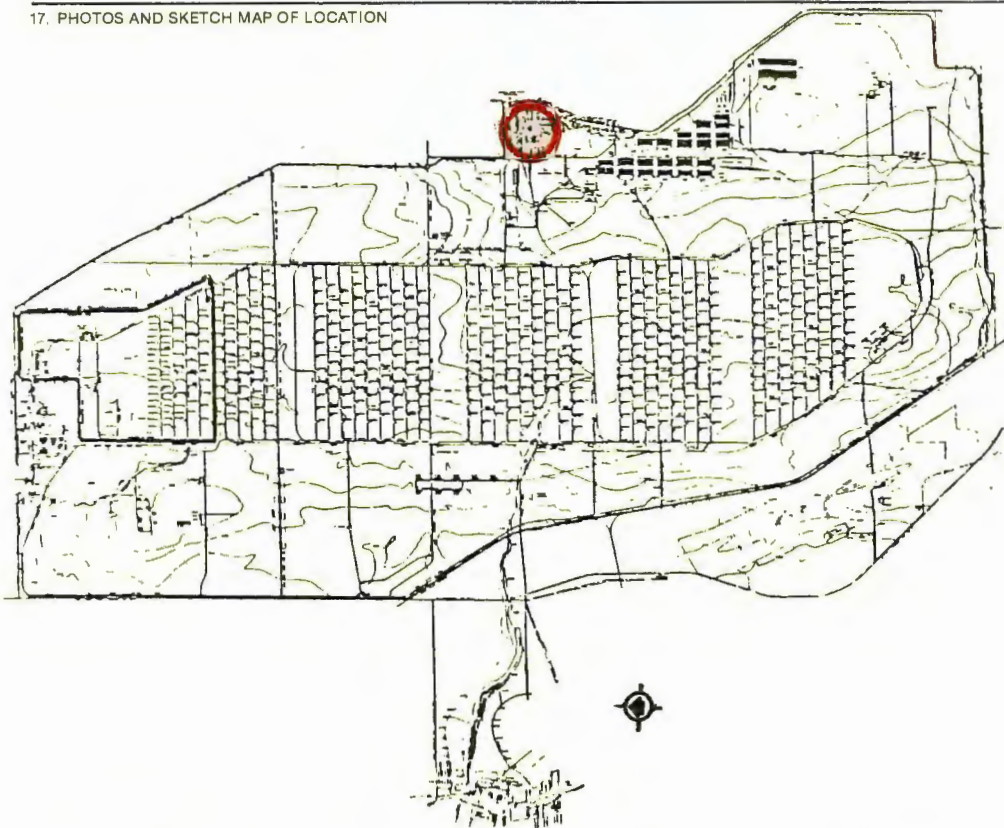
East & North Elevations
4:29A

Reinforced concrete foundation. Steel frame. Brick walls. Rectangular 94' x 42' with a 24' x 35' wing. Two stories. Flat tar and gravel roof. One-over-one-light double hung sash. Wood and glass double doors with a transom, east side. Faces east.

DETERIORATED

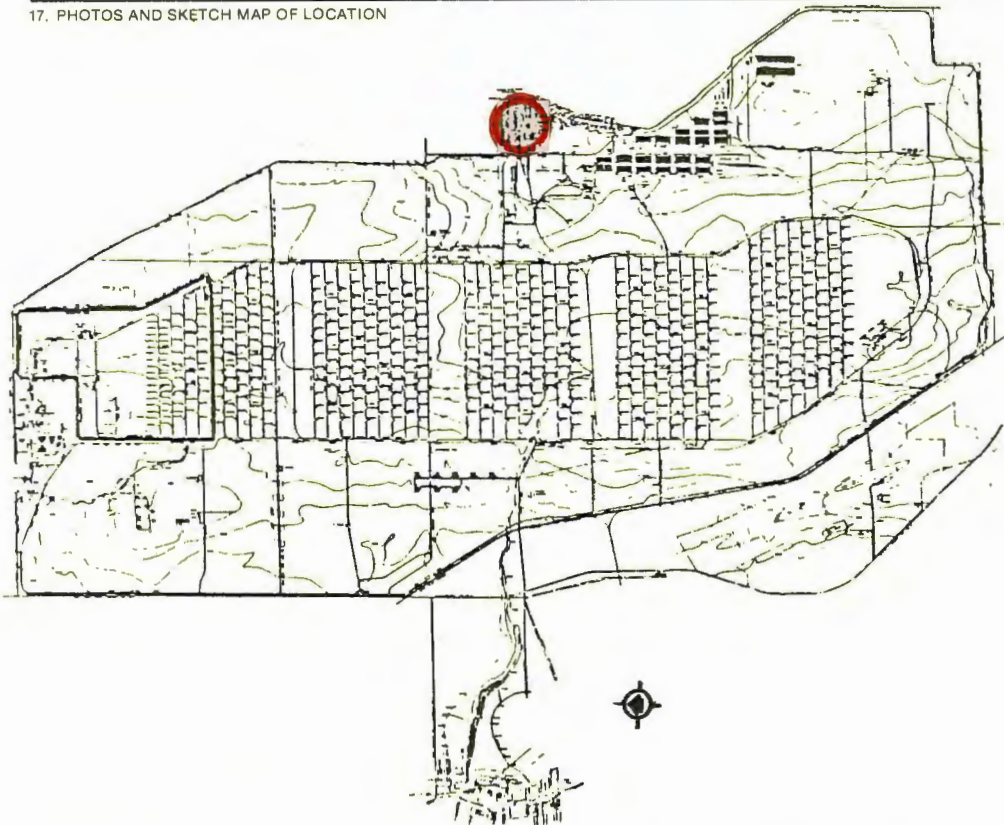
East → South Elevations
4:28 A

Reinforced concrete foundation. Steel frame. Brick walls. The south addition is clad with vertical wood siding. Rectangular, 77' x 34' with a 46' x 34' wing and 5' x 6' offset. The main block is two stories, and the garage on the north and the wing on the south are one story. Flat tar and gravel roof with a tower at the northeast corner. Double hung sash. Three metal overhead doors and personnel door, east side. Concrete block windbreak at east entrance. Faces east.

DETERIORATED

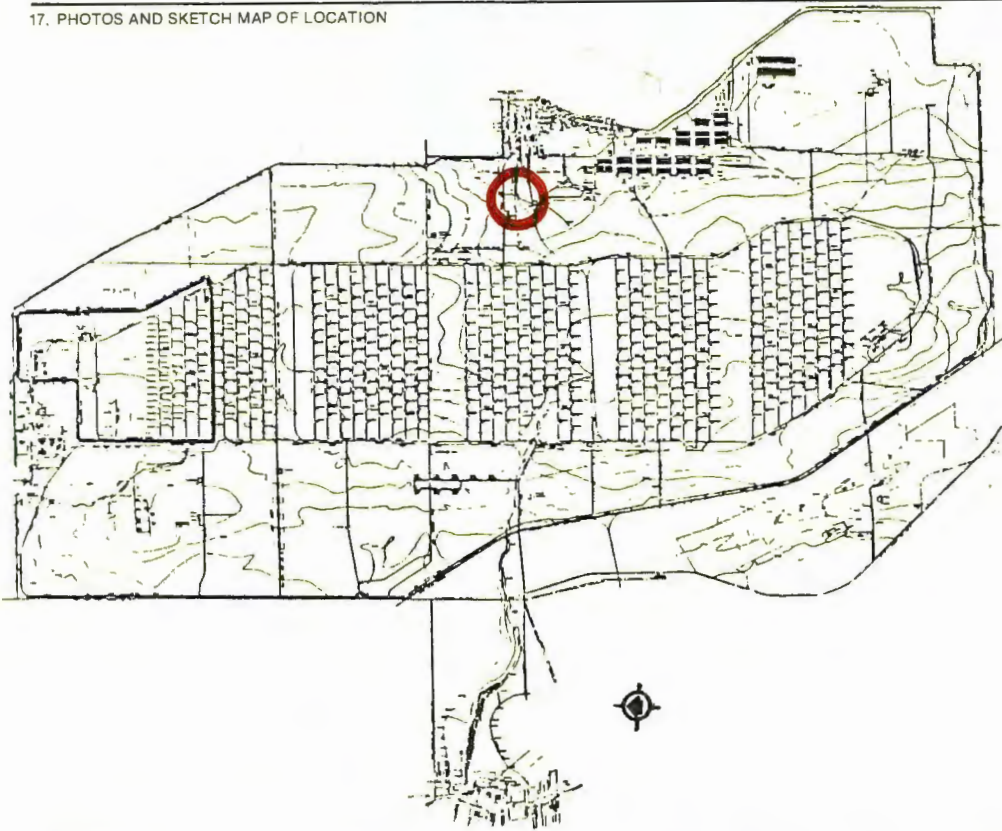
East & South Elevations
4:14A

Reinforced concrete foundation. Steel frame. Concrete block walls. Rectangular, 64' x 256' with a 16' x 7' wing. Flat tar and gravel roof. Double hung windows. Metal overhead doors and wood personnel doors, north and west sides. Metal burning hopper, north side. Faces east.

DETERIORATED

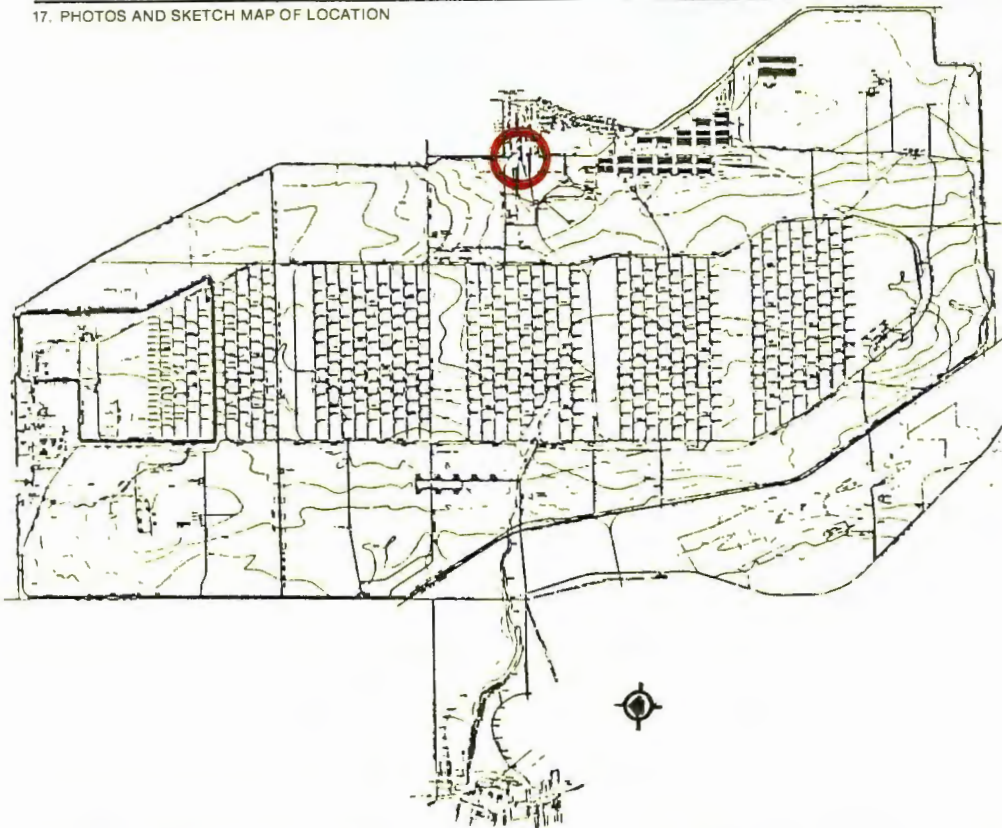
East + North Elevations
4:15A

Reinforced concrete foundation. Steel frame. Concrete block walls. Rectangular, 69' x 200'. One story. Flat built-up roof. Metal overhead doors, north, south and east sides and personnel door, north side. Reinforced concrete loading docks, north and south sides. Faces east.

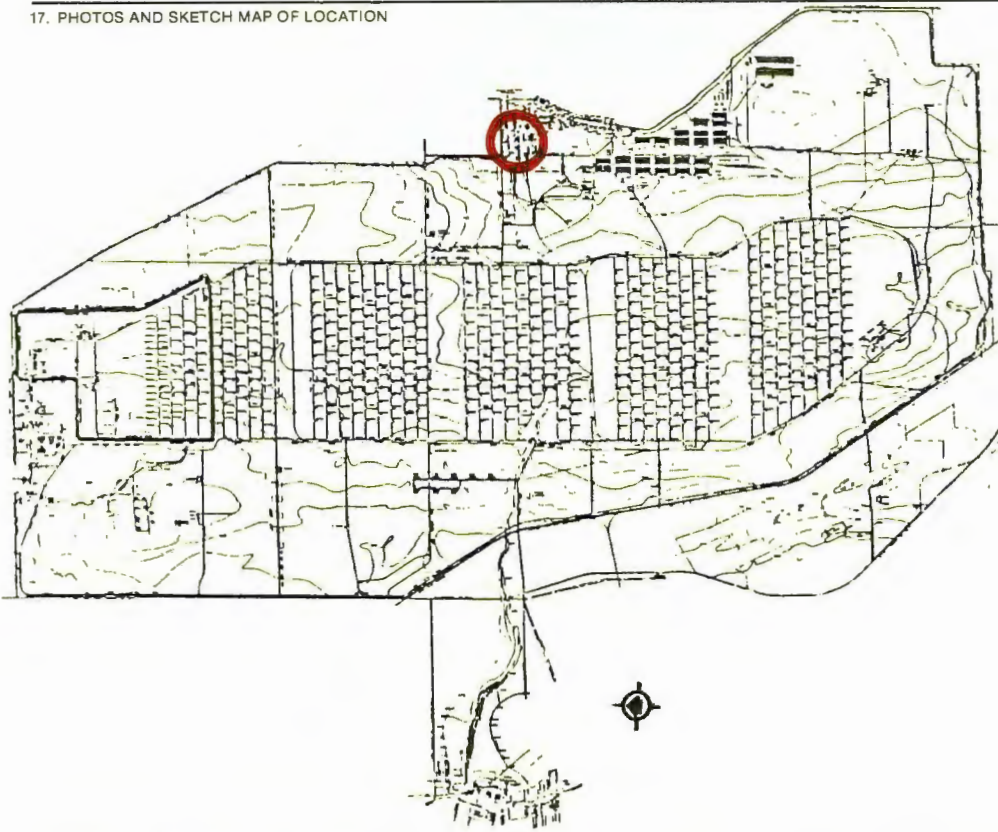
East & South Elevations
4:26A

Reinforced concrete foundation. Steel frame. Brick walls. Rectangular, 201' x 61'. One story. Flat tar and gravel roof. Louvered vents, east and west ends. Metal loading doors and reinforced concrete loading docks, north and south sides. The long dimension is on the north and south sides.

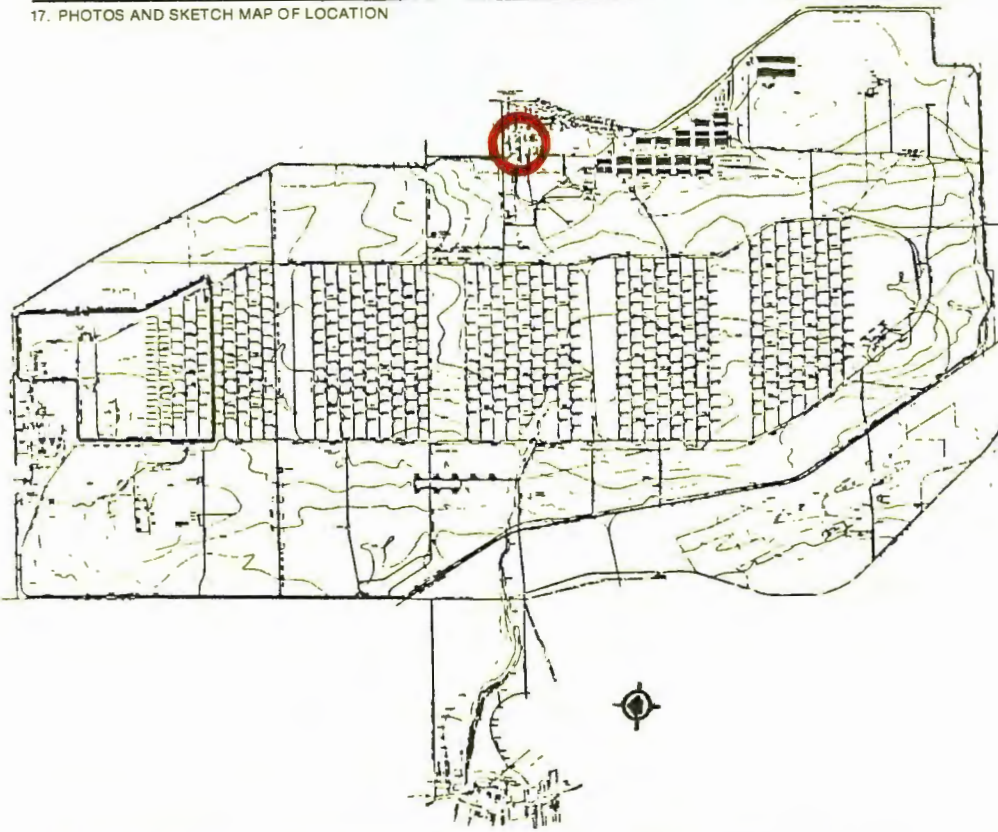
West & South Elevations
4:24A

Reinforced concrete foundation. Steel frame. Concrete block walls. Rectangular, 68' x 283'. One story. Flat tar and gravel roof. Double hung sash. Metal personnel and metal overhead doors on the west side. Faces west.

DETERIORATED

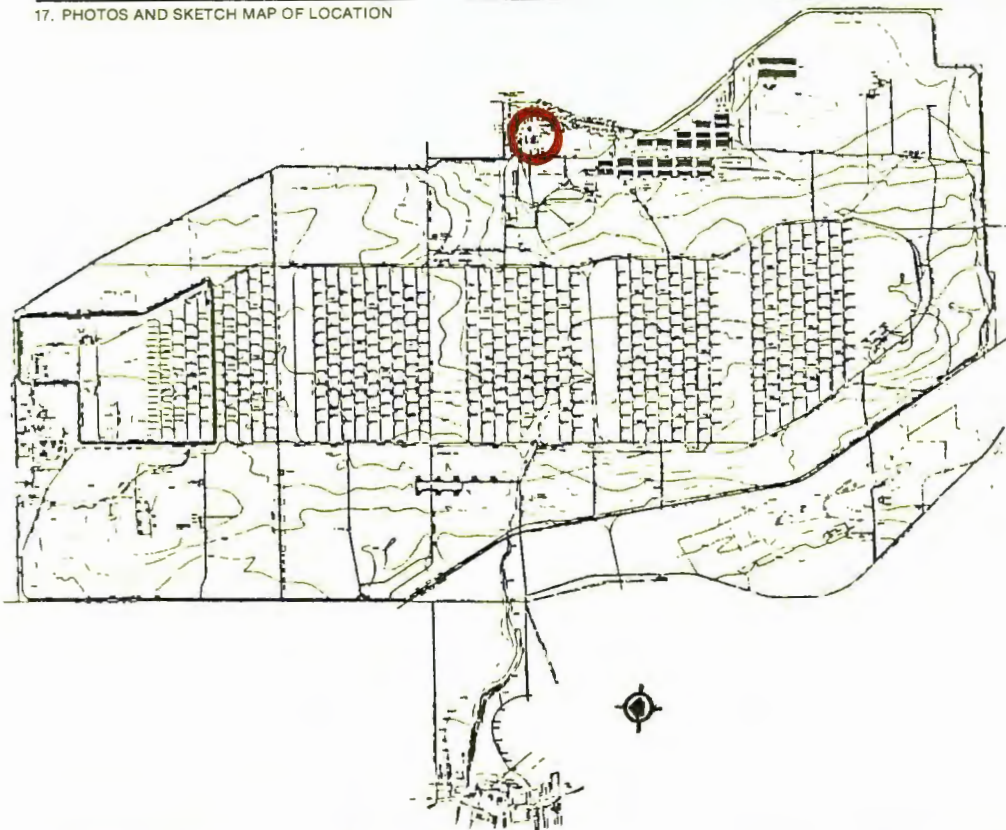
West & South Elevations
4:21A

Reinforced concrete foundation. Steel frame. Brick walls. Rectangular, 281' x 67'. One story. Flat tar and gravel roof. Double hung sash. Metal overhead and metal personnel doors, south, west and east sides. The long dimensions are on the north and south sides.

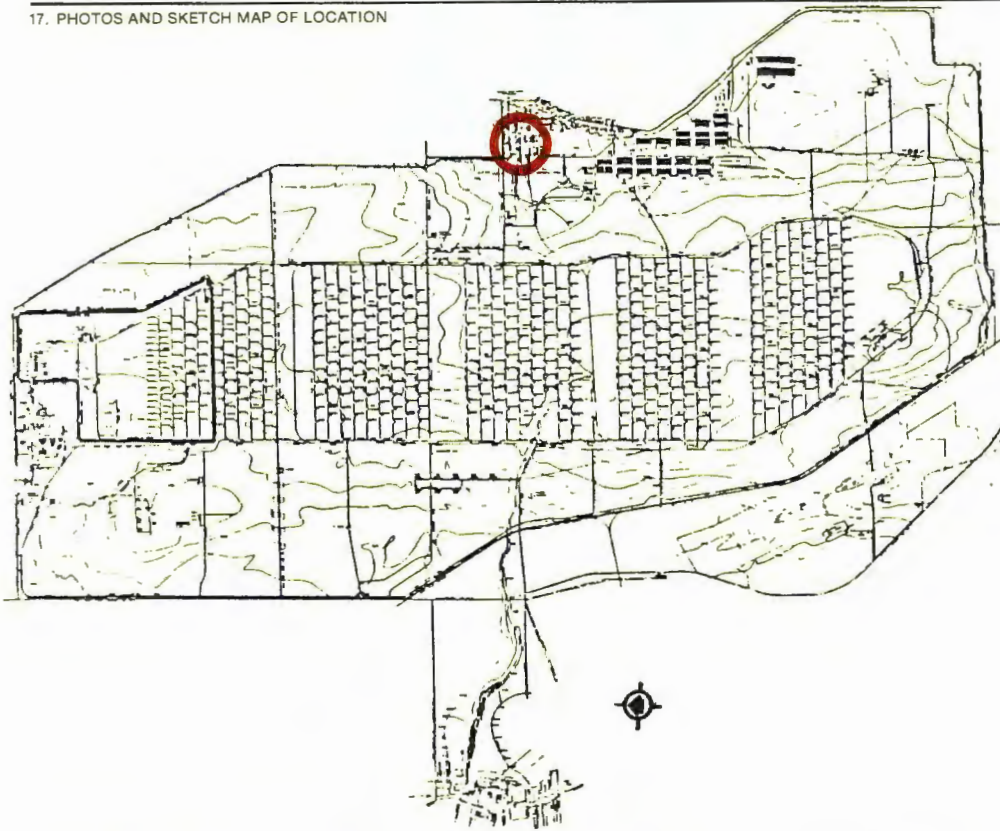
East + North Elevation 3
4:25A

Reinforced concrete foundation. Reinforced concrete pier frame with concrete block infill on the east end and wood siding on the west end. Rectangular 28' x 53' with 33' x 28', 12' x 10', and 20' x 13' wings. One story. Gable roof, asphalt shingles and rolled roofing. Double hung sash and awning windows. Metal personnel door, west end. The ridgeline is oriented east-west.

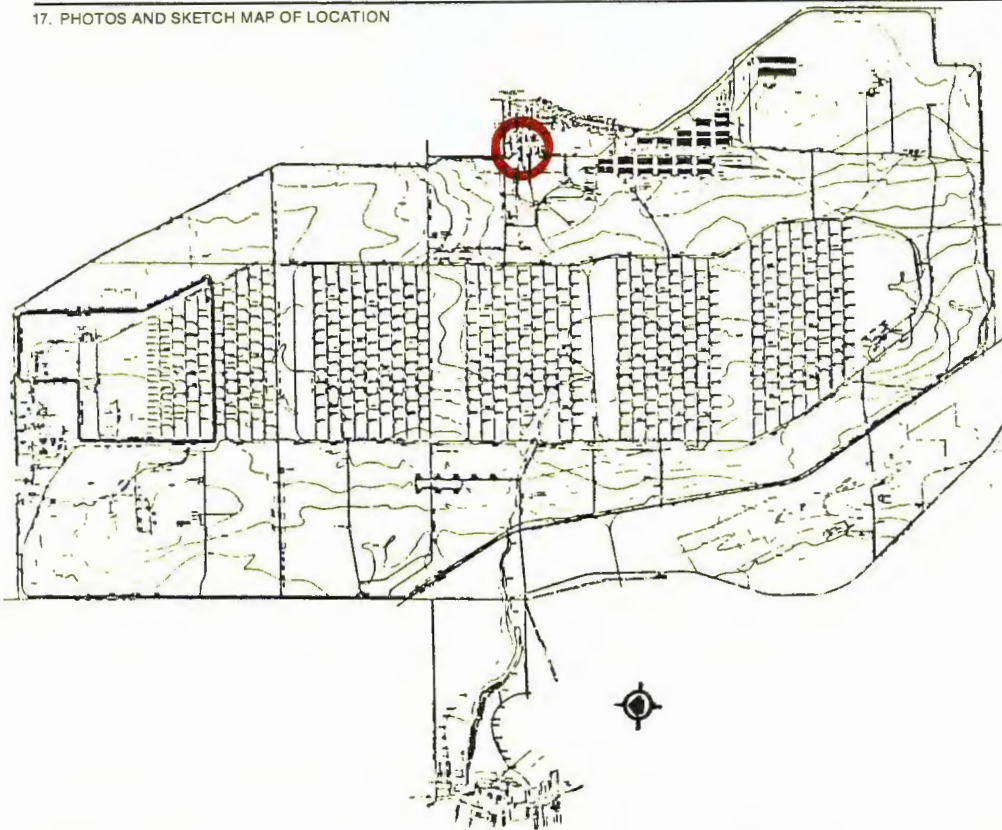
East & South Elevations
4:23A

Reinforced concrete foundation. Steel frame. Brick walls. Rectangular, 53' x 61'. One story. Flat tar and gravel roof. Industrial steel sash. Metal personnel door, east side. 117' high brick smoke stack on the north side. Reinforced concrete ramp on the south side. Faces east.

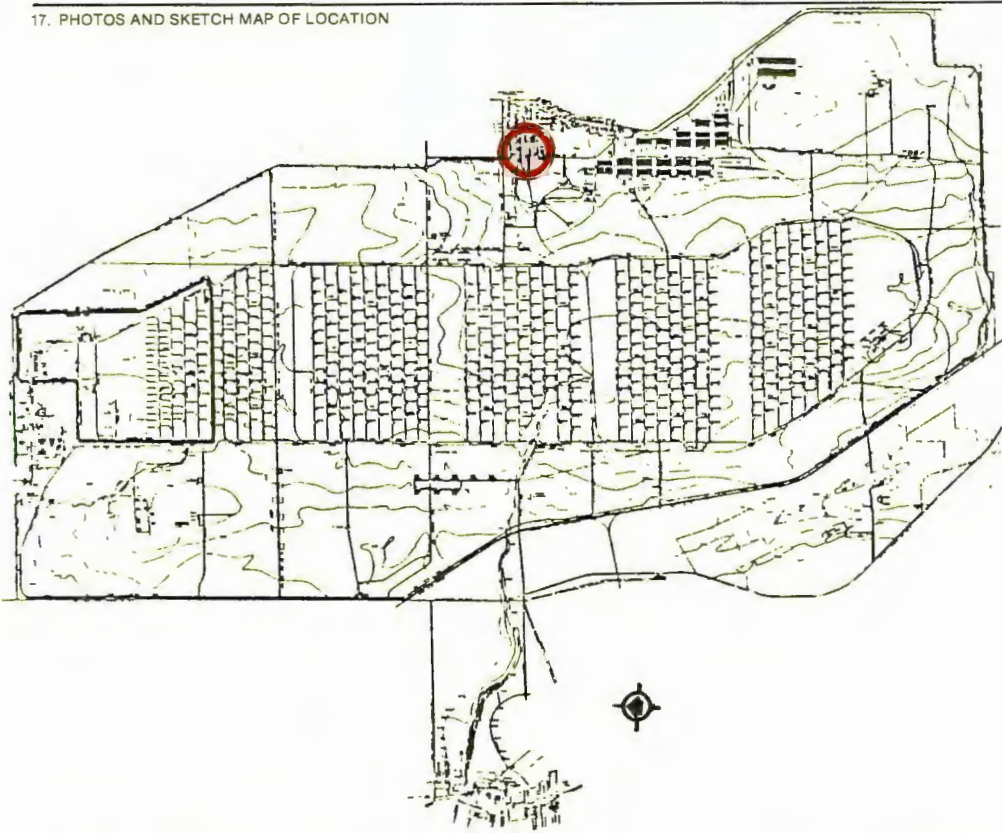
East Elevation
4:22A

Reinforced concrete foundation. Steel frame. Brick walls. Rectangular, 76' x 162'. One story with a clerestory. Flat tar and gravel roof. Industrial steel sash. Wood and glass personnel doors, east side. Vehicle door, east side. Faces east.

DETERIORATED

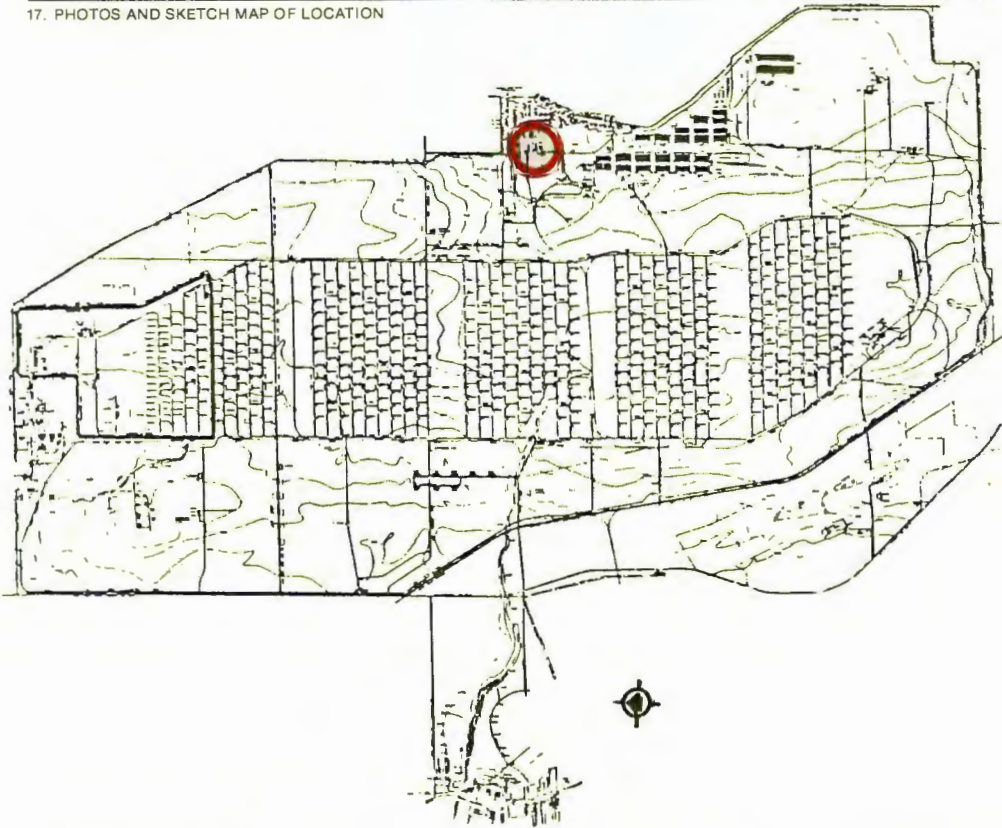
South & west Elevations
4:20A

Reinforced concrete foundation. Steel frame. Brick walls. Rectangular, 68' x 65'. One story. Flat tar and gravel roof. One-over-one-light double hung sash and casement windows. Glass personnel doors on the south, north and east sides. Wood windbreak on the south side. Faces south.

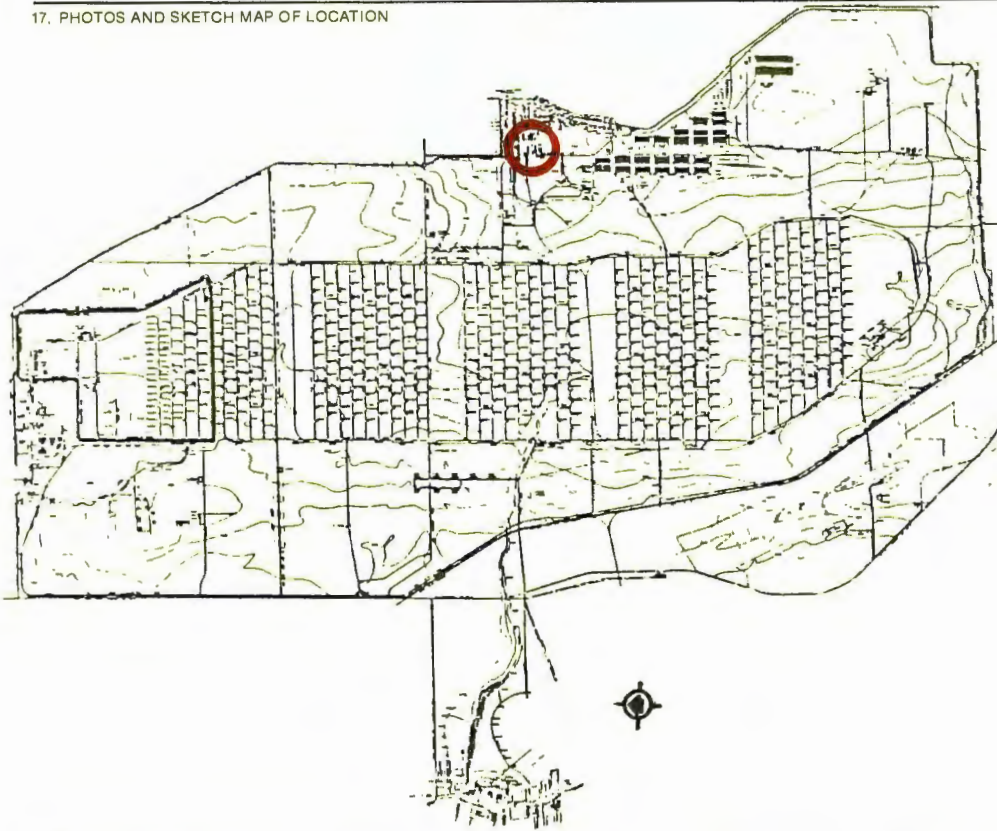
South + West Elevations
4:19A

Reinforced concrete foundation. Steel frame. Brick walls. Rectangular, 31' x 50'. One story. Flat tar and gravel roof. Glass block and casement windows. Windbreak, south side. Faces south.

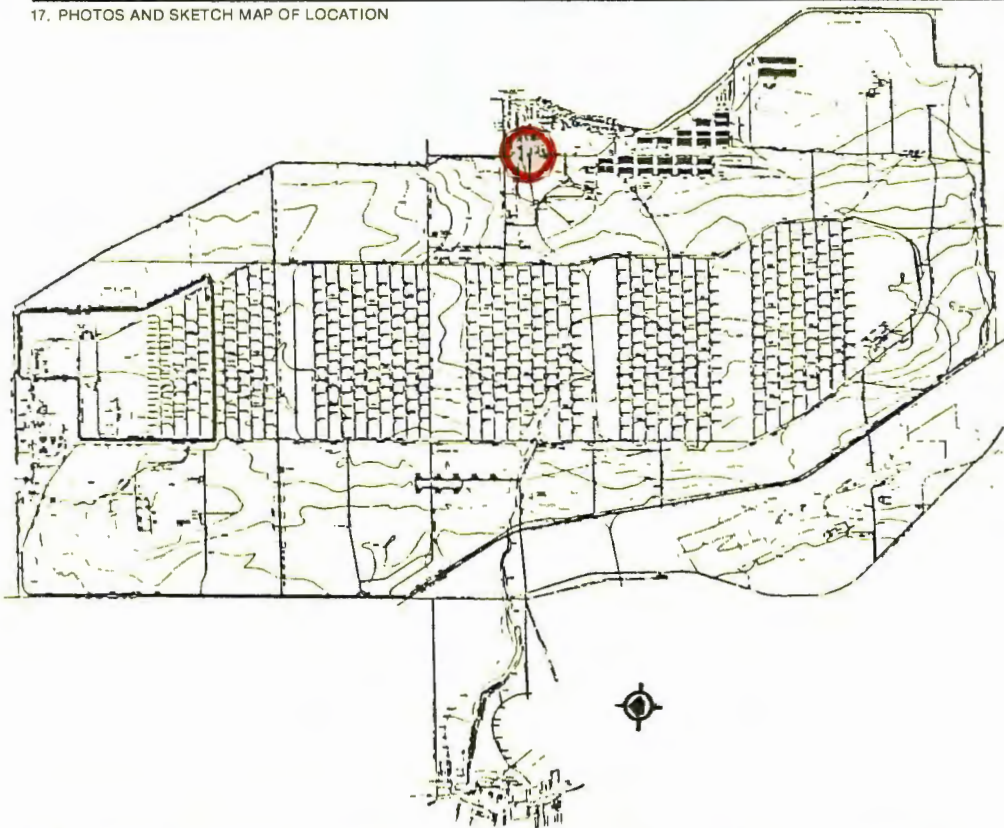
East + North Elevations
4:16A

Reinforced concrete foundation. Steel frame. Brick walls. Rectangular, 58' x 101' with a 14' x 46' wing. One story. Flat tar and gravel roof with metal ventilators. Industrial steel sash. Metal and glass personnel door, east side and three metal overhead doors, west side. Faces east.

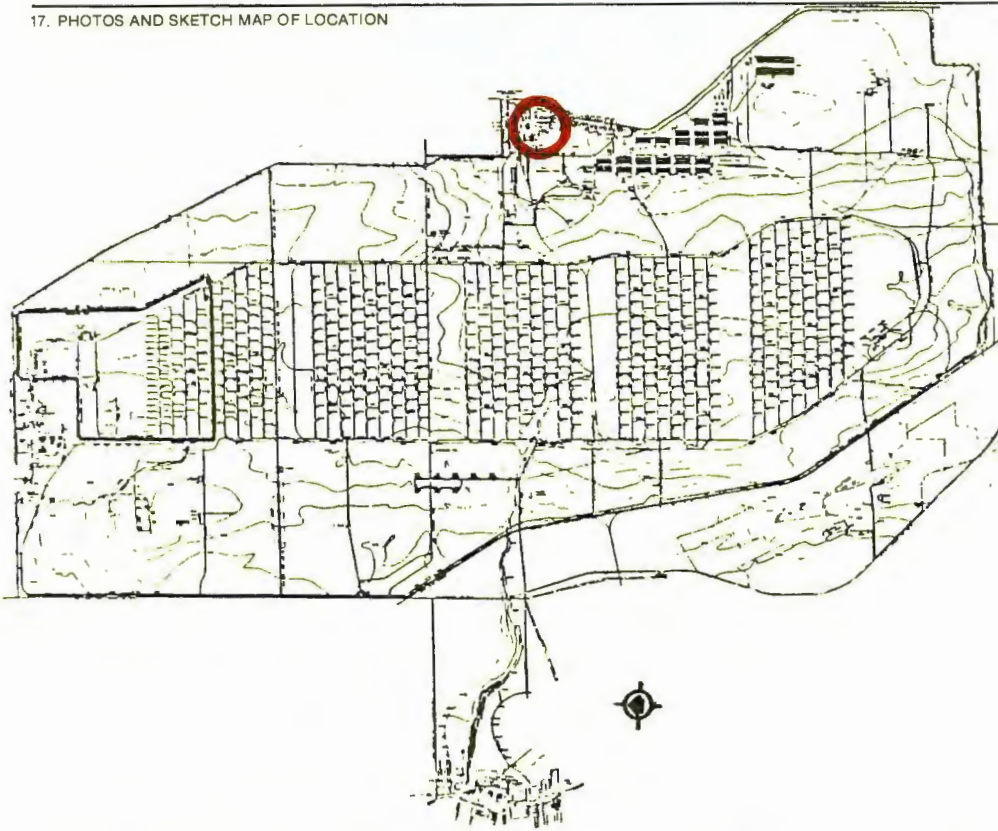
South & East Elevations
4:32A

Concrete pier foundation. Wood frame construction clad with vinyl and wood siding (north end); concrete block load bearing walls (south end). Irregular plan, 58' x 109' with 27' x 68', 9' x 31', and 5' x 47' wings and a 20' x 65' offset. Intersecting gable roofs, rolled roofing (north end); flat built-up roof (south end). Double hung sash. Frame windbreak, south side. Faces south.

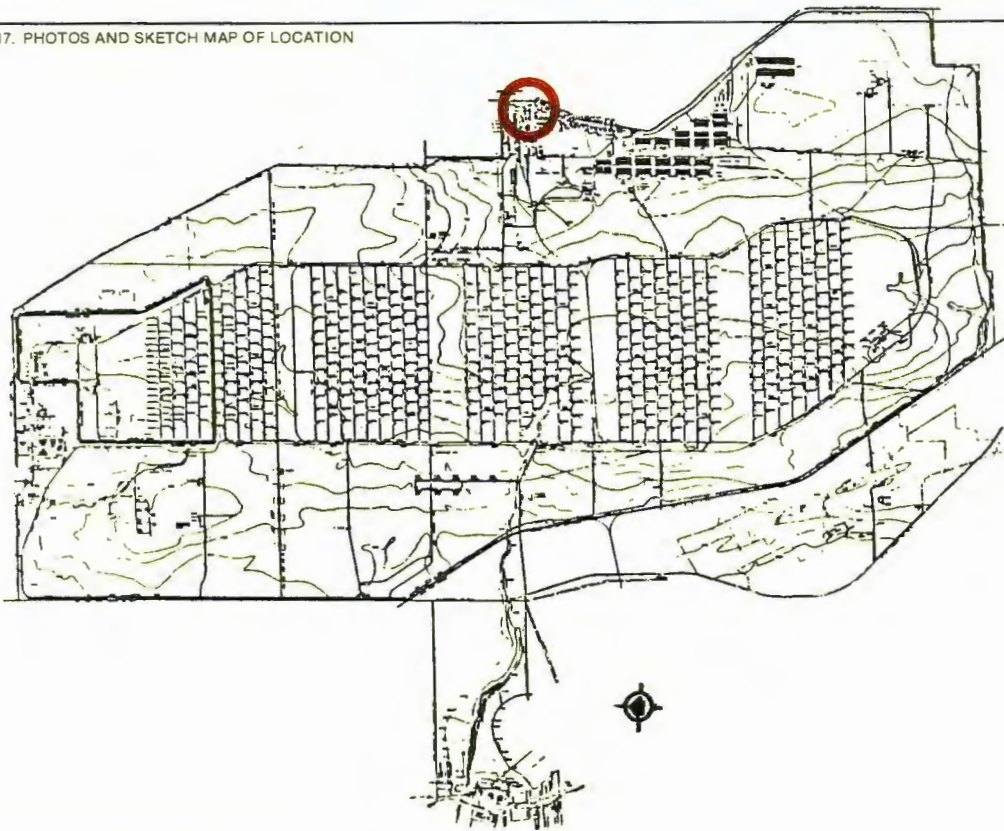
South Elevation
3:20

Concrete block foundation. Wood frame construction clad with brick veneer and vertical wood siding. Rectangular, 50' x 26' with 45' x 17' wings and 50' x 30' offsets. Two stories. Built-up gable roof. Casement windows. Wood doors, south side. Faces south.

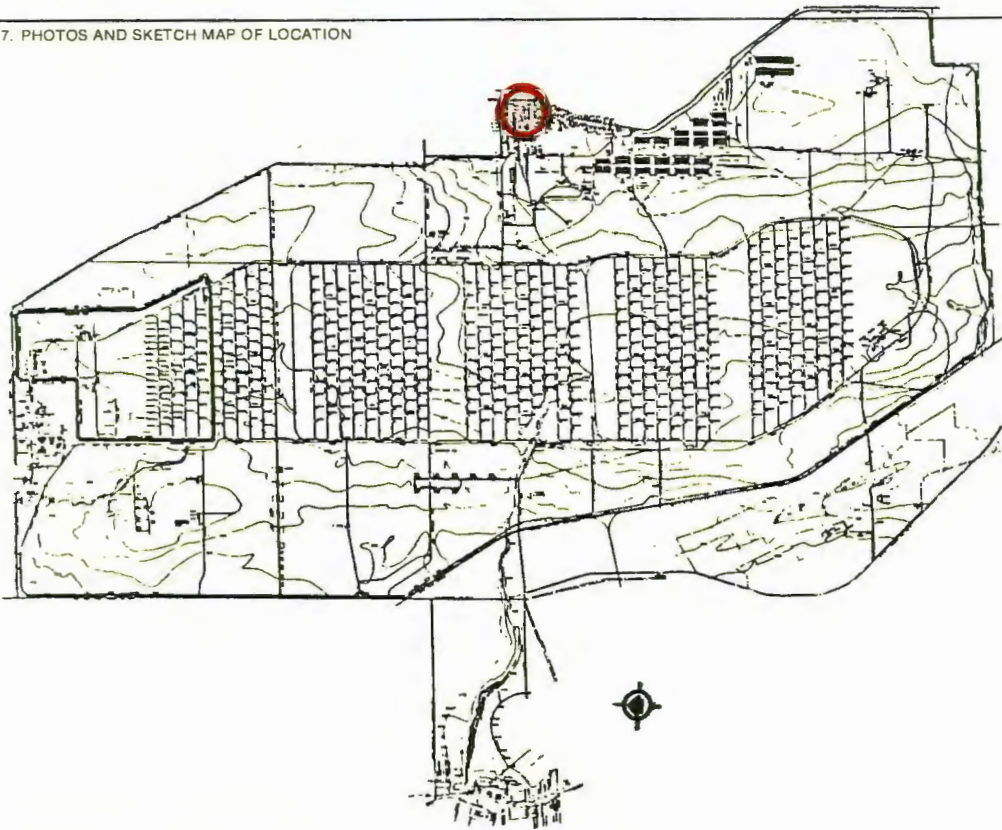
Buildings 202, 203, & 204
South Elevation
3:21

Concrete block foundation. Wood frame construction clad with brick veneer and wood siding. Rectangular, 52' x 30' with an 11' x 21' carport and 5' x 14' offset. One story. Built-up gable roof. One-over-one-light double hung sash. Wood door, south side. Faces south.

DETERIORATED

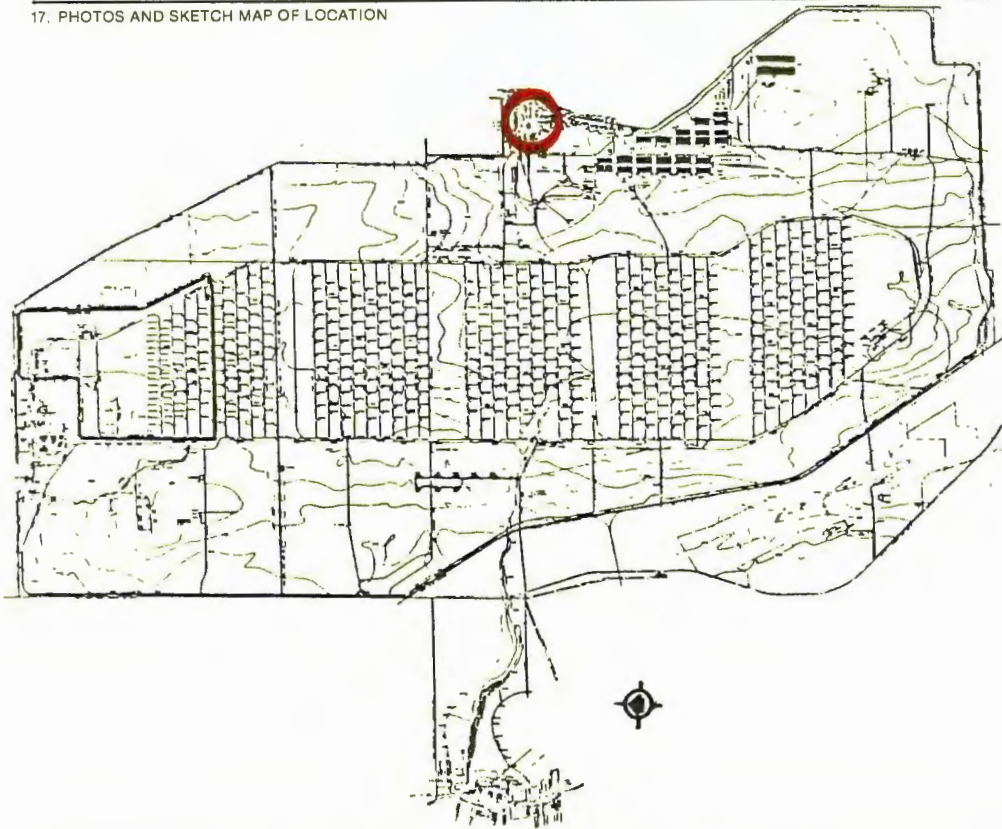
South Elevation
4:30A

Reinforced concrete foundation. Brick load bearing walls. Rectangular, 44' x 31' with two 11' x 18' wings. Two stories with one-story wings. Flat tar and gravel roof. Casement windows. Wood frame enclosed entrance clad with asbestos cement shingles.

DETERIORATED

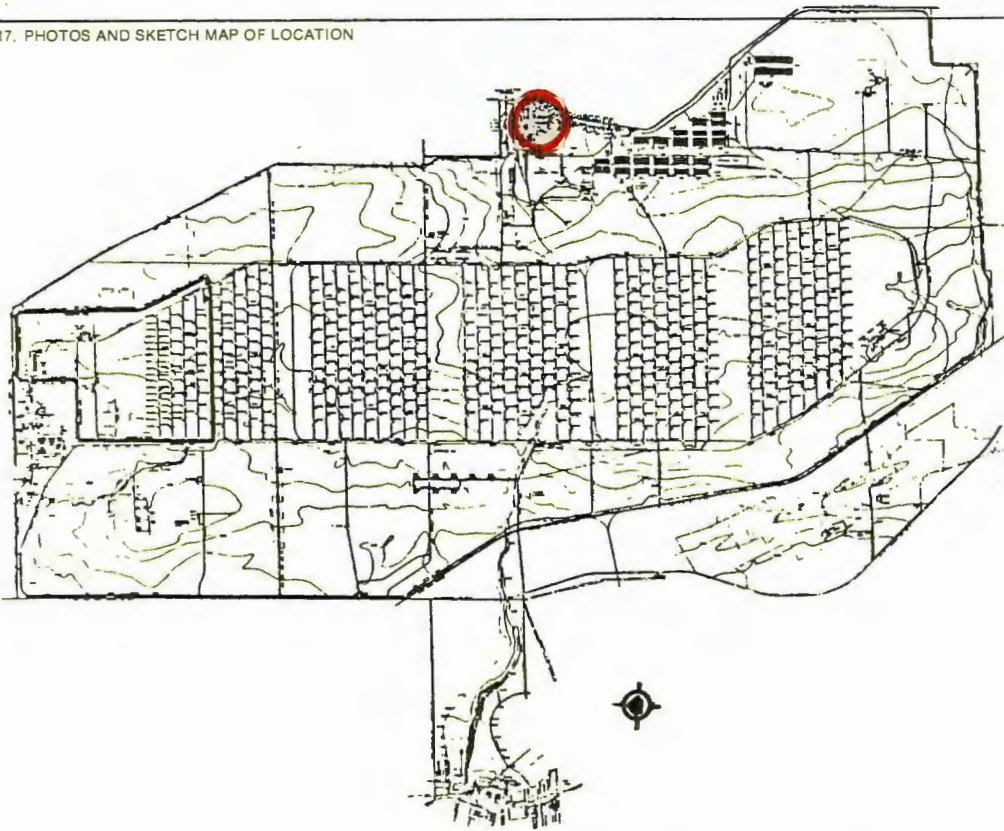
West Elevation
4:31A

Concrete block foundation. Wood frame construction clad with wood siding. Rectangular, 44' x 29' with two 12' x 20' carports and 5' x 12' storage sheds. One story. Built-up gable roof. Sliding windows. Wood doors, east side. Faces east.

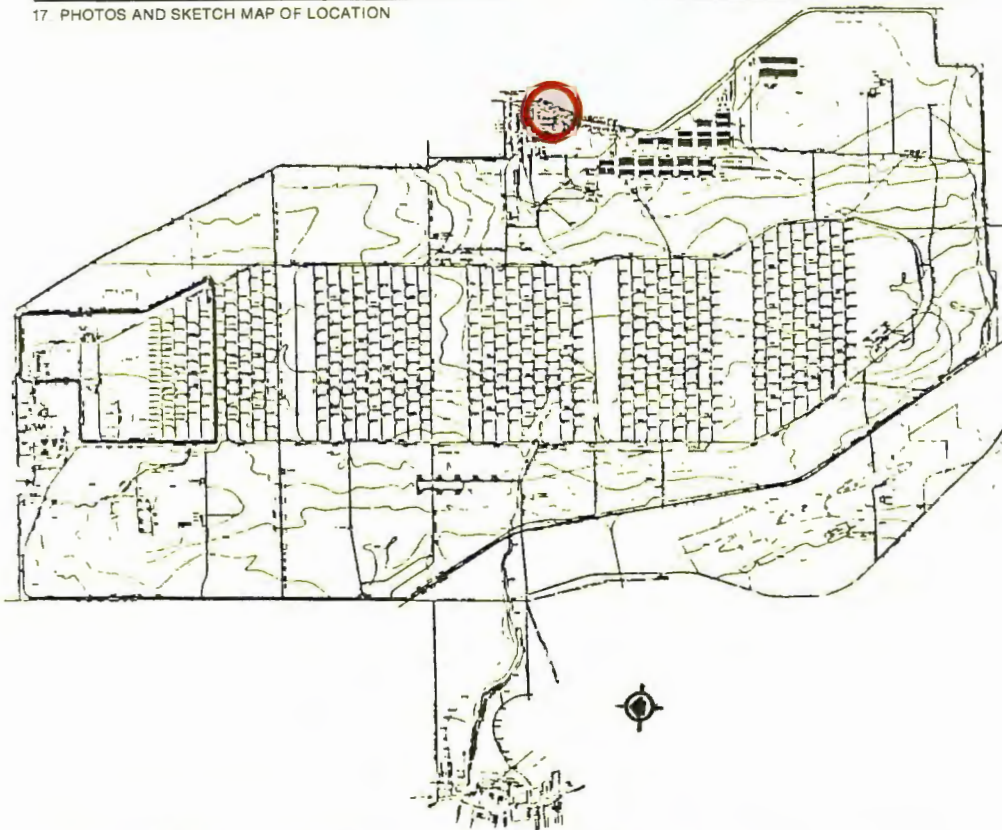
East Elevation
3:18

Concrete block foundation. Wood frame construction clad with brick veneer and vertical wood siding. Rectangular, 100' x 22' with a 65' x 4' offset and 4' x 14' storage sheds. Two stories. Gable roof, asbestos shingles. Casement windows. Wood doors, east side. Faces east.

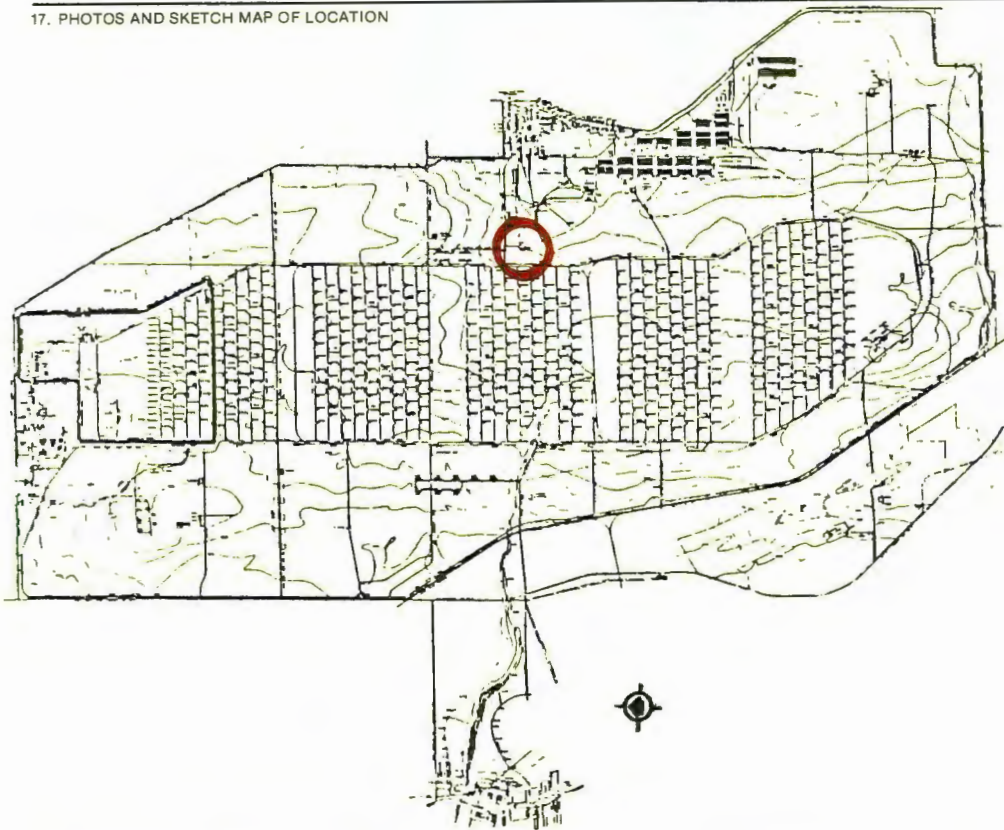
East & South Elevations
3:9

Reinforced concrete foundation. Original building (south side) is wood frame construction clad with clapboarding, and the addition (north side) has concrete block walls. L-shaped, 36' x 123' with a 24' x 10' wing. One story. Gable roof, asbestos shingles and rolled asphalt. Double hung sash. Wood and glass personnel doors, south and north sides. Gabled and shed roof porches, south side. Faces south.

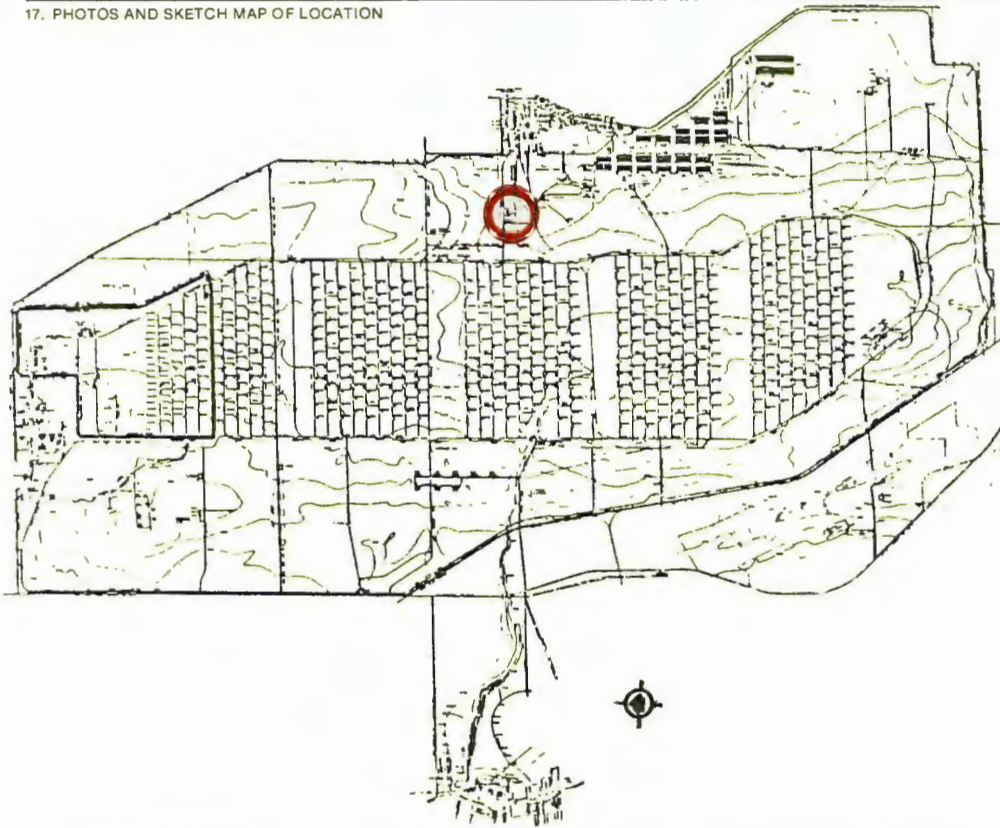
South Elevation
4:12A

Reinforced concrete foundation. Concrete block load bearing walls. Rectangular, 130' x 26' with 75' x 26', 41' x 140', and 22' x 13' wings and a 14' x 18' offset. One story. Flat roof, rolled roofing. Six-over-six-light double hung sash and industrial steel sash. Sliding wood doors, east side. Wood and glass personnel doors, east and west sides. Loading docks, east and west sides. Metal cooling tower, south end.

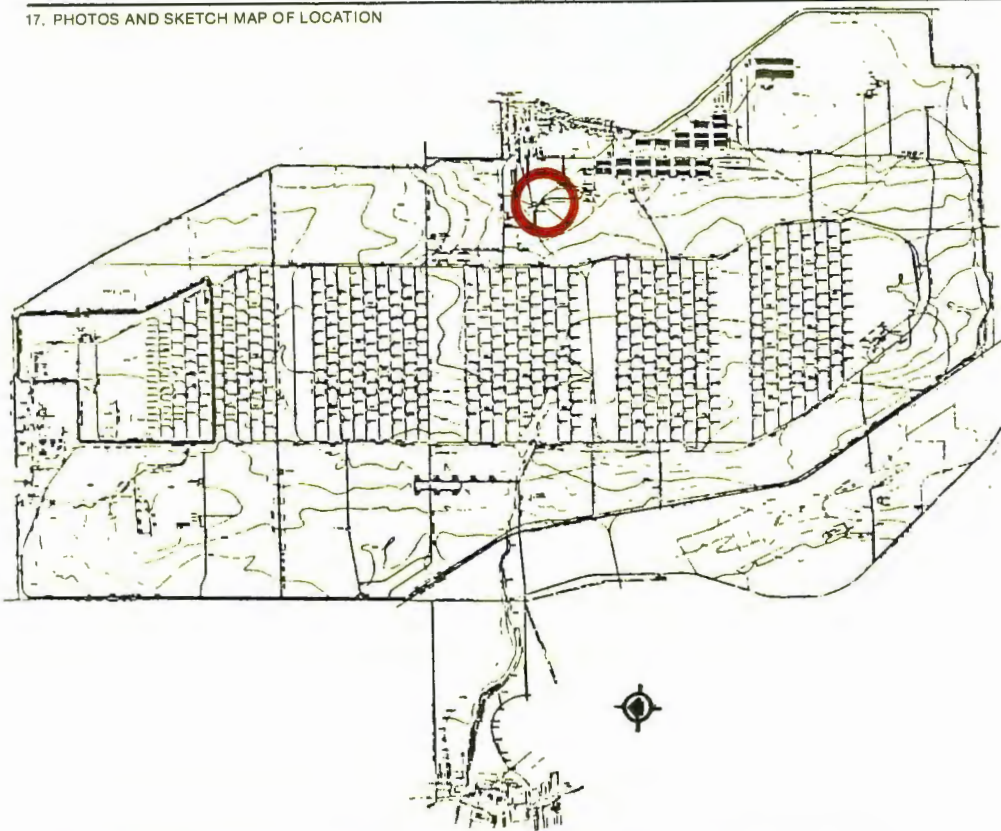
West Elevation
3:23

Reinforced concrete gravity retaining wall foundation. Concrete block load bearing walls. Rectangular, 60' x 200'. One story. Flat tar and gravel roof. Double hung windows. Wood and glass personnel and sliding metal doors on the northeast and southwest sides. Reinforced concrete loading docks on the northeast and southwest sides. Southeast side faces the road.

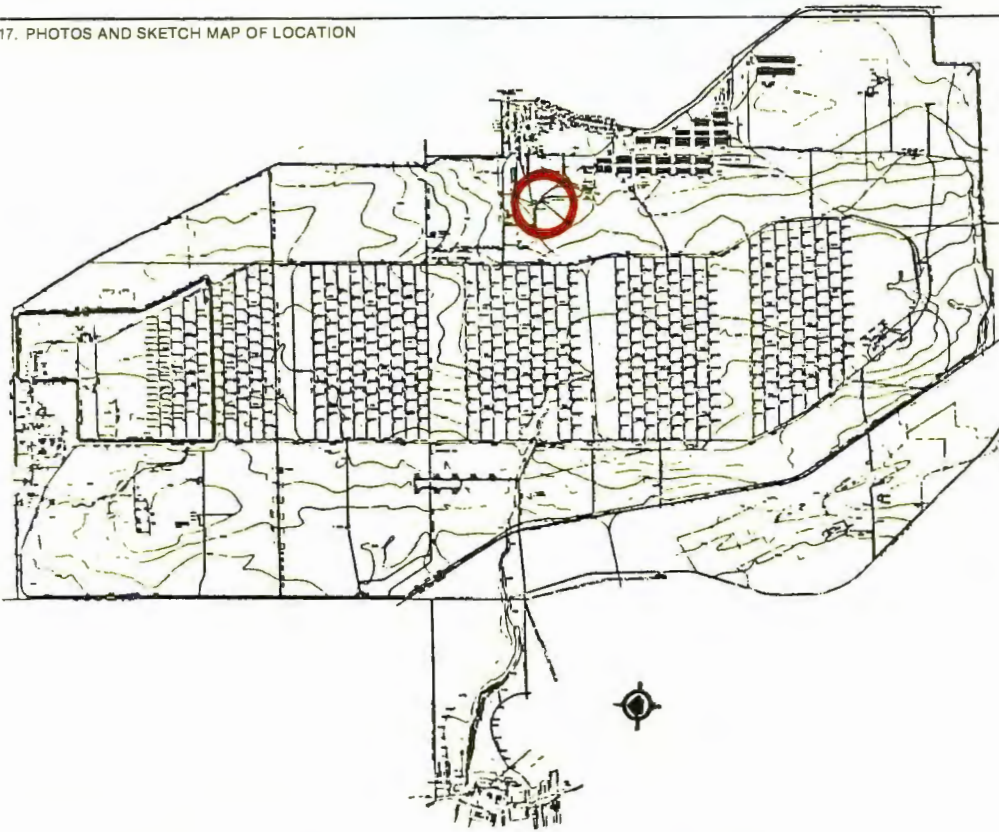
Southwest & Southeast Elevations
4:11A

Reinforced concrete foundation. Steel frame. Corrugated sheet metal walls. Rectangular, 60' x 302'. One story with clerestory. Corrugated sheet metal gable and shed roofs. Industrial steel sash. Metal overhead doors on the south, east and west sides. Faces south.

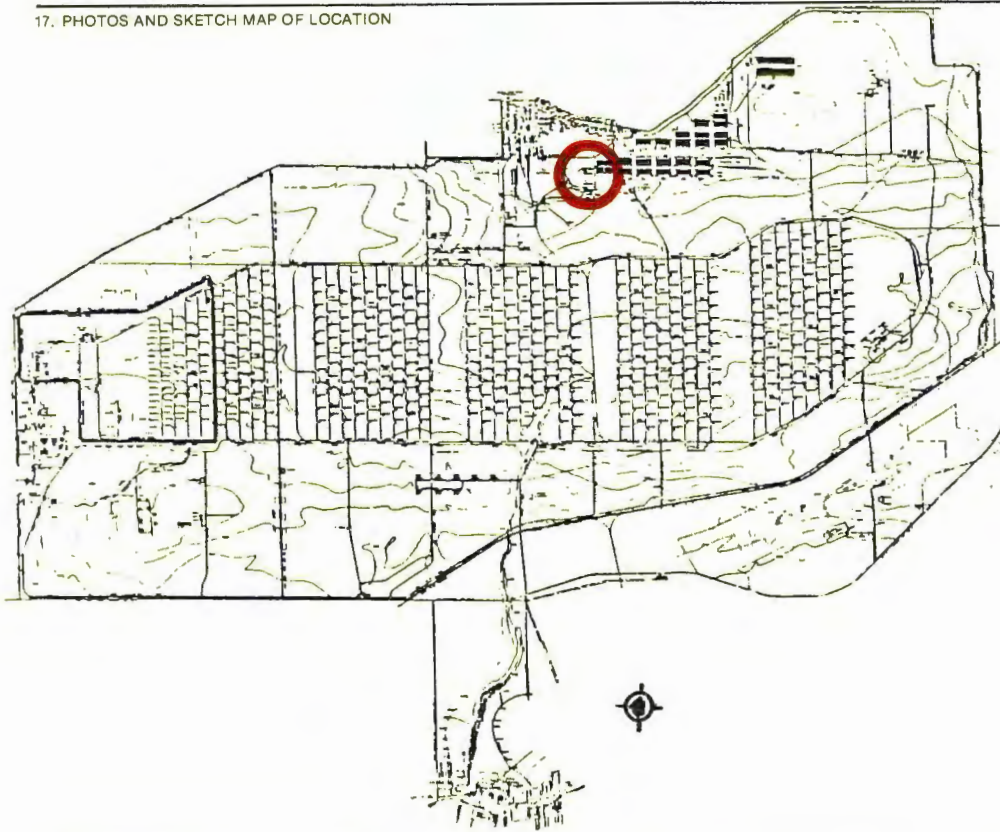
South Elevation
4:8A

Reinforced concrete foundation. Concrete block load bearing walls. Rectangular. Two stories with one story wing on the west side. Flat built-up roof. Double hung sash. Metal and glass personnel door on the south side. Attached brick smoke stack on the north side. Faces south.
