Environmental
Historical Bldgs.
Survey

HABS/HAER INVENTORY

Seneca Army Depot

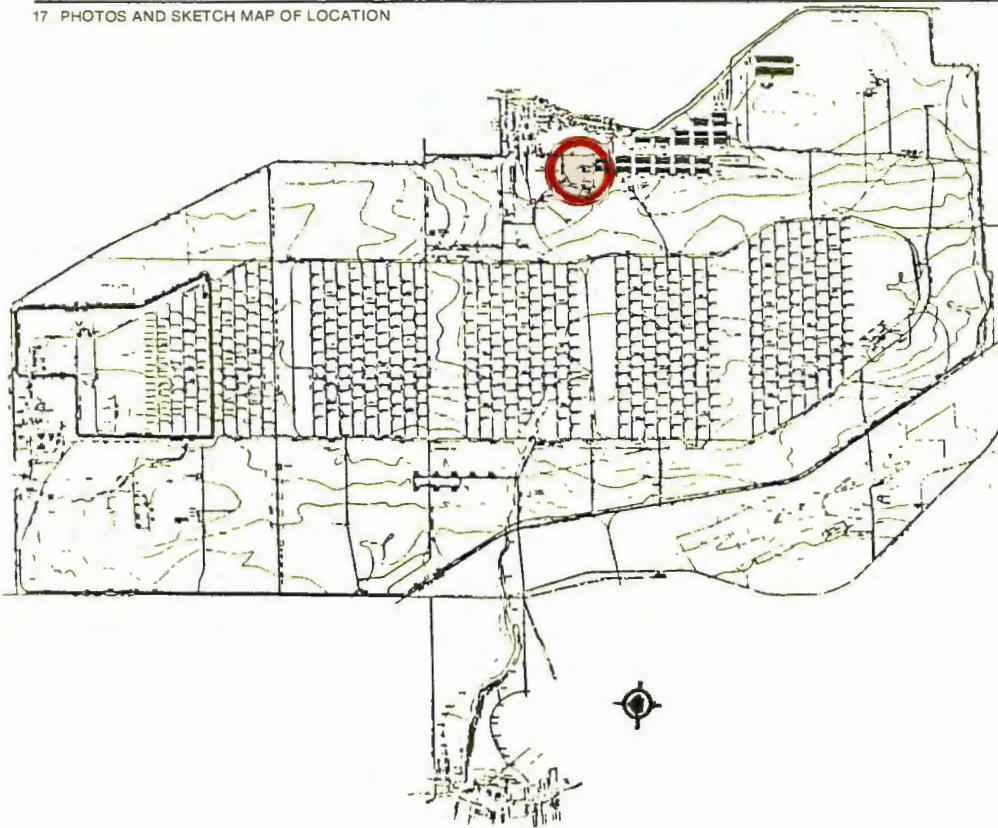
South & west Elevations
4:7A

Foundations of concrete gravity retaining walls at the ends and 10" concrete curtain walls carried by concrete piers 20' on centers. Concrete block walls braced by brick piers 20' on centers. Rectangular, 180' x 500'. One story. Flat built-up tar and gravel roof with stepped gables. Brick firewall extends above the roof near the center of the building. Sliding wood doors and personnel doors, all sides. Industrial steel sash. Reinforced concrete loading docks, east and west sides. Faces north.

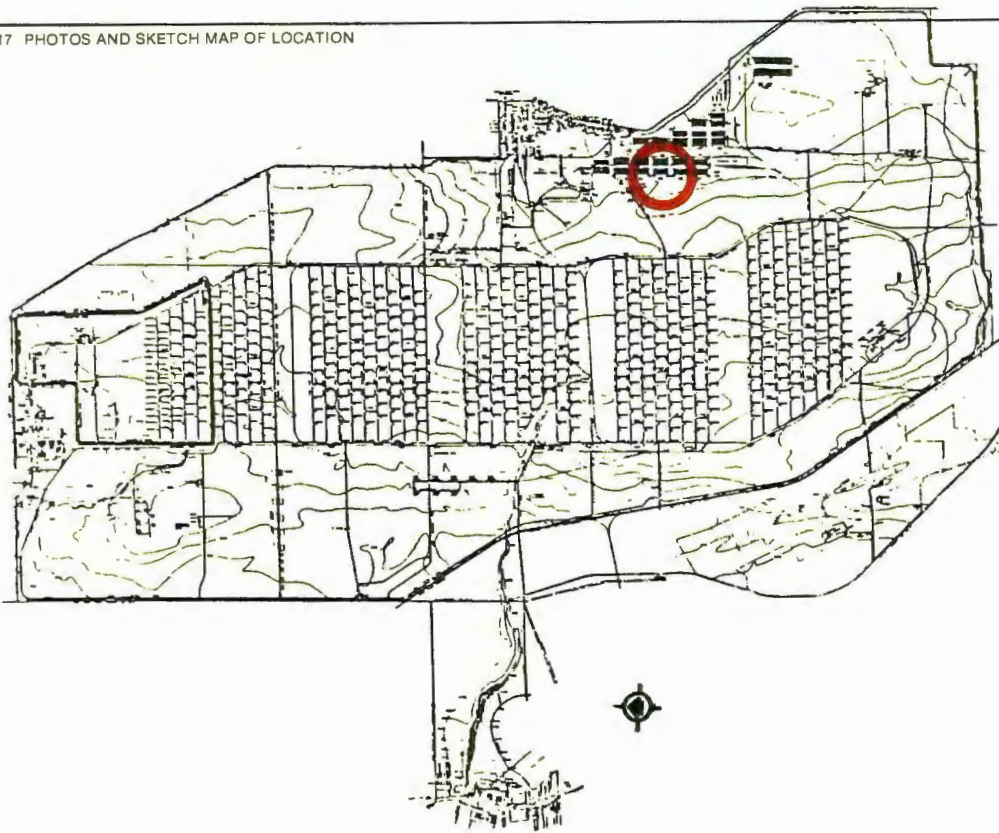
North & West Elevations
3:14

Reinforced concrete foundation. Concrete block load bearing walls. Rectangular, 67' x 26'. One story. Flat roof, rolled asphalt. Eight-over-eight-light double hung sash. Metal doors, south side. Faces south. Open, reinforced concrete reservoir, 117' x 117', on the north side.

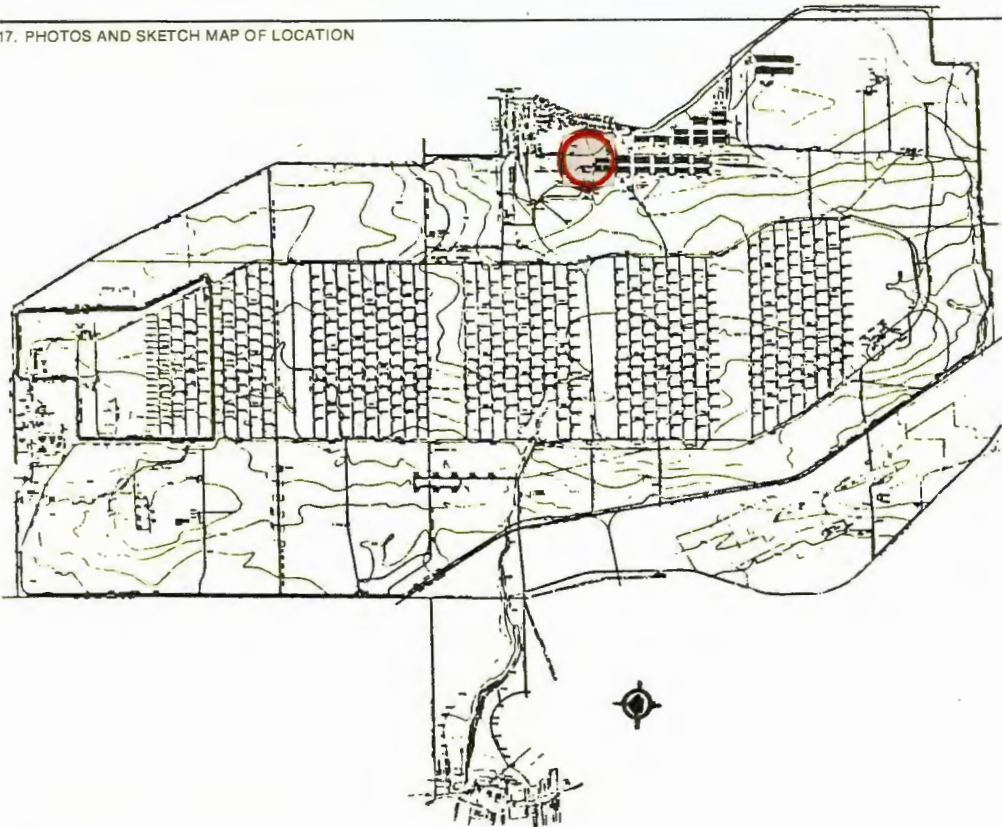
South Elevation
4.6A

Concrete pier foundation. Wood frame construction clad with wood siding. Rectangular, 37' x 32' with a 25' x 70' wing. One story. Gable roof, asbestos shingles and rolled roofing. Eight-over-eight-light double hung sash. Wood overhead door, south side; wood and glass personnel doors, east and west sides. Ridgeline is oriented north-south.

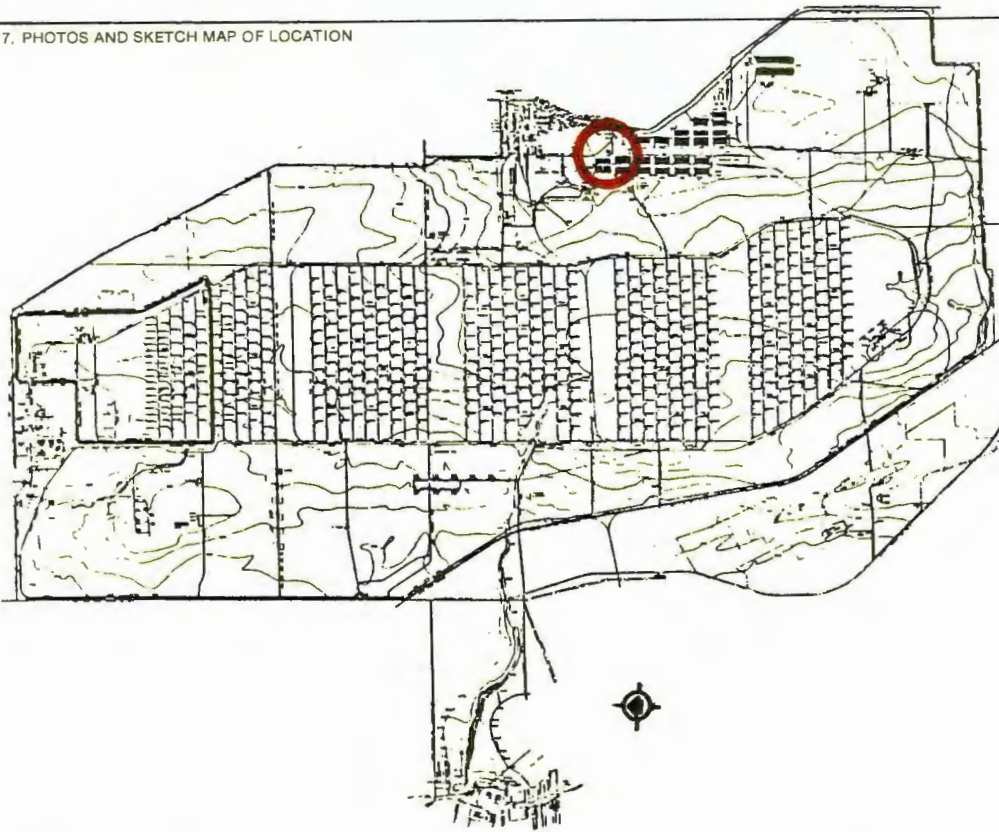
South & East Elevations
4:5A

Foundation of concrete curtain walls carried by concrete piers 20' on centers. Concrete block walls braced by brick piers 20' on centers. Rectangular, 180' x 500'. One story. Flat built-up tar and gravel roof with stepped gables. Brick firewall extends above the roof near the center of the building. Sliding wood doors and personnel doors, all sides. Industrial steel sash. Faces north.

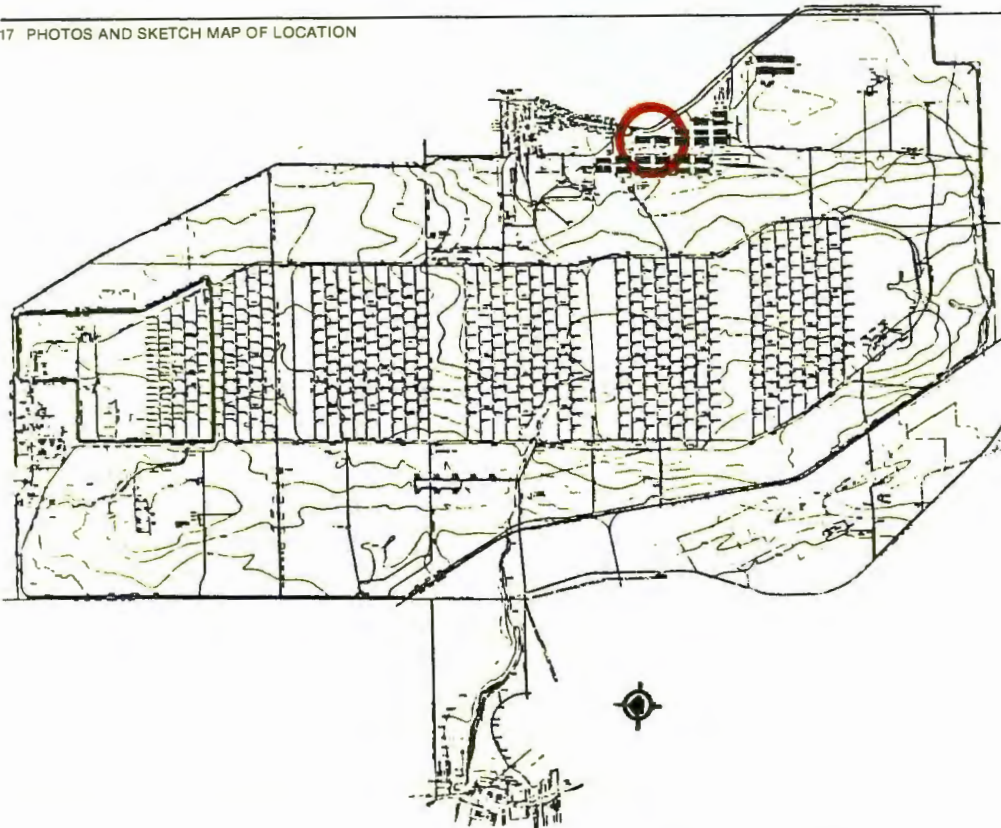
North & East Elevations
3:15

Reinforced concrete foundation. Steel frame. Concrete block walls. Rectangular, 201' x 1006'. One story. Flat five-ply built-up roof. Metal vehicle and personnel doors, west and east sides. Long dimensions are on the west and east sides.

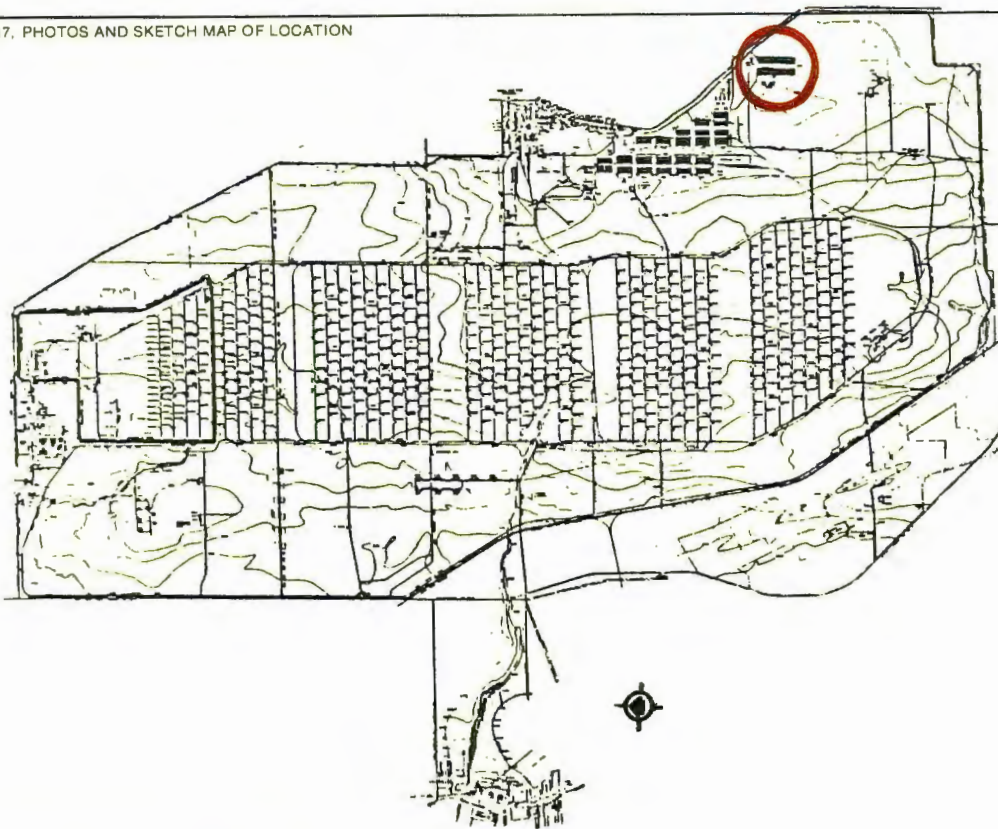
North & East Elevations
3:16

Reinforced concrete foundation. Steel frame clad with corrugated metal (east end) and concrete block walls (west end). Rectangular, 28' x 130'. One story. Slightly pitched roof, corrugated metal. Metal doors, south side. Metal environmental control structure located on the south side. Ridgeline oriented east-west.

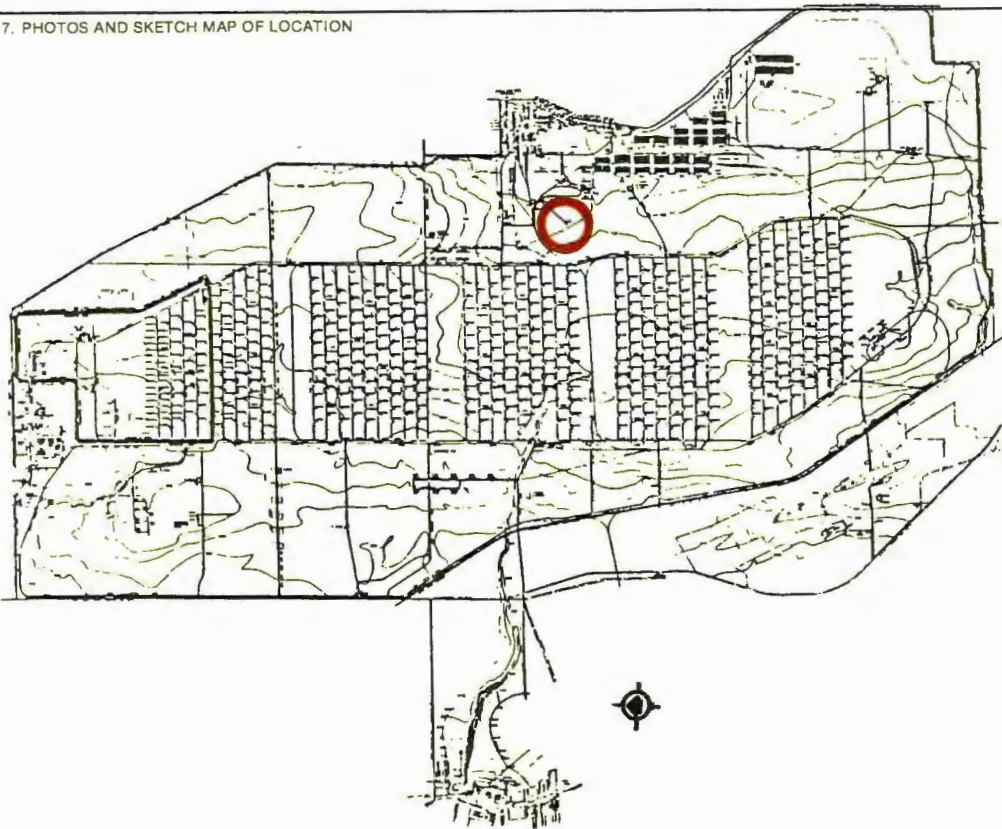
Southeast + Northeast Elevations
3:24

Reinforced concrete foundation. Reinforced concrete pier structural frame with concrete block infill walls. Rectangular, 60' x 300' with a 20' x 20' offset. One story. Flat built-up roof with metal ventilators. Metal doors, all sides. Covered, reinforced concrete platform, south side. Faces west.

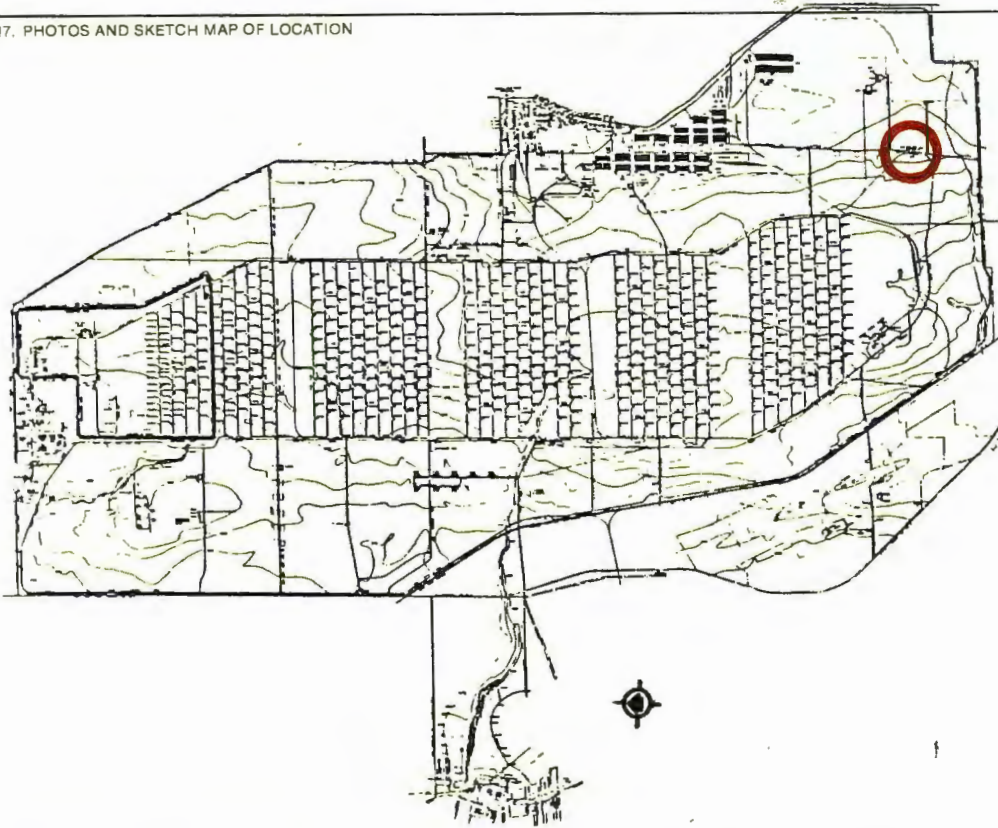
South & West Elevations
3:7

Reinforced concrete foundation. Reinforced concrete pier structure with concrete block infill walls. Rectangular, 170' x 42' with two 18' x 17' wings. Two stories with one-story wings. Flat roof, tar and gravel. Projected windows. Double leaf glass door, south side. Faces south.

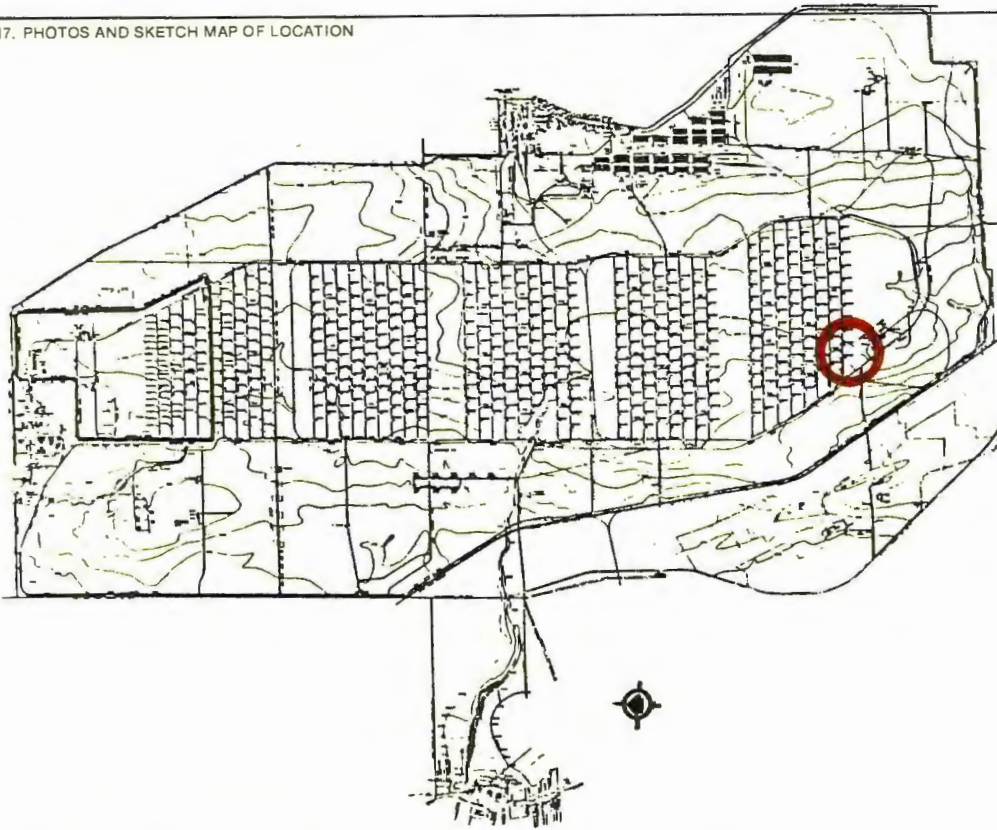
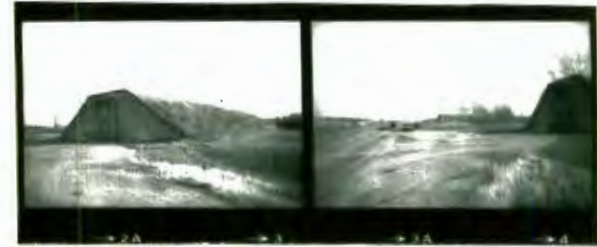
North + West Elevations
3:3

Reinforced concrete foundation. Reinforced concrete walls. Rectangular, 215' x 41' with a 64' x 48' offset. Main building is two stories; offset is one story. Flat built-up roof. Projected windows. Metal and glass doors, all sides. Faces south.

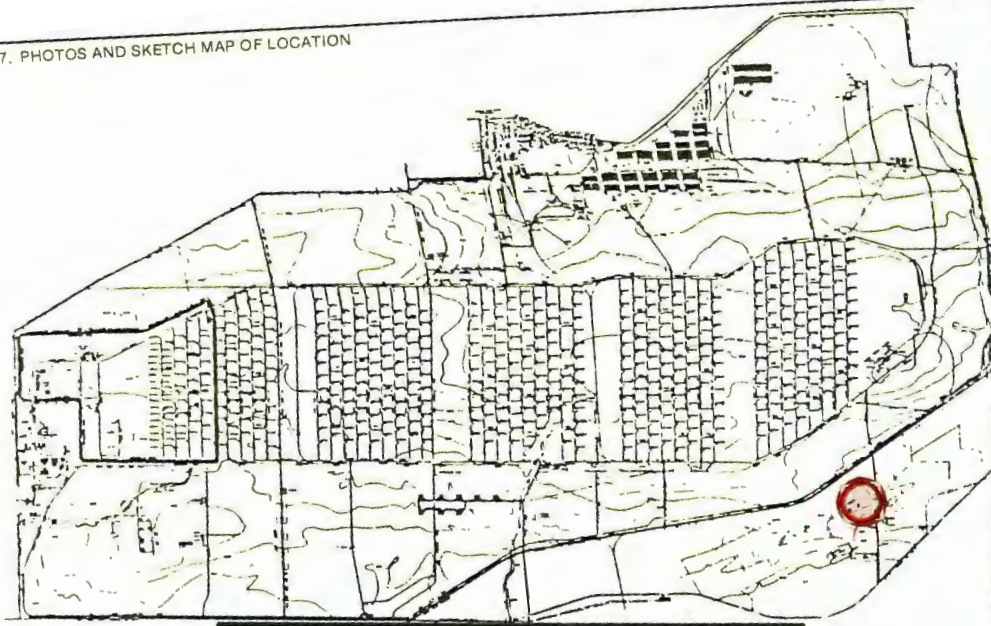
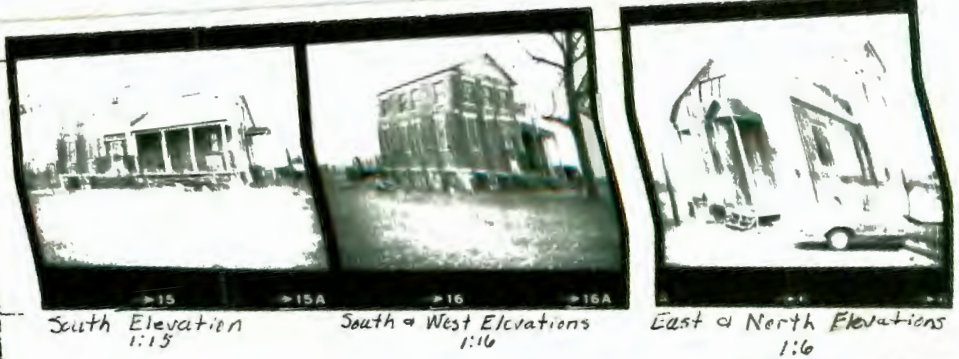
South Elevation
1:15

Located in the southwest corner of the depot, this brick and stone building was probably constructed during the first two decades of the nineteenth century and may have once been a tavern and inn. Since acquisition by the military, it has been utilized as family housing, offices, and the depot rod and gun clubhouse. The building is a Category III property because it is a locally important example of early nineteenth century classical revival architecture.

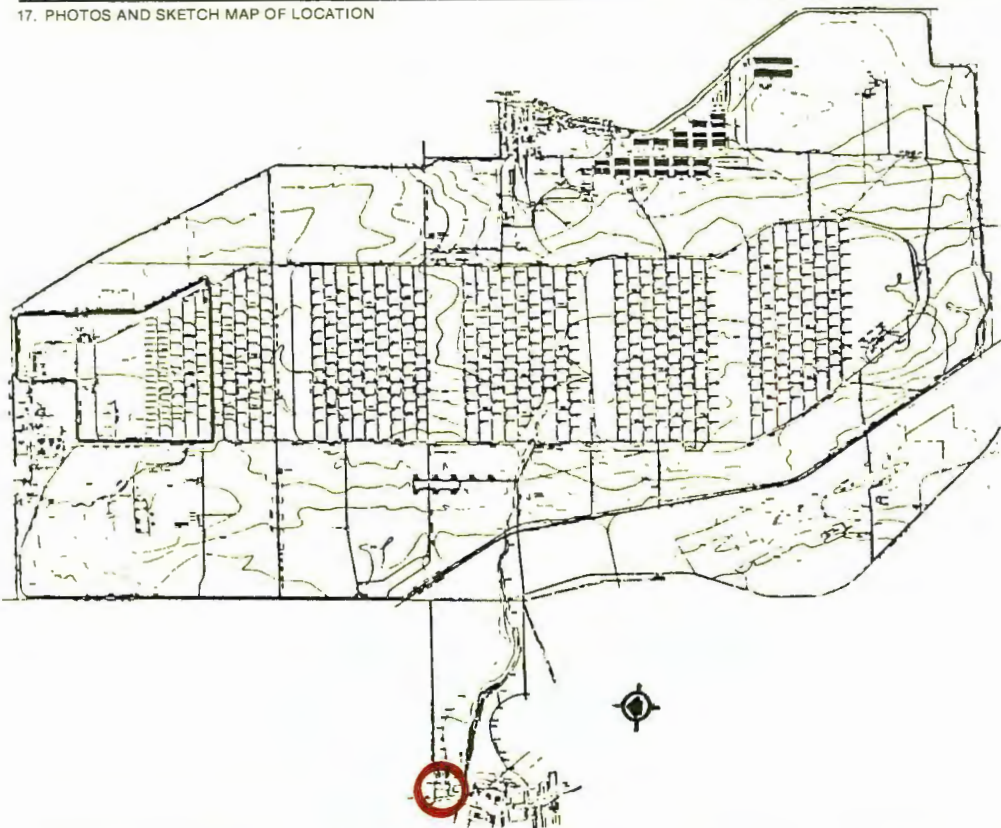
West + South Elevations
2:12A

Concrete block foundation. Wood frame construction clad with vinyl siding. Square, 30' x 30'. Two stories. Hip roof, asbestos shingles. Six-over-six-light double hung sash; round window, center bay of second story on the west side. Wood and glass door flanked by fluted pilasters, west side. Faces west.

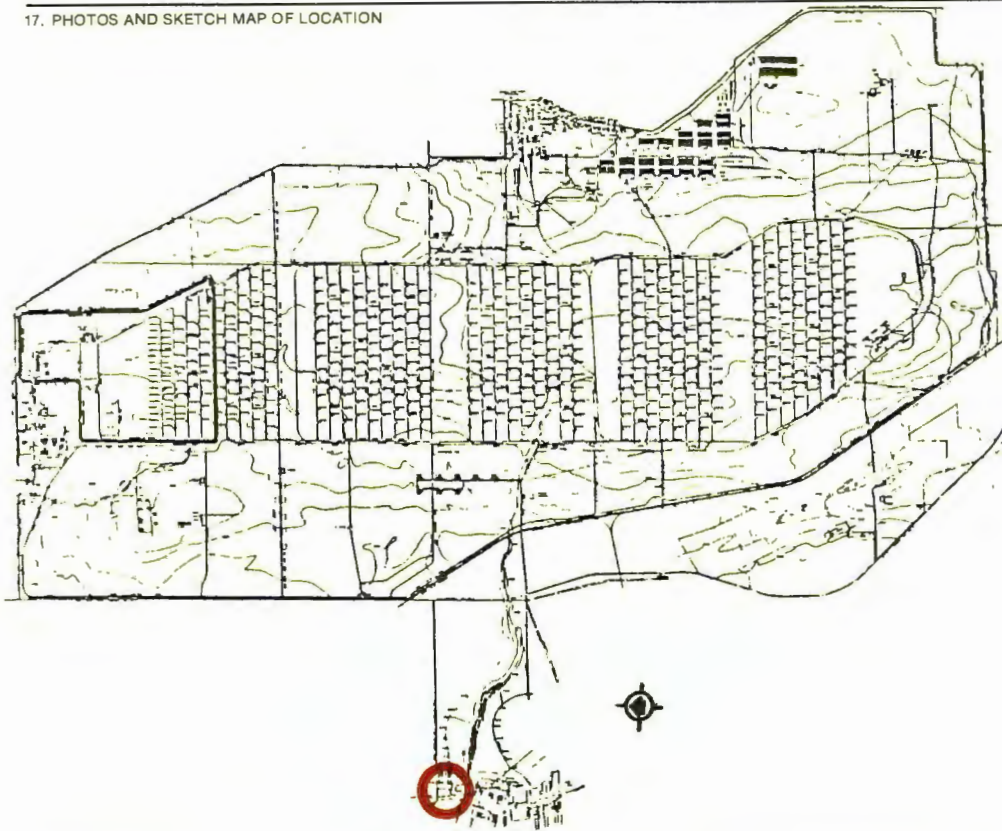
West & South Elevations
2:11A

Concrete foundation. Wood frame construction clad with clapboarding. Rectangular 32' x 24'. Two stories. Hip roof, asphalt shingles. Six-over-six-light double hung sash. Panelled wood door, west side. Faces west.

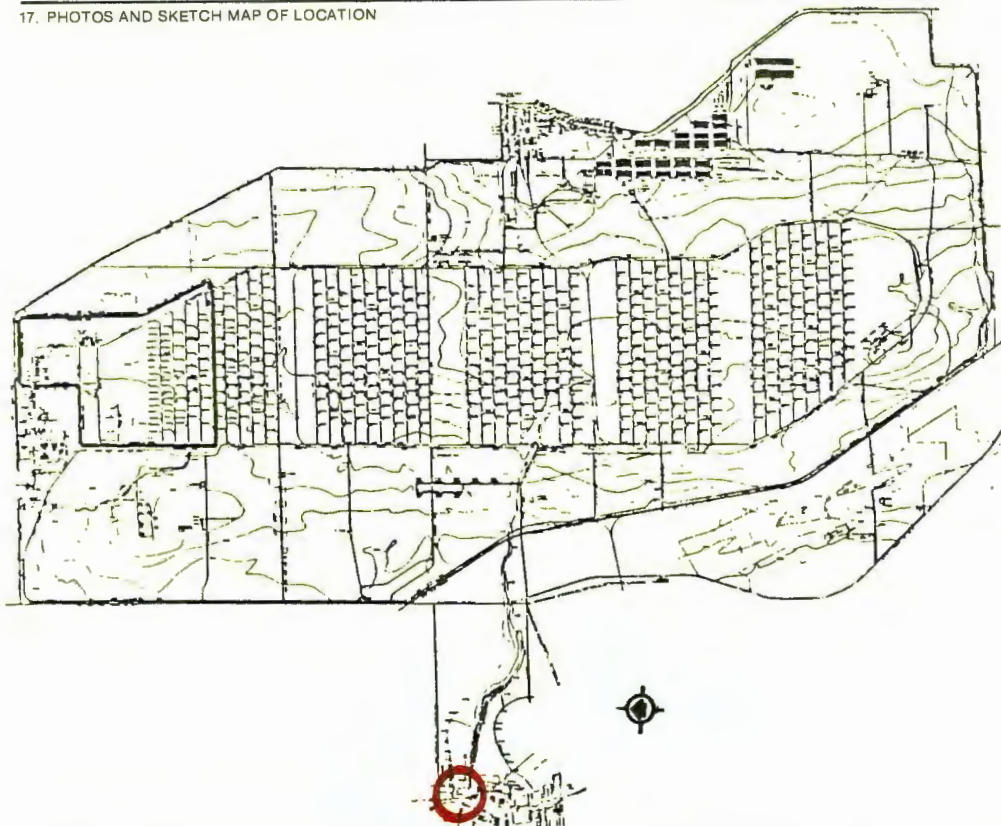
West Elevation
2:10A

Concrete foundation. Wood frame construction clad with clapboarding. Rectangular 29' x 15' with 15' x 27', 19' x 44' and 20' x 12' wings. One-and-a-half stories. Gable roof with gabled dormers, asbestos shingles. One-over-one-light double hung sash and casement windows. Wood and glass door, west side. Faces west.

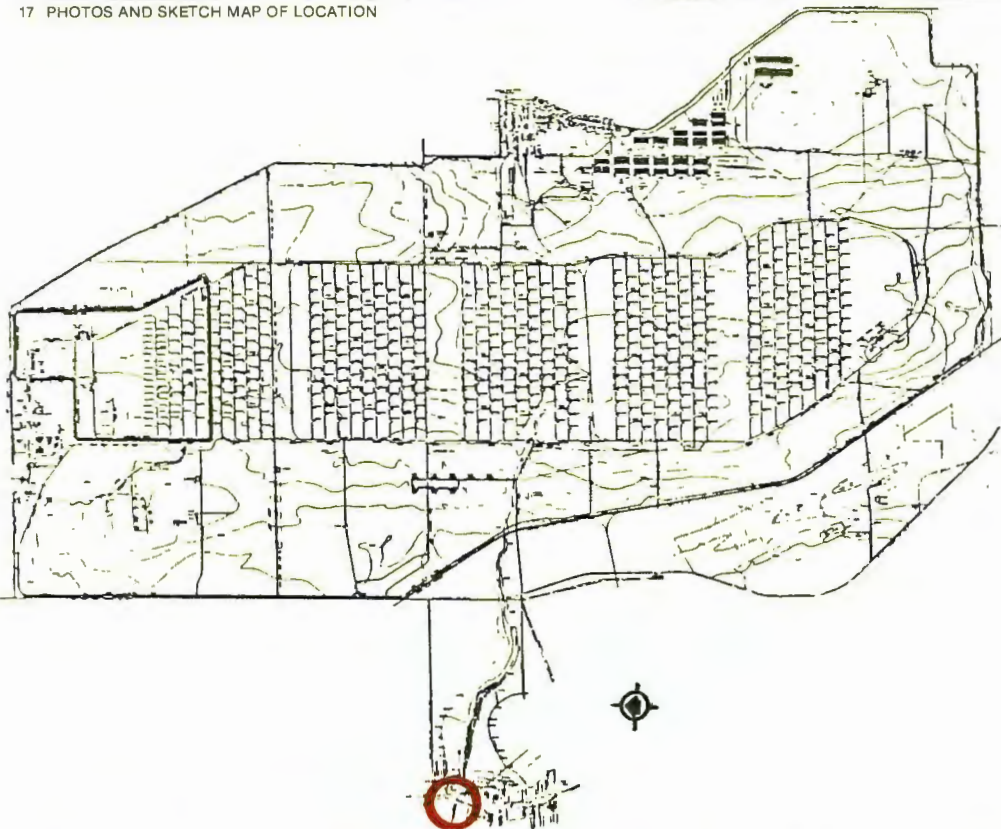
West & North Elevations
2:8A

Concrete foundation. Wood frame construction clad with vertical wood siding. Irregular plan, 80' x 28' with two 20' x 12' offsets, a 23' x 12' wing and a 21' x 12' enclosed porch. One story. Gable and flat built-up roofs, composition shingles. Casement windows. Wood and glass door, north side. Faces north.

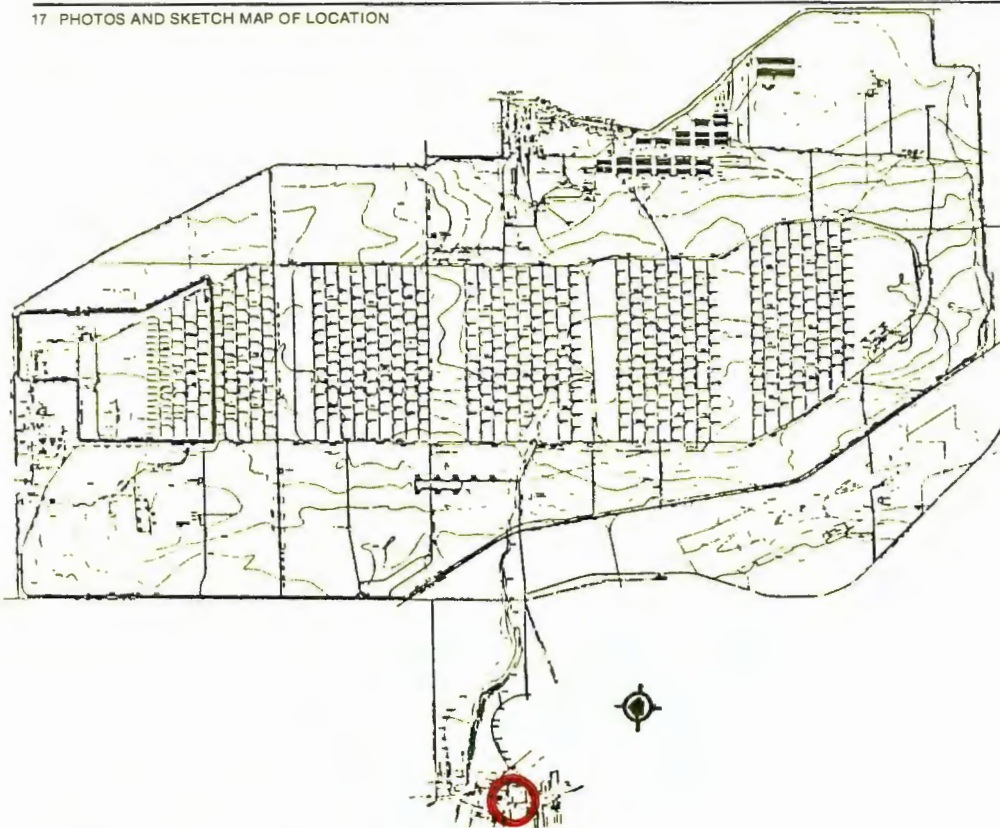
East Elevation
1:31

Reinforced concrete foundation. Masonry load bearing walls of red brick laid in 5/1 common bond. Round, 33' in diameter with rectangular wings measuring 32' x 20' and 29' x 35'. One story. Flat built-up roof. Prominent brick chimney, west side. Six-over-six-light double hung sash. Wood and glass door, west side. Faces west.

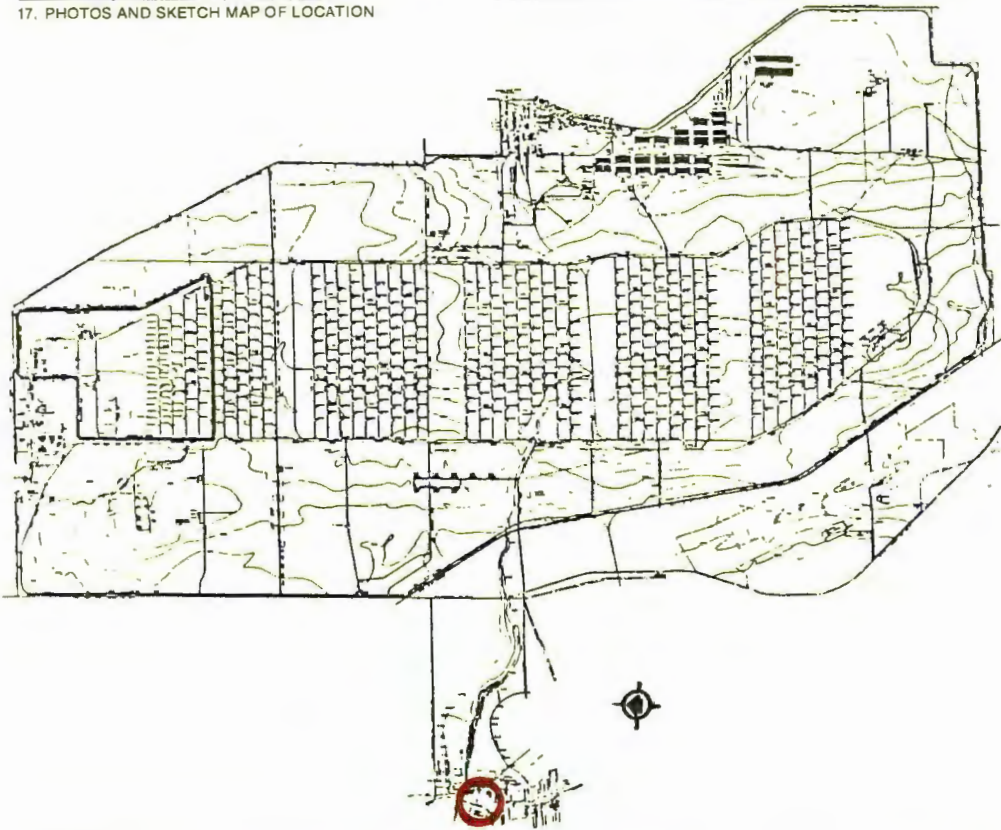
East & South Elevations
2:7A

Concrete block foundation. Wood frame construction clad with clapboarding. Rectangular, 37' x 24'. One story. Hip roof, asbestos shingles. One-over-one-light double hung sash. Wood and glass door, south side. Faces east.

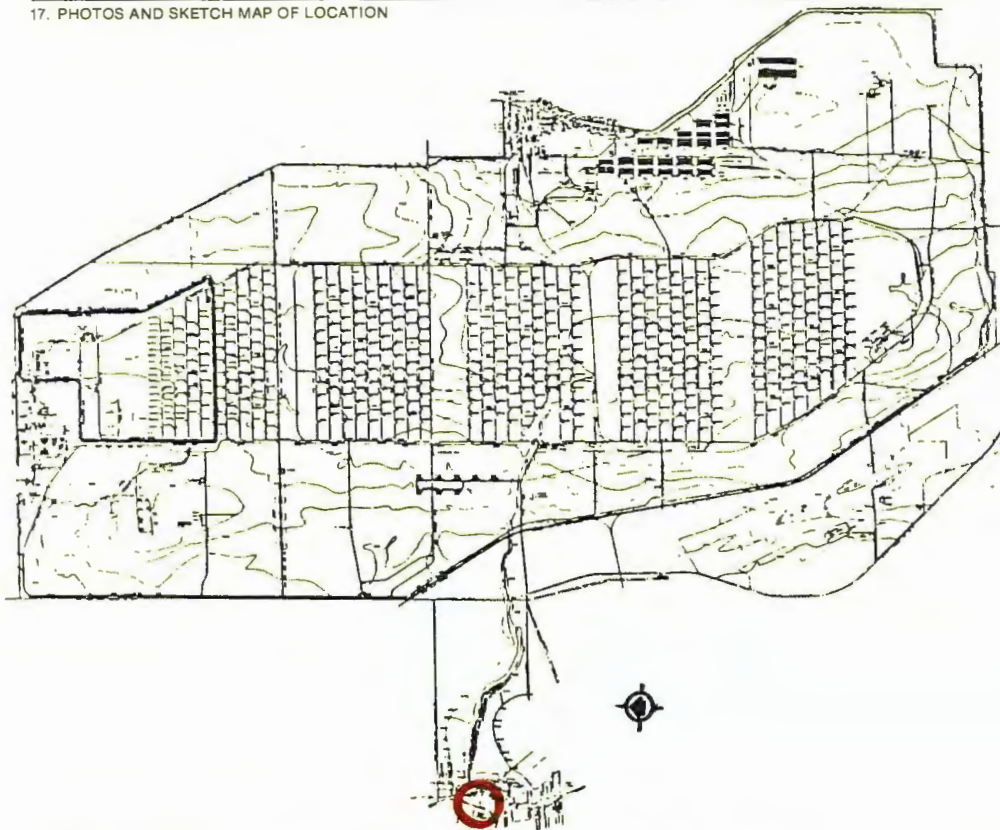
East & South Elevations
2:6A

Concrete foundation. Wood frame construction clad with vinyl siding. Rectangular. Two stories. Gable roof, asbestos shingles. One-over-one-light and six-over-one-light double hung sash. Wood and glass door, south side. Faces east.

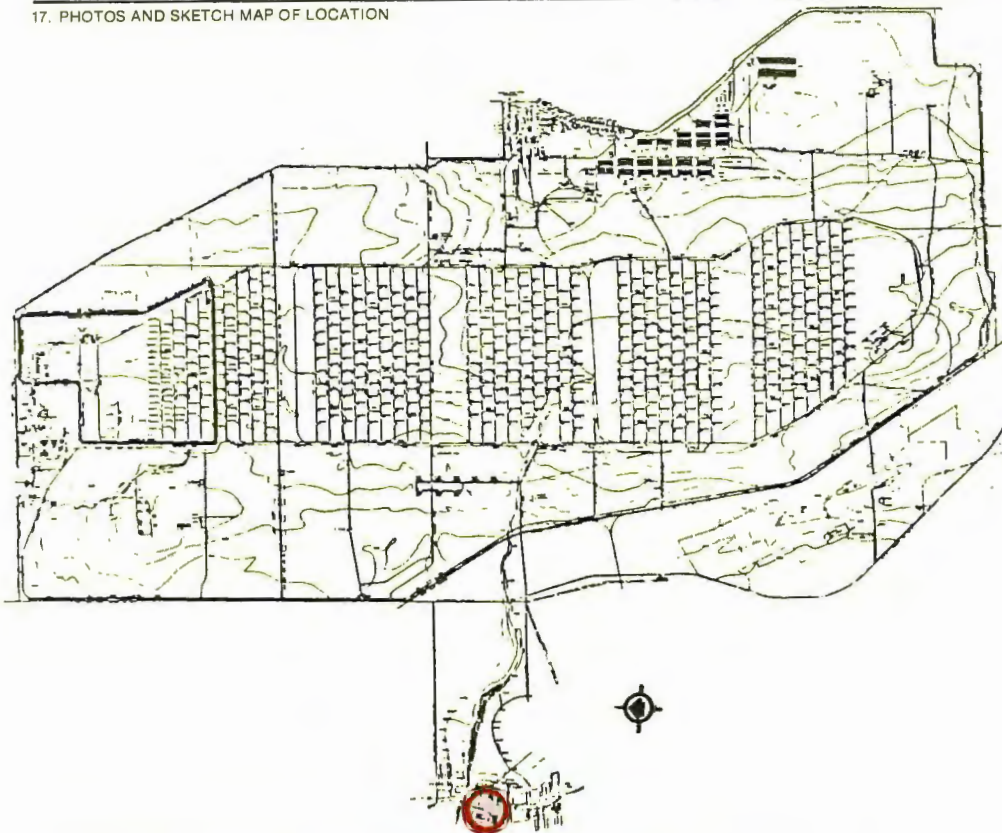
East Elevation
2:5A

Concrete block foundation. Wood frame construction clad with vinyl siding. Rectangular 32' x 24' with 16' x 12' and 12' x 10' wings. One story. Gable roof, asbestos shingles. One-over-one-light double hung sash. Wood and glass door, east side. Faces east.

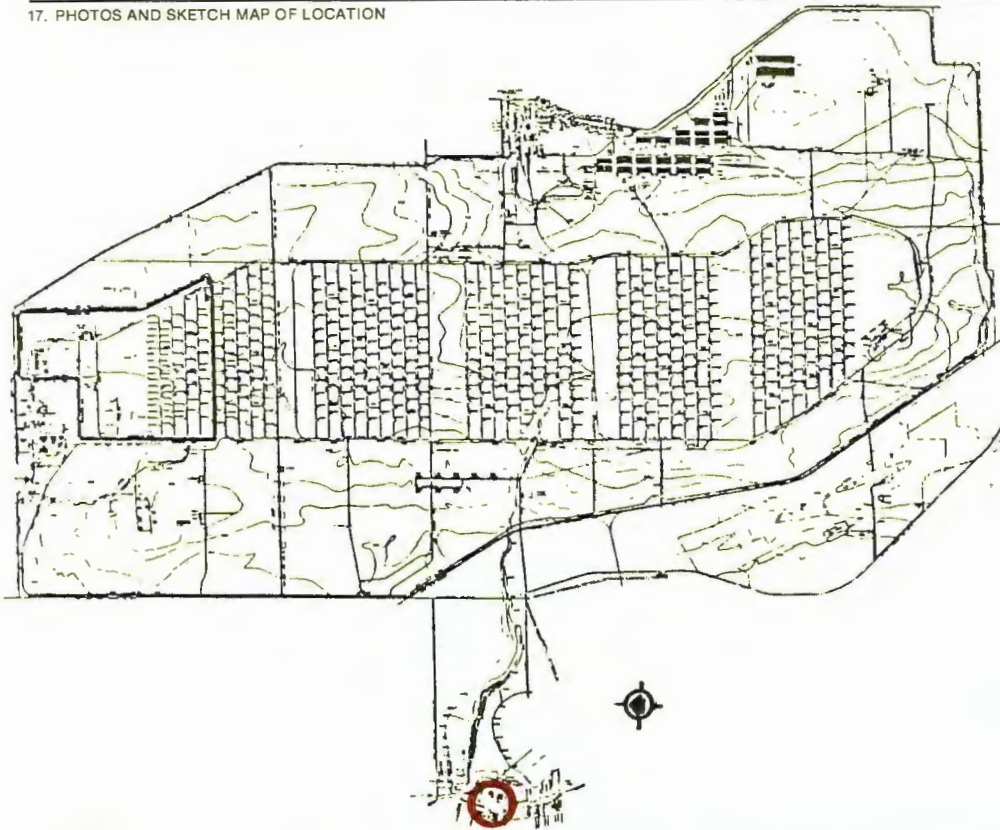
East Elevation
2:4A

Concrete block foundation. Wood frame construction clad with clapboarding. Rectangular 41' x 20'. One story. Intersecting gable roofs, asbestos shingles. One-over-one-light double hung sash. Wood and glass door, east side. Faces east.

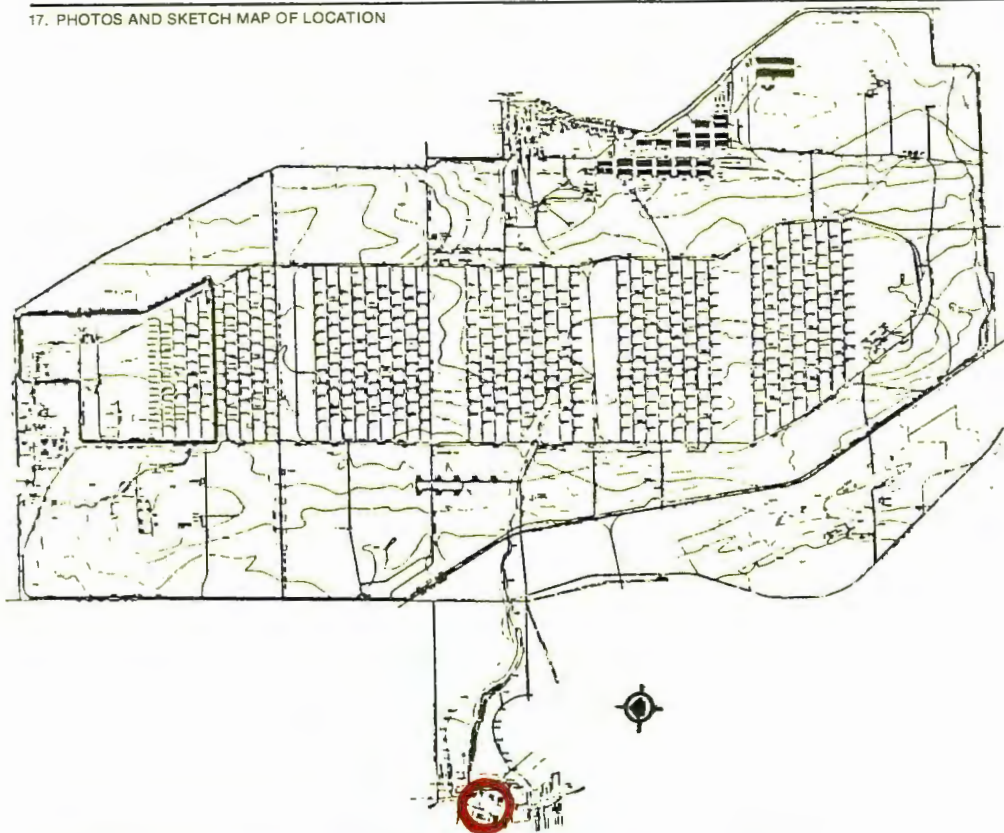
East & South Elevations
2:2A

Concrete block foundation. Wood frame construction clad with vinyl siding. Rectangular, 20' x 24' with a 4' x 6' offset and a 6' x 6' wing. Two-story main block and one-story wing. Gable roof, asbestos shingles. One-over-one-light and six-over-six-light double hung sash. Wood and glass door, south side. Ridgeline oriented east-west.

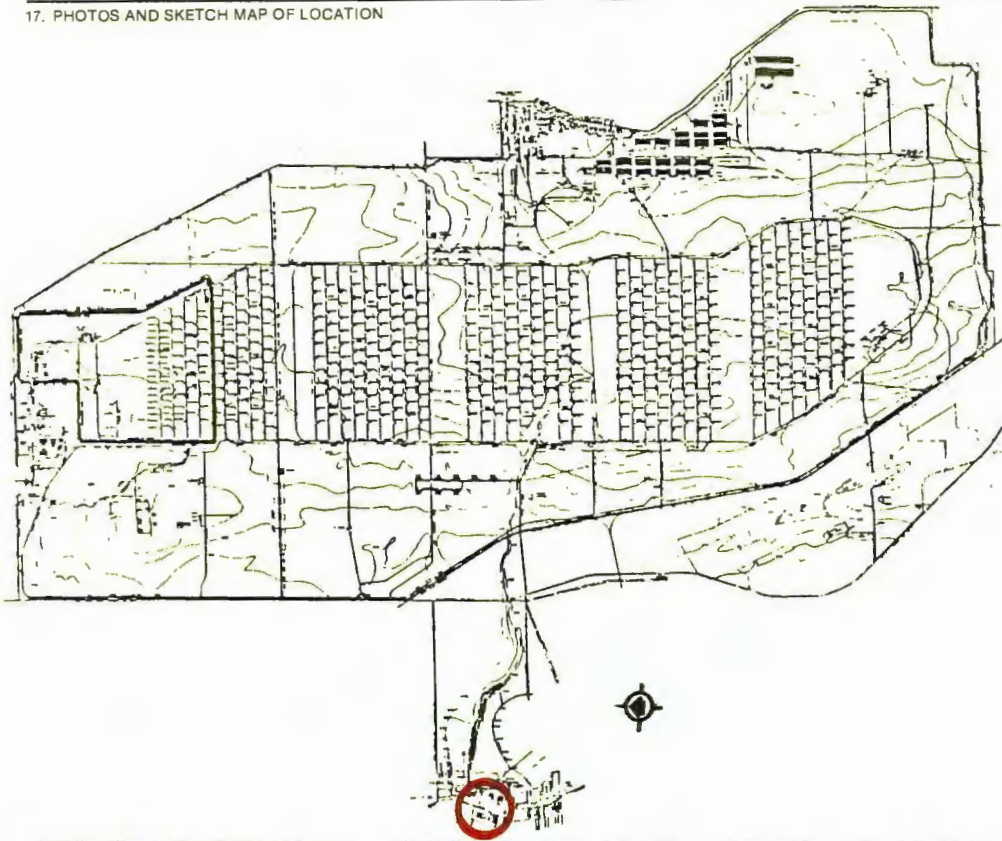
East Elevation
2:2A

Concrete foundation. Wood frame construction clad with vinyl siding. Rectangular, 34' x 24' with an 8' x 11' offset. One-and-a-half stories. Gable roof with shed roof dormers, asbestos shingles. One-over-one-light double hung sash and six-over-one-light double hung sash. Wood and glass door, east side. Faces east.

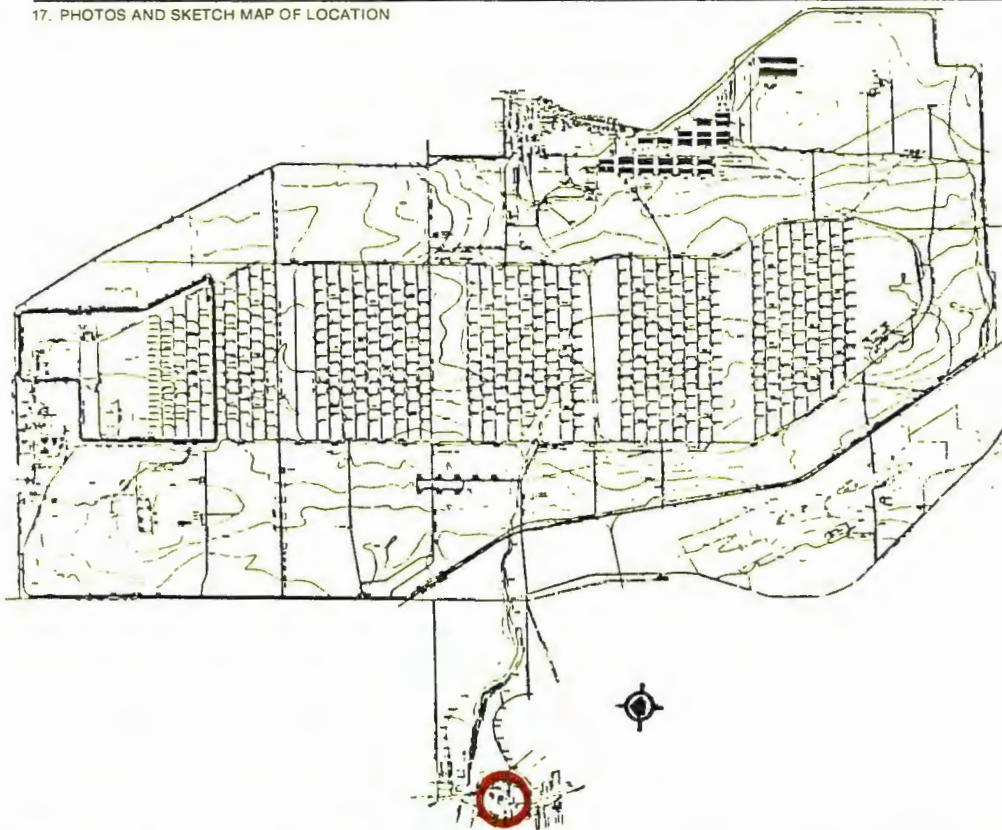
East & South Elevations
1:37

Concrete foundation. Wood frame construction clad with vinyl siding. Rectangular 32' x 30' with a 6' x 4' offset and a 6' x 7' wing. Two story and one story on the south. Gable roof, asbestos shingles. One-over-one-light double hung sash. Wood and glass door, south side. Faces east.

14. CONDITION	<input type="checkbox"/> EXCELLENT	<input checked="" type="checkbox"/> GOOD	<input type="checkbox"/> FAIR	<input type="checkbox"/> DETERIORATED	<input type="checkbox"/> RUINS	15. DANGER OF DEMOLITION? (SPECIFY THREAT)	<input type="checkbox"/> YES	<input checked="" type="checkbox"/> NO	<input type="checkbox"/> UNKNOWN
---------------	------------------------------------	--	-------------------------------	---------------------------------------	--------------------------------	---	------------------------------	--	----------------------------------

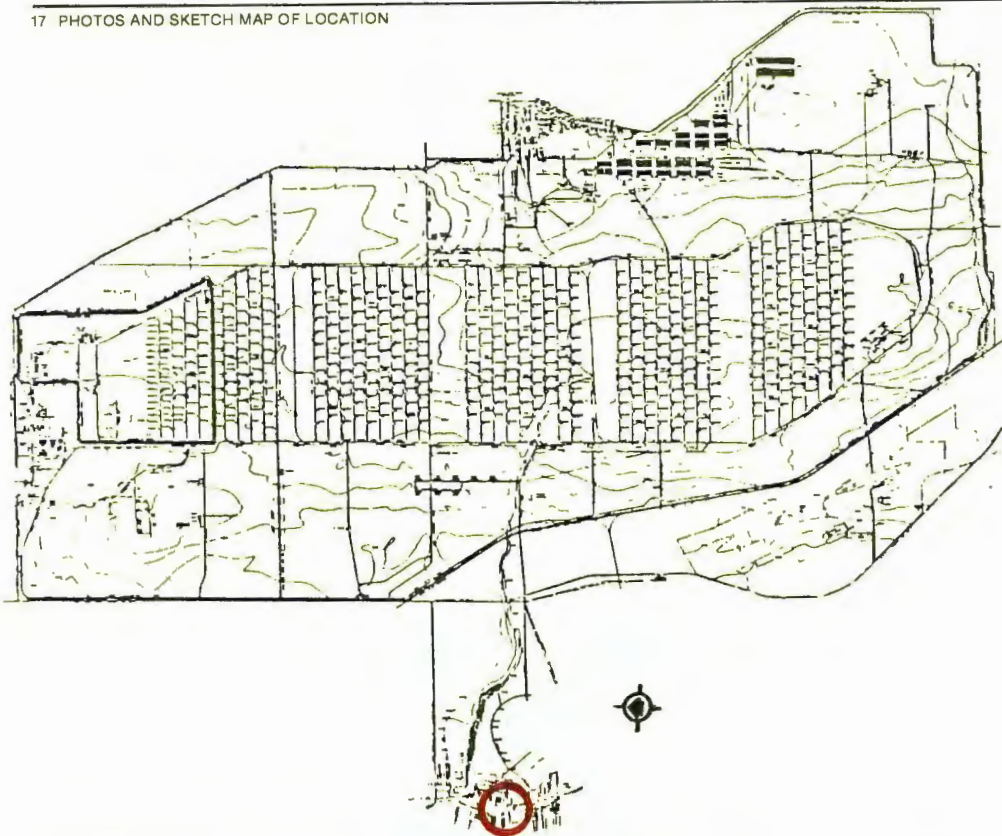
East Elevation
1:36

Concrete block foundation. Wood frame construction clad with vinyl siding. L-shaped, 41' x 26' with an offset of 6' x 6'. One story. Intersecting gable roof, asbestos shingles. One-over-one-light double hung sash. Wood and glass door, north side. Faces east.

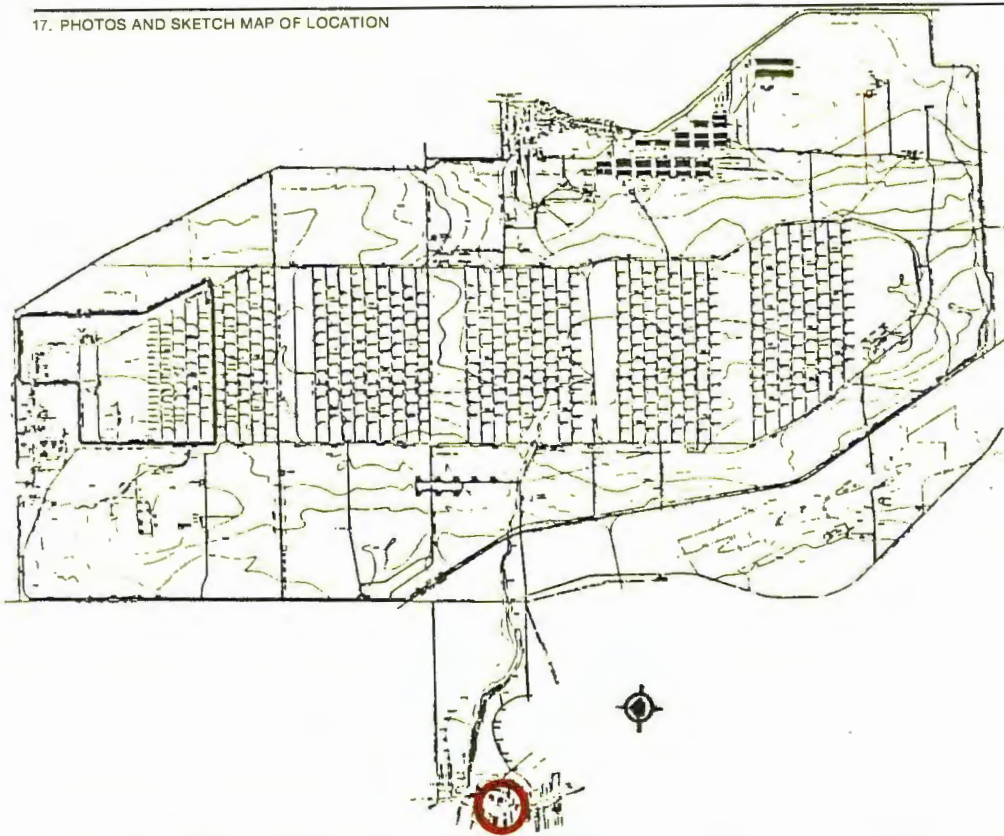
East & South Elevations
1:35

Concrete block foundation. Wood frame construction clad with vinyl siding. Rectangular, 22' x 45'. One story. Gable roof, asbestos shingles. Six-over-six-light double hung sash. Wood and glass door, north side. Faces north.
