Environmental
Historical Bldgs.
Survey

HABS/HAER INVENTORY

Seneca Army Depot

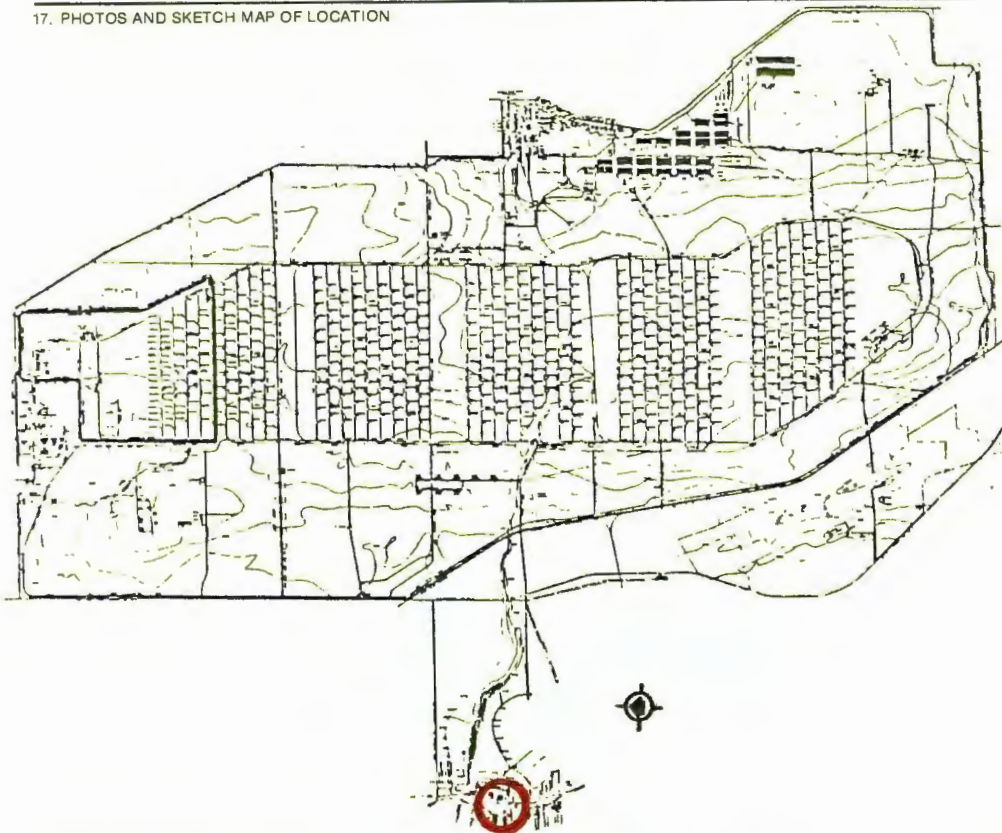
East Elevation
1:34

Concrete block foundation. Wood frame construction clad with vinyl siding. Rectangular, 31' x 18' with a 4' x 6' offset. One story. Intersecting gable roof, asbestos shingles. Six-over-six-light double hung sash. Wood and glass door, north side. Faces east.

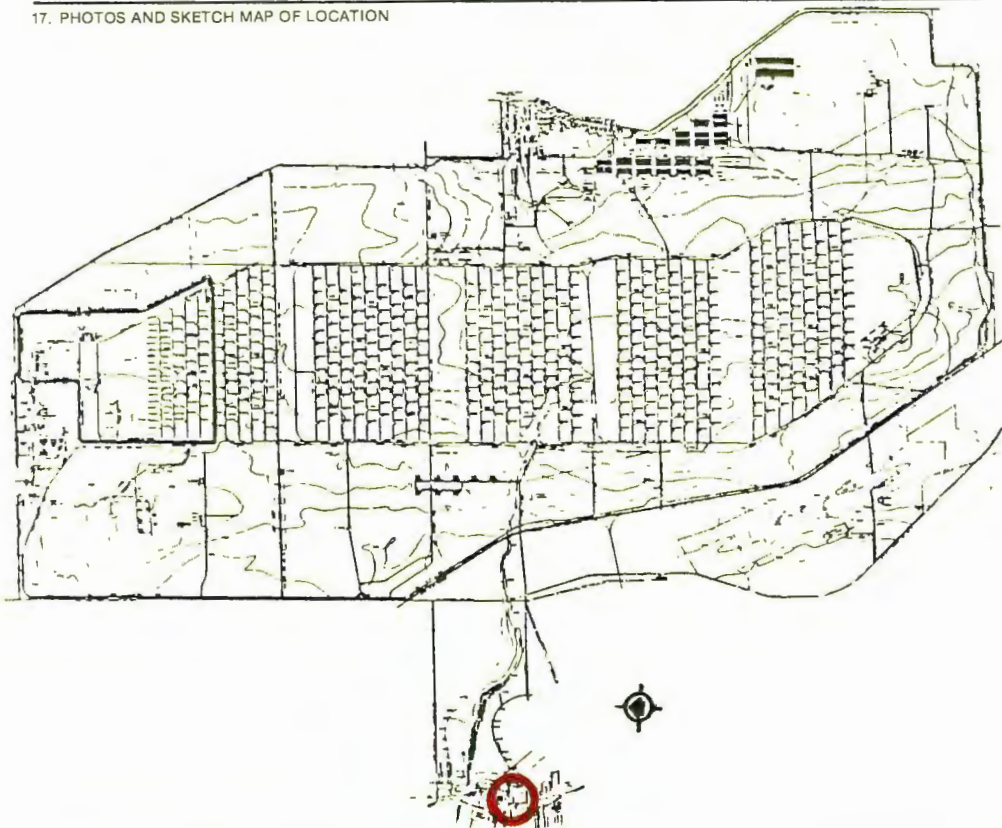
East Elevation

Concrete block foundation. Wood frame construction clad with vinyl siding. Rectangular, 22' x 11' One story. Gable roof, asbestos shingles. One-over-one-light double hung sash. Wood and glass doors, east and south sides. Faces east.

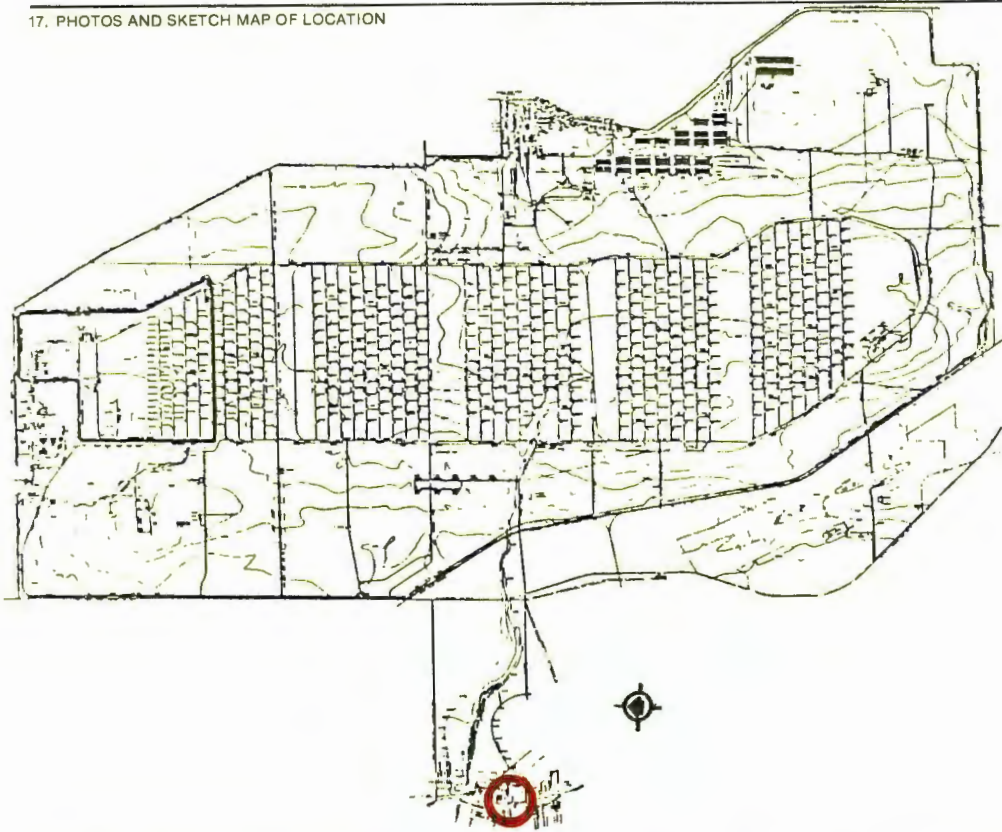
East Elevation
1:32

Concrete block foundation. Wood frame construction clad with vinyl siding. Rectangular, 33' x 29' with a 10' x 12' offset. Two-story main block with one-story offset. Gable roof, asbestos shingles. One-over-one-light double hung sash. Wood and glass door, east side. Faces east.

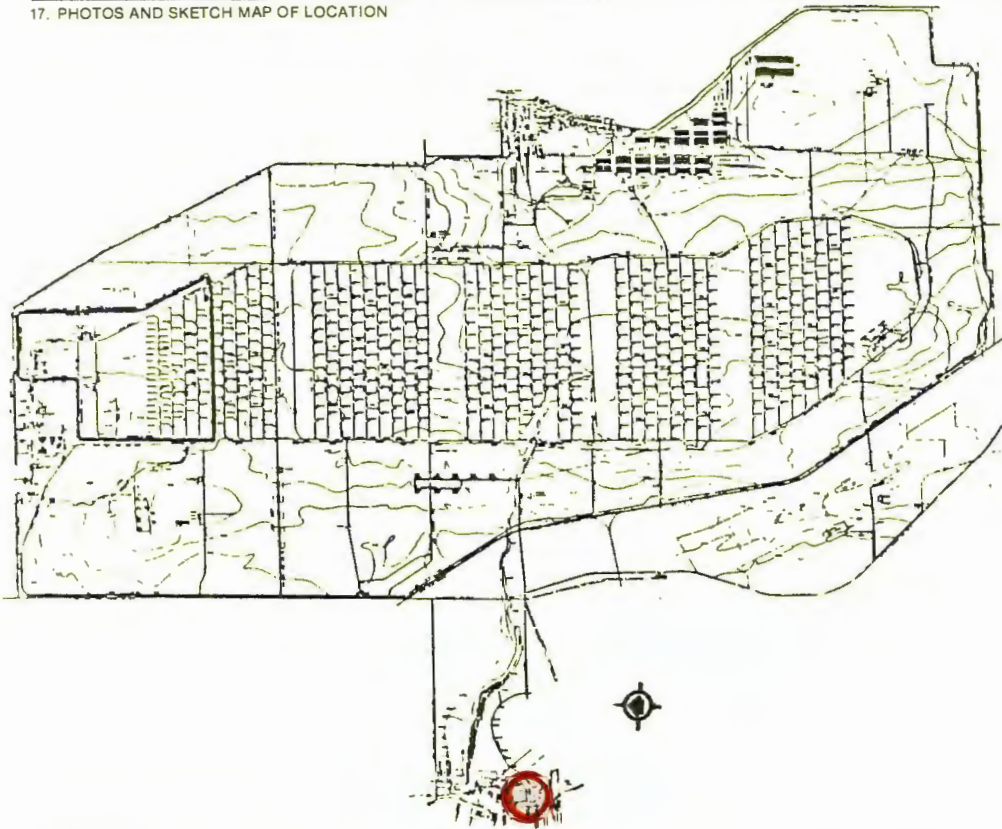
East & South Elevations
1:30

Concrete block foundation. Wood frame construction clad with vinyl siding. Rectangular, 24' x 36' with a 12' x 16' wing. Two-story main block and one-story wing. Gable roof, asbestos shingles. Six-over-six-light double hung sash. Wood and glass door with small frame gabled stoop, east side. Faces east.

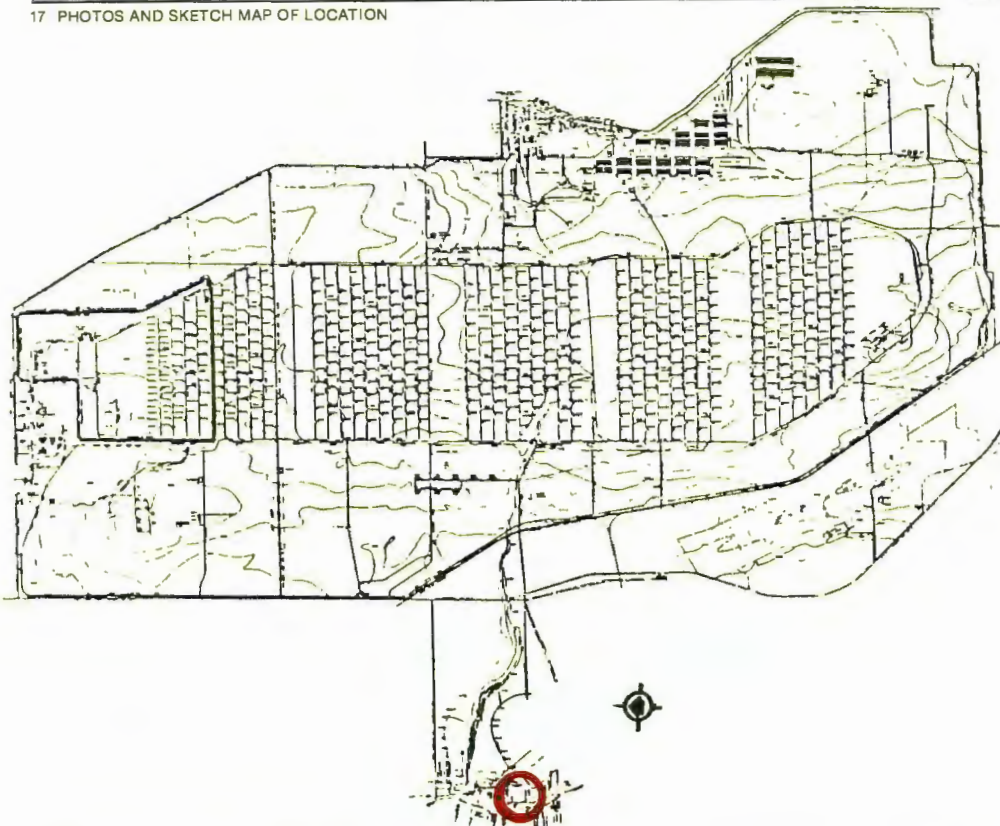
East & South Elevations
1:29

Concrete block foundation. Wood frame construction clad with vinyl siding. Rectangular, 37' x 26' with a 12' x 12' and 6' x 6' offsets and 12' x 20' wing. One story. Gable roof, asbestos shingles. One-over-one-light double hung sash. Wood and glass door, east side. Faces east.

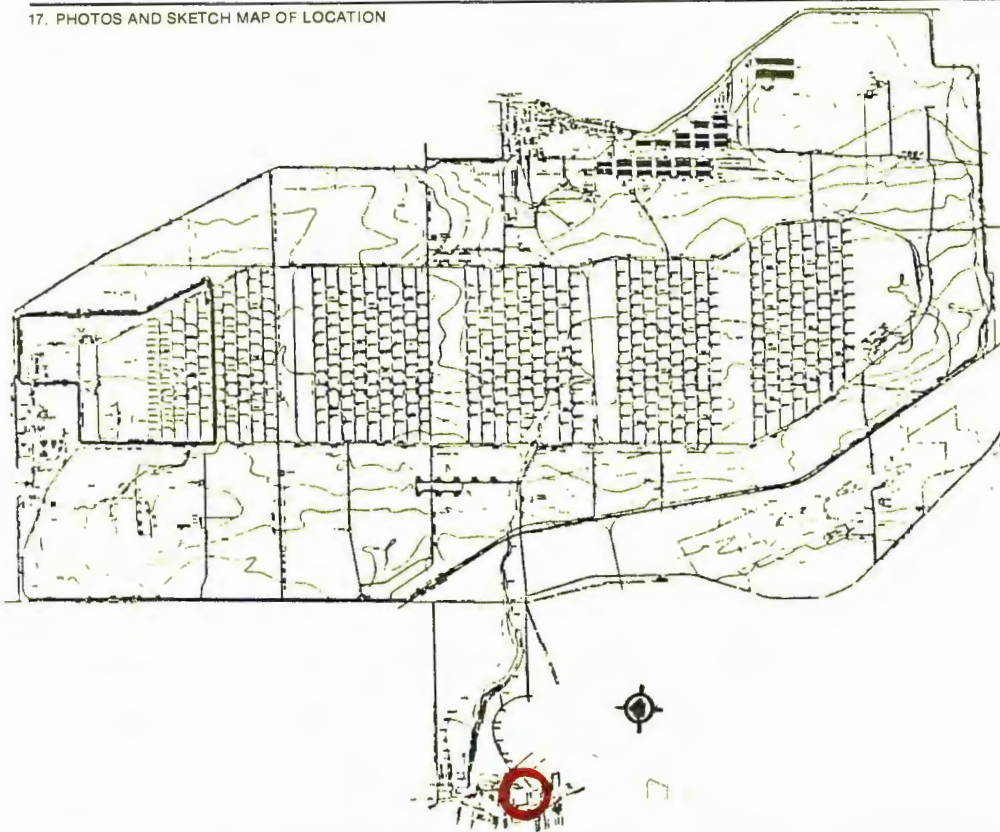
East & North Elevations
1:28

Concrete block foundation. Wood frame construction clad with vinyl siding. L-shaped, 44' x 19' with a 6' x 5' offset. One story. Intersecting gable roof, asbestos shingles. Six-over-six-light double hung sash. Wood and glass door, north side. Faces north.

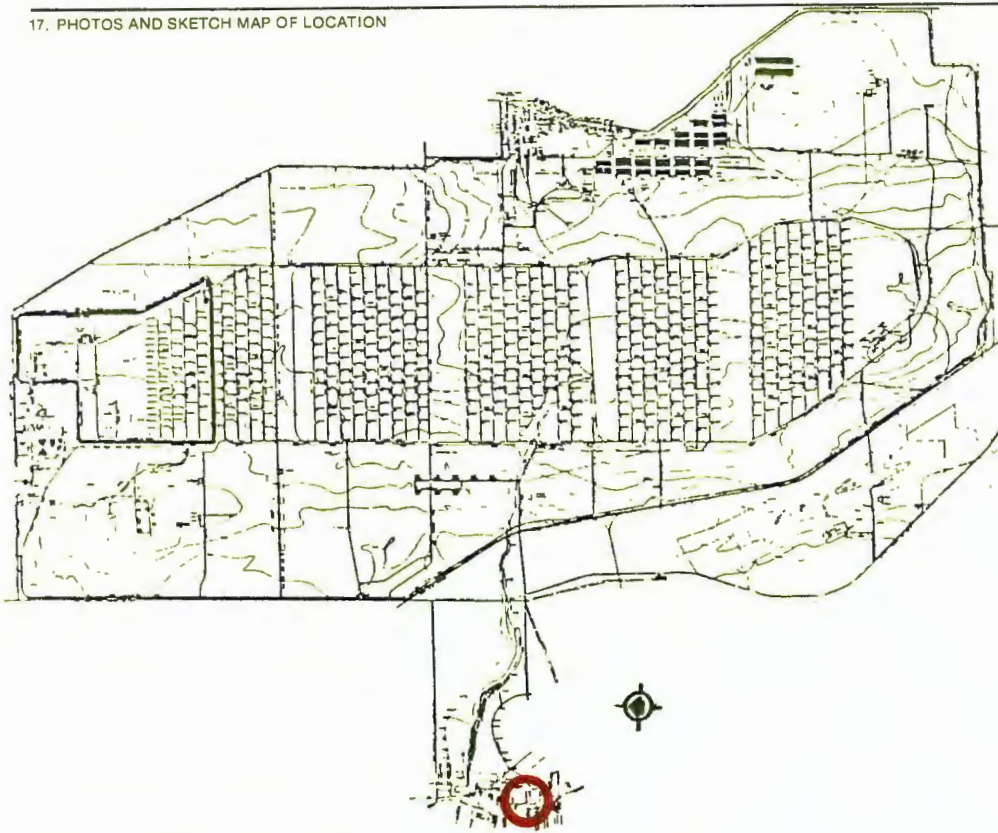
East & South Elevations
1:27

Concrete block foundation. Wood frame construction clad with vinyl siding. Irregular plan, 24' x 53' with 12' x 24' offset and 11' x 14' and 20' x 20' wings. One story. Intersecting gable roof, asbestos shingles. Six-over-six-light double hung sash. Wood and glass door, east side. Faces east.

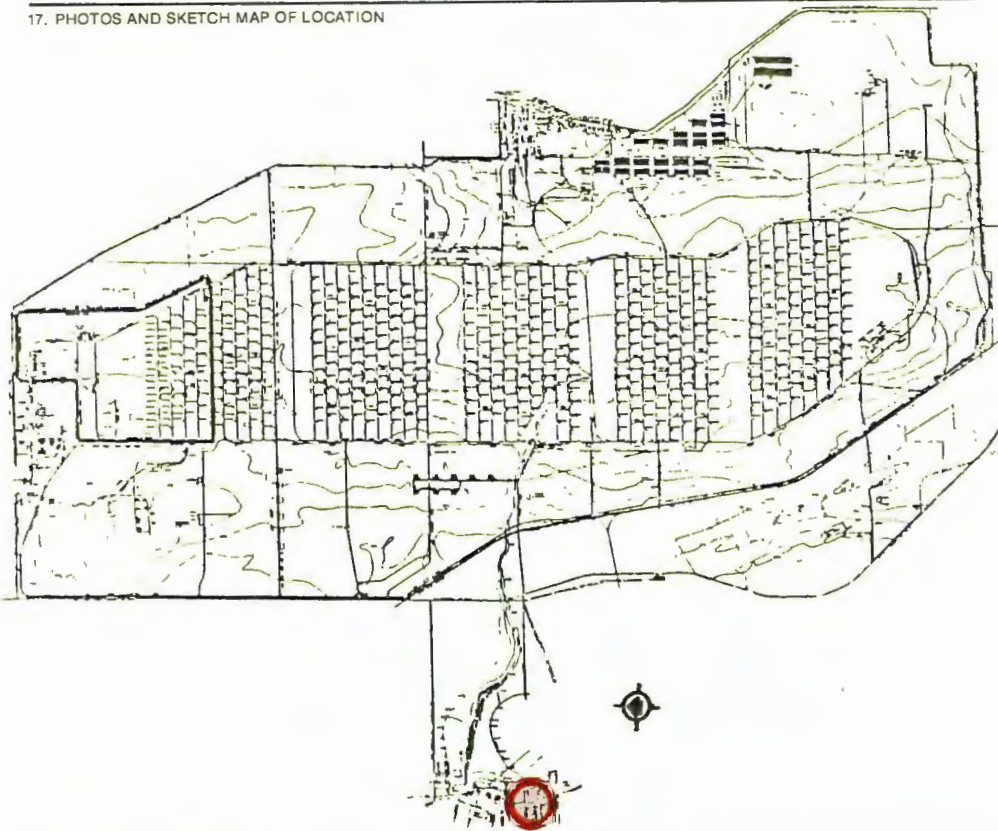
East Elevation
1:26

Concrete foundation. Wood frame construction clad with vinyl siding. Rectangular, 30' x 24' with a 17' x 8' offset and a 21' x 13' wing. One story. Gable roof, asbestos shingles. One-over-one-light double hung sash. Wood and glass door, east side. Faces east.

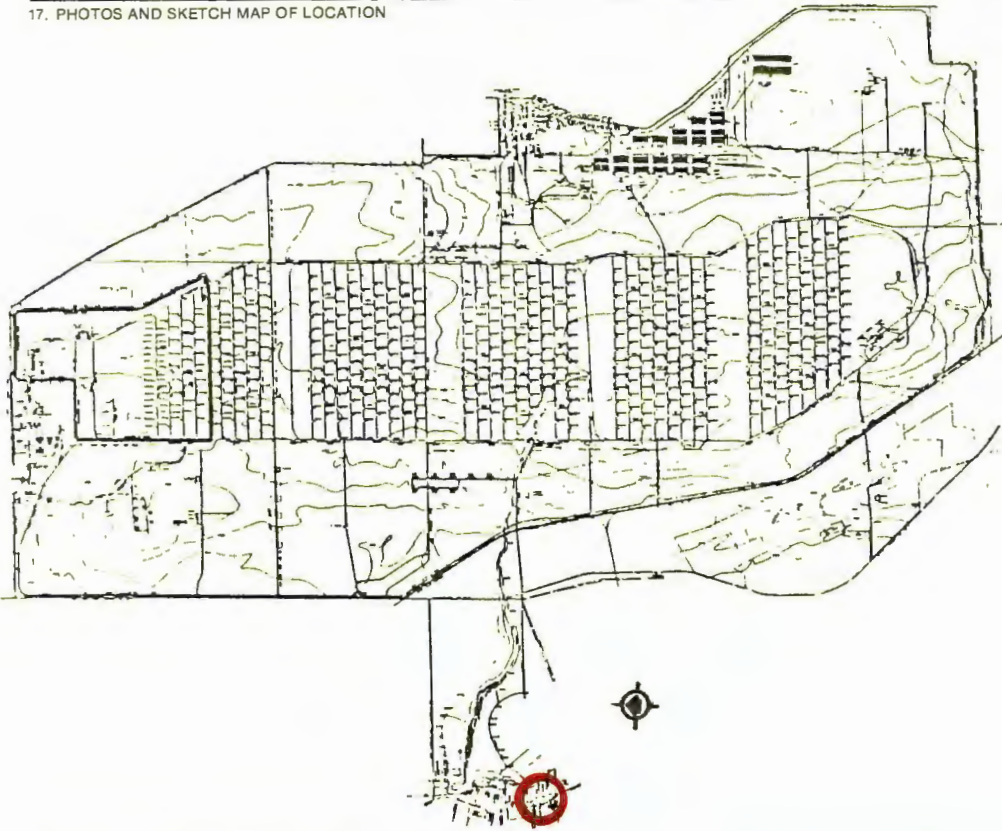
East & South Elevations
1:25

Concrete block foundation. Wood frame construction clad with vinyl siding. L-shaped, 43' x 30'. One story. Intersecting gable roof, asbestos shingles. One-over-one-light double hung sash. Wood and glass door, east side. Faces east.

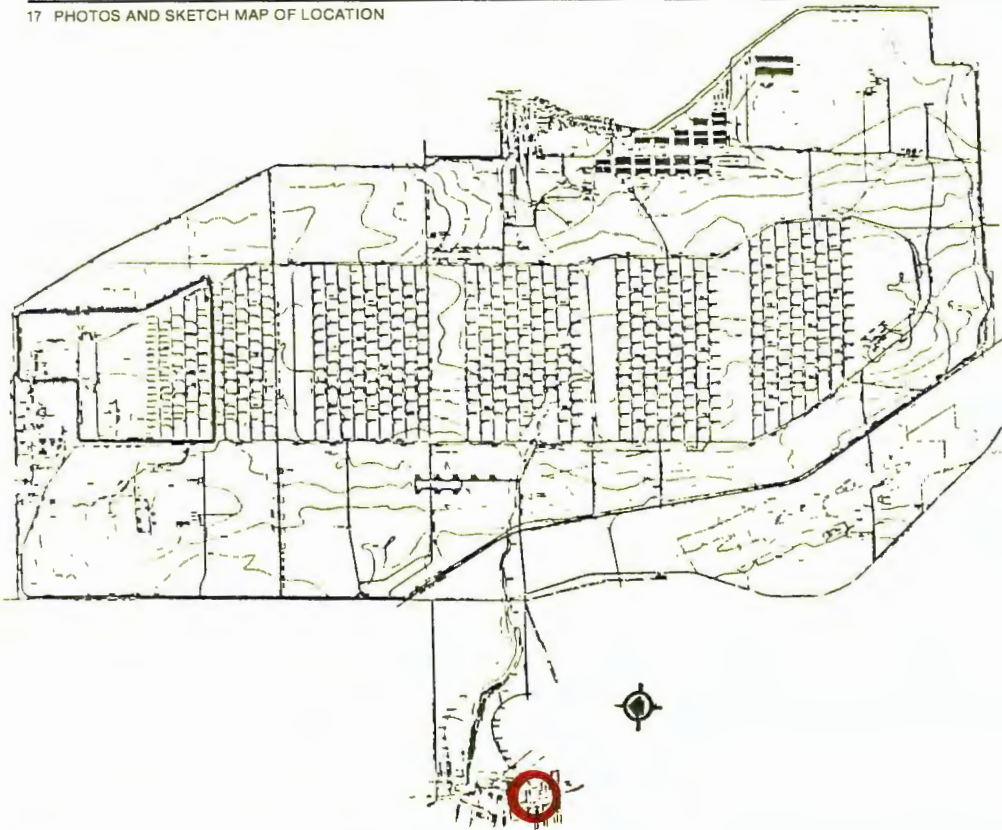
East Elevation
1:24

Concrete block foundation. Wood frame construction clad with vinyl siding. T-shaped, 44' x 24'. One-and-a-half stories. Hip roof with single dormer on the east side, asbestos shingles. One-over-one-light double hung sash. Wood and glass door, east side. Faces east.

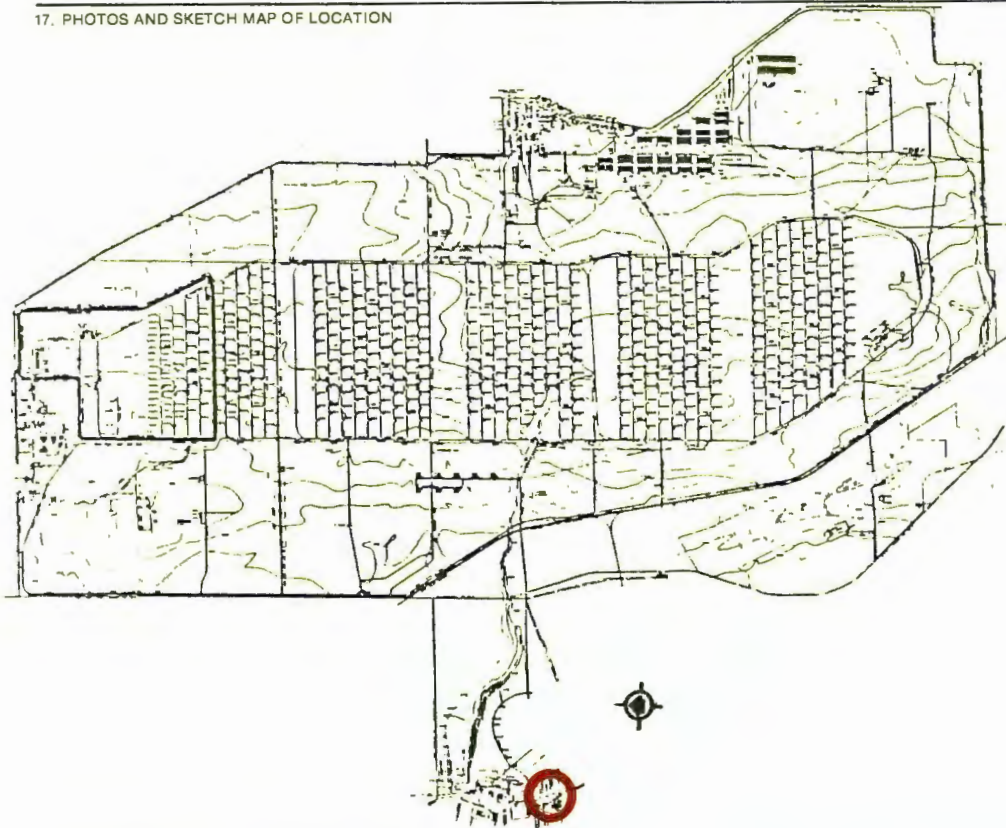
East Elevation
1:23

Concrete block foundation. Wood frame construction clad with vinyl siding. T-shaped, 44' x 24' with a 9' x 3' offset. One story. Intersecting gable roof, asbestos shingles. One-over-one-light double hung sash. Wood and glass door, east side. Faces east.

14. CONDITION	<input type="checkbox"/> EXCELLENT	<input checked="" type="checkbox"/> GOOD	<input type="checkbox"/> FAIR	<input type="checkbox"/> DETERIORATED	<input type="checkbox"/> RUINS	15. DANGER OF DEMOLITION? (SPECIFY THREAT)	<input type="checkbox"/> YES	<input checked="" type="checkbox"/> NO	<input type="checkbox"/> UNKNOWN
---------------	------------------------------------	--	-------------------------------	---------------------------------------	--------------------------------	---	------------------------------	--	----------------------------------

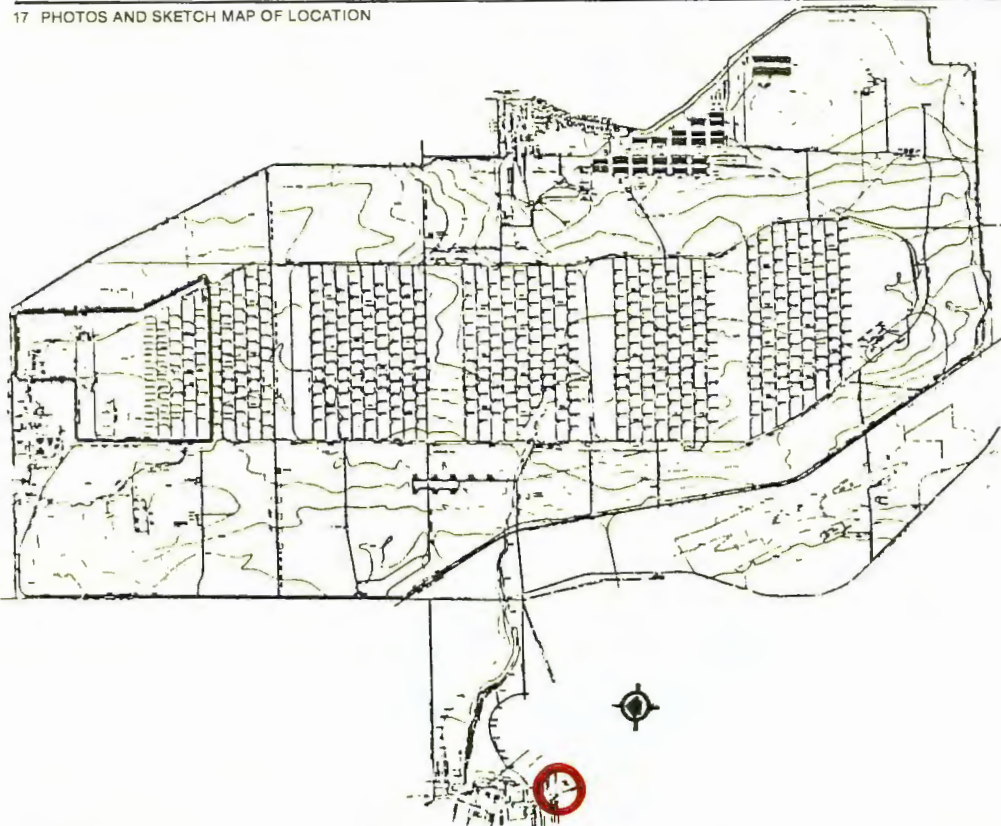
East Elevation
1:22

Concrete block foundation. Wood frame construction clad with vinyl siding. Rectangular, 47' x 21' with a 13' x 20' wing and a 14' x 12' offset. One story. Gable roof, asbestos shingles. One-over-one-light double hung sash. Wood and glass door, east side. Faces east.
