**Seneca Army Depot Activity  
Romulus, New York**

# **Final Five-Year Review**

**August 2021**

SEAD 1, 2, 5, 12, 13, 16, 17, 23, 25, 26, 27, 39, 40, 41, 43, 44A,  
44B, 46, 52, 56, 59, 62, 64A, 64B, 64C, 64D, 66, 67, 69,  
71, 121C, 121I, 122B, 122E, 002-R-01, 003-R-01, 007-R-01,  
AND THE ASH LANDFILL OPERABLE UNIT (SEADs 3, 6, 8, 14, and 15)

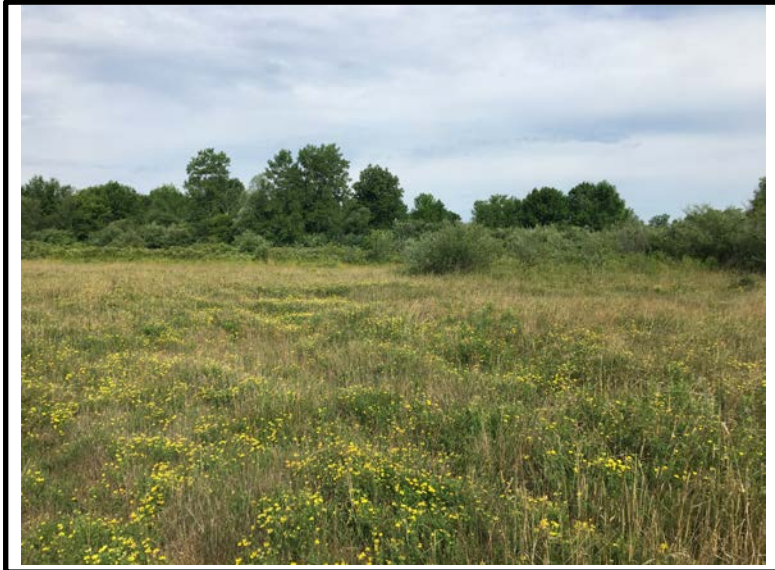
**2020 Site Visit Photo 1**

Status as of: 7/22/2020 Photo ID: IMG\_3851.jpg  
 Description: SEAD-17, Building 367 foundation.

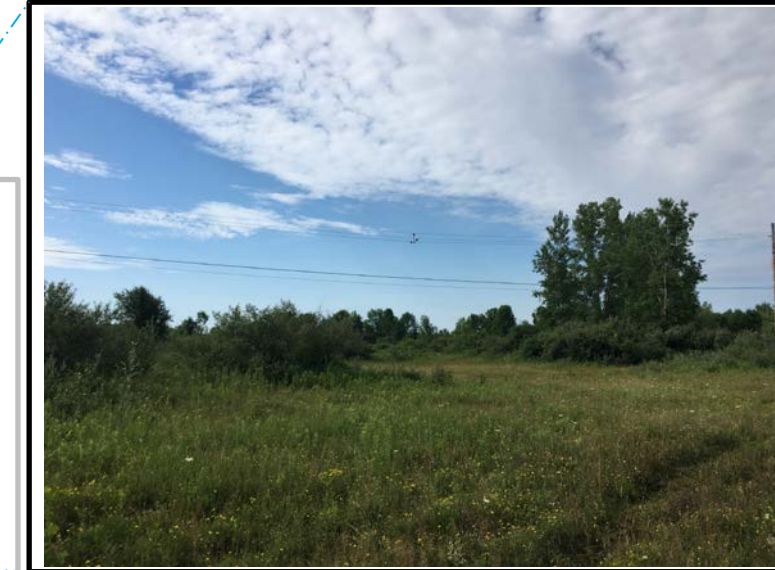
**2020 Site Visit Photo 3**

Status as of: 7/22/2020 Photo ID: IMG\_3852.jpg  
 Description: SEAD-17, Building 367 foundation.

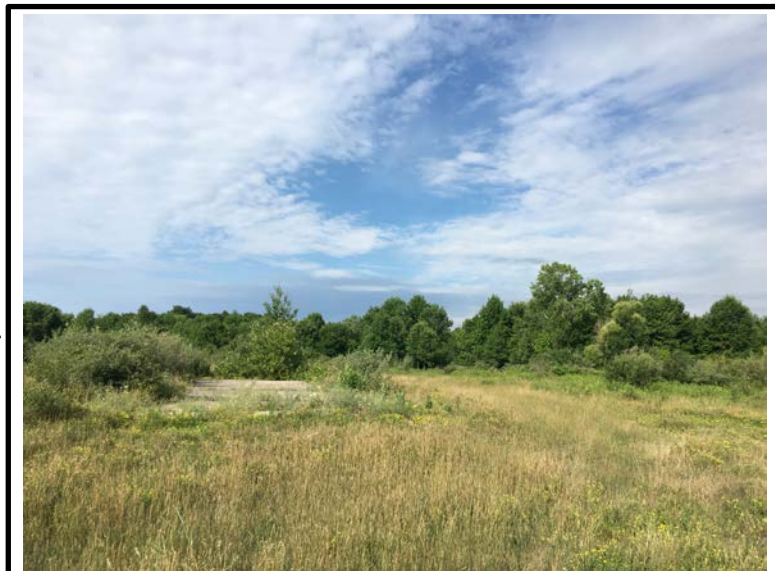
**2020 Site Visit Photo 2**

Status as of: 7/22/2020 Photo ID: IMG\_3850.jpg  
 Description: SEAD-17, Building 367 foundation.

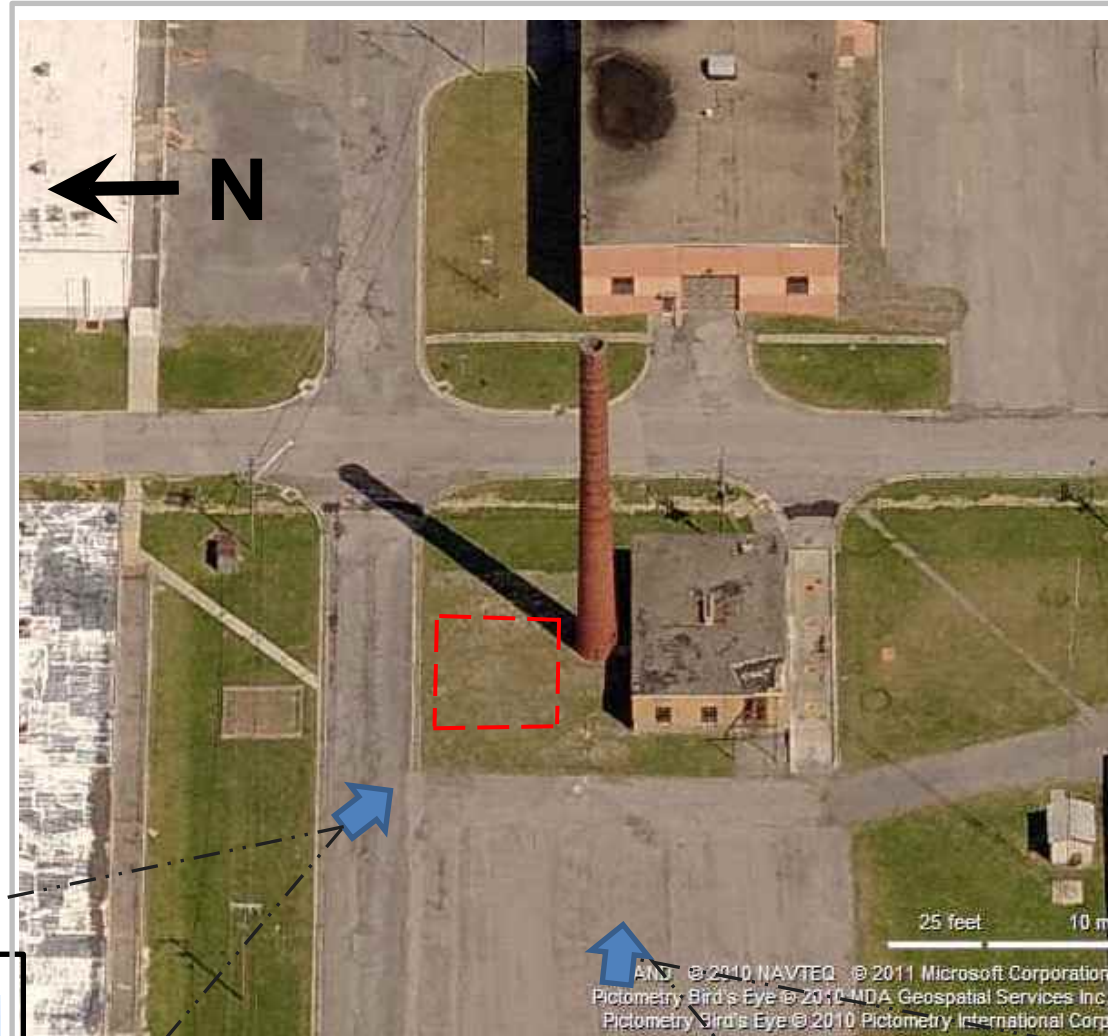
Status as of: 7/22/2020 Photo ID: IMG\_3870.jpg  
 Description: SEAD-39 blowdown pit in foreground

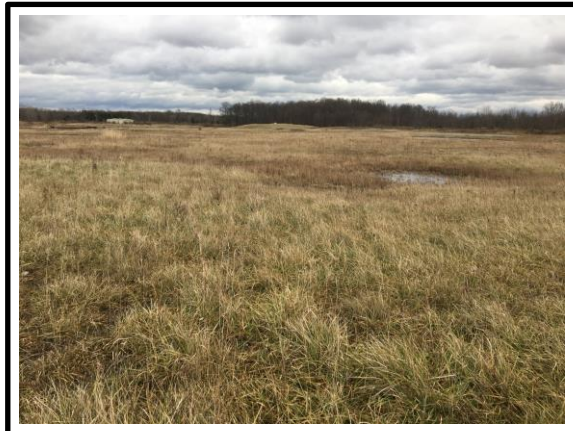
### 2019 Site Visit Photo 1 - 3

Status as of: 11/22/2019 Grid D7. Dense vegetation. No erosion or disturbances observed. Two low areas (NW and NE corners) collecting water. View to southeast

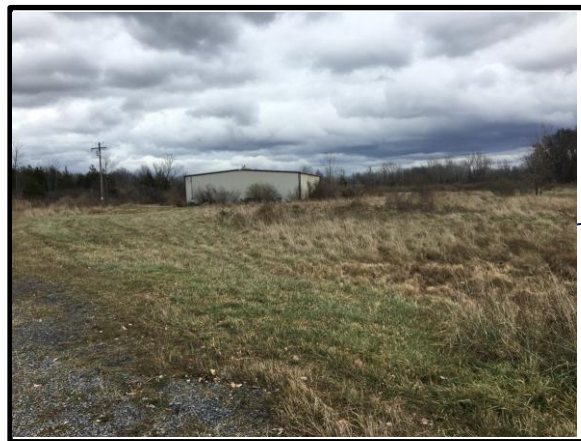
Status as of: 11/22/2019 Grid P10. No erosion or disturbances to the cap were observed. The grid is well vegetated. Wet swampy area in northeast portion of grid. View to the southeast

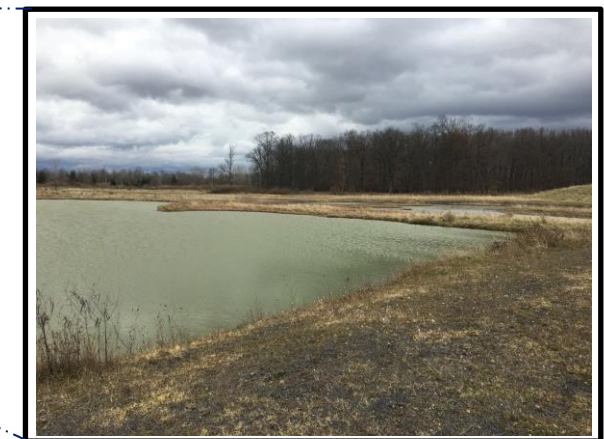
Status as of: 11/22/2019 Grid L9. The grid is well vegetated along the edges of the pond; thin areas noted in center of grid and along slopes. View to the southeast
