**SUBJECT:** Final Historical Records Review, Supplemental Site Inspection at Four Known PFAS Sites and Preliminary Assessment/Site Inspection at Suspected PFAS Sites, Former Seneca Army Depot Activity in Romulus, NY; EPA Site ID# NY0213820830 and NY Site ID# 8-50-006

# **HISTORICAL RECORDS REVIEW**

## **SUPPLEMENTAL SITE INSPECTION AT FOUR KNOWN PFAS SITES AND PRELIMINARY ASSESSMENT/SITE INSPECTION AT SUSPECTED PFAS SITES FORMER SENECA ARMY DEPOT ROMULUS, NEW YORK**

**Prepared by  
HydroGeoLogic, Inc.  
Northway 10 Executive Park  
313 Ushers Road  
Ballston Lake, NY 12019**

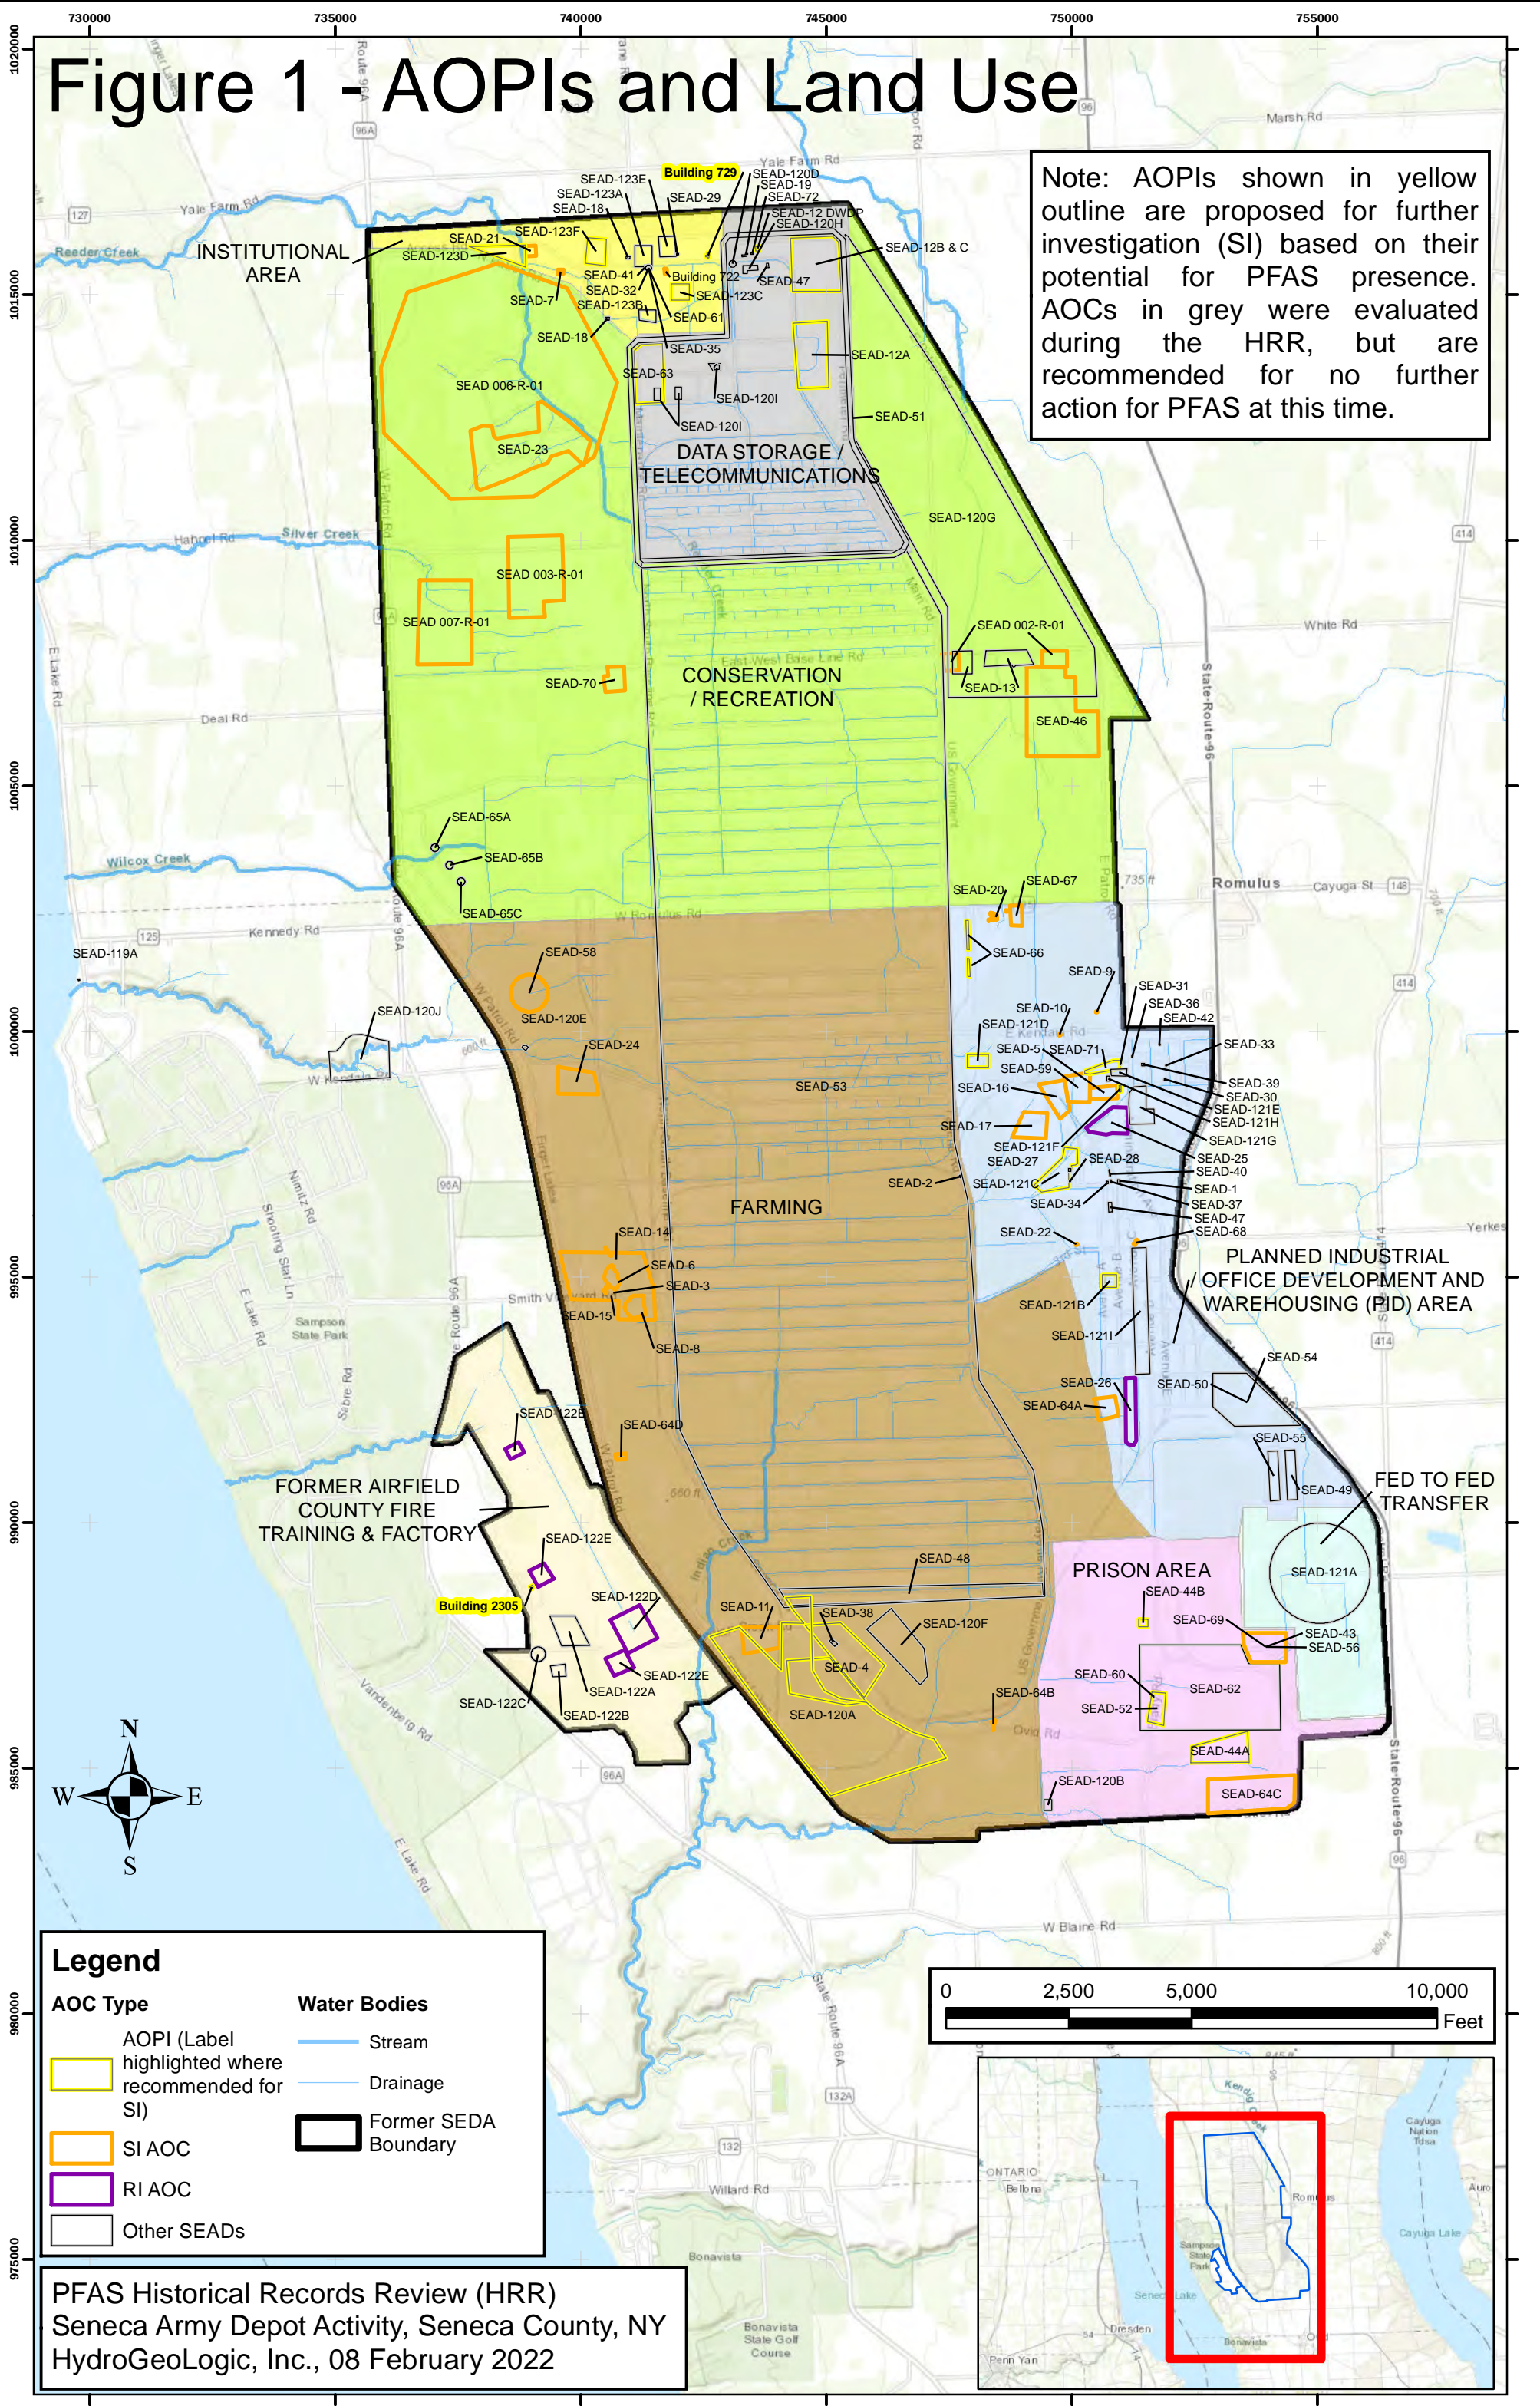
# Figure 1 - AOPIs and Land Use

Note: AOPIs shown in yellow outline are proposed for further investigation (SI) based on their potential for PFAS presence. AOCs in grey were evaluated during the HRR, but are recommended for no further action for PFAS at this time.

If any of those five activities were either suspected or confirmed to occur based on the finding of the HRR, the SEAD was identified as an AOPI (Table 1B). The result of the PA and HRR is that all 34 sites initially recommended by the Army to investigate are still recommended to proceed to the SI stage (Table 1A). Of the additional 78 identified SEADs evaluated and presented in Table 1B, 20 individual SEADs and two buildings are proposed as AOPIs for potential further investigation. The two building AOPIs, Buildings 729 and 2305, are recommended for SI due to their former use as fire stations. The remaining AOPIs are recommended for no action at this time pending the 34 SIs of similar type sites. These AOPIs will be reevaluated subsequent to results received from the SIs. If SI analytical results indicate a particular site type (e.g., disposal area) is not associated with a PFAS release, these AOPI site types may be recommended for no action.

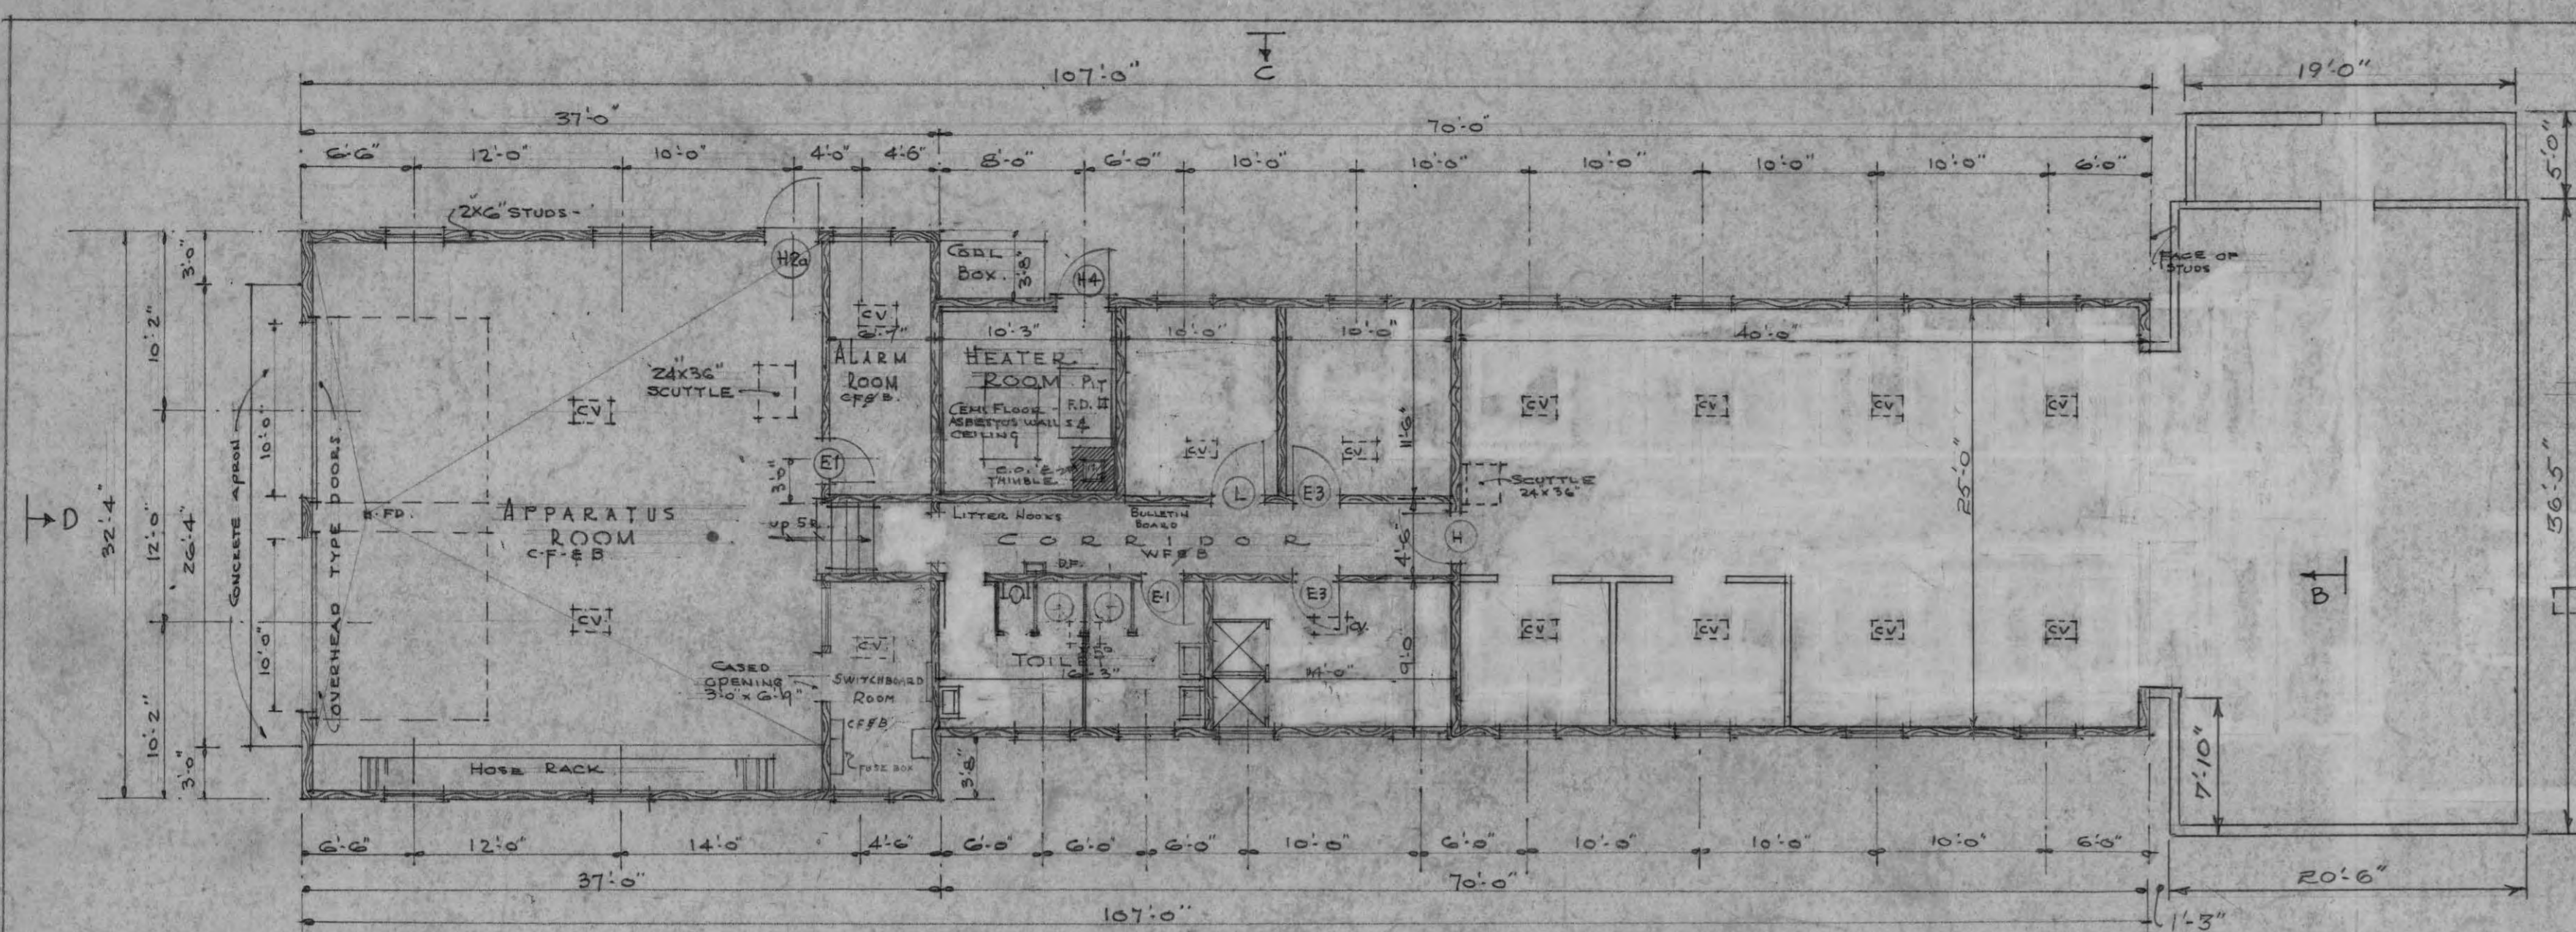
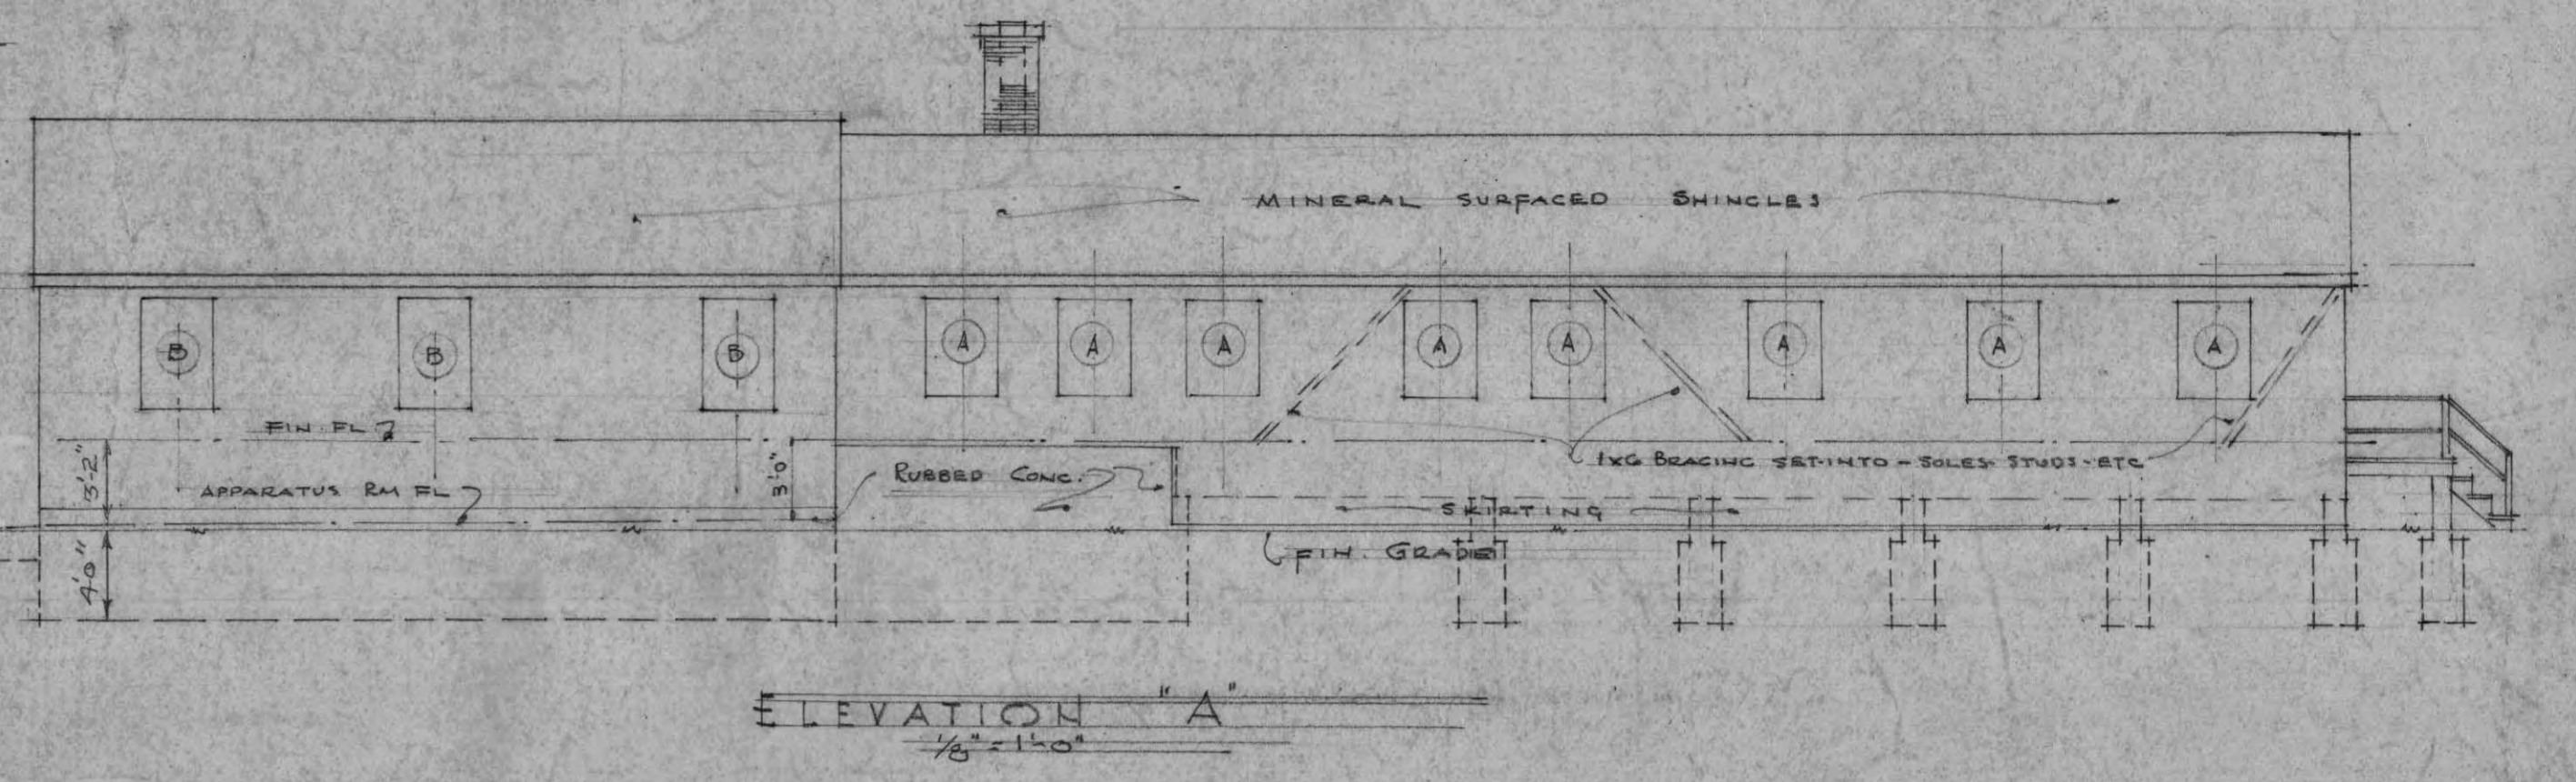
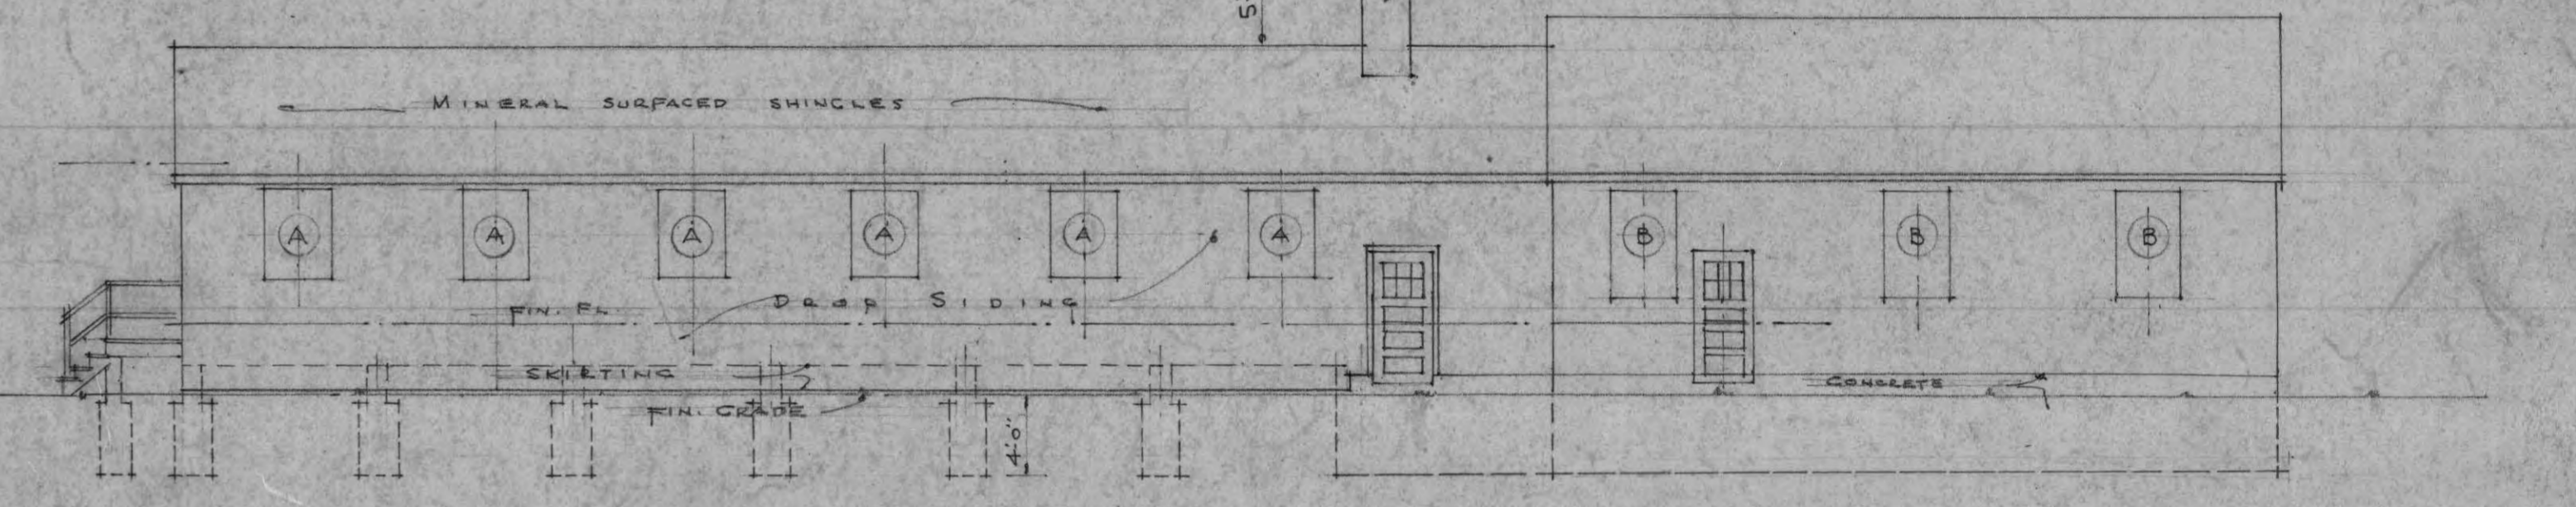
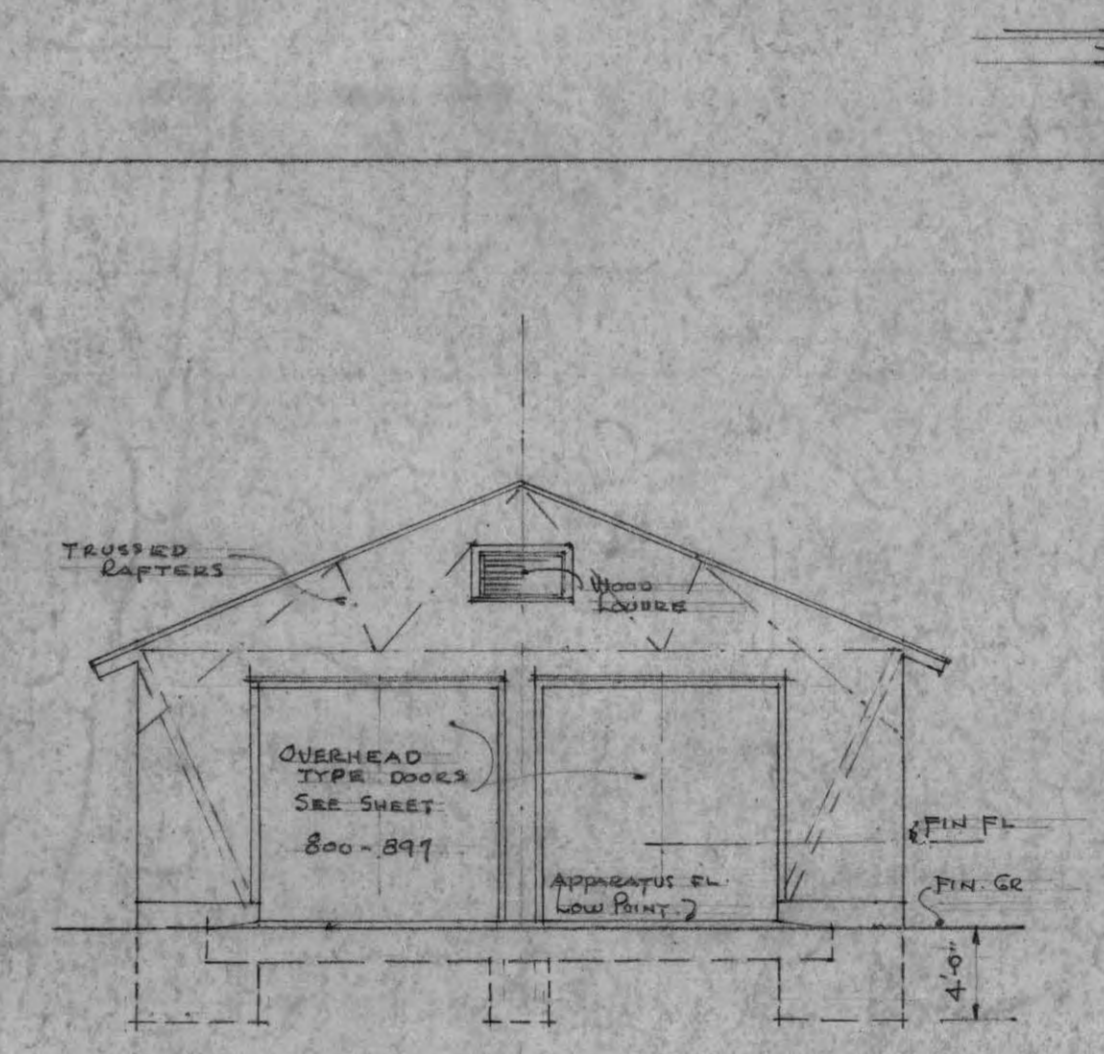
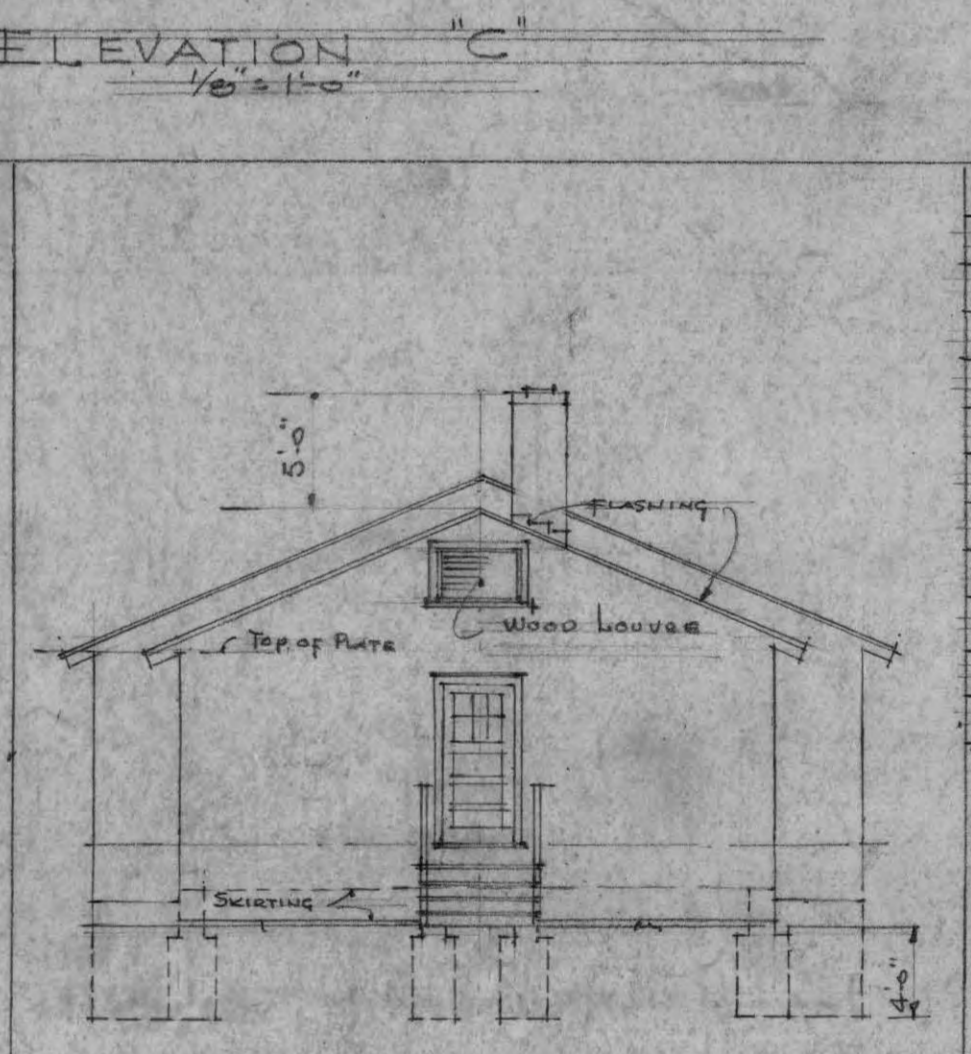
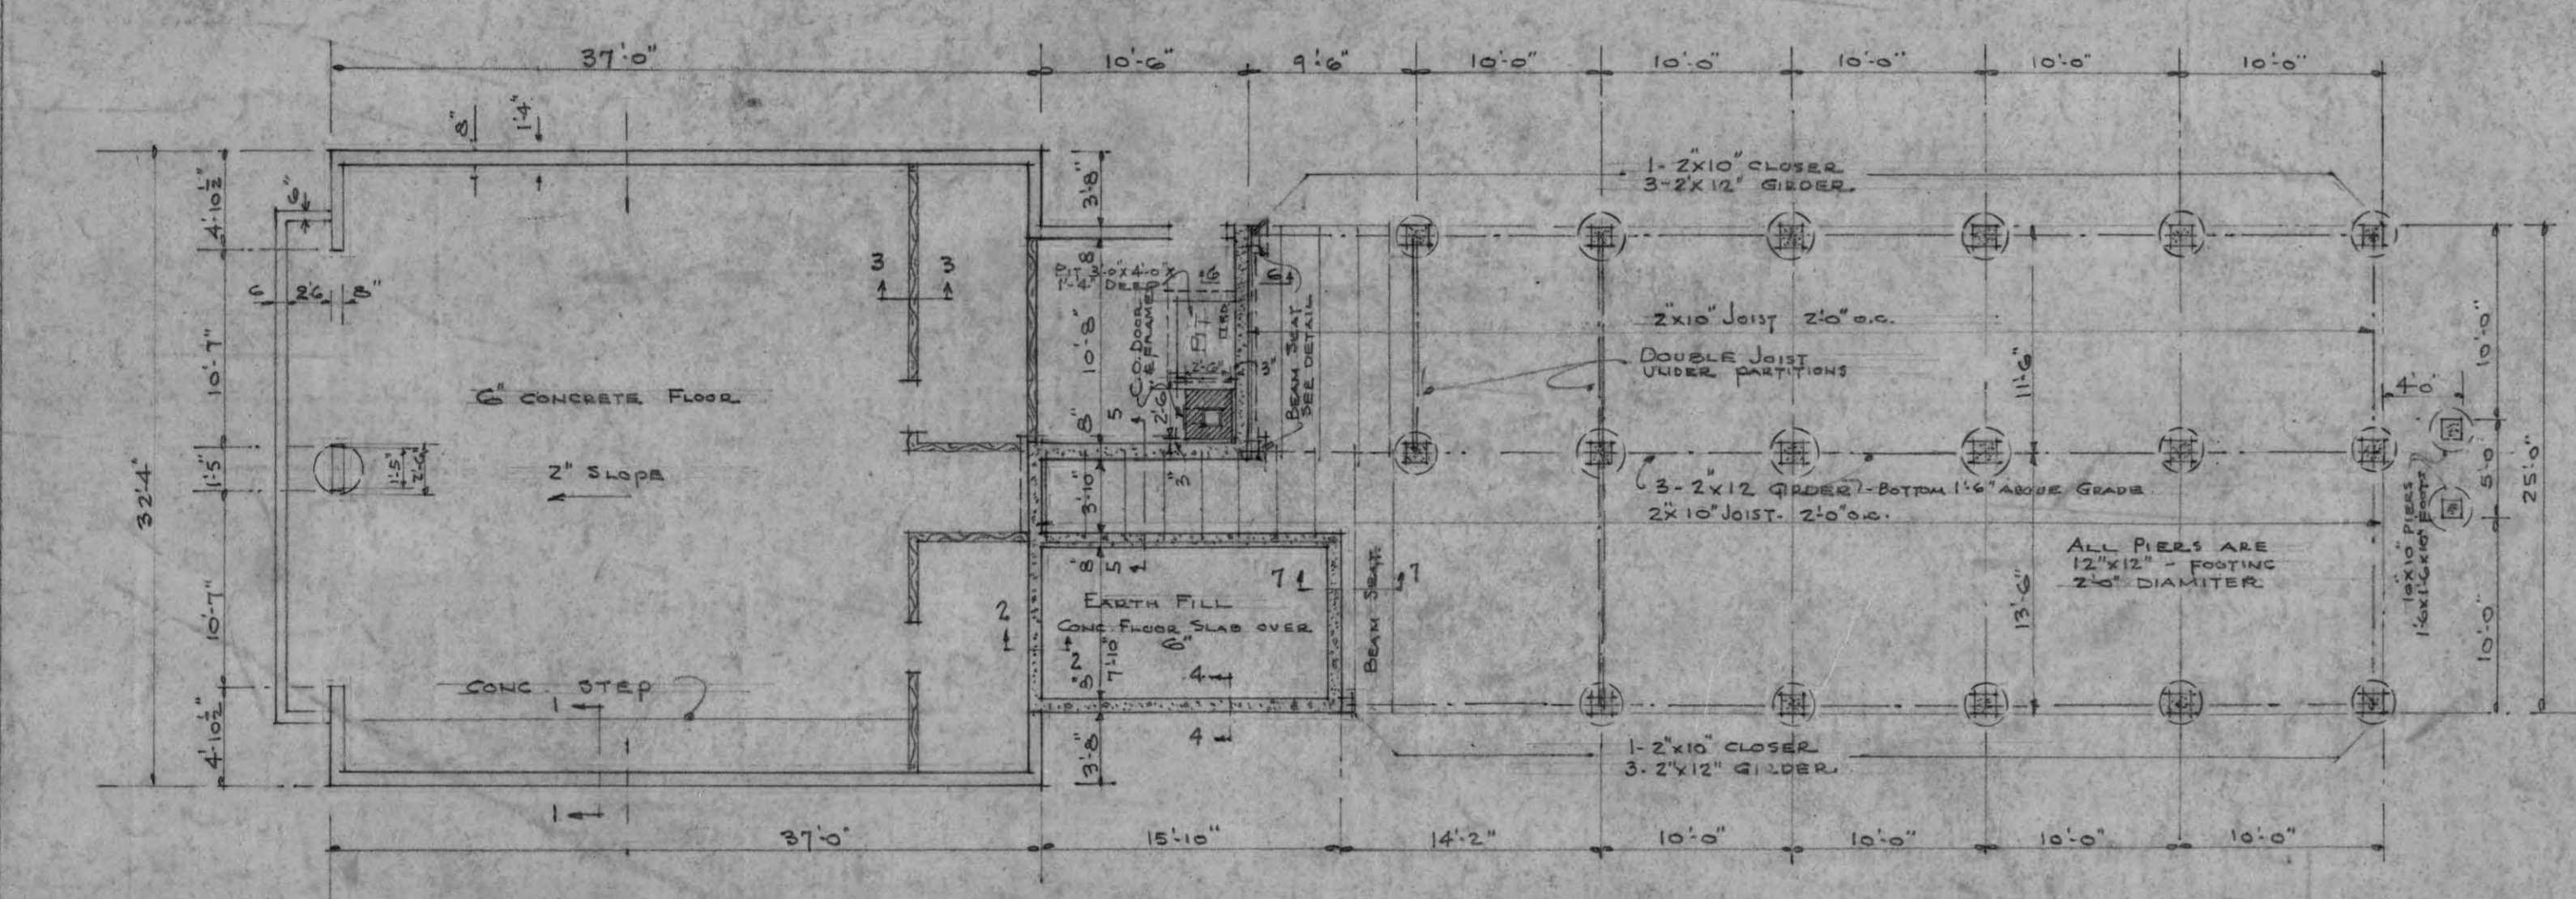
General Supply Area Fire Station Type F-3

**NOTE**  
ALL FOOTINGS SHALL REST ON SOLID BEARING AND IN ALL CASES SHALL EXTEND 12" MIN. BELOW NATURAL GRADE.

**NOTE: REVISION TO FLOOR PLAN - THIS SHEET ONLY. CHANGES TO HEATING, PLUMBING, & ELECTRICAL LAYOUTS NOT KNOWN OR REVISED.**

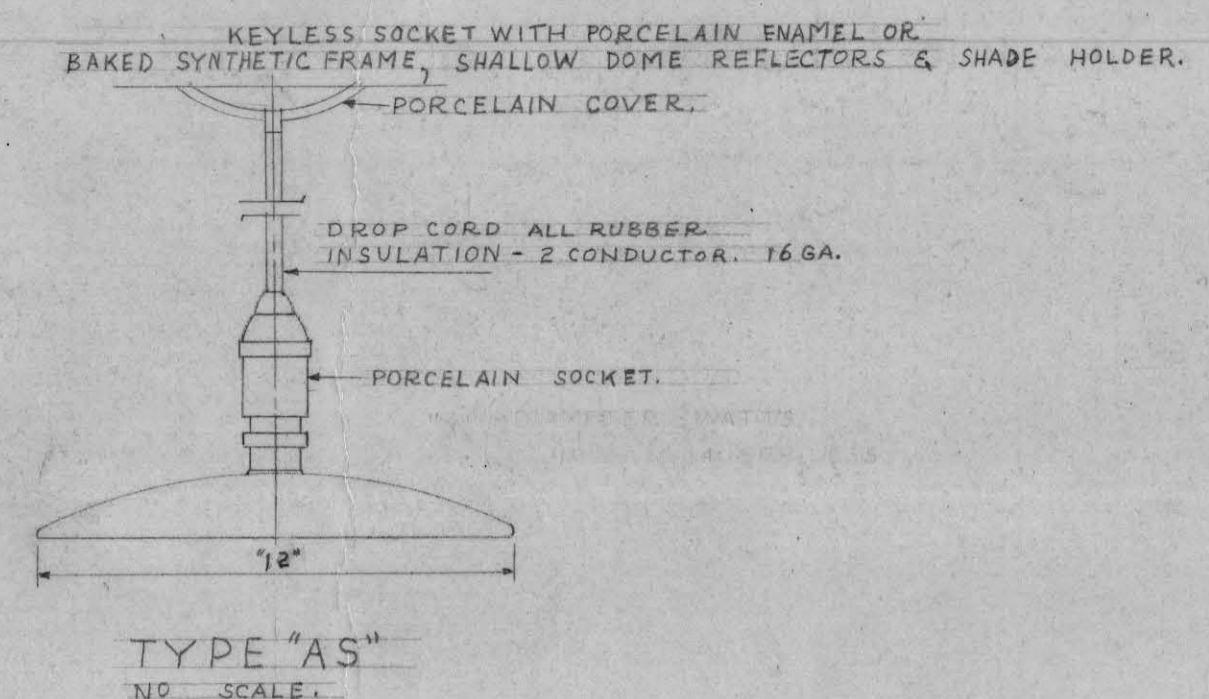
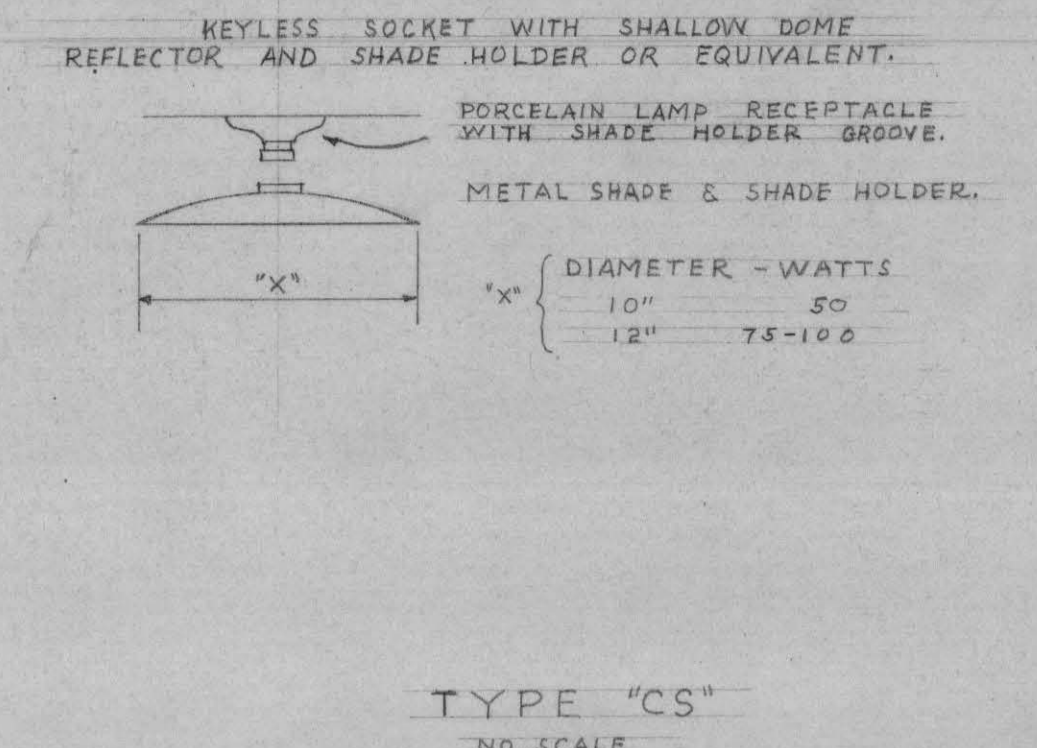
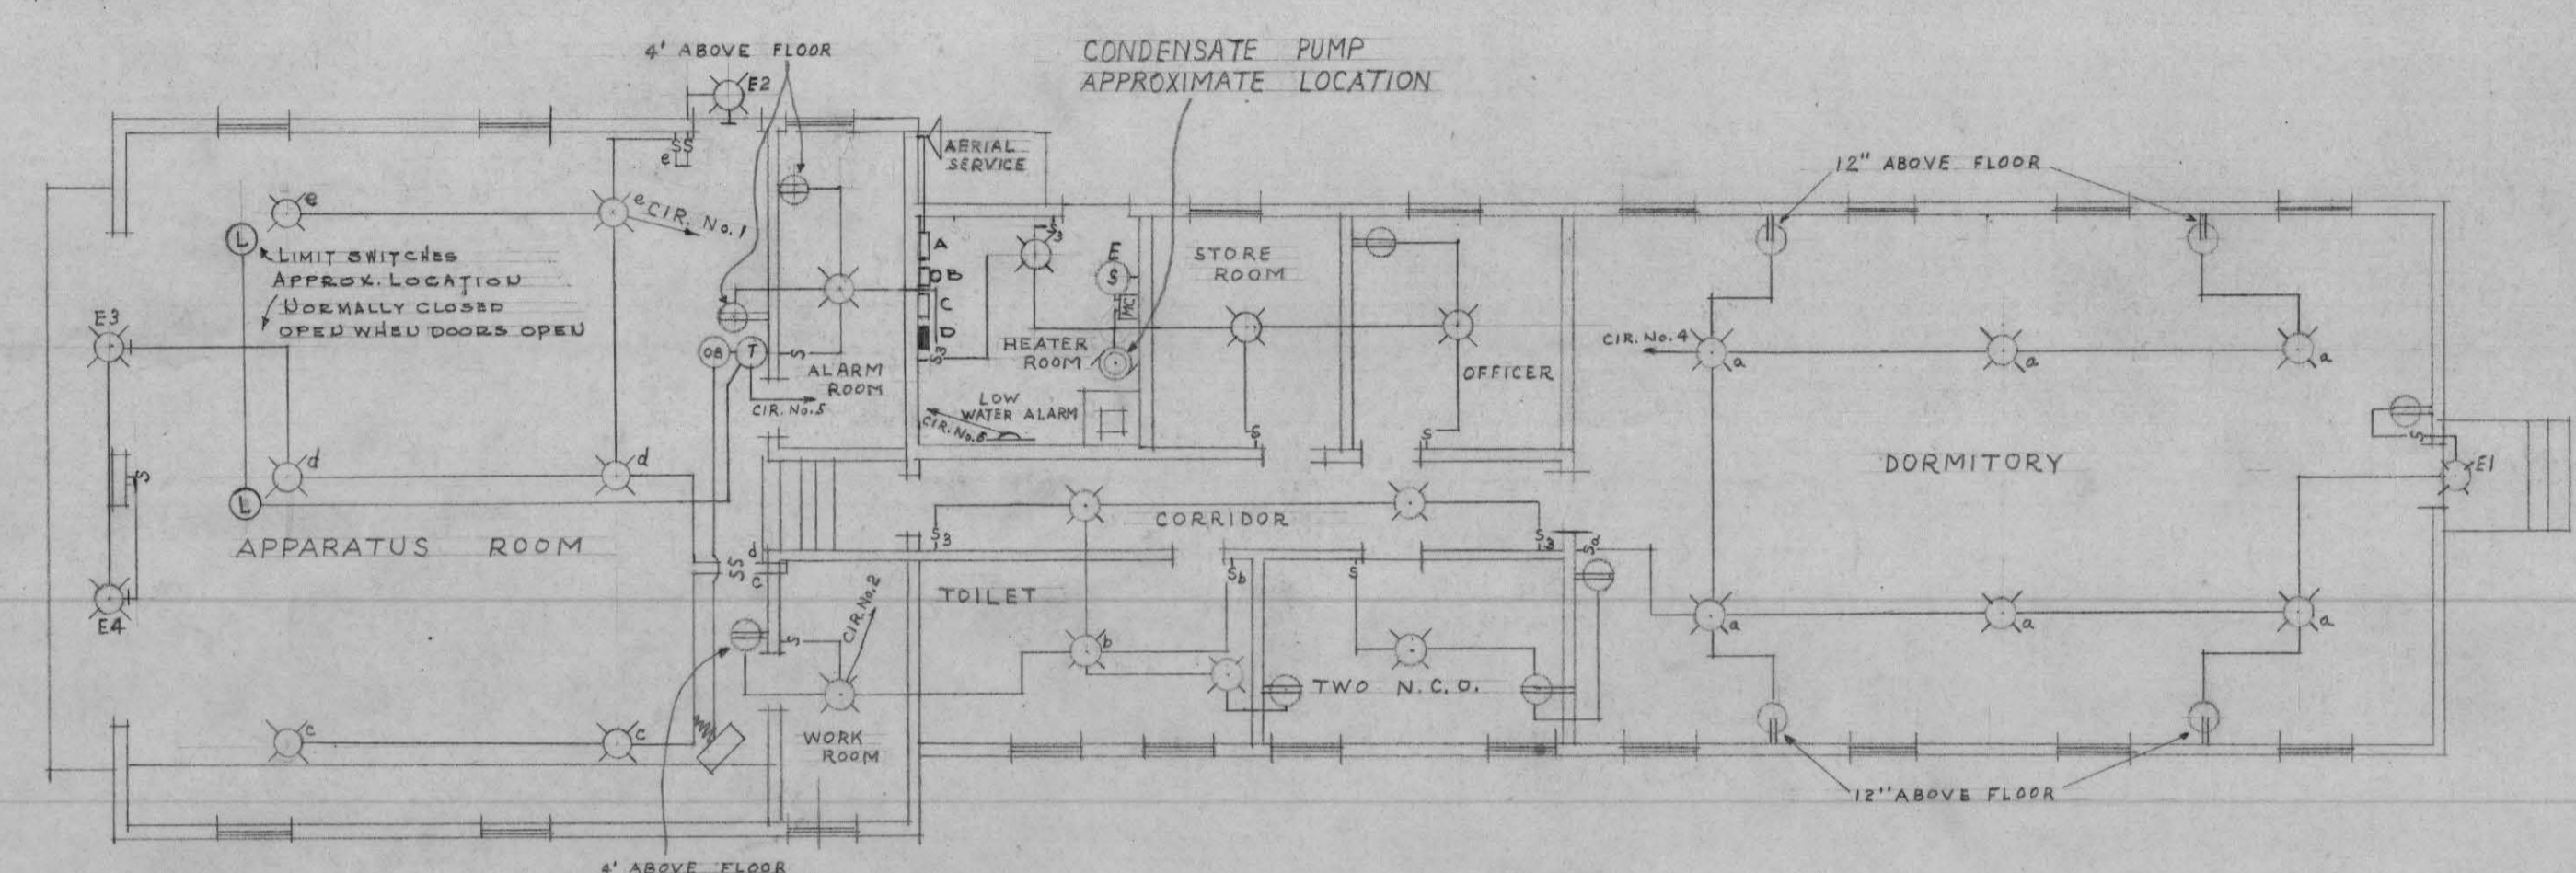
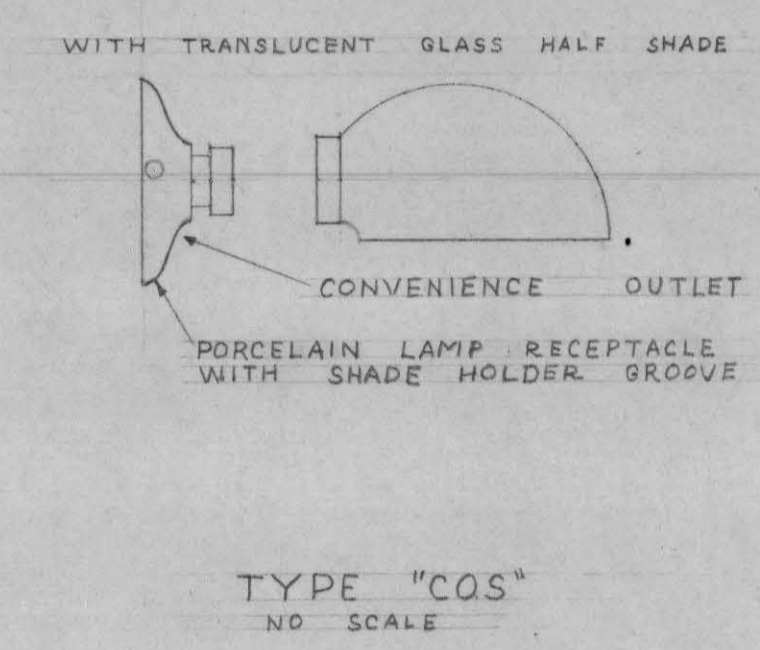
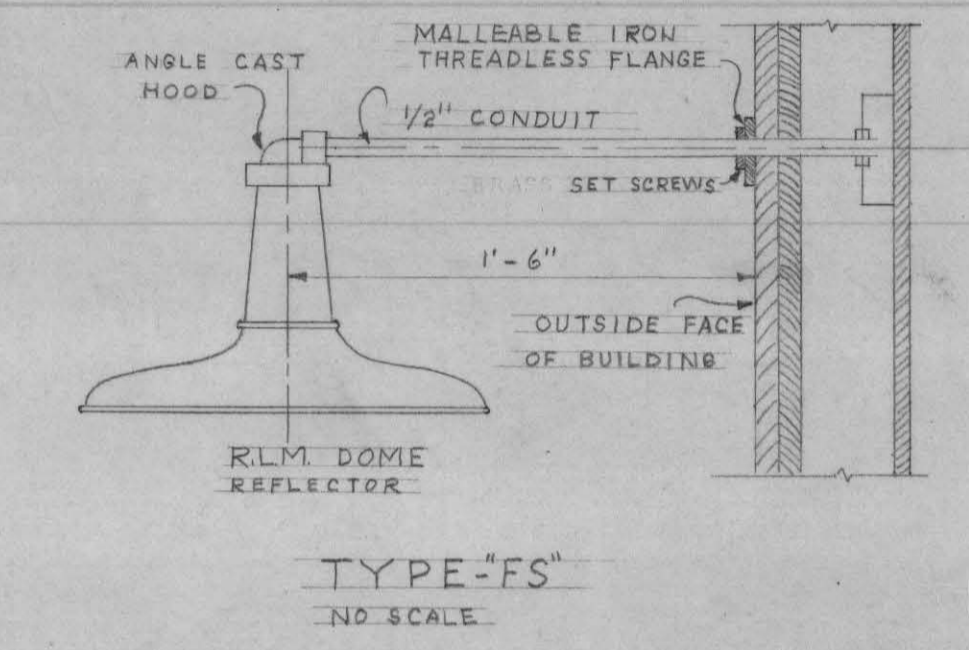
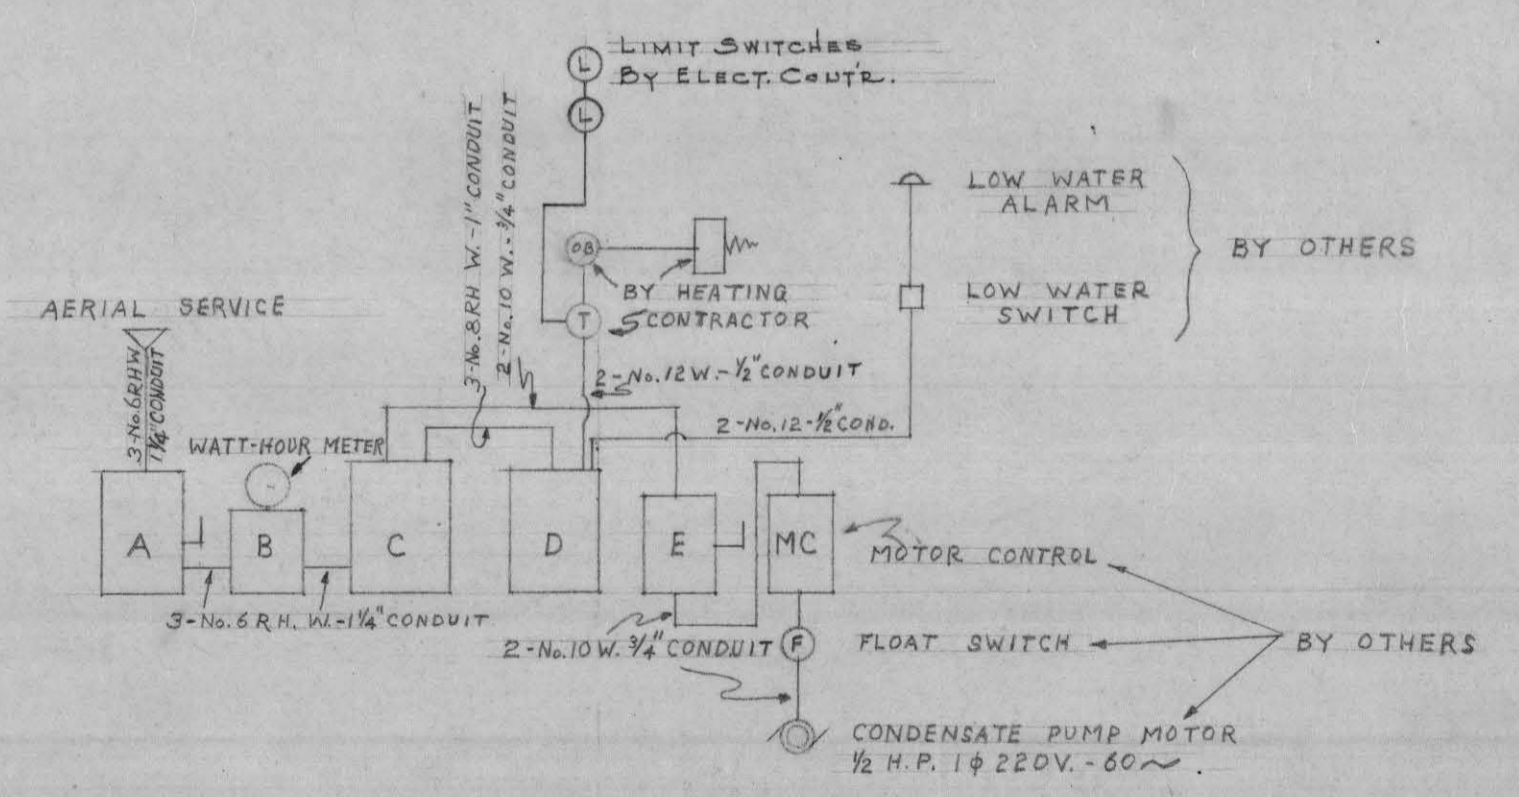
General Supply Area Fire Station Type F-3  
Electrical Layout

FIRST FLOOR PLAN  
SCALE = 1/8" = 1'-0"

ALL WIRING TO BE WITH No. 12 NON METALLIC SHEATHED CABLE CONCEALED EXCEPT AS NOTED.  
ALL WIRING IN HEATER ROOM TO BE WITH R.H. CONDUCTORS IN RIGID CONDUIT.  
SERVICE - 3 WIRE 1  $\phi$  50 CYCLE - 120/240 VOLTS.  
A- MAIN SWITCH - TYPE "C" - 60 AMP. 3 P.S.N. - 250 VOLT. FUSED.  
B- METER & CONN. BOX - METER 15 AMP. SELF CONTAINED 1  $\phi$  3 WIRE - 120/240 VOLTS.  
C- MAIN DISTRIBUTION PANEL - 4 CIRCUIT - PULFUZ TYPE.  
D- LIGHTING PANEL - 8 CIRCUIT - SW. & PLUG FUSE TYPE.  
E- MOTOR DISCONNECT SWITCH - 30 AMP. 2 POLE - 250 VOLT FUSED - TYPE C.  
UNIT HEATER - THERMOSTAT - OVERLOAD BREAKER & MOTOR CONTROL TO BE FURNISHED BY HEATING CONTRACTOR - WIRING TO BE DONE BY ELECTRICAL CONTRACTOR.  
LOW WATER ALARM TO BE FURNISHED BY HEATING CONTRACTOR AND INSTALLED BY THIS ELECTRICAL CONTRACTOR.  
FIXTURE OUTLET BOXES TO BE SHEET STEEL - BLACK ENAMEL.

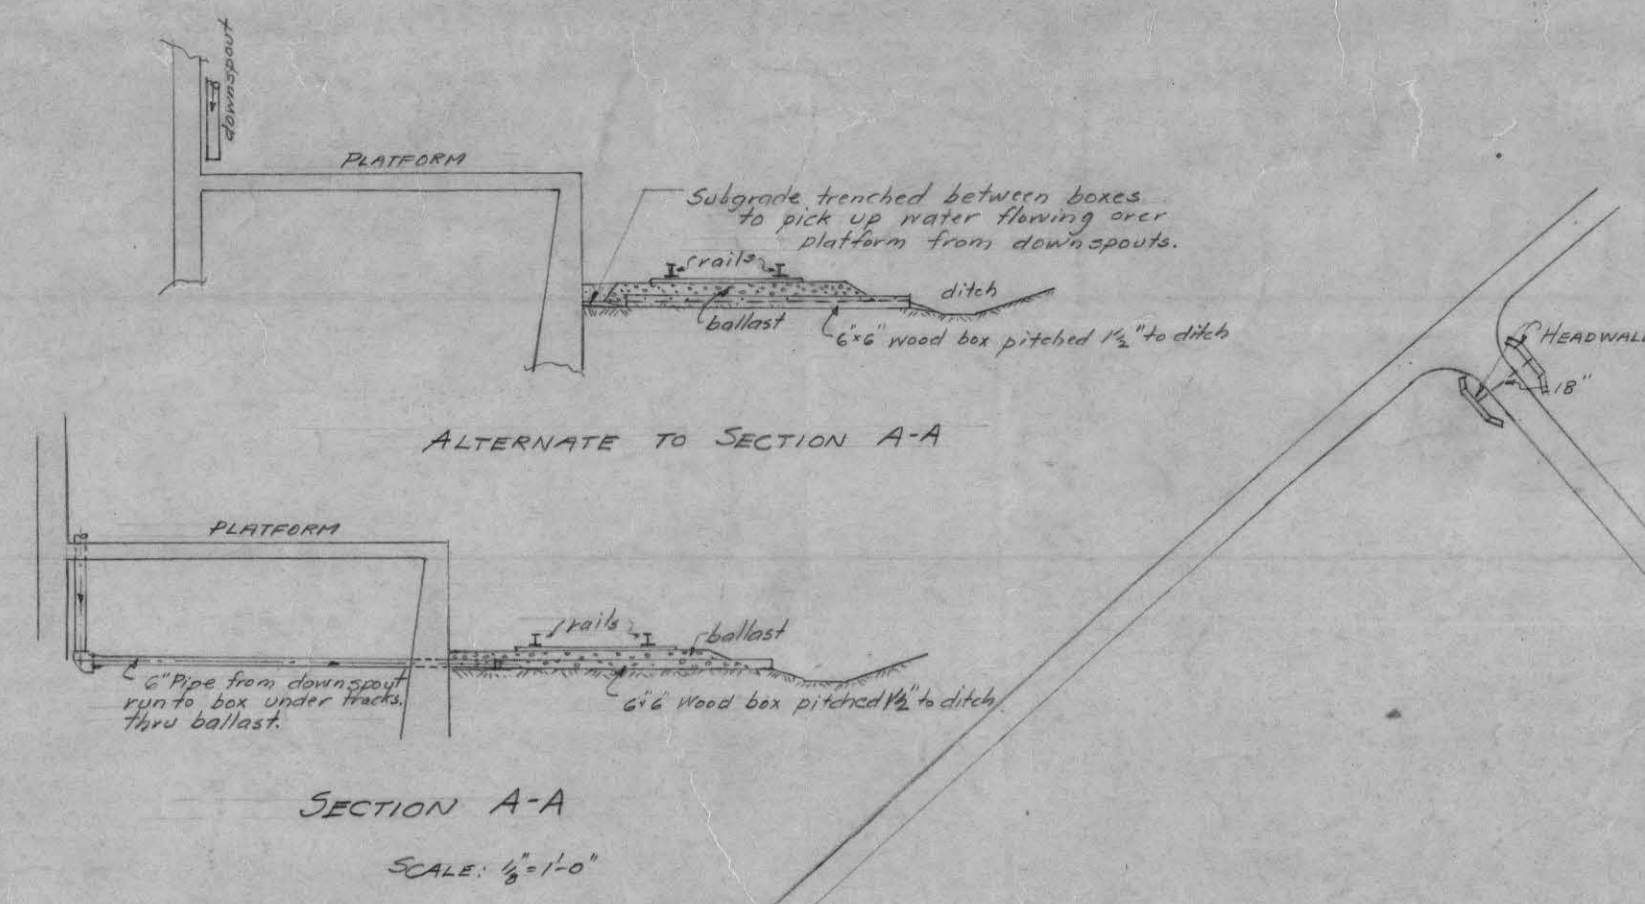
**U. S. ENGINEER OFFICE  
 SENECA AREA  
 ROMULUS, N. Y.  
 SENECA ORDNANCE DEPOT  
 WATER LINES  
 GENERAL SUPPLY AREA  
 (SOUTH SECTION)  
 WATER & SEWER PLAN**

- SEWERS**
1. Sanitary Sewers shall be located 48 feet from the centerline of the East-West roads.
  2. Storm Sewers shall be located 33 feet from the centerline of the East-West roads.
  3. Concrete Pipe may be used as an alternate to the vitrified tile pipe for storm drains only.
  4. Laterals to Drainage Inlets shall be 6" pipe, steel long unless otherwise noted.
  5. Storm Sewers crossing the roads to be put in by others. For size, grade, and amount to be placed by others refer to drawing No. 6256-A.

Provide guard posts for hydrants as directed by the Engineer.  
 Sanitary Truck Sewer on Avenues "A" & "B" and down 5th Street not in this Contract.  
 Connect three (3) roof drains for sheds into south sewer.  
 Connect remaining drains with North sewer.  
 For Warehouse connect half of roof drains into south & half into North sewers.
