**SUBJECT:** Final Historical Records Review, Supplemental Site Inspection at Four Known PFAS Sites and Preliminary Assessment/Site Inspection at Suspected PFAS Sites, Former Seneca Army Depot Activity in Romulus, NY; EPA Site ID# NY0213820830 and NY Site ID# 8-50-006

# **HISTORICAL RECORDS REVIEW**

## **SUPPLEMENTAL SITE INSPECTION AT FOUR KNOWN PFAS SITES AND PRELIMINARY ASSESSMENT/SITE INSPECTION AT SUSPECTED PFAS SITES FORMER SENECA ARMY DEPOT ROMULUS, NEW YORK**

**Prepared by  
HydroGeoLogic, Inc.  
Northway 10 Executive Park  
313 Ushers Road  
Ballston Lake, NY 12019**

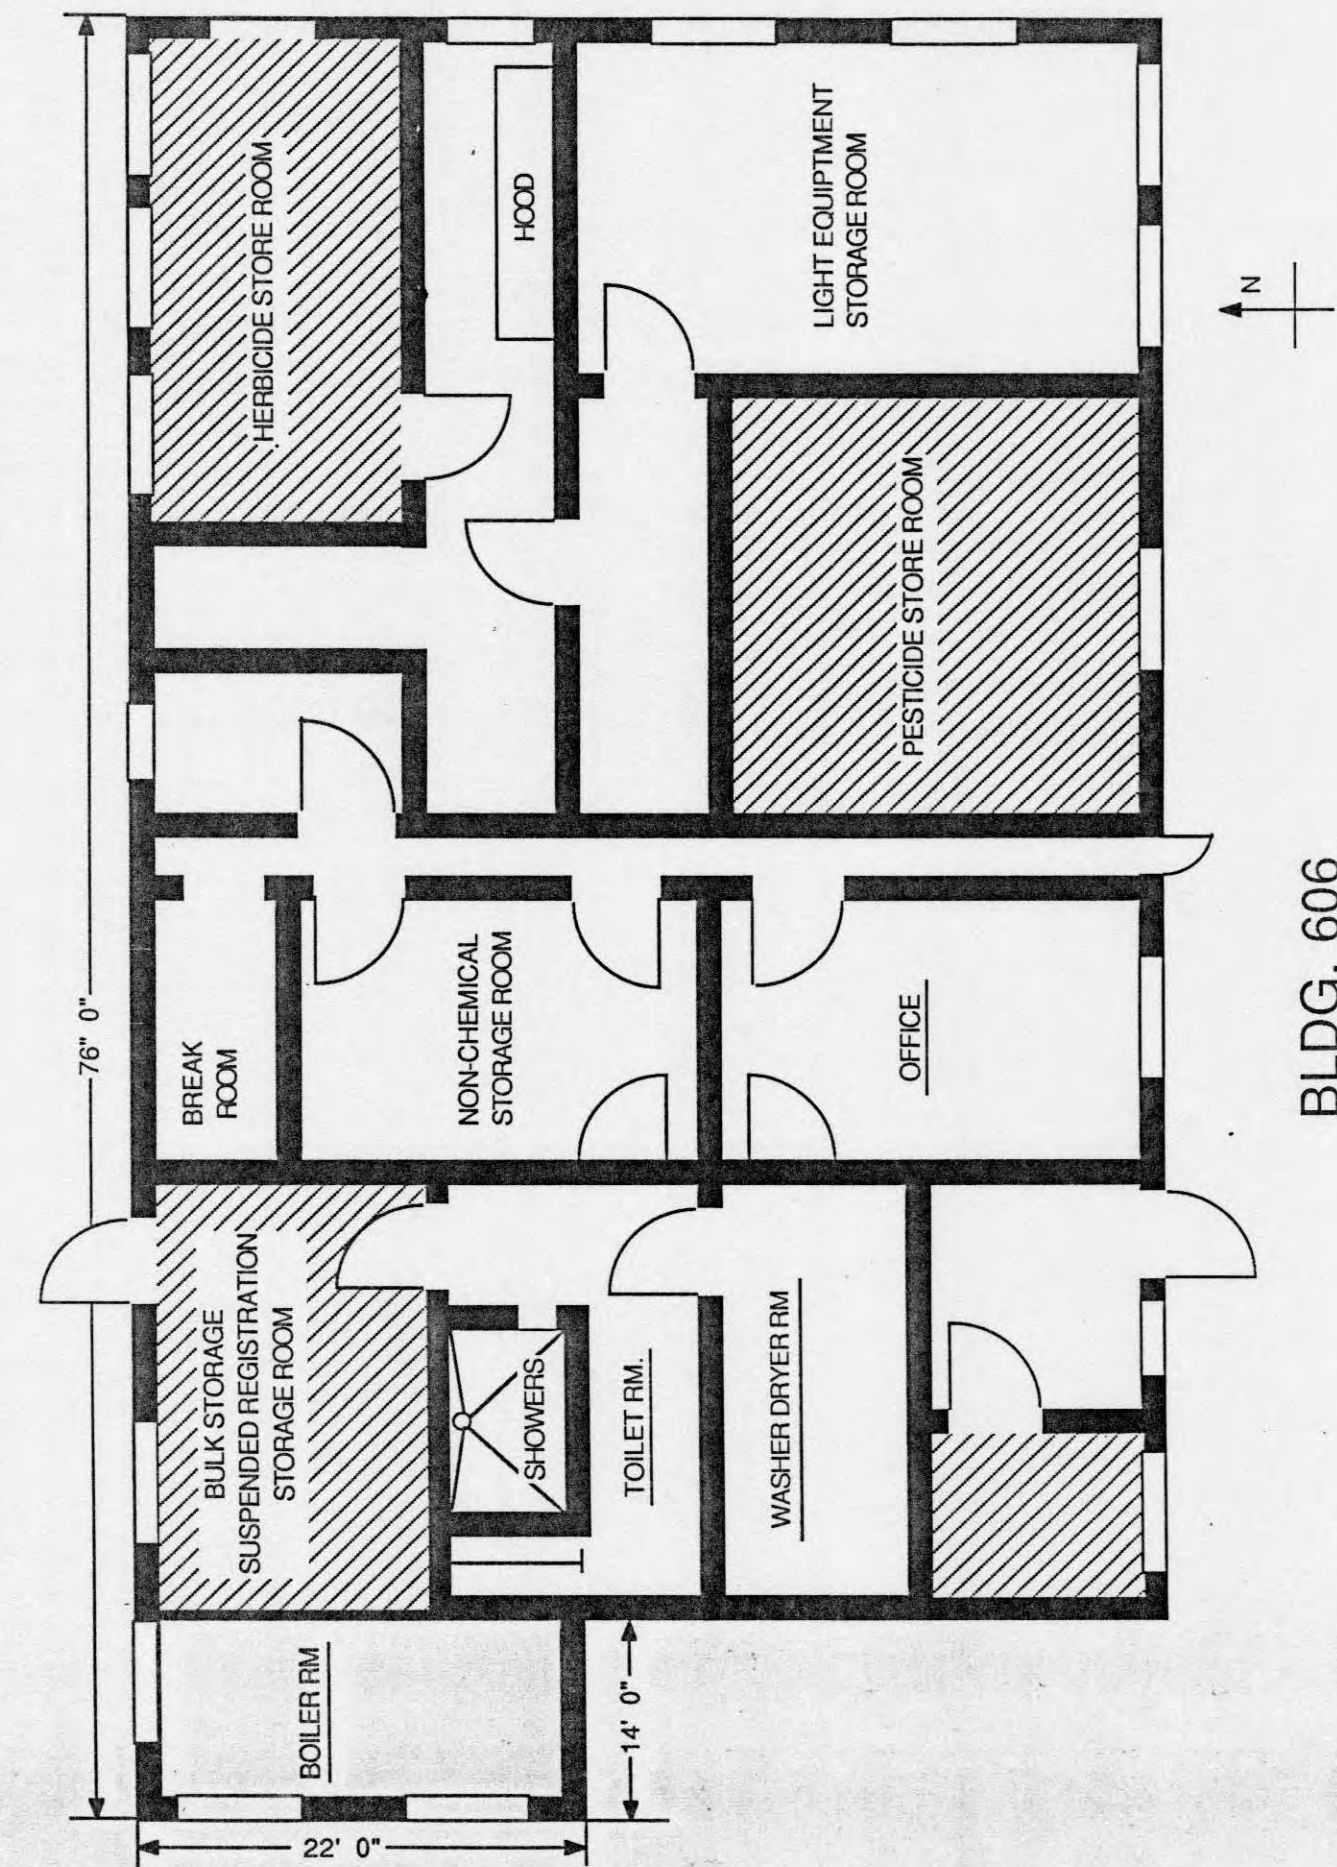
Pesticide Storage Building Floor Plan

- (1) Pesticide storage room
- Diazinon 4E spray
  - Ortho Hornet & Wasp Killer
  - D-phenothrin aerosol
  - FICAM-W WWP
  - OFF aerosol
  - Synthrin liquid concentrate
  - Pegeon-9 strychnine grain bait
  - Diazinon dust
  - Phostoxin tablets, gas
  - Marlate 2-MR emulsifiable concentrate
  - Sythion 5E emulsifiable concentrate
  - Vaposector liquid concentrate
    - Sevin Carbaryl WWP
  - Malathion liquid concentrate
  - Warfarin Anticoagulant
  - Diphacin paraffin anticoagulant
  - Cutter insect repellent aerosol
  - Tree wound dressing aerosol
  - D-Con flea fogger

- (2) Herbicide storage room
- Round-up liquid concentrate
  - Low Vol 2, 4-D liquid concentrate
  - Liquid concentrate
  - Princep 80W WWP
  - UROX-B-water sol. concentrate
  - Attrex
  - Arsenal

SEAD 56	Building 606 Herbicide and Pesticide Storage	OU14	2	Former use of pesticide/herbicide storage.	Pesticide/Herbicide Storage or Use		Potential storage, spill and disposal of pesticides/herbicides that contain PFAS.	AOPI boundaries of SEADs 43, 56 and 69 are collocated. SEAD 69 is an SI AOC (Table 1A).
SEAD 63	Miscellaneous Components Burial Area	OU14	2, 4	Disposal area for miscellaneous classified components. Test pits found battery assemblies, accelerometers, lock mechanisms, fire/safe pins, baroswitches, wiring, quick connects, full trash bags, carpet, paint cans, and electronics components.	Disposal Area		Evidence of dumping and disposal. Some materials found may contain PFAS (wiring, electronic components, carpet, paint). Designated AOPI to be consistent with other burial sites identified for SI.	Site boundary envelopes SEAD-120I, a NA site.
SEAD 66	Pesticide Storage Area near Buildings 5 and 6	OU12	9	Pesticide Storage Area near Buildings 5 and 6. SMWU report documents evidence of release of pesticides and PCBs in soil.	Pesticide/Herbicide Storage or Use		Potential storage, spill and disposal of pesticides/herbicides that contain PFAS.
