SUBJECT: **Revised Final Characterization Report**
Small Arms Range Airfield Parcel (SEAD-122B)
Seneca Army Depot Activity
Romulus, New York

REVISED FINAL
CHARACTERIZATION REPORT
SMALL ARMS RANGE- AIRFIELD (SEAD-122B)
SENECA ARMY DEPOT ACTIVITY

EPA Site ID# NY0213820830
NY Site ID# 8-50-006
CONTRACT NO. DACA87-95-D-0031
DELIVERY ORDER NO. 0032

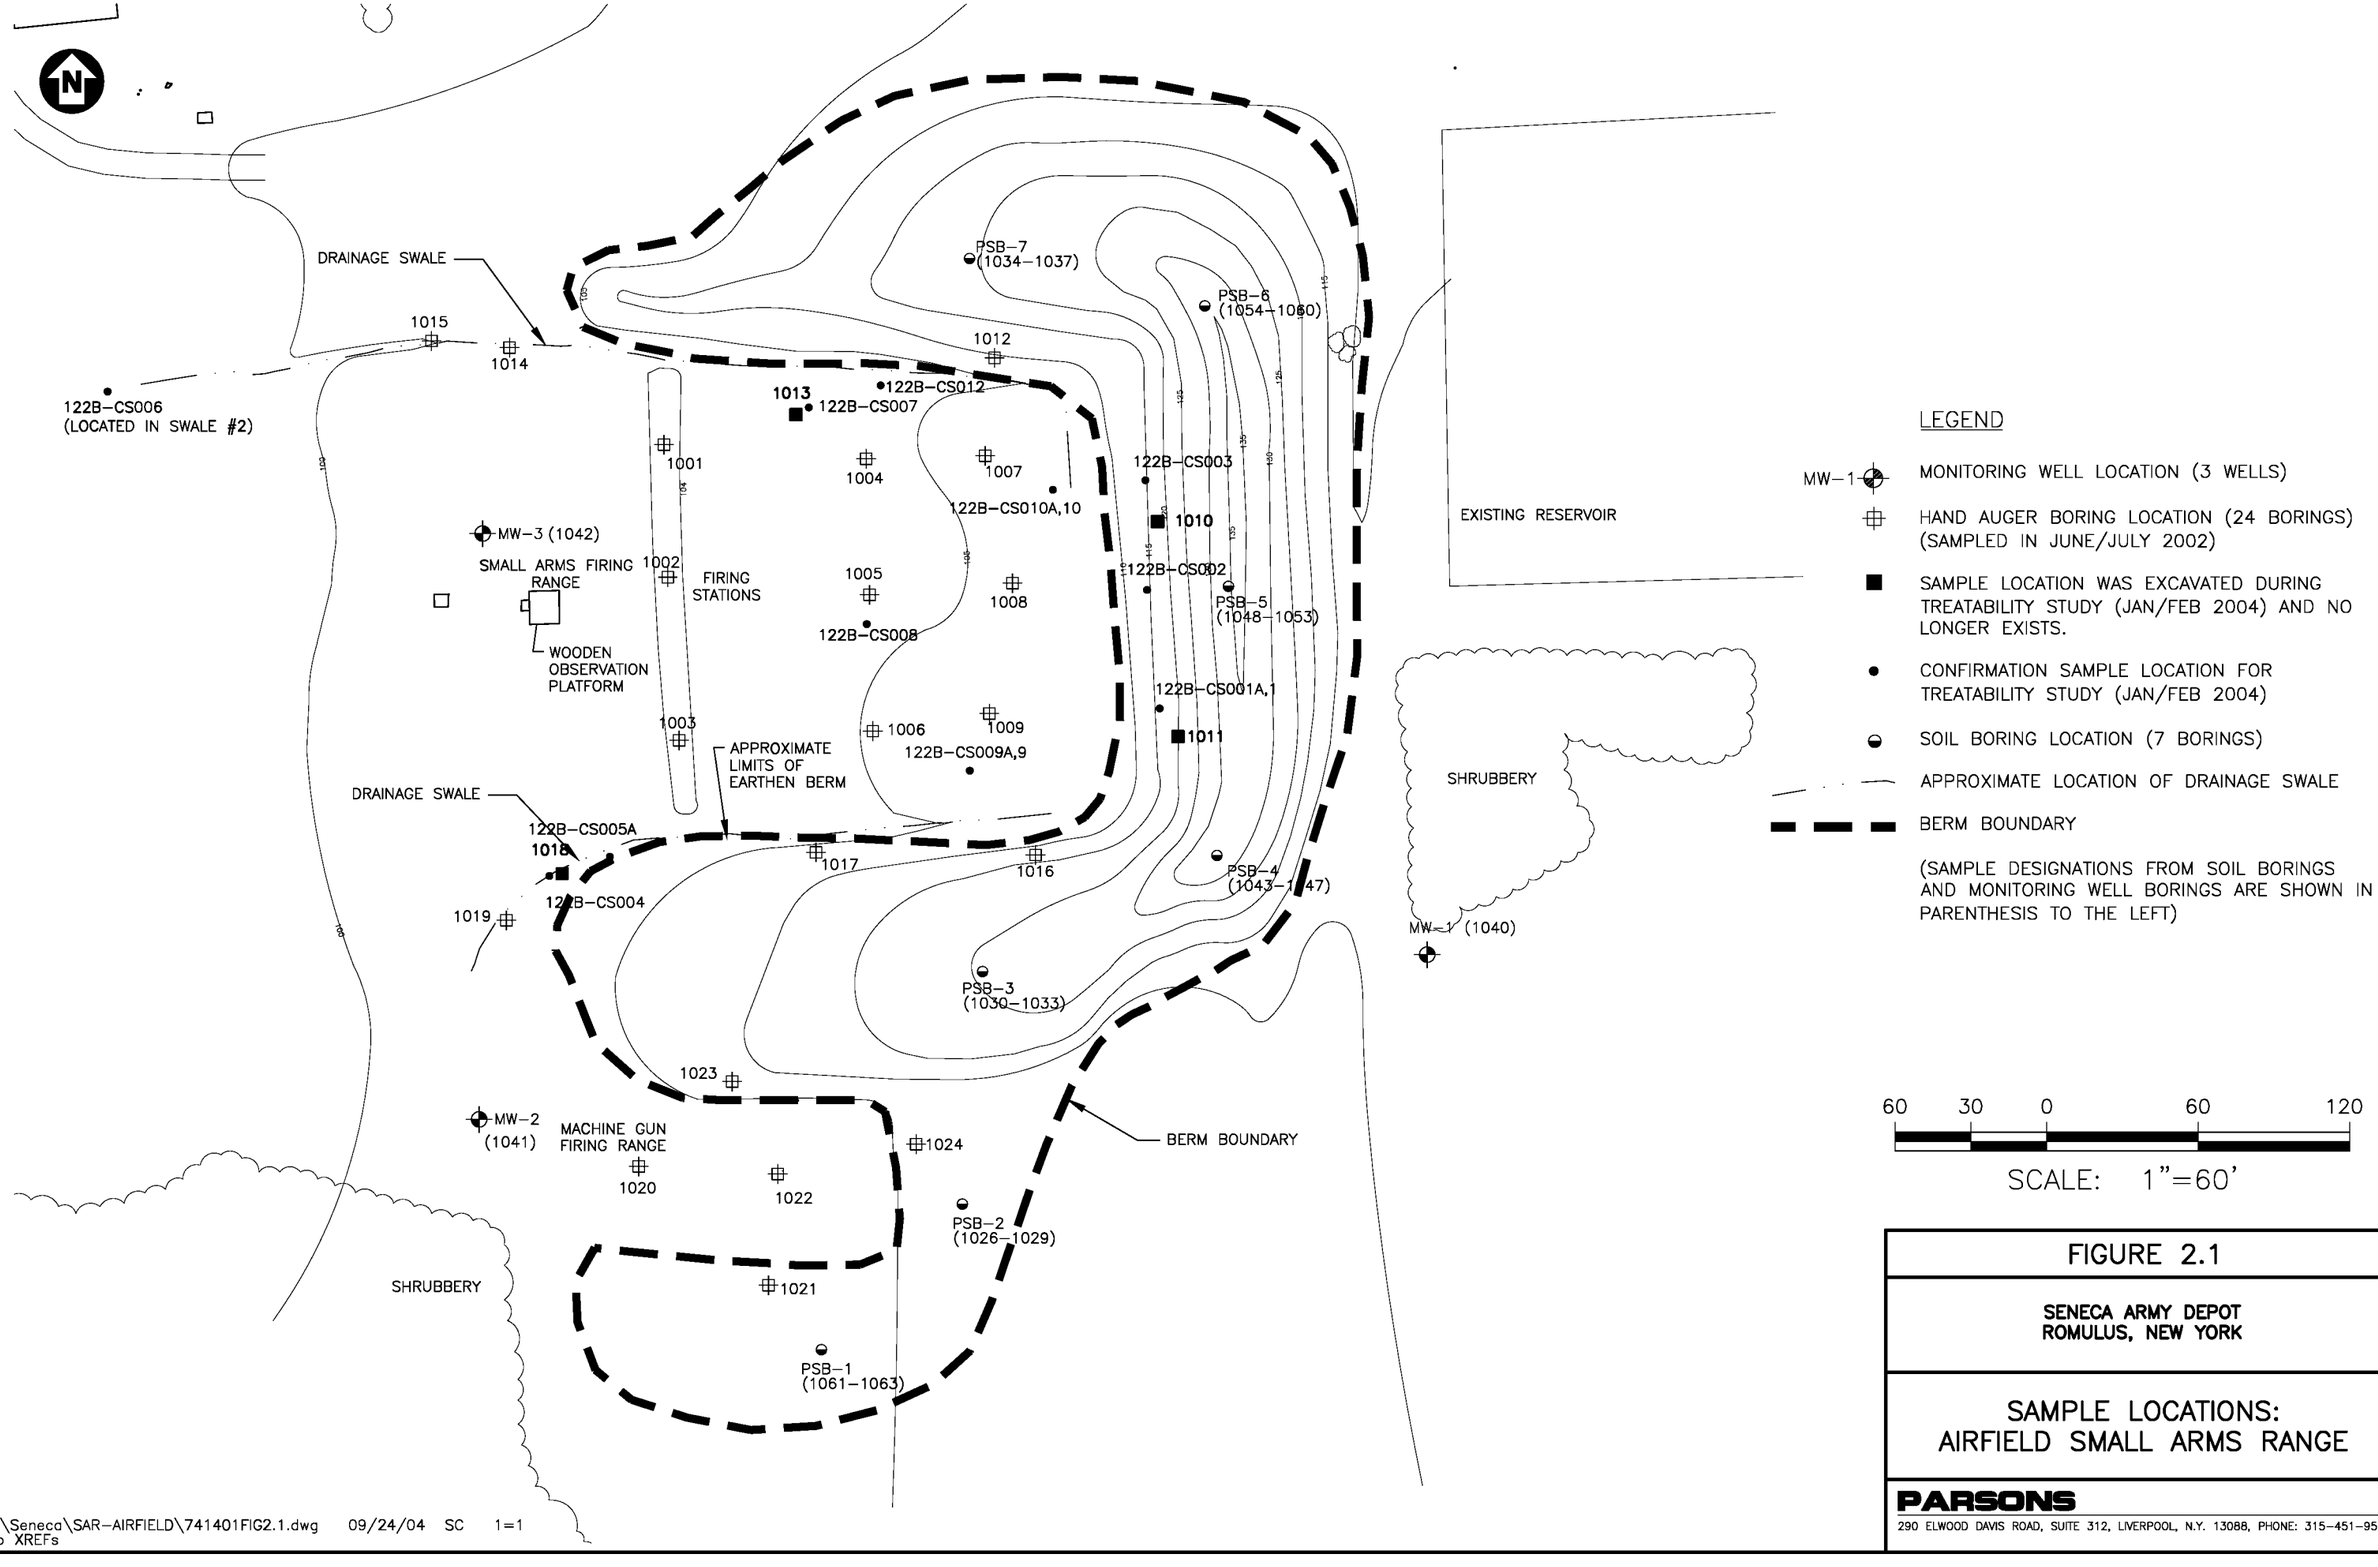
FIGURE 2.1

- A bullet casing, somewhat new in appearance, was observed at the small arms shooting range;
- Bullet fragments were only observed during soil collection at locations 1010 and 1024 within the 0 to 0.5 feet bgs interval; and
- A wooden stand with a metal screen, possibly a weapon cleaning station, was observed at the small arms range.
- The small arms range and machine gun firing range berms were comprised of approximately 28 to 30 feet of brown to dark brown to gray, silt with clay with interbedded shale, and traces of fine sand and fine to medium gravel. The above soil description was based on the drilling of seven soil borings (PSB-1 through PSB-7) on top of the berms in June 2002.

SAMPLE LOCATIONS:
AIRFIELD SMALL ARMS RANGE

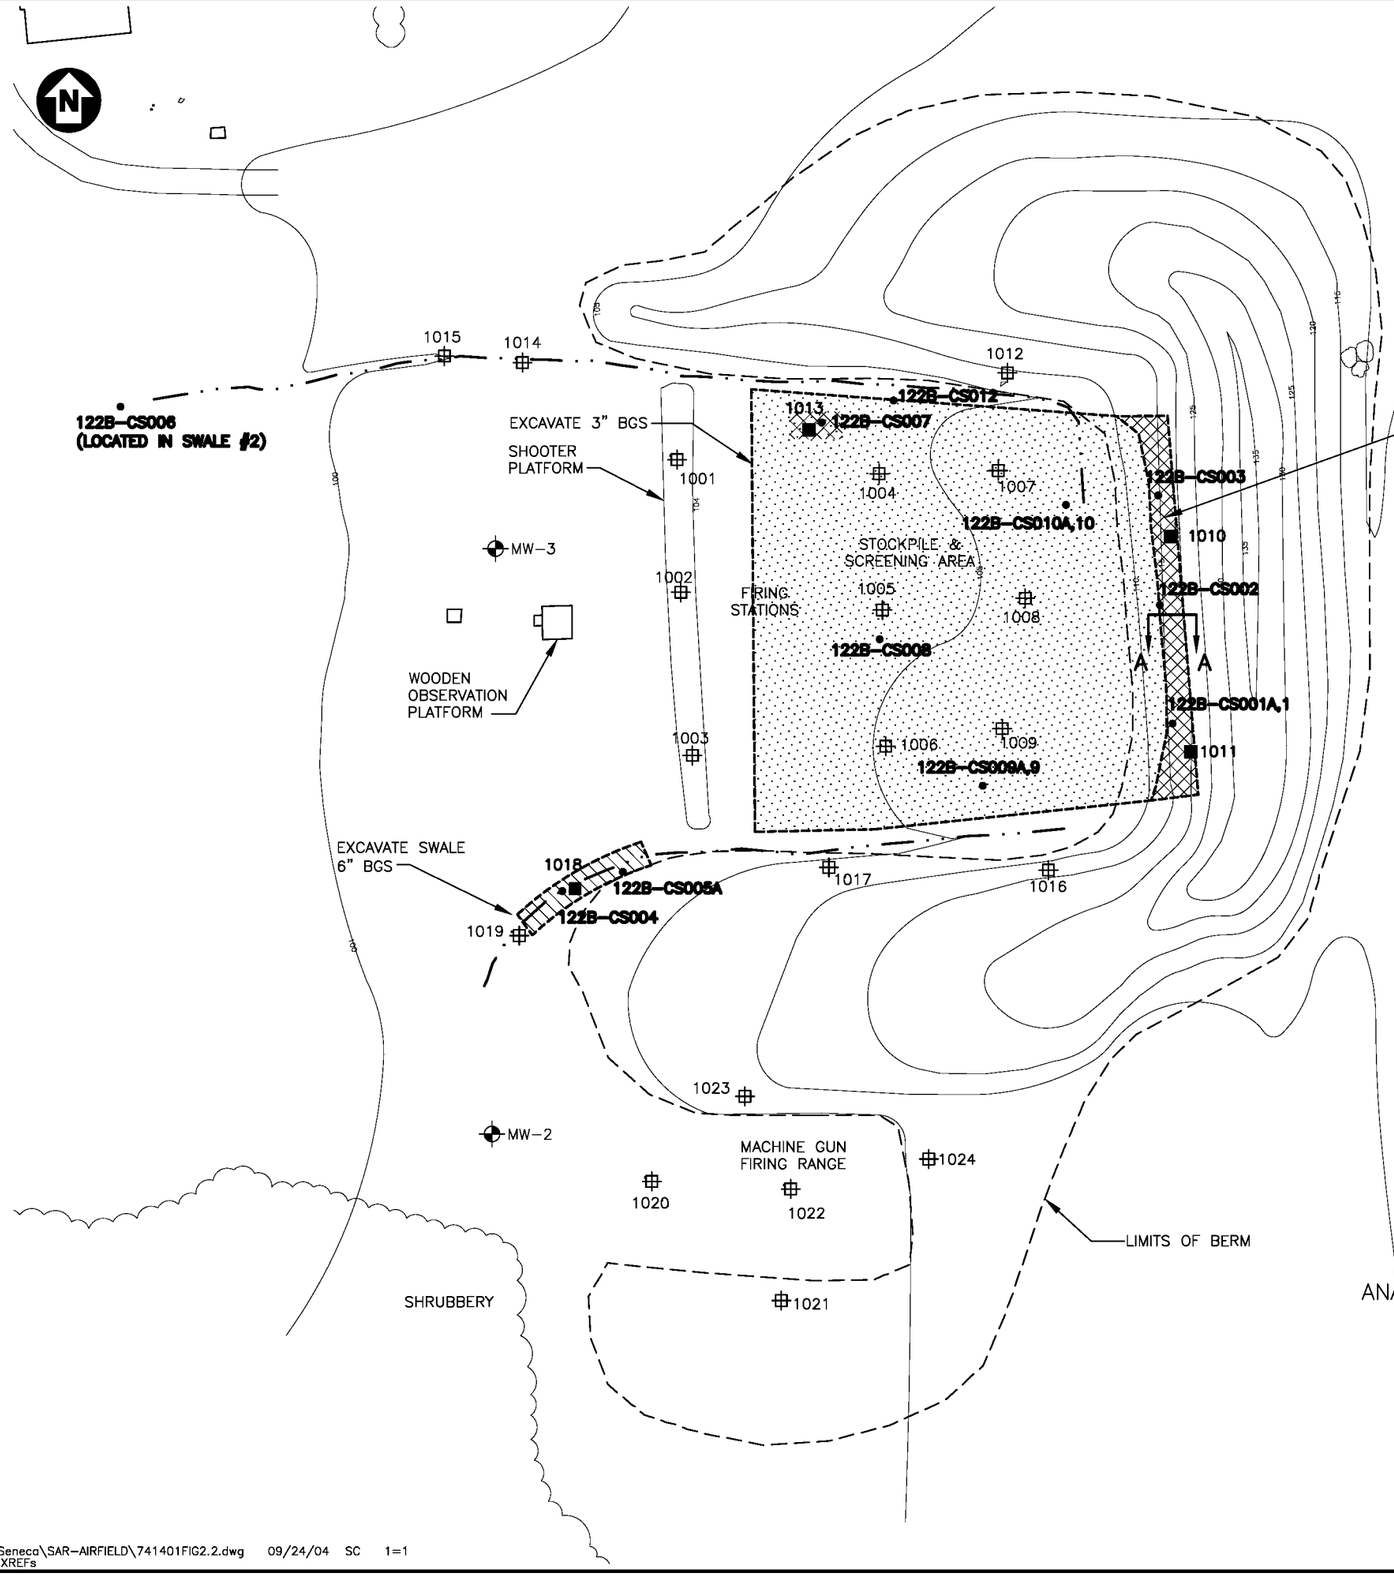
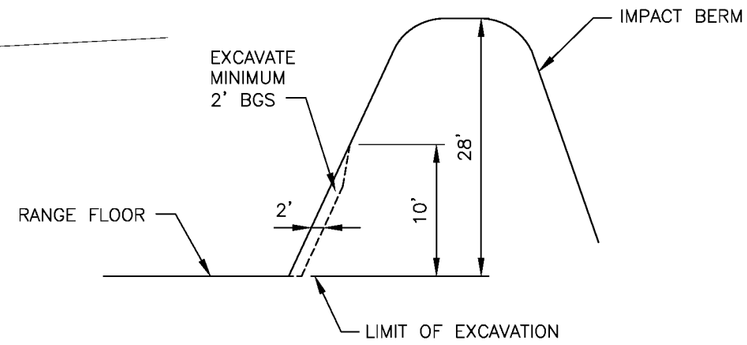
Four of the surface soil samples showed lead concentrations greater than 400 ppm, which is the screening level recommended by USEPA (1998) for lead in soil at residential properties. The two samples located at target height along the east side of the berm (impact area), 1010A and 1011A, showed the highest lead levels, with concentrations of an estimated (i.e., "J") 7,320 ppm (the average of the sample and the field duplicate) and an estimated 60,650 ppm (the average of the sample and the field duplicate), respectively. The maximum lead value (88,700 J ppm) was detected in one of the duplicate pair samples collected at location 1011A, at the southeastern perimeter of the small arms berm.

Sample 1018A collected from the drainage swale in the 0-6 inch interval showed lead at 927 ppm. The lead concentration in the 18-24-inch interval at the same location was 19.3 ppm. Thus, the contamination was surficial only. Sample 1019A was collected further downstream and was 13.7 ppm. Thus, the end point (clean sample) was found and the lateral contamination is limited. Soil from the drainage swale, between the location of the range and sample 1019A was excavated and used in the treatability study operation.

CONCENTRATIONS IN GRAY AND ITALICS DENOTE RESULTS THAT ARE NO LONGER CHARACTERISTIC OF SITE CONDITIONS DUE TO EXCAVATION OF THAT AREA DURING THE TREATABILITY STUDY (JAN/FEB 2004)

FINAL SURFACE SOIL CONDITIONS
ANALYTICAL RESULTS FOR LEAD
(0-6" BELOW GROUND SURFACE)

Based on these findings, no further action is recommended for soil at this site.

No further action is recommended for the Small Arms Range at the Airfield at the Seneca Army Depot. The site is considered suitable for transfer to the State for unrestricted use. The site should be closed out in accordance with procedures established in the Seneca Army Depot Activity Federal Facilities Agreement (FFA) (USEPA et al., 1993). The Army will prepare a No Further Action Proposed Plan and Record of Decision (ROD) for this site, in accordance with the FFA, for concurrence by USEPA and NYSDEC.
