SUBJECT: **Final Remedial Design Work Plan for the Ash Landfill Operable Unit and Draft Final Construction Completion Report for SEAD-25 and SEAD-26 at Seneca Army Depot Activity; Contract FA8903-04-D-8675, Delivery Order 0012, CDRL A001B, A001C, and A004**

REMEDIATION OF FIRE TRAINING AND DEMONSTRATION PAD (SEAD-25) AND FIRE TRAINING PIT AND AREA (SEAD-26) SENECA ARMY DEPOT ACTIVITY ROMULUS, NEW YORK

DRAFT CONSTRUCTION COMPLETION DRAWINGS
(FEBRUARY 2006)

Photo Documentation
Construction Completion Report for SEAD-25 and SEAD-26

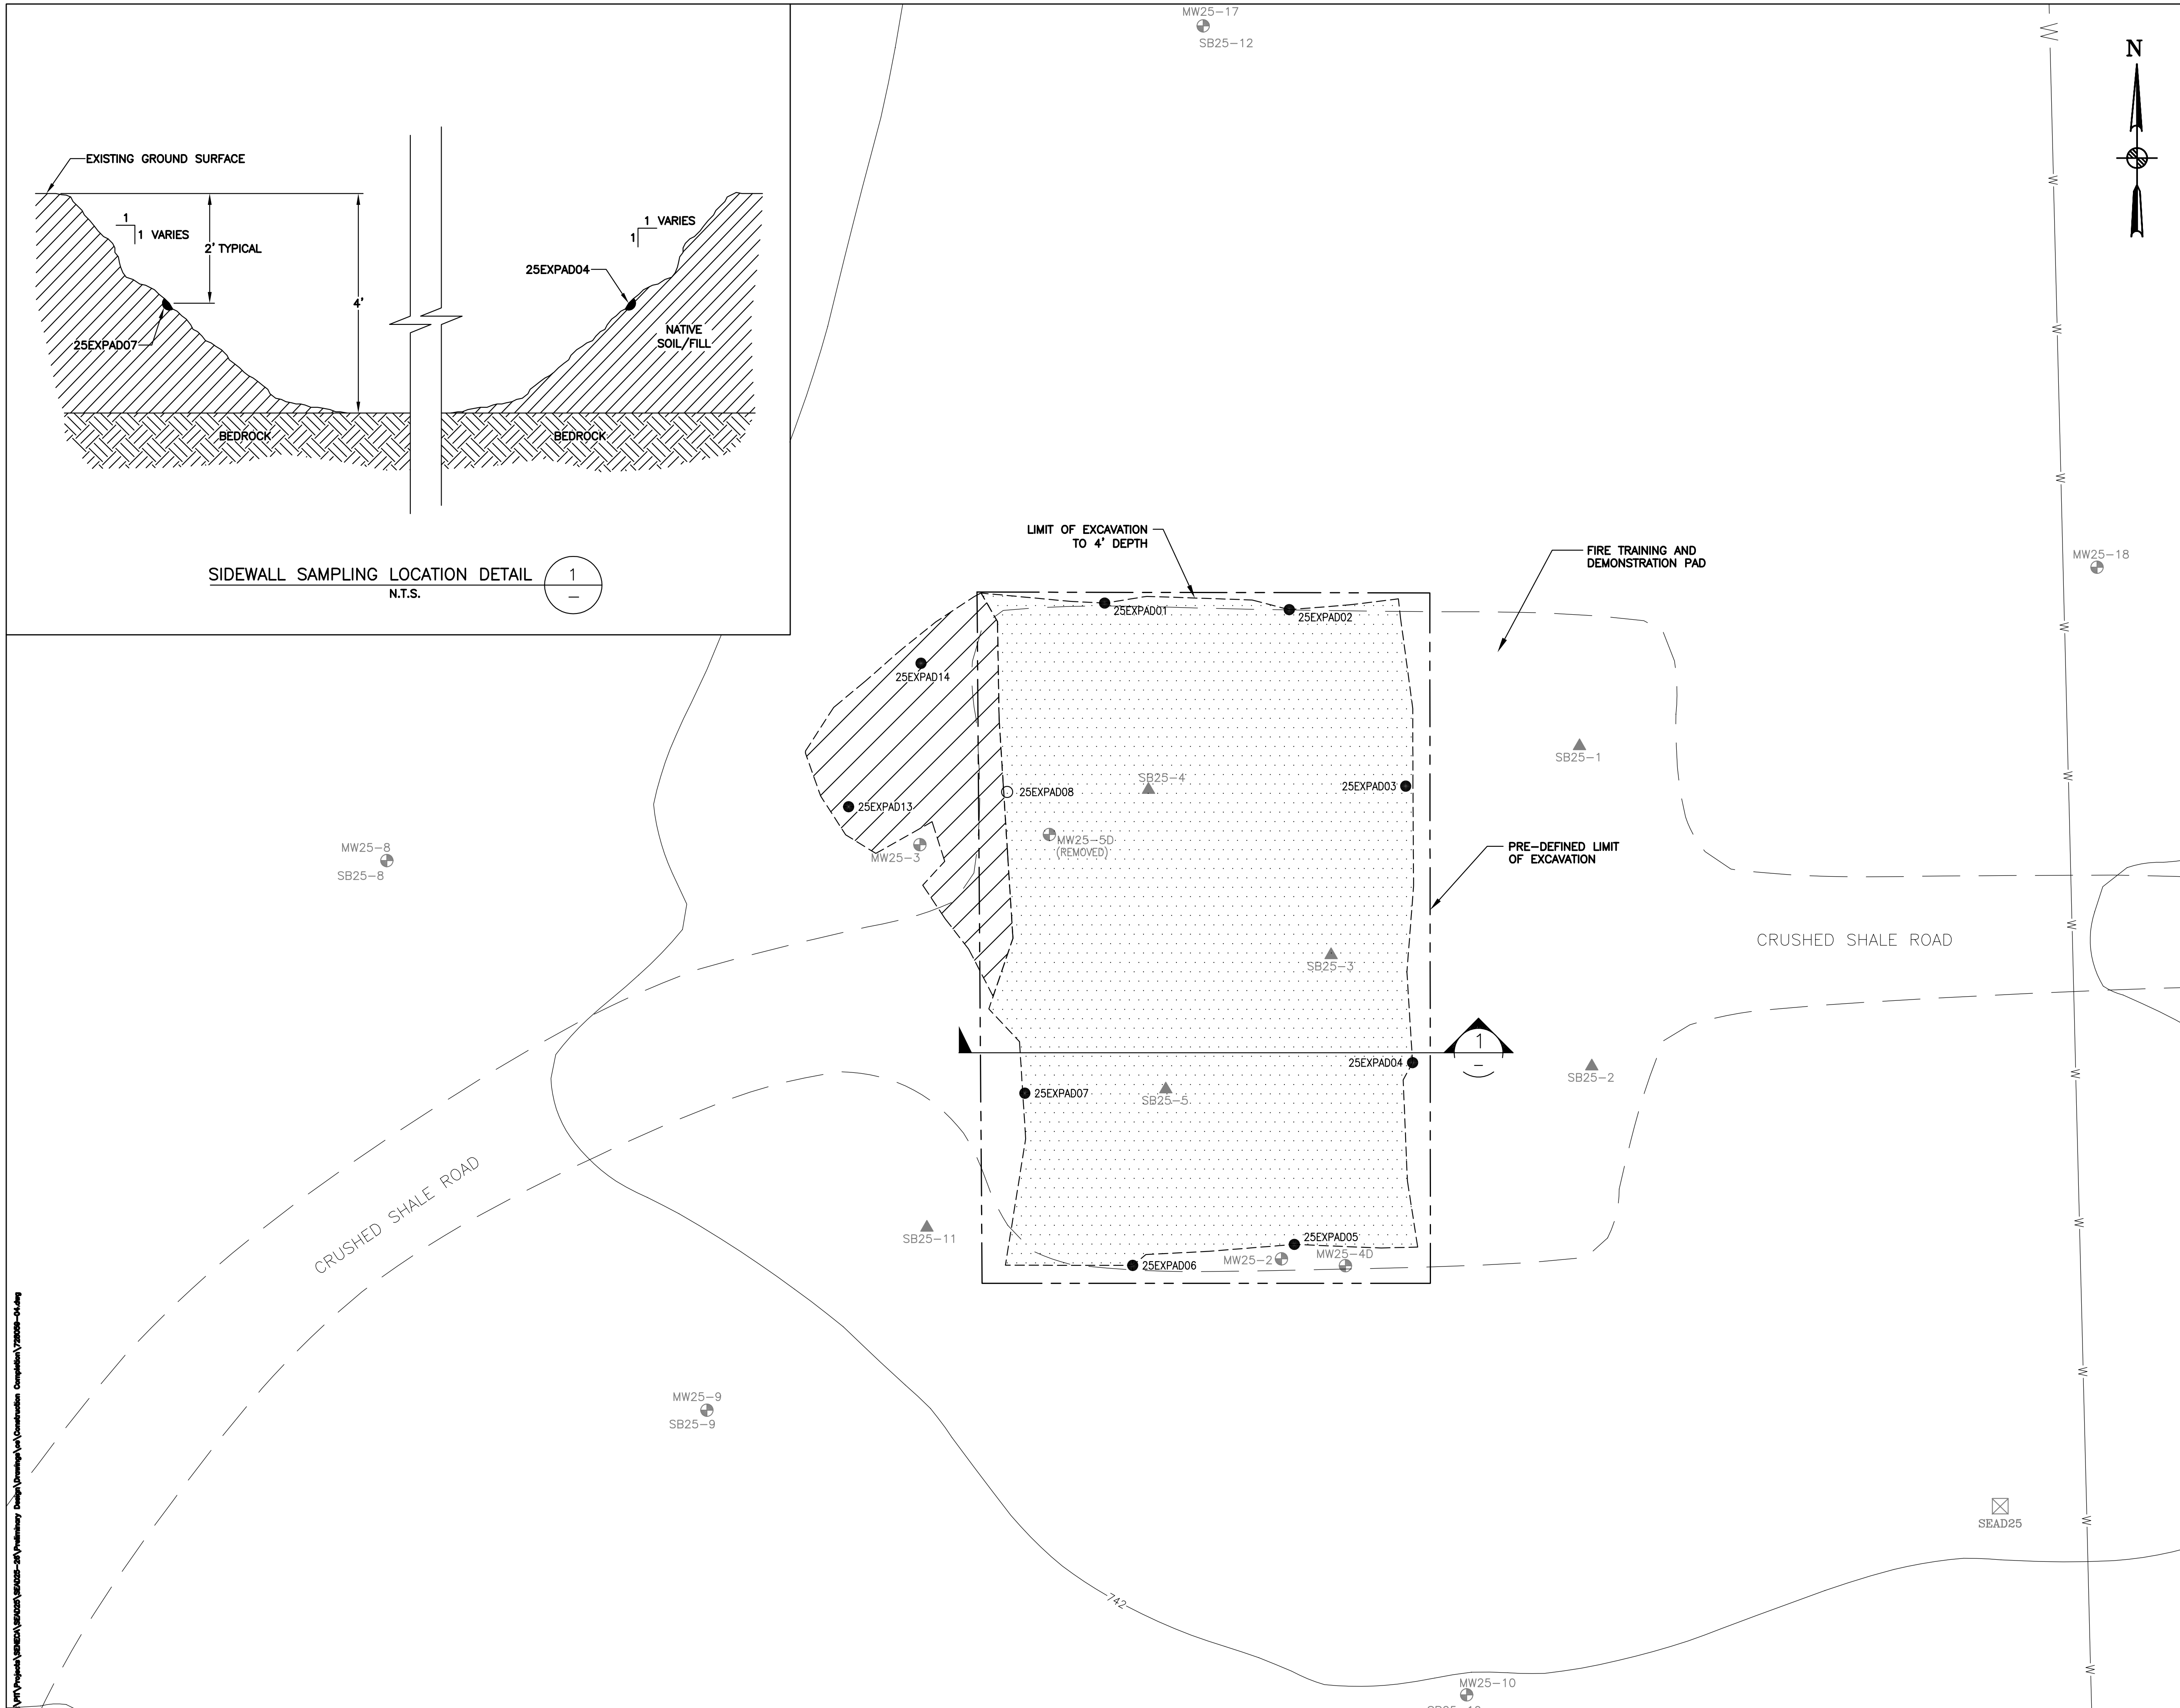
6. EXCAVATED MATERIALS WERE DIRECTLY LOADED INTO DUMP TRUCKS AND TRANSPORTED TO ONTARIO COUNTY LANDFILL BY EARTHWATCH.
7. THE INTERIM SAMPLE 25EXPAD08 FAILED TO MEET THE CLEANUP GOALS, AND THE SOIL AROUND THE INTERIM SAMPLE WAS EXCAVATED UNTIL BEDROCK WAS ENCOUNTERED, APPROXIMATELY 4 FT. BGS. THE SOIL REPRESENTED BY THE INTERIM SAMPLE HAS BEEN REMOVED FROM THE SITE AND IS NOT CHARACTERISTIC OF CURRENT SITE CONDITIONS.

Based on the total xylenes data, sample location 25EXPAD08 failed to meet the cleanup goals for VOCs. As a result, a 760 sf area of soil surrounding 25EXPAD08 was removed down to bedrock, resulting in the excavation of an additional 113 cy from the pad, as shown on **Drawing C-4**. The additional excavation was conducted in the same manner as the initial excavation. The additional excavation extended until bedrock was encountered at 4 feet bgs and the sides were sloped at 1:1. The excavation was conducted to protect monitoring well MW25-3, which is needed for long-term groundwater monitoring.

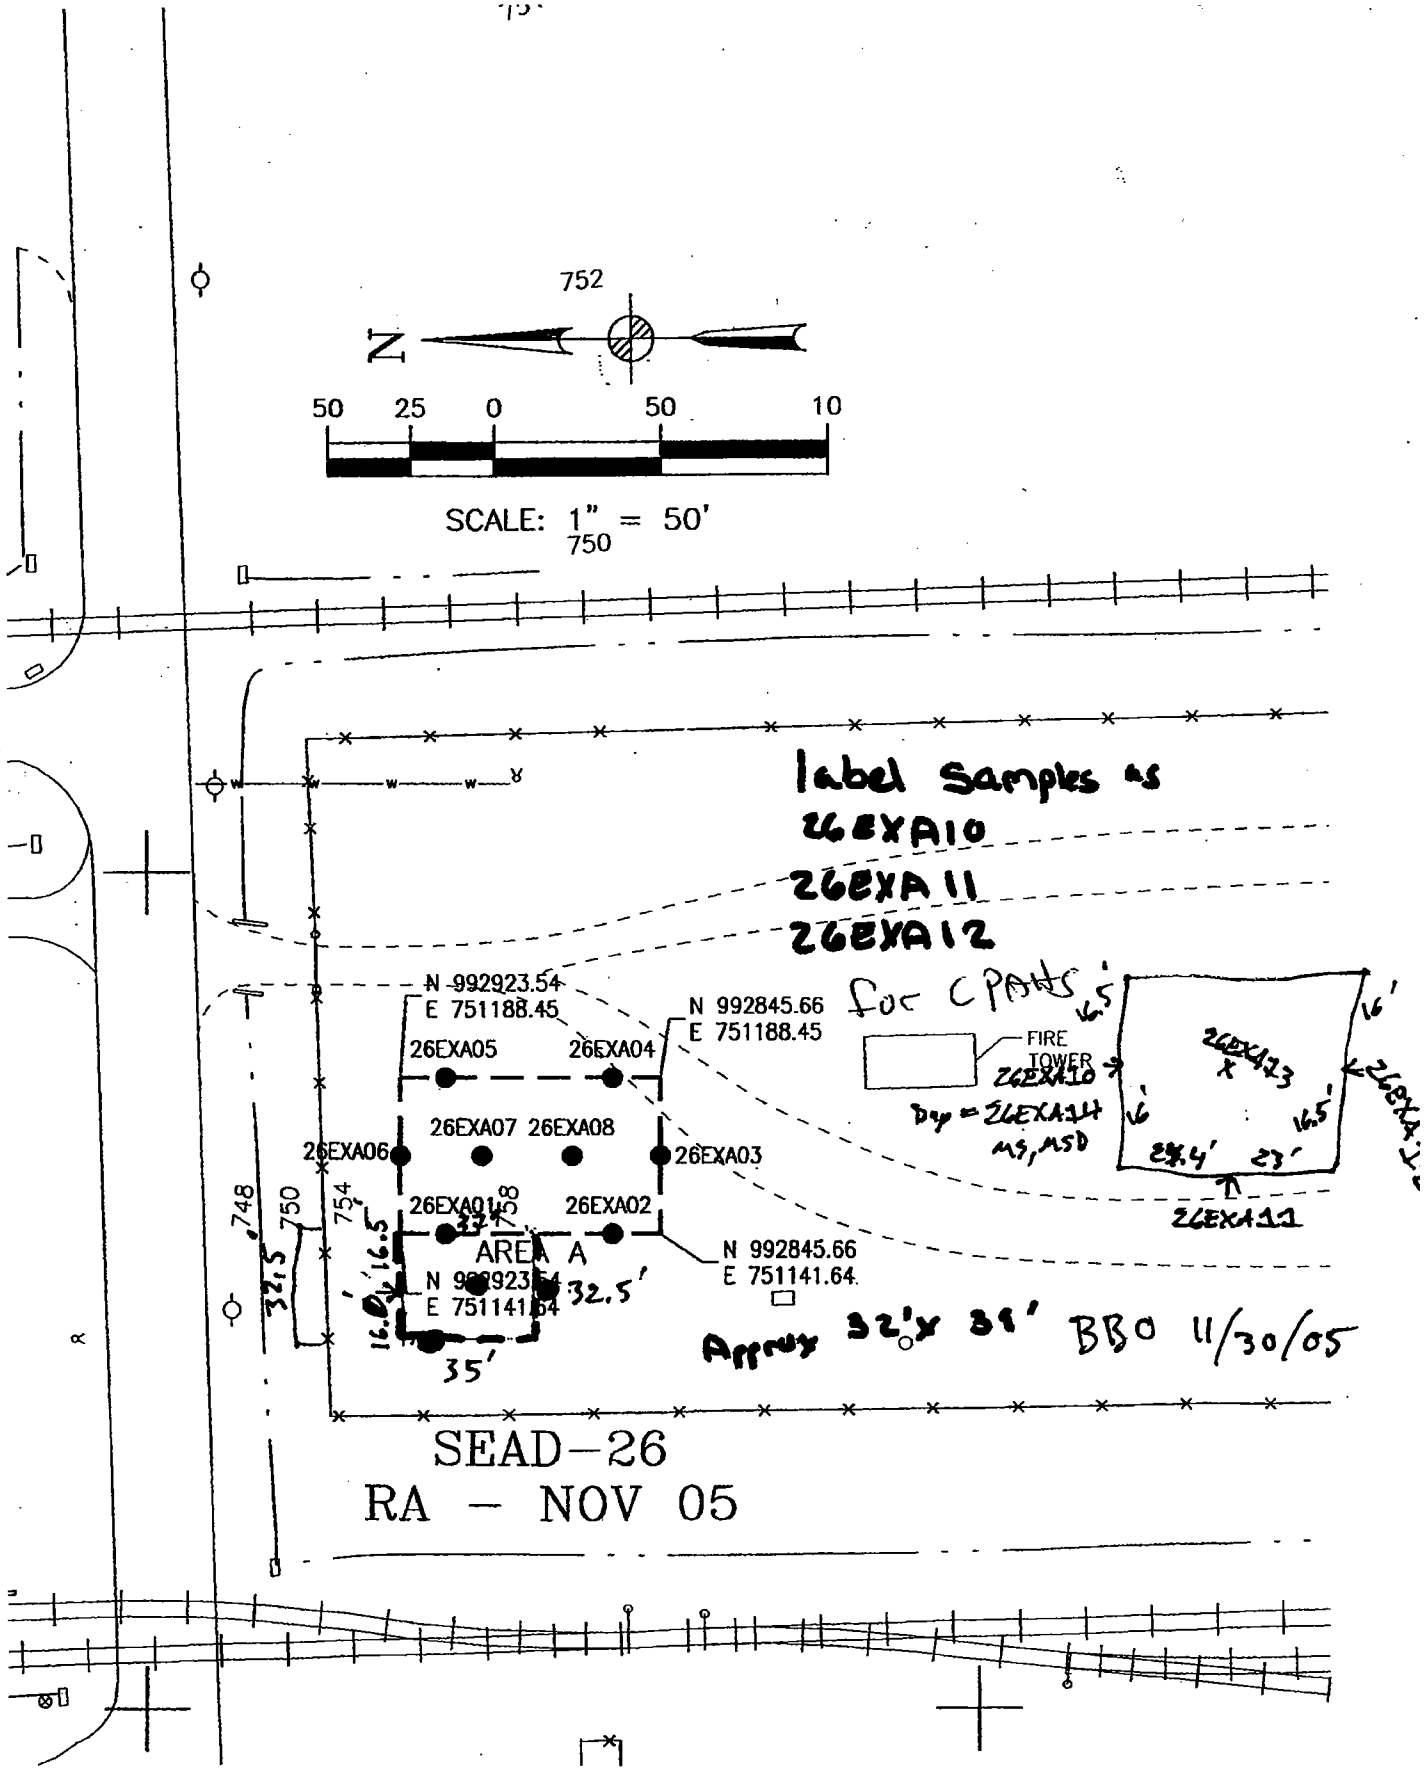
752
N
50 25 0 50 10
SCALE: 1" = 50'
750
label samples as
26EXA10
26EXA11
26EXA12
N 992923.54
E 751188.45
N 992845.66
E 751188.45
for CPAHS
FIRE TOWER
26EXA10
Dup = 26EXA11 MS, MSD
26EXA13
26EXA05
26EXA04
26EXA07 26EXA08
26EXA06
26EXA03
26EXA01
26EXA02
AREA A
N 992923.54
E 751141.64
N 992845.66
E 751141.64
748
750
754
758
32.5'
16.5'
35'
16'
6'
16.5'
23.4'
23'
26EXA11
Approx 32' x 39' BBO 11/30/05
SEAD-26
RA - NOV 05

Since sample location 26EXA01 failed to meet the 10 mg/Kg BTE cleanup goal, an additional 1,174 sf area of soil outside of the contaminated sample was removed to a depth of 1 foot. As shown on **Drawing C-6**, an additional 43 cy of soil was excavated in the area due west of 26EXA01. The drawing and **Table 3-4** shows that four additional confirmatory samples (plus one duplicate) were collected and submitted to Chemtech for analysis for cPAHs. One sample was collected from the base of the new excavation, and a total of three (plus one duplicate) perimeter samples were collected along the northern, western, and southern boundaries of the additional excavation area at Area A. Each new perimeter sample was collected within 50 LF of the neighboring perimeter sample. The analytical results of the additional sampling are included in **Table 3-5**. The BTE concentrations for all of the new samples were less than the cleanup goal, with a maximum BTE concentration of 1.7 mg/Kg.
