DRAFT
CLOSURE REPORT
THE FORMER MIXED WASTE STORAGE FACILITY, BUILDING 803 (SEAD-72)
SENECA ARMY DEPOT ACTIVITY

Contract No. W912DY-08-D-0003
Task Order No. 0003
EPA Site ID# NY0213820830
NY Site ID# 8-50-006

PARSONS
November 2009

FOR THE FORMER MIXED WASTE STORAGE FACILITY, BUILDING 803 (SEAD-72) SENECA ARMY DEPOT ACTIVITY, ROMULUS, NEW YORK

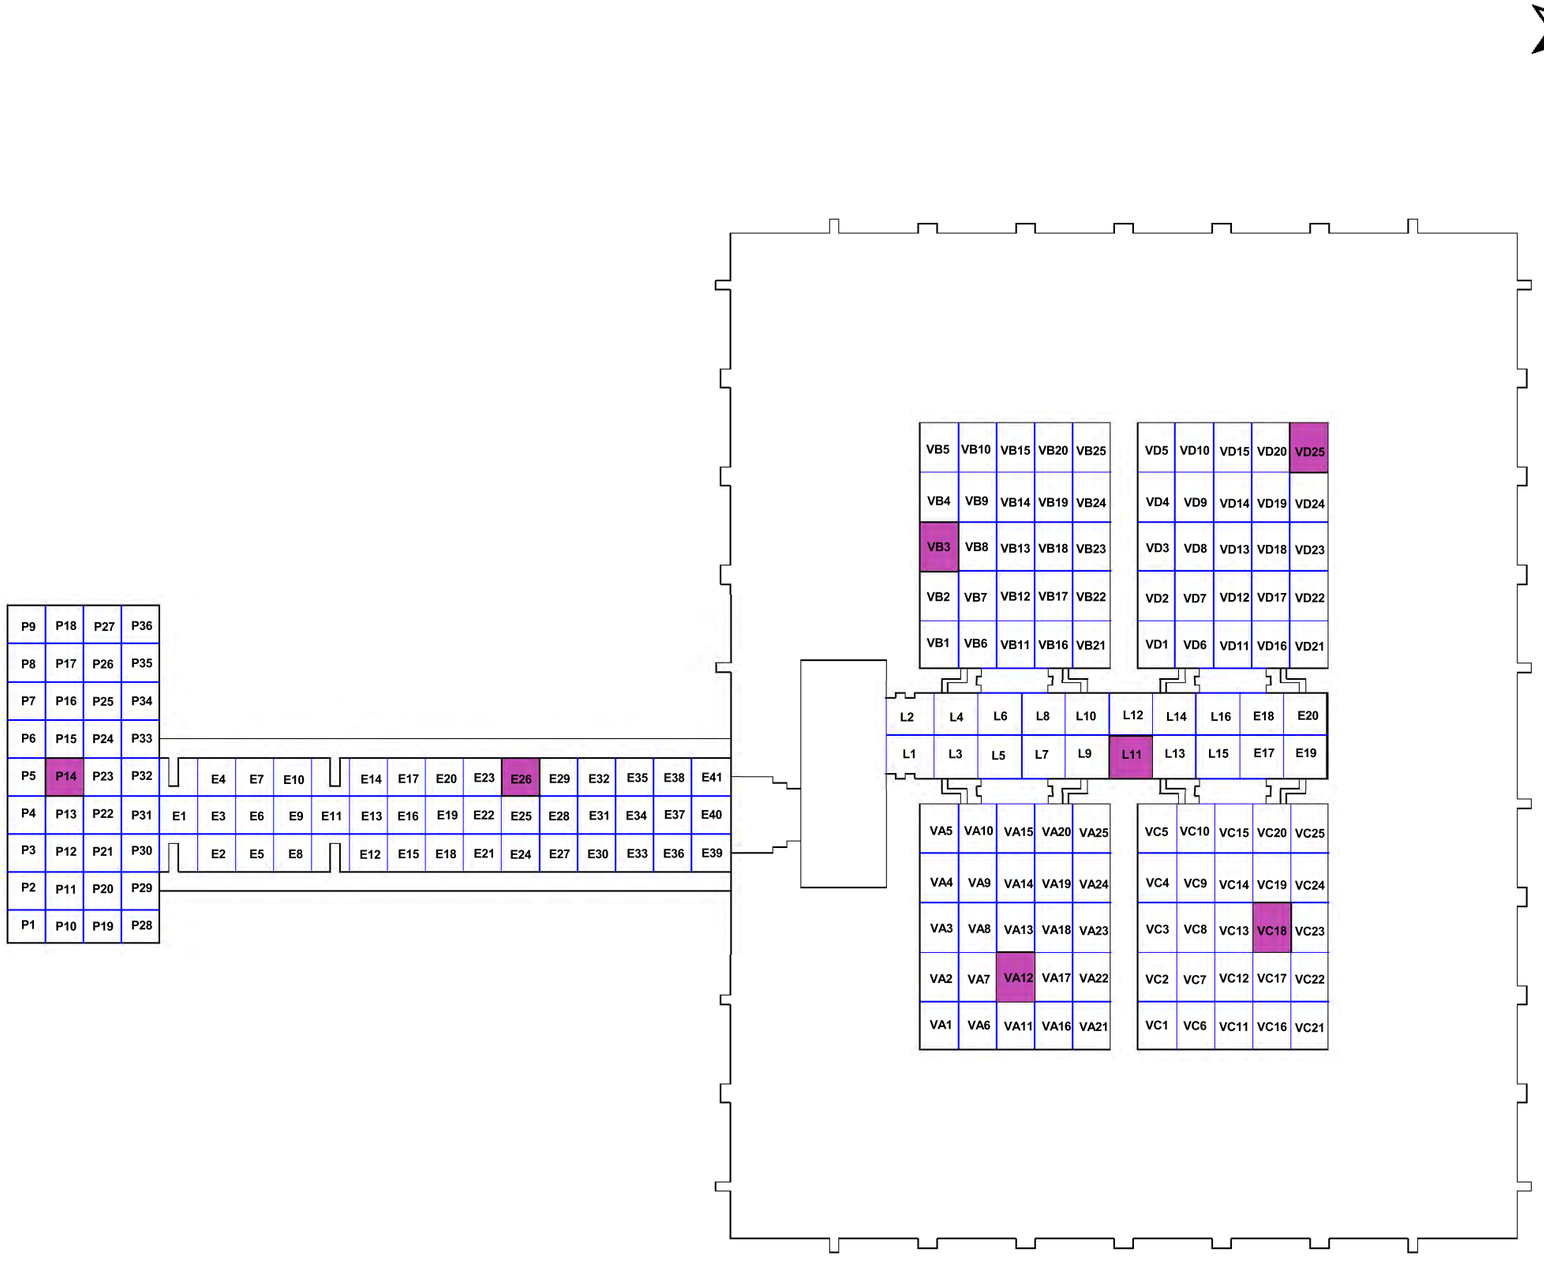
FIGURE 3
BUILDING 803 -
RINSATE SAMPLING LOCATIONS

Seven (7) locations were chosen for collection of rinsate samples, plus one additional quality assurance and quality control (QA/QC) sample. The samples were collected from the surfaces (i.e., ramps and contained floor) of Building 803 and the locations are shown on **Figure 3**. The analytical results for the conformational samples are presented in **Table 1**. A review of this table indicates that the results of the rinsate sample are all below the defined limit, and thus the decontamination of Building 803, SEAD-72 is considered complete.

Analytical results from the rinsate samples are summarized on **Table 1** and the laboratory data sheets are provided in **Appendix A**. The analytical results were compared to the 500 microgram per liter (ug/L) Toxicity Characteristic (TC) level for trichloroethene described in 6 NYCRR 373.3(e) (also 40 CRF Part 261.24). This cleanup value was also used as the comparator value for isopropanol, Freon® 11, acetone, and toluene since there are no TC levels for these compounds. Concentrations of the five compounds detected in all rinsate samples were significantly below the TC cleanup value of 500 ug/L.
