AMSDS-EN-F (AMCEN-A/14 May 90) (200-1a) 1st End
SUBJECT: Work Classification Guidance for the Defense Environmental Restoration Program (DERP)

SUBJECT: Work Classification Guidance for the Defense Environmental Restoration Program (DERP)

11. TITLE (Include Security Classification) Update of the Initial Installation Assessment of Seneca Army Depot	
12. PERSONAL AUTHOR(S) J.D. Bonds, G.T. Kaminski, J.K. Sherwood, and K.A. Becker	
13a. TYPE OF REPORT Draft Final 13b. TIME COVERED FROM FEB 1987 TO TBA 14. DATE OF REPORT (Year, Month, Day) TBA 15. PAGE COUNT TBA	
16 SUPPLEMENTARY NOTATION N/A	
17 COSATI CODES FIELD / GROUP / SUB-GROUP	18. SUBJECT TERMS (Continue on reverse if necessary and identify by block number) Seneca Army Depot; Installation Restoration Program; Hazardous Waste; Installation Assessment

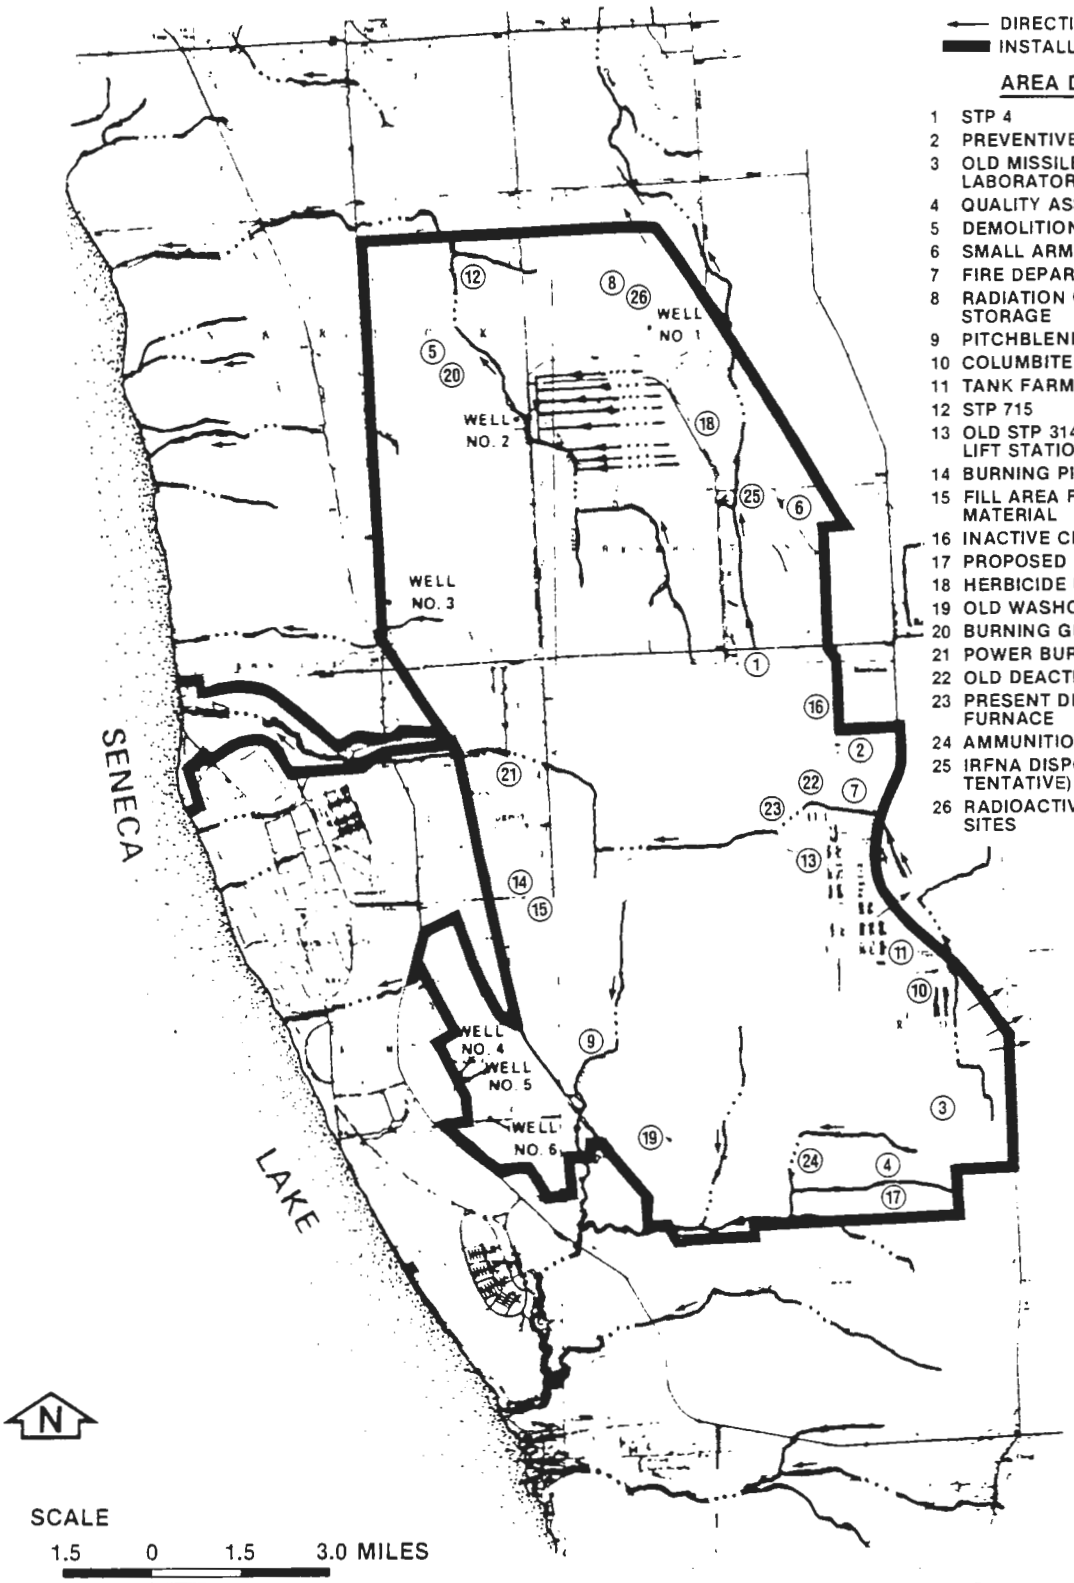
Figure 2-1
POTENTIAL CONTAMINATION AREAS IDENTIFIED IN THE 1980 INSTALLATION ASSESSMENT

The IIA indicated that SEAD was in the process of developing a program for decontaminating the E800 row of igloos (Area 12 on Fig. 2-1). The 11 igloos that stored pitchblende in the 1940s were radiologically surveyed by Oak Ridge National Laboratory for the U.S. Department of Energy (DOE). The survey indicated no health hazards existed; however, the radiation levels present were in excess of allowable concentrations which would permit unrestricted use of the igloos and surrounding areas.

Pesticides are stored in Bldg. 606 at SEAD (Area 3 on Fig. 2-1). An underground tank at this building is used to store rinseates from pesticide operations. In 1984, a Pest Management Review (USAEHA, 1984b) recommended that the underground tank be removed and placed above ground. The installation has since terminated use of this tank. The installation plans to excavate the tank and place it above ground in a concrete pit (to contain any accidental spills or leaks). Once the tank is placed above ground and construction is finished, SEAD plans to resume use of the tank for storing pesticide rinseates. The rinseates are used to formulate subsequent batches of pesticides in accordance with Federal and Army Pesticide Handling Guidelines.

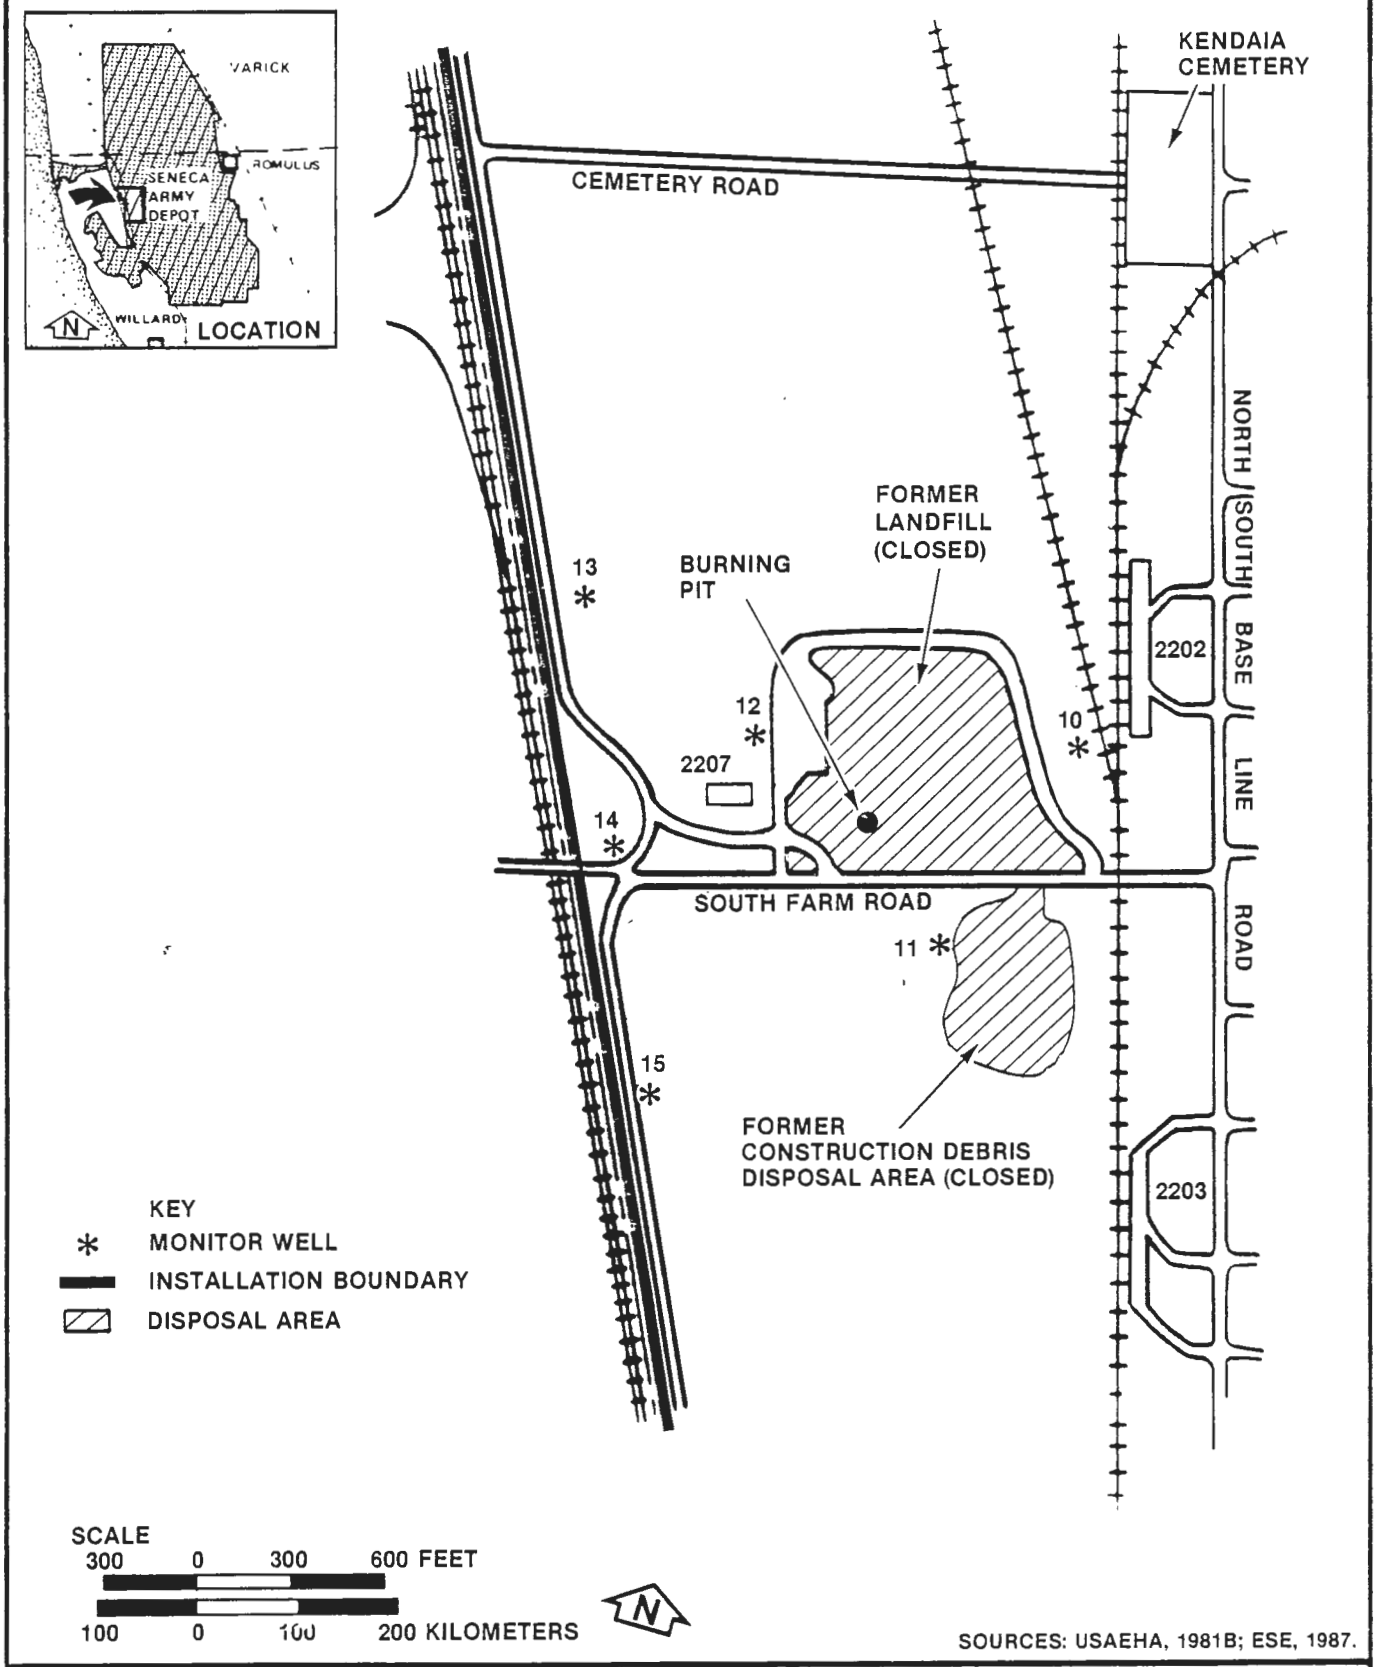
Figure 2-2
LOCATIONS OF MONITOR WELLS IN THE VICINITY OF THE FORMER LANDFILL, BURNING PIT, AND CONSTRUCTION DEBRIS DISPOSAL AREAS

destroyed by fire in 1977. The former landfill area is located adjacent to Bldg. 2207 (see Fig. 2-2). The landfill has been closed and capped. Due to the possibility of leachate from the landfill entering the ground water, five monitoring wells were installed to assess ground water quality. Several indicator parameters (sulfate, chloride, and specific conductance) indicated the possibility of leachate from the landfill entering the ground water (USAEHA, 1981b).

In a recent study (USAEHA, 1986), four of the five monitoring wells were sampled and the ground water analyzed. Well PT-14 was not sampled because it had been broken off at ground level and was not accessible. The study determined that downgradient Well PT-12 exceeded State standards for chlorides and sulfates. Measurable concentrations of total organic halogens (TOX) were also found in Well PT-12, but concentrations did not exceed State or Federal standards. Since the onsite visit, SEAD has repaired Well PT-14 and all the wells have been sampled. The samples will be analyzed for volatile organics to determine if the ground water is contaminated by organic compounds. The results from the December 1986 and March 1987 analysis of the ground water are included as App. C. These results indicate the presence of trans-1, 2-dichloroethylene, trichloroethylene, and vinyl chloride in the ground water from monitor wells PT-12 and PT-14 at concentrations which exceed the proposed maximum contaminant levels (MCL) for all three compounds. Wells PT-12 and PT-14 are located downgradient from the former disposal areas. Because the concentrations in onpost wells exceeded the proposed MCL, the installation tested three offpost wells with a 0.3-mile radius downgradient of the incinerator/landfill disposal area. These tests were conducted by a SEAD contractor during the last week of August 1987. The results of the testing did not indicate contaminants were migrating offpost. The installation plans to continue the monitoring program and evaluate the extent of the problems and has requested that USAEHA perform additional health assessment and monitor well tests at this area.

Monitoring wells were installed around the incinerator (Bldg. 2207) and the adjacent landfill. The presence of indicator compounds (sulfate, chloride, etc.) indicates that contaminants may be migrating in the ground water. A 1986 study by USAEHA determined that TOX was present in a downgradient well. In 1987, USAEHA monitored for volatile pollutants and found trans-1, 2-dichloroethylene, trichloroethylene, and vinyl chloride in wells PT-12 and PT-14 at concentrations which exceed proposed maximum contaminant levels. Because the concentrations in onpost wells exceeded MCL, the installation tested three offpost wells located within 0.3 mile downgradient of the former disposal location. The results of the testing did not indicate contaminants were migrating offpost. The installation plans to continue the ground water monitoring program and evaluate the extent of the problem.

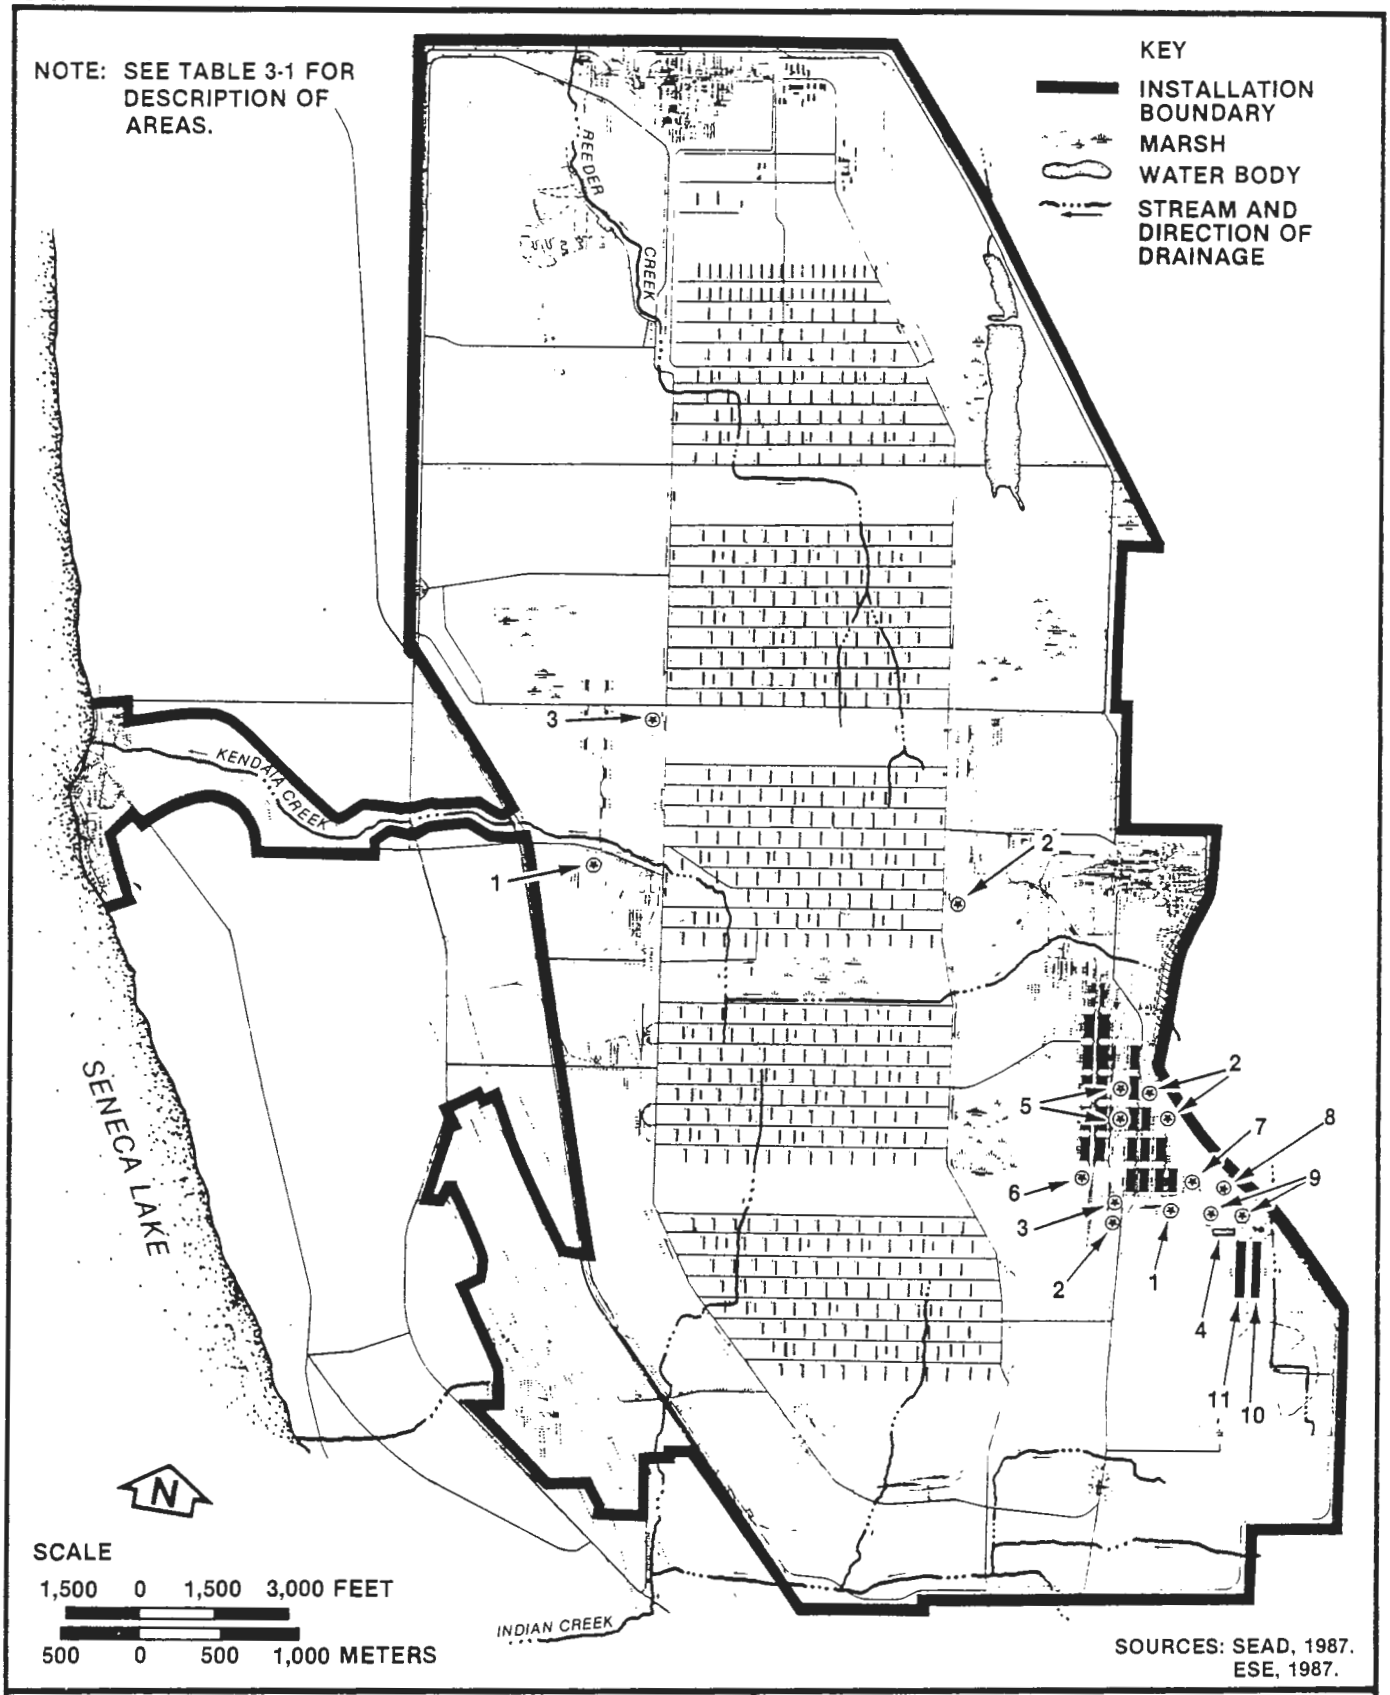
Figure 3-1
LOCATIONS AND TYPES OF MINERALS AND ORE STOCKPILES ON SENECA ARMY DEPOT

Exposed ore piles were reportedly of some concern due to the possibility that acid rain may leach toxic metals. A review of the ore types indicates they are highly insoluble, even when exposed to atmospheric conditions, including acid rain. Therefore, the ground water would not be expected to be contaminated as a result of leaching from the ore storage areas. The uncovered ore could migrate into the environment through air dispersal of dust particulate or transport of particulate through surface water runoff.

Location (See Fig. 3-1)	Ore/Mineral
1	Silicon Carbide
2	Chromite Ore
	Chromium Ore
3	Aluminum Oxide
4	Ferrochromium Ore
5	Ferro Manganese
6	Zinc (metallic)
7	Rutile (Titanium)
8	Asbestos
9	Antimony
10	Chrome Metal, Electrolyte (ore) (Bldg. 356)
	Chrome Metal, Exothermic (ore) (Bldg. 356)
	Columbite Ore (Bldg. 356)
	Columbium (Bldg. 356)
	Ferrocolombium Ore (Bldg. 356)
	Graphite Powder (Bldg. 356)
	Nickel Ore (Bldg. 356)
	Tantalum Ore (Bldg. 356)
11	Cadmium Ore (Bldg. 357)
	Tannin (Bldg. 357)

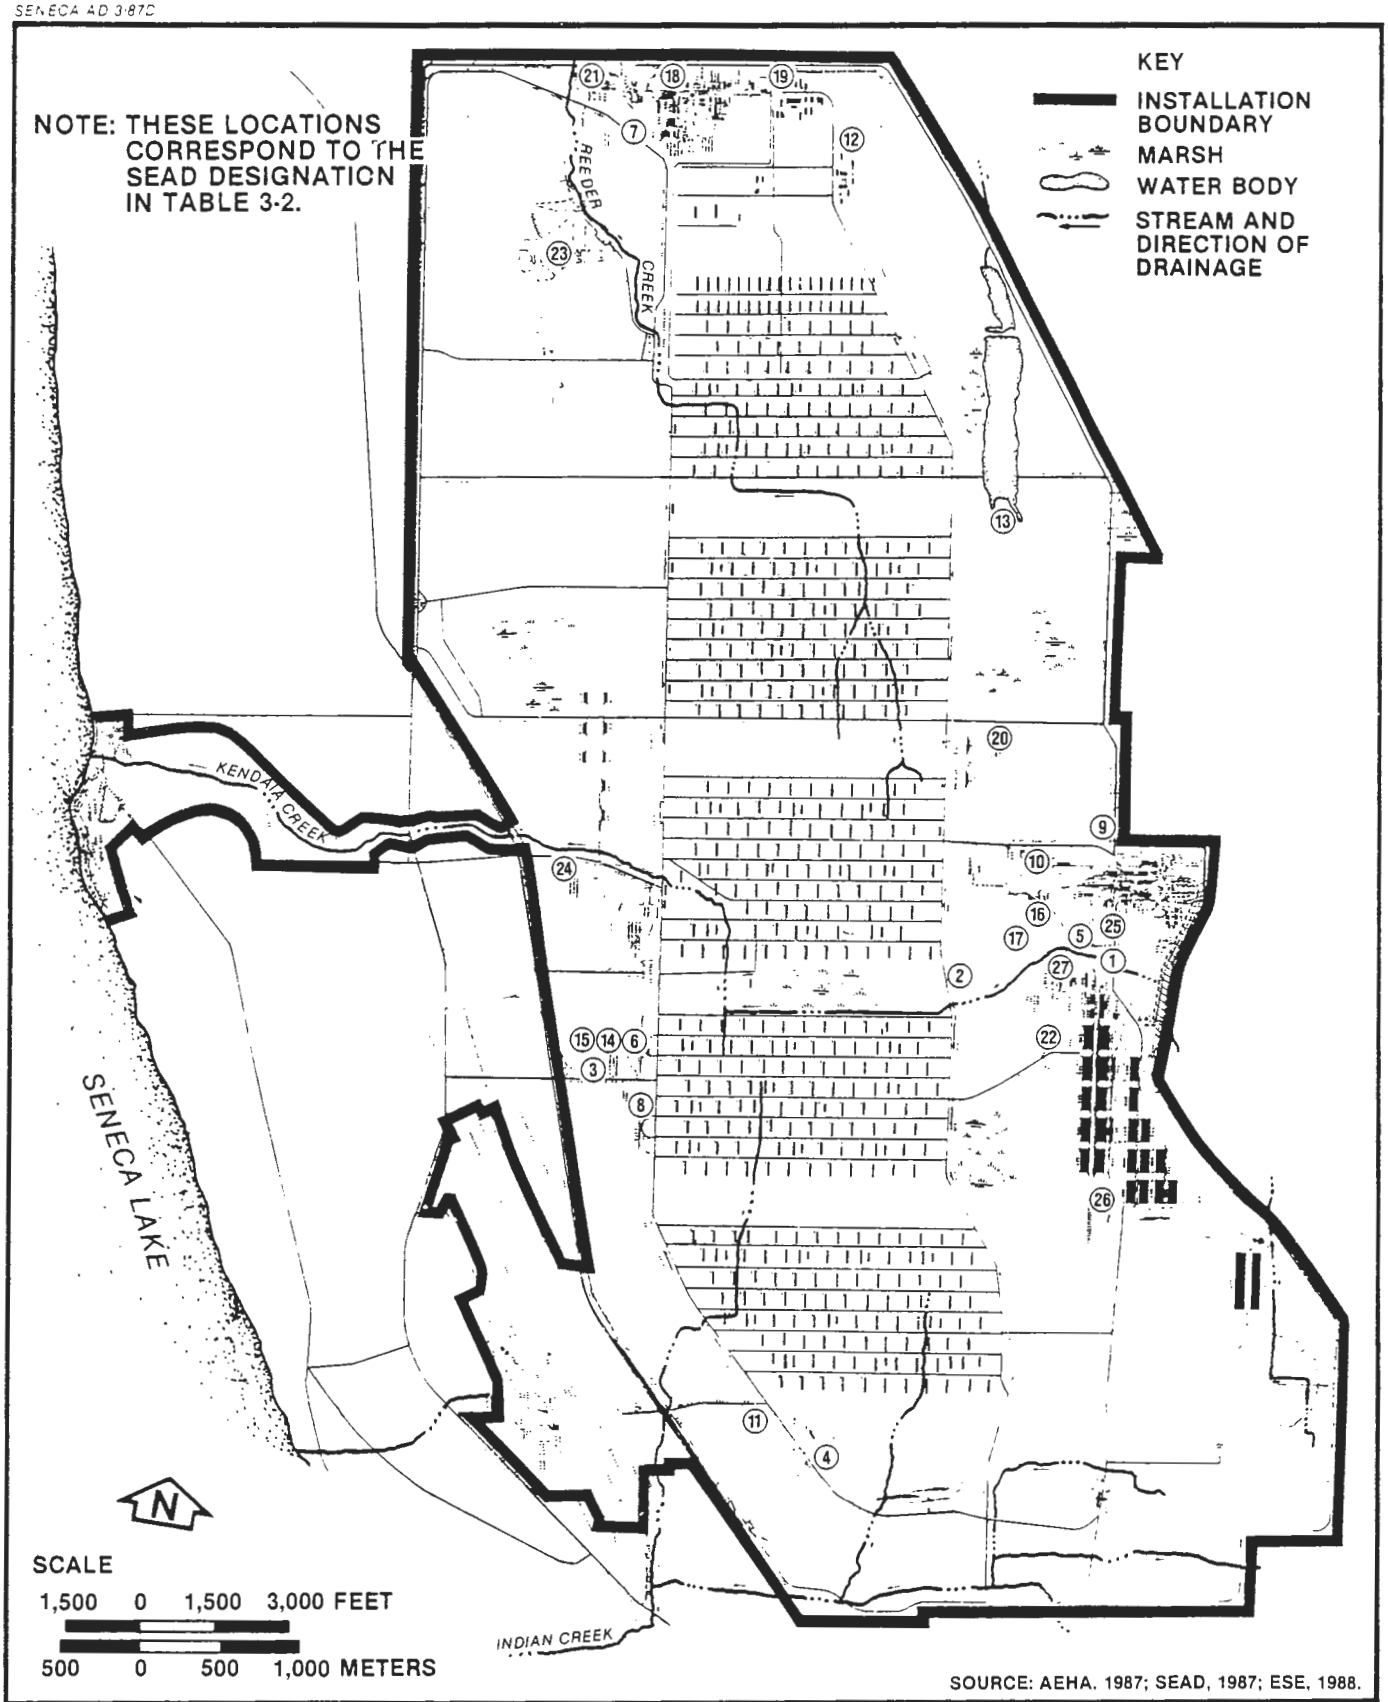
Figure 3-2
LOCATIONS OF SOLID WASTE MANAGEMENT UNITS ON SENECA ARMY DEPOT

Since the onsite visit to prepare this report, an additional survey to identify, describe, and evaluate Solid Waste Mangement Units (SWMU) has been completed at SEAD. The study identified 41 SWMUs at SEAD (see Table 3-2 and Fig. 3-2). The study recommended that SEAD coordinate the SWMU list with EPA Region II and NYSDEC and implement a sampling program, including SEAD SWMUs 3, 4, 6, 8, 11, 14, 16, 17, 18, 19, 23, 24, 25, and 26.

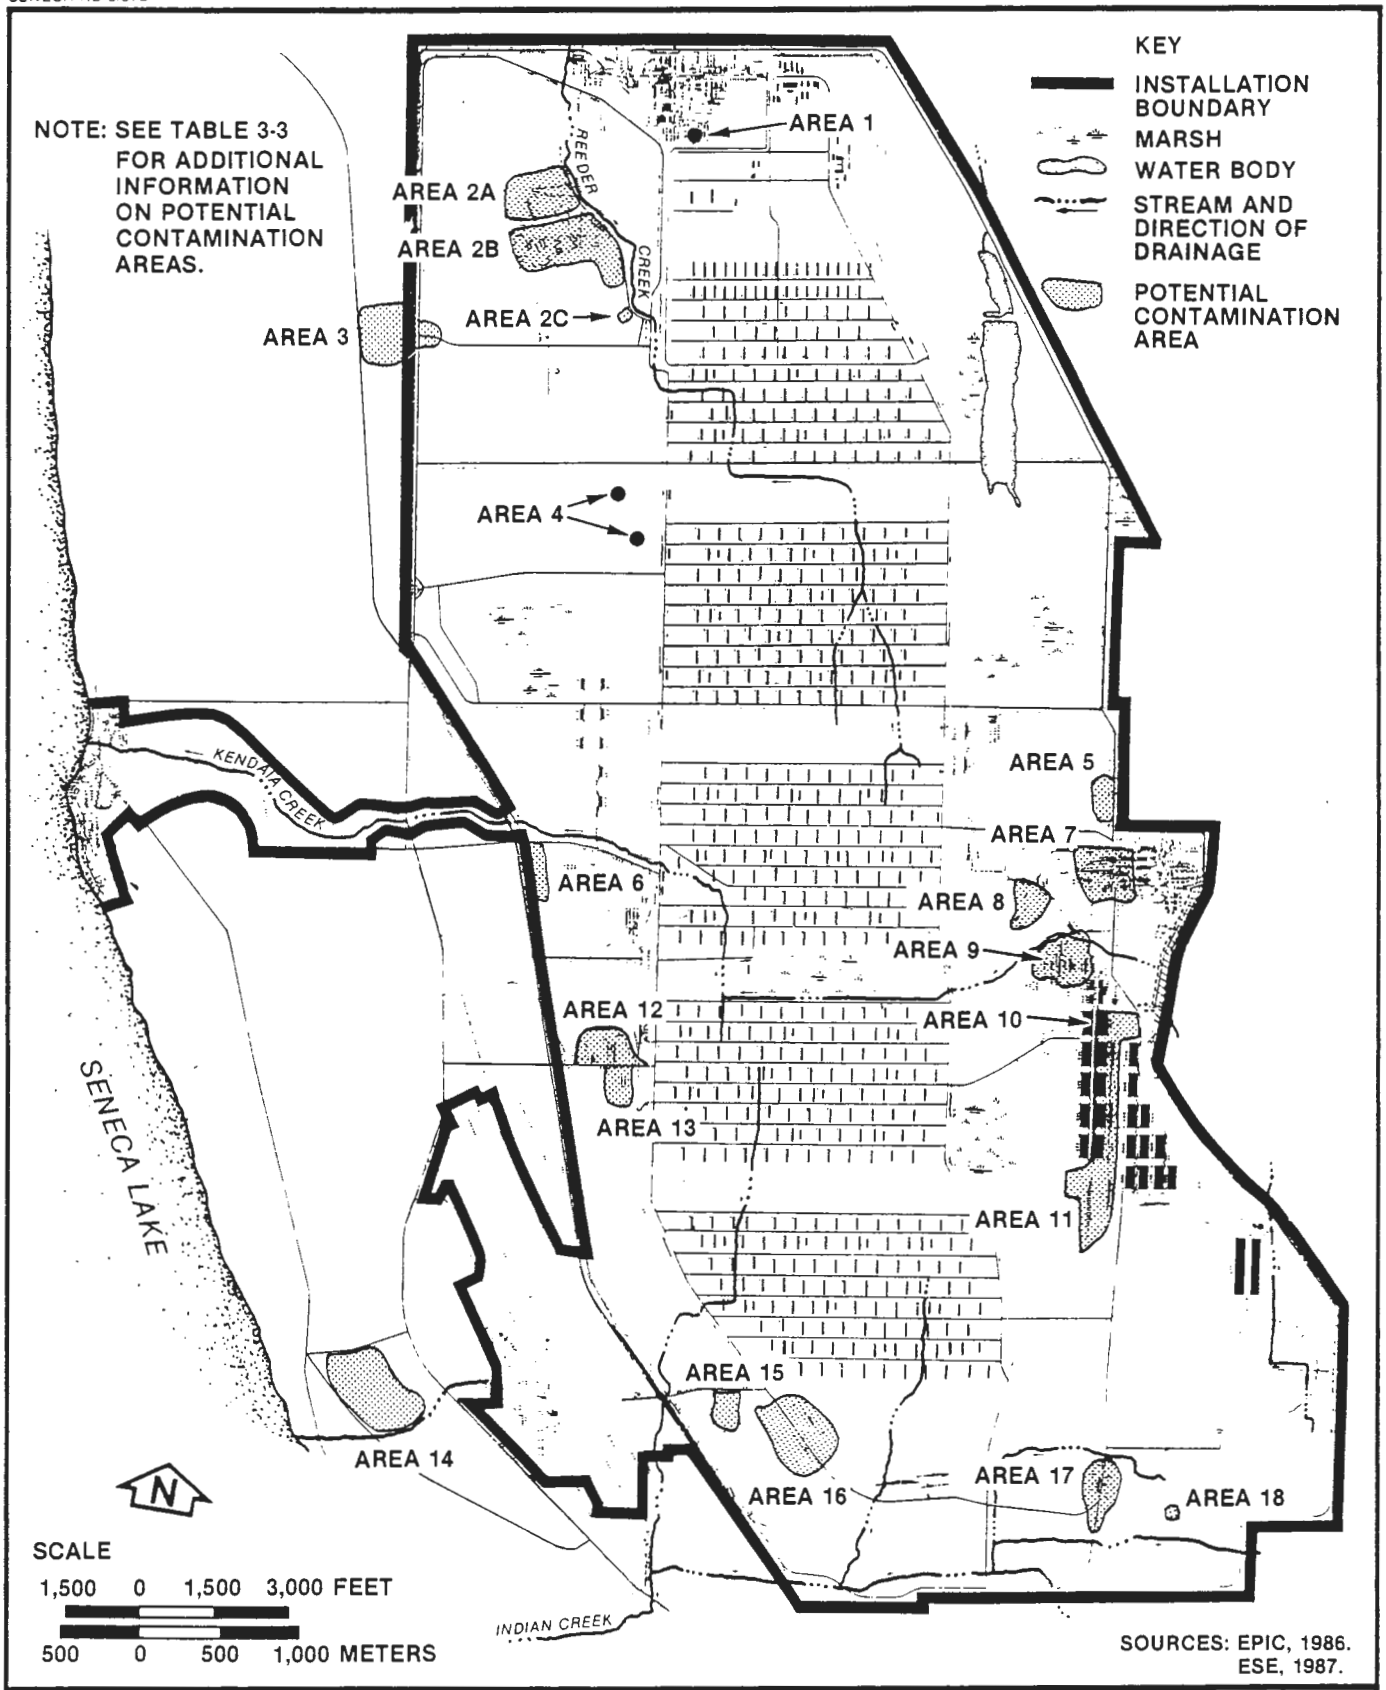
Figure 3-3
POTENTIAL CONTAMINATION AREAS IDENTIFIED FROM AERIAL PHOTOGRAPHIC IMAGERY

The United States Environmental Protection Agency's Environmental Photographic Interpretation Center, under an interagency agreement with USATHAMA, prepared a report in which potential contamination areas on SEAD were identified. These areas (see Fig. 3-3) were identified based on ground staining, ground scarring, pits, revetted areas, aboveground tanks, extraction areas, raw materials piles, smokestacks, equipment storage area, and other signatures which are readily recognizable to photographic imagery experts.
