SENECA ARMY DEPOT ACTIVITY
TIME CRITICAL REMOVAL ACTION
METAL SITES – SEAD 67
SENECA COUNTY
ROMULUS, NEW YORK

FINAL
COMPLETION REMOVAL REPORT

February 2005

COMPLETION REMOVAL REPORT
TIME-CRITICAL REMOVAL ACTION
METALS SITE – SEAD 67
SENECA COUNTY
ROMULUS, NEW YORK

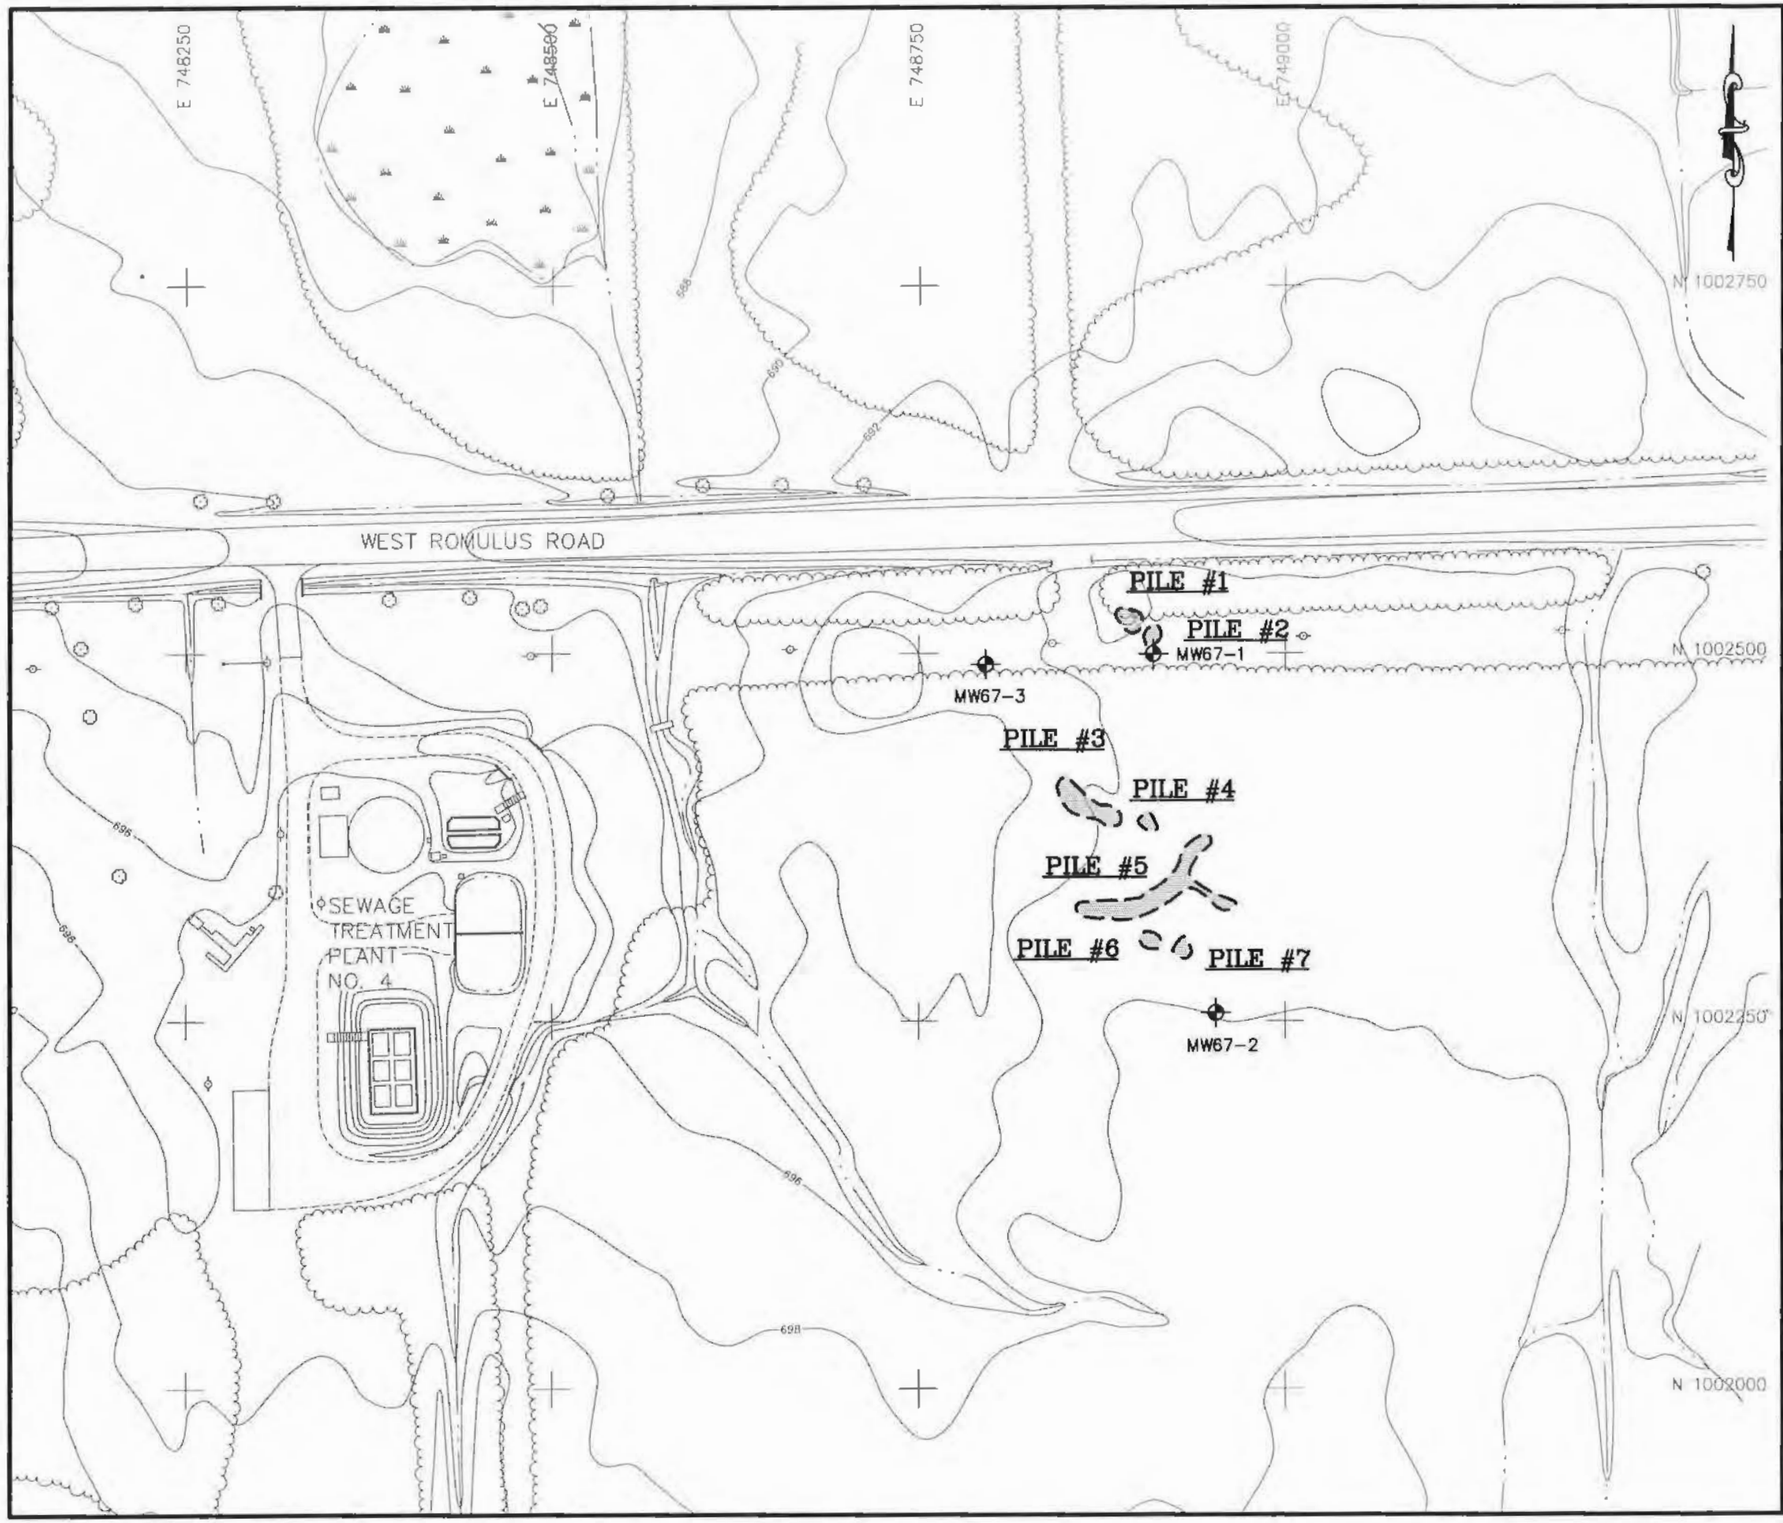
SITE MAP

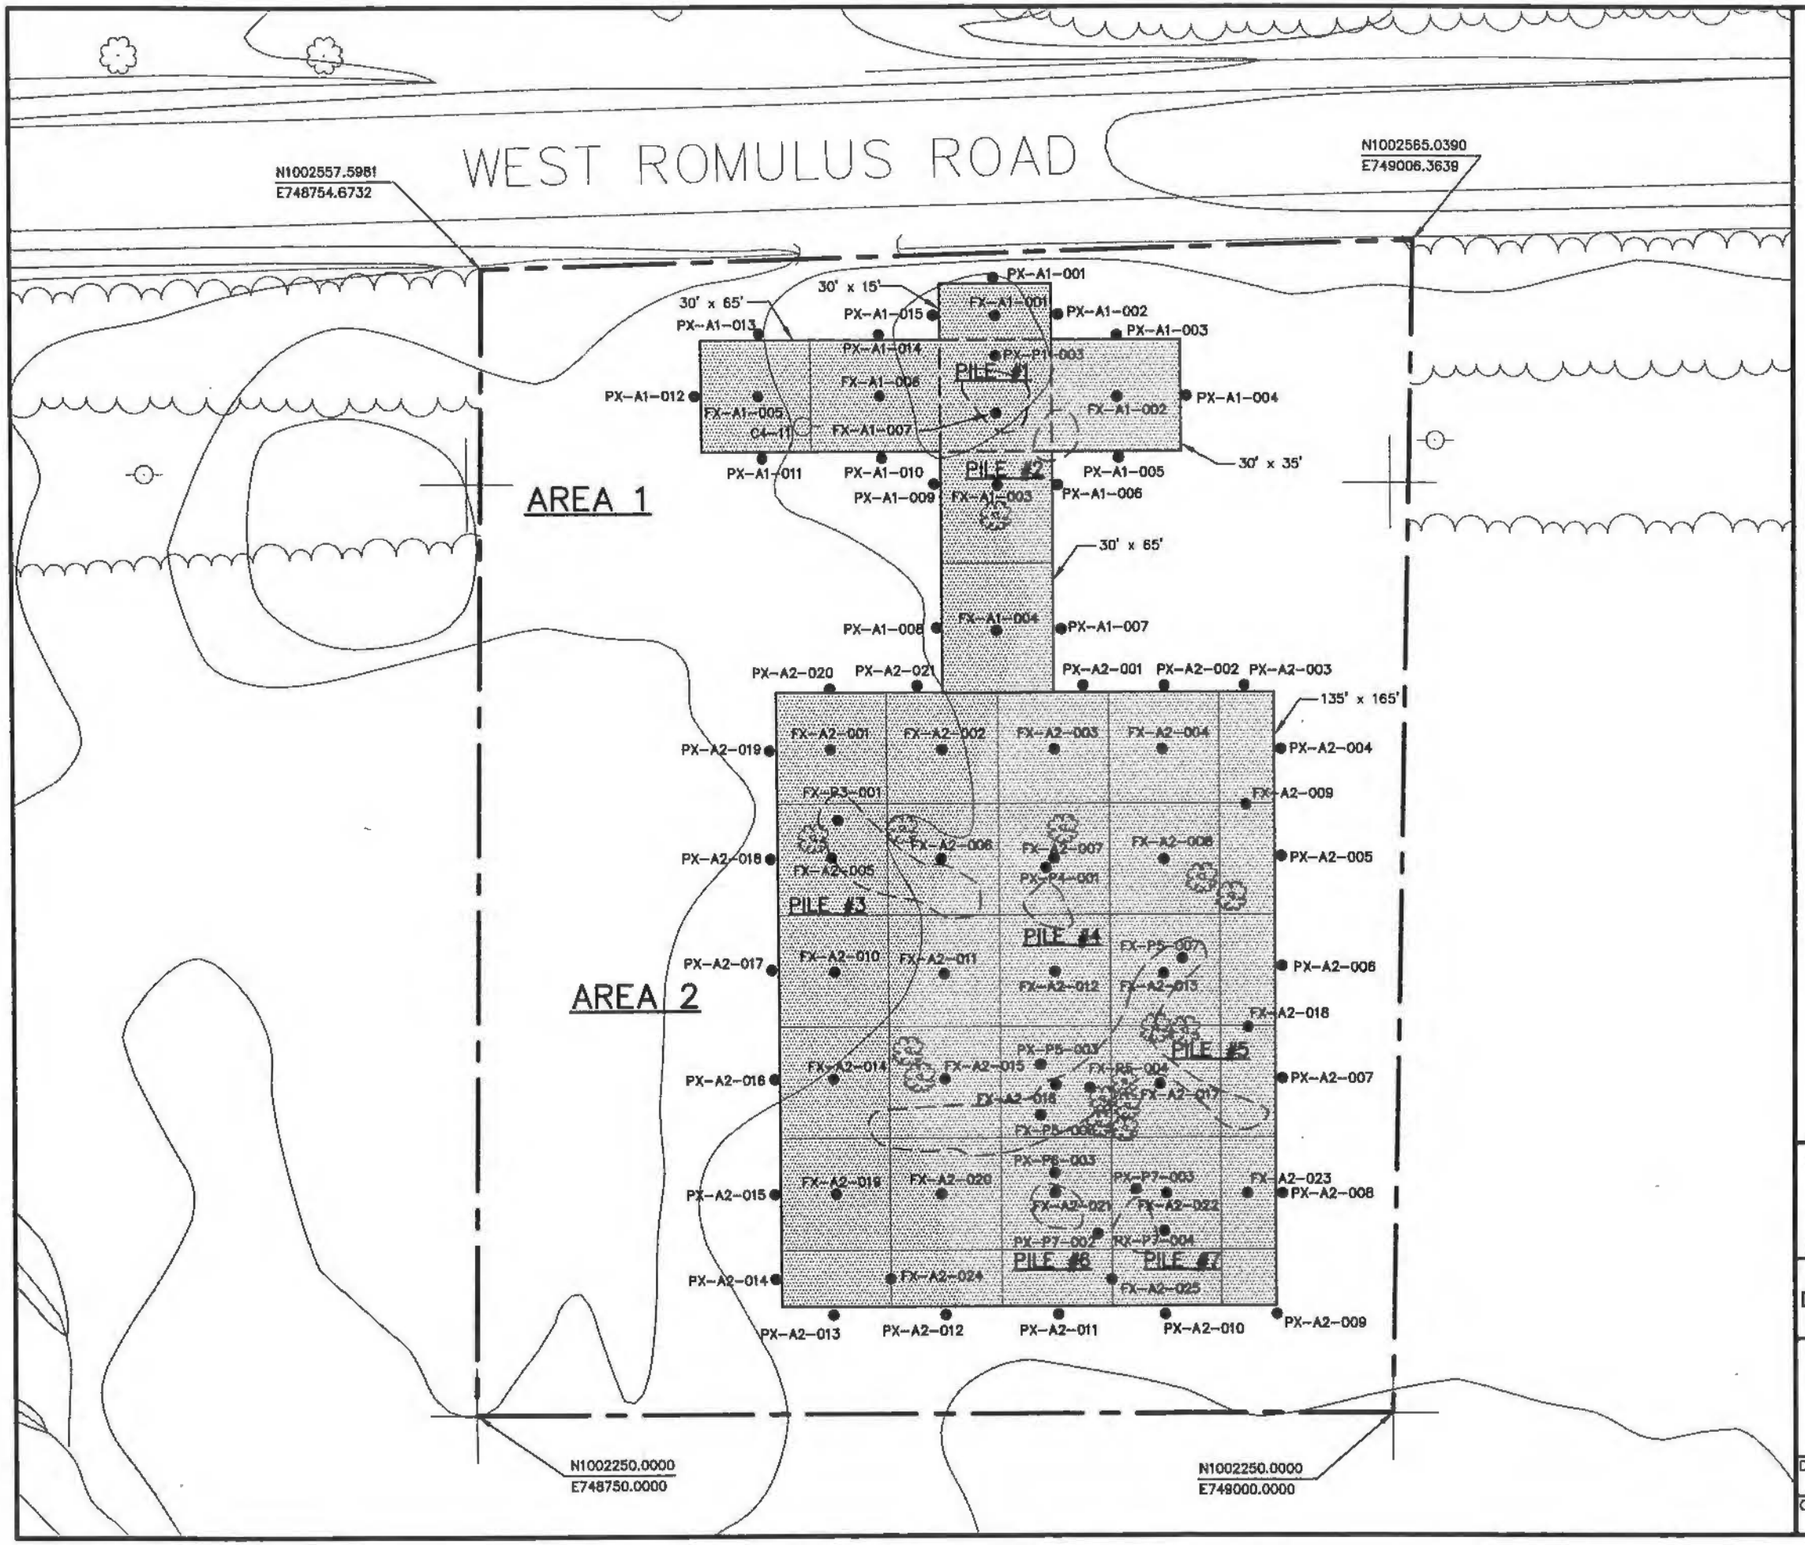
CONFIRMATORY SOIL SAMPLE LOCATION MAP

On 11 May 2004, 8 confirmatory floor samples and 15 confirmatory perimeter samples were collected from the Area 1 excavation. Samples were collected as discrete grab samples between 2-6 inches below ground surface (bgs). Refer to Figure 3-2 for sample locations and Appendix A for sample results. Of the 23 confirmatory samples collected in Area 1, two floor samples and three perimeter samples were analyzed for the full suite of TAL metals and TCL PAHs. The remaining samples were analyzed for arsenic, mercury, and zinc only. An evaluation of the maximum confirmatory sample results for Area 1 (refer to Appendix A), indicates three exceedances in Area 1 for mercury. However, the overall average result for mercury in Area 1 is 0.08 mg/kg, which is below the cleanup goal of 0.1 mg/kg. Maximum confirmatory sample results also indicate exceedances for the following PAHs in Area 1: benzo(a)anthracene;

benzo(a)pyrene; benzo(k)fluoranthene; chrysene; and dibenzo(a,h)anthracene. However, evaluation of the Benzo(a)pyrene TEQ does not result in an exceedance of the 10,000 µg/kg limit for total cPAHs in Area 1. The overall average Benzo(a)pyrene TEQ for Area 1 is 598 ug/kg.

On 11 May 2004, 35 confirmatory floor samples and 21 confirmatory perimeter samples were collected from the Area 2 excavation. Samples were collected as discrete grab samples between 2-6 inches bgs. Refer to Figure 3-2 for sample locations and Appendix A for confirmatory sample results. A total of 12 floor samples and 4 perimeter samples were analyzed for the full suite of TAL metals and TCL PAHs. The remaining samples were analyzed for arsenic, mercury, and zinc only. Evaluation of the maximum confirmatory sample results for Area 2 (refer to Appendix A), indicates five exceedances in Area 2 for mercury; however, the overall average result for mercury in Area 2 is 0.08 mg/kg, which is below the cleanup goal of 0.1 mg/kg. Maximum confirmatory sample results for Area 2 also indicate exceedances for benzo(a)pyrene and dibenzo(a,h)anthracene. Although there were exceedances for two PAH parameters, an evaluation of the Benzo(a)pyrene TEQ does not result in an exceedance of the 10,000 µg/kg limit for total cPAHs in Area 2. The overall average Benzo(a)pyrene TEQ for Area 2 is 73 ug/kg.
