FINAL SWMU CLASSIFICATION REPORT SENECA ARMY DEPOT ACTIVITY

**SOLID WASTE MANAGEMENT
CLASSIFICATION STUDY
SENECA ARMY DEPOT
ROMULUS, NEW YORK**

**Seneca Army Depot Activity
Romulus, New York**

**Engineering-Science, Inc.
Prudential Center
Boston, Massachusetts**

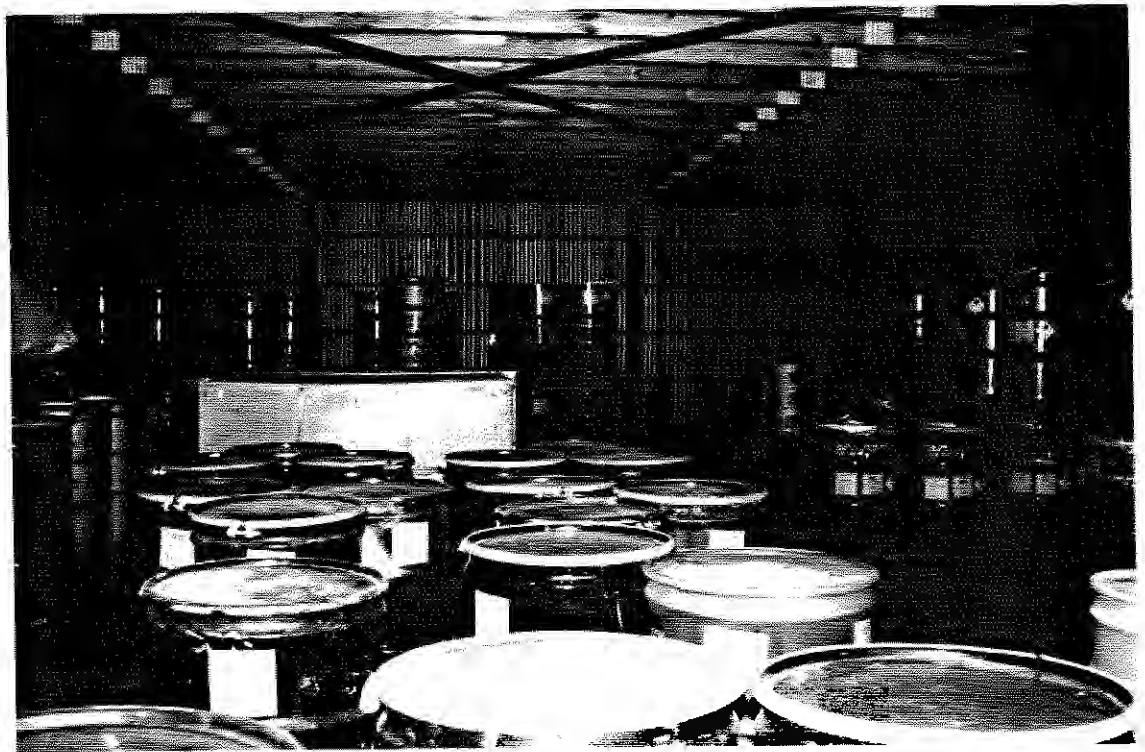
Photo 3: SEAD-1, 11/27/90. Interior of the Hazardous Waste Container Storage Facility - Building 307, facing northeast.

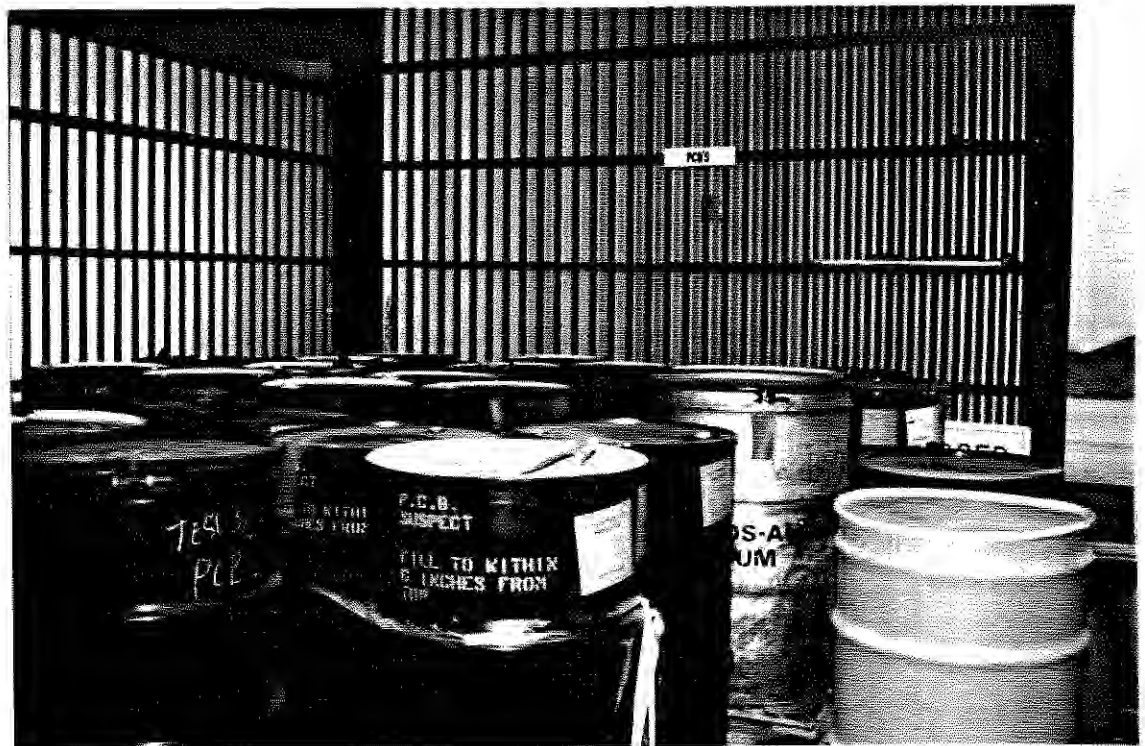
Photo 4: SEAD-1, 11/27/90. Interior of the Hazardous Waste Container Storage Facility - Building 307, facing southeast.

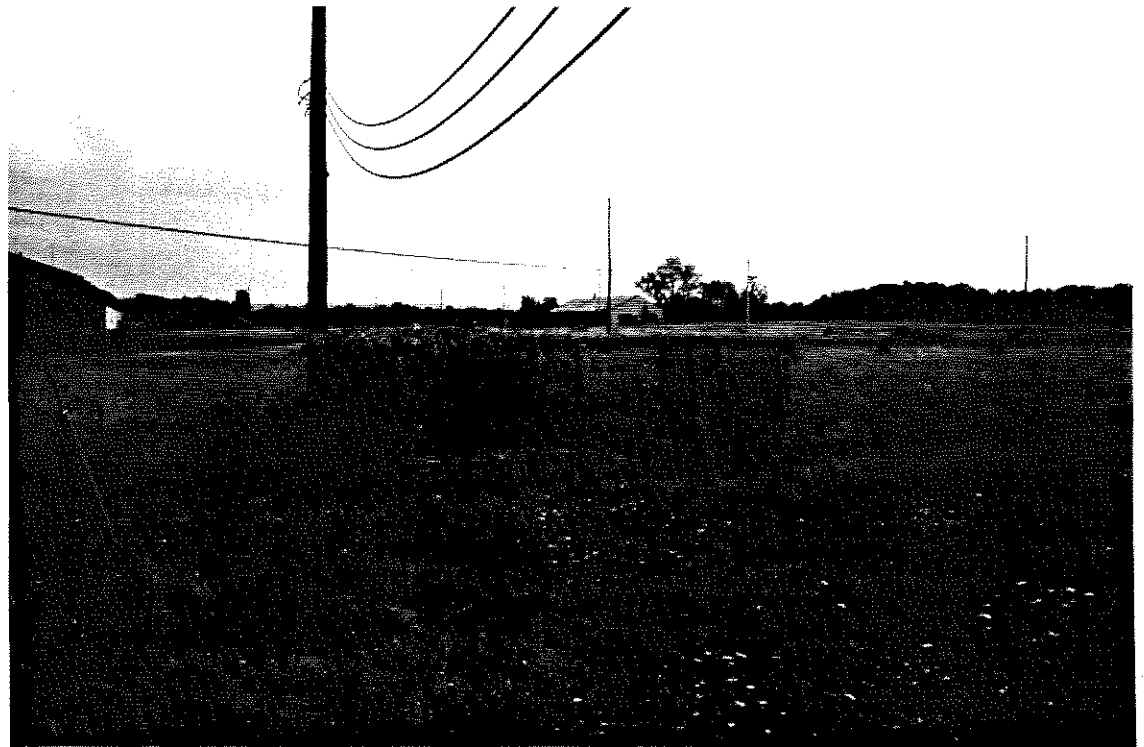
Photo 9: SEAD-4, 9/13/90. View of the Munitions Washout Facility Leach Field, facing south.

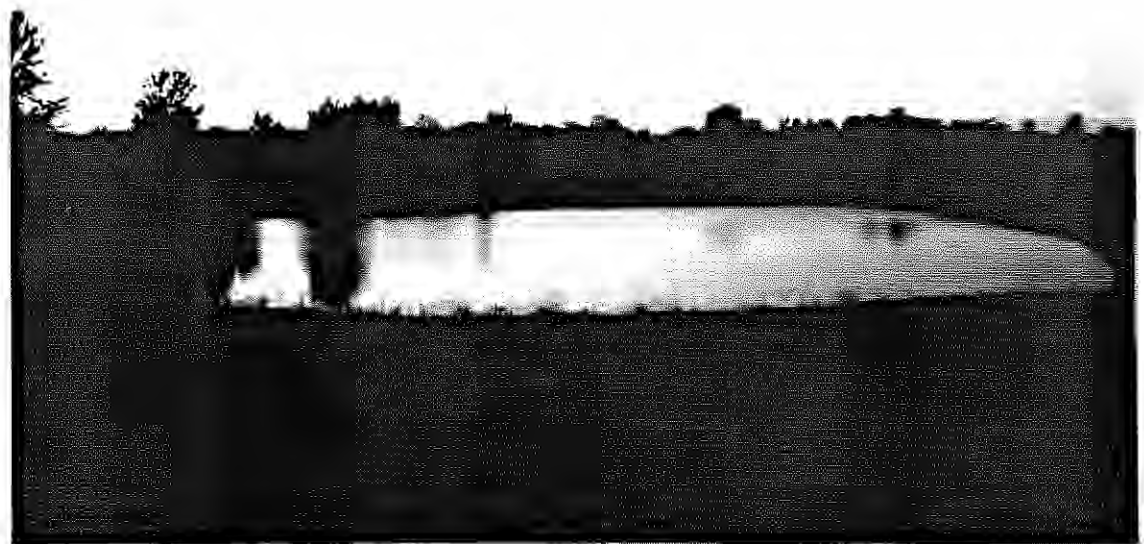
Photo 11: SEAD-4, 9-11-90. View of the pond which collects the drainage from the Munitions Washout Facility Leach Field, facing west.

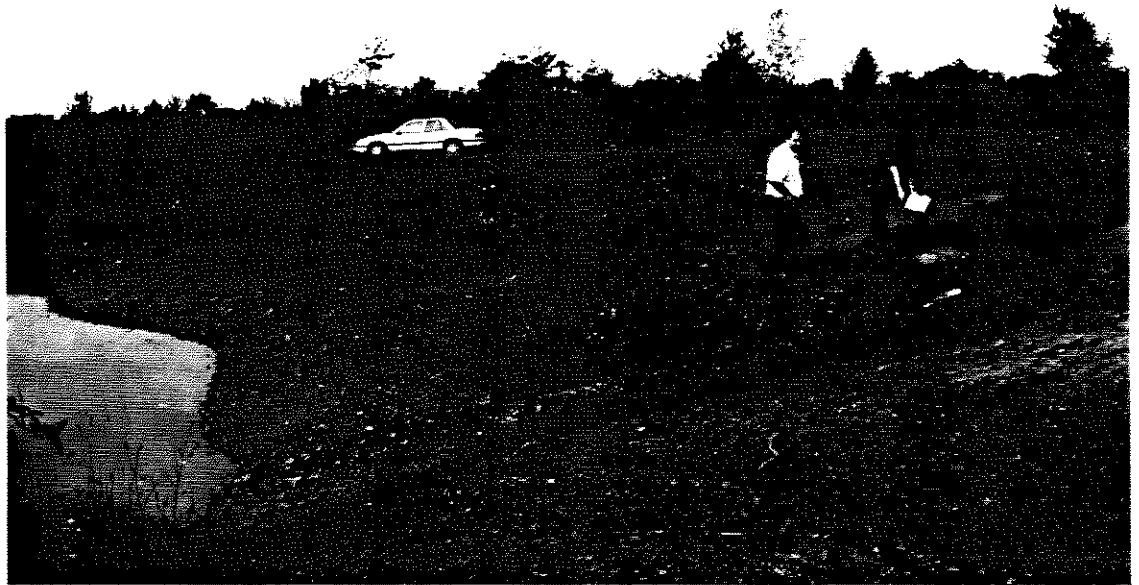
Photo 12: SEAD-4, 9/11/90. View of the drainage ditch from the Munitions Washout Facility Leach Field, leading to the pond, facing northeast.

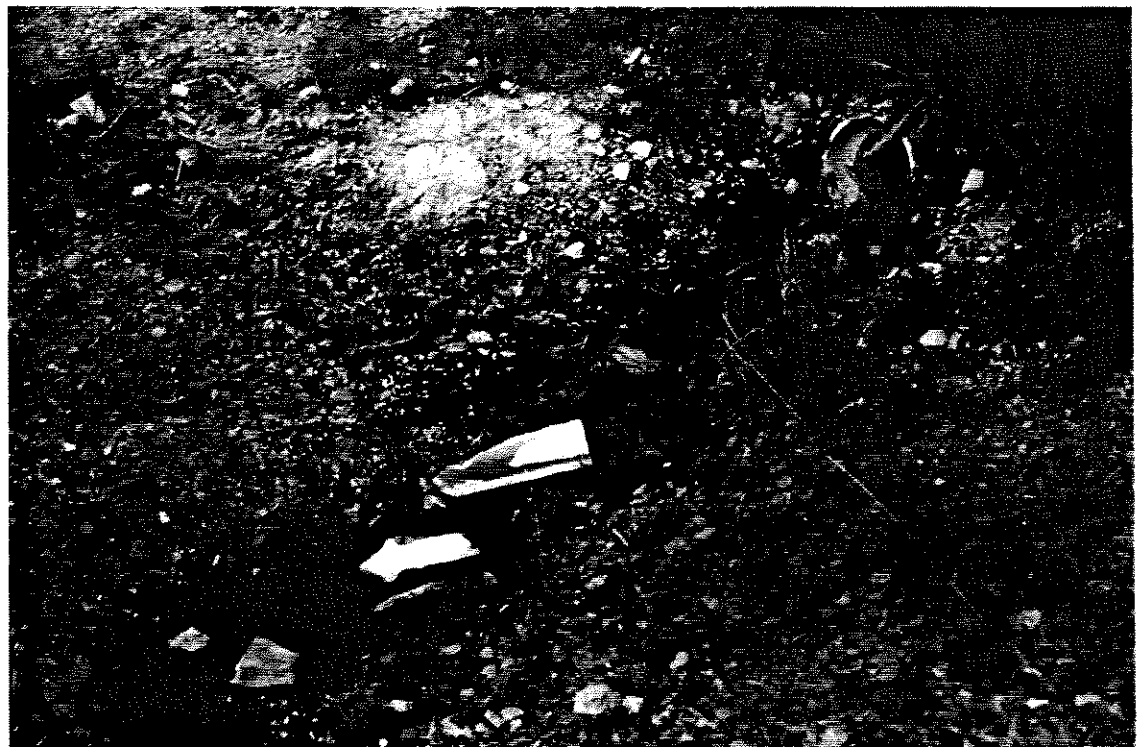
Photo 13: SEAD-4, 9/11/90. Close-up of the drainage ditch from the Munitions Washout Facility Leach Field, leading to the pond, facing northeast.

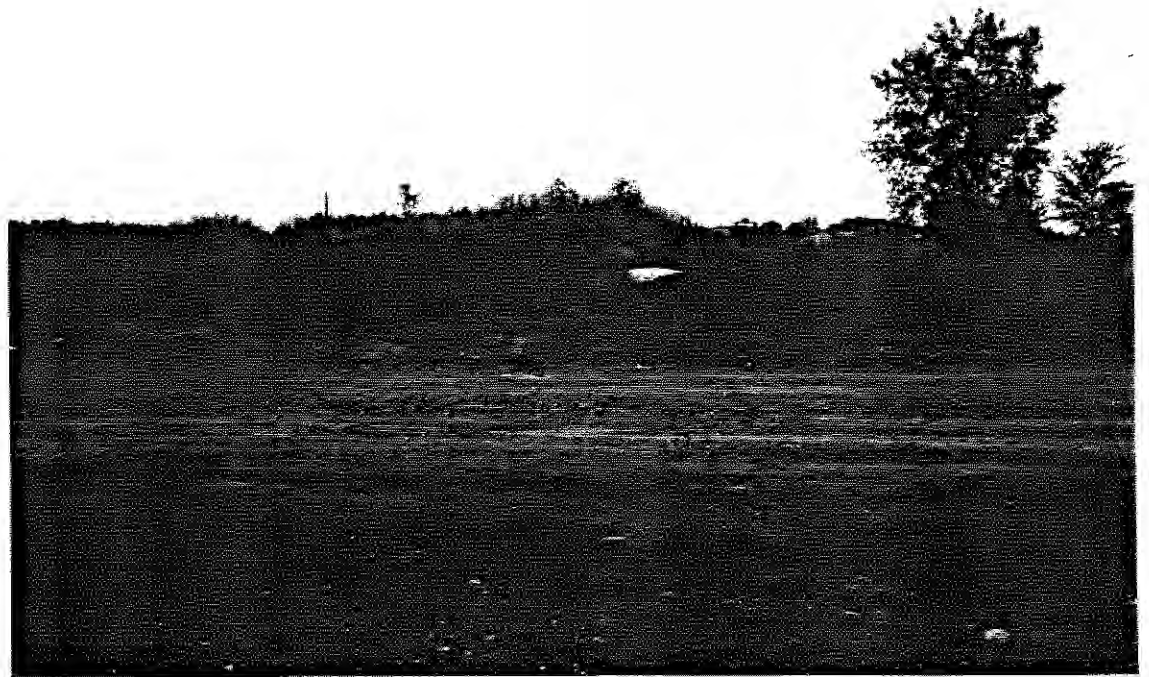
Photo 15: SEAD-5, 9/13/90. View of the Sewage Sludge Waste Piles, facing south.

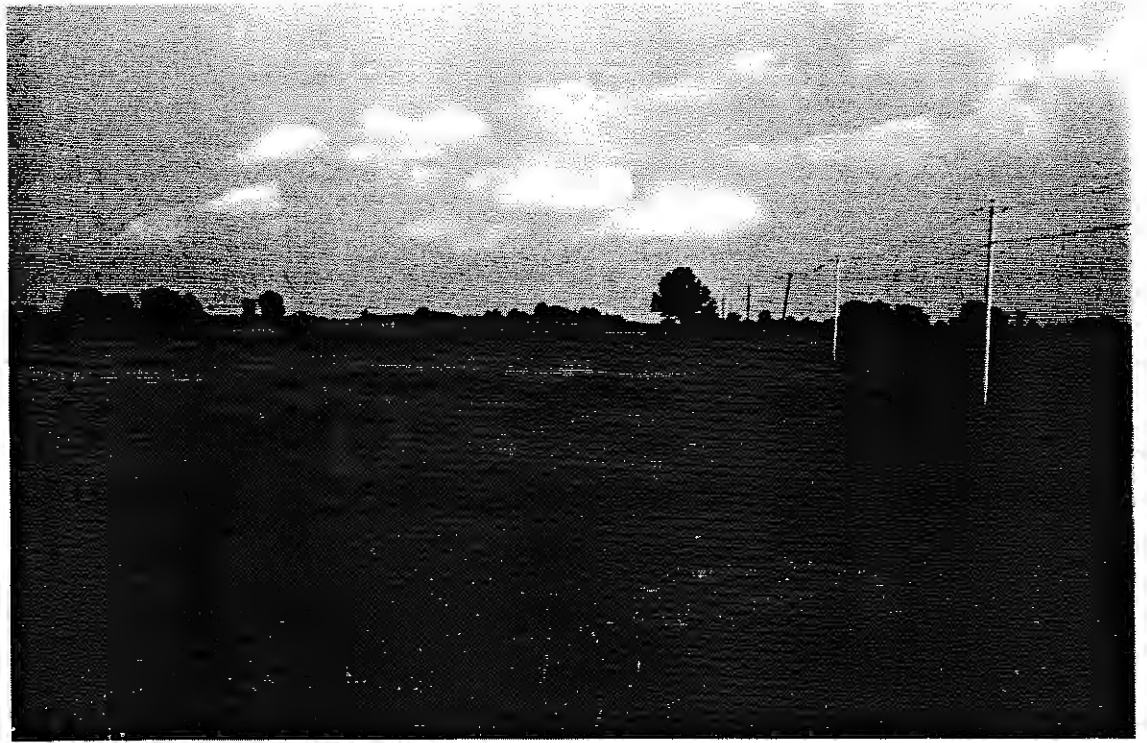
Photo 17: SEAD-6, 9/10/90. View of the Abandoned Ash Landfill, facing east.

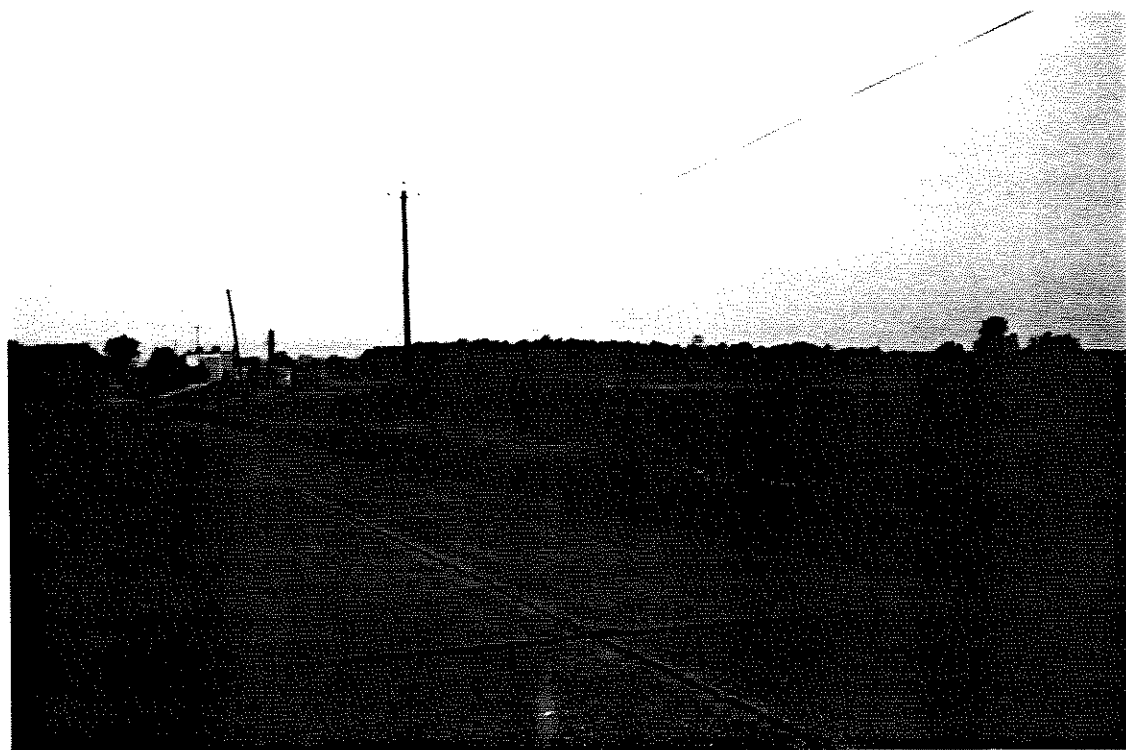
Photo 19: SEAD-6 and SEAD-15, 9/14/90. View of the Abandoned Ash Landfill (SEAD-6) and the Abandoned Solid Waste Incinerator - Building 2207 (SEAD-15), facing northwest.

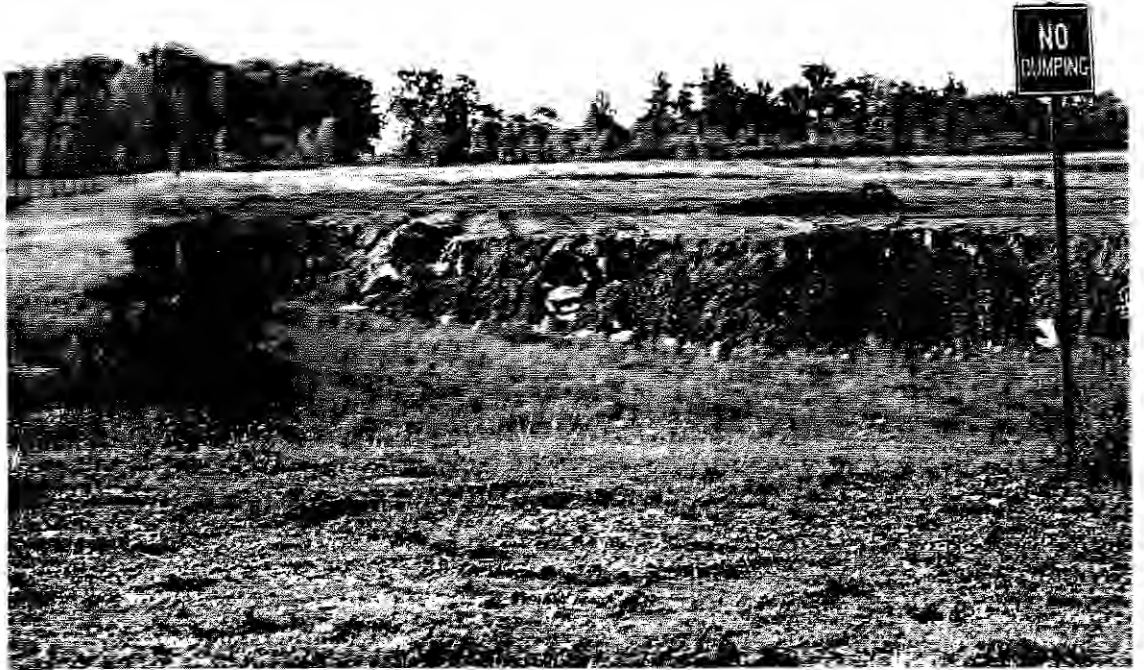
Photo 20: SEAD-7, 9/13/90. View of the Shale Pit, facing southwest.

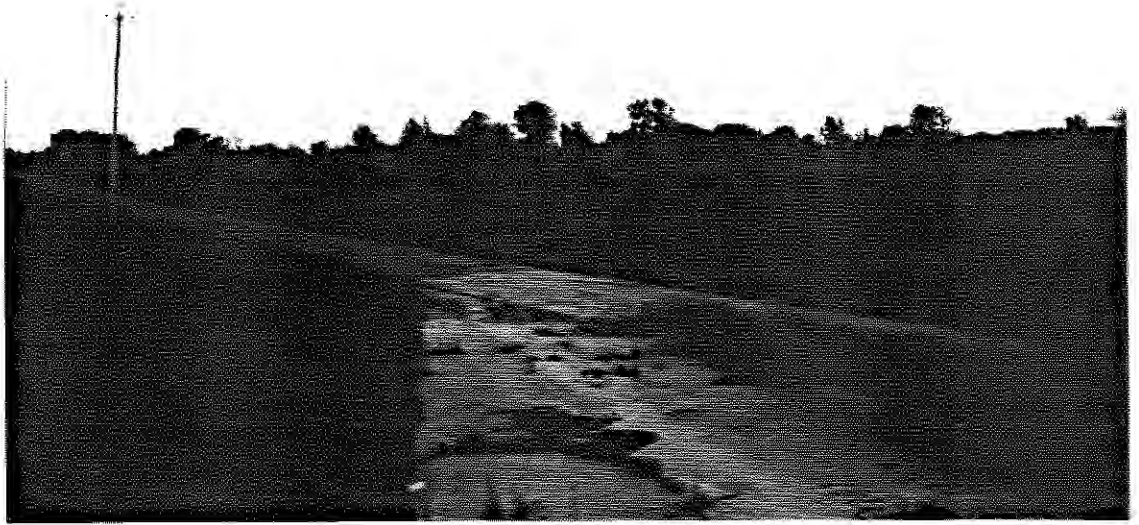
Photo 21: SEAD-8, 9/14/90. View of the Non-Combustible Fill Area, facing southeast.

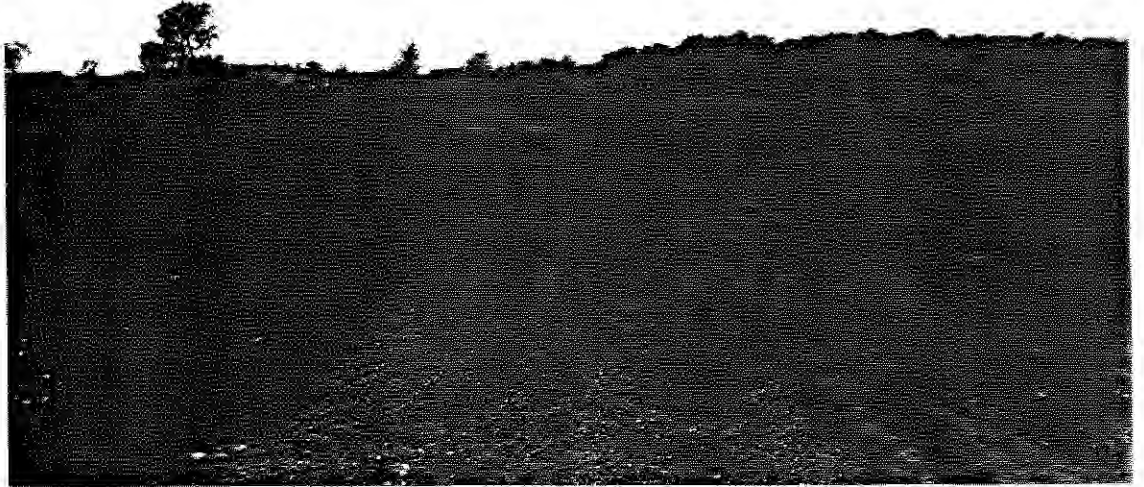
Photo 22: SEAD-9, 9/12/90. View of the Old Scrap Wood Site, facing northwest.

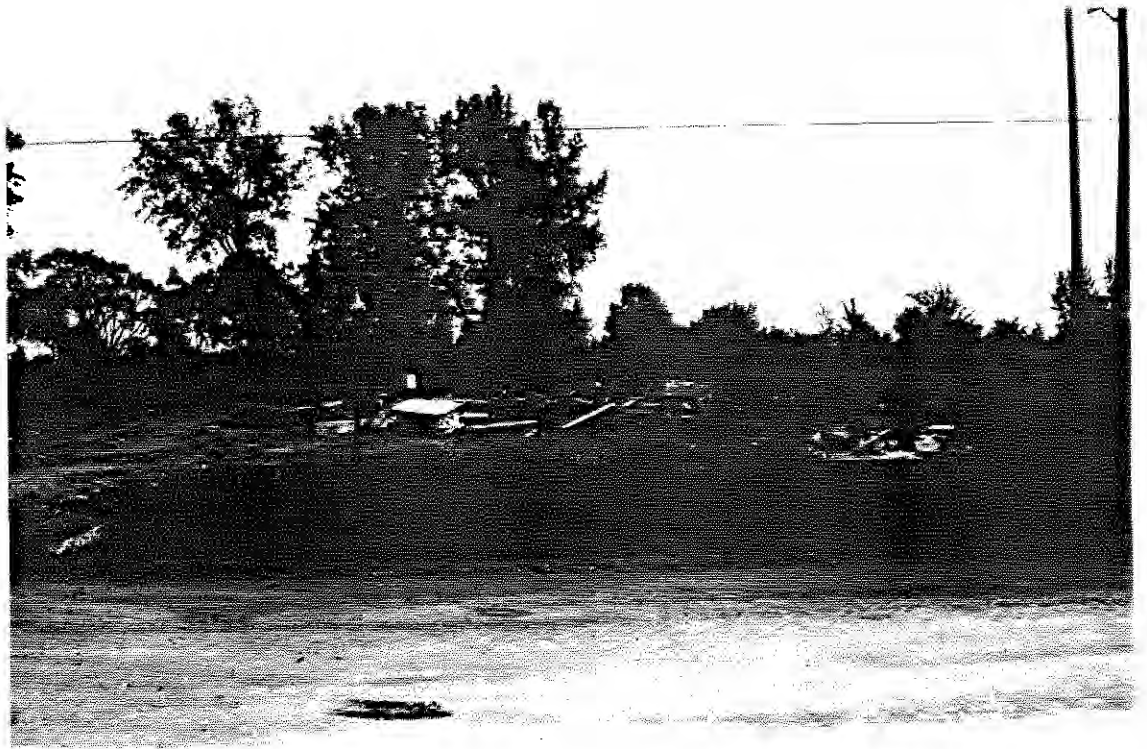
Photo 25: SEAD-10, 9/12/90. View of the western pile of the Present Scrap Wood Site, facing south.

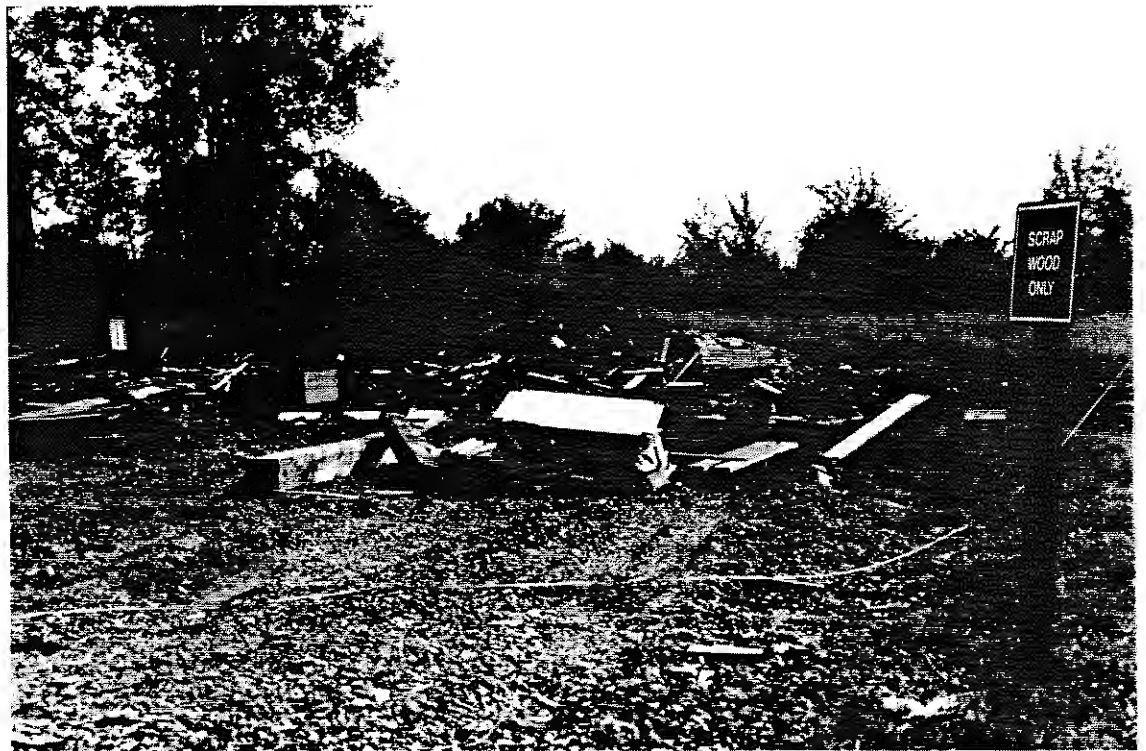
Photo 26: SEAD-10, 9/12/90. Close-up of the western pile of the Present Scrap Wood Site, facing southwest.

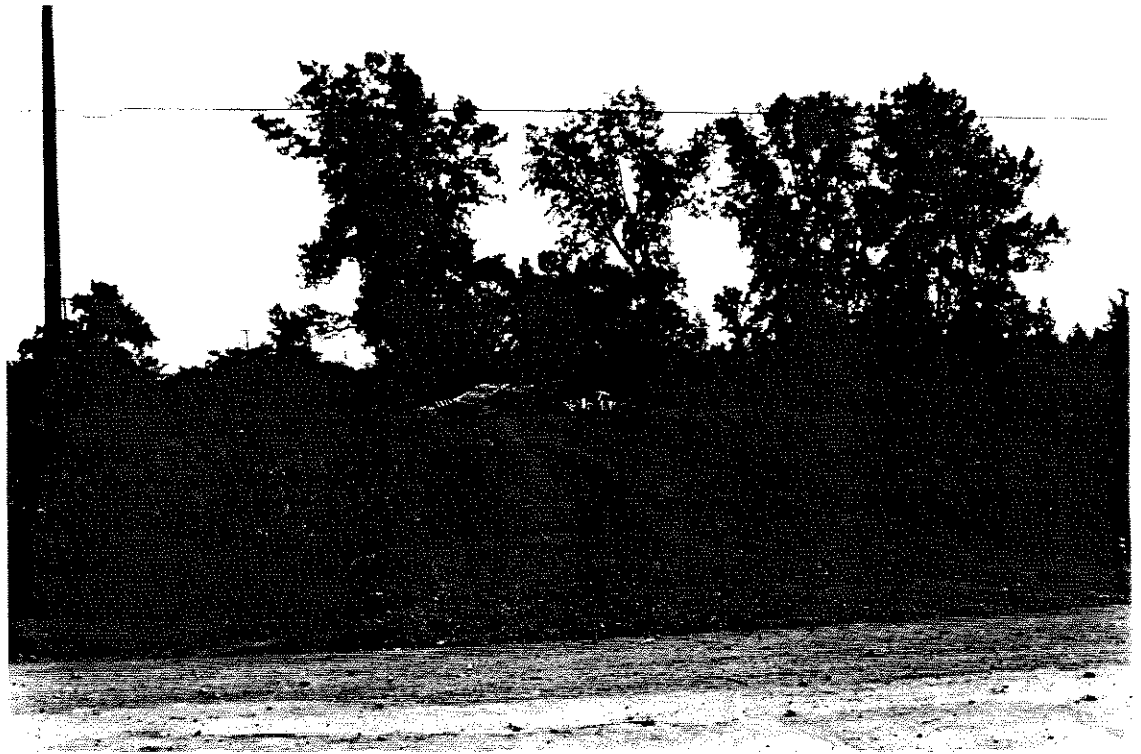
Photo 27: SEAD-10, 9/12/90. View of the middle pile of the Present Scrap Wood Site, facing south (wooden pallet disposal area).

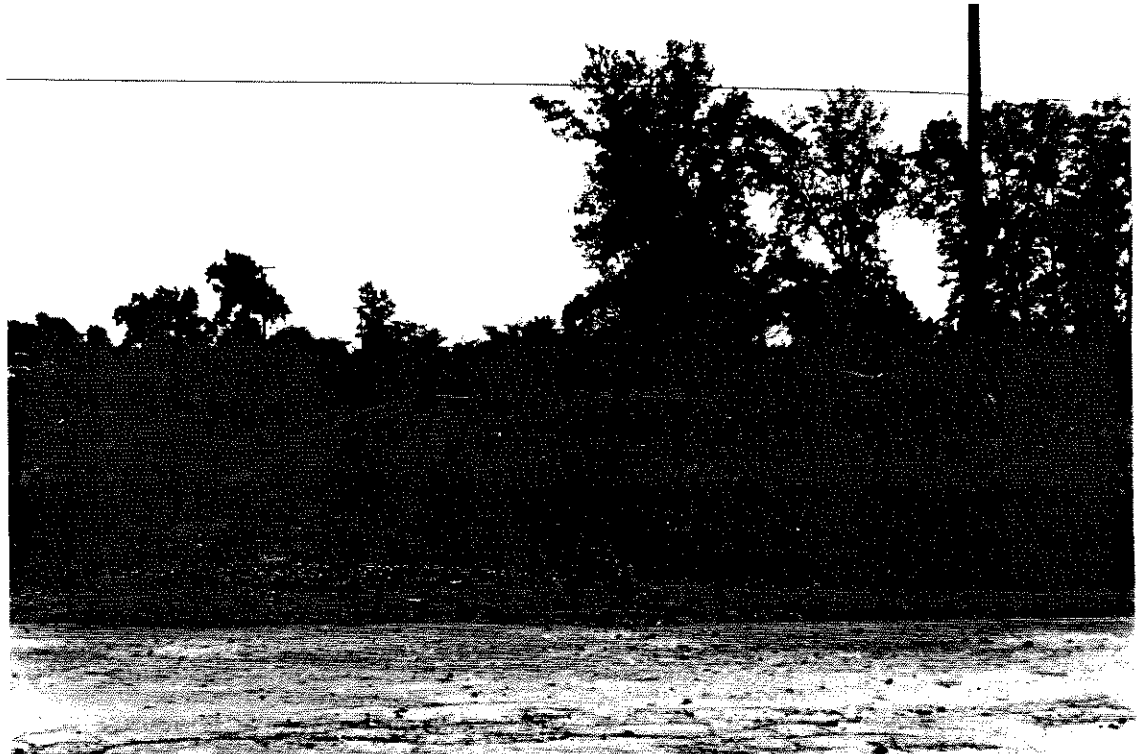
Photo 28: SEAD-10, 9/12/90. View of the east pile of the Present Scrap Wood Site, facing south (pressure treated wood and pole sales area).

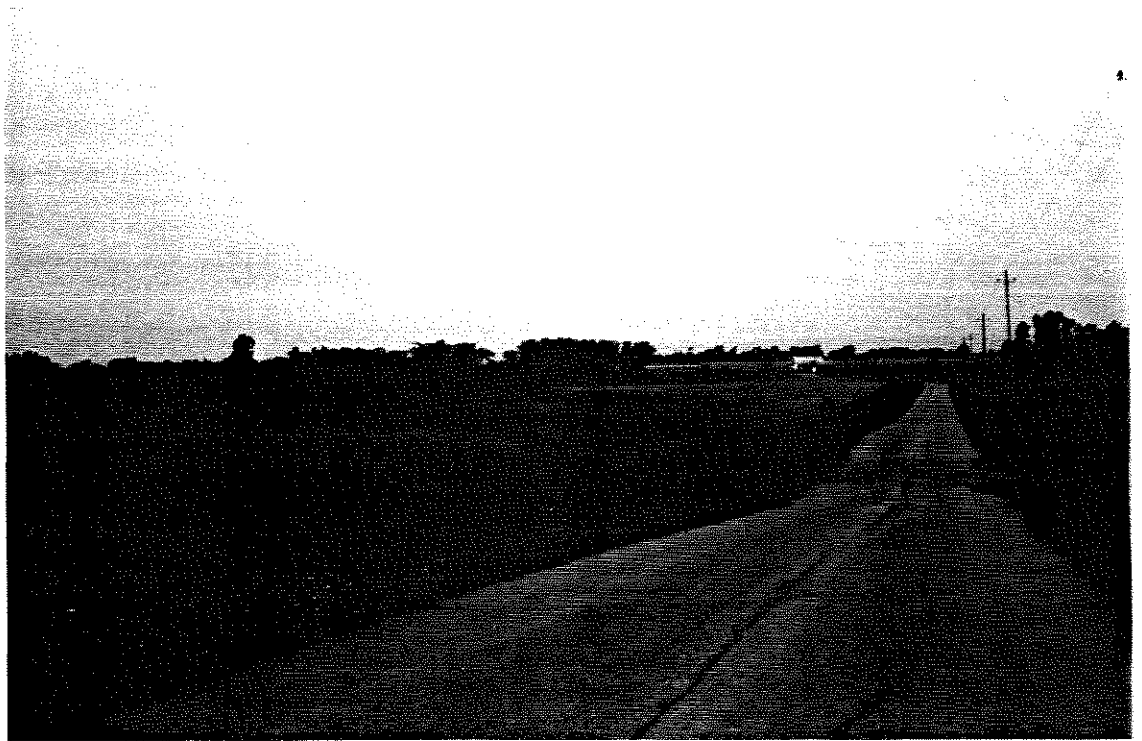
Photo 29: SEAD-11, 9/14/90. View of the Old Construction Debris Landfill, facing west.

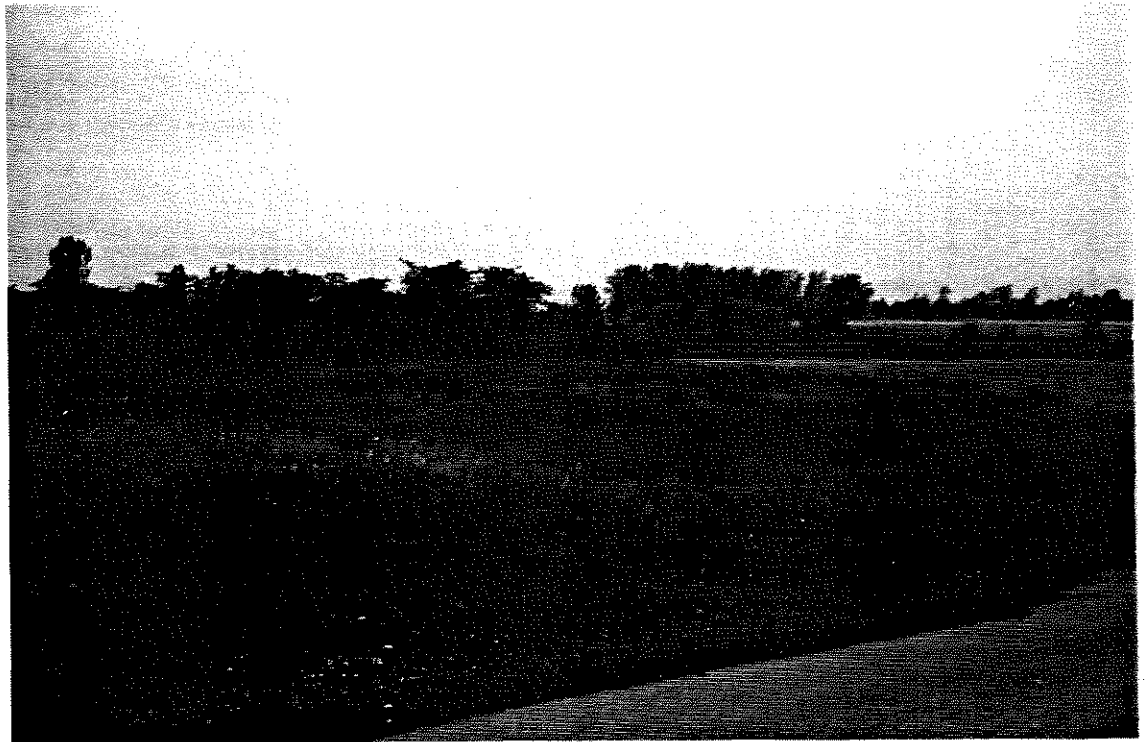
Photo 30: SEAD-11, 9/14/90. Close-up of the Old Construction Debris Landfill, facing west.

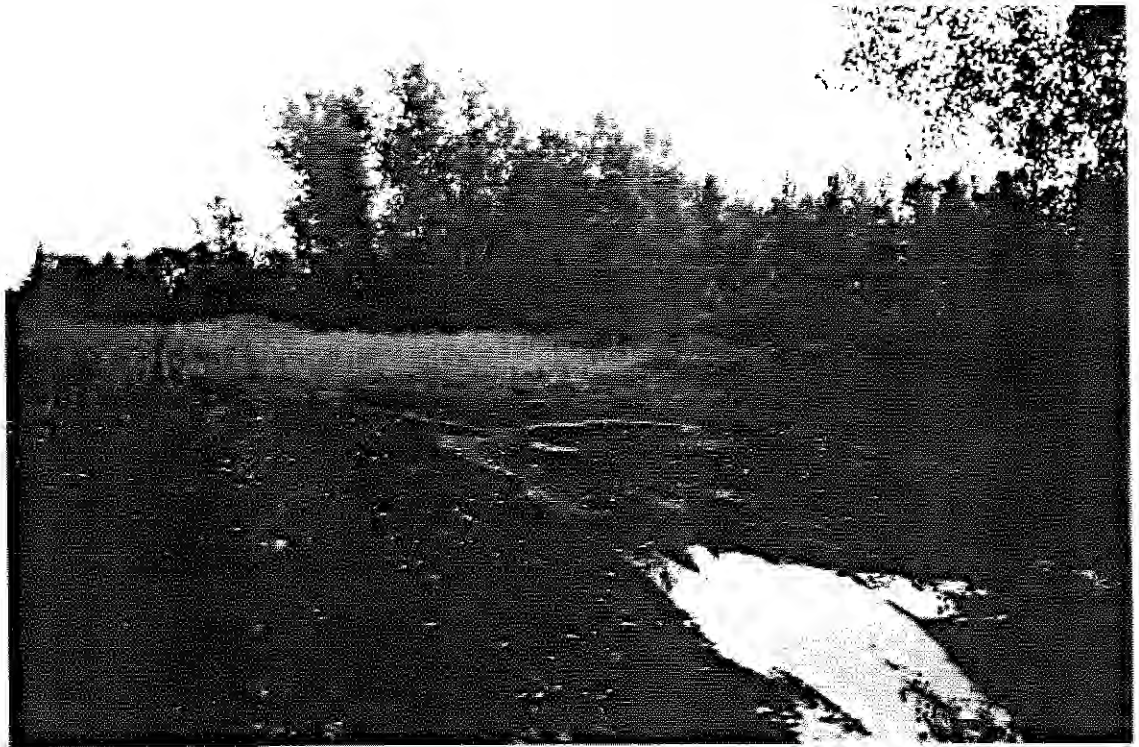
Photo 33: SEAD-13, 9/11/90. View of one possible location of the IRFNA Disposal Site (south of East-West Base Line Road), facing south.

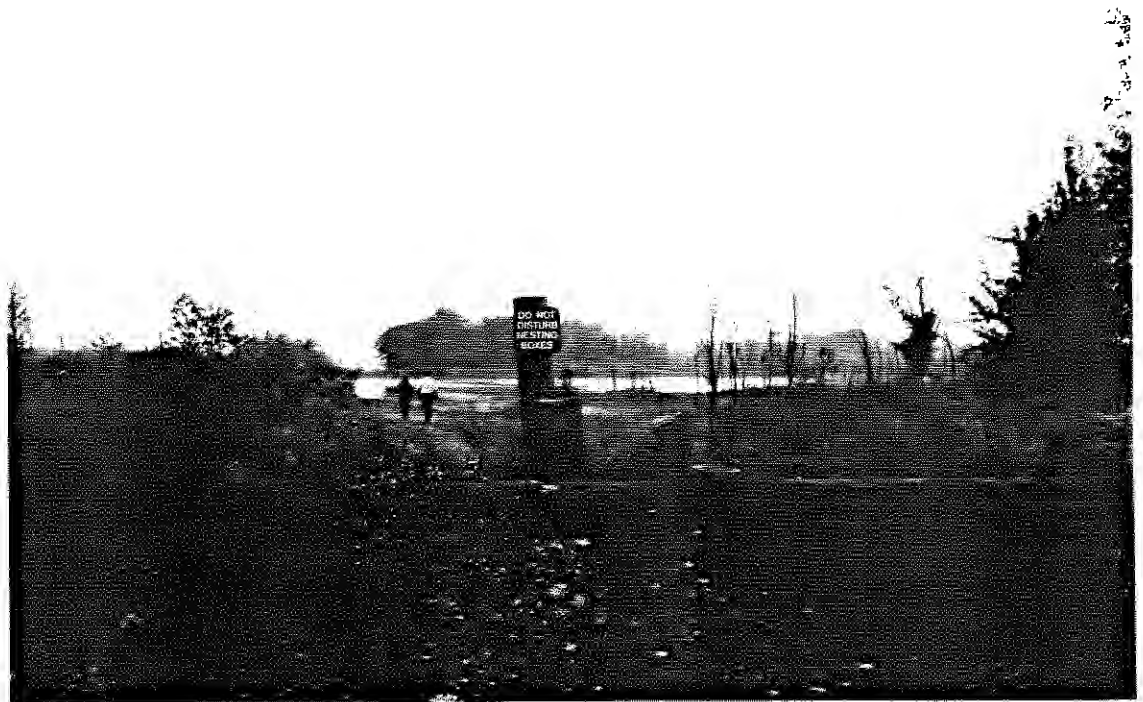
Photo 34: SEAD-13, 9/11/90. View of one possible location of the IRFNA Disposal Site (under the Duck Ponds; south of East-West Base Line Road), facing west; the possible site is located at the left side of the photograph, in the southern part of the pond.

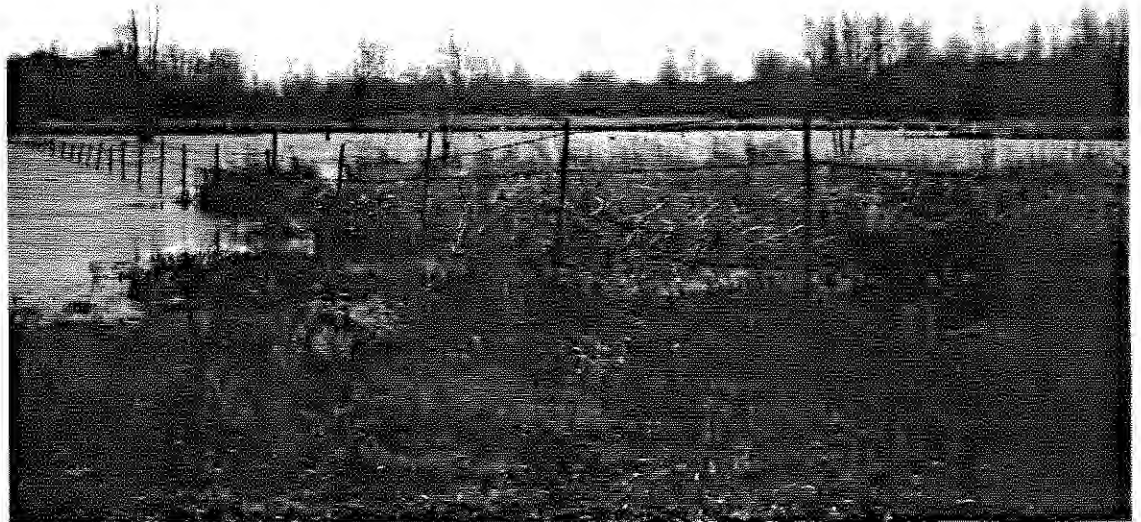
Photo 35: SEAD-13, 11/27/90. View of the possible location of the IRFNA Disposal Site, facing east; the possible site is located to the right side of the fence, in the southern part of the pond.

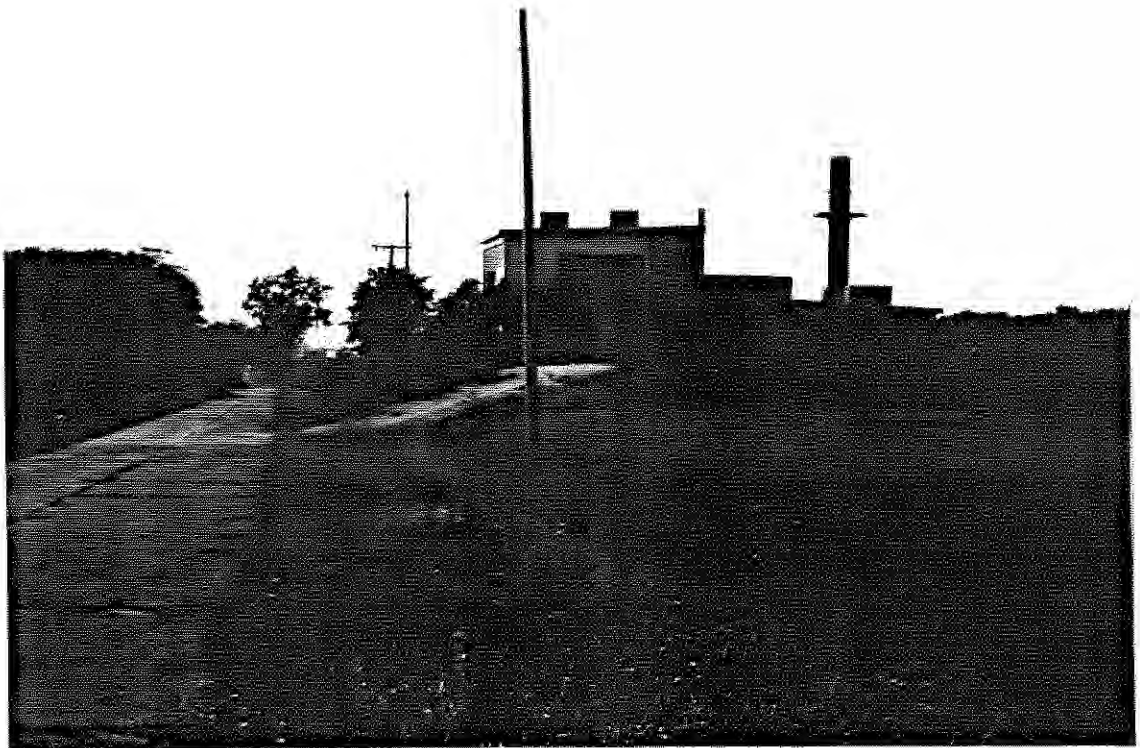
Photo 41: SEAD-15, 9/10/90. View of the Abandoned Solid Waste Incinerator - Building 2207, facing northwest.

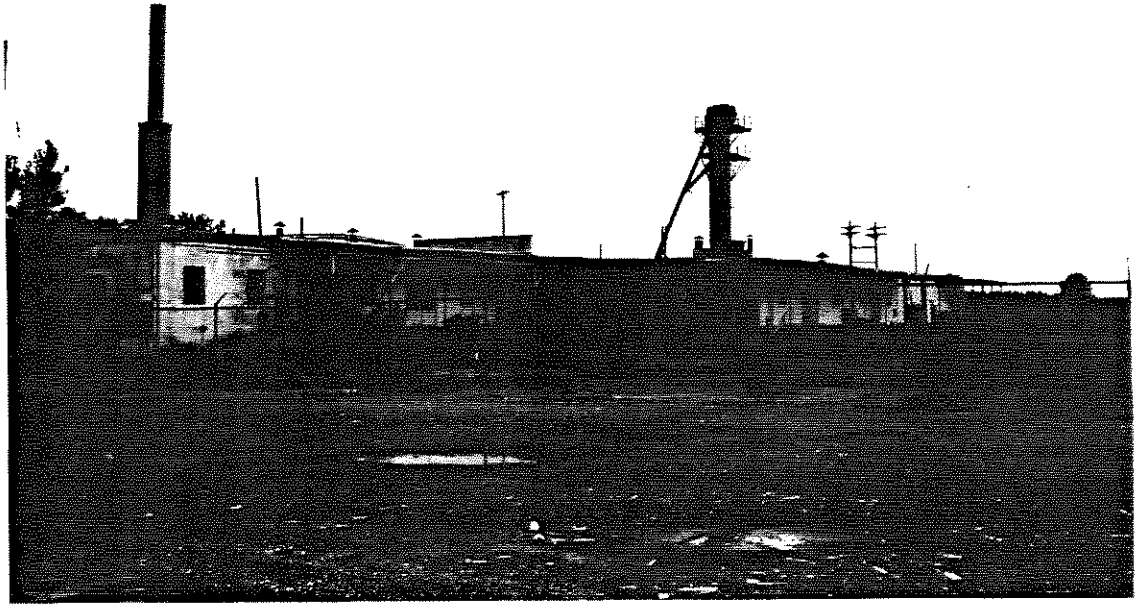
Photo 42: SEAD-16, 9/11/90. View of the Abandoned Deactivation Furnace - Building S-311, facing southeast.

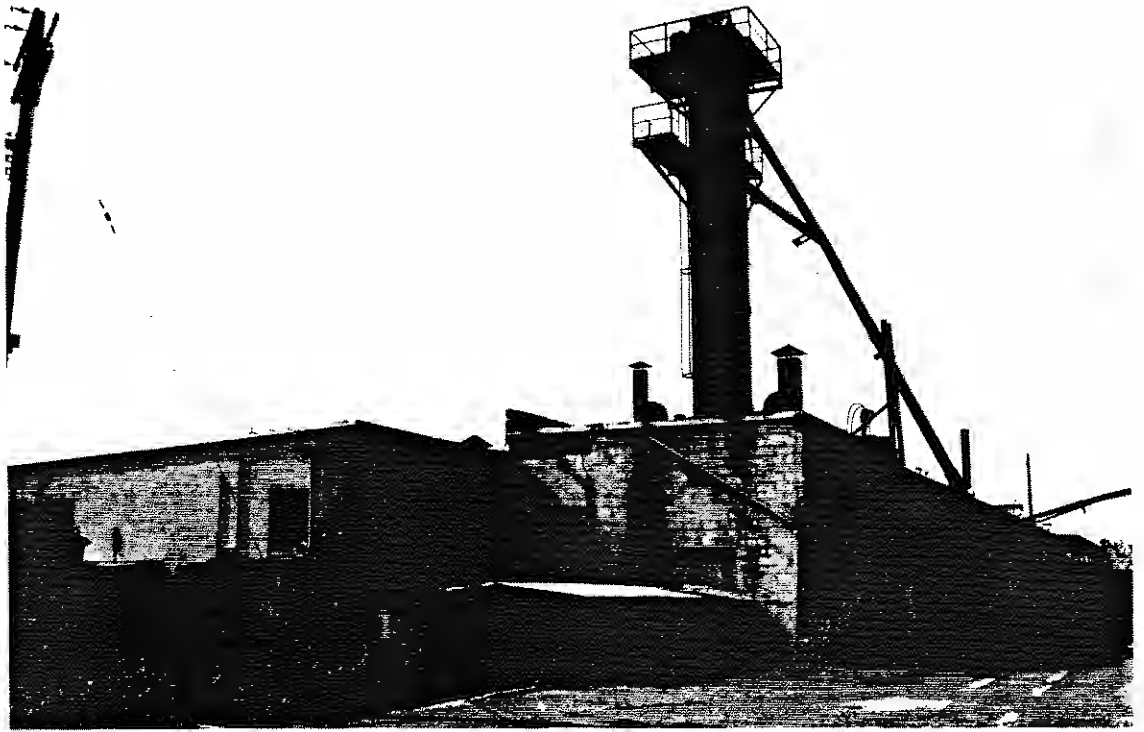
Photo 44: SEAD-16, 9/13/90. View of the Abandoned Deactivation Furnace - Building S-311, facing northwest.

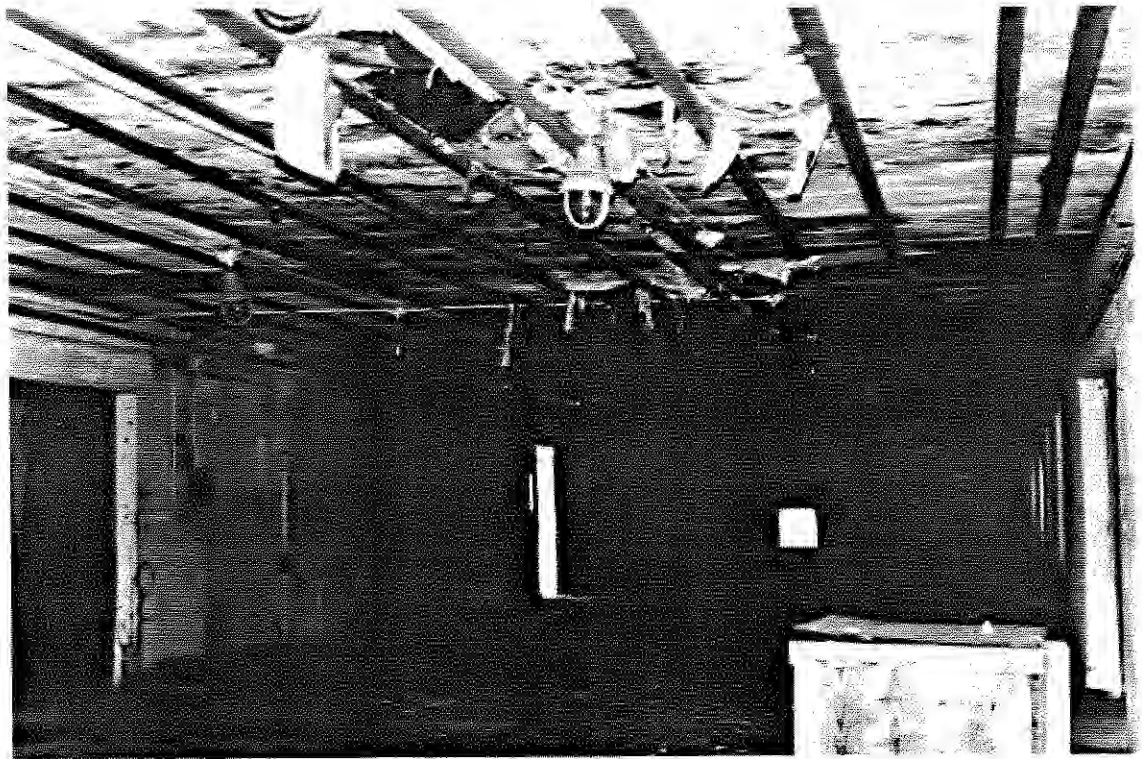
Photo 47: SEAD-16, 9/13/90. Interior of the Abandoned Deactivation Furnace - Building S-311, facing north away from the furnace room.

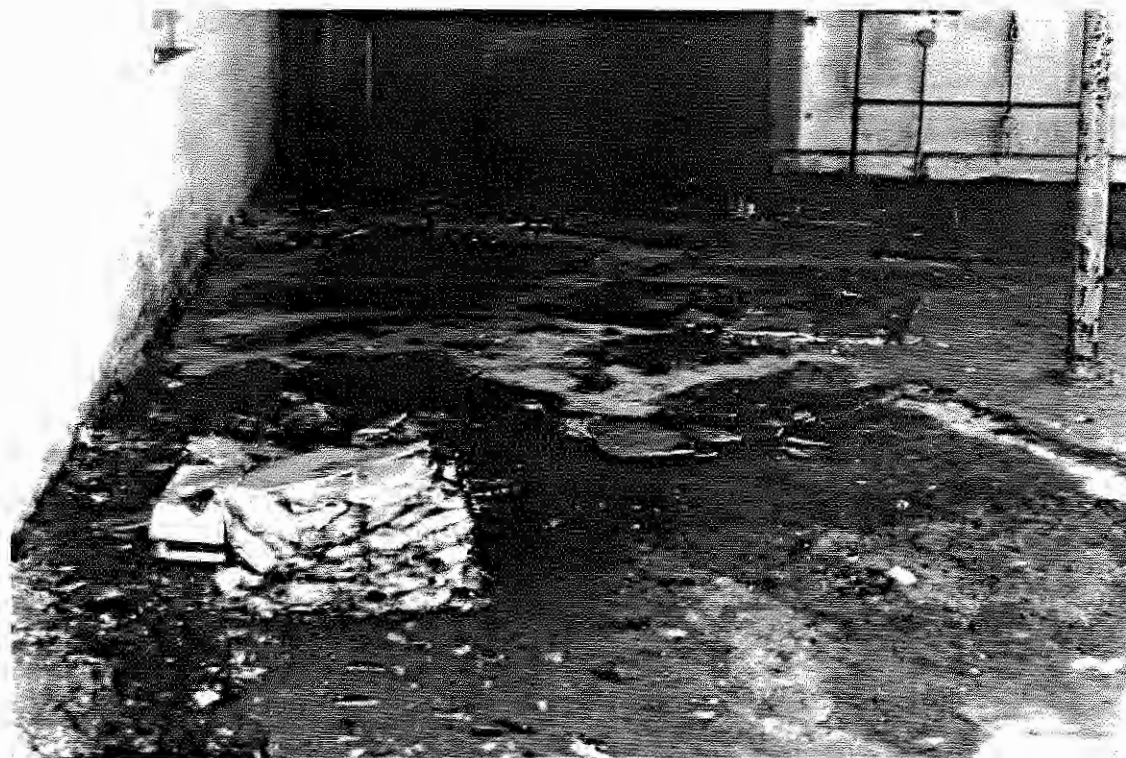
Photo 49: SEAD-16, 9/13/90. Interior of the Abandoned Deactivation Furnace - Building S-311, facing south, (view of the room adjacent to the furnace room).

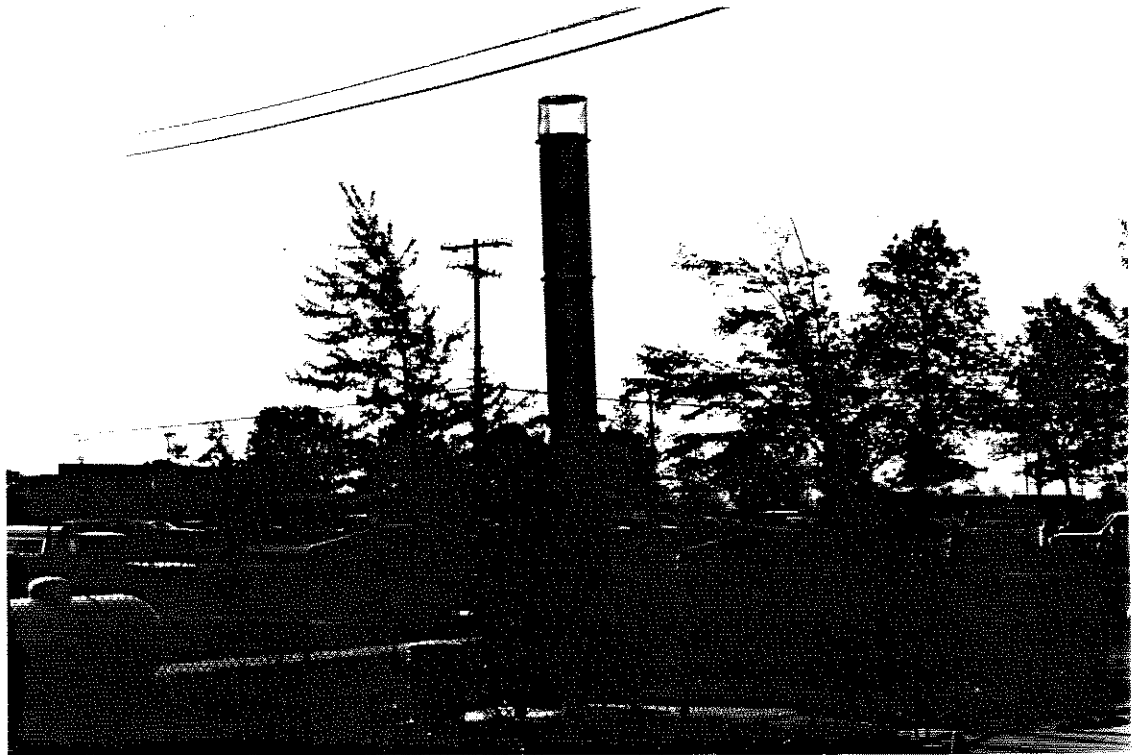
Photo 51: SEAD-18, 9/13/90. View of the Classified Document Incinerator - Building 709 (Location B), facing southeast.

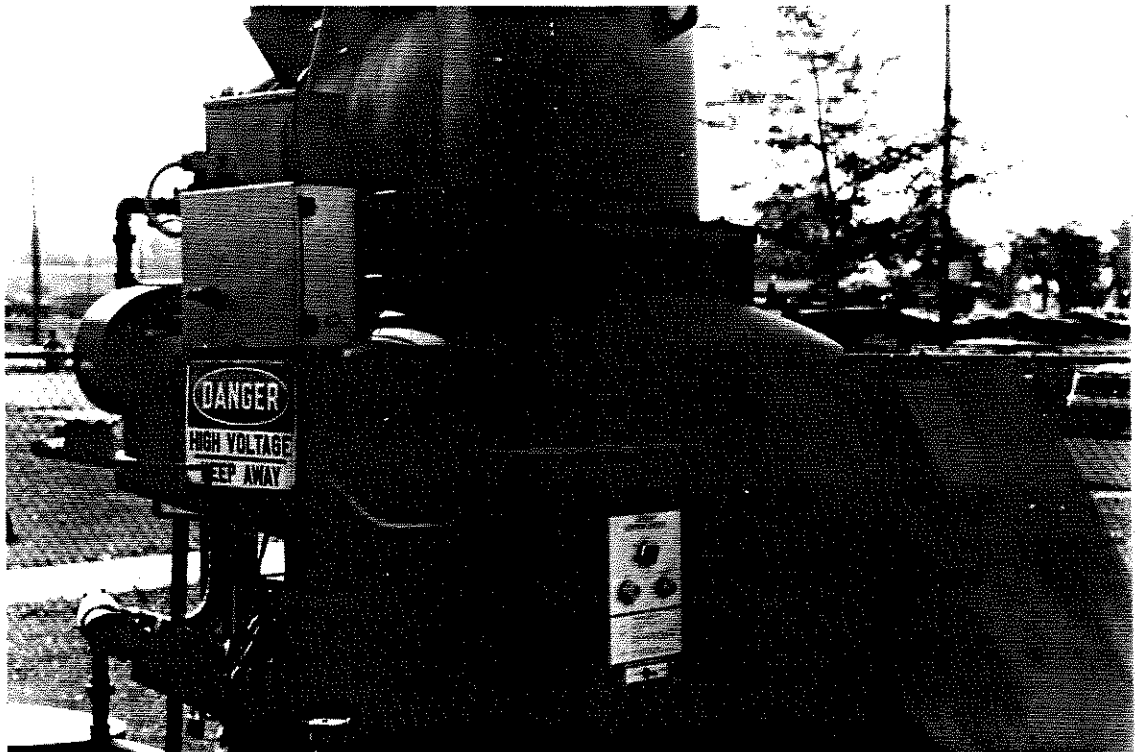
Photo 52: SEAD-18, 9/13/90. Close-up of the Classified Document Incinerator - Building 709 (Location B), facing east.
