FINAL SWMU CLASSIFICATION REPORT SENECA ARMY DEPOT ACTIVITY

**SOLID WASTE MANAGEMENT
CLASSIFICATION STUDY
SENECA ARMY DEPOT
ROMULUS, NEW YORK**

**Seneca Army Depot Activity
Romulus, New York**

**Engineering-Science, Inc.
Prudential Center
Boston, Massachusetts**

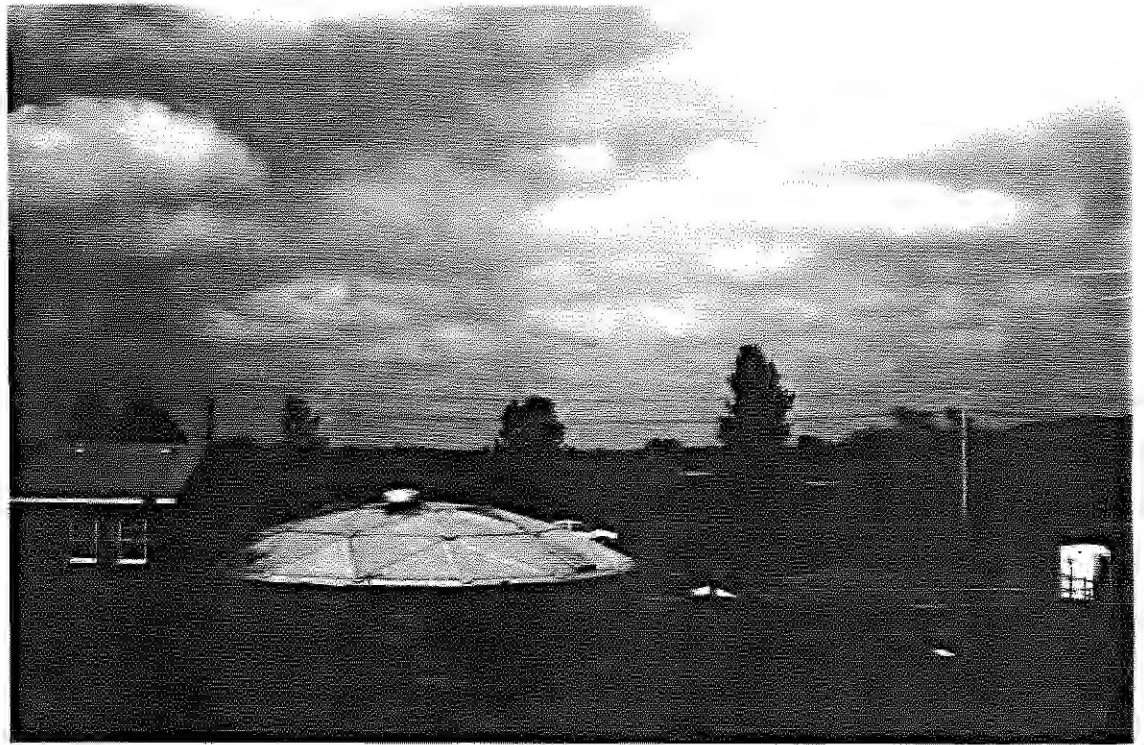
Photo 53: SEAD-20, 9/11/90. View of the Sewage Treatment Plant No.4, facing north.

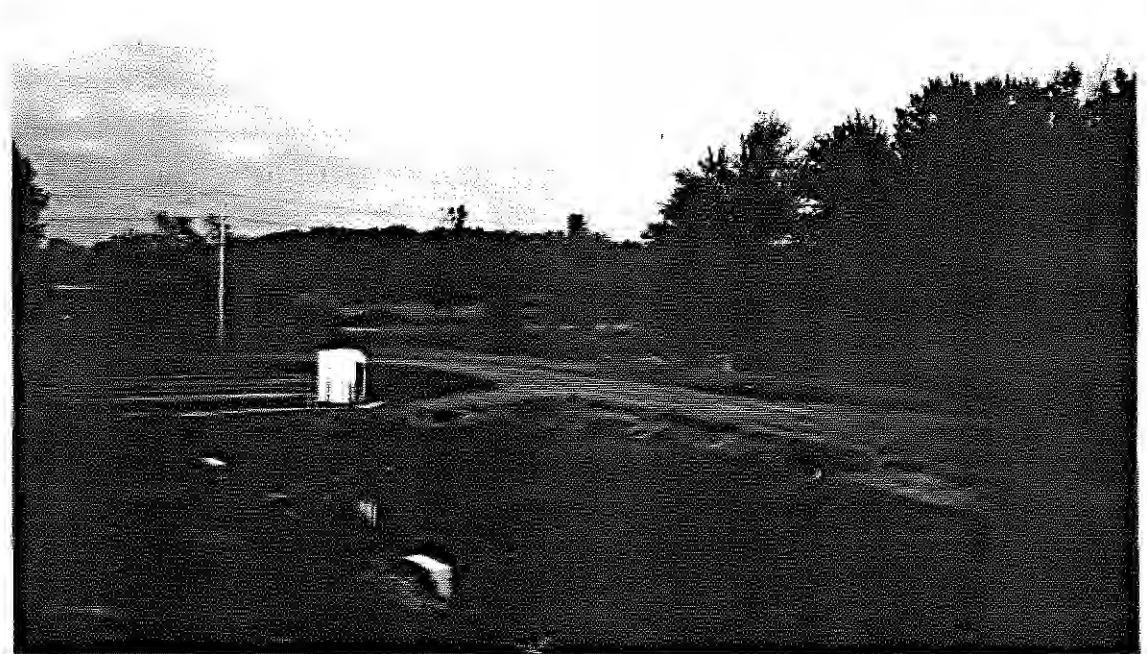
Photo 54: SEAD-20, 9/11/90. View of the sludge drying beds - Sewage Treatment Plant No.4, facing northeast

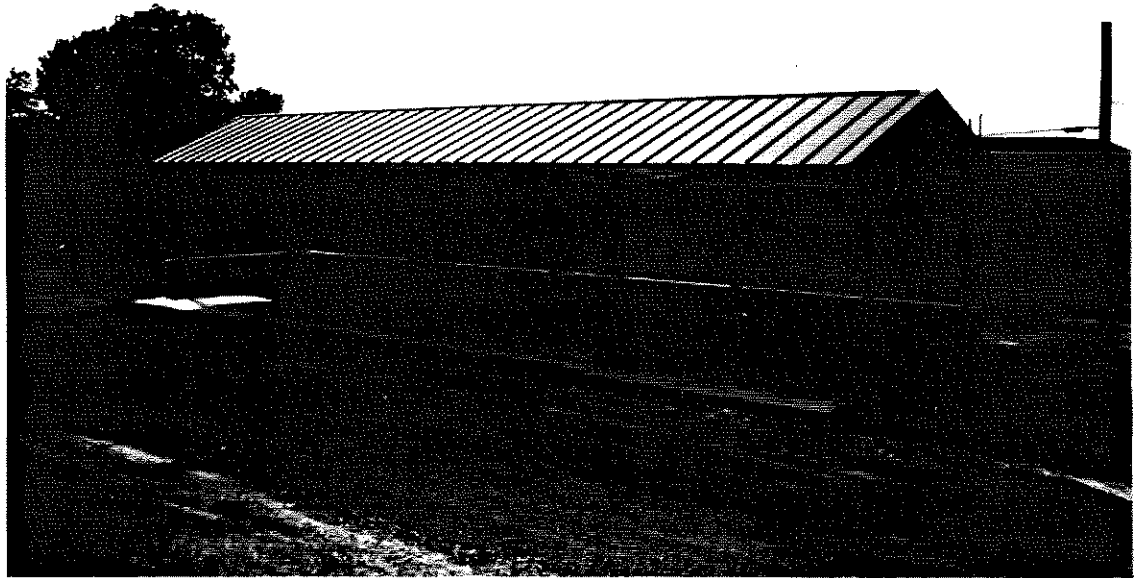
Photo 56: SEAD-20, 9/11/90. View of the sludge storage area - Sewage Treatment Plant No 4, facing southwest.

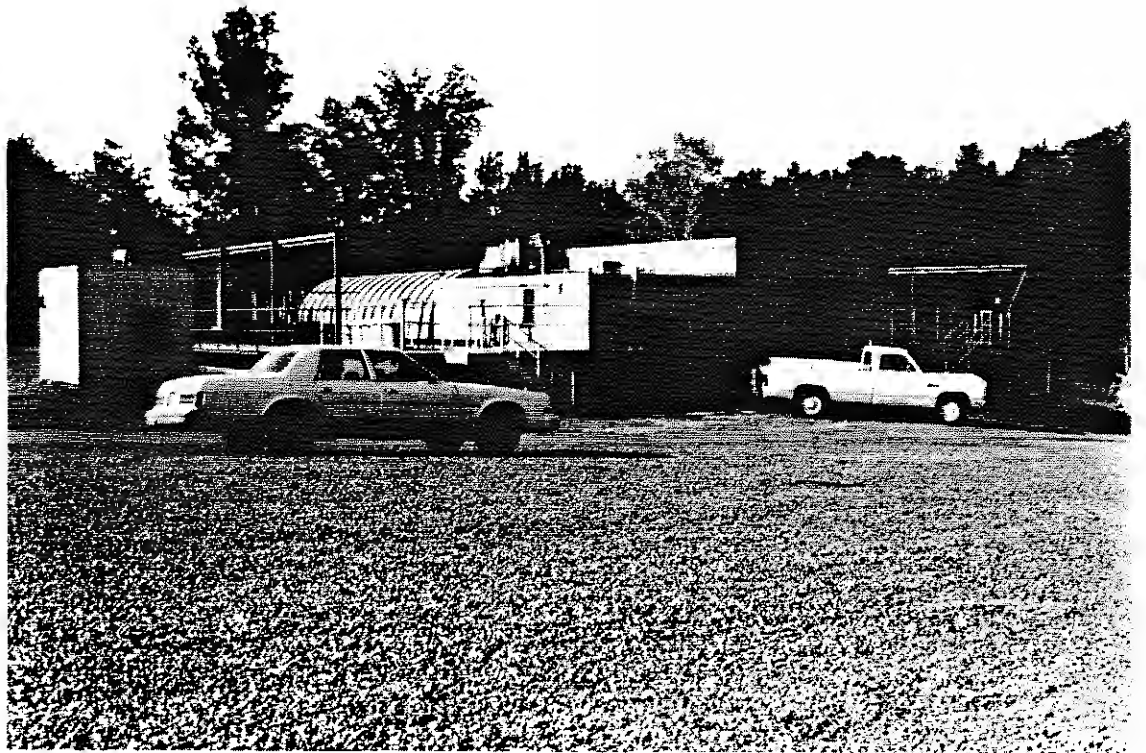
Photo 57: SEAD-21, 9/13/90. View of the Sewage Treatment Plant No.715, facing southwest.

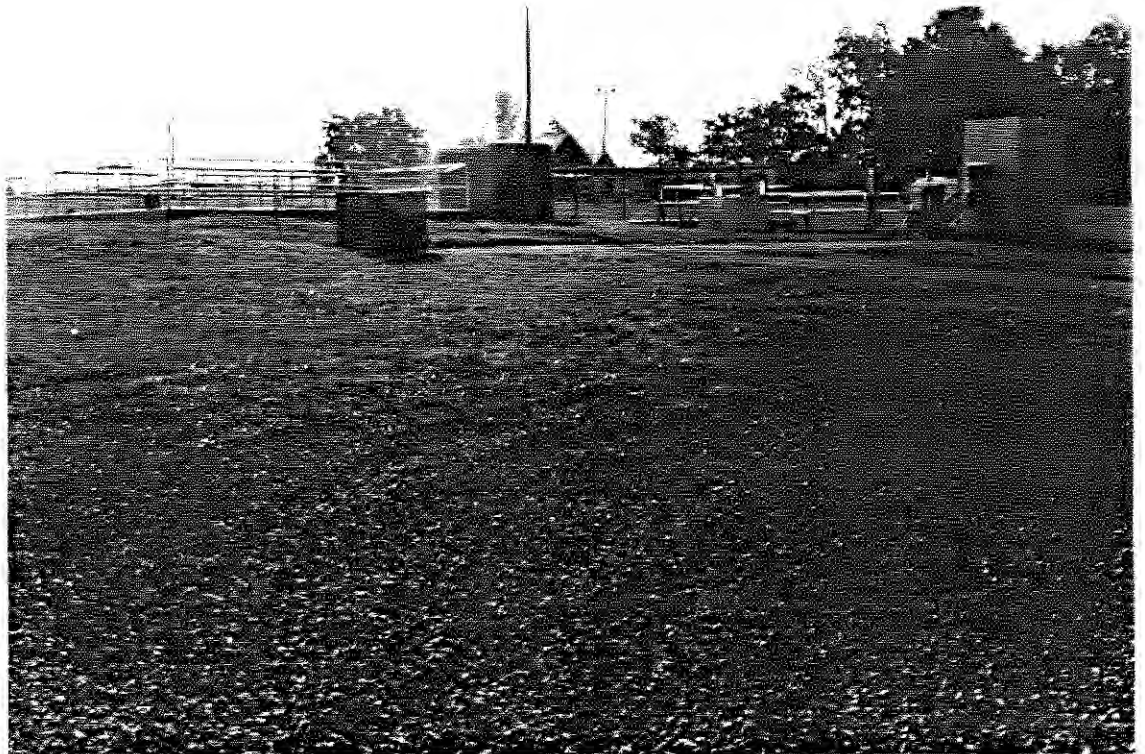
Photo 58: SEAD-21, 9/13/90. View of Primary Treatment - Sewage Treatment Plant No.715, facing east.

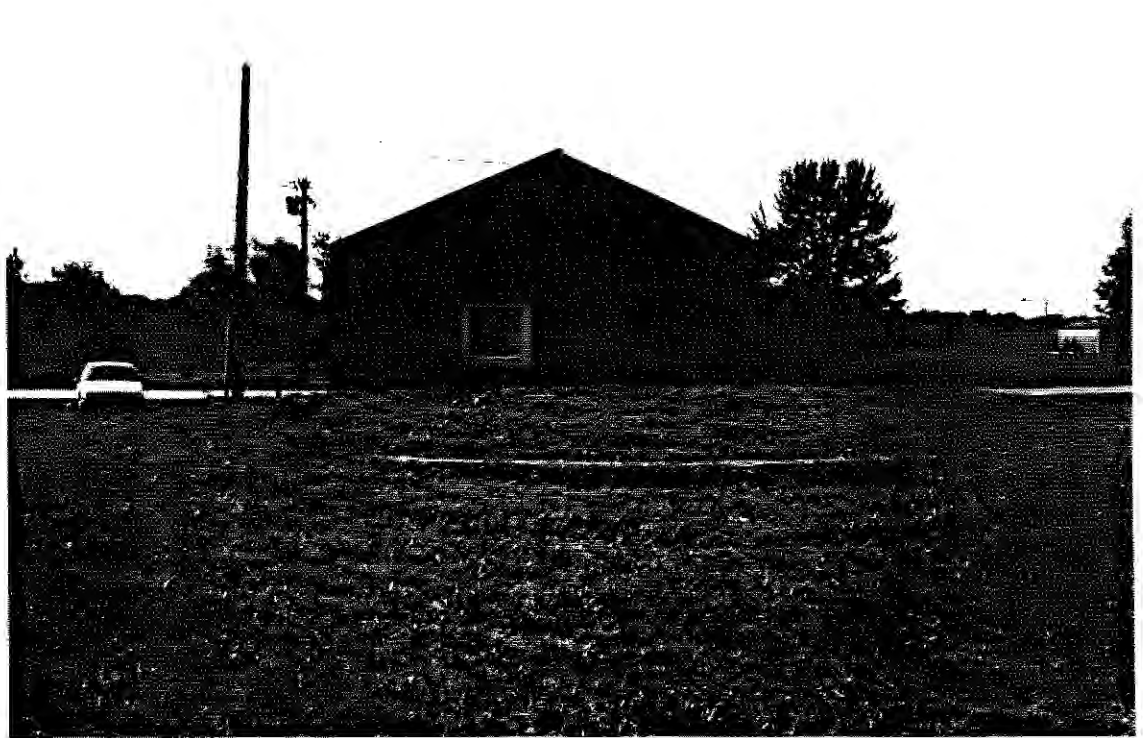
Photo 63: SEAD-22, 9/13/90. View of the trickling filter, Sewage Treatment Plant No.314, facing south.

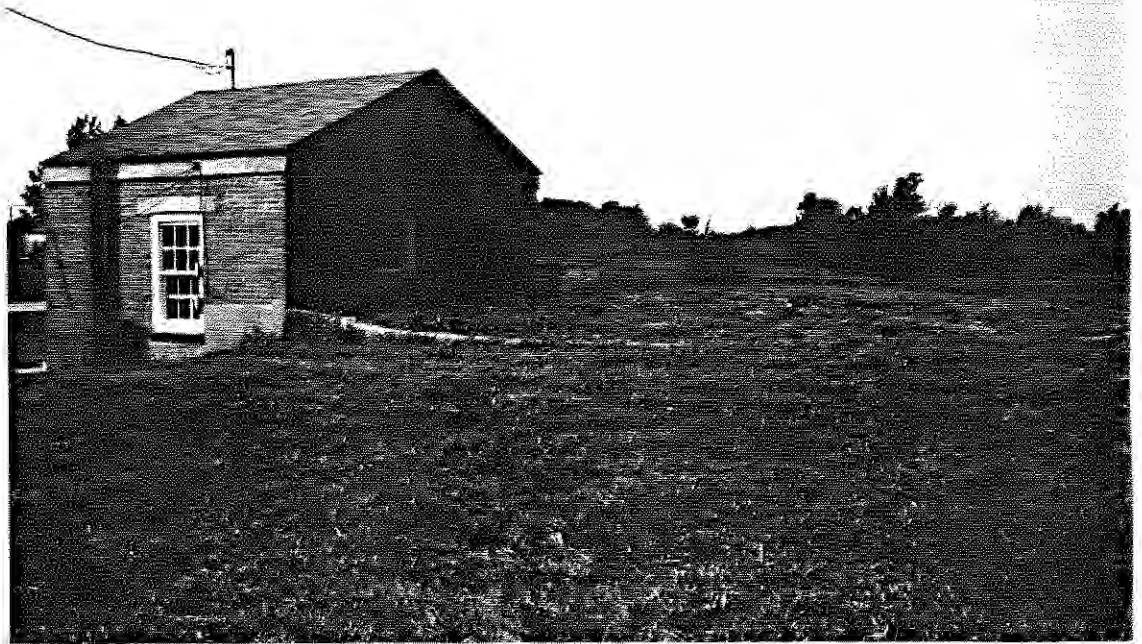
Photo 64: SEAD-22, 9/13/90. View of the trickling filter, Sewage Treatment Plant No.314, facing southeast.

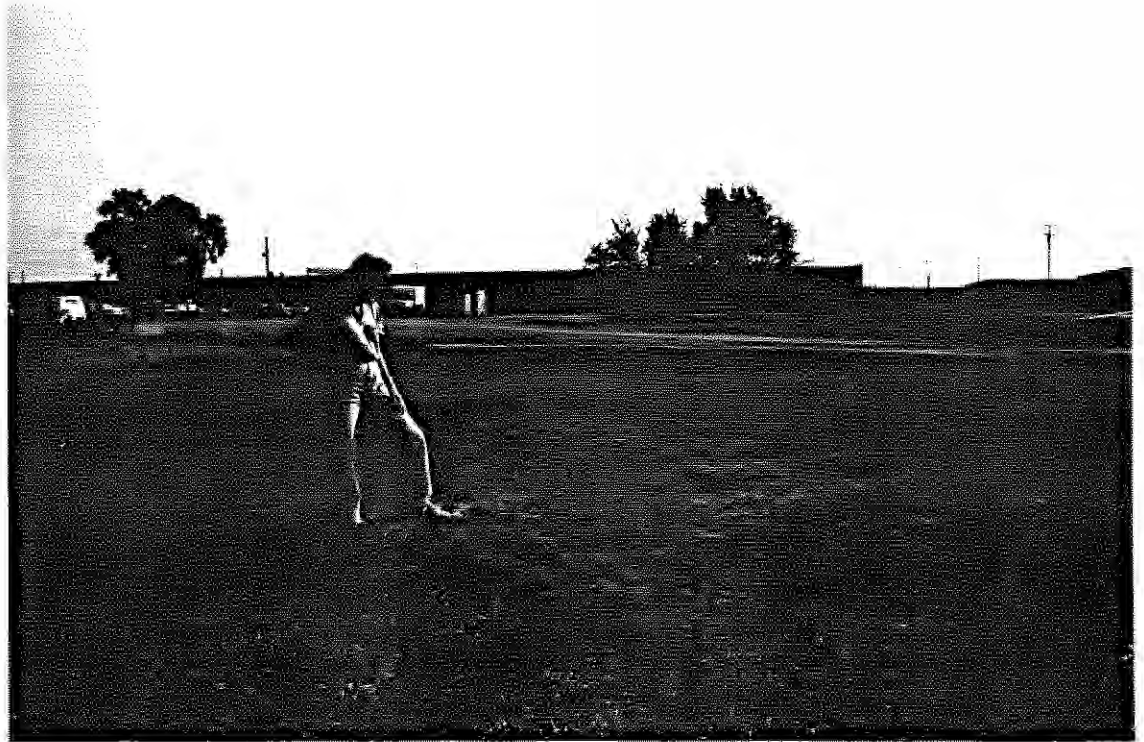
Photo 65: SEAD-22, 9/10/90. View of the location of the former sludge drying beds, Sewage Treatment Plant No.314, facing west (the concrete in the foreground indicates the approximate location).

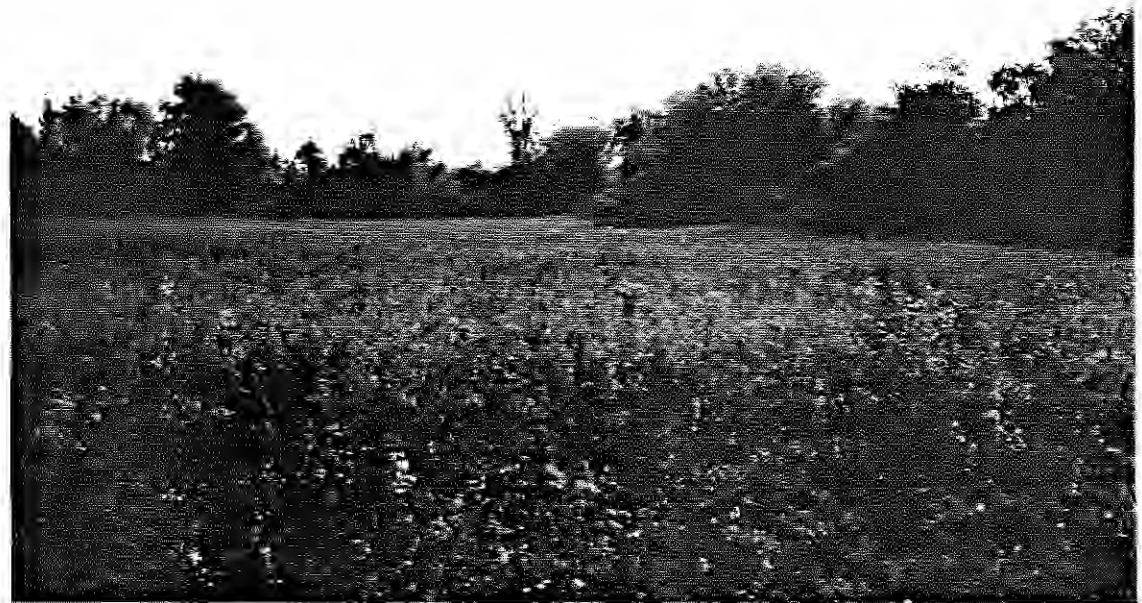
Photo 70: SEAD-24, 9/10/90. View of the Abandoned Power Burning Pit, facing south.

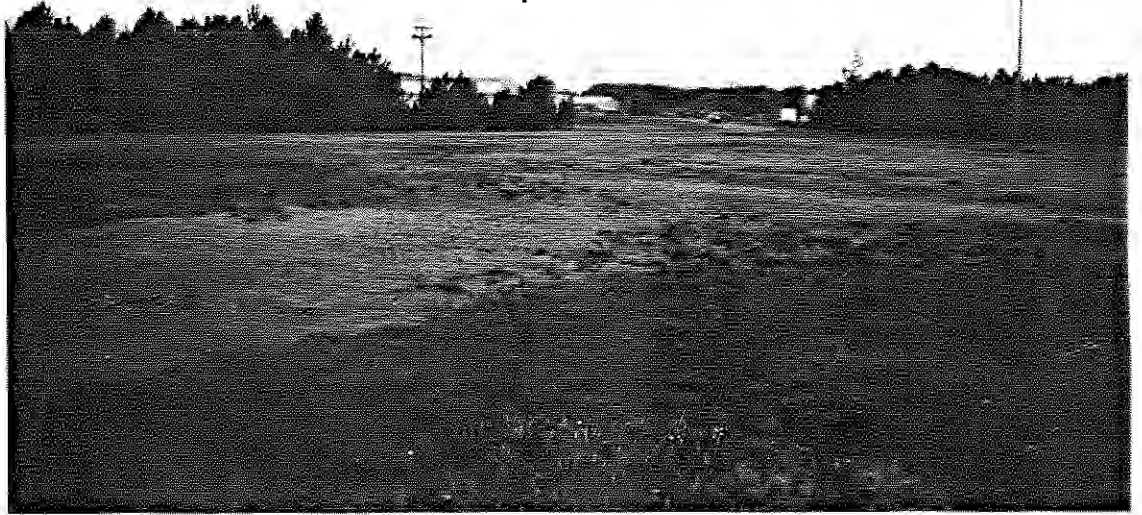
Photo 71: SEAD-25, 9/14/90. View of the Fire Training and Demonstration Pad, facing southwest.

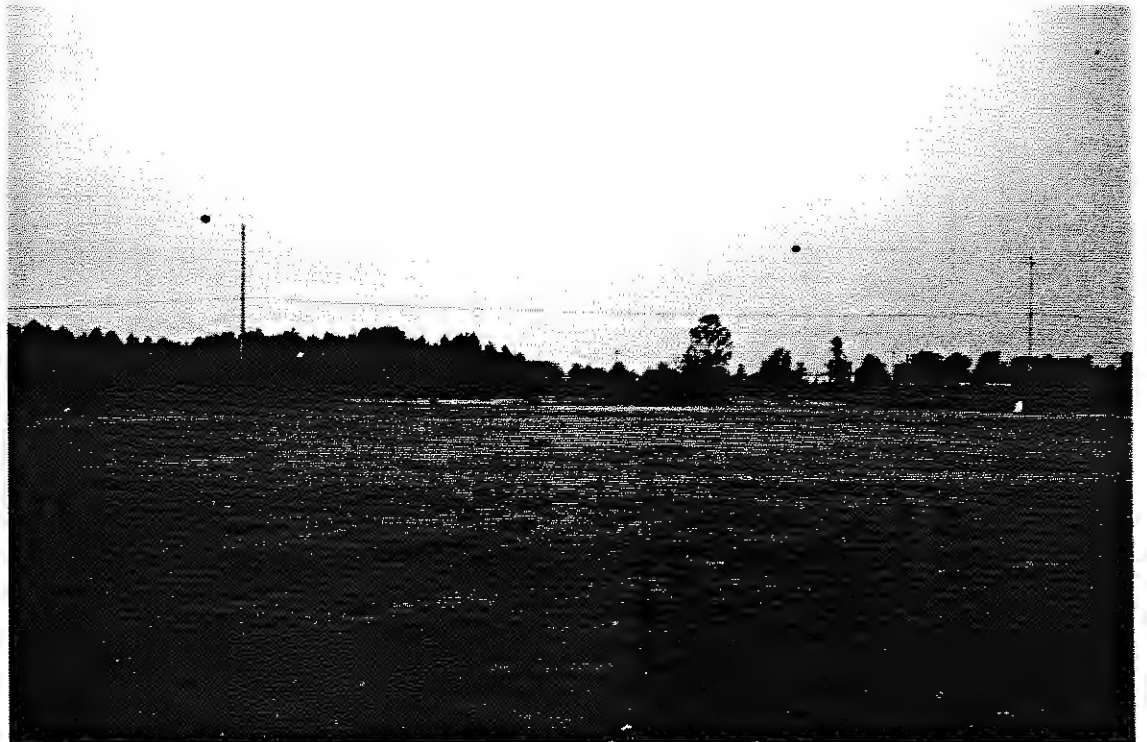
Photo 72: SEAD-25, 9/14/90. View of the Fire Training and Demonstration Pad, facing west.

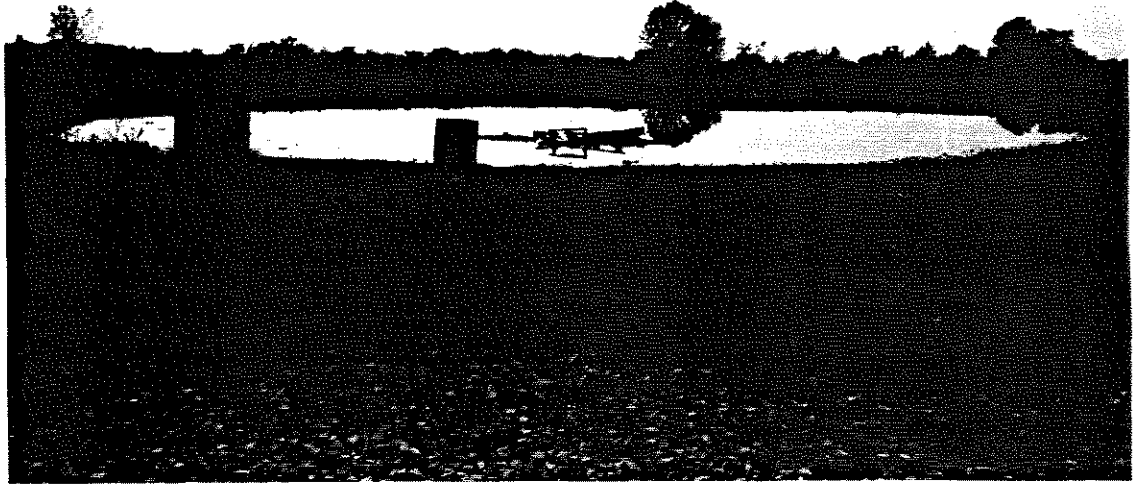
Photo 74: SEAD-26, 9/11/90. View of the Fire Training Pit, facing west.

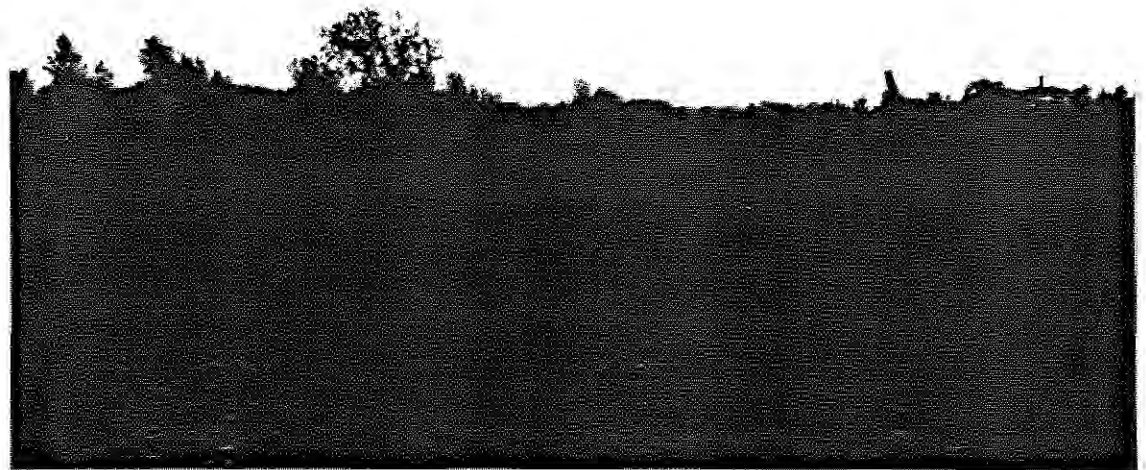
Photo 77: SEAD-26, 9/11/90. View of the Fire Training Pit Area, facing south

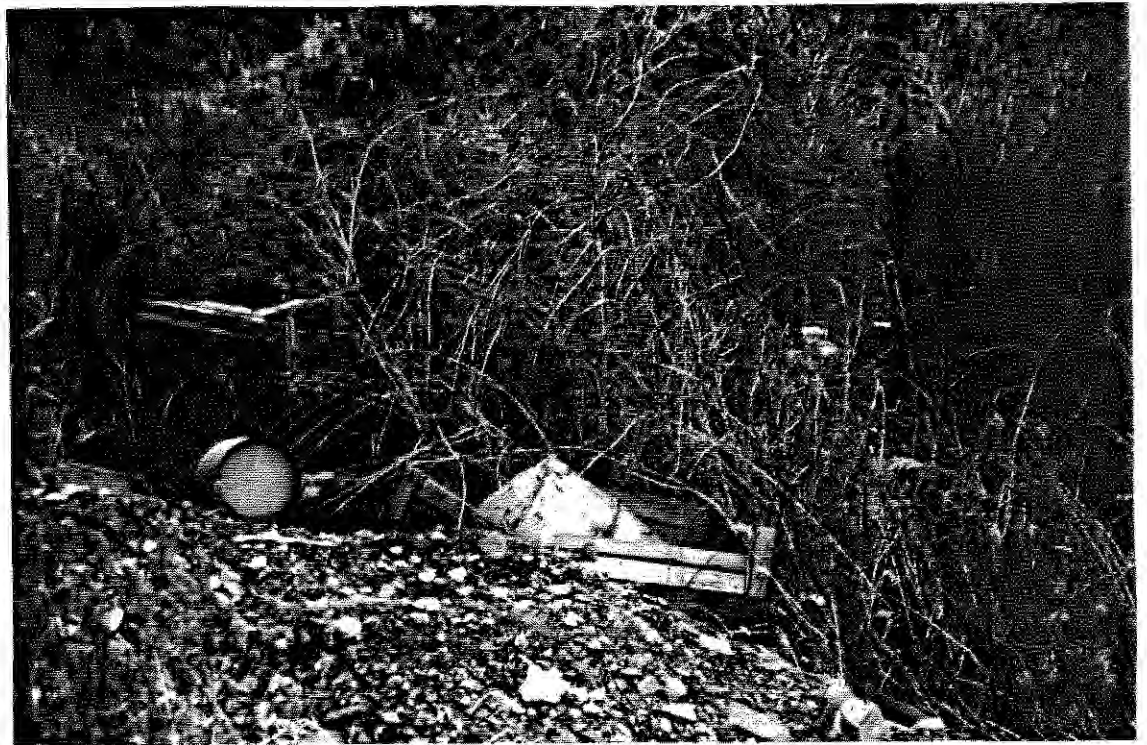
Photo 78: SEAD-26, 11/27/90. View of the debris area located south of the Fire Training Pit, facing south.

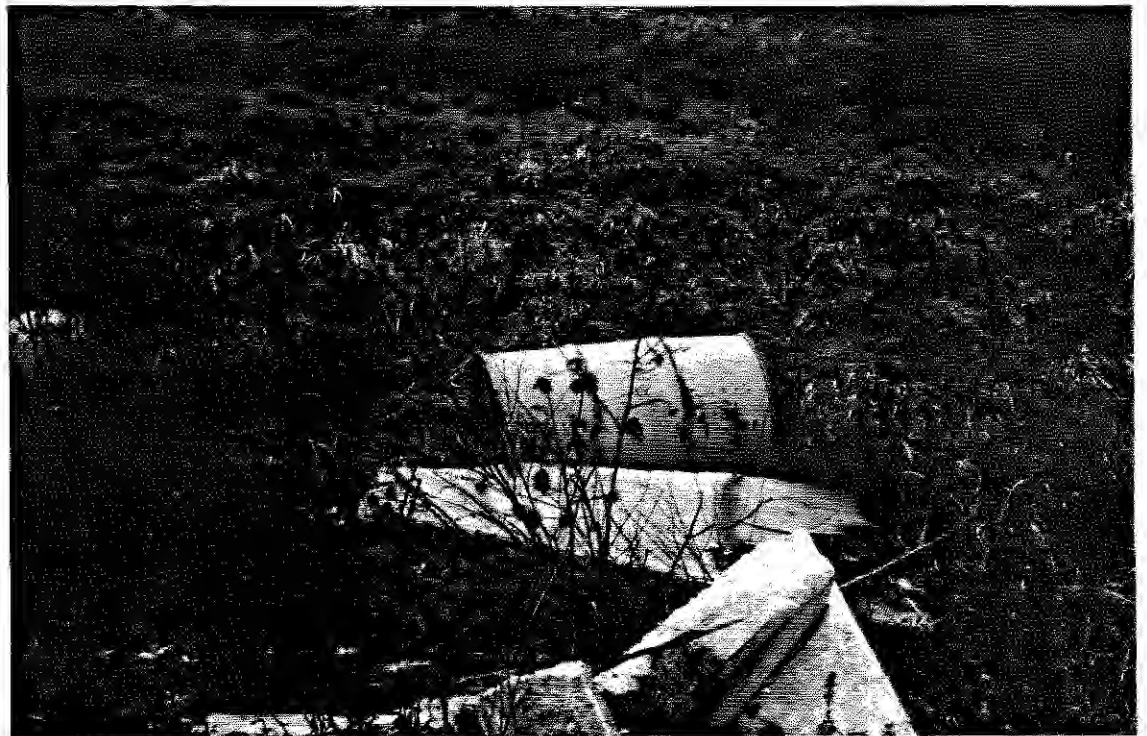
Photo 79: SEAD-26, 11/27/90. View of the debris area located south of the Fire Training Pit, facing south

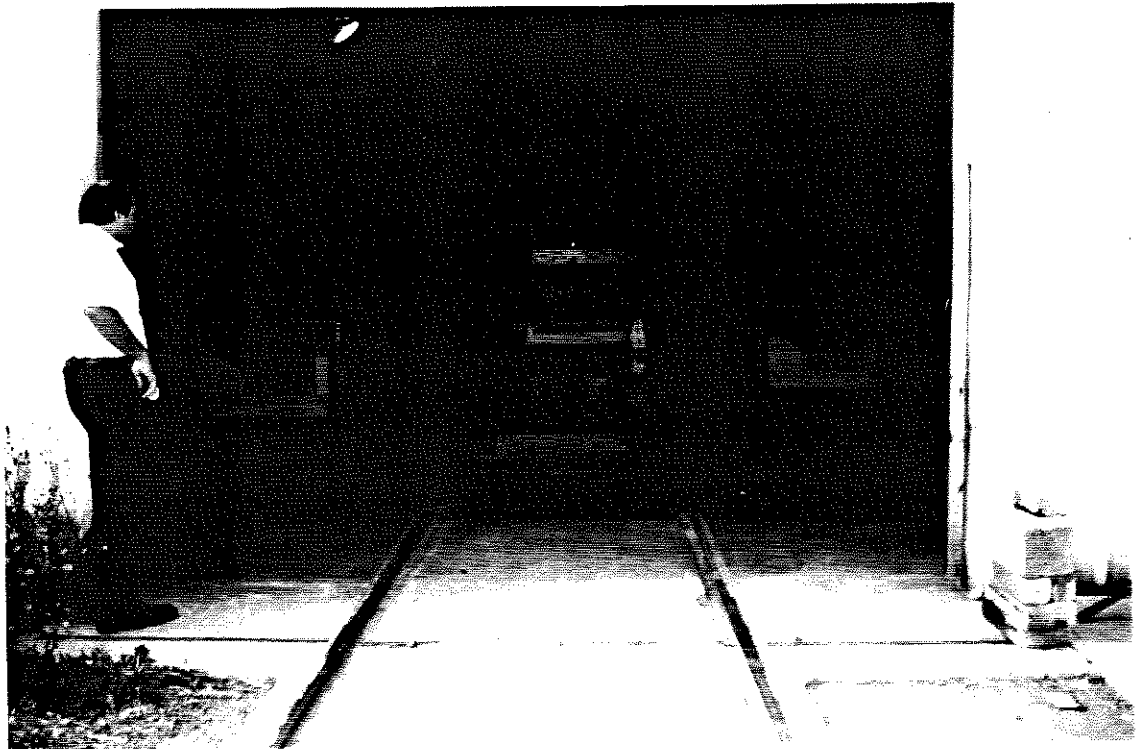
Photo 81: SEAD-27, 9/12/90. View of the Steam Cleaning Waste Tank - Building 360, facing west.

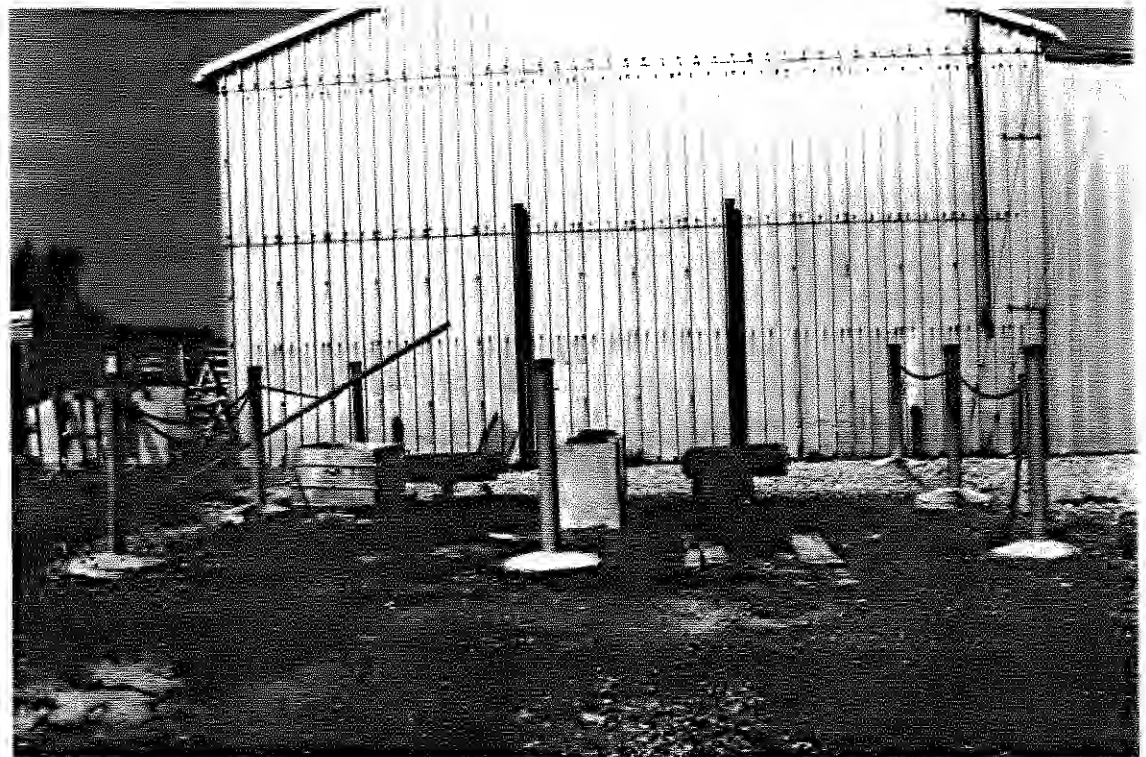
Photo 84: SEAD-28, 9/12/90. View of the location of two Underground Waste Oil Tanks - Building 360, facing northeast.

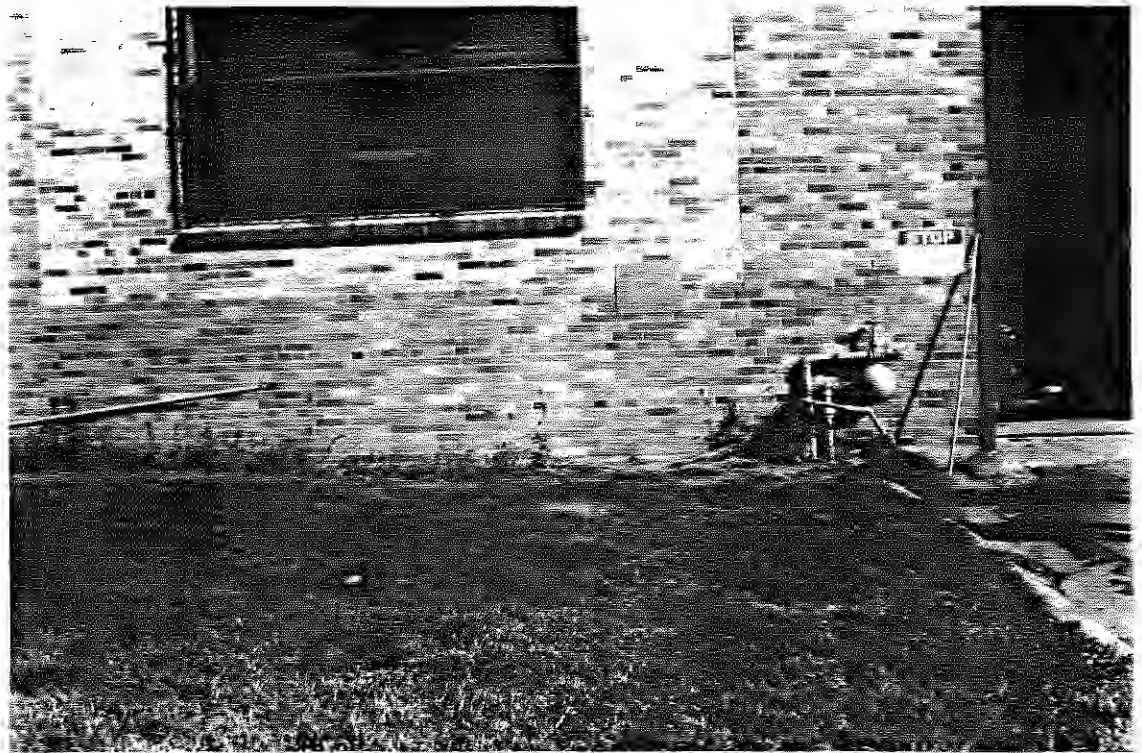
Waste oil had been spilled around the tank as shown in Photo 88. However, there was no visual evidence that the spill area constituted more than surficial contamination. Since the visual site inspection, SEDA personnel have reported that the surficial soils have been removed and disposed of appropriately. The tank was tested for tightness using the "Tegrity Tester" method on September 23, 1992 (Exhibit A-29). The results indicate that the tank tested tight with a leak rate of +.012 gallons per hour. A copy of the tank test is attached.

Photo 88: SEAD-30, 9/13/90. View of the location of the Underground Waste Oil Tank - Building 118, facing north.

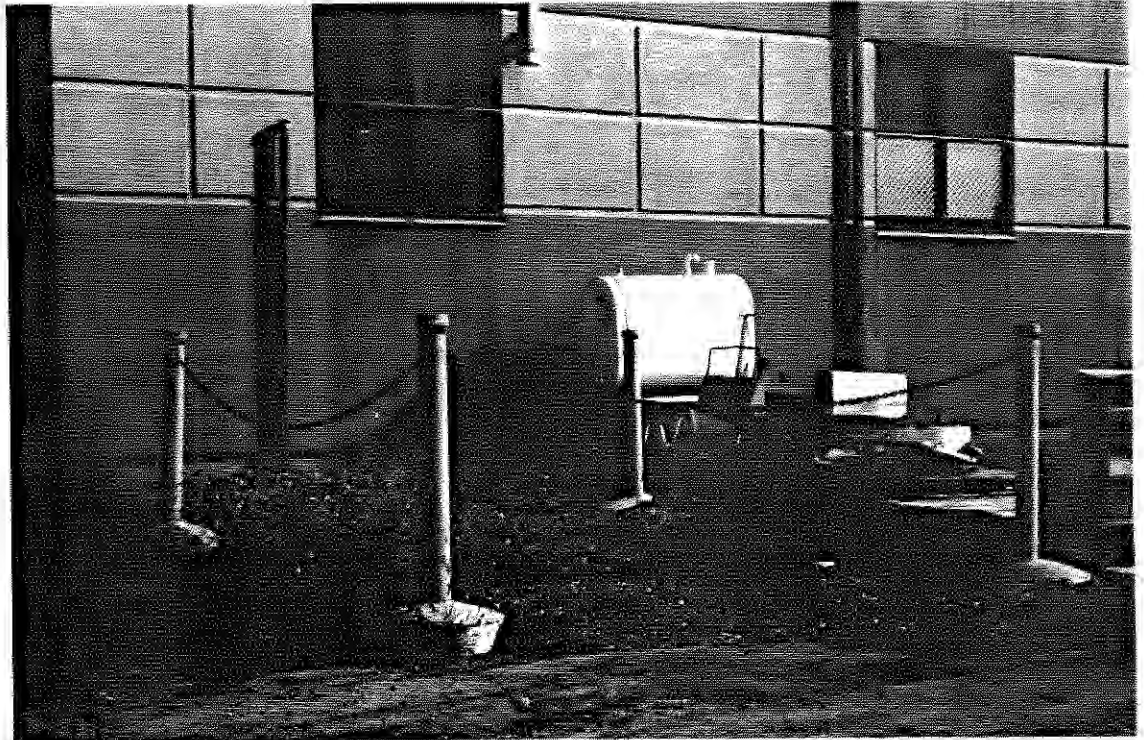
Photo 90: SEAD-31, 9/12/90. Close-up of the location of Underground Waste Oil Tank - Building 117, facing northeast

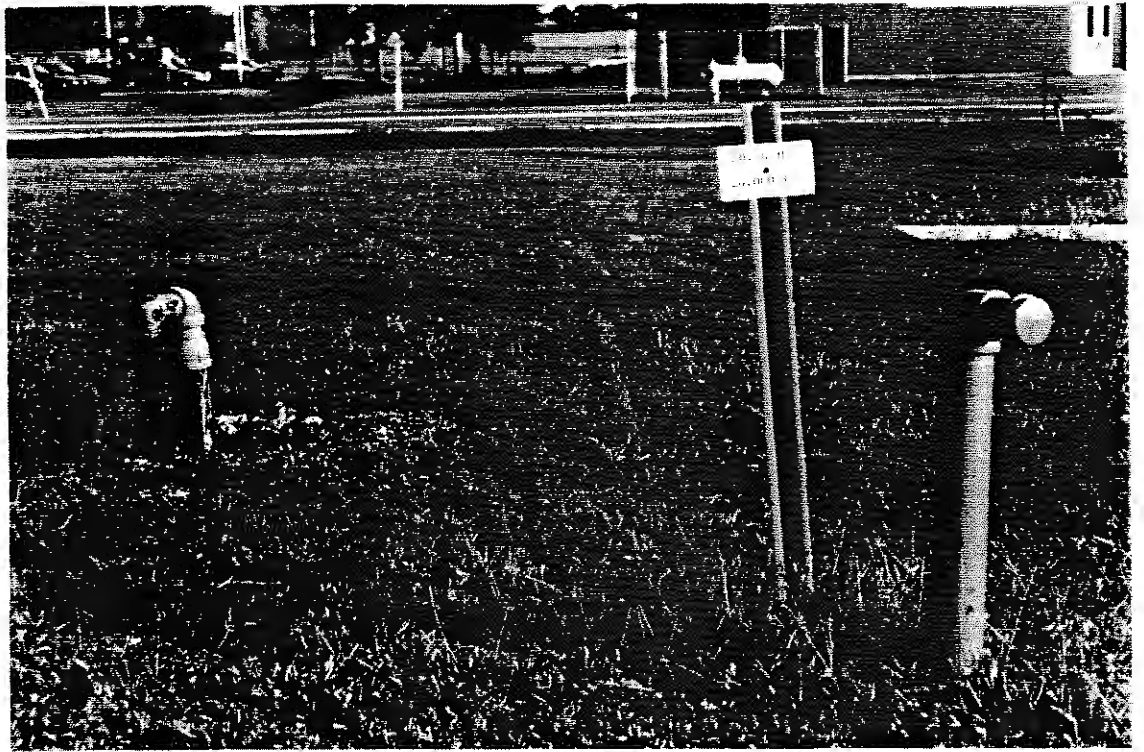
Photo 91: SEAD-32, 9/13/90. View of the location of the 20,000 gallon Underground Waste Oil Tank - Building 718, facing north.

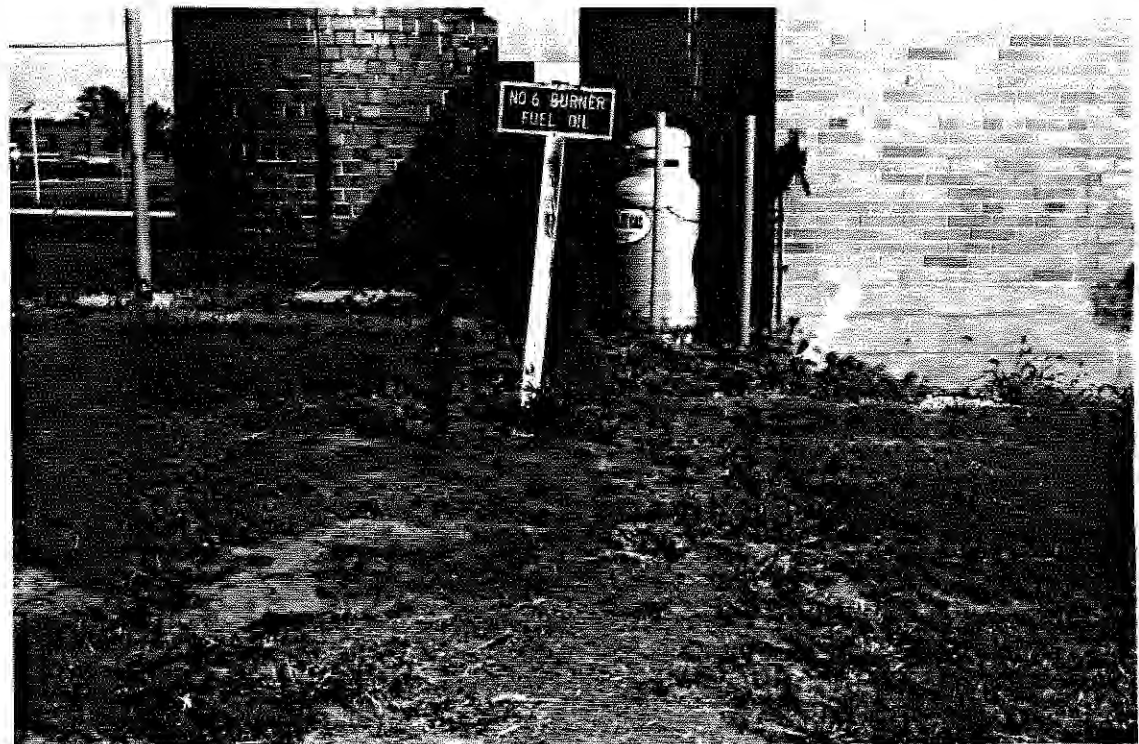
Photo 94: SEAD-33, 9/13/90. Close-up of the location of Underground Waste Oil Tank - Building 121, facing east.

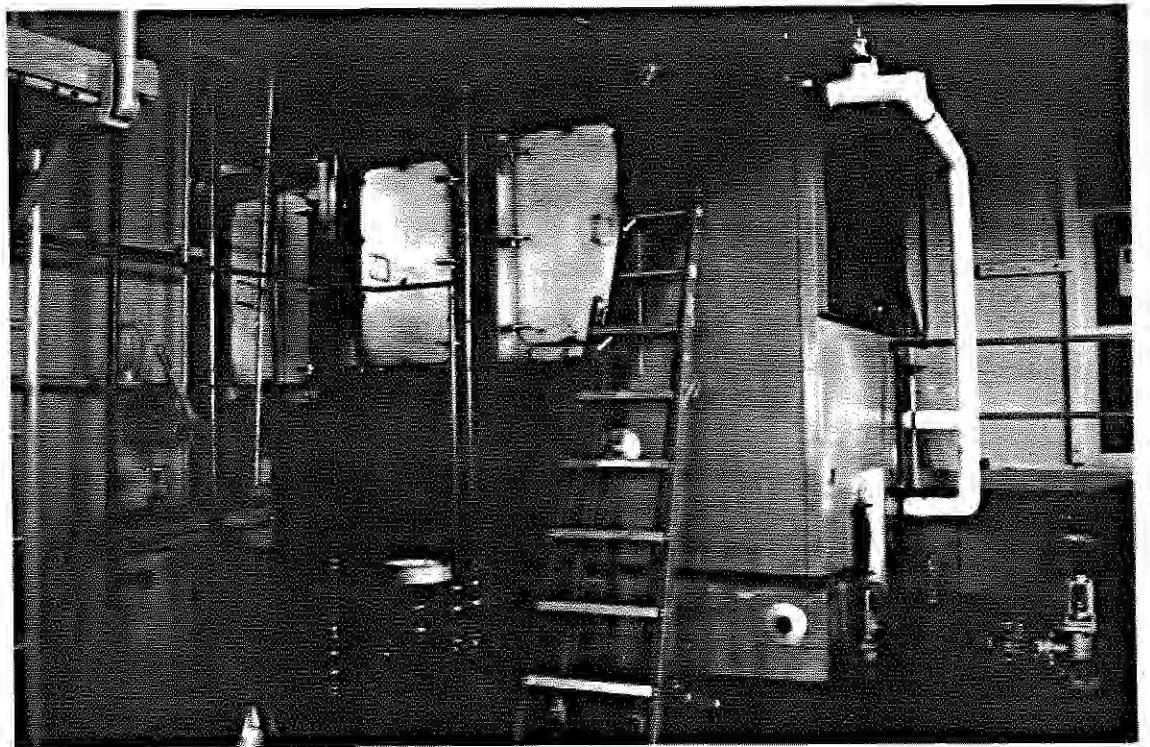
Photo 104: SEAD-37, 9/12/90. View of Waste Oil - Burning Boiler - Building 319, facing west.

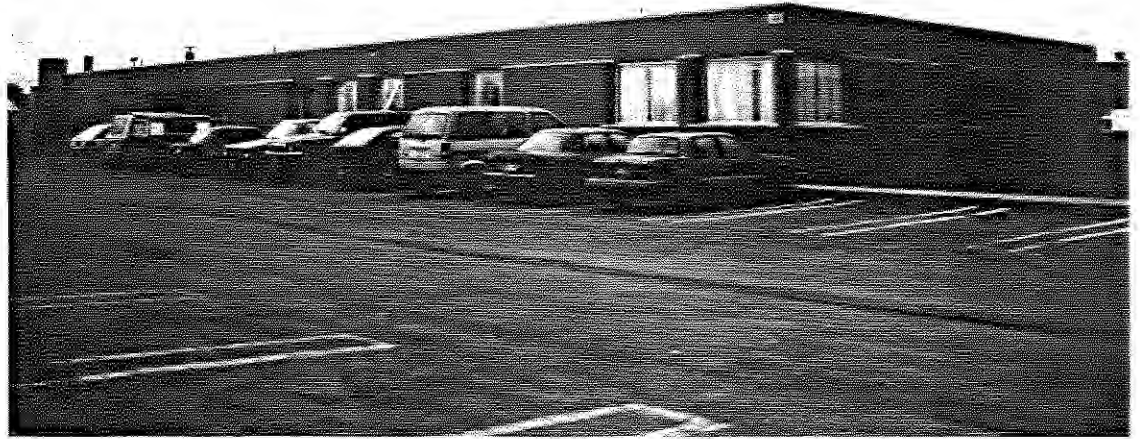
Photo 106: SEAD-42, 9/14/90. View of Building 106, where the Preventive Medicine Laboratory is located, facing southeast.

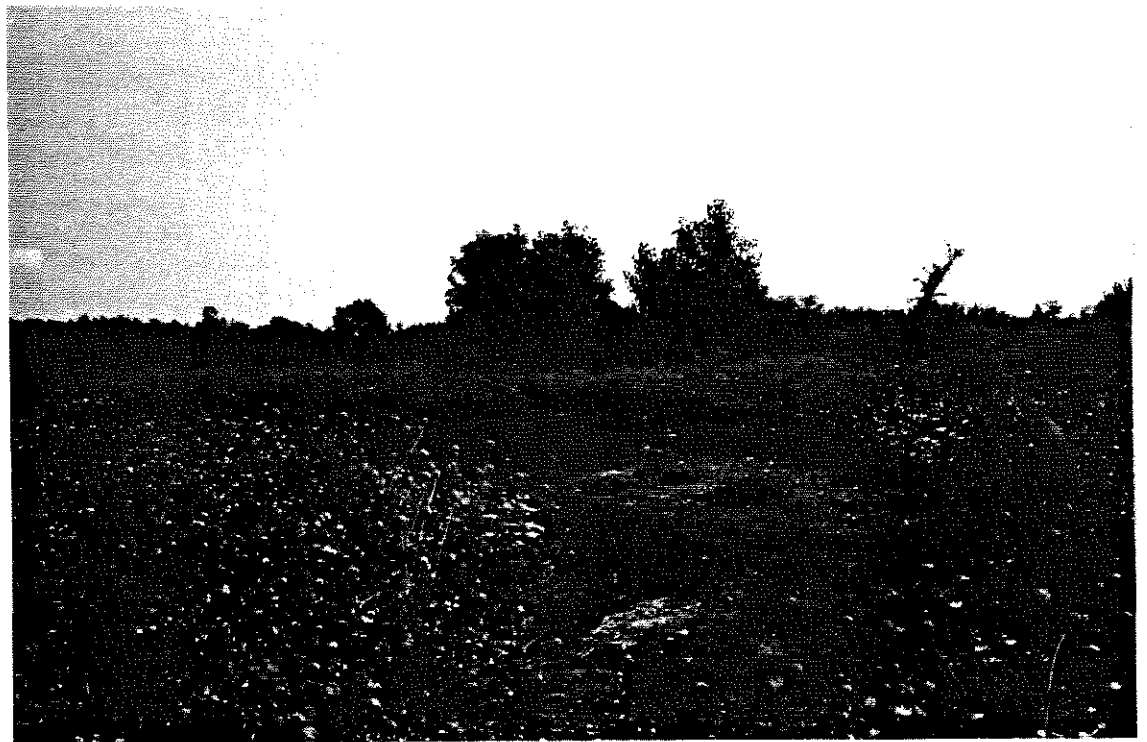
Inactive. A barren area, covered with shale, was observed at Location A (see photographs 108 and 109). A concrete pad, metal shed and flag pole were observed at Location B (see photographs 110 through 113 included at the end of this text).

Photo 109: SEAD-44, 9/13/90. Close-up of Location A of the Quality Assurance Test Laboratory, facing south.

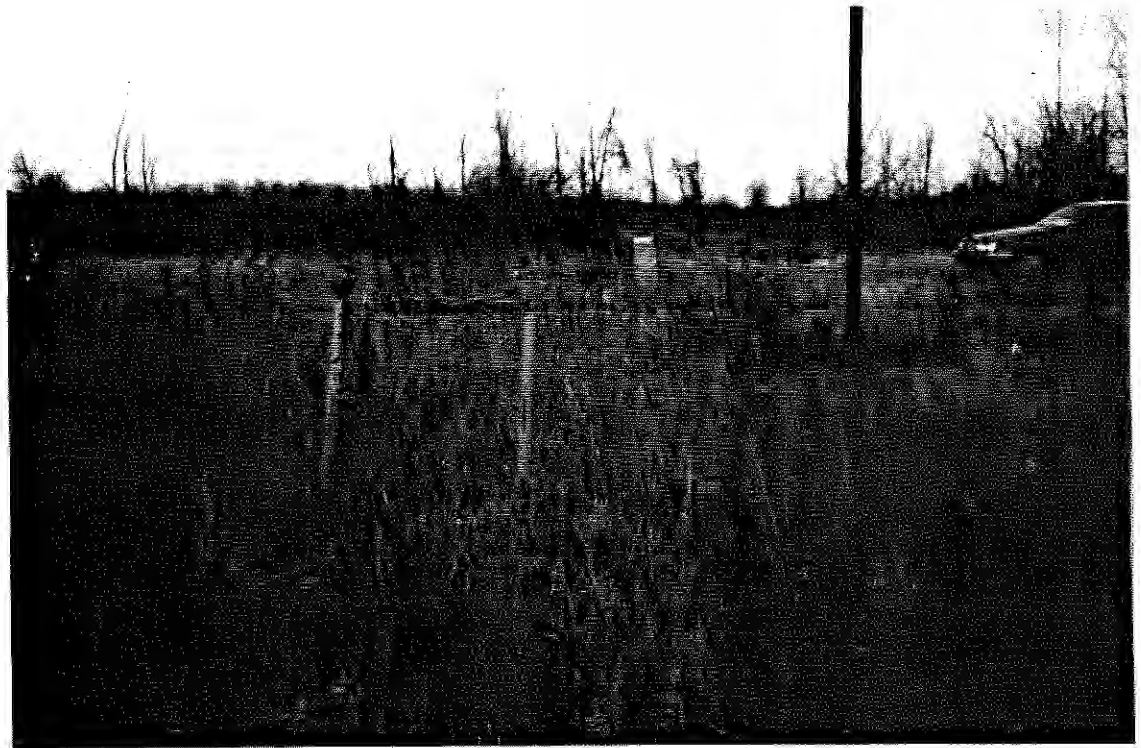
Photo 113: SEAD-44, 11/29/90. View of Location B of the Quality Assurance Test Laboratory, facing east.

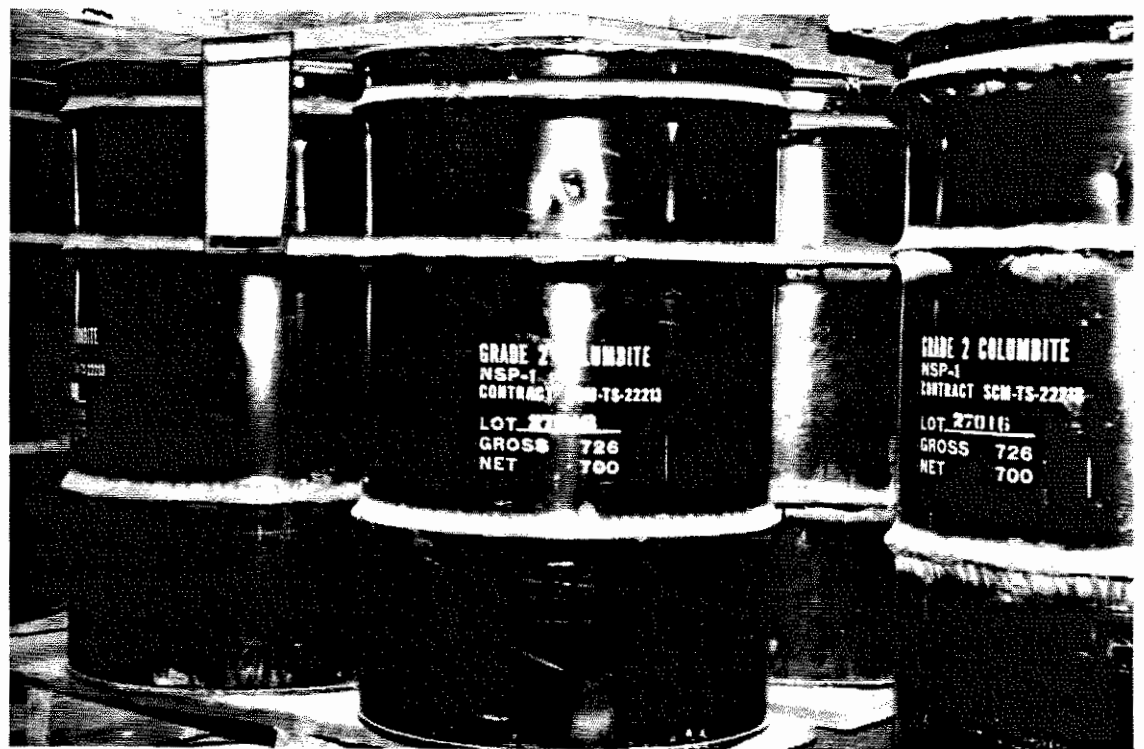
Photo 118: SEAD-49, 11/29/90. Close-up of the Columbite Ore - Building 356.

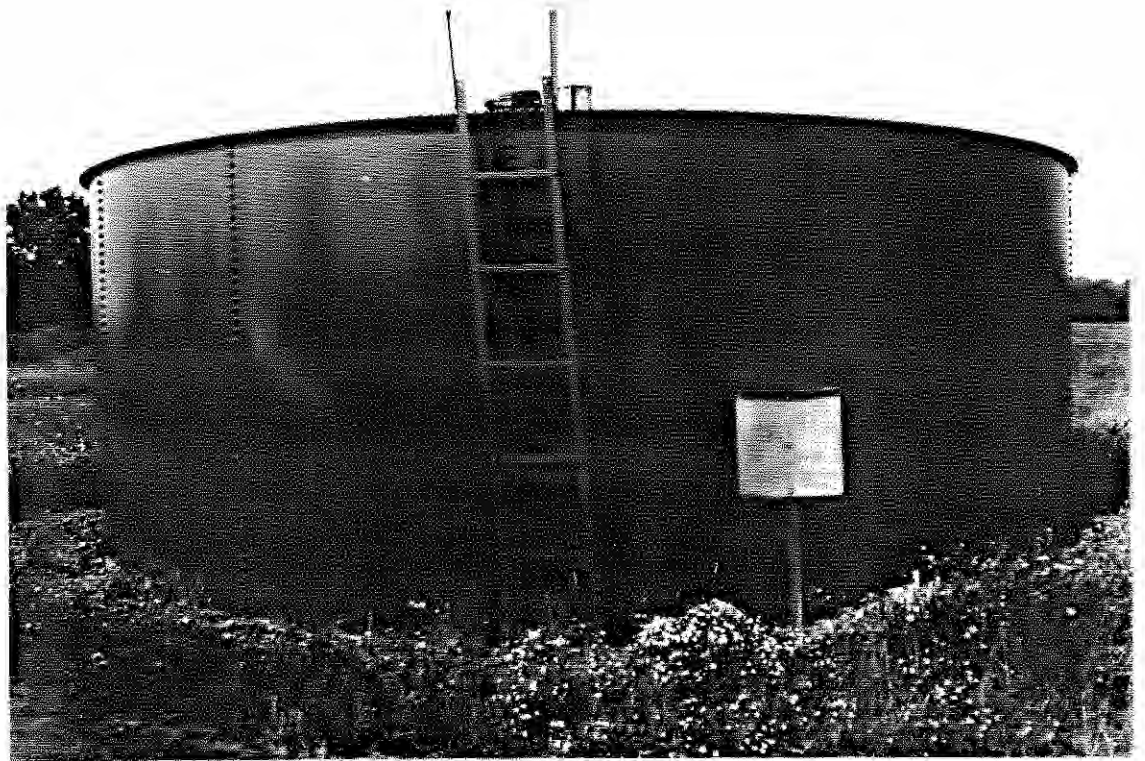
50.2.5.1 Tank # 8; Antimony B; Domestic and Bolivia; SB 68.24%; Type Sulfide Ore (Photo 122).

Photo 122: SEAD-50, 9/12/90. View of the Sulfide Ore Tank (Tank No. 17) located at the Tank Farm, facing north.

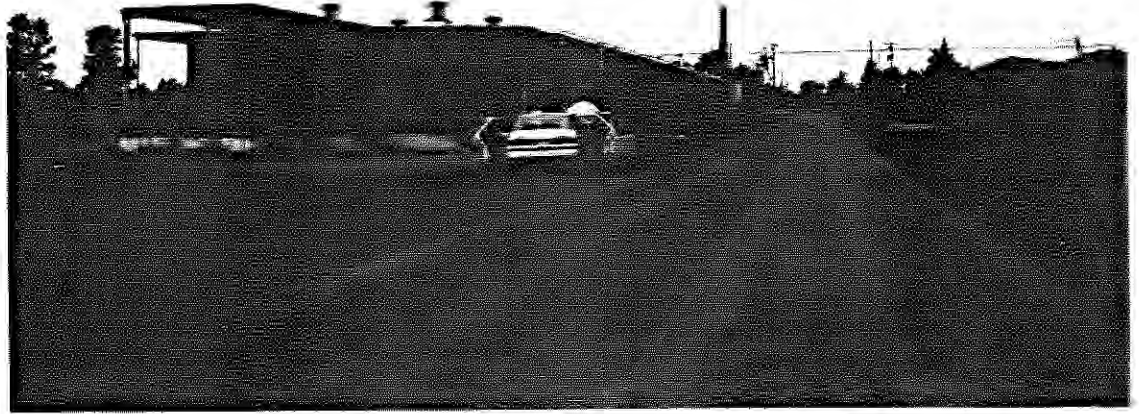
Photo 124: SEAD-52, 9/11/90. View of the Ammunition Breakdown Area - Building 612, facing north.
