FINAL SWMU CLASSIFICATION REPORT SENECA ARMY DEPOT ACTIVITY

**SOLID WASTE MANAGEMENT
CLASSIFICATION STUDY
SENECA ARMY DEPOT
ROMULUS, NEW YORK**

**Seneca Army Depot Activity
Romulus, New York**

**Engineering-Science, Inc.
Prudential Center
Boston, Massachusetts**

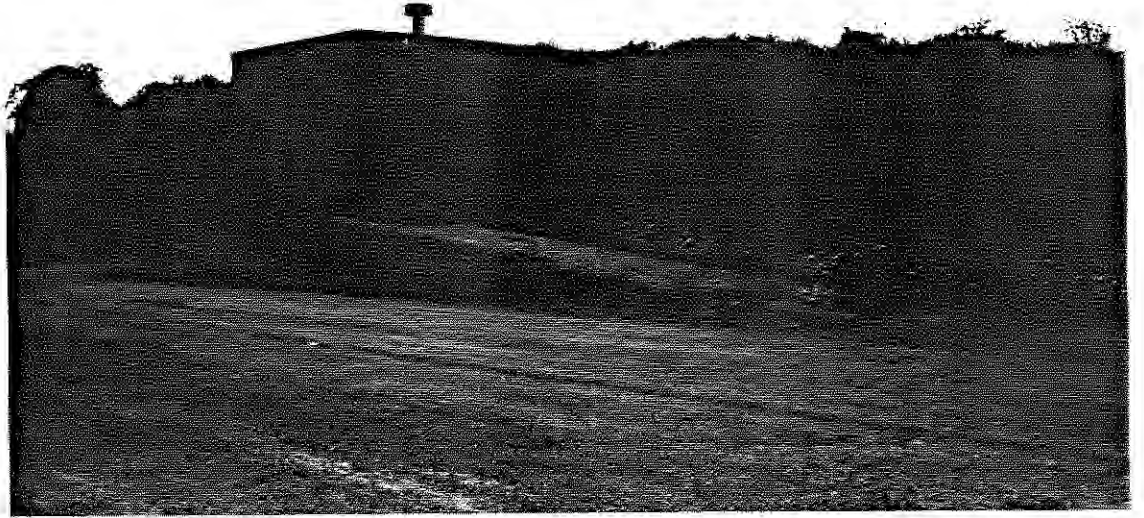
Building 612 is a concrete block structure which is approximately 60 feet wide, 300 feet long, and 15 feet high. Covered platforms are located on the north and south ends of the building. Building 608 is also a concrete block structure which is approximately 20 feet wide by 20 feet long and 12 feet high. A concrete ramp extends from the front of the building to north of the building as shown in Photo 126 included at the end of this text.

Photo 126: SEAD-52, 9/13/90. View of the Ammunition Breakdown Area - Building 608, facing southwest.

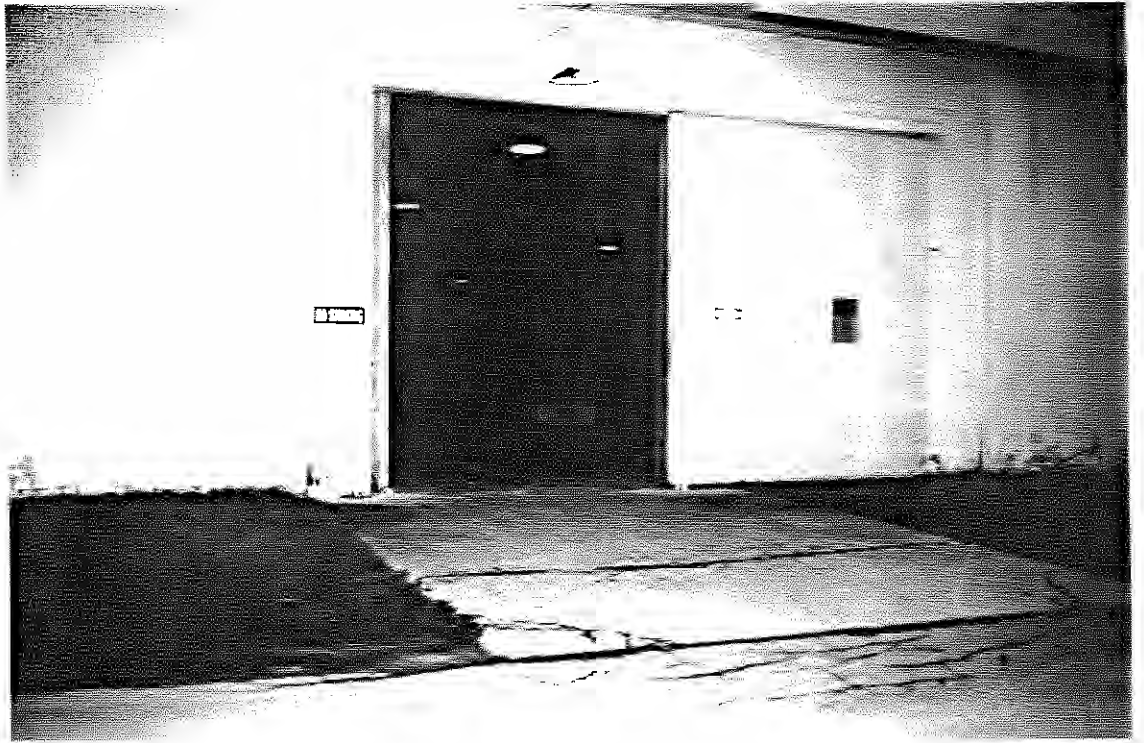
Photo 127: SEAD-55, 9/12/90. View of the Tannin Storage Area - Building 357, facing east.

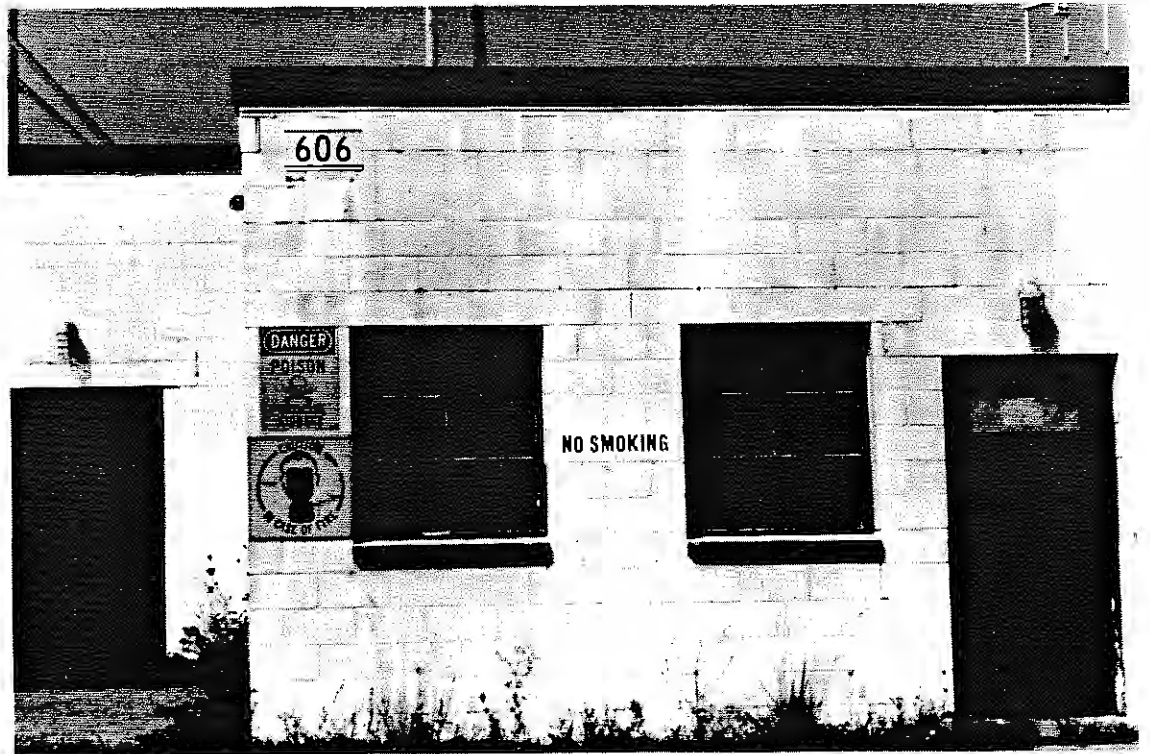
Photo 130: SEAD-56, 9/12/90. Close-up of the signs posted on the Herbicide and Pesticide Storage Area, facing north.

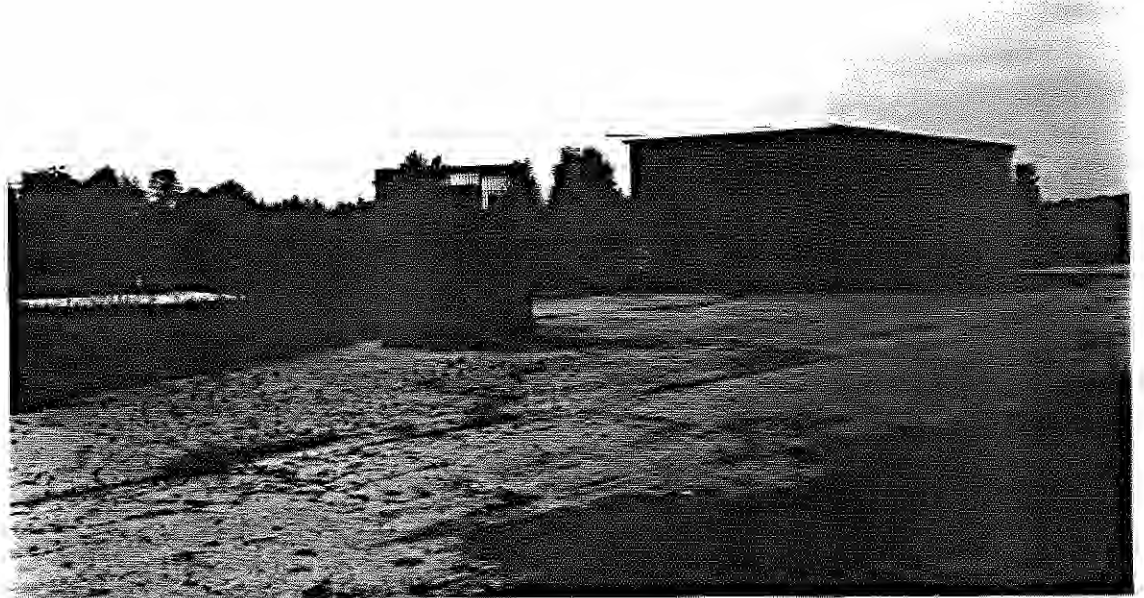
Photo 132: SEAD-56, 9/12/90. Pesticide Rinseate Building located west of the Herbicide and Pesticide Storage Building, facing west.

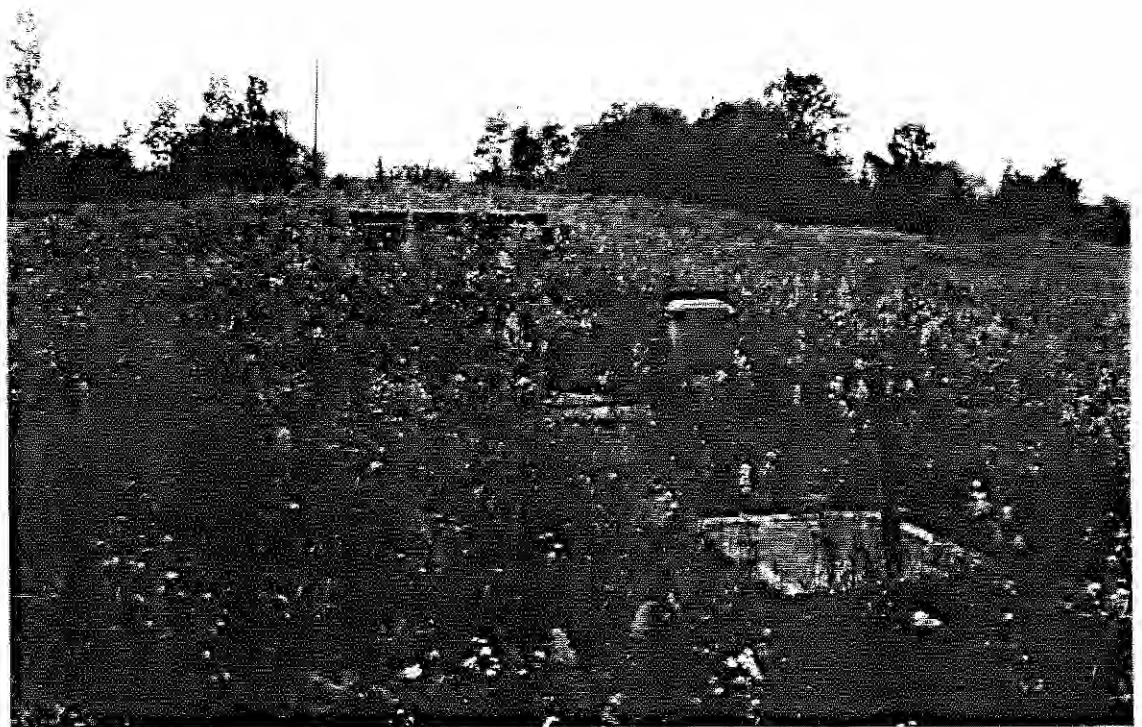
Photo 134: SEAD-56, 9/12/90. View of the septic tank system, Herbicide and Pesticide Storage Area - Building 606, facing south.

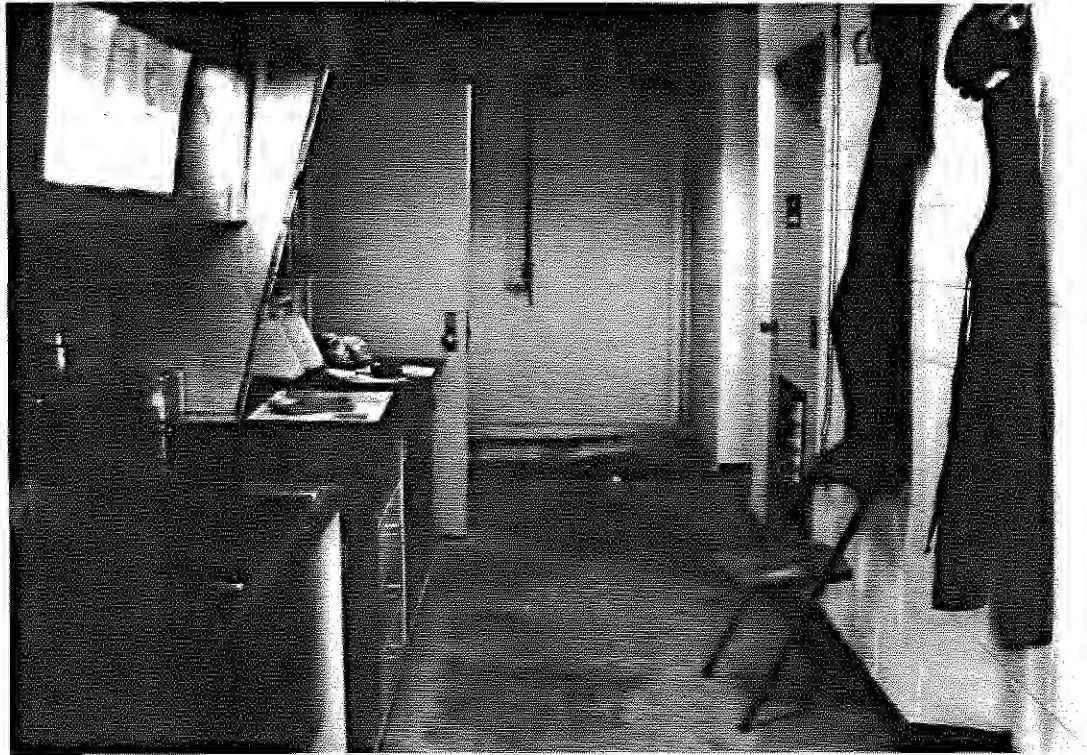
Photo 135: SEAD-56, 11/28/90. View of the Mixing Area Room, Herbicide and Pesticide Storage Area - Building 606, facing west.

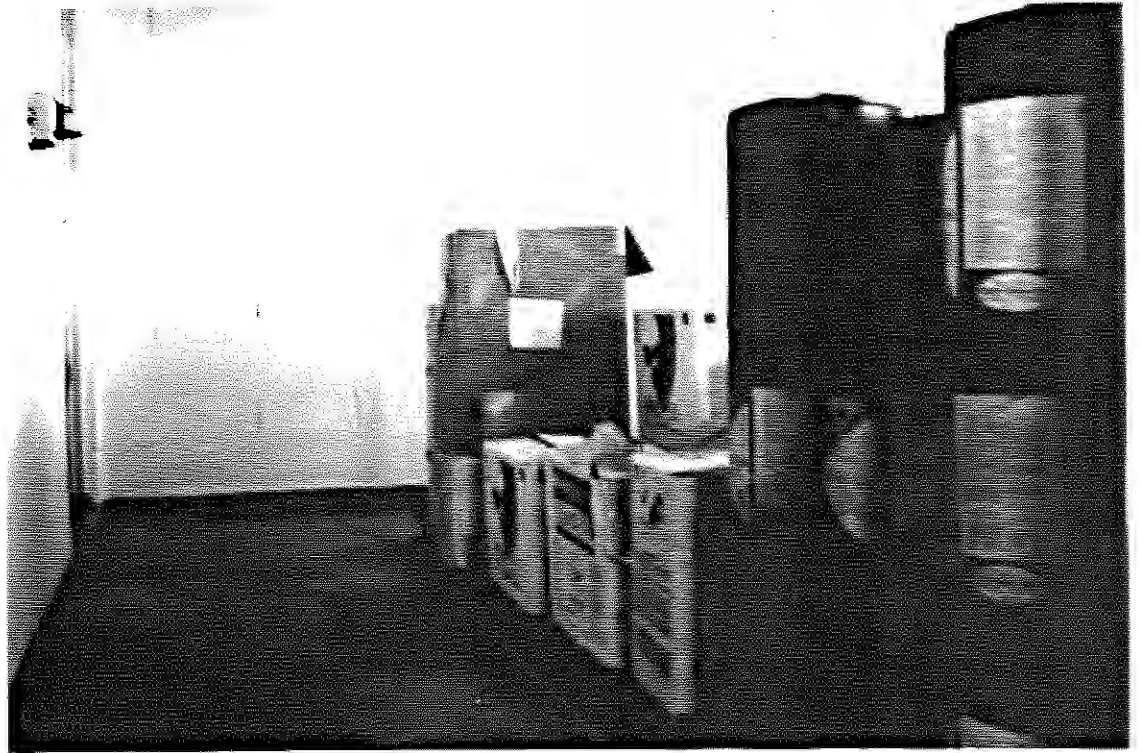
Photo 137: SEAD-56, 11/28/90. View of the Herbicide Storage Room, Herbicide and Pesticide Storage Area - Building 606, facing west.

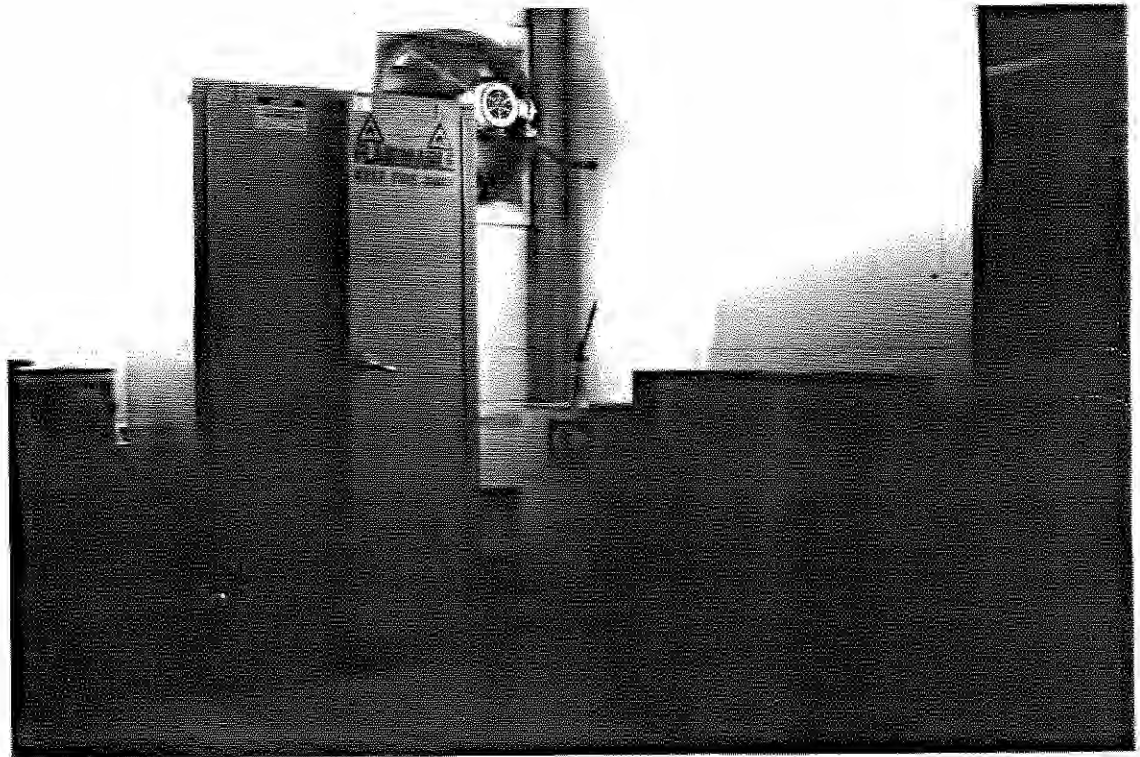
Photo 138: SEAD-56, 11/28/90. View of the Pesticide Storage Room, Herbicide and Pesticide Storage Area - Building 606, facing south.

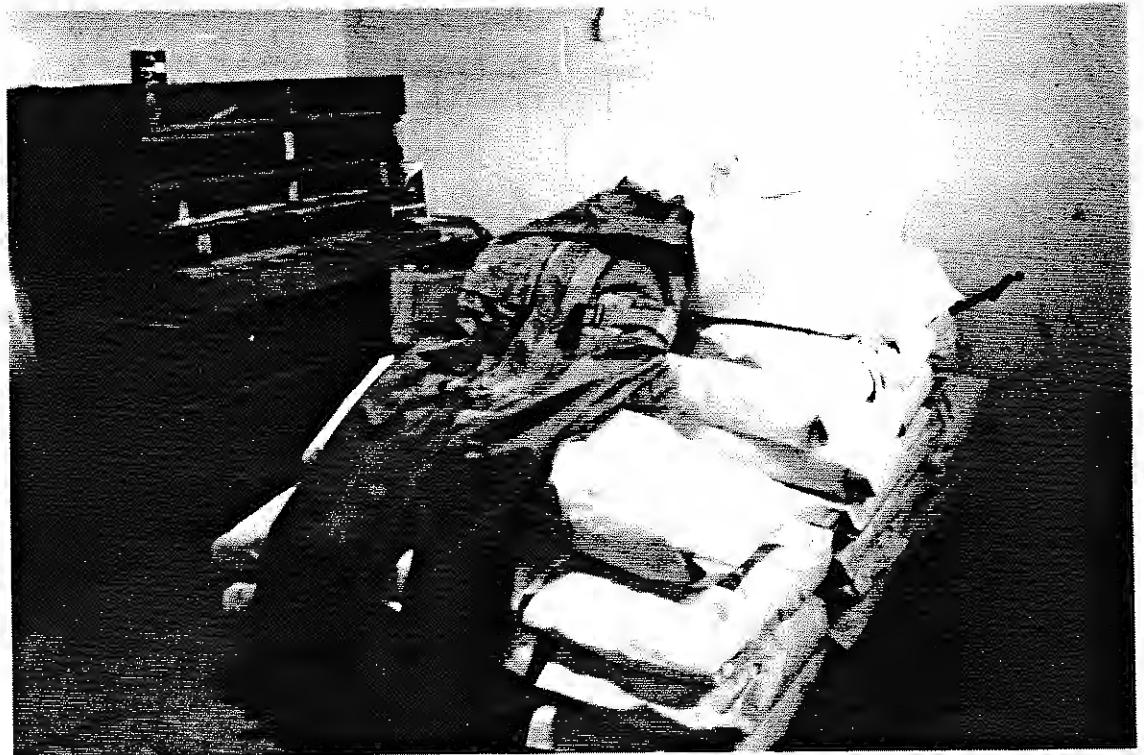
Photo 140: SEAD-56, 11/28/90. View of the Bulk Storage and Suspended Registration Room, Herbicide and Pesticide Storage Area - Building 606, facing west.

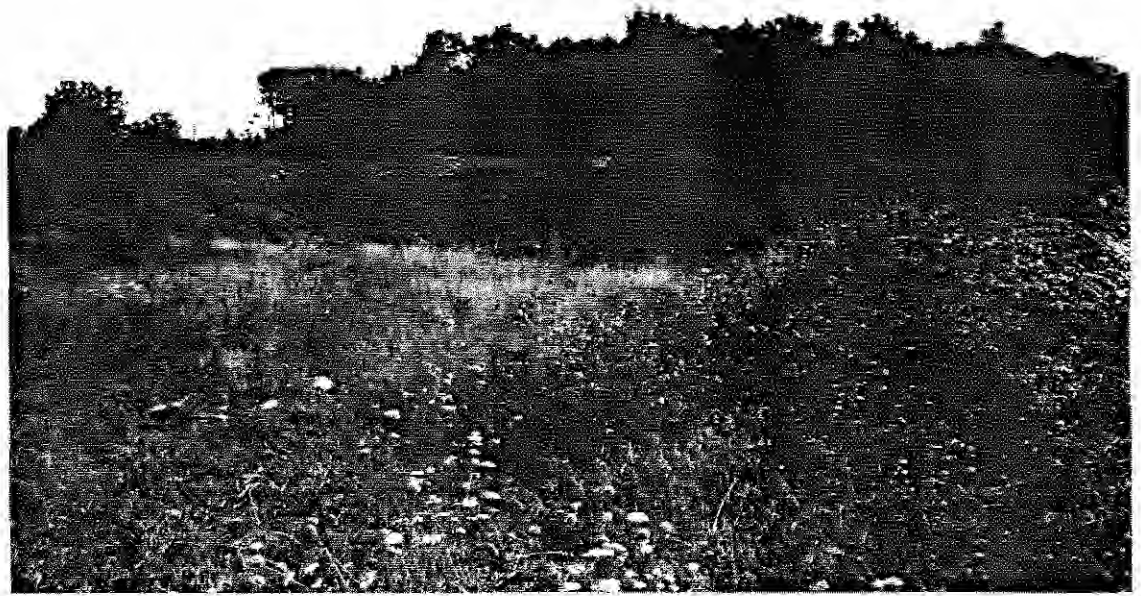
Photo 145: SEAD-57, 9/12/90. Close-up of the Explosive Ordnance Disposal Area, facing southeast.

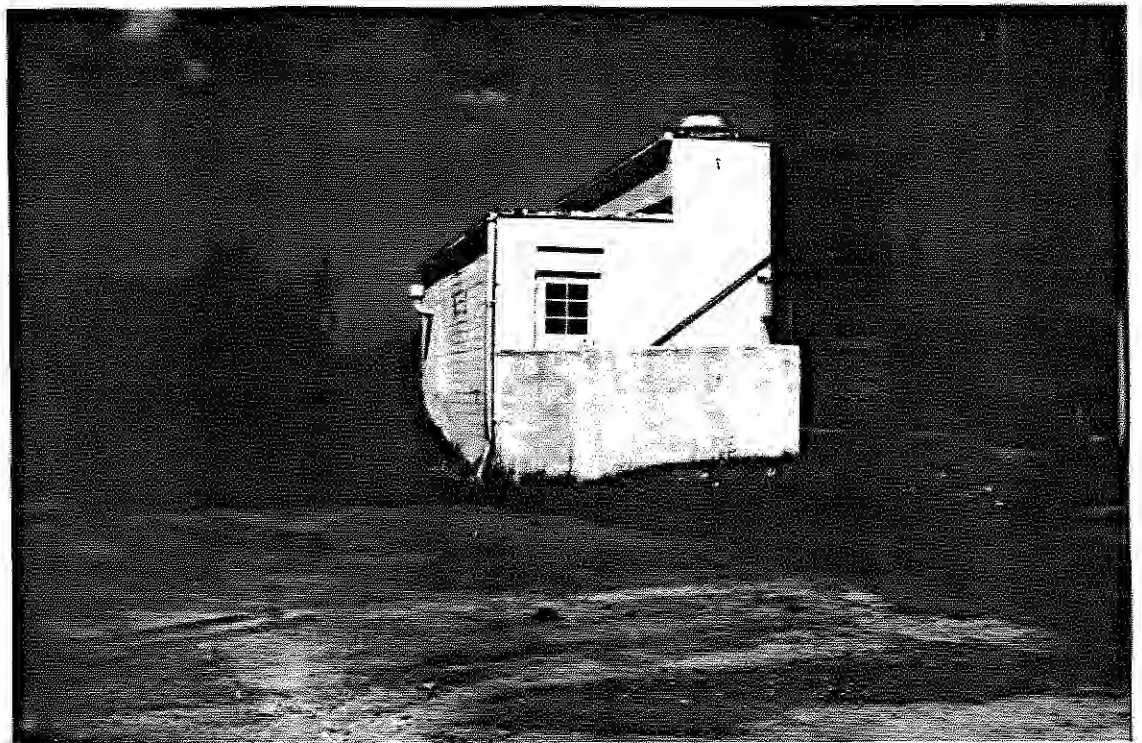
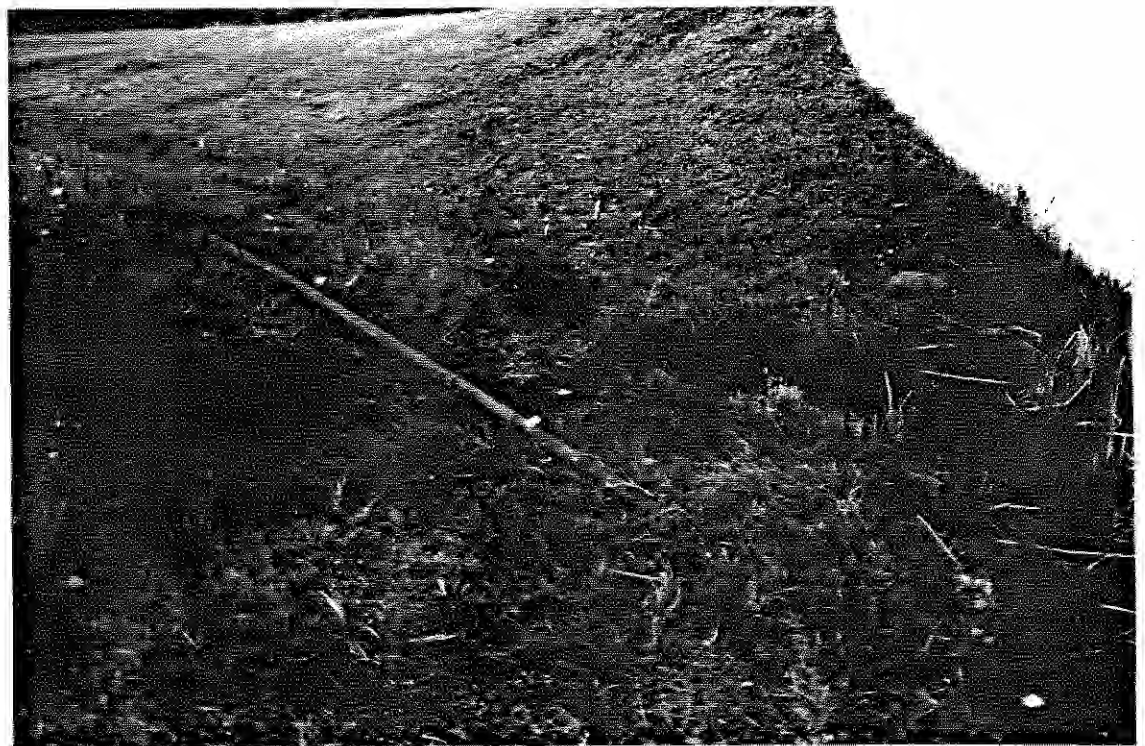
Apparently, the oil which caused the spill came from a pipe located within the boiler building.

Yes, evidence of a release was observed. A stained spill area is present.

Photo 150: SEAD-60, 9/13/90. View of Oil Discharge - Building 609, facing north.

Photo 151: SEAD-60, 9/13/90. View of Oil Discharge - Building 609, facing north.

Photo 152: SEAD-60, 9/11/90. Close-up of Oil Discharge - Building 609, facing northeast.

Photo 153: SEAD-60, 9/11/90. Close-up of Oil Discharge - Building 609, facing northeast.

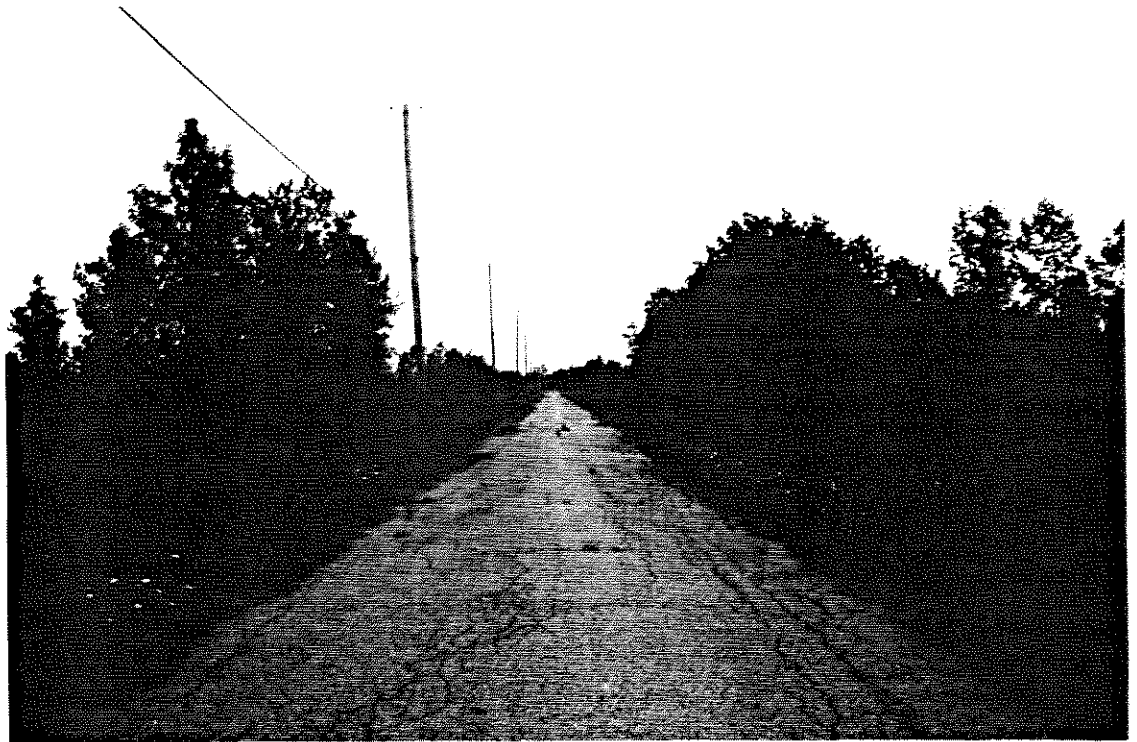
Unknown. However, no evidence of a release has been observed at the SWMU.

Photo 155: SEAD-62, 9/11/90. View of the location of the Nicotine Sulfate Disposal Area - on south side of road near Buildings 606 and 612, facing east.

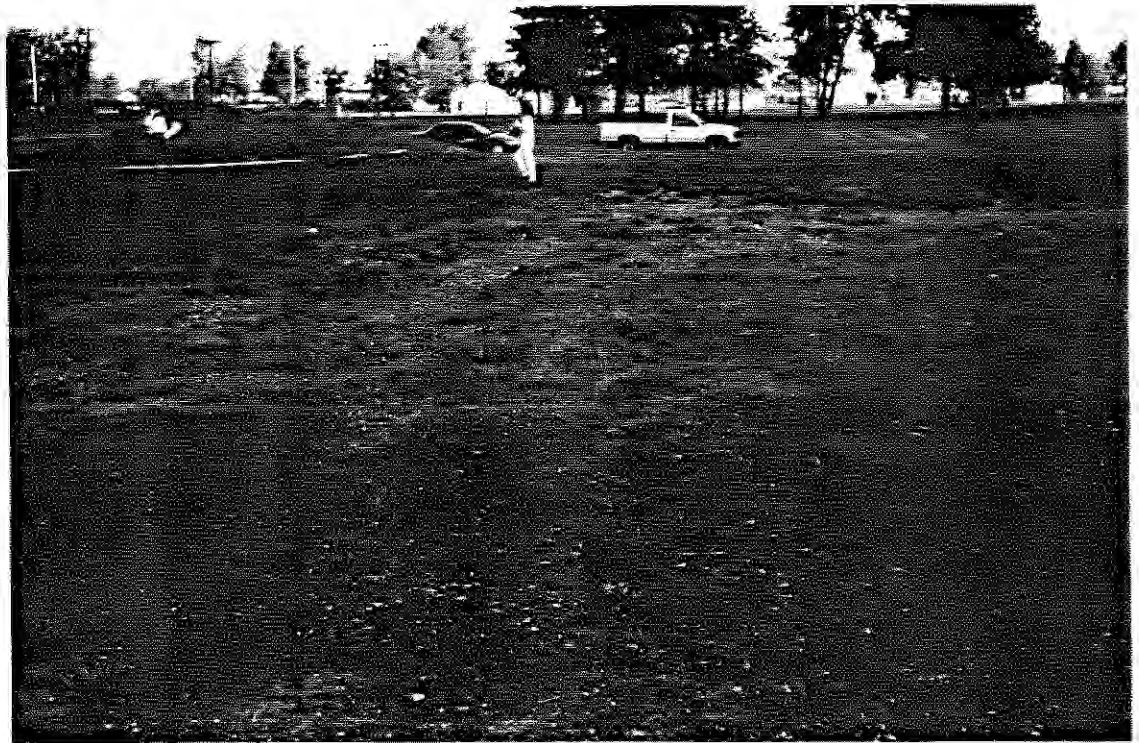
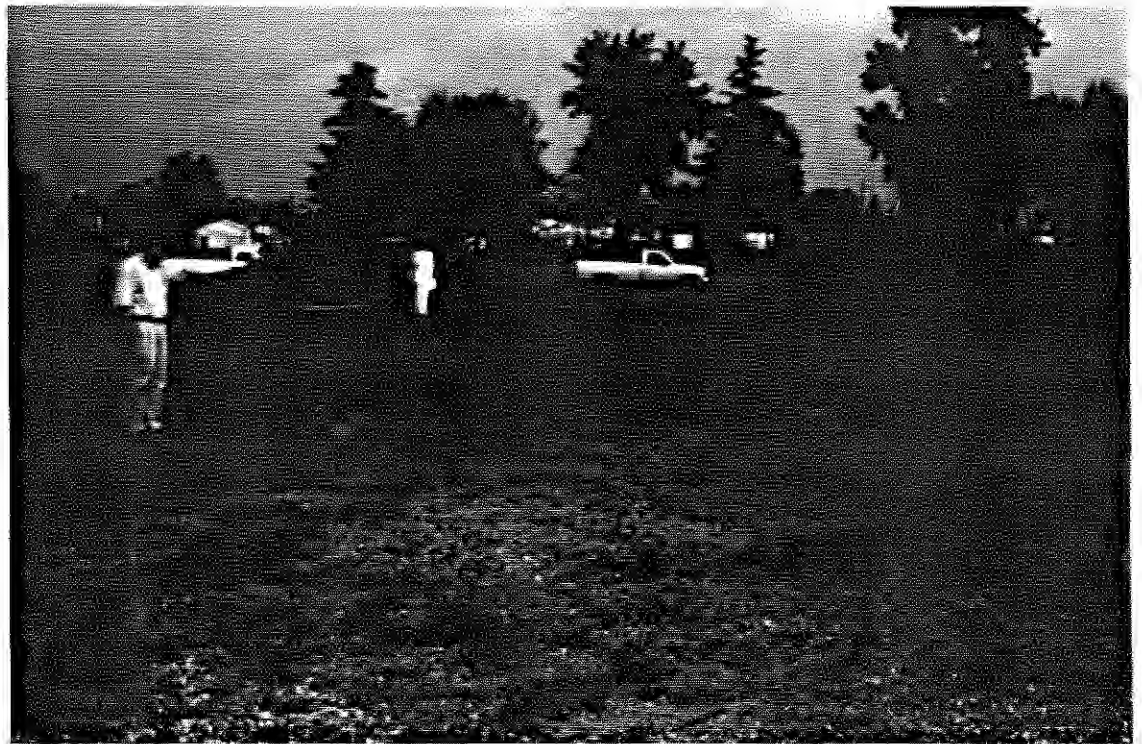
No evidence of a release was observed.

Photo 156: SEAD-63, 9/12/90. View of the location of the Miscellaneous Components Burial Site, facing north.

Photo 157: SEAD-63, 9/12/90. View of the location of the Miscellaneous Components Burial Site, facing northwest; the tape is held across north-south dimension of the burial site.

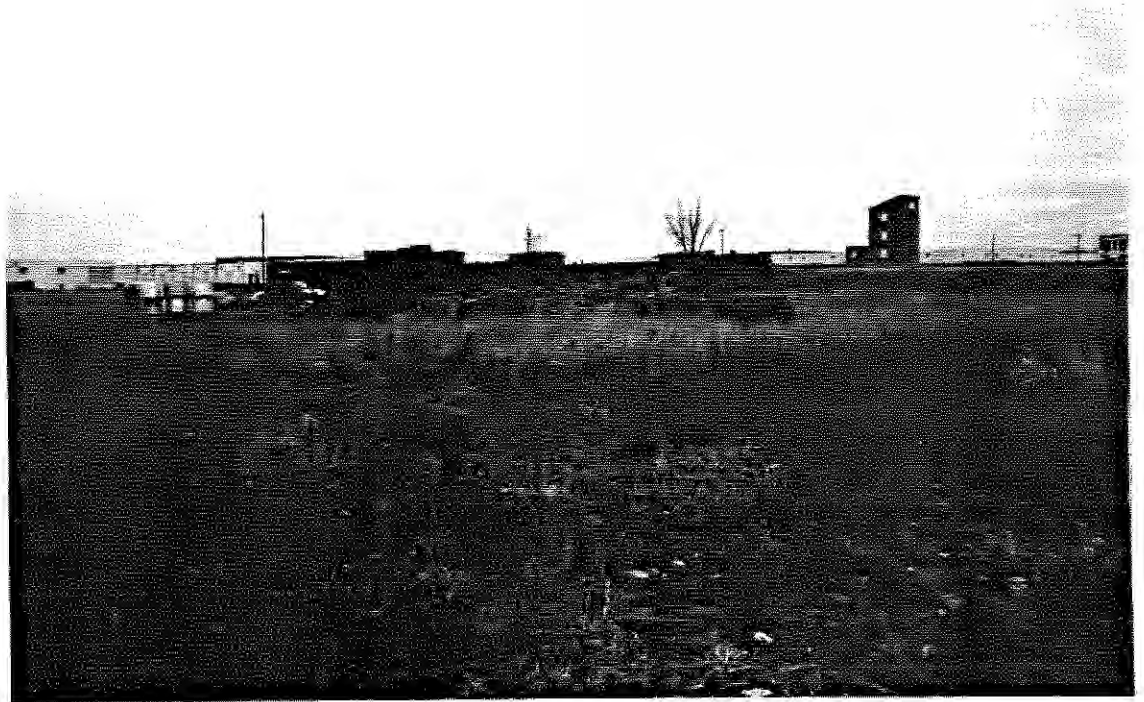
This debris landfill is located south of the storage pads at 7th Street. The area appeared to have been disturbed. A "No Dumping" sign has been placed in the area. No garbage or debris was observed. (Photos 158 and 159).

Photo 158: SEAD-64, 11/27/90. View of Location A of Garbage Disposal Areas, Debris Landfill south of Storage Pad, facing south.

Photo 159: SEAD-64, 11/27/90. View of Location A of Garbage Disposal Areas, Debris Landfill south of Storage Pad, facing north.

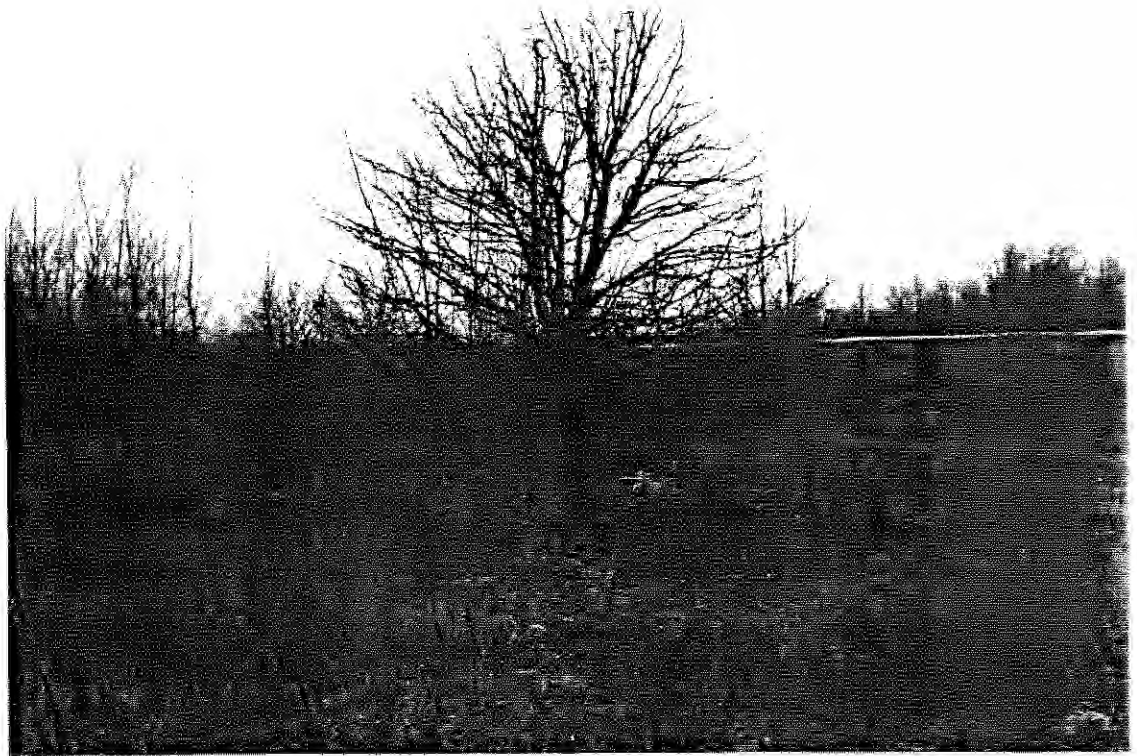
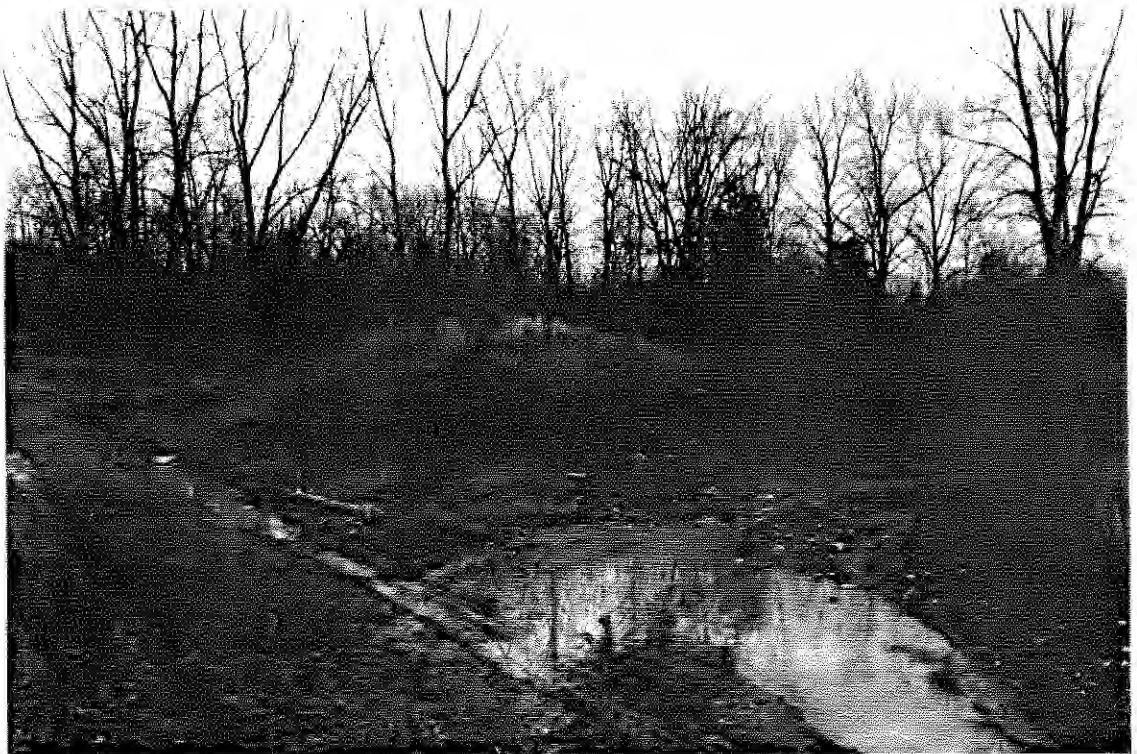
This debris area is located south of the classified yards and north of Ovid Road. Piles of fill material were observed in the area as shown in Photo 161.

Photo 160: SEAD-64, 11/29/90. View of Location B of Garbage Disposal Areas, Debris Area south of Classification Yards, facing north.

Photo 161: SEAD-64, 11/29/90. View of Location B of Garbage Disposal Areas, Debris Area south of Classification Yards, facing east.

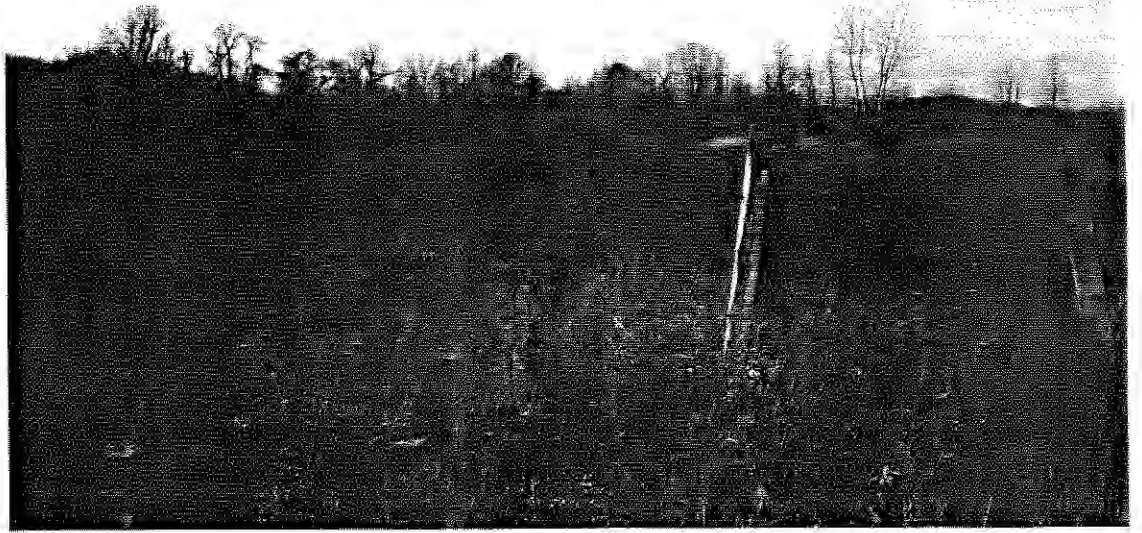
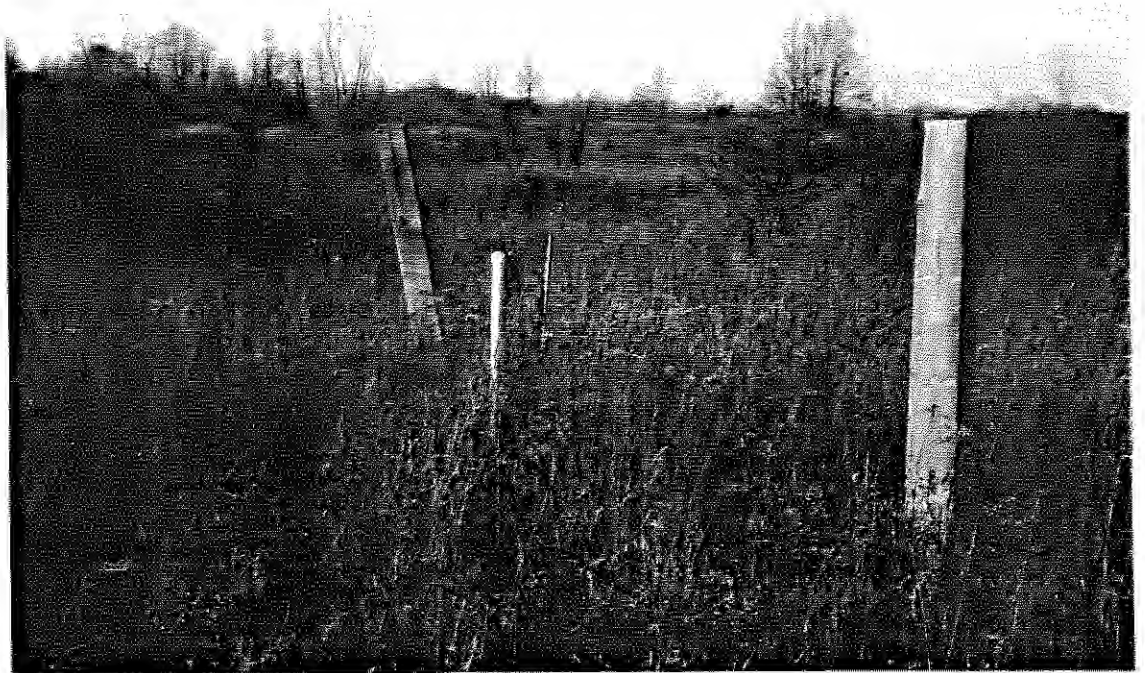
The proposed landfill site is located north of South Patrol Road. A SEDA employee has reported that debris has been dumped at the site. The debris area could not be located during the visual site inspection. Groundwater monitoring wells have been placed around the unit as shown in Photos 162 and 163.

Photo 162: SEAD-64, 11/29/90. View of Location C of Garbage Disposal Areas, Proposed Landfill Site, facing northwest.

Photo 163: SEAD-64, 11/29/90. View of groundwater monitoring well, Location C of Garbage Disposal Areas, Proposed Landfill Site, facing northwest.

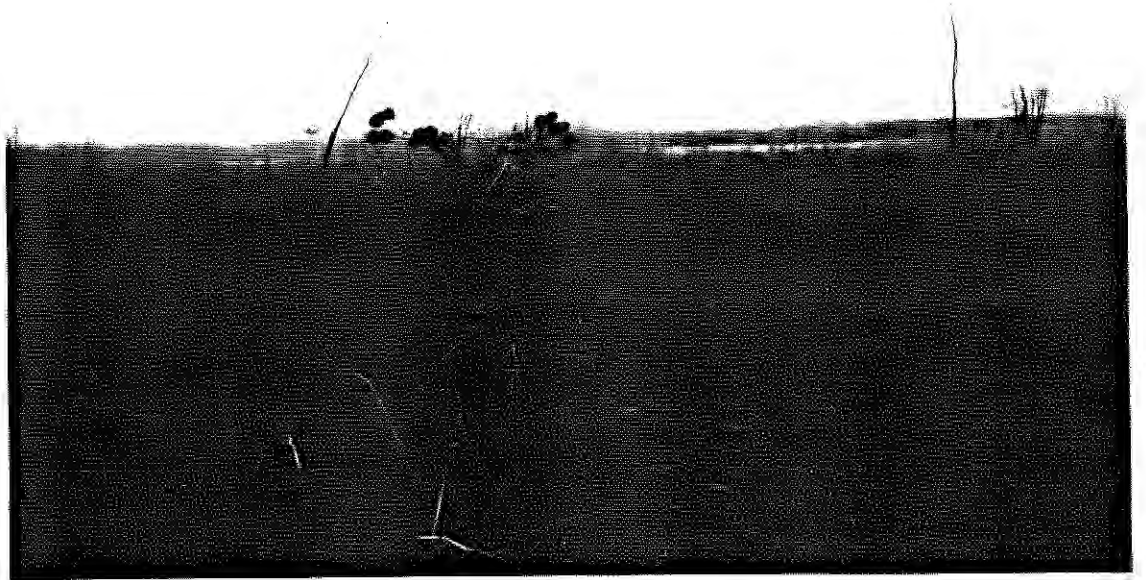
It has been reported that debris (i.e. crushed heavy gauge metal drums, empty smoke generating canisters and various other metallic debris) has been dumped at an area west of Building 2203 and east of West Patrol Road (Photos 164 and 165). The debris area could not be located during the visual site inspection.

Photo 164: SEAD-64, 11/29/90. View of Location D of Garbage Disposal Areas, Disposal Area west of Building 2203, facing southwest.

Photo 165: SEAD-64, 11/29/90. View of Location D of Garbage Disposal Areas, Disposal Area west of Building 2203, facing southwest.

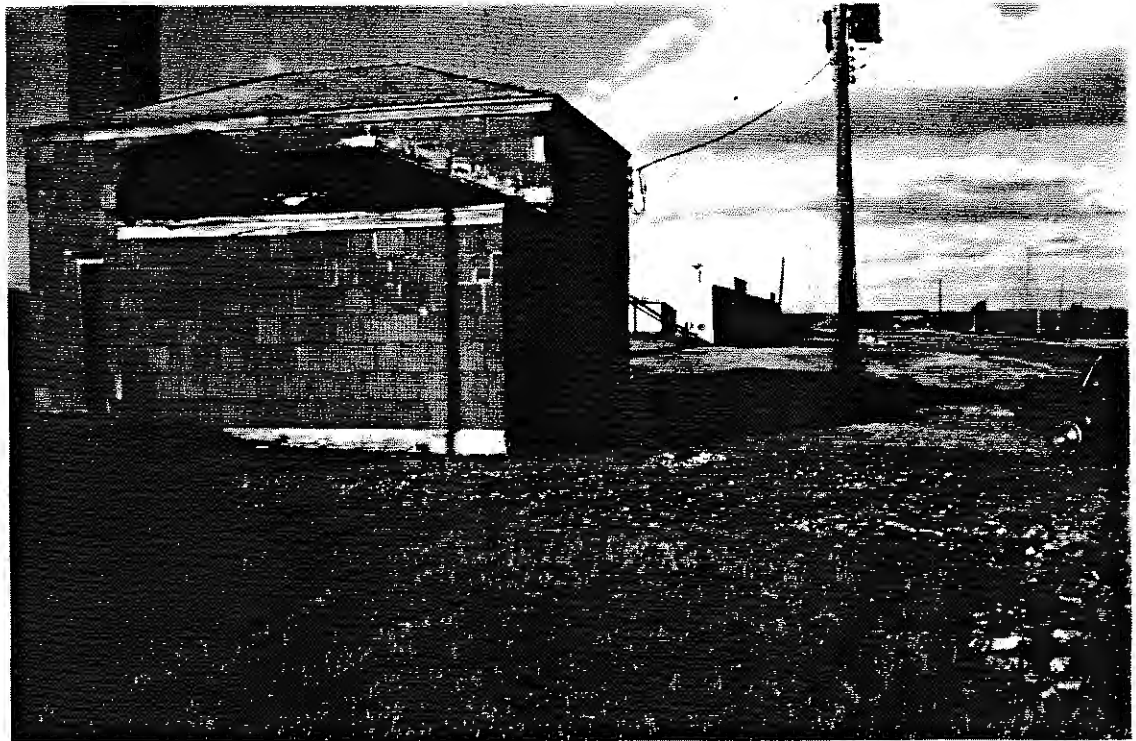
The exact location of the pesticide storage building is unknown. A small metal shed was observed adjacent to Building 5. This shed possibly could have been used for storage of pesticides. A concrete pad was observed adjacent to Building 6. This area may have also been used for the storage of pesticides. Photographs of these areas are shown on the pages following the text.

Photo 172: SEAD-66, 11/29/90. View of possible Pesticide Storage Area near Buildings 5 and 6 (Building 5 is the white block structure located in back of Building 6), facing north.

Photo 173: SEAD-66, 11/29/90. View of possible Pesticide Storage Area near Building 5, facing north.

Photo 174: SEAD-66, 11/29/90. Close-up of possible Pesticide Storage Area near Building 5, facing north.

Photo 175: SEAD-66, 11/29/90. Close-up of possible Pesticide Storage Area near Building 6, facing northwest.

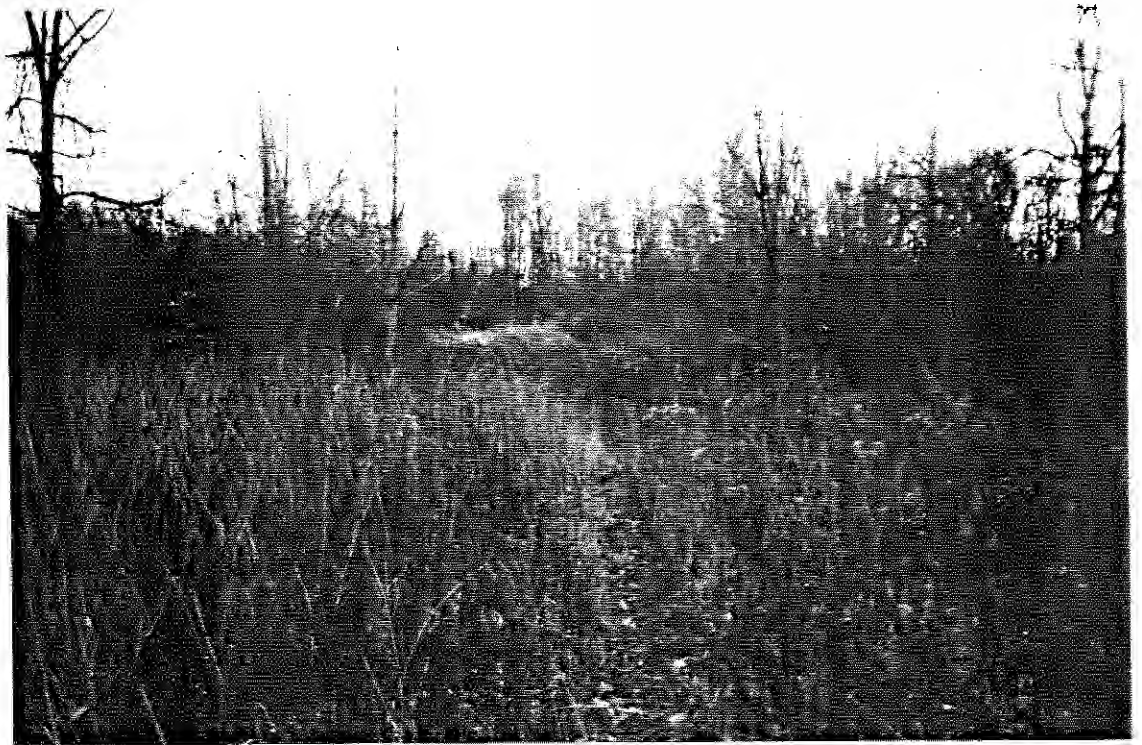
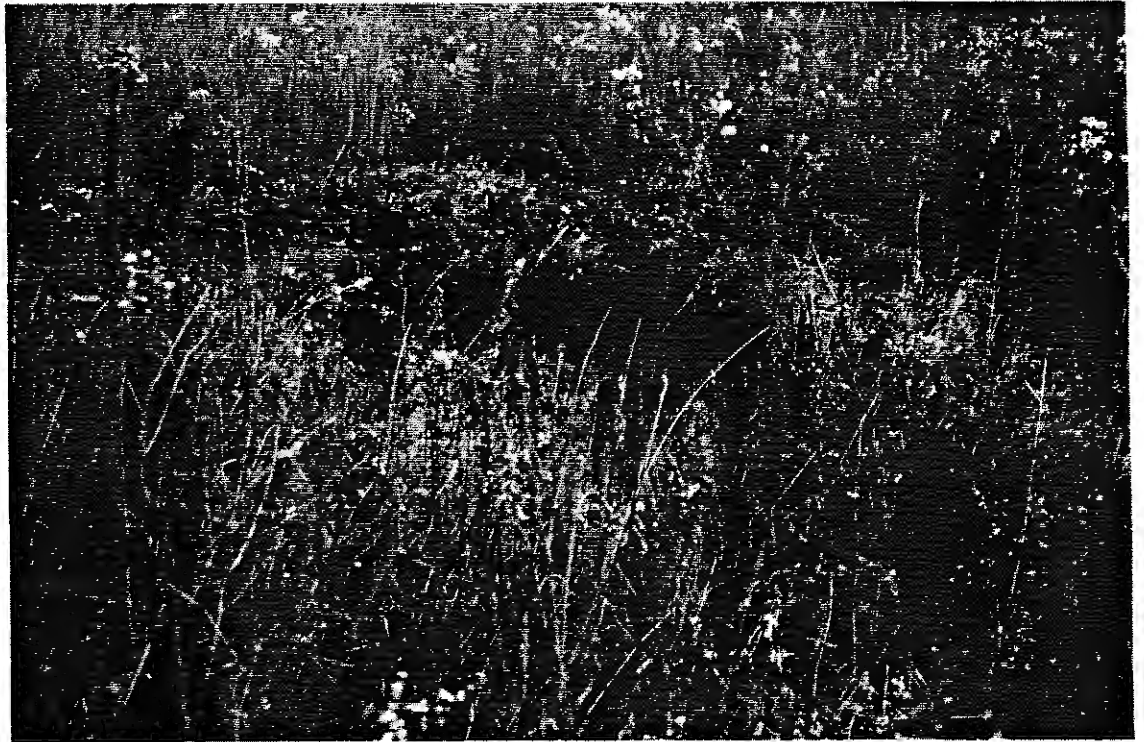
Piles covered with vegetation were observed in the area. Photographs of the site are shown on the pages following this text.

Photo 176: SEAD-67, 11/29/90. View of Dump Site east of Sewage Treatment Plant No. 4, facing south.

Photo 177: SEAD-67, 11/29/90. View of Dump Site east of Sewage Treatment Plant No. 4, facing east.

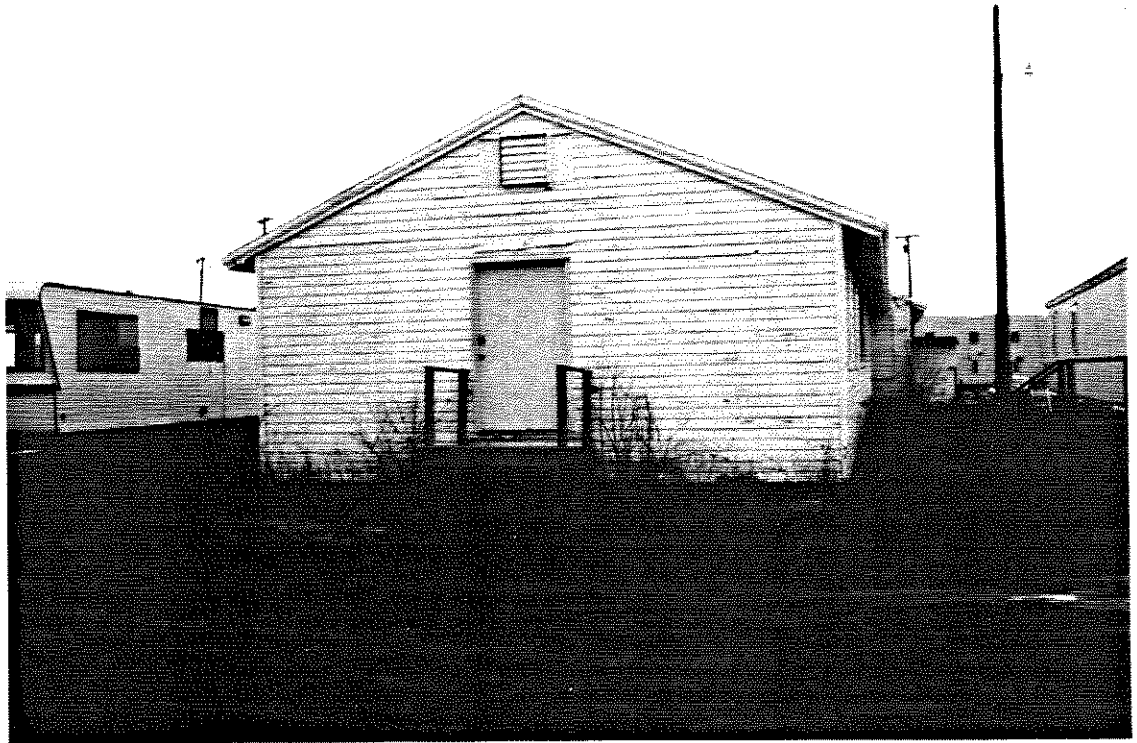
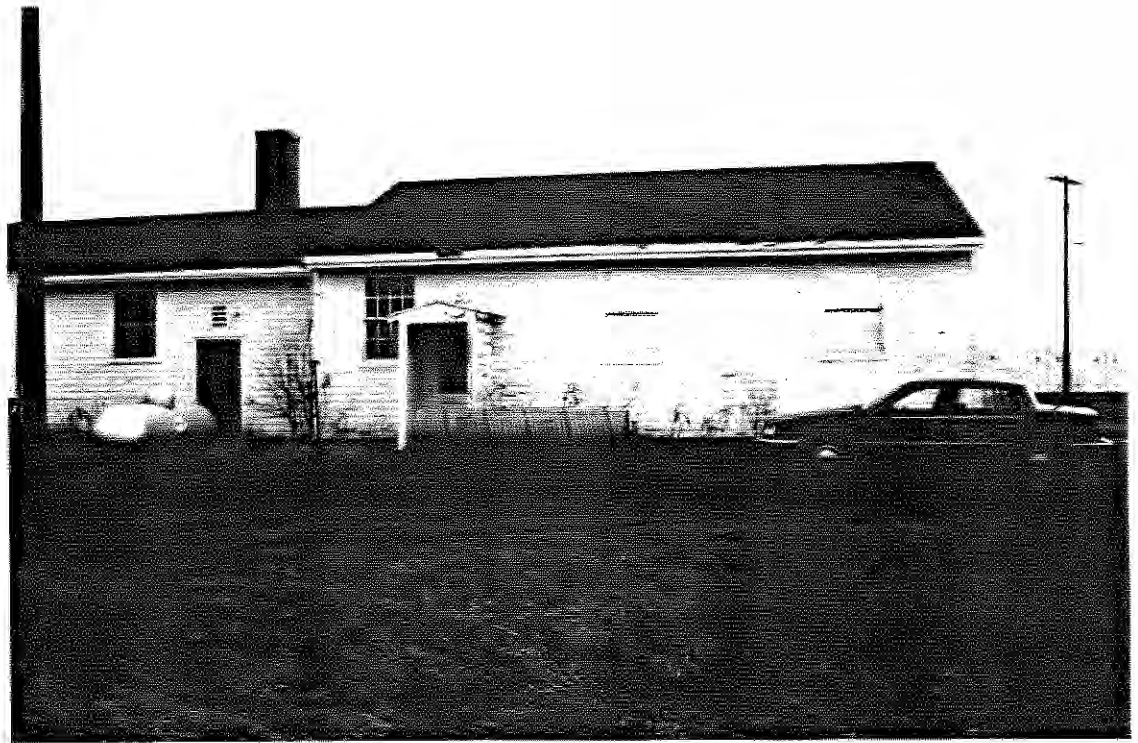
The building is presently used for fire fighting training exercises. During the visual site inspection, fire fighting training equipment was observed in the south end of the building. The north end of the building was locked and could not be accessed. However, it was observed through a window that this section of the building was empty. Debris was observed on the floor.

Photo 178: SEAD-68, 11/27/90. View of Pest Control Shop - Building S-335 (Old Firehouse), facing northeast.

Photo 179: SEAD-68, 11/27/90. View of Pest Control Shop - Building S-335 (Old Firehouse), facing south.

Photo 180: SEAD-68, 11/27/90. View of Pest Control Shop - Building S-335 (Old Firehouse), facing east.

Photo 181: SEAD-68, 11/27/90. View of interior of Pest Control Shop - Building S-335 (Old Firehouse), facing southwest.

No documentation or visual evidence of a release from the SWMU, has been recorded. However, SCR Resolution Meeting Minutes (9/25/92) document that this SWMU was classified as an Area of Concern by NYSDEC and SEDA was in agreement with this. EPA in a December 29, 1992 letter to SEDA recommended further study of this SWMU.
