FINAL SWMU CLASSIFICATION REPORT SENECA ARMY DEPOT ACTIVITY

**SOLID WASTE MANAGEMENT
CLASSIFICATION STUDY
SENECA ARMY DEPOT
ROMULUS, NEW YORK**

**Seneca Army Depot Activity
Romulus, New York**

**Engineering-Science, Inc.
Prudential Center
Boston, Massachusetts**

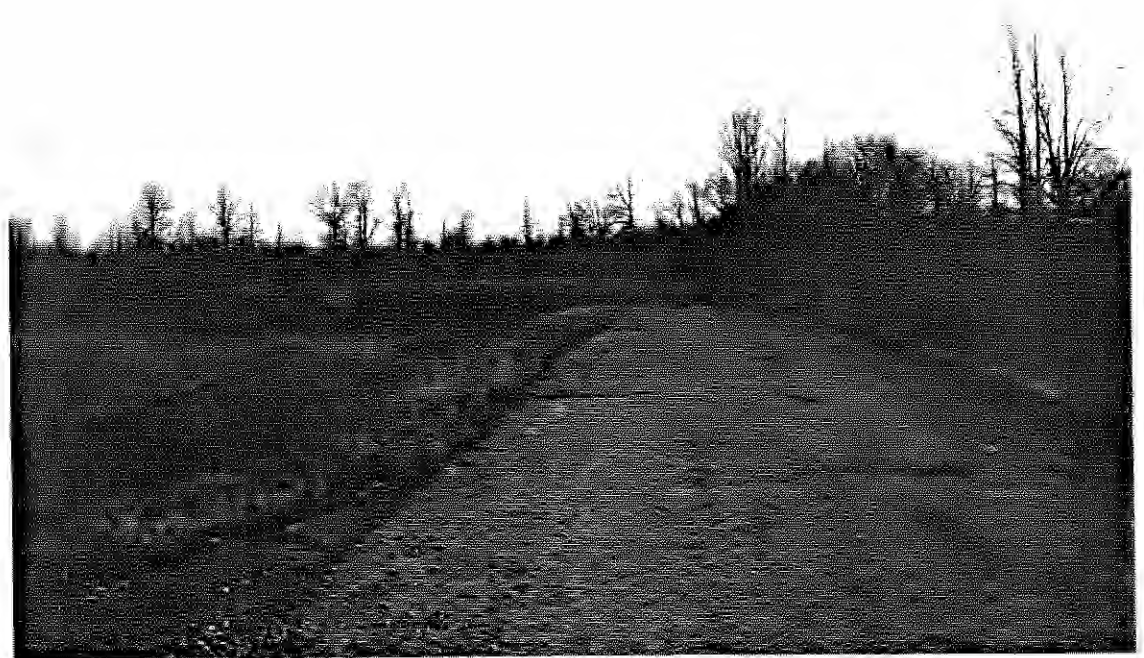
A pile covered with vegetation was observed in the area. Also, a depressed area which contained wire fence and concrete posts was observed to the north of the pile area. Photographs of the area are shown on the pages following this text.

Photo 182: SEAD-69, 11/28/90. View of Disposal Area - Building 606, facing north.

Photo 183: SEAD-69, 11/28/90. View of Disposal Area - Building 606, facing east.

Photo 184: SEAD-69, 11/29/90. Close-up of Disposal Area - Building 606, facing east.

Photo 185: SEAD-69, 11/29/90. Close-up of Disposal Area - Building 606, facing east.

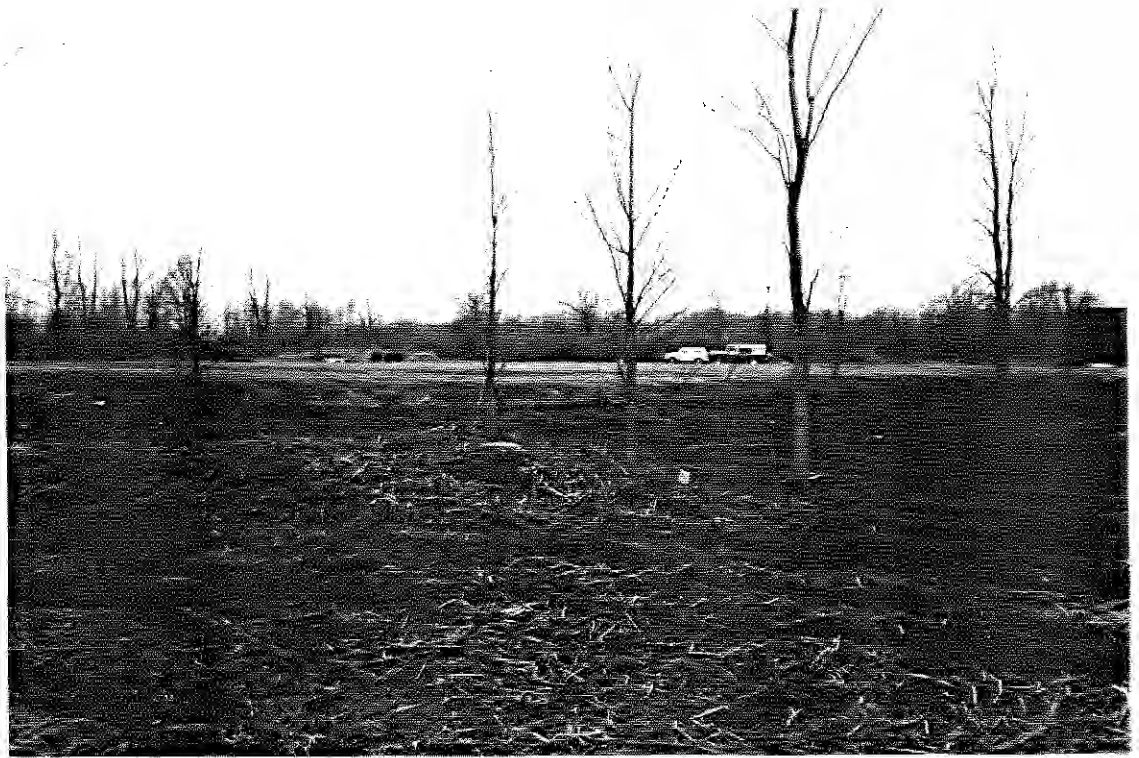
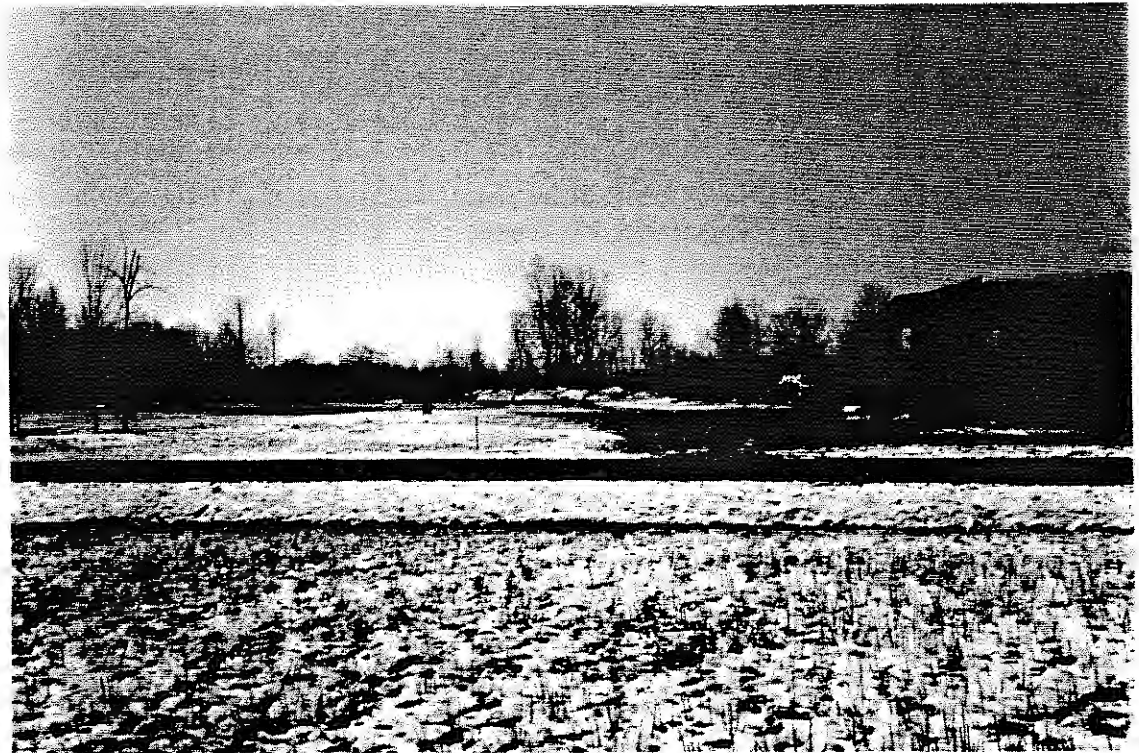
The eastern section of this fill area contains railroad ties, rolls of barbed wire, wooden pallets, and other miscellaneous items. The area is sparsely vegetated, being covered with low lying grass and moss. The eastern sections of this site drops off several feet to a wooded area characterized by wetlands. Building T-2110 is old and dilapidated with piles of hay and sawdust located inside. The walls are broken and the contents are visible from the outside.

Photo 186: SEAD-70, 4-5-94. View of the filled area near Building 2110, the fill scarp occurs at the left-central portion of the photo, facing southwest.

Photo 187: SEAD-70, 4-5-94. View of the western portion of the filled area and a portion of Building 2110, facing south.

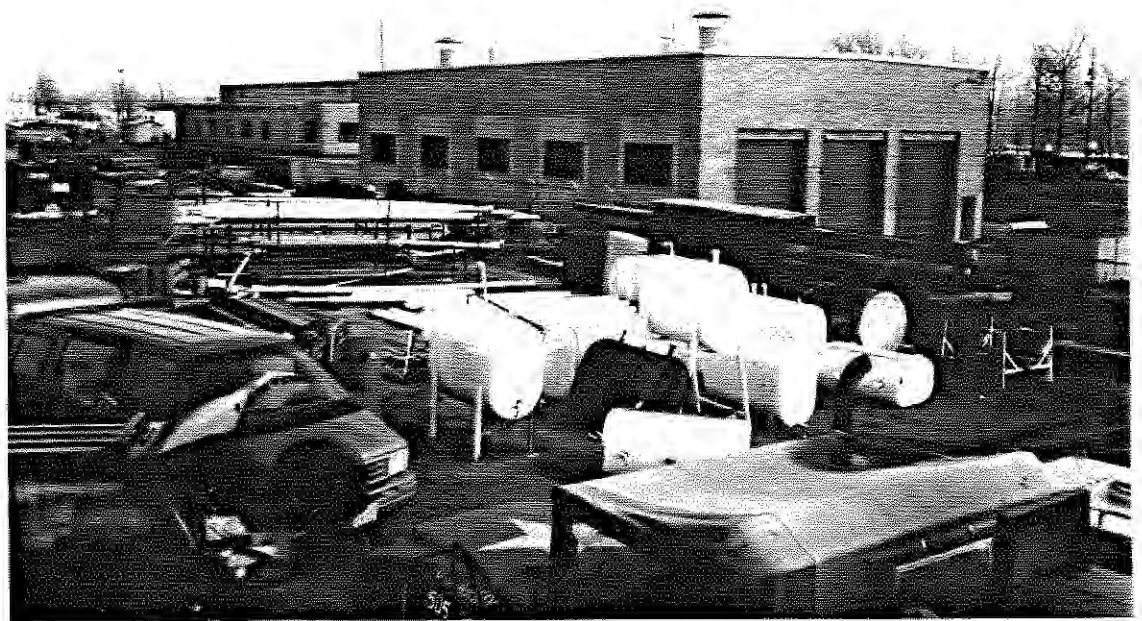
Photo 189: SEAD-71, 4-4-94. Close-up view of the Alleged Paint Disposal Area, facing southeast.
