# TECHNICAL MEMORANDUM

Date:	May 19, 2008	00473					
То:	Julio Vazquez, USEPA						
	Kuldeep Gupta, NYSDEC						
	Mark Sergott, NYSDOH						
From:	Todd Heino, Parsons; Jacqueline Tra	ivers, Parsons					
Subject:	Year 1, Round 2 – Long-Term Mo Depot Activity, Romulus, New York	-	Grounds at Seneca Army

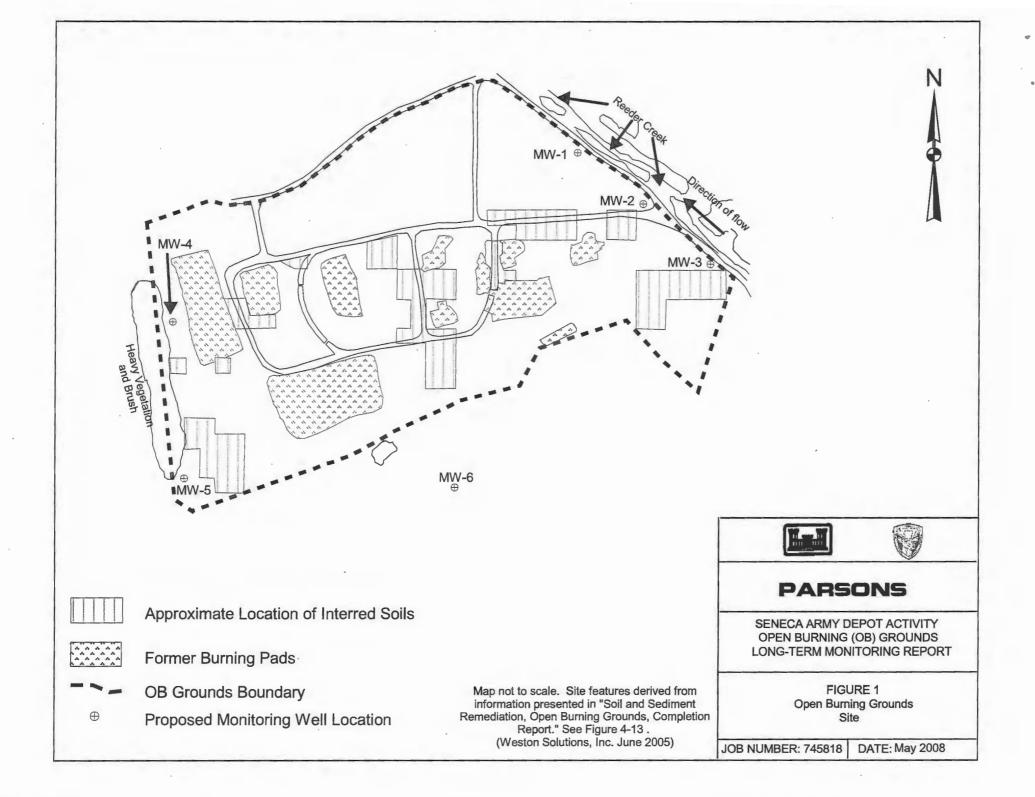
Overall, minimal erosion and a lack of animal burrowing activity were observed in the capped areas. There had been surface melt of snow and the accumulation of new snow, since the Round 2 cap inspection was completed. Shallow surface water drainage paths were observed in three grids (L8, I8, and J6). At Grid I8, sparse vegetation was observed.

The observations were reported to the Army, and the washout areas observed in grids L8, I8, and J6 were immediately repaired in May 2008. The areas of the cap that were sparsely vegetated were reseeded.

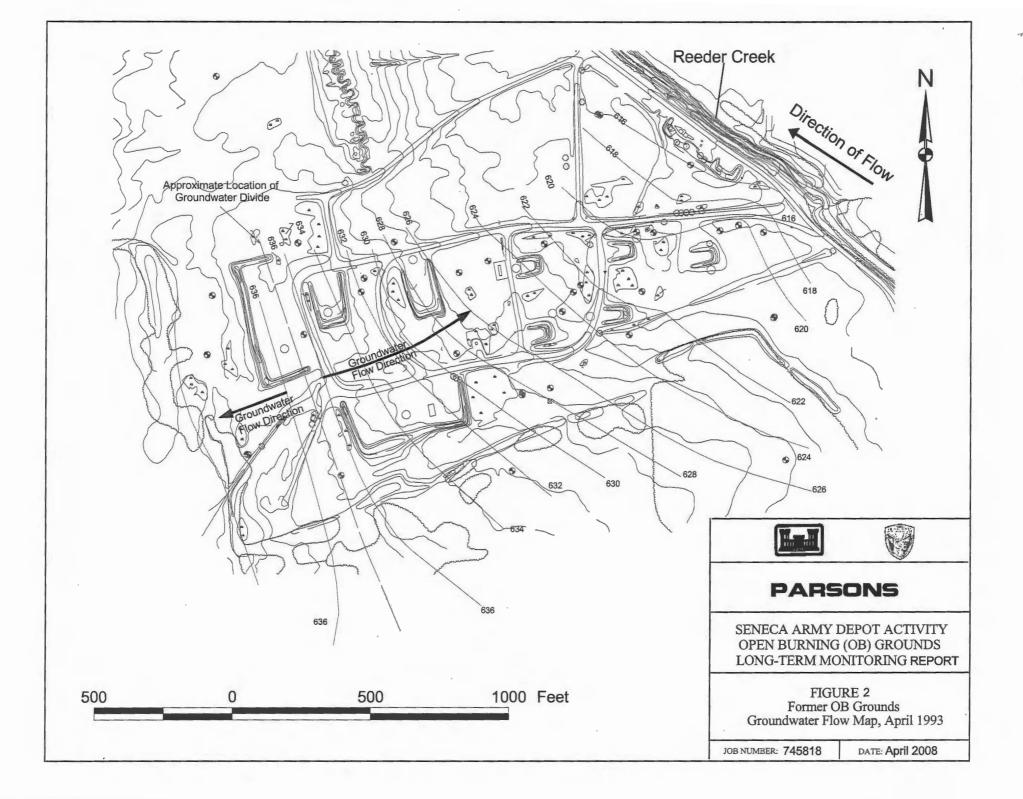
18	Minor erosion of the soil cap.	Surface water runoff path forming. Repaired drainage path May 2008.					
16	A cluster of 1" to 2" size mice holes was observed.	No change					
J6	2" mice holes were observed on the ground surface.	Short surface water drainage path; native soil not visible. Repaired drainage path May 2008.					
H9	Two mice 2" size holes was observed.	No change					
D7	Two mice 2" size holes was observed.	No change					
B3	A mouse hole approximately 6" wide and approximately 6" deep was	No change

2. The Army repaired the washout areas noted above, and reseeded areas with sparse vegetation on or before May 12, 2008.
