SUBJECT: Five-Year Review, Former Solid Waste Management Units SEAD 1, 2, 5, 13, 16, 17, 25, 26, 27, 32, 39, 40, 41, 43, 44A, 44B, 52, 56, 59, 62, 64A, 64B, 64C, 64D, 66, 67, 69, 71, 121C, 121I, 122B, 122E, and the Ash Landfill Operable Unit (SEADs 3, 6, 8, 14, and 15) at Seneca Army Depot Activity, Romulus, New York; Contract W912DY-08-D-0003, Task Order 0008

FIVE-YEAR REVIEW REPORT

SENECA ARMY DEPOT ACTIVITY
 Five Year Review Report for 32 Former
 SWMUs and the Ash Landfill Operable Unit

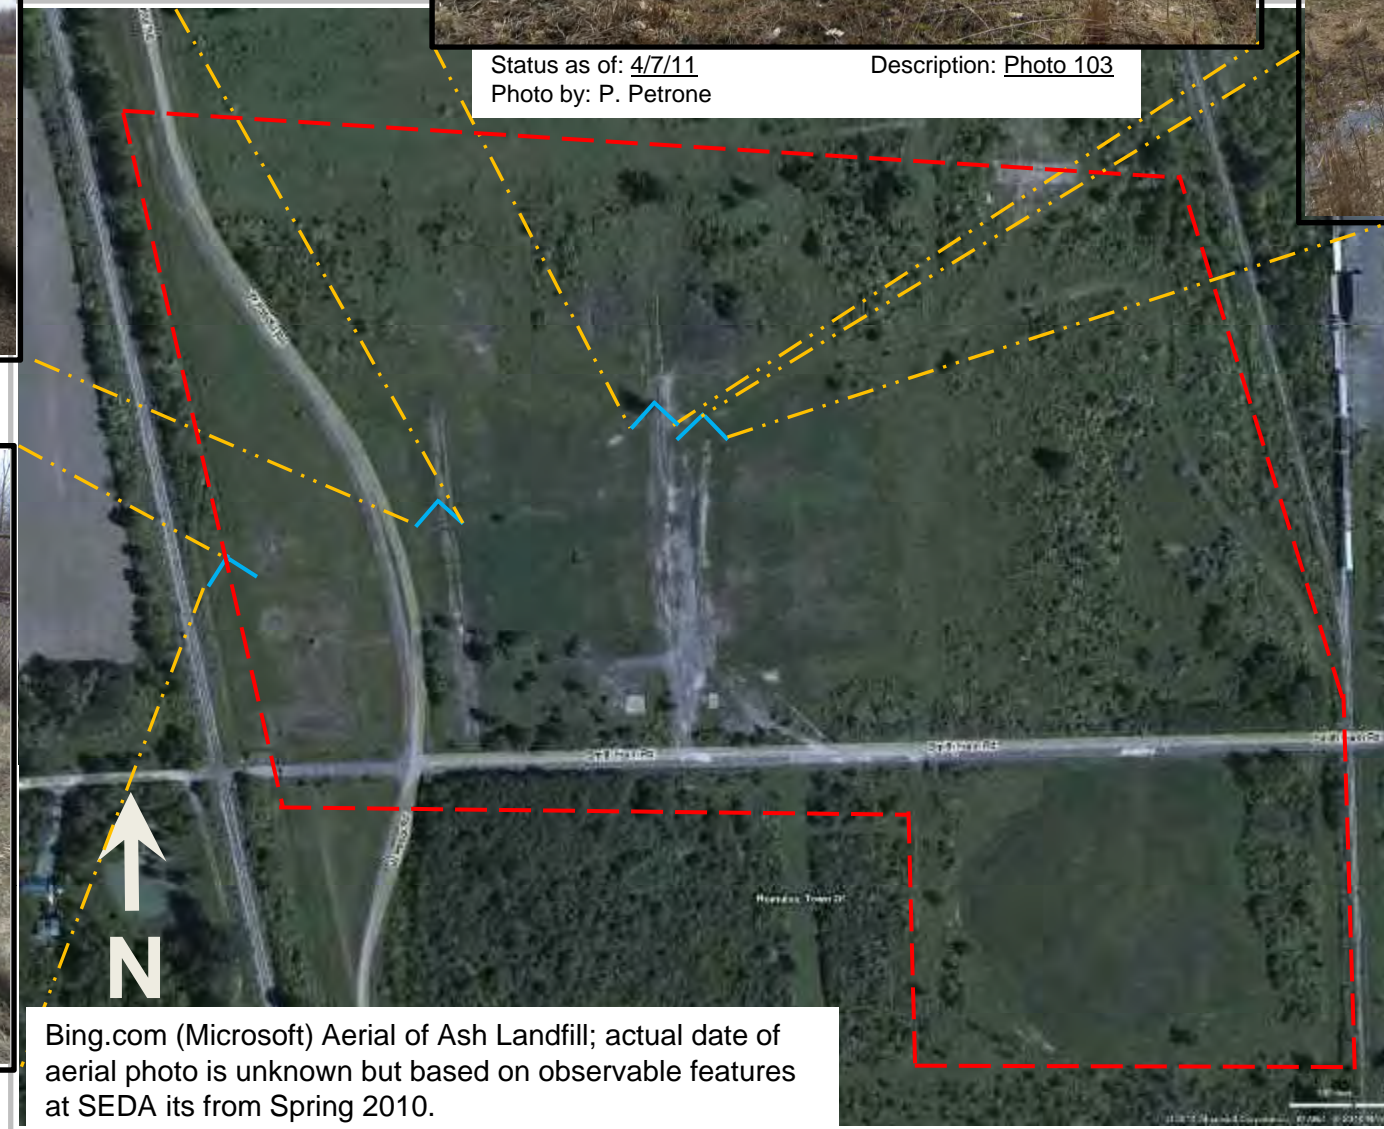
Bing.com (Microsoft) Aerial of Ash Landfill; actual date of aerial photo is unknown but based on observable features at SEDA its from Spring 2010.

- Ash Landfill Operable Unit consists of:
- SEAD-3 Incinerator Cooling Water Pond
 - SEAD-6 Abandoned Ash Landfill
 - SEAD-8 Non-Combustible Fill Area
 - SEAD-14 Refuse Burning Pits (2 units)
 - SEAD-15 Abandoned Solid Waste Incinerator (Building 2207)

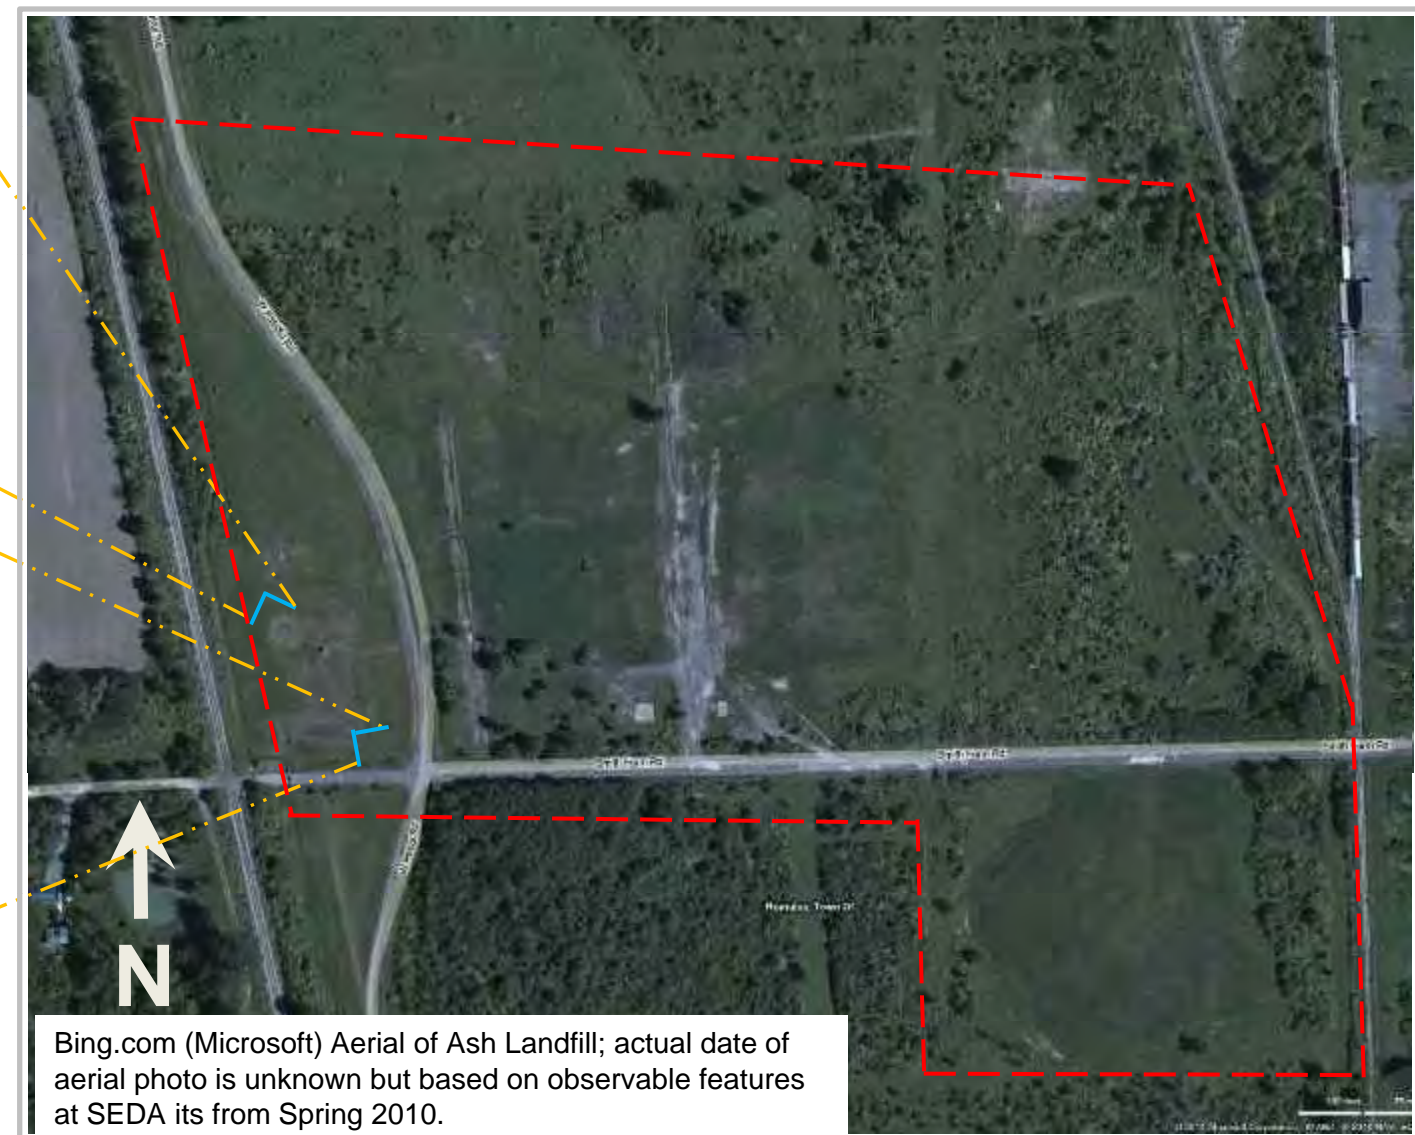
Bing.com (Microsoft) Aerial of Ash Landfill; actual date of aerial photo is unknown but based on observable features at SEDA its from Spring 2010.
