DRAFT FINAL

**DECISION DOCUMENT FOR REMOVAL ACTIONS
AT SWMUs SEAD-11, SEAD-25, SEAD-26, SEAD-38,
SEAD-39, SEAD-40, AND SEAD-41, SENECA ARMY
DEPOT ACTIVITY**

AUGUST 1995

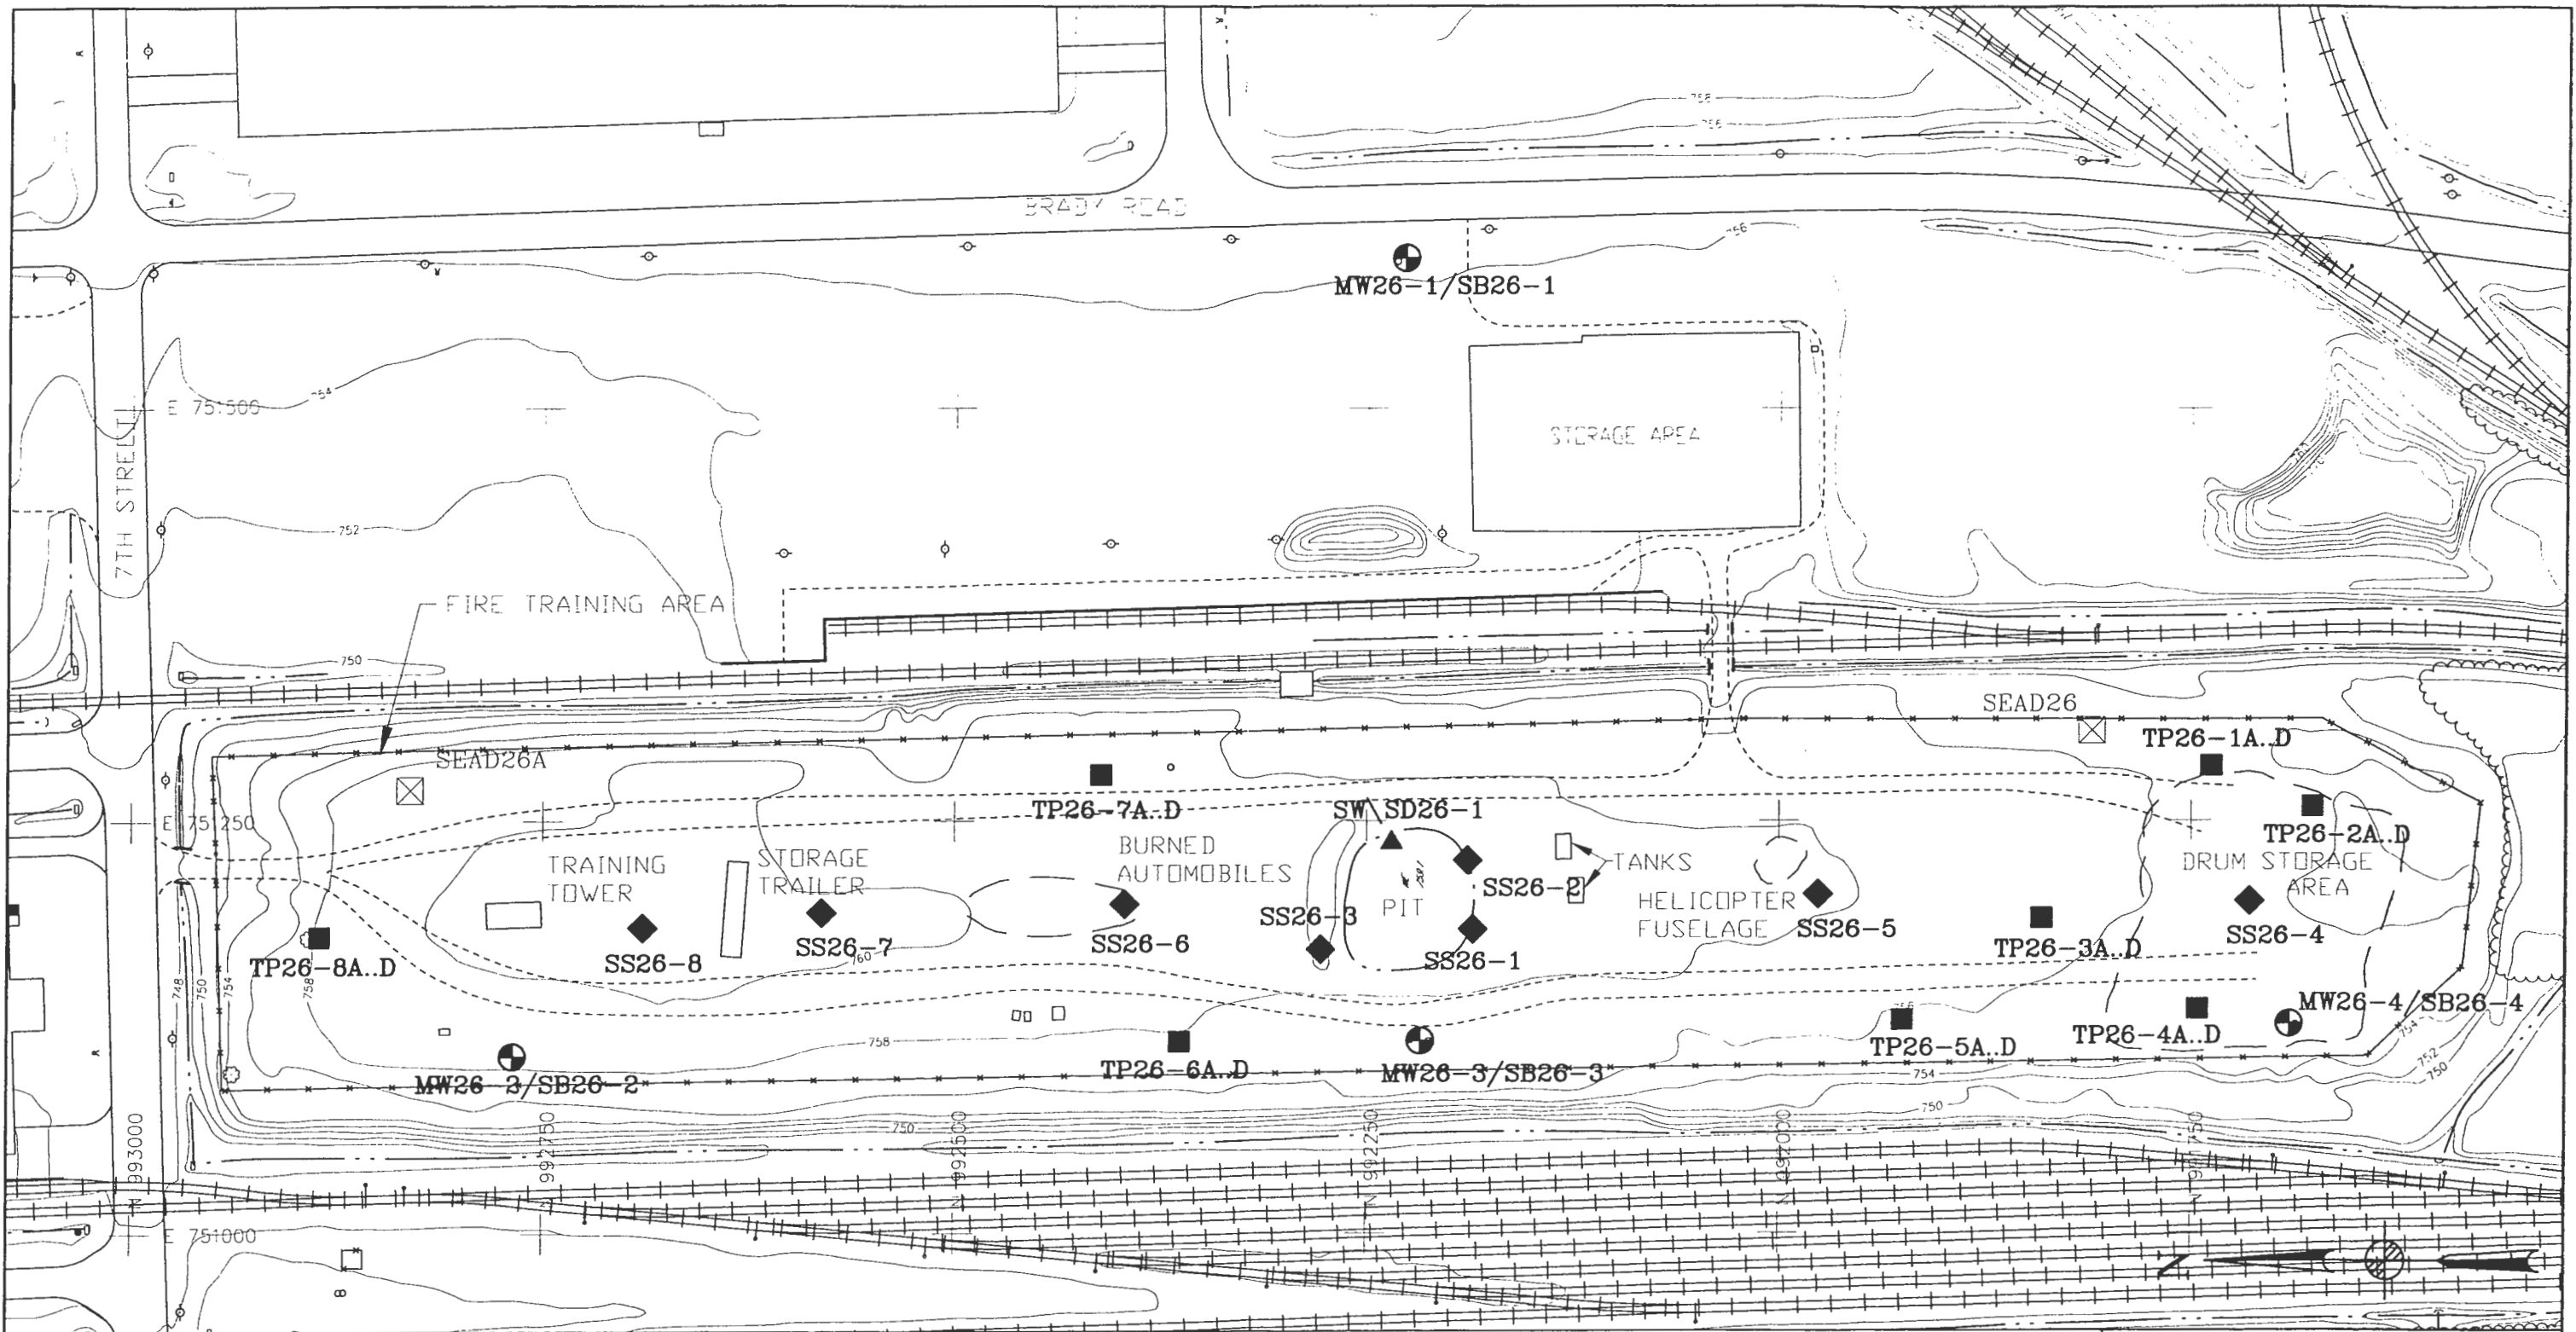
An oval unpaved road parallels the fenced boundaries within the training area. The fire training tower, storage trailer and seven burned automobiles are located in the northern portion of the site. Small oil-stained areas were noted on the ground surface near the automobiles. The circular burning pit (i.e., pond) has a diameter of approximately 75 feet and is located in the central portion of the site. The bermed perimeter of the pond is characterized by blackened soil and is void of vegetation. Approximately 30 feet south of the pond are two large cylindrical steel tanks, which are believed to be empty. Approximately 120 feet south of these tanks is the fuselage of a burned helicopter. In the far southern end of the site is a drum storage area where tens of 55-gallon drums were stacked as well as other sizes and types of drums. These drums are believed to be empty. Several 55-gallon drums were observed to be at the base of the western scarp of the site (outside the fenced portion), although these are believed to be empty.

Based on recent correspondence from SEDA, in August 1994 all of the drums in the southern area of the site, which is labelled "zone of numerous anomalies" in the draft ESI Report (Parsons ES, June 1994), were removed. In addition, 24 tanks were removed from this drum storage area after being cleaned of any petroleum residue in October 1994. These tanks were underground

Tanks were removed from various areas within SEDA and brought to SEAD-26 because they either failed a leakage test or were scheduled for removal through SEDA's tank upgrade program. The condition of the tanks probably ranged from intact to poor. The tanks were empty and unclean when they were brought to SEAD-26.

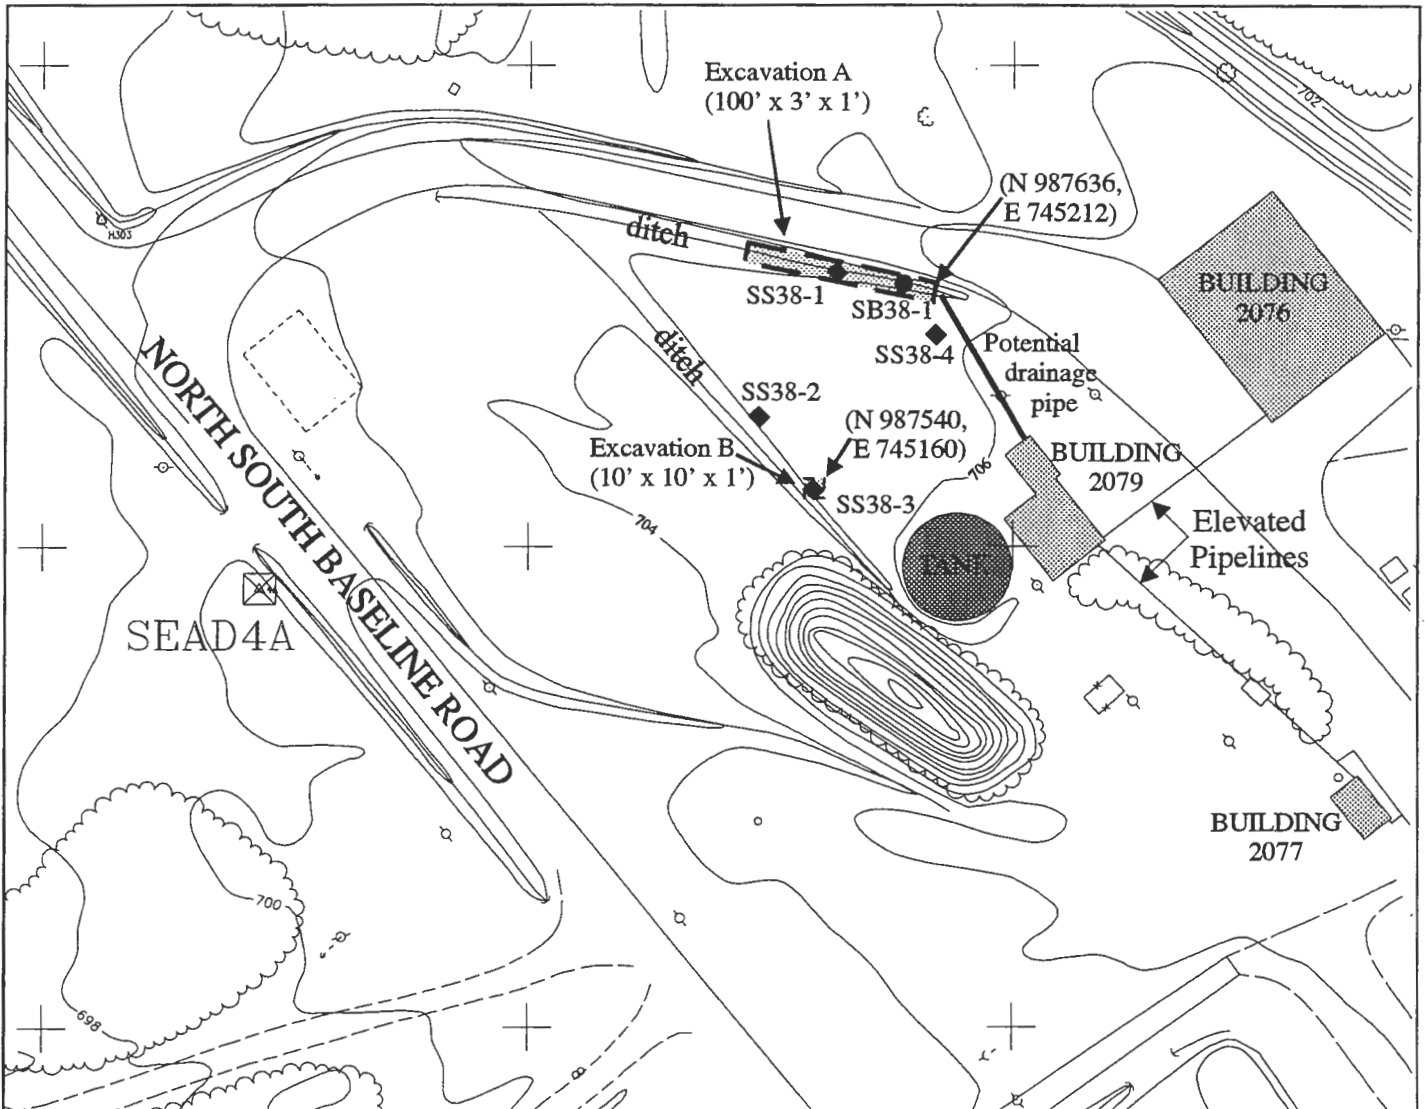
From the time the boilers were installed in the fall of 1942, until 1979 or 1980, when all blowdown points were connected to the sanitary sewer system, the boilers discharged a total of 400 to 800 gallons per day. The flow drained partly into nearby drainage ditches and partly into the ground. The boiler blowdown probably contained tannins, caustic soda (sodium hydroxide), and sodium phosphate.

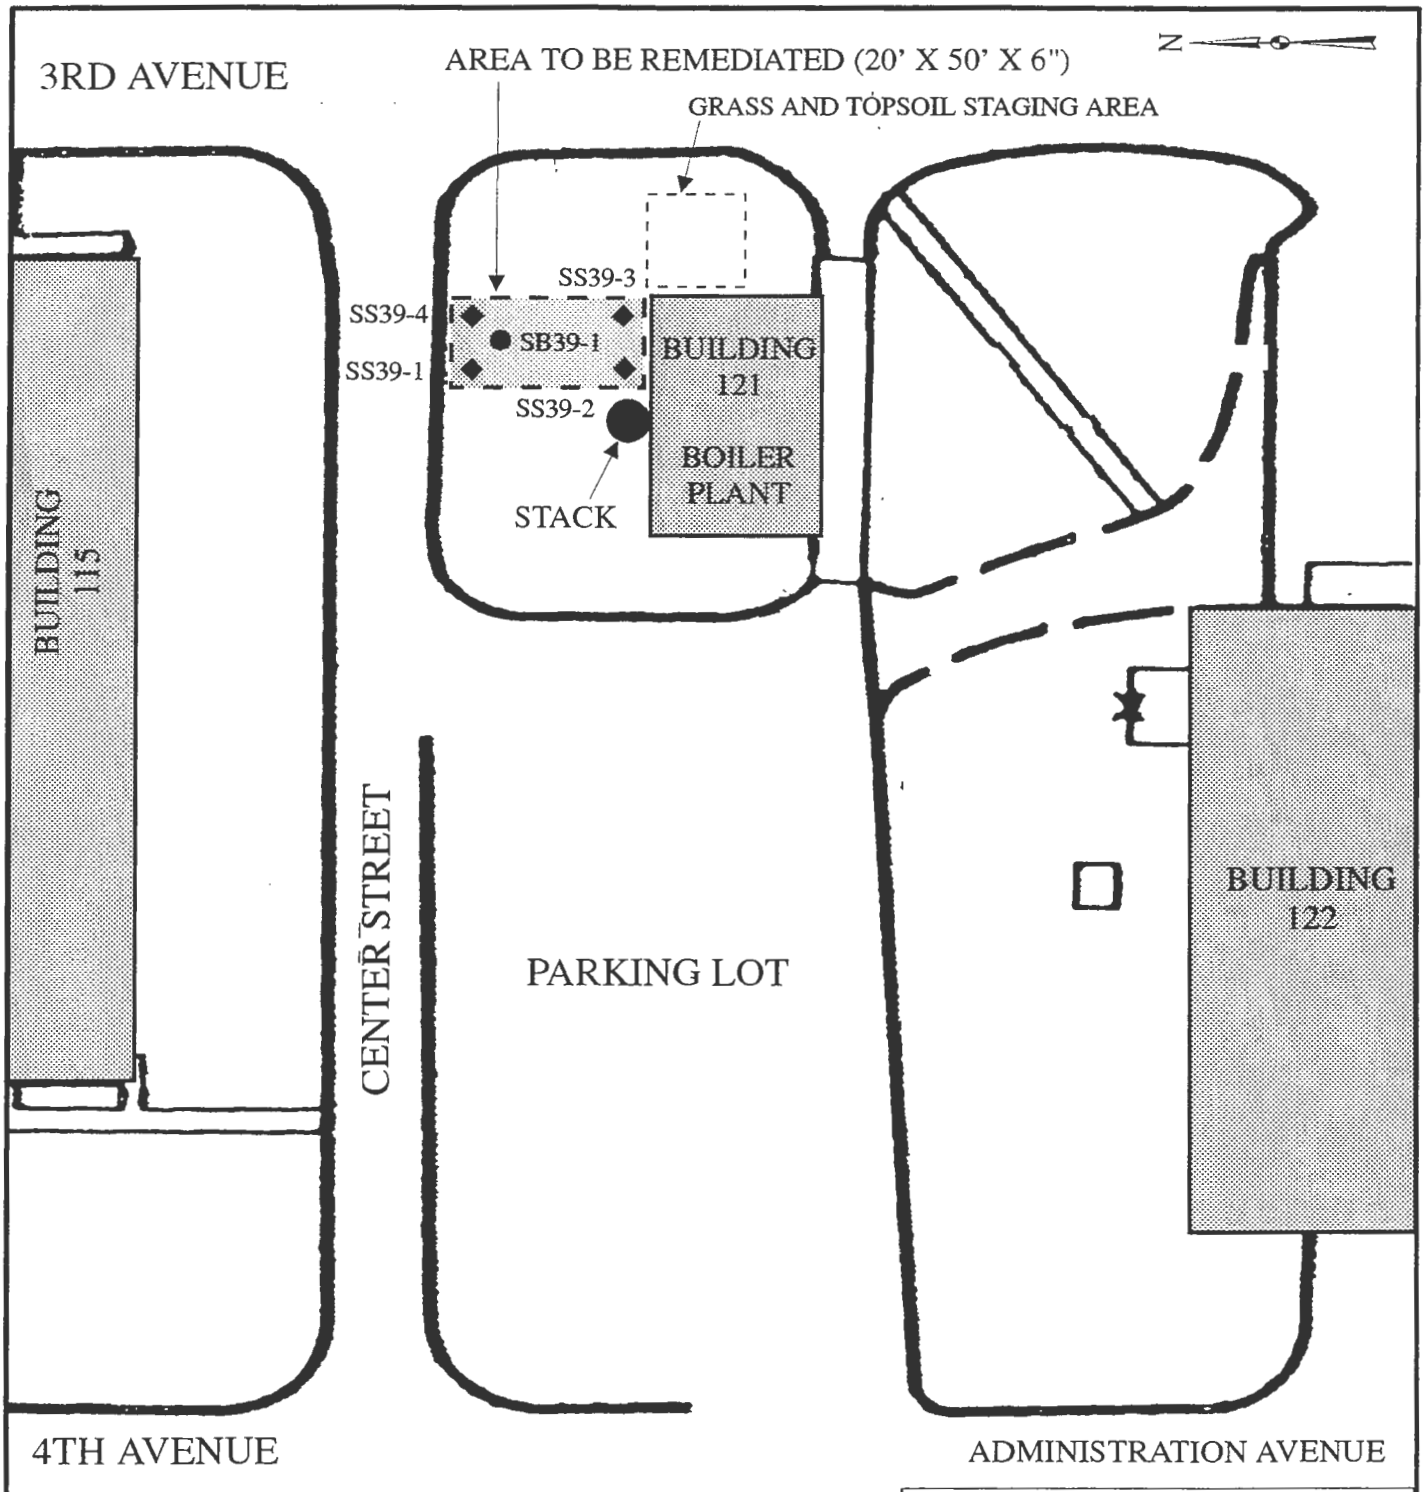
CLIENT/PROJECT TITLE
**SENECA ARMY DEPOT ACTIVITY
 DECISION DOCUMENT FOR REMOVAL ACTION
 SEAD-39**

From the time the boilers were installed in the fall of 1942, until 1979 or 1980, when all blowdown points were connected to the sanitary sewer system, the boilers discharged three times every 24 hour period for a total of 400 to 800 gallons per day. The flow drained partly into drainage systems in the street and partly into the ground. The boiler blowdown probably contained tannins, caustic soda (sodium hydroxide), and sodium phosphate.

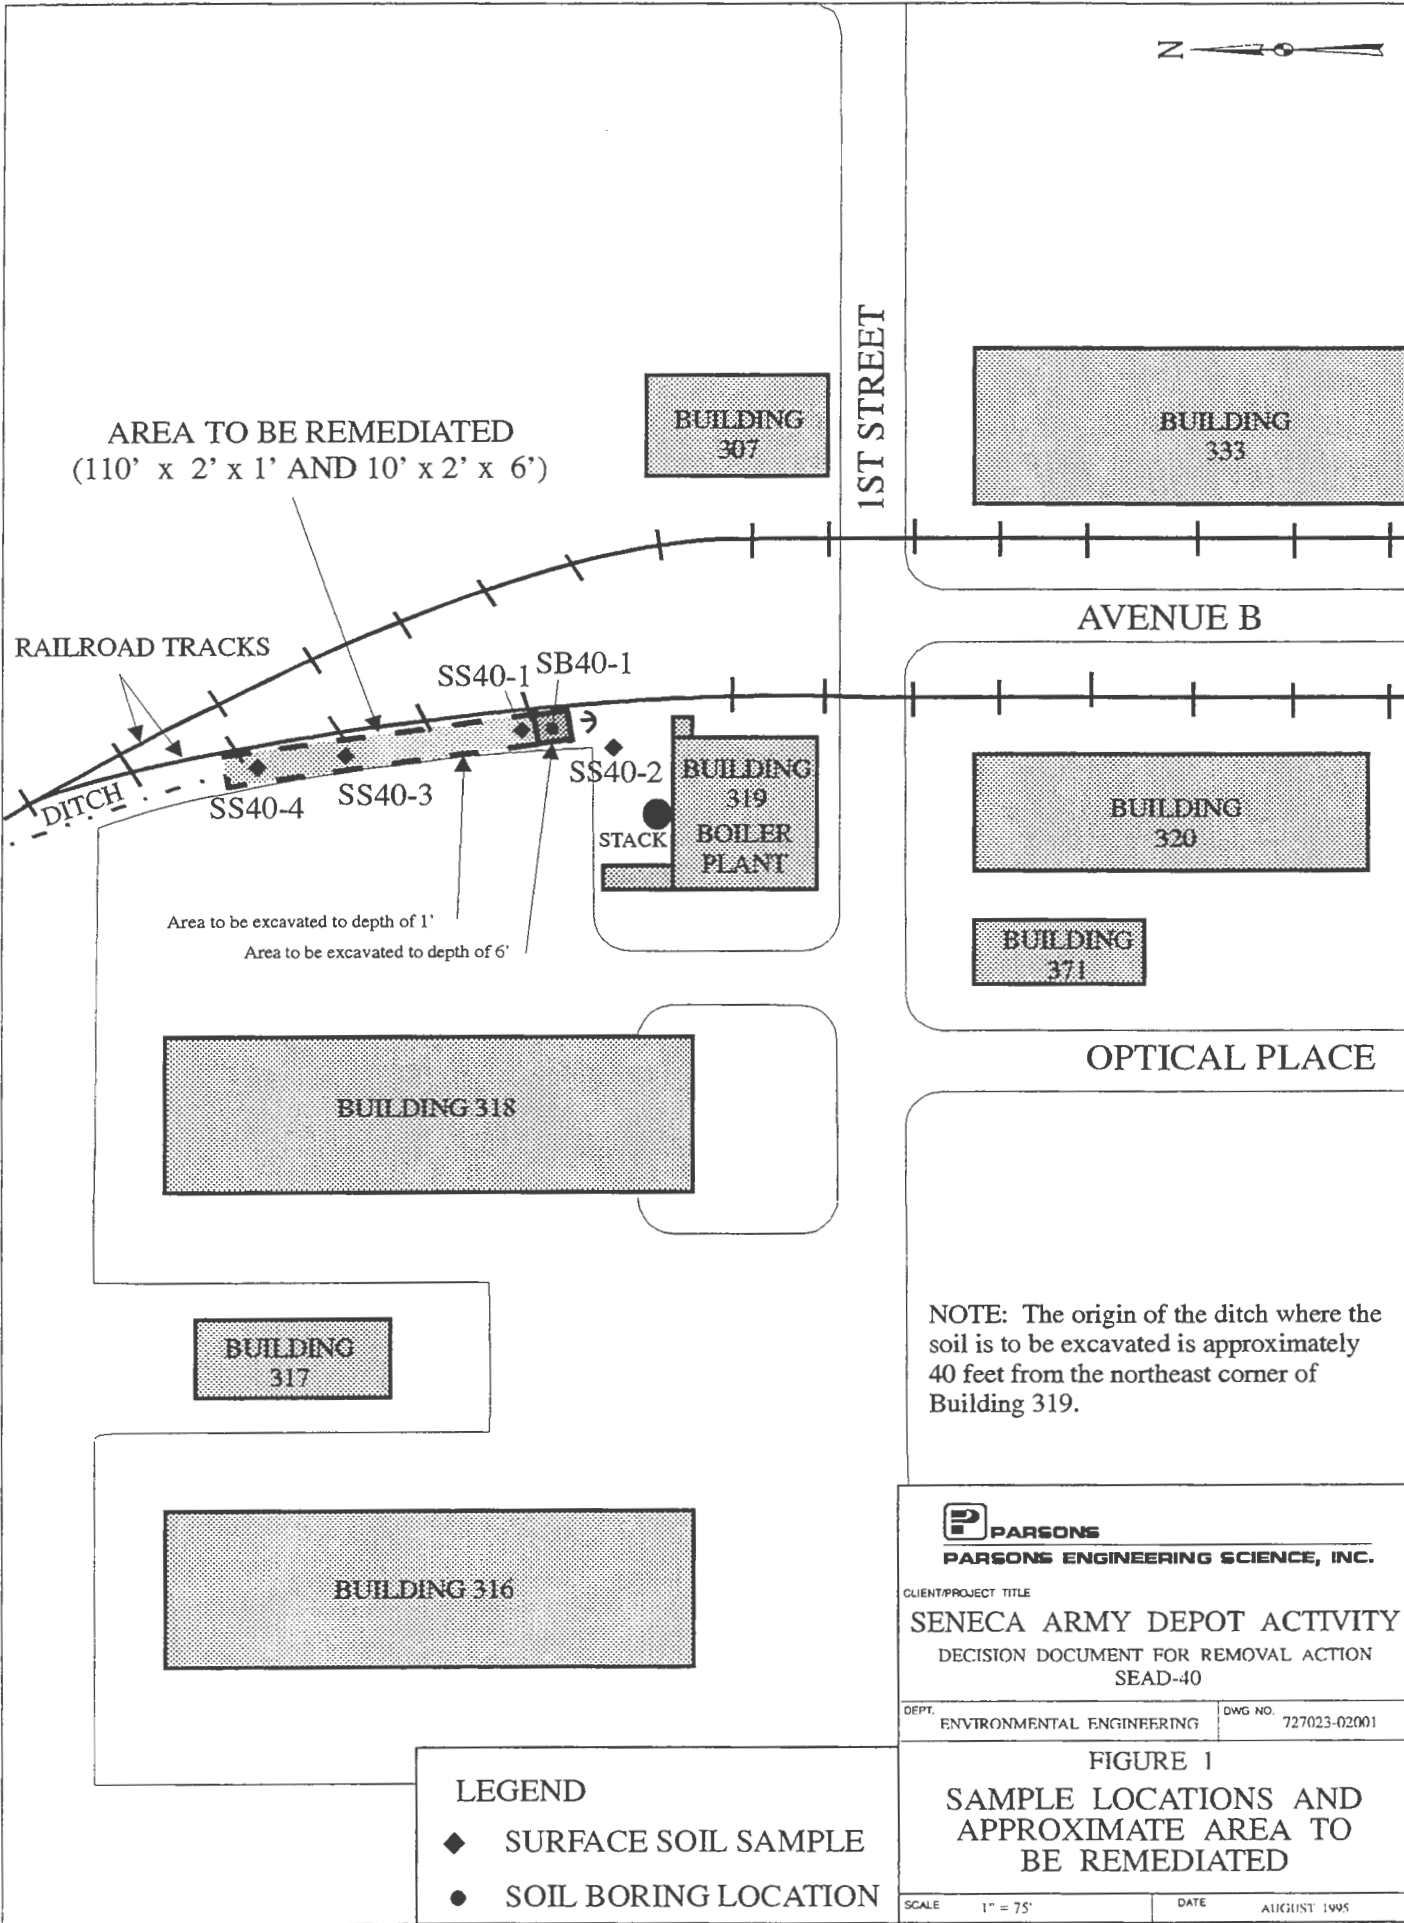
From the time the boilers were installed in the fall of 1942, until 1979 or 1980, when all blowdown points were connected to the sanitary sewer system, the boilers discharged three times every 24 hour period for a total of 400 to 800 gallons per day. The flow drained partly into drainage systems in the street and partly into the ground. The boiler blowdown probably contained tannins, caustic soda (sodium hydroxide), and sodium phosphate.

NOTE: The origin of the ditch where the soil is to be excavated is approximately 40 feet from the northeast corner of Building 319.

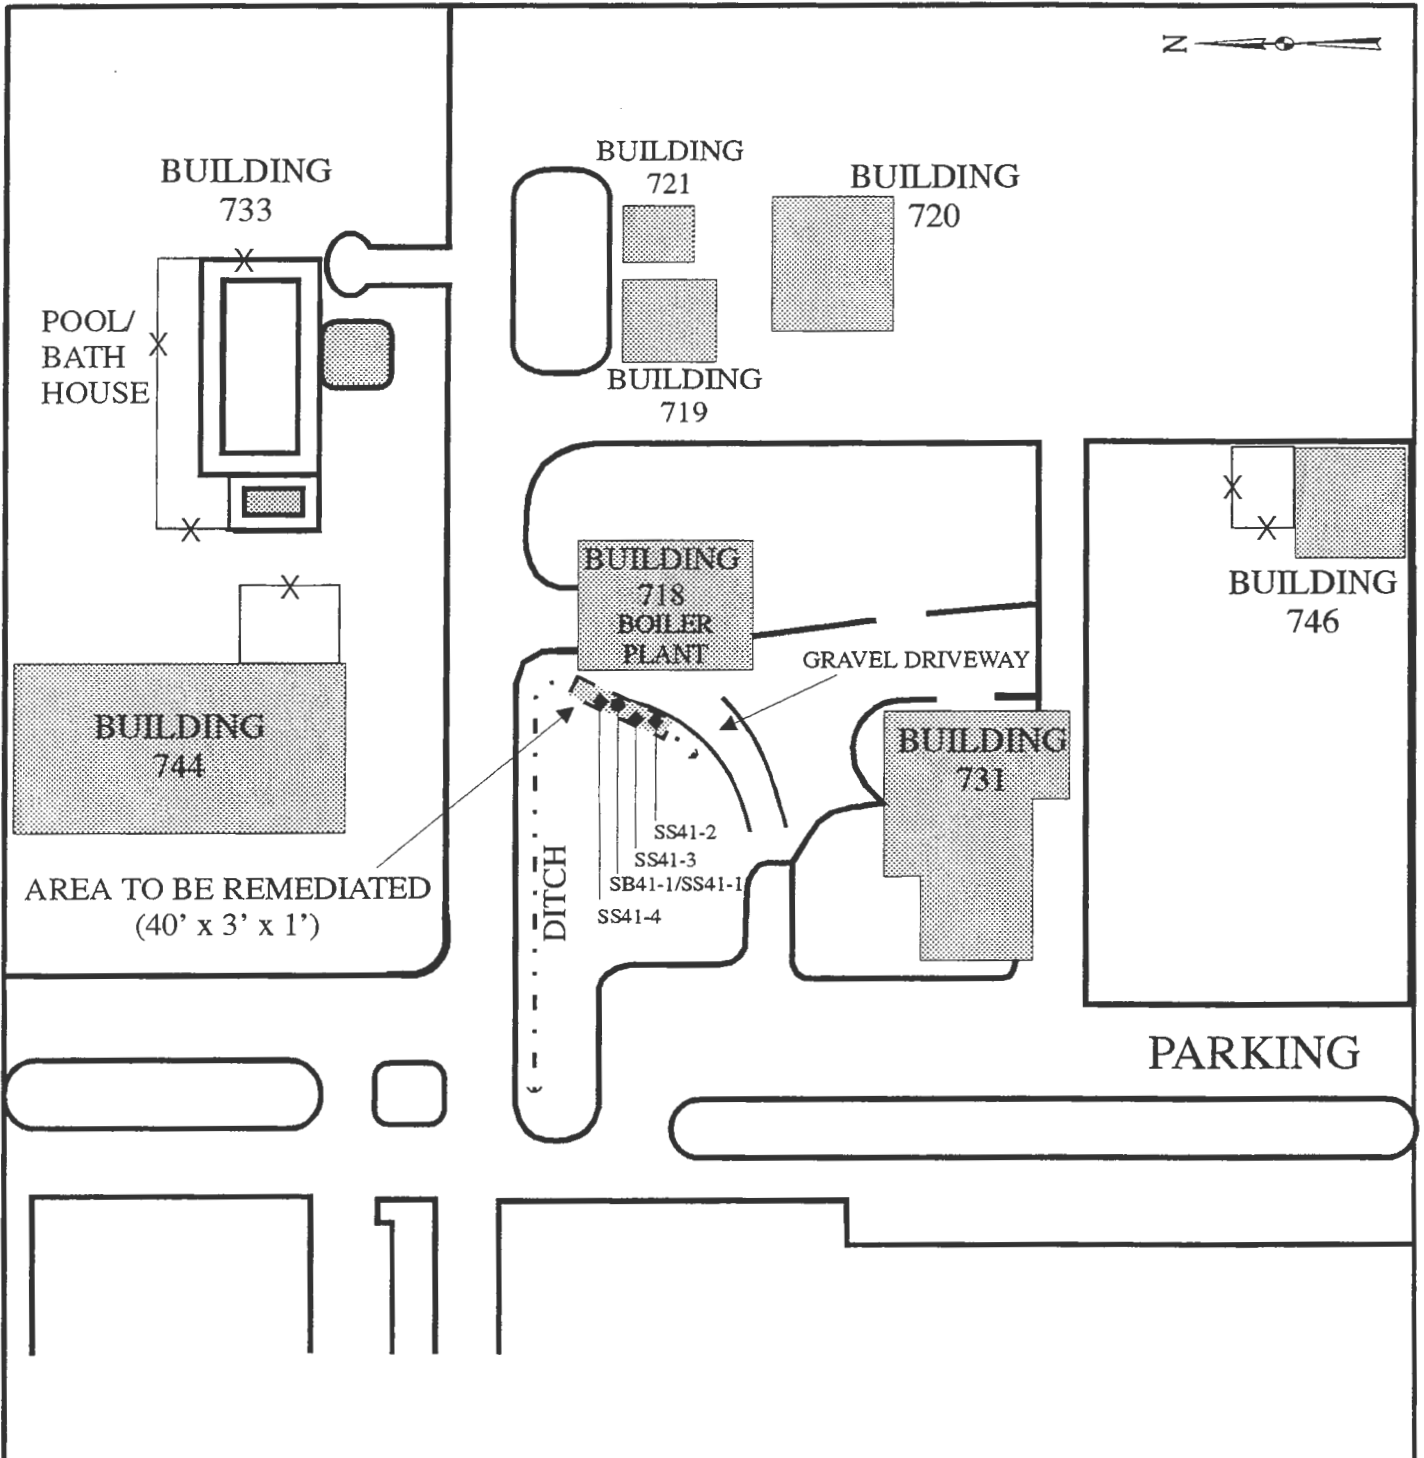
From the time the boilers were installed in the fall of 1942, until 1979 or 1980, when all blowdown points were connected to the sanitary sewer system, the boilers discharged three times every 24 hour period for a total of 400 to 800 gallons per day. The flow drained partly into drainage systems through the ditches and partly into the ground. It is unknown whether the blowdown liquid was discharged directly into the ditch to the west of Building 718, or whether it was discharged next to the building and flowed into the ditch. The boiler blowdown probably contained tannins, caustic soda (sodium hydroxide), and sodium phosphate.
