**SUBJECT: Annual Report – Year 2 for the Abandoned Deactivation Furnace (SEAD-16) and the Active Deactivation Furnace (SEAD-17) Sites at Seneca Army Depot Activity; Contract FA8903-04-D-8675, Delivery Order 0031, CDRL A001G**

## **FINAL ANNUAL REPORT - YEAR 2**

**THE ABANDONED DEACTIVATION FURNACE (SEAD-16)  
AND THE ACTIVE DEACTIVATION FURNACE (SEAD-17)  
SENECA ARMY DEPOT ACTIVITY**

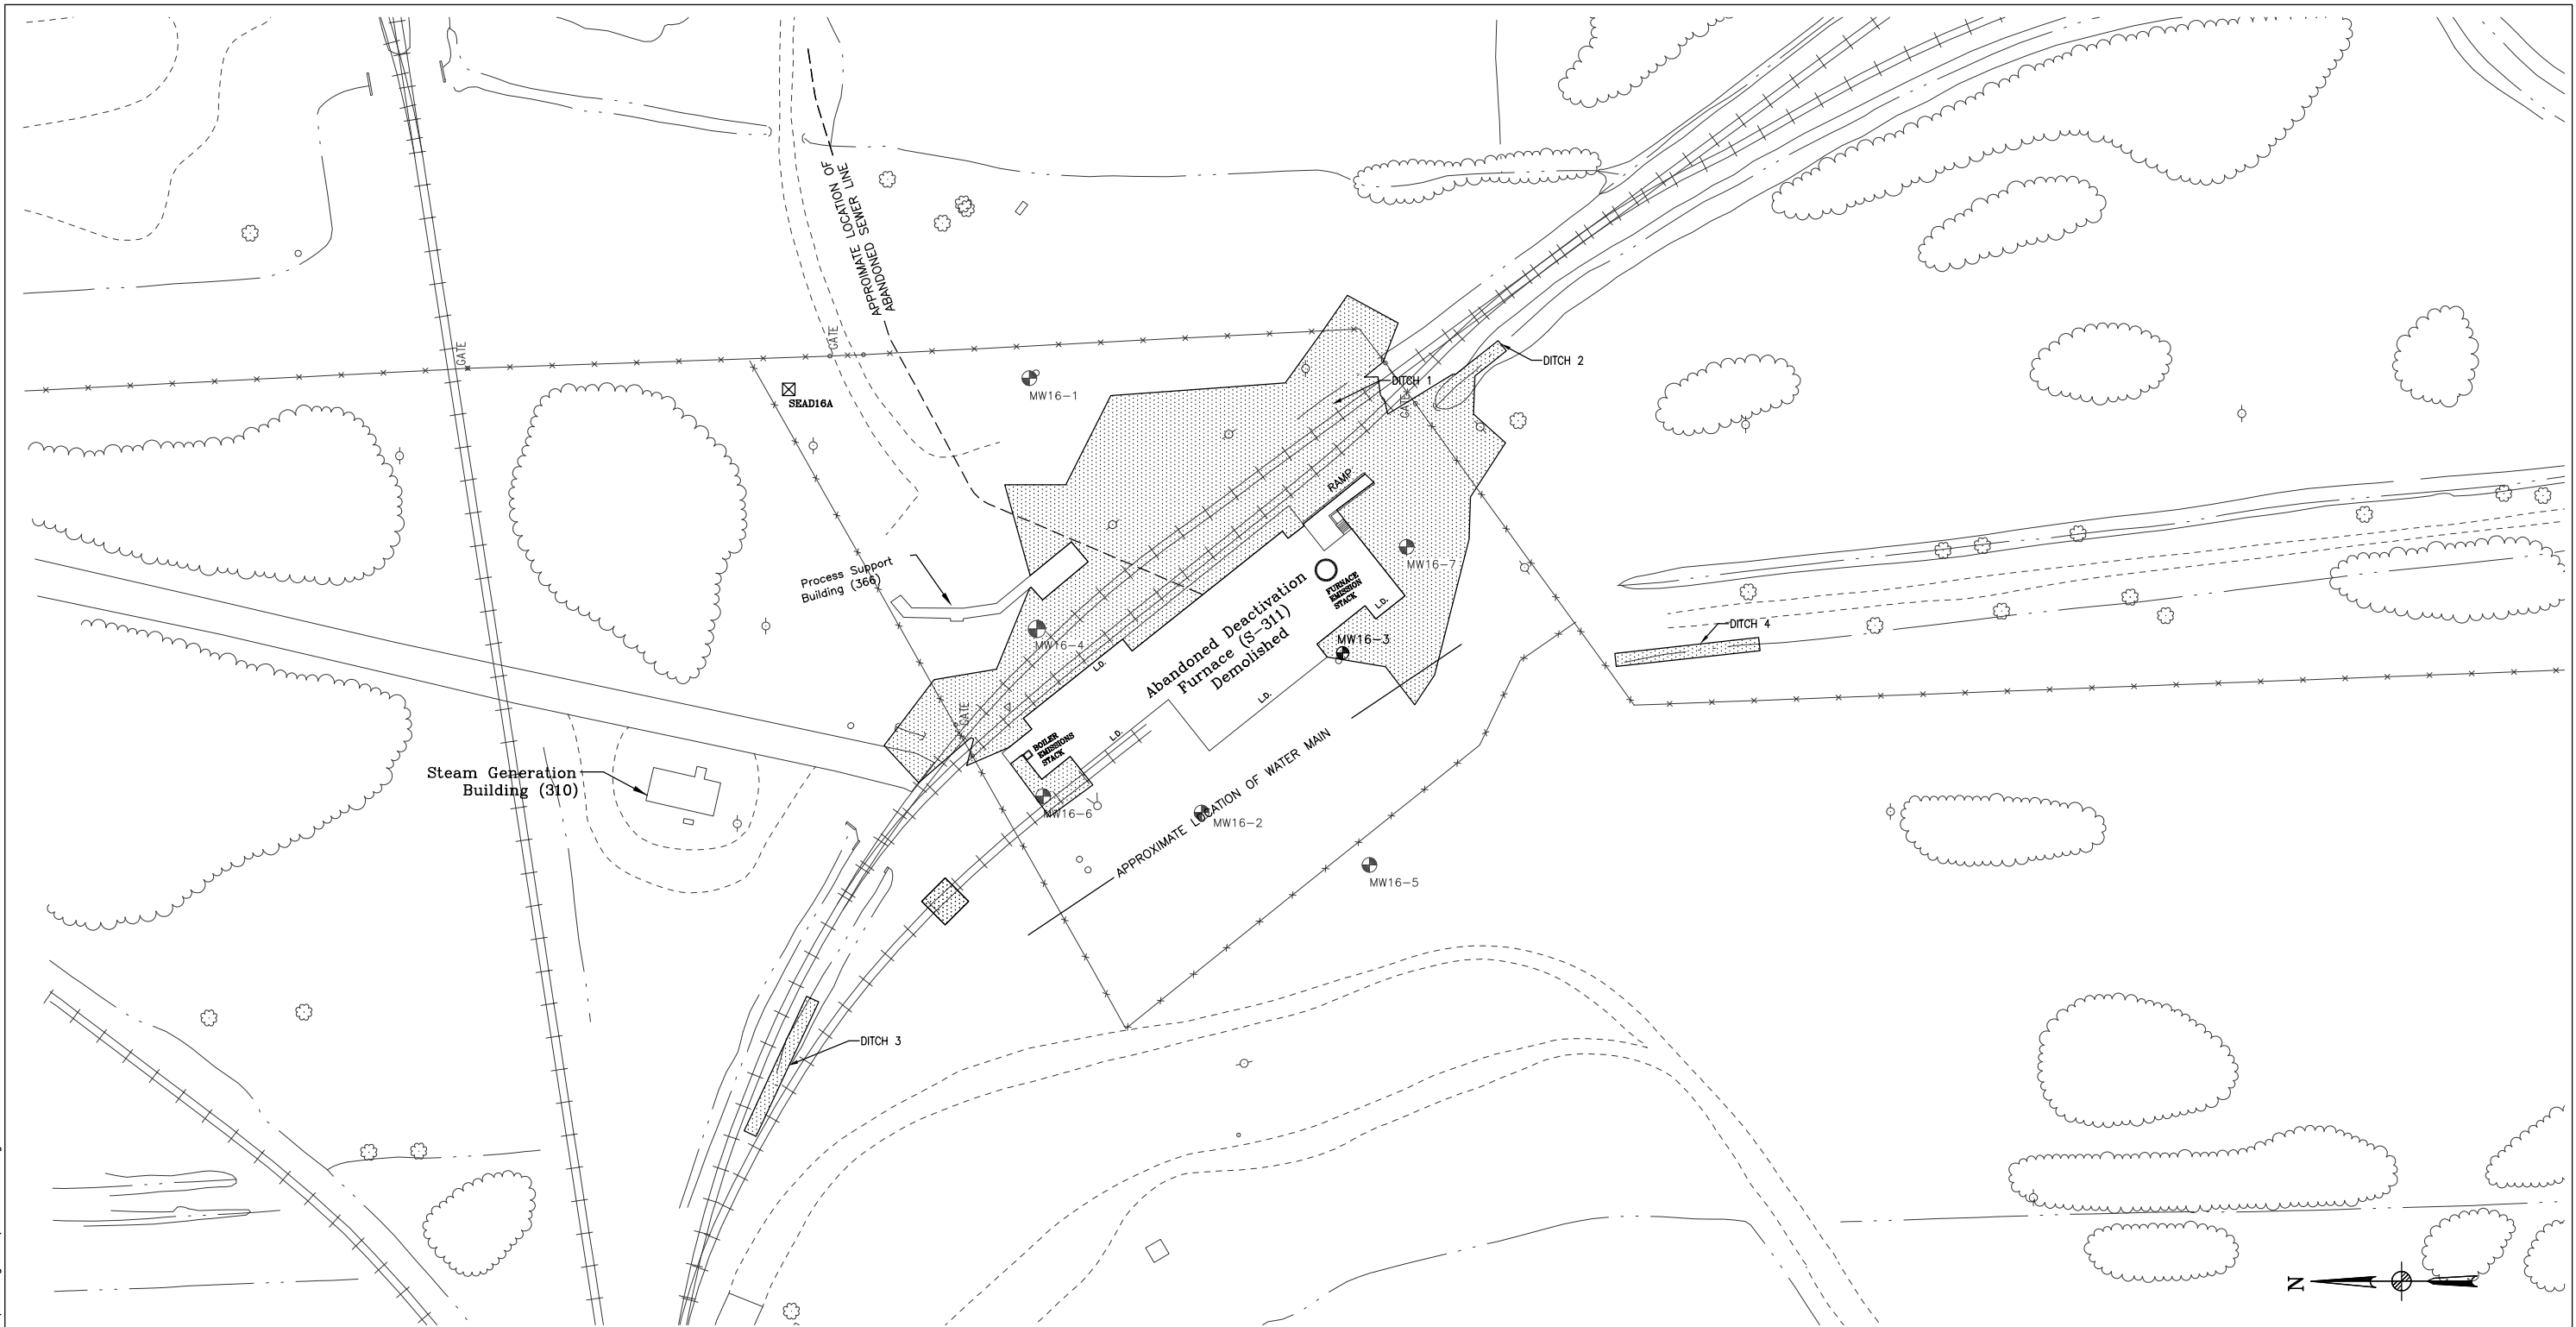
**FIGURE 3**  
**SEAD-16**  
**SITE PLAN**

Three groundwater monitoring wells (MW16-1, MW16-2, and MW16-3) were installed as part of the Expanded Site Investigation (ESI) conducted at SEAD-16 in 1993/1994. Four additional groundwater monitoring wells (MW16-4, MW16-5, MW16-6, and MW16-7) were installed during the RI. The locations of the seven groundwater monitoring wells installed at SEAD-16 are shown on **Figure 3**.

The excavation of the impacted soil at SEAD-16 and SEAD-17 began on July 9, 2007 and was completed on August 2, 2007 with 1,862 cy of impacted soil removed from SEAD-16 and 2,565 cy of impacted soil removed from SEAD-17. The limit of the excavations for SEAD-16 is shown on **Figure 3** and for SEAD-17 on **Figure 4**.

**Comment 3:** According to Section 3.2, Year 2 Groundwater Sampling, monitoring well MW16-3 was destroyed during the remedial action and was not sampled. No comment on the significance of the exclusion of this well has been provided in the Annual Report, and it is unclear whether a data gap now exists in the monitoring well network at SEAD-16. Provide a discussion in the Annual Report which addresses this issue. In addition, provide the former location of well MW16-3 on Figure 3, SEAD-16 Site Plan.

**Response 3:** Figure 3 was revised to include the location of former monitoring well MW16-3. Destruction of monitoring well MW16-3 does not present a data gap since there are monitoring wells located down gradient from the location of the former well.

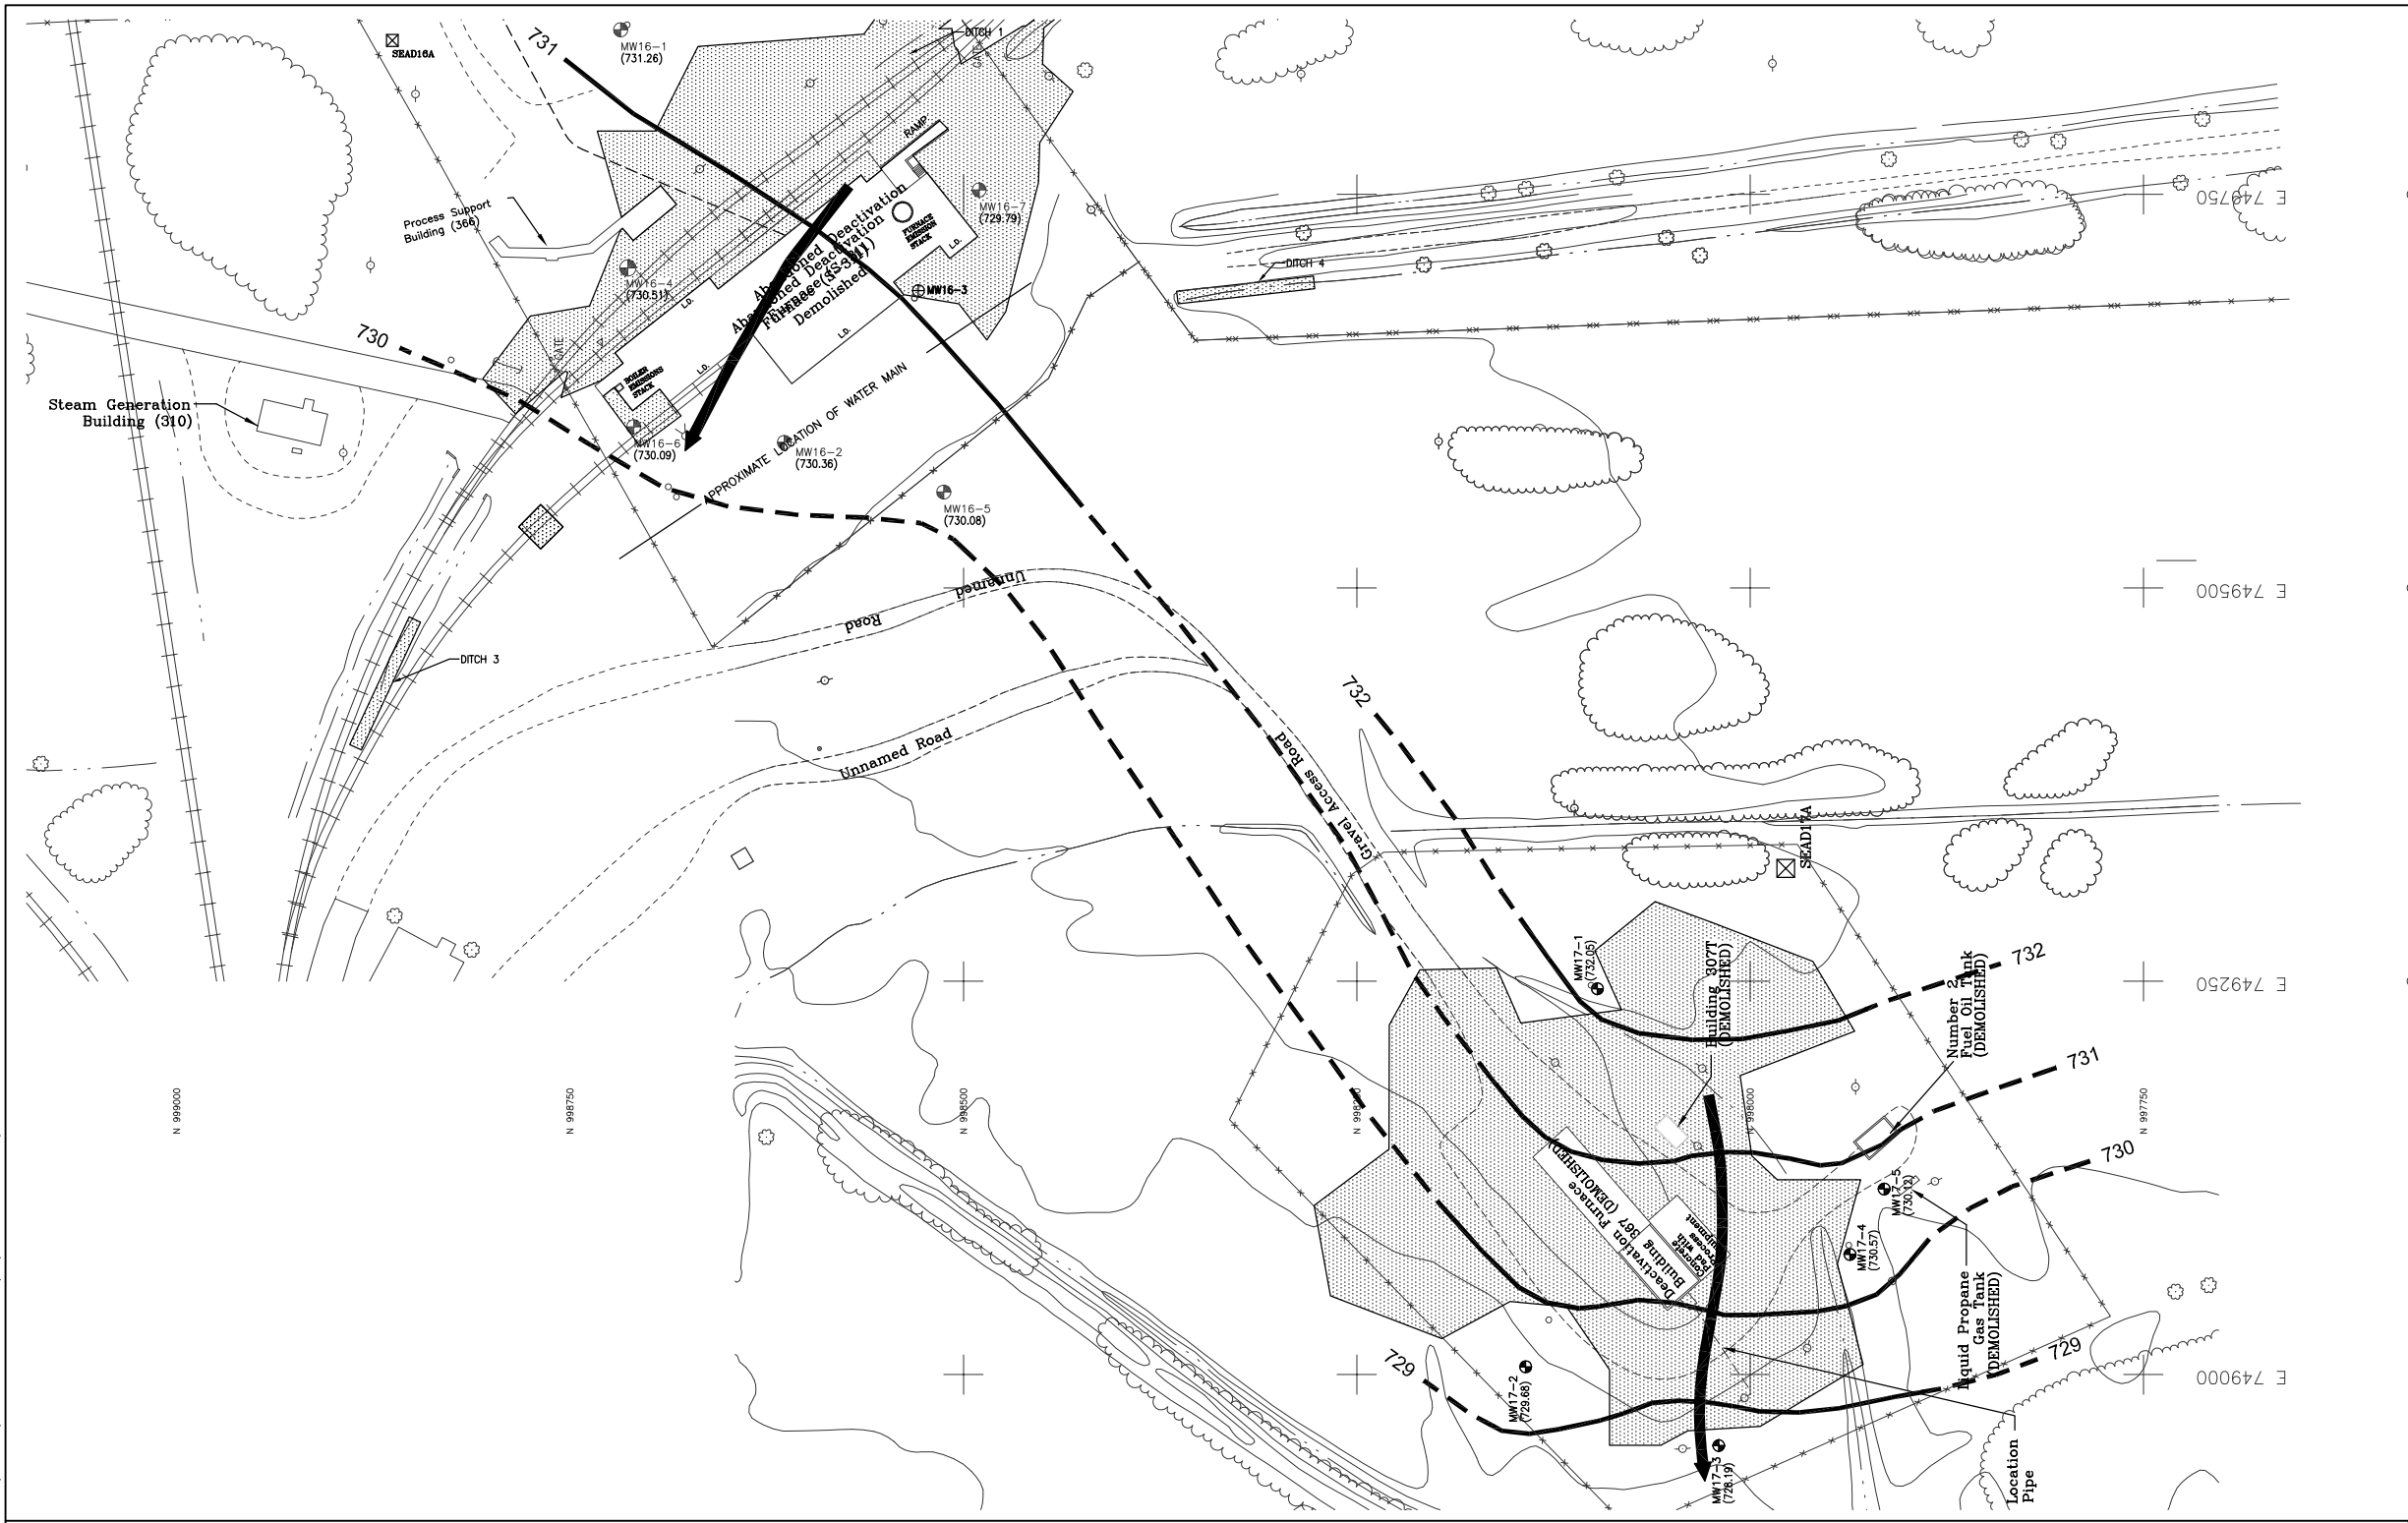
**FIGURE 5  
SEAD-16 AND 17  
GROUNDWATER FLOW TREND**

table. Based on the most recent elevation data (December 2008), groundwater appears to flow in a westerly direction at SEAD-16 as shown on **Figure 5**.

SEAD-17 groundwater elevation data were recorded on December 9, 2008 for Year 2 and are presented on **Table 2**. Groundwater elevation data also collected during the pre-remedial action (April 4, 1994, August 1996, December 1996) and Year 1 post remedial action events are also shown on the table. Based on the most recent elevation data (December 2008), groundwater appears to flow in a southwesterly direction at SEAD-17 as shown on **Figure 5**.
