**Munitions Washout Facility
(SEAD-4)
Building 2079 Boiler Blowdown Pit
(SEAD-38)**

Seneca Army Depot Activity (SEDA)

**Public Presentation
December 12, 2007**

CLIENT/PROJECT TITLE
**SENECA ARMY DEPOT ACTIVITY
 PROPOSED PLAN FOR
 SEAD-4 AND SEAD-38**

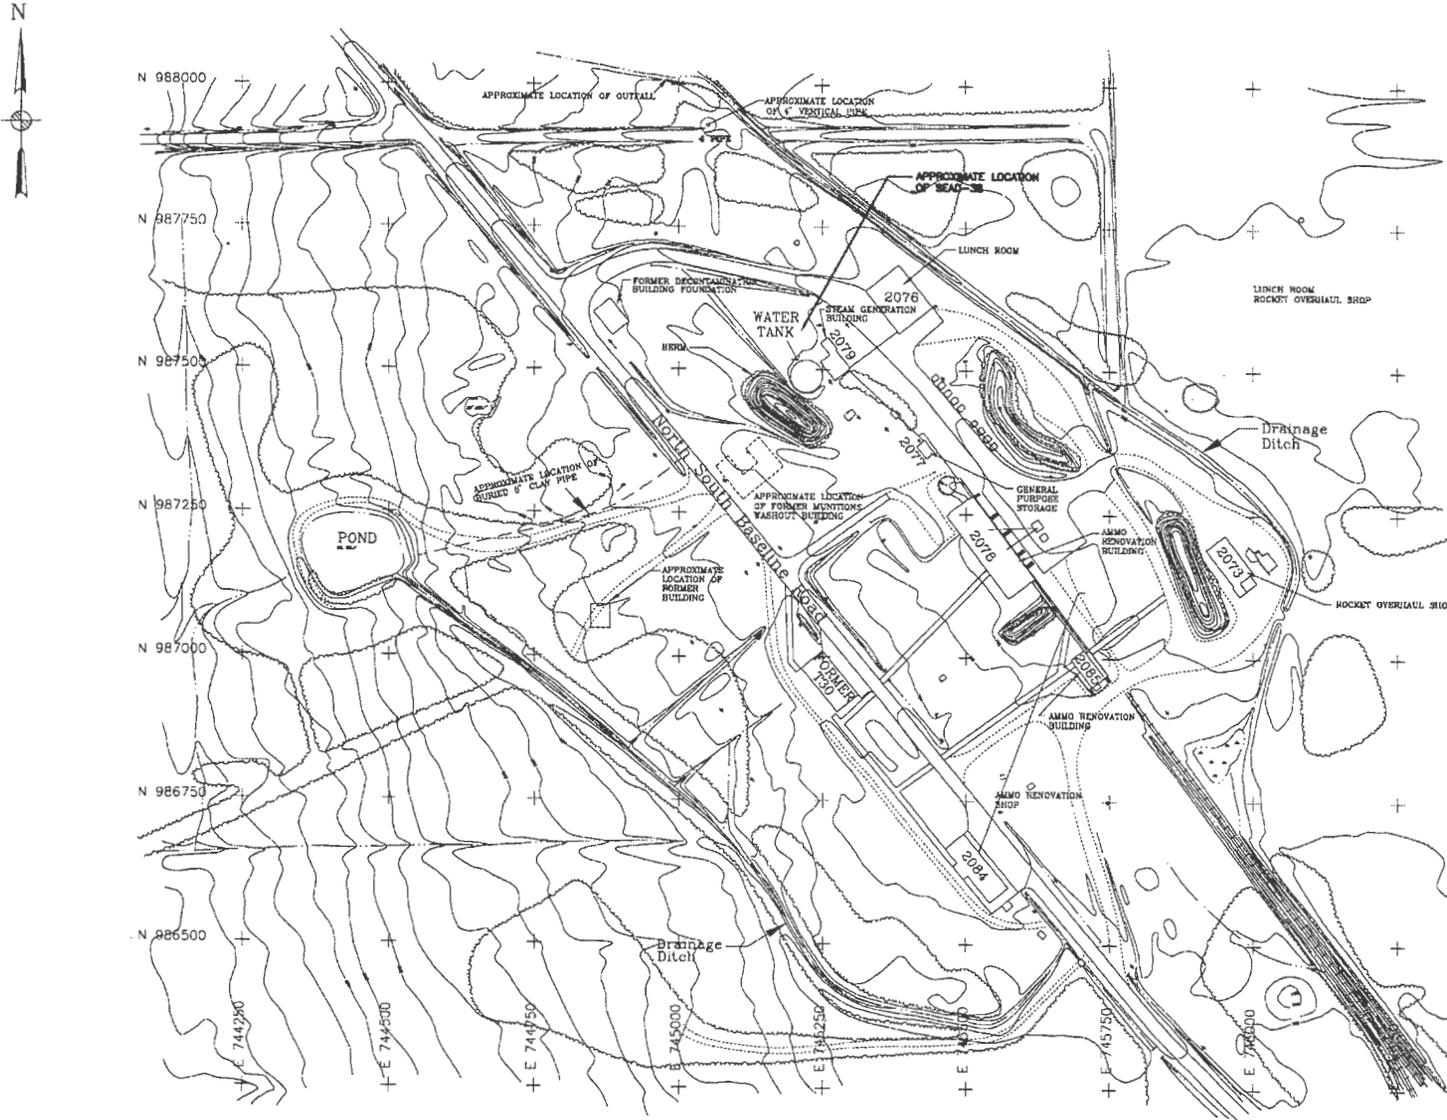
Figure 2 - SEAD-4/38 Site Map

FIGURE 2
 SEAD-4 MUNITIONS WASHOUT FACILITY & SEAD-38
 THE BLDG. 2079 BOILER BLOWDOWN PIT
 LOCATION MAP

- The Building 2079 Boiler Blowdown Pit (SEAD-38) is located within SEAD-4 footprint to the north-northwest of Building 2079, a vacant boiler plant.
- 400 to 800 gallons of blowdown solution was reportedly discharged per day during operation.
- Boiler blowdown reportedly contained water, tannins, caustic soda (sodium hydroxide), and sodium phosphate.
