PROPOSED PLAN

TWENTY NO ACTION SWMUs (SEADs 7, 9, 10, 18, 19, 20, 21, 22, 33, 35, 36, 37, 42, 47, 49, 51, 53, 55, 65, and 68) AND EIGHT NO FURTHER ACTION SWMUs (SEADs 28, 29, 30, 31, 32, 34, 60, and 61)

SENECA ARMY DEPOT ACTIVITY (SEDA)

JULY 2003

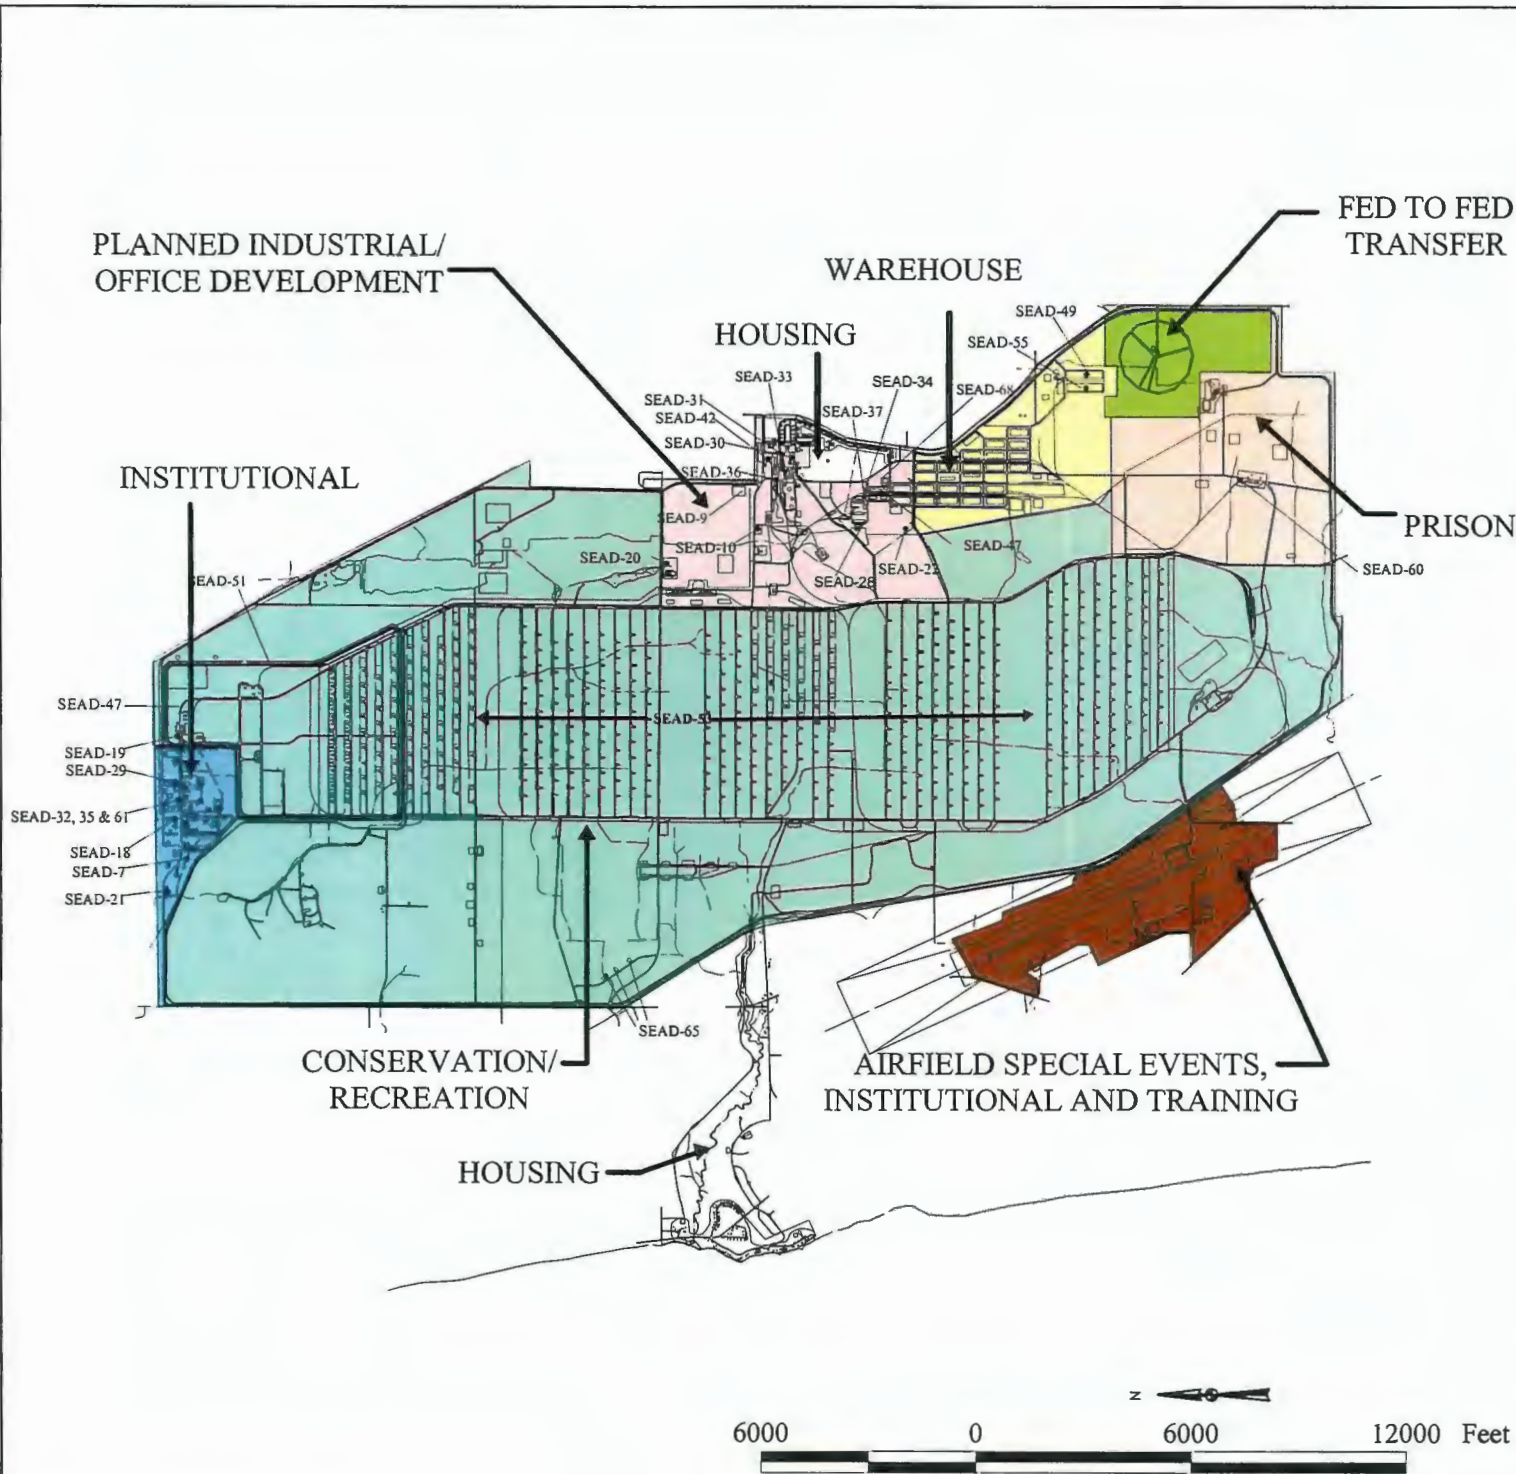
Figure 1
Future Land Use

- Airfield
- Conservation
- Federal
- Industrial
- Institutional
- Prison
- Warehouse
- Housing

SEAD-35 consisted of three oil-fired boilers that are located in Building 718, each of which is designed to burn either fuel oil or waste oil/fuel oil mixtures. Building 718 is located in the north-central portion of the Depot in an area where the land use is designated as institutional. Building 718, and its contents, was included in the property that was transferred by the U.S. Government to the SCIDA on February 14, 2000. The approximate location of SEAD-35 is shown on **Figure 1**, and in greater detail on **Figure 2**.
