SUBJECT: Final Annual Report and Year Two Review – Ash Landfill Operable Unit at Seneca Army Depot Activity; W912DY-08-D-0003, Delivery Order 0001

FINAL
ANNUAL REPORT AND YEAR TWO REVIEW
FOR THE ASH LANDFILL OPERABLE UNIT
SENECA ARMY DEPOT ACTIVITY

Contract No. W912DY-08-D-0003
Task Order No. 0001
EPA Site ID# NY0213820830
NY Site ID# 8-50-006

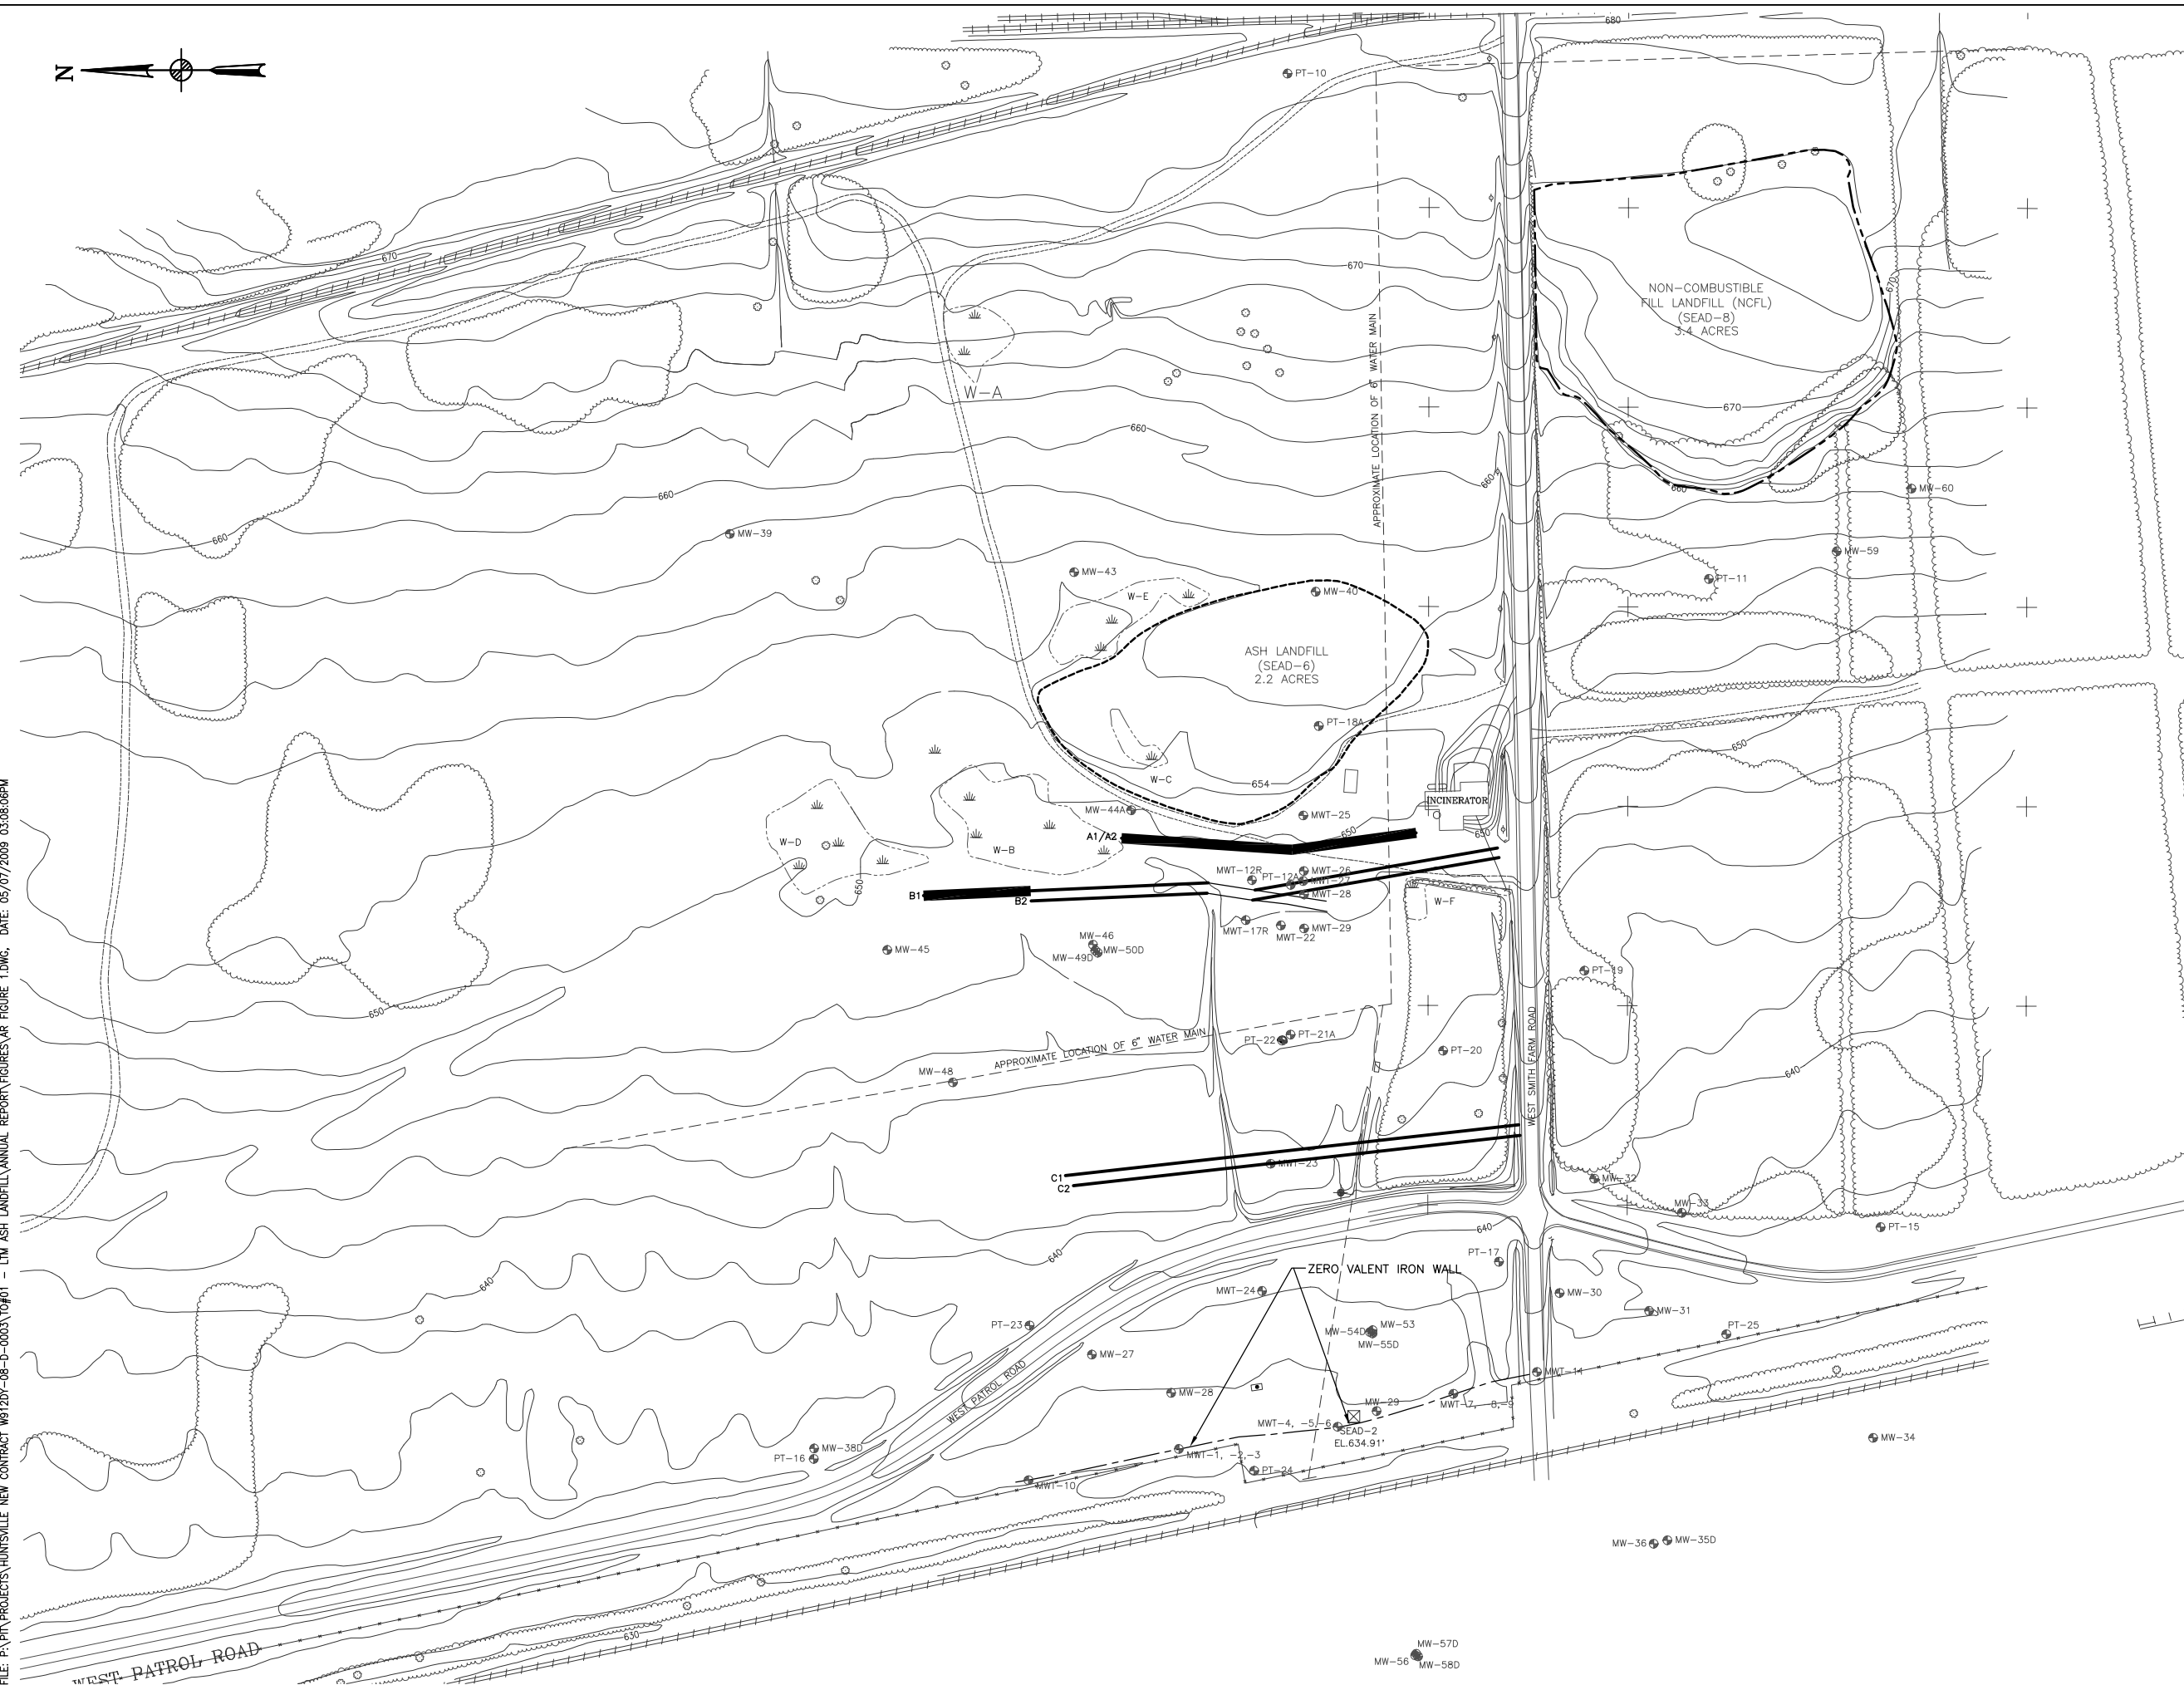
CLIENT/PROJECT TITLE	
SENECA ARMY DEPOT ASH LANDFILL ANNUAL REPORT	
DEPT. ENVIRONMENTAL ENGINEERING	Dwg. No. 744538-01400
FIGURE 1 ASH LANDFILL SITE PLAN	
SCALE 1" = 200'	DATE MAY 2009
	REV -

Biowalls A1/A2, B1/B2, and C1/C2 (**Figure 1**) were constructed perpendicular to the chlorinated solvent plume at the locations prescribed in the RDR. The entire length of Biowalls A1/A2 and the northern portion of B1/B2 were combined into a single double-width trench (minimum of 6 feet in width) due to unstable soil conditions, which caused trench widening. All trenches were excavated to competent bedrock. Approximately 2,840 linear feet (lf) of biowalls were constructed in the areas downgradient of the Ash Landfill at depths ranging from 7 feet below ground surface (bgs) to 18.5 feet bgs.

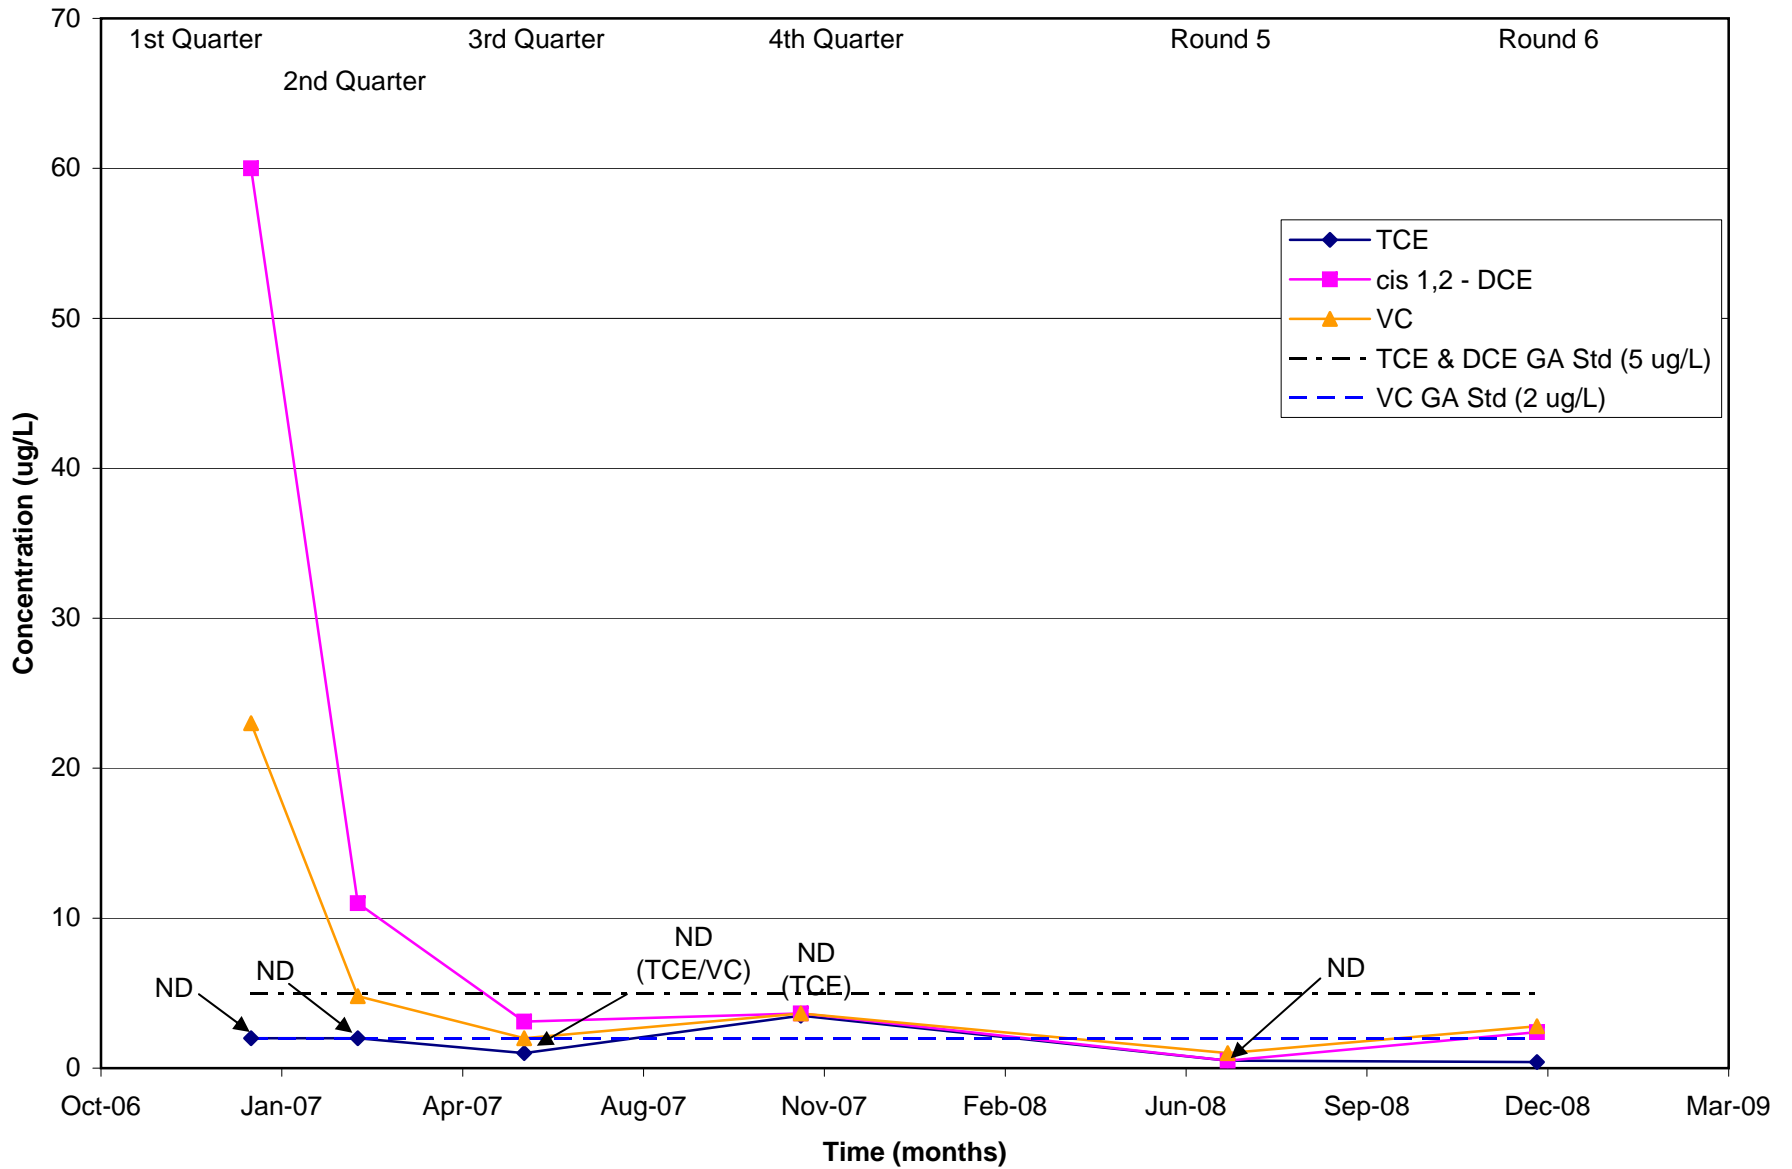
Figure 7G
 Concentrations of Chlorinated Organics Over Time at MWT-23
 Ash Landfill Annual Report, Year 2
 Seneca Army Depot Activity

Note:
 Round 4 data is the average of the sample and its duplicate.
 ND = not detected.
