FINAL SWMU CLASSIFICATION REPORT SENECA ARMY DEPOT ACTIVITY

**SOLID WASTE MANAGEMENT
CLASSIFICATION STUDY
SENECA ARMY DEPOT
ROMULUS, NEW YORK**

**Seneca Army Depot Activity
Romulus, New York**

**Engineering-Science, Inc.
Prudential Center
Boston, Massachusetts**

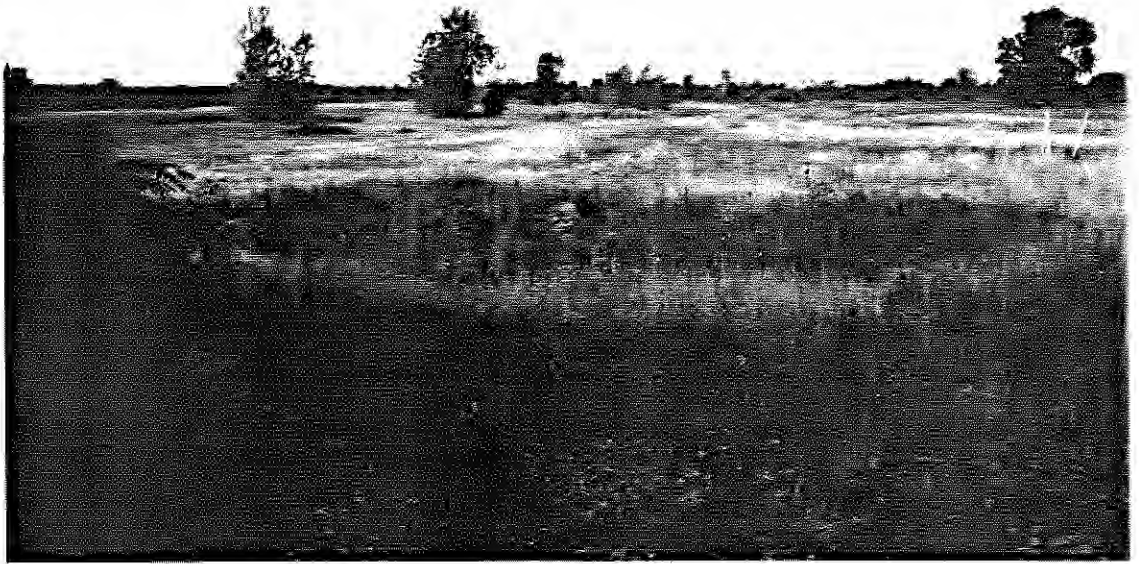
This SWMU is classified as a High Priority Area of Concern. The SWMU is part of the Ash Landfill Operable Unit and is being investigated under the CERCLA RI/FS process.

Photo 7: SEAD-3, 3/10/90. View of the Incinerator Cooling Water Pond, facing north.

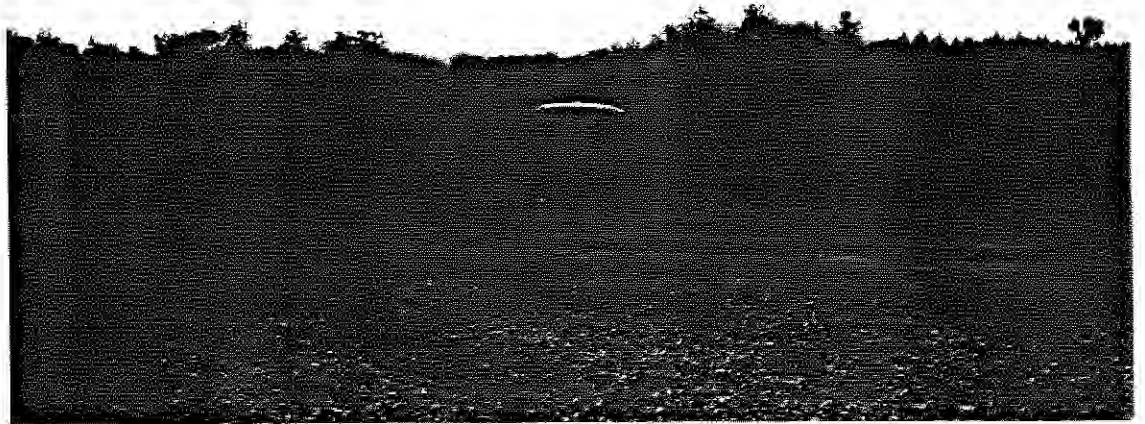
Photo 14: SEAD-5, 9/13/90. View of the Sewage Sludge Waste Piles, facing southeast.

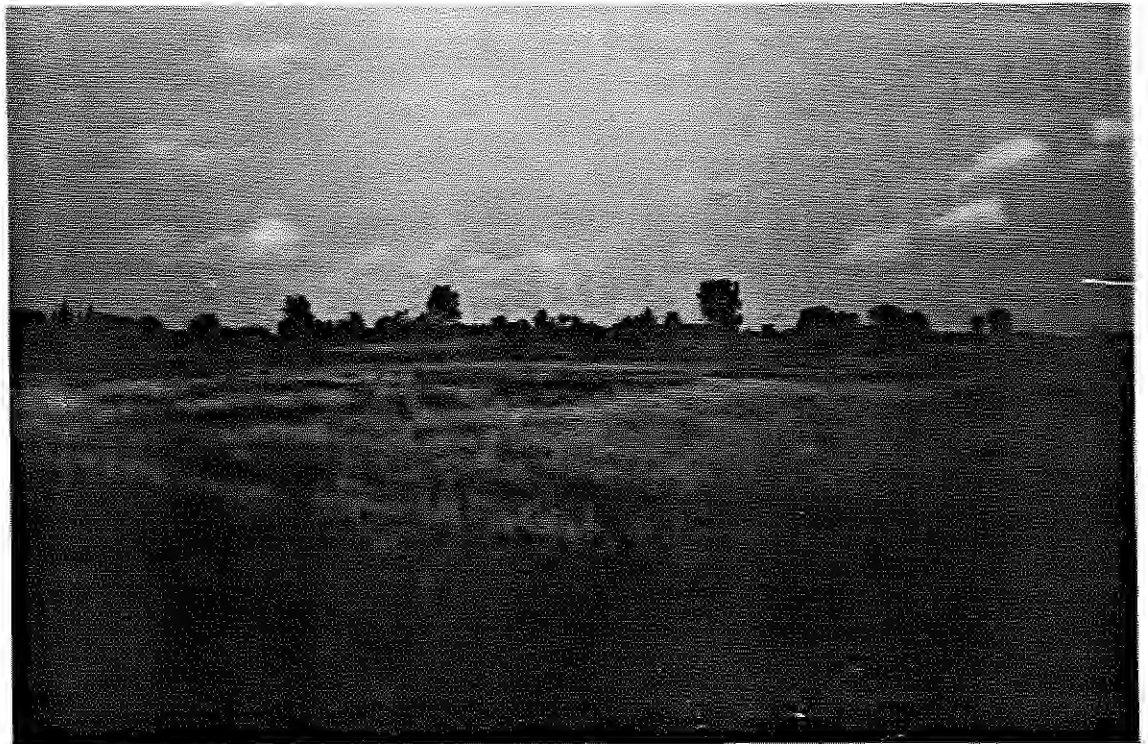
Photo 18: SEAD-6, 9/10/90. View of the Abandoned Ash Landfill, facing northeast.

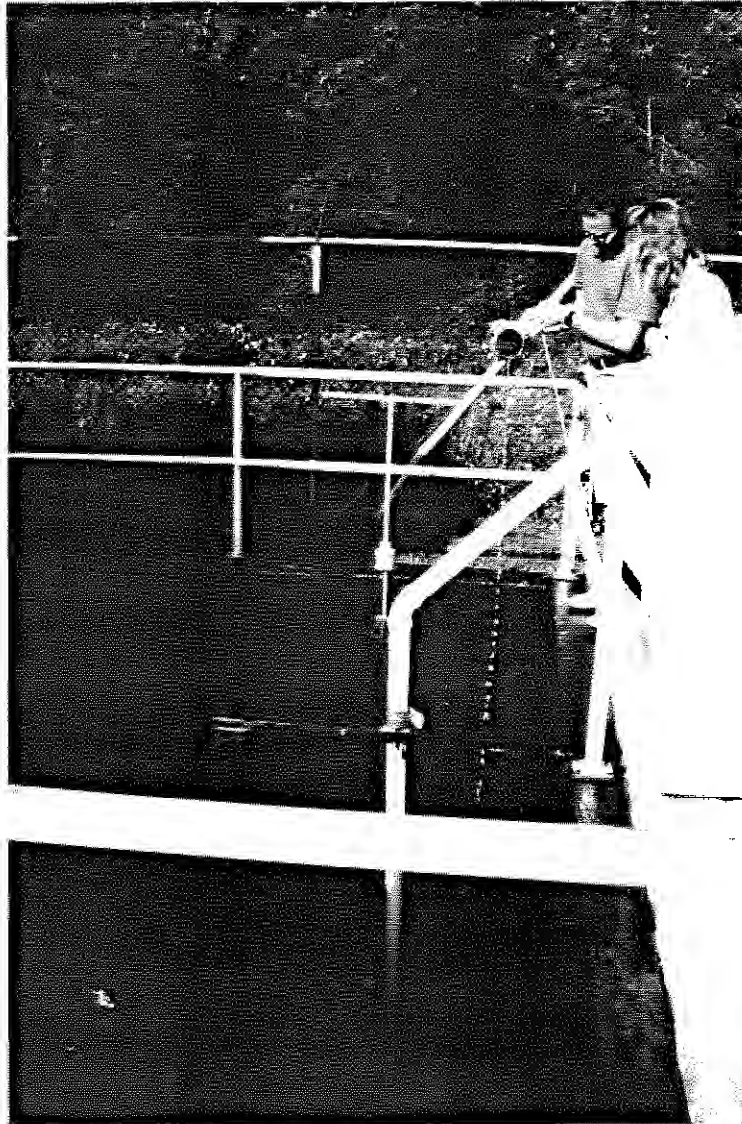
Photo 61: SEAD-21, 9/13/90 View of the effluent from Sewage Treatment Plant No 715, facing west.

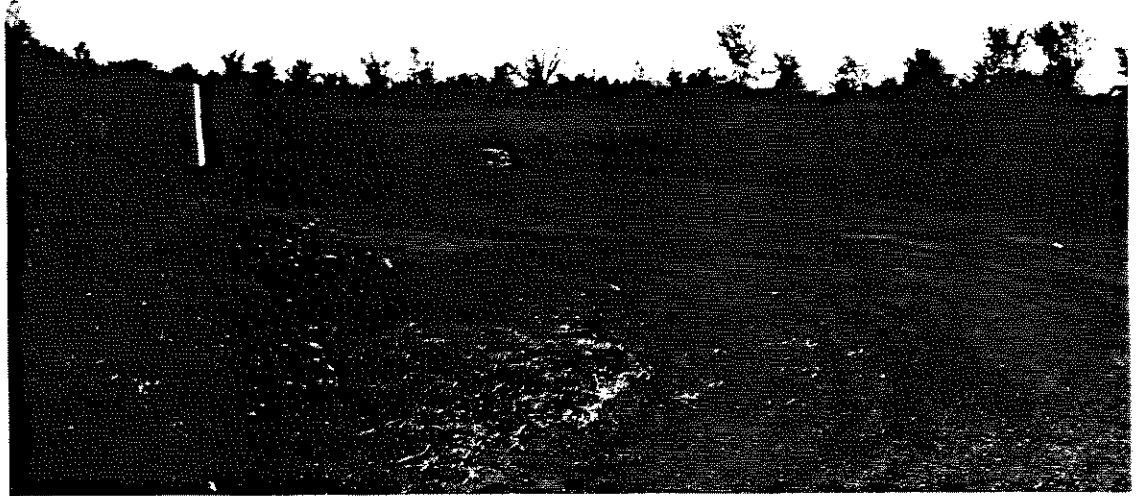
Photo 115: SEAD-46, 9/13/90. View of the Small Arms Range Area, facing east.

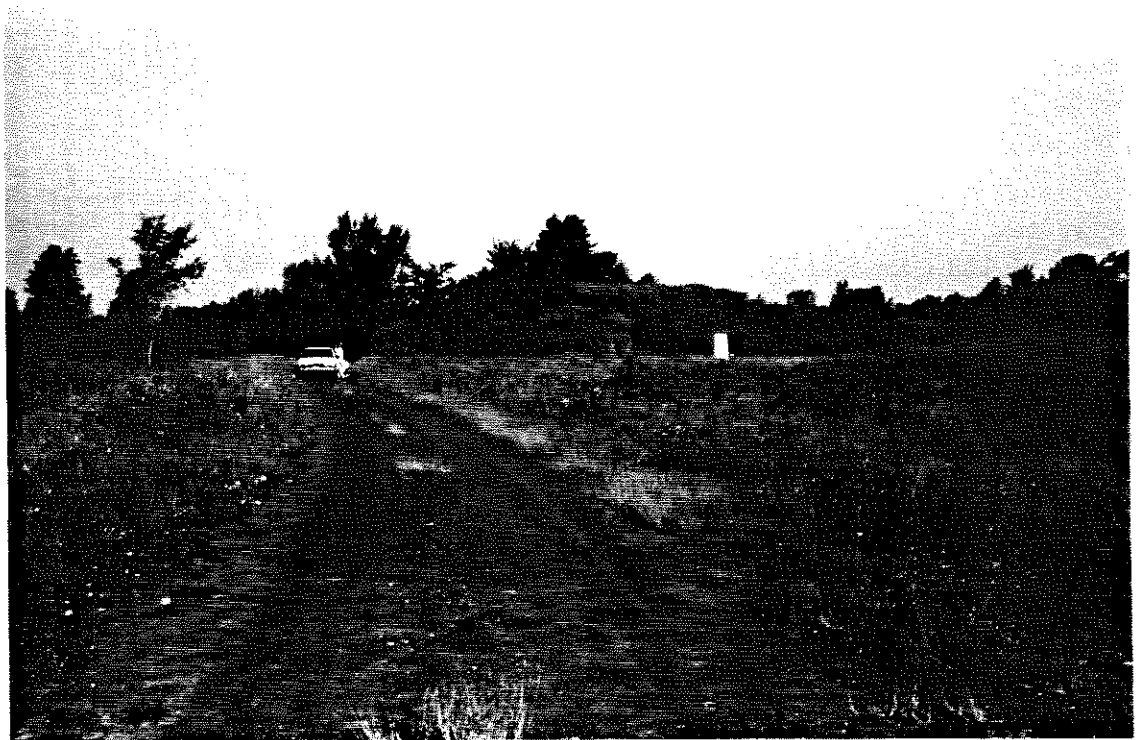
The range was used for testing fire tracers. An unknown number of rockets (3.5-inch) were fired into an earthen barricade at one end of the range. Possibly the hill shown in Photo 116 was used as a backdrop during target practice.

Photo 116: SEAD-46, 9/13/90. View of the Small Arms Range Area, facing north.

Soil samples should be collected from the face of the hill shown in Photo 116. Since explosive compounds may exist in the soils, all sampling should be supervised by UXO personnel.

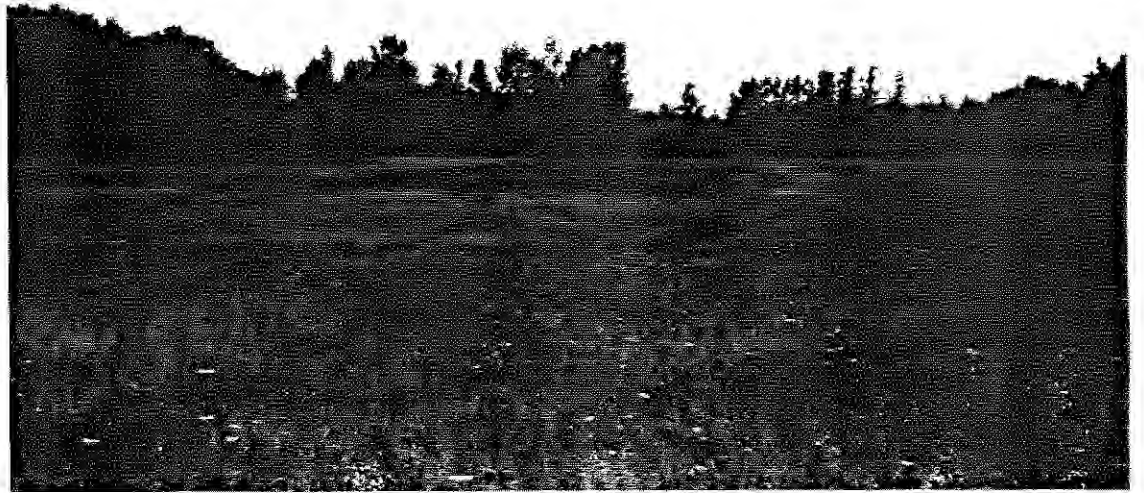
Photo 143: SEAD-57, 9/12/90. View of the Explosive Ordnance Disposal Area, facing south.

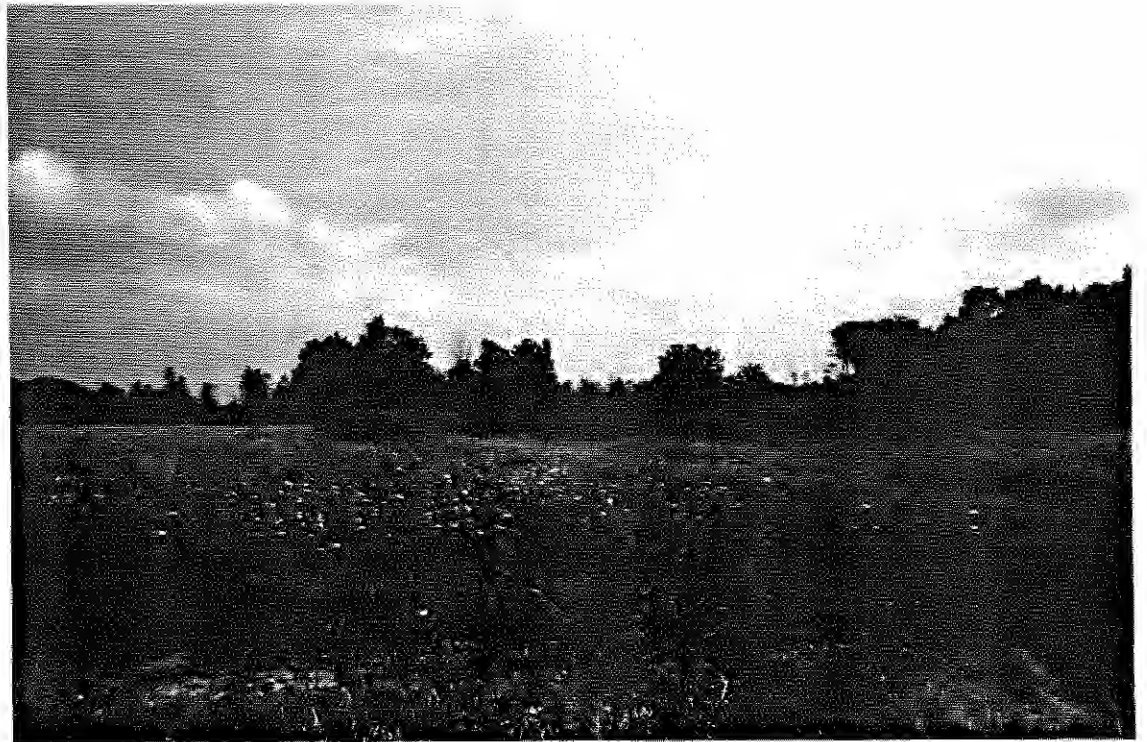
Photo 144: SEAD-57, 9/12/90. Close-up of the Explosive Ordnance Disposal Area, facing east.

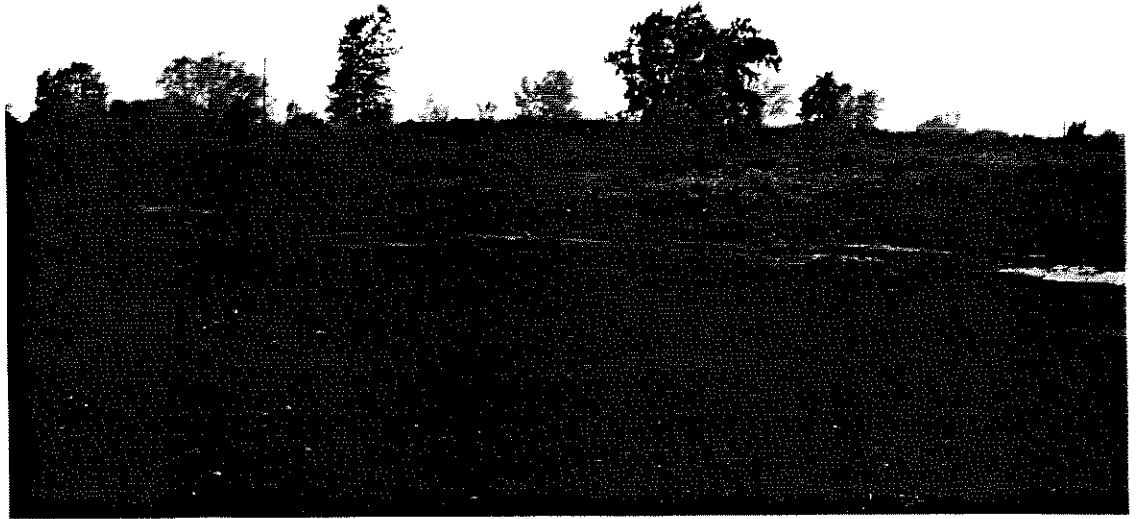
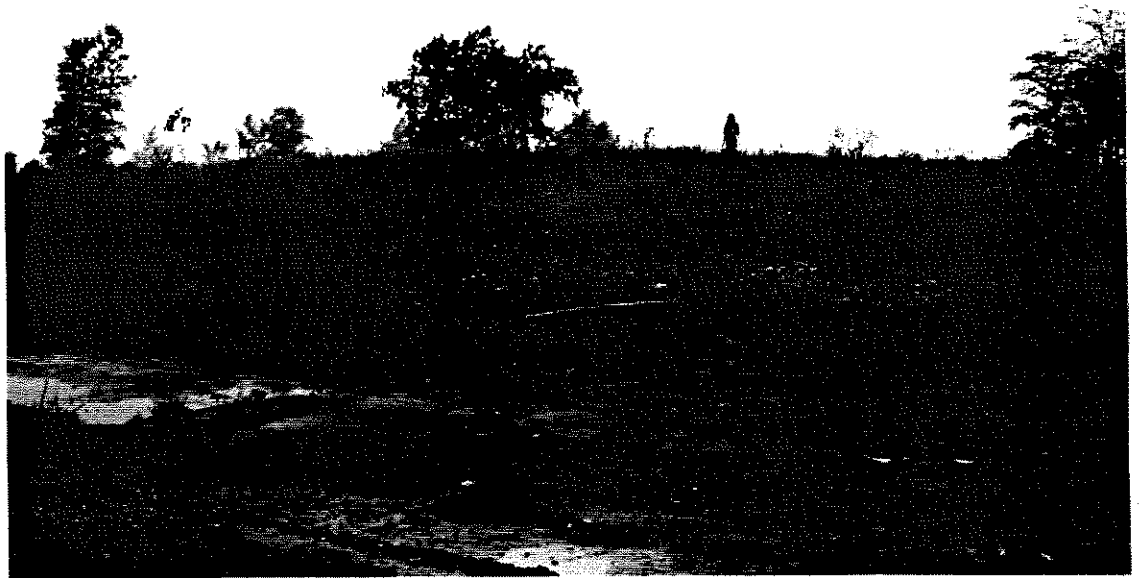
No evidence of a release was observed.

Photo 147: SEAD-59, 9/11/90. View of the Fill Area - West of Building 135, facing northwest.

Photo 148: SEAD-59, 9/11/90. View of the Fill Area - West of Building 135, facing northwest.

Photo 149: SEAD-59, 9/11/90. View of the Fill Area - West of Building 135, facing northeast.

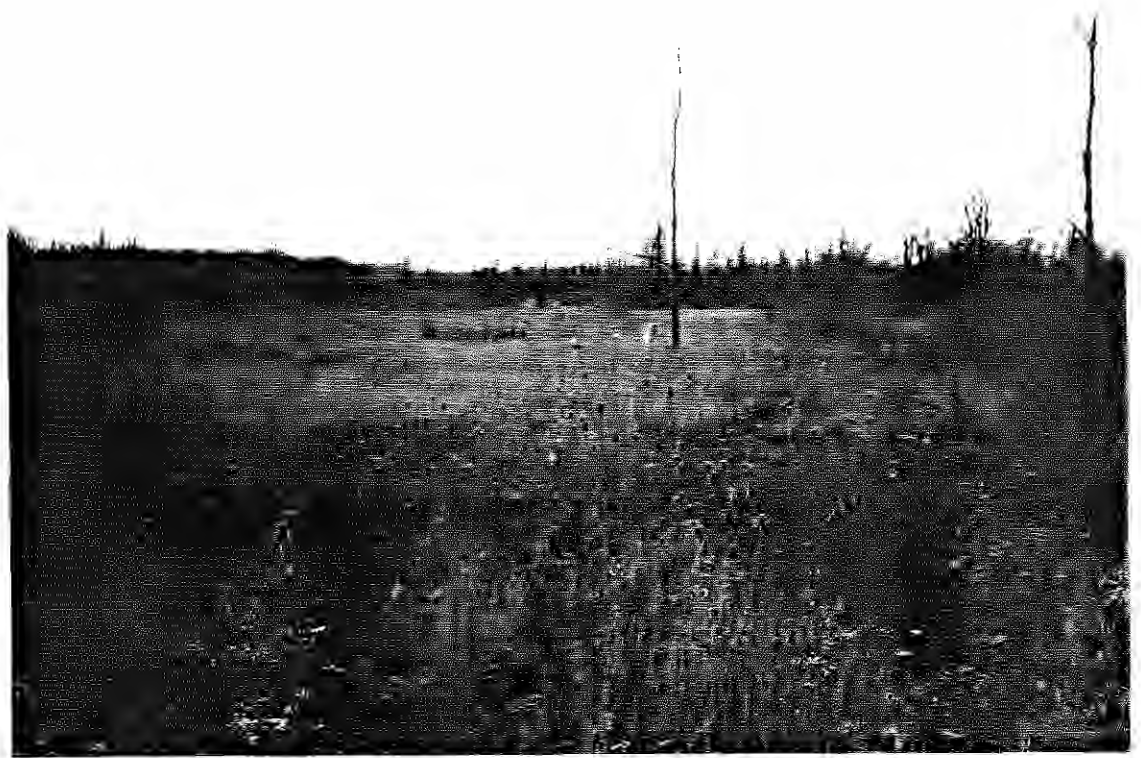
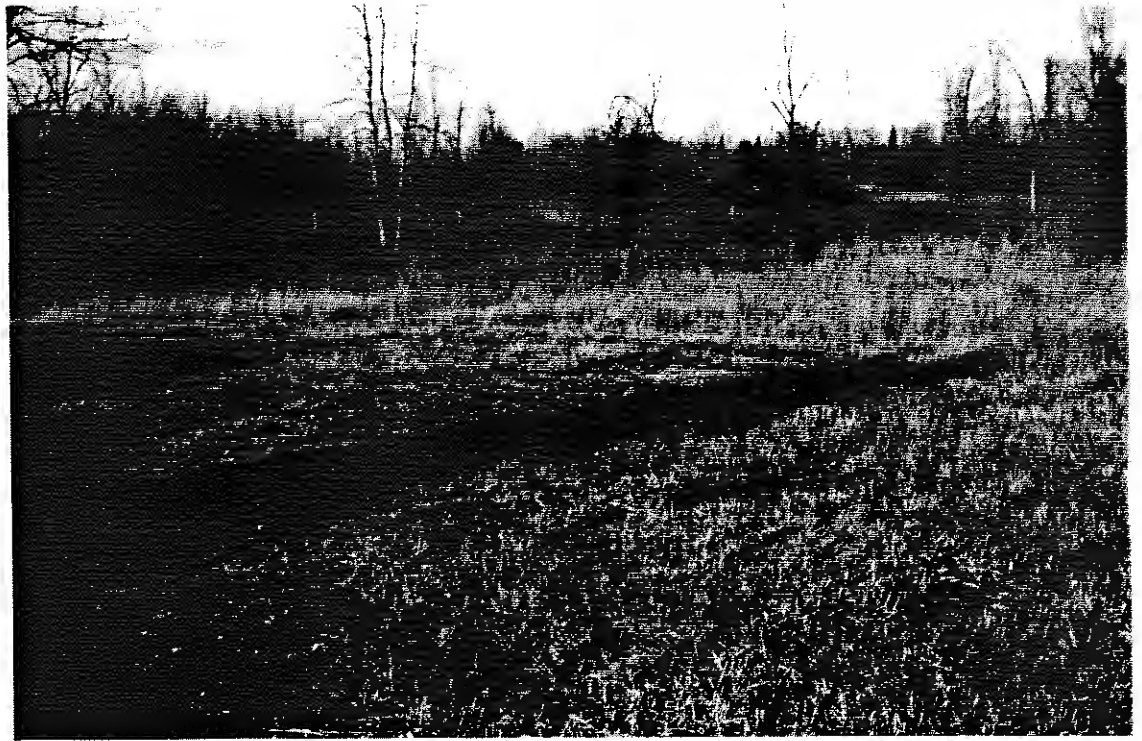
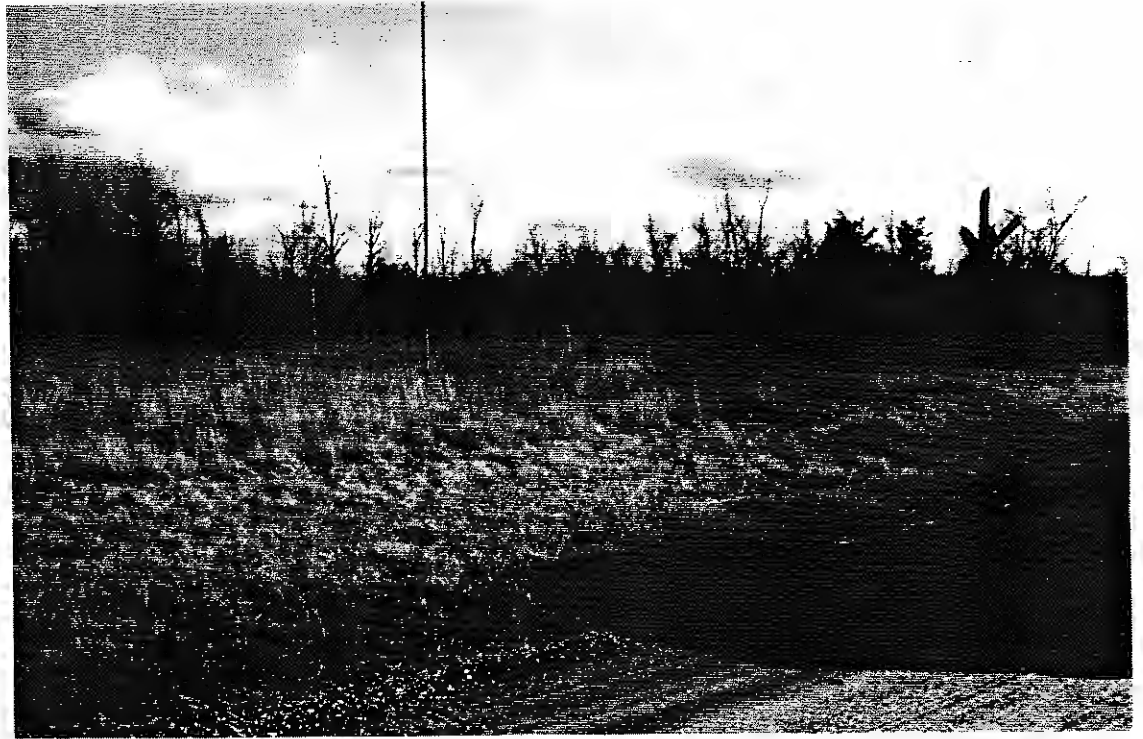
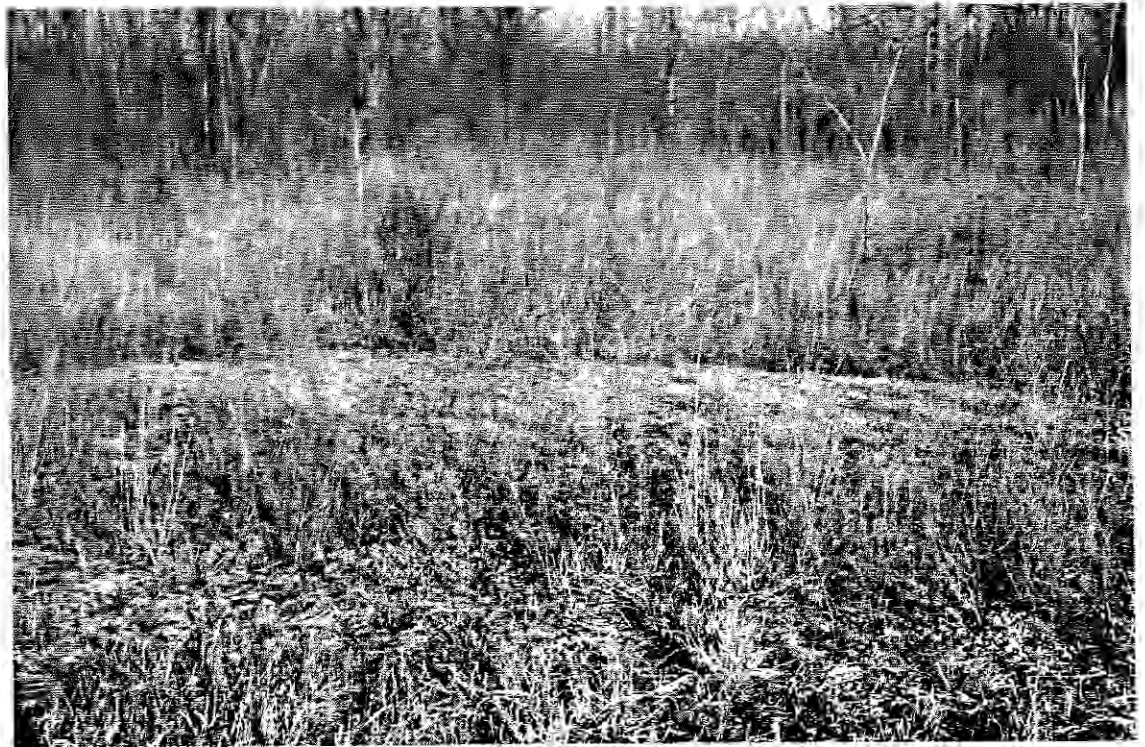
The area located south of the truck entrance gate was visually inspected on November 27, 1990. Three possible locations where structures may have existed were observed. Portions of a concrete foundation were observed at Locations A and B. A concrete pad and flagpole were observed at Location C. Photographs of these areas are shown on the pages following this text.

No evidence of a release was observed. However, in a December 29, 1992 letter to SEDA EPA recommended measuring the pH of surface soils in the vicinity of the three acid storage areas.

Photo 166: SEAD-65, 11/29/90. View of Location A of Acid Storage Area, facing west.

Photo 168: SEAD-65, 11/29/90. View of Location B of Acid Storage Area, facing northeast.

Photo 170: SEAD-65, 11/29/90. View of Location C of Acid Storage Area, facing southeast.

Photo 171: SEAD-65, 11/29/90. Close-up of Location C of Acid Storage Area, facing east.

No additional sampling is recommended.

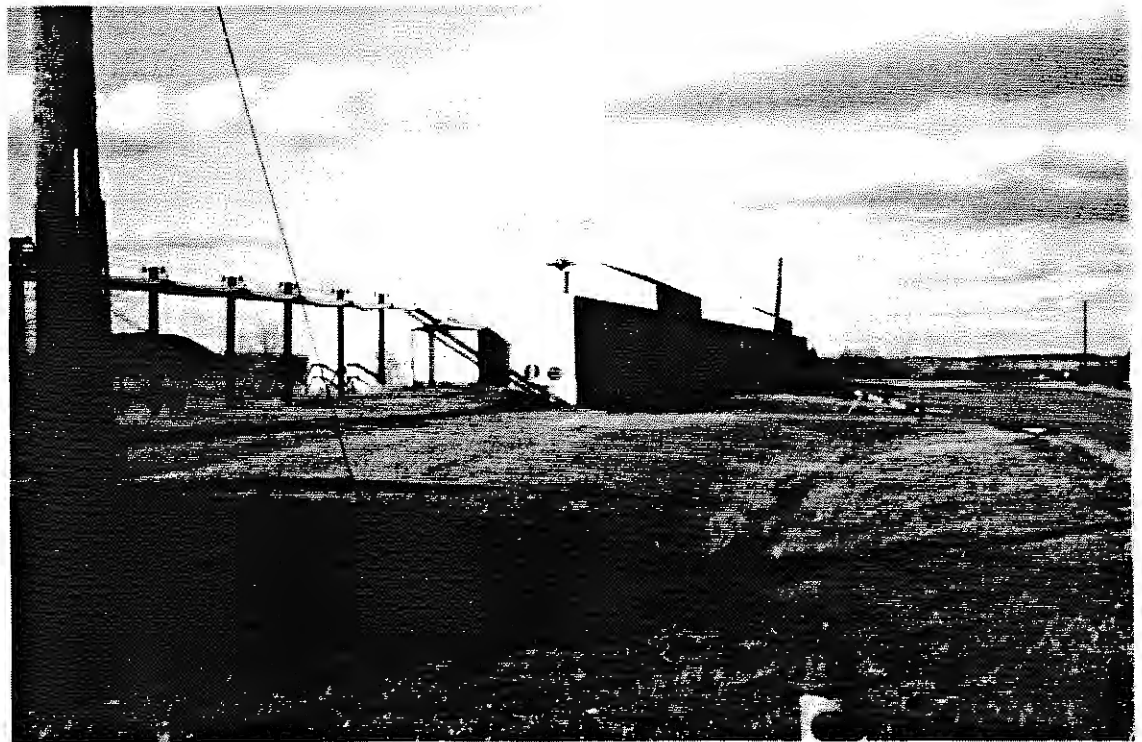
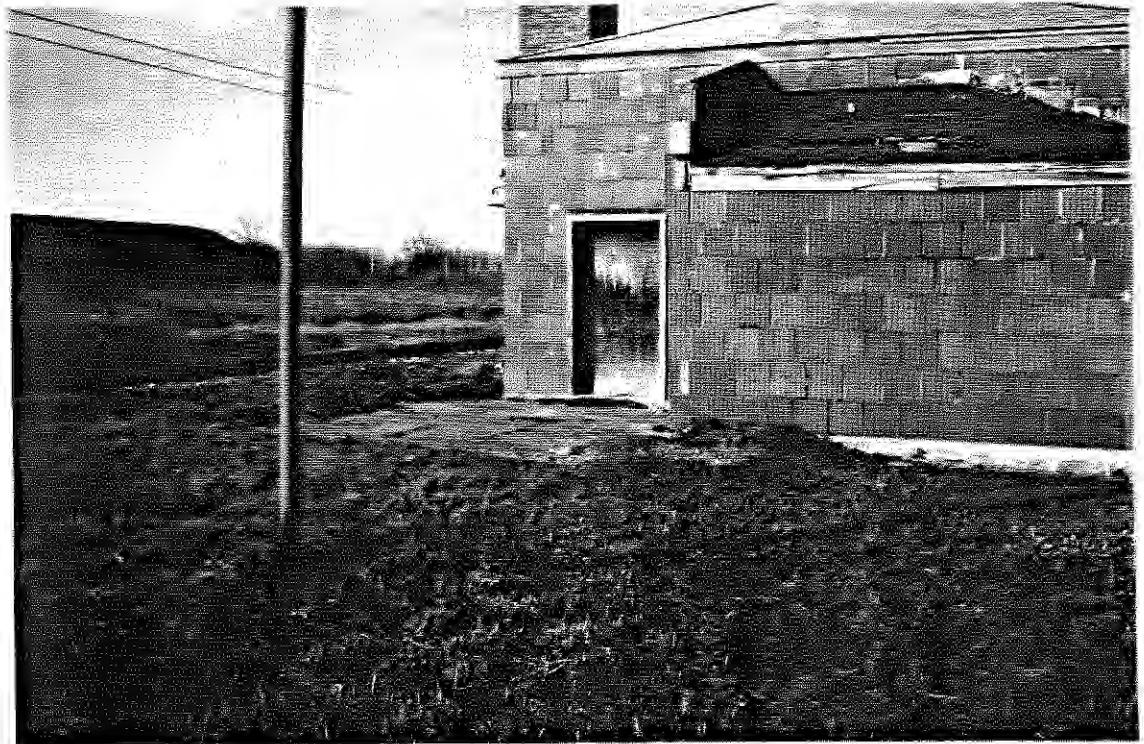
The exact location of the pesticide storage building is unknown. A small metal shed was observed adjacent to Building 5. This shed possibly could have been used for storage of pesticides. A concrete pad was observed adjacent to Building 6. This area may have also been used for the storage of pesticides. Photographs of these areas are shown on the pages following the text.

Photo 172: SEAD-66, 11/29/90. View of possible Pesticide Storage Area near Buildings 5 and 6 (Building 5 is the white block structure located in back of Building 6), facing north.

Photo 173: SEAD-66, 11/29/90. View of possible Pesticide Storage Area near Building 5, facing north.

Photo 174: SEAD-66, 11/29/90. Close-up of possible Pesticide Storage Area near Building 5, facing north.

Photo 175: SEAD-66, 11/29/90. Close-up of possible Pesticide Storage Area near Building 6, facing northwest.

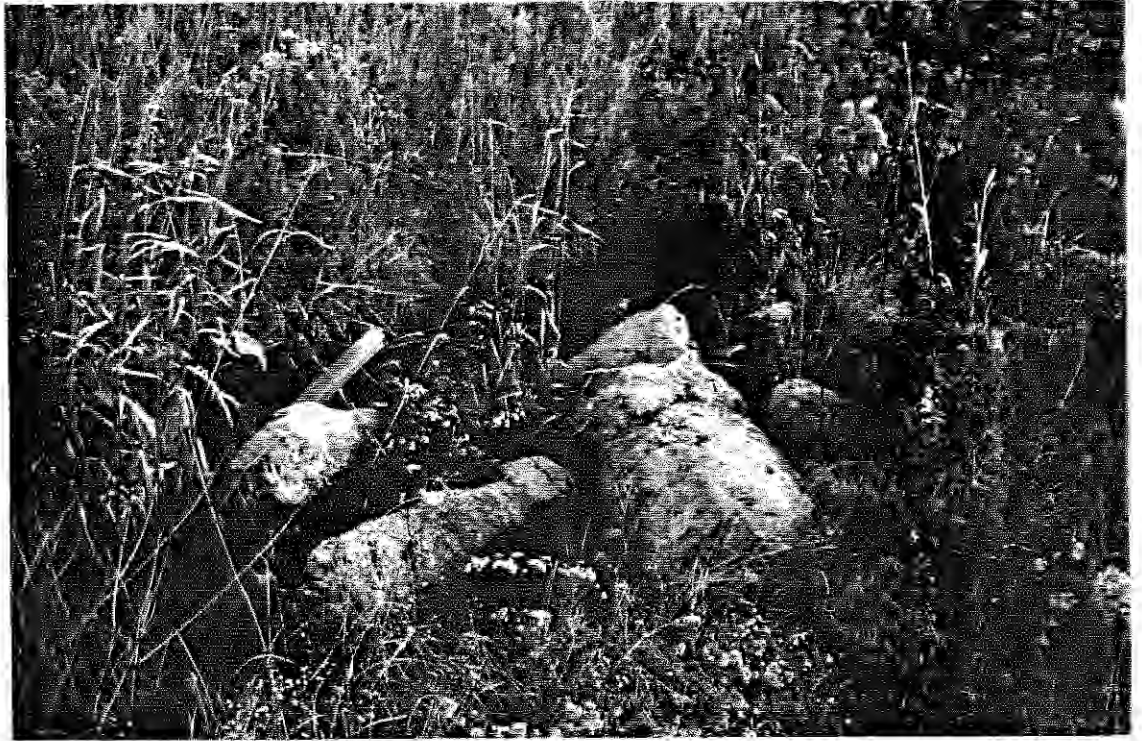
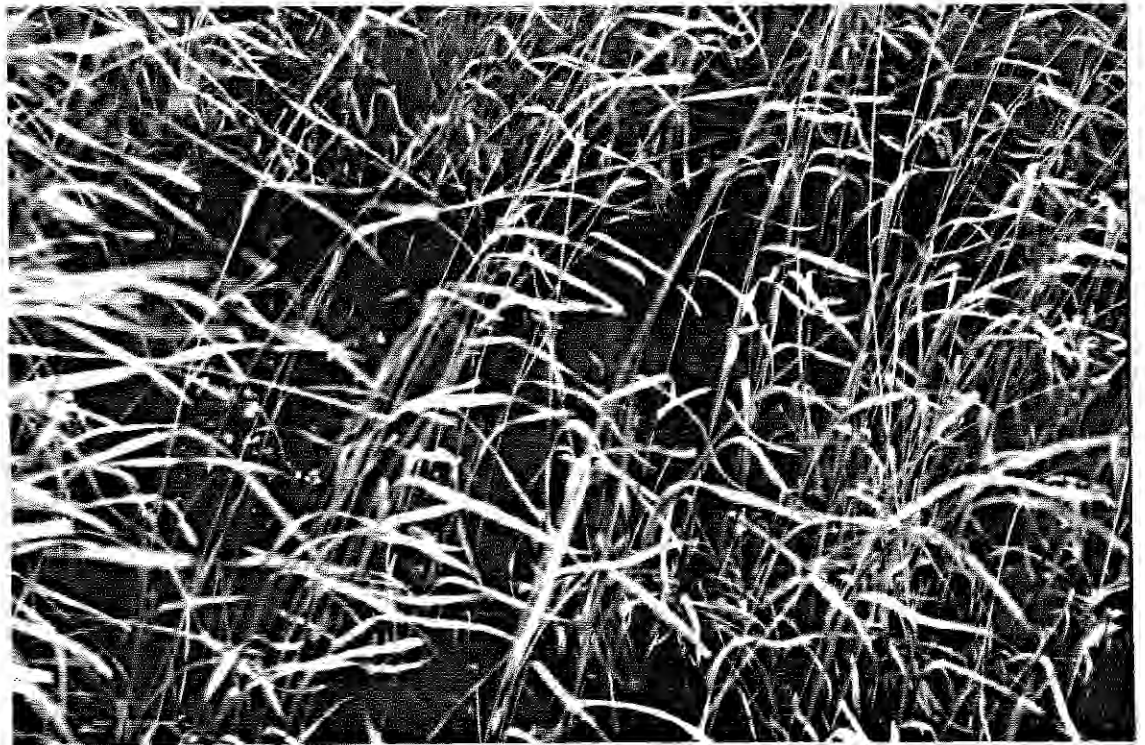
A pile covered with vegetation was observed in the area. Also, a depressed area which contained wire fence and concrete posts was observed to the north of the pile area. Photographs of the area are shown on the pages following this text.

Photo 182: SEAD-69, 11/28/90. View of Disposal Area - Building 606, facing north.

Photo 183: SEAD-69, 11/28/90. View of Disposal Area - Building 606, facing east.

Photo 184: SEAD-69, 11/29/90. Close-up of Disposal Area - Building 606, facing east.

Photo 185: SEAD-69, 11/29/90. Close-up of Disposal Area - Building 606, facing east.
